# **DRAFT Mitigated Negative Declaration**

## **Eucalyptus Pruning**

## Carmel Area Wastewater District Wastewater Treatment Plant

January 2020

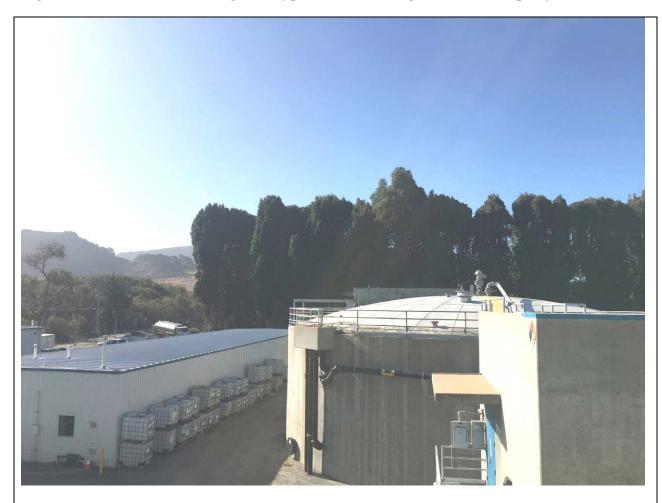
Photo 1: Taken from on top of an existing building inside the WWTP looking Southeasterly at southern property line.

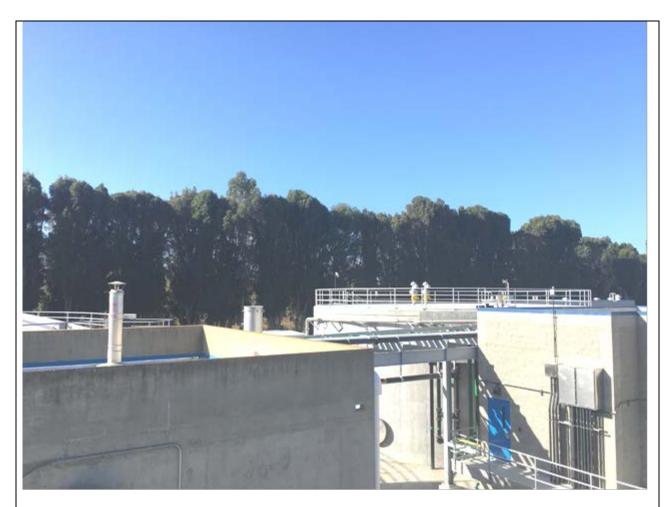
Photo 2: Taken from on top of an existing building inside the WWTP looking Southwesterly at southern property line.

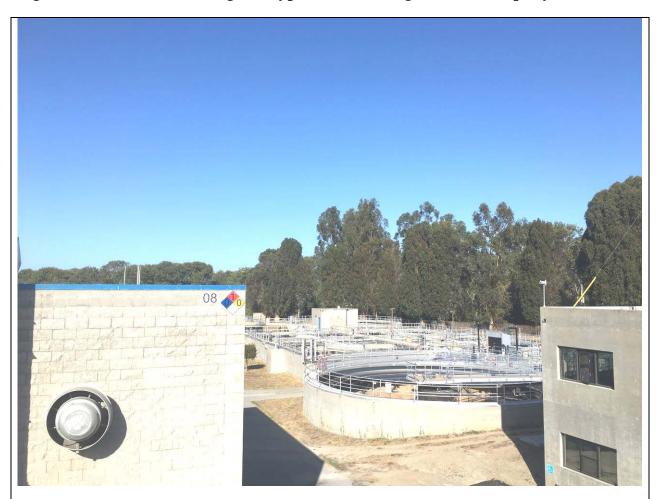
Photo 7: Taken from on top of an existing building inside the WWTP looking Northwesterly at Northern property line.

About 25 eucalyptus trees exist along the northern property line. There is also a significant contingent of cottonwood trees on the Northern property line which provide part of the visual screen. The eucalyptus trees on the North side of the WWTP are less dominant than on the South side of the WWTP. Most of them are located on the Northwest side of the plant. The Northeast side of the plant does not have any eucalyptus trees.

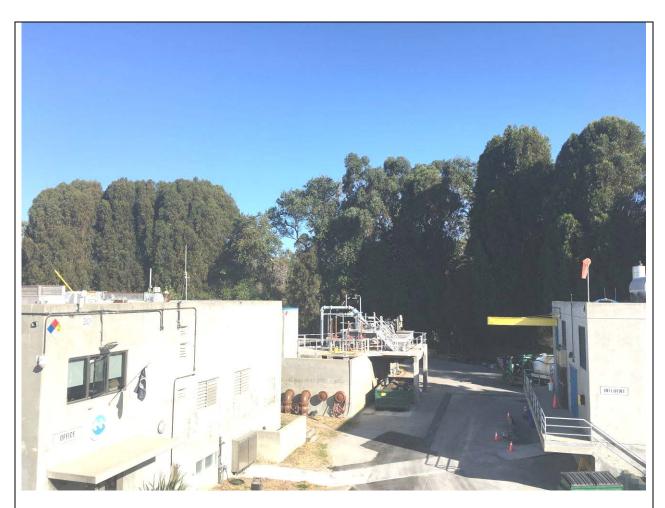
Photo 8: Taken from on top of an existing building inside the WWTP looking North at Northern property line. Note gap in eucalyptus filled in with cottonwood trees.

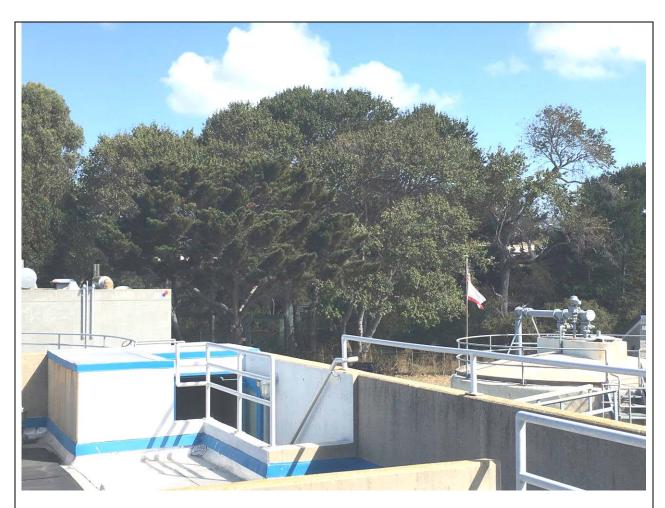
Photo 9: Taken from on top of an existing building inside the WWTP looking Northeasterly at Northern property line (No Eucalyptus). Note that buildings can be seen in the distance through gaps in the existing cottonwood trees.

Based on a line of site analysis, there would be no significant change to the visual aesthetic of the WWTP associated with trimming the eucalyptus trees to no shorter than 42 feet tall along the Southern property line and 52 feet tall along the Northern property line. Ground survey data at the WWTP and the surrounding neighborhoods was used to develop site line scenarios (See Figure 7 and 8). These figures illustrate the continued visual screening provided by shorter eucalyptus trees. The existing cottonwoods on the North and Northeast property line will not be modified and there are currently gaps in those trees that allow "peekaboo" views of the treatment plant from offsite (as seen in Photo 9, 12, and 14).

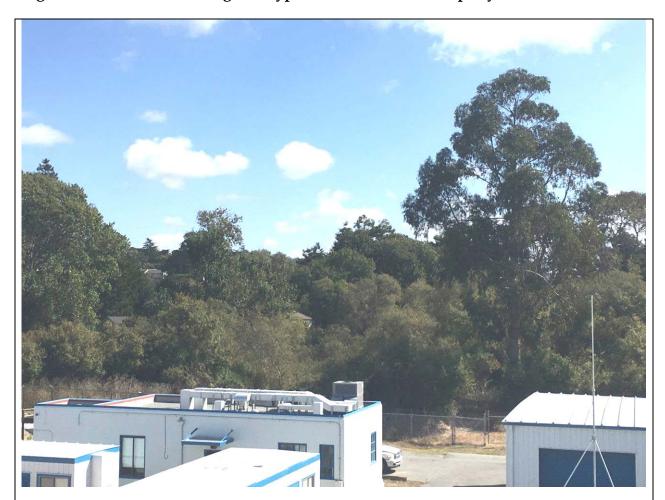
Figure 6: Photo of Existing Eucalyptus Tree at Eastern Property Line

There is one eucalyptus tree just East of the WWTP that would be removed as part of the project as it does not provide any visual screening. There is no development East of the WWTP that is at a high enough elevation to see the WWTP.

Photo 14: Taken from on top of an existing building inside the WWTP looking northeast at eastern property line. One eucalyptus tree is seen on East property line would be removed. Note that buildings can be seen in the distance through gaps in the existing trees.

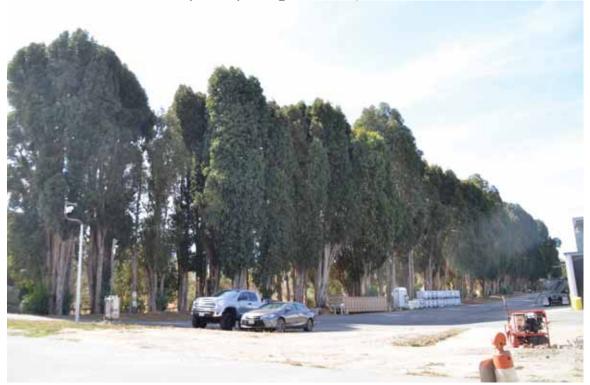
- The majority of the trees are mature and range in height from 75 to 90 feet with diameters of 12 to over 40 inches.
- The majority of the trees have been pruned in the past utilizing heading cuts to reduce the trees height.
- The majority of the trees have included bark at their branch attachments and stem junctions.
- A suppressed tree adjacent to the entrance gate has a dead stem that will need to be removed.
- Two trees were observed with large fugal conks growing from their stems, the trees and their locations are as follows:
  - A multi-stemmed tree across from the solid waste conveyor belt.
  - The westmost tree in the north row of trees adjacent to several storage containers.
- Most trees have a high amount of water sprout "sucker" growth at the base. These sprouts may be removed to avoid future tree growth or retained for lower visual screening.

South row of trees viewing west.

Pruning of the tree will entail crown reduction to one third the tree height and entail deadwood removal down to 1-1/2" in diameter, crossing limbs where practical, clearances for access points and fences where needed, weight reduction on long heavy limbs and selective removal of interior growth. This does not completely remove all interior growth. Re-growth of the limbs of pruned eucalyptus trees will be very high in the first years, however, growth will be mainly vertical, and the new branches should not put on the significant diameter growth necessary for damage until three to five years from old pruning. Inspections of other limbs over the wastewater compound should be made during the pruning. Periodic monitoring and pruning should also occur every three to four years depending on the concerns of the district underneath the trees. All tall trees (both Eucalyptus globulus and Eucalyptus globulus compacta) should also be crown cleaned to allow better movement of wind through the canopy and help decrease breakage during storms. During this pruning event all broken, torn, cracked or weakly attached branches discovered should be removed for safety.

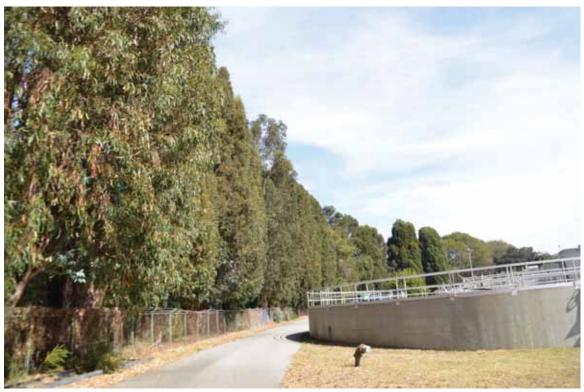
North row of trees viewing east.

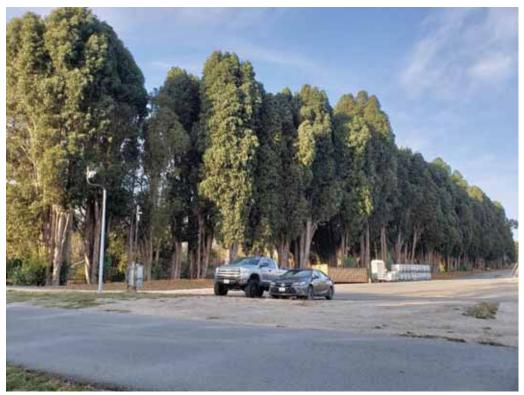
Photo 2. Eucalyptus trees along the southern boundary.

Approximately 90 eucalyptus (*Eucalyptus* sp.) trees line the northern and southern boundary of the Plant creating a visual screen from surrounding neighborhoods. Approximately 64 eucalyptus trees line the southern boundary and approximately 26 eucalyptus trees line the northern boundary (see Photos 1, 2 and 3). One eucalyptus tree is present on the eastern boundary. Most of the trees are densely foliated with some sparse canopy mixed in (see Photo 4). The trees are approximately 80 feet tall. The Plant plans to trim the top 20-30 feet of each tree to reduce the potential for falling limbs during high winds and maintain the visual screen.

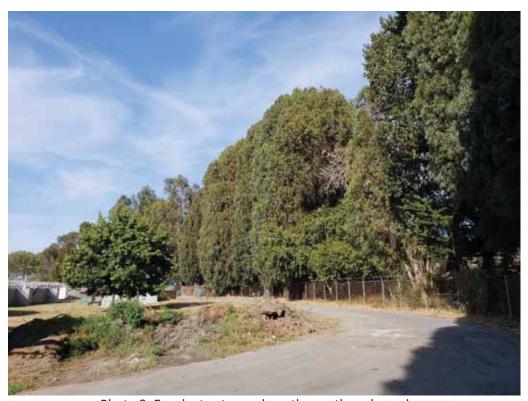
Photo 3. Eucalyptus trees along the northern boundary

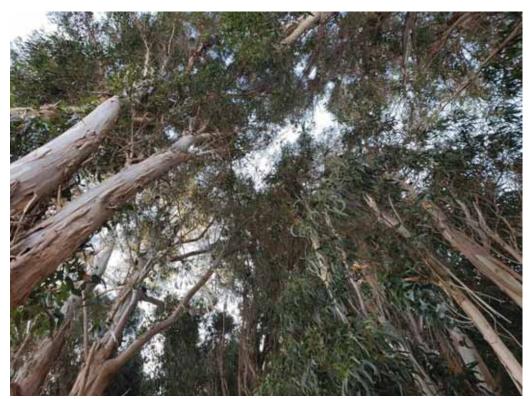
There was a moderate level of avian activity during the survey and common resident/wintering species expected to occur in riparian and mixed native woodland areas were observed. One stick nest structure was observed within a sparse eucalyptus tree along the southern boundary. The biologist determined that this stick nest was an inactive passerine (songbird) nest and well below the planned trimming footprint. No other nests were observed during the survey. Additionally, no sign of nesting or residing owls were observed in any of the eucalyptus trees (i.e. no white-wash or pellets were found). No cavities or crevices were observed in the eucalyptus trees during the survey, and no roosting bats or roosting bat sign were observed in the canopy of any of the eucalyptus trees.

Photo 4. Representative canopy density of eucalyptus trees.

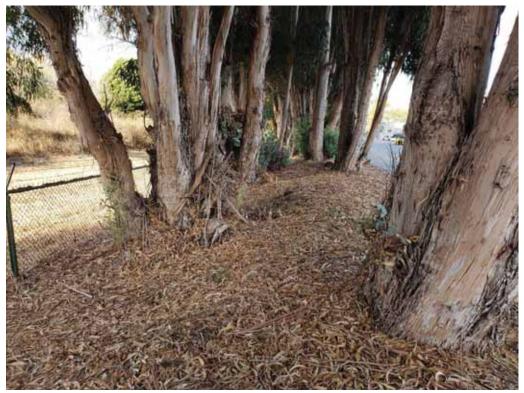
Photo 5. Representative understory of eucalyptus trees.

Little to no understory persists under the eucalyptus trees that line the Plant boundary due to the negative allelopathic properties (compounds which inhibit other plant species from growing nearby) of their leaves (see Photo 5). The surrounding habitat beyond the Plant is associated with the Carmel River and mixed riparian native woodland and floodplain dominated by cottonwood (*Populus* sp.) and willow (*Salix* sp.). The Plant interior is developed, and very little vegetation is present.
