# LOMA ALTA SLOUGH WETLANDS ENHANCEMENT PROJECT

Biological Technical Report

Prepared for  
City of Oceanside

May 2020

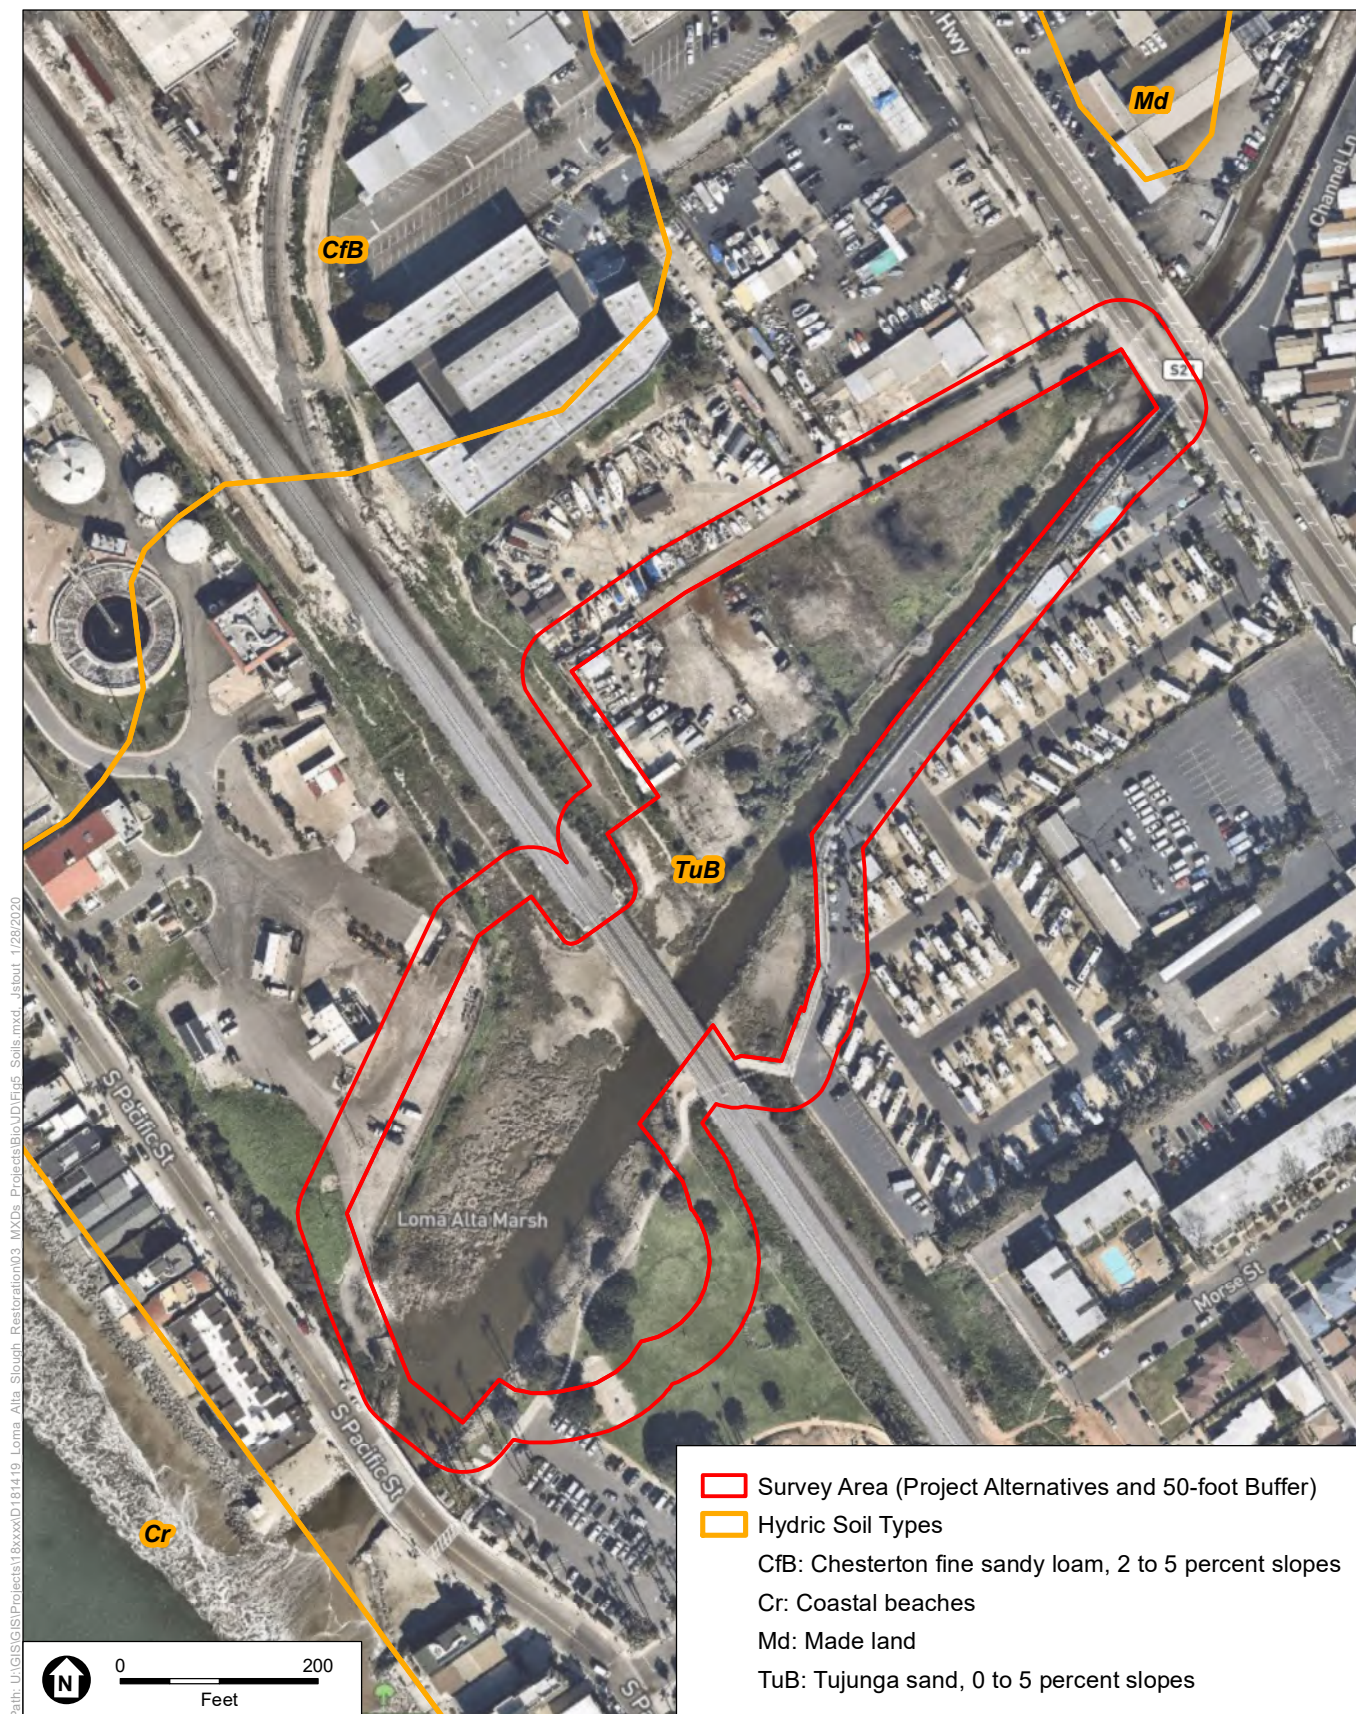
**Figure 5**  
Soils

Soils within the survey area are mapped entirely as Tujunga sand, 0 to 5 percent slopes (USDA 2020), as shown in **Figure 5**. This soil map unit typically occurs on floodplains, is somewhat excessively drained, and is not rated as a hydric soil. The typical depth to water table is more than 80 inches; however, this was not representative of the observed water table depth along Loma Alta Creek.

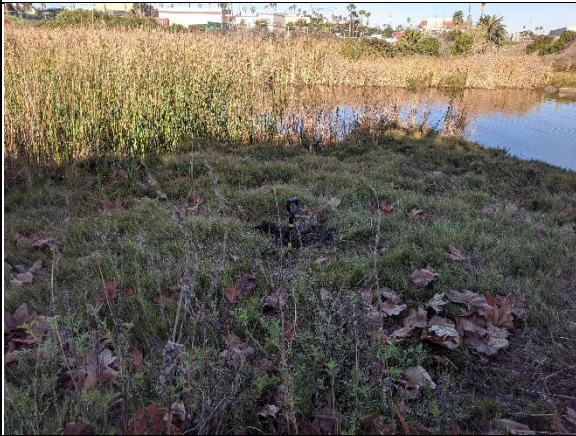
Photo point 2 at sample point 7a (wetland) facing northwest

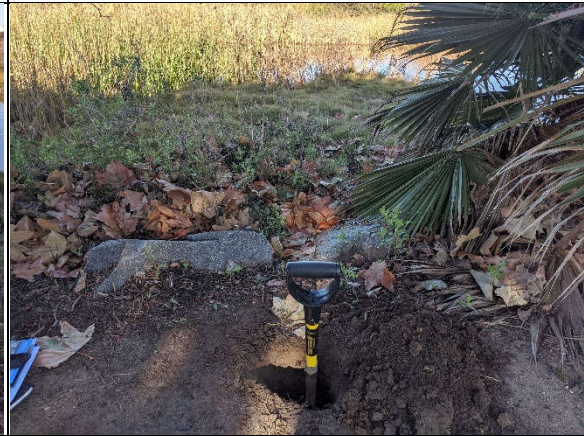
Photo point 3 at sample point 7b (upland) facing northwest
