# **Waters and Wetlands Delineation Report**

## **Dove Creek Self-Storage Development Project**

### **Atascadero, San Luis Obispo County, California**

**March 2019**

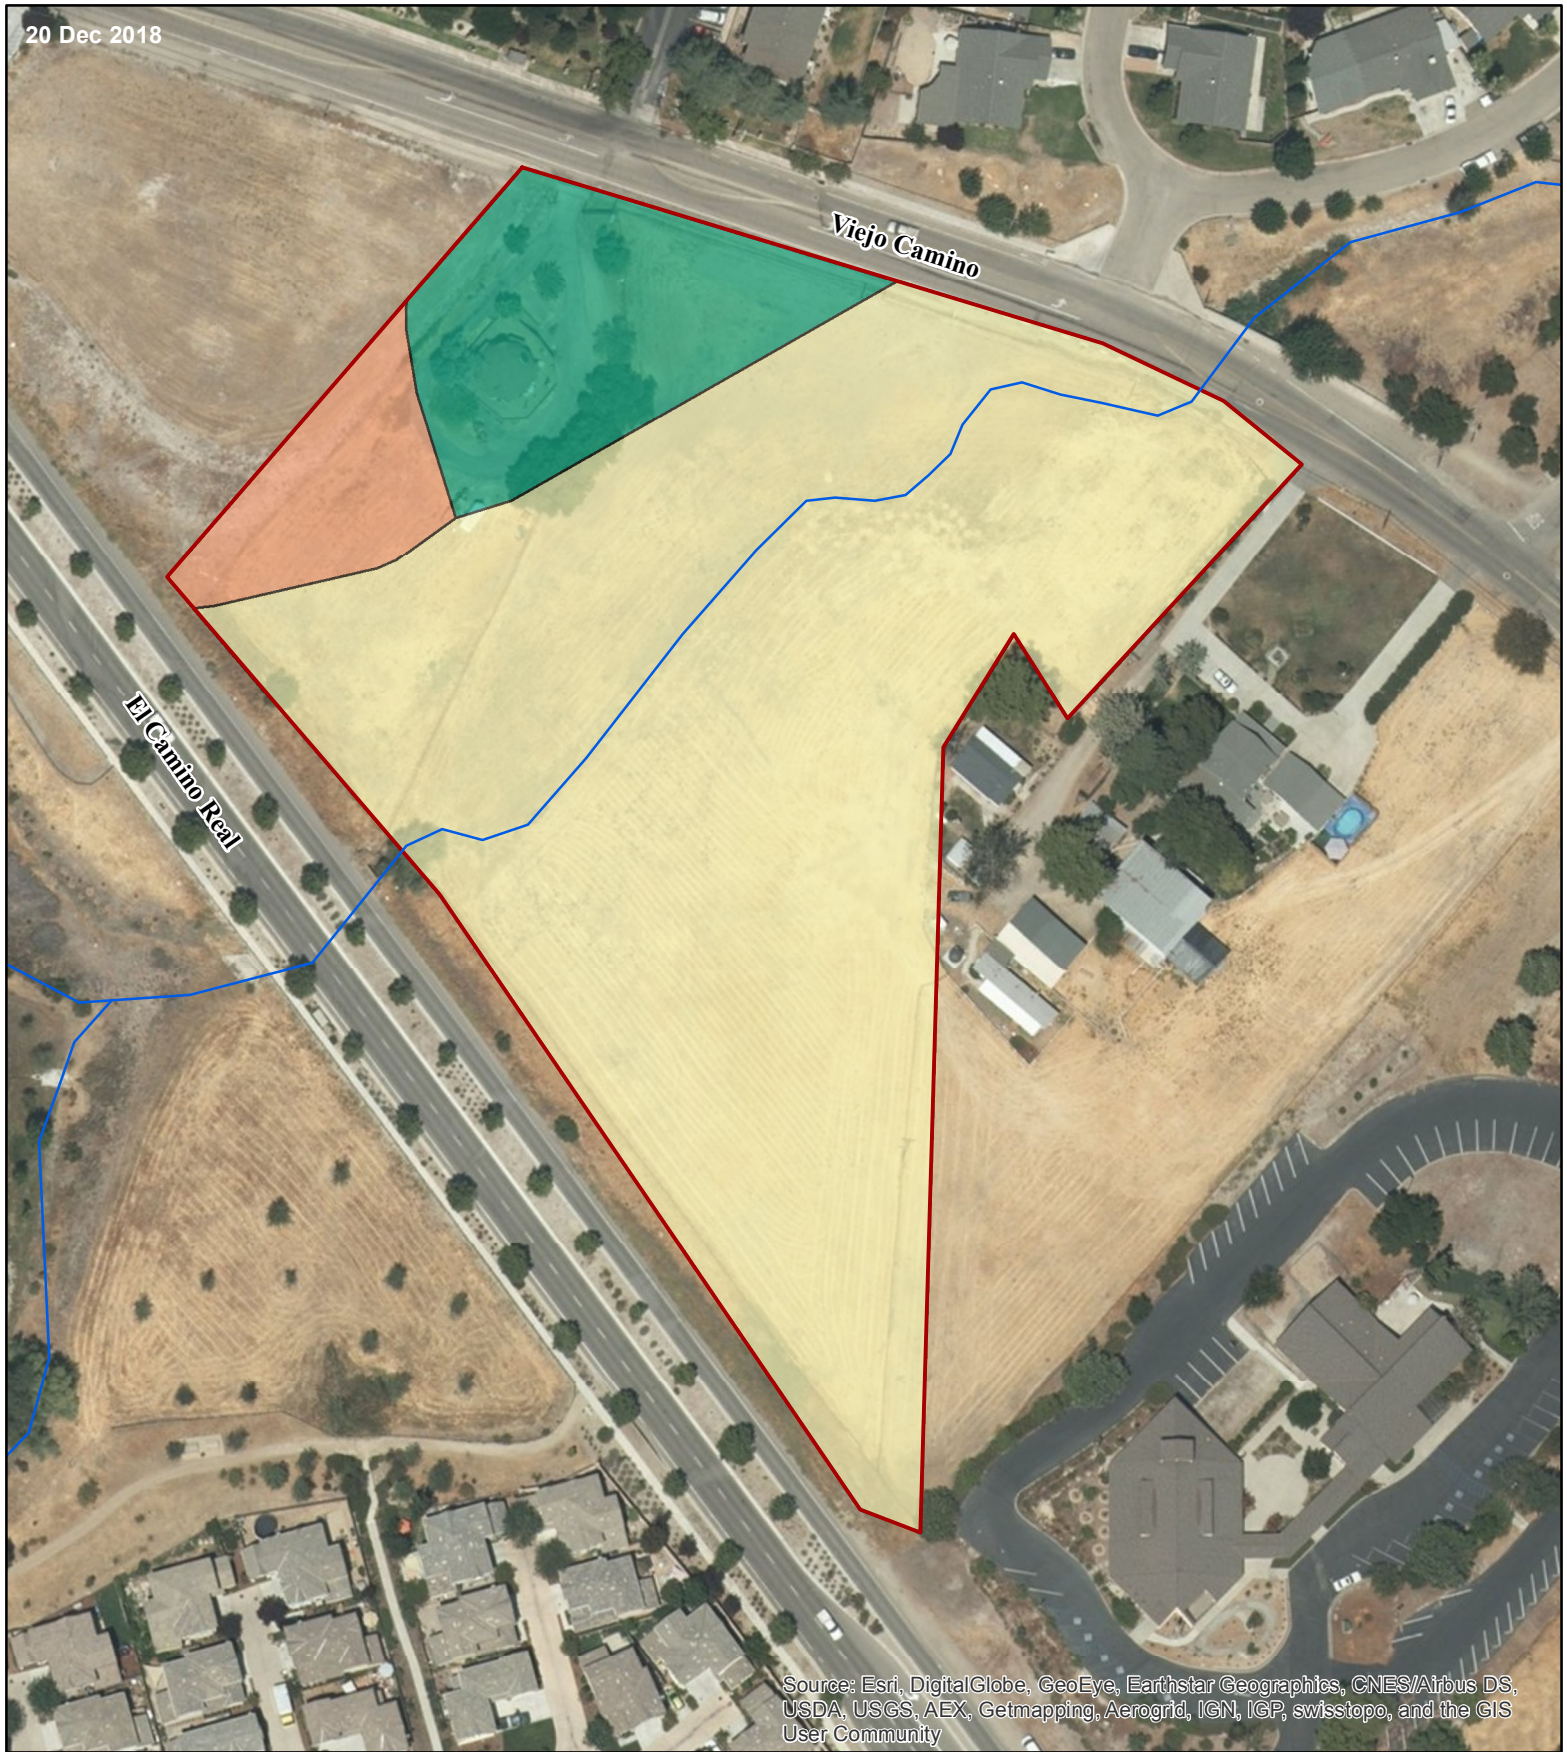
**Dove Creek Self-storage Project - Waters and Wetlands Delineation**  
**Figure 4: Soil Units Map**

According to the NRCS online soil survey of San Luis Obispo County, three soil units occur within the survey area (U.S. Dept. of Ag., 2018). These include: Unit 193 (San Andreas-Arujo complex, 9 to 15 percent slopes), Unit 198 (Santa Lucia-Lopez complex, 15 to 50 percent slopes), and Unit 208 (Still clay loam, 0 to 2 percent slopes) (see Figure 4 – Soil Units Map). These soil units are not listed as hydric soils (U.S. Dept. of Ag., 2018). A summary of the dominant characteristics of these soil types is provided below.

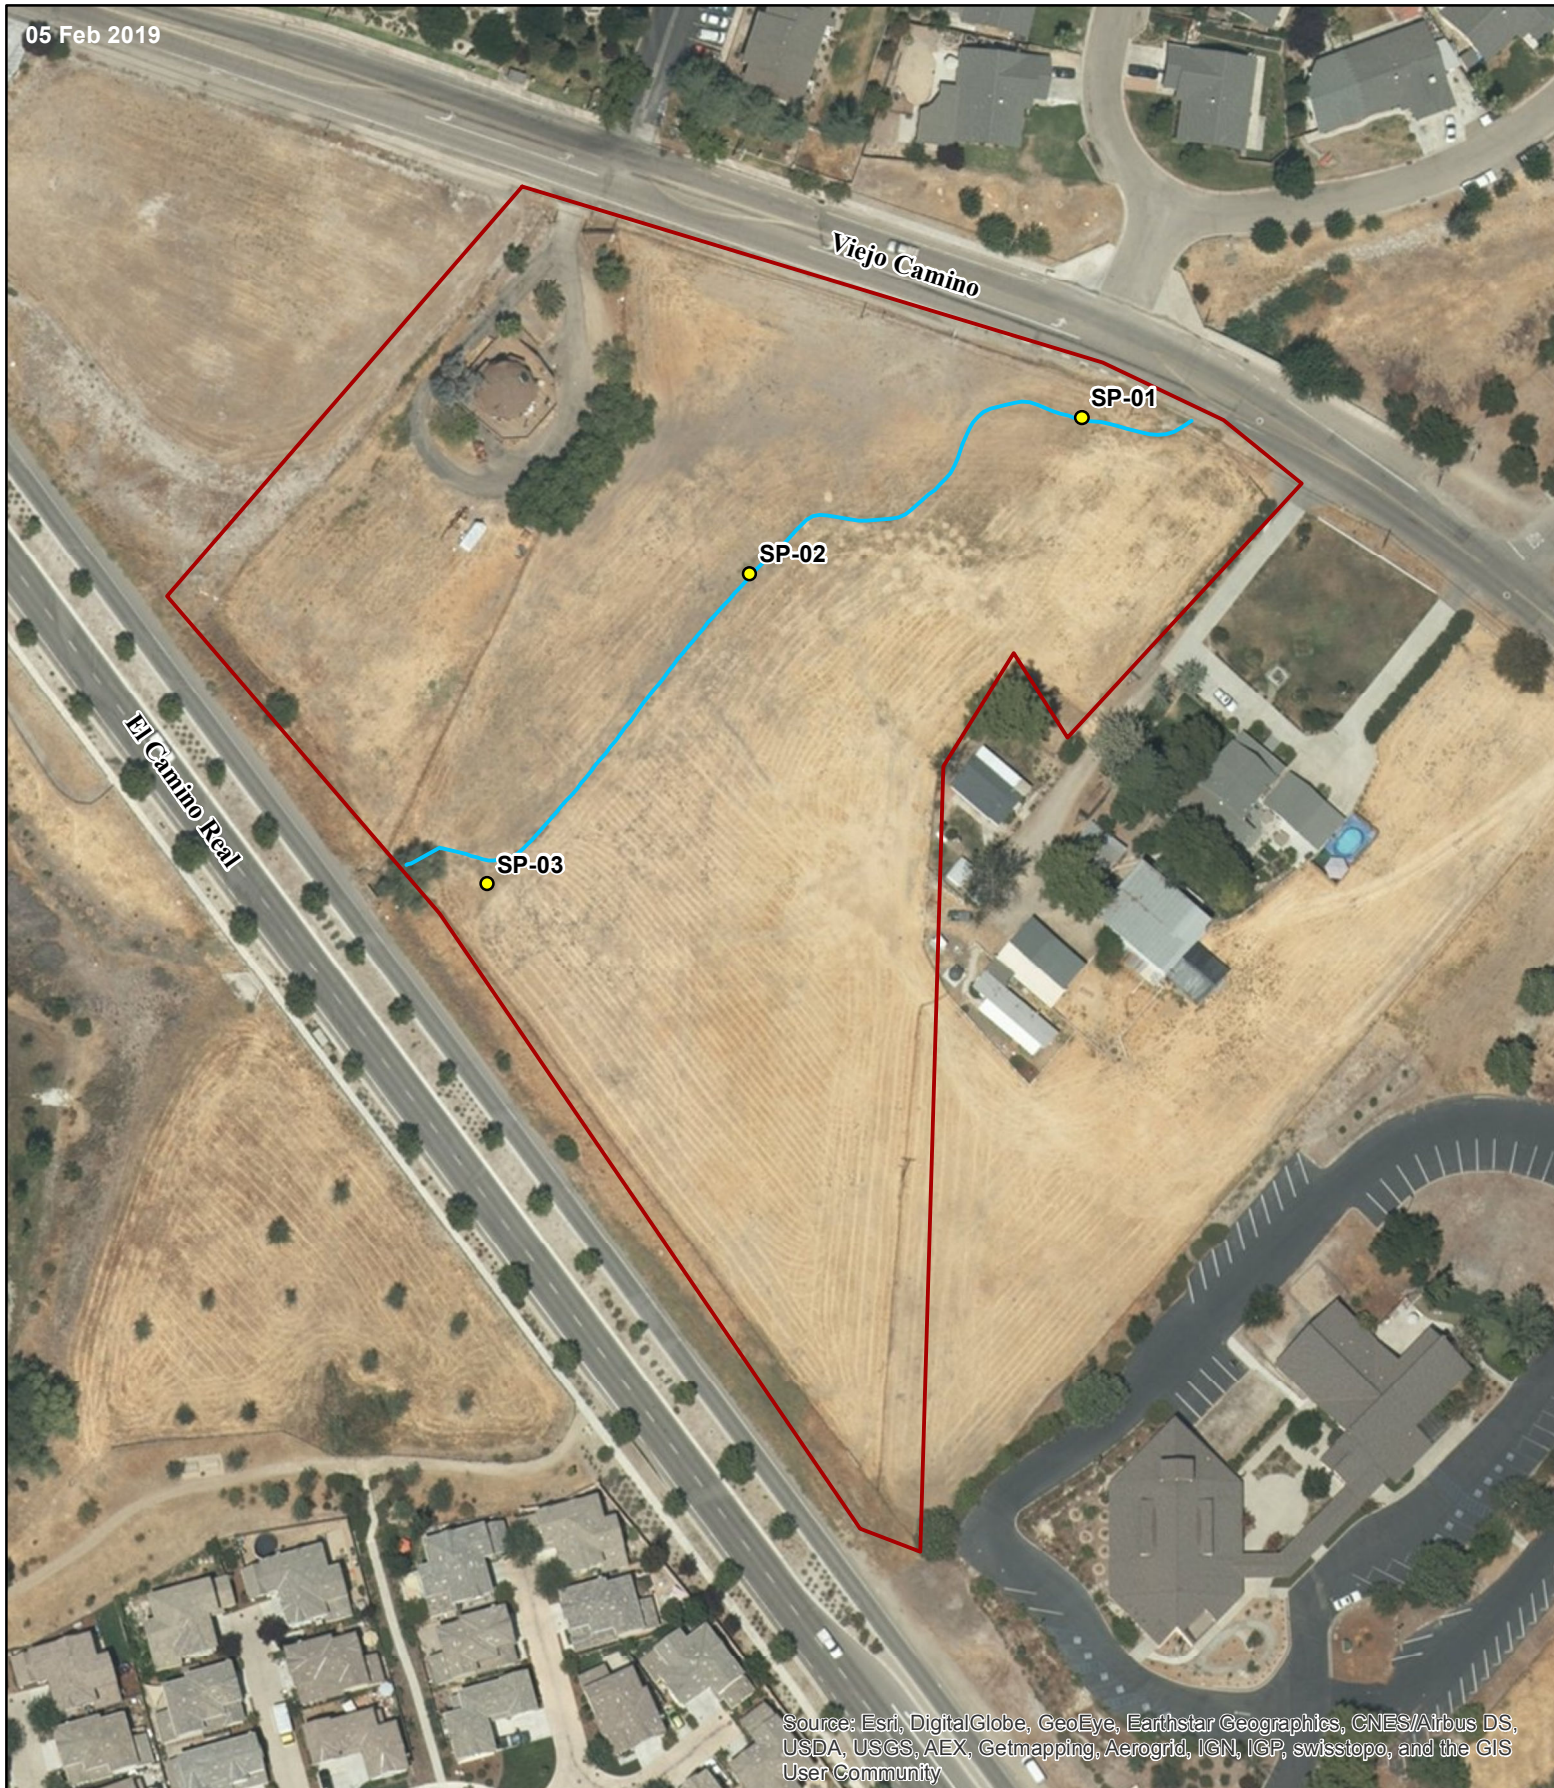
**Dove Creek Self-storage Project - Waters and Wetlands Delineation**  
**Figure 5: Waters and Wetlands Delineation Map**

Field observations of wetland hydrology were limited to secondary indicators, including: riverine drift deposits (B3), drainage patterns (B10), and saturation visible on aerial imagery (C9). In addition, the FAC-Neutral Test (D5) was documented as a secondary indicator at SP-02. Wetland hydrology was determined to be present at all three sampling points (see Figure 5: Waters and Wetlands Delineation Map).

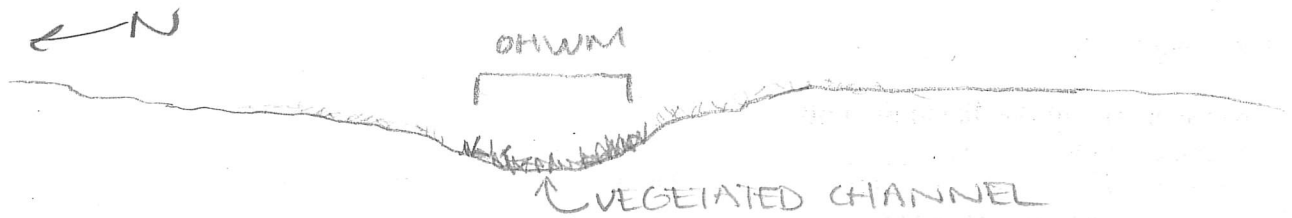
Project ID: DCSSCross section ID: 02Date: 05/17/18 Time: 1600Cross section drawing:

LOW FLOW CHANNEL DEFINED BY CHANGE IN ELEVATION /  
BENCHING & CHANGE IN VEGETATION SPECIES & COVER

OHWMGPS point: DCSS-02  
35.453727 / -120.637320

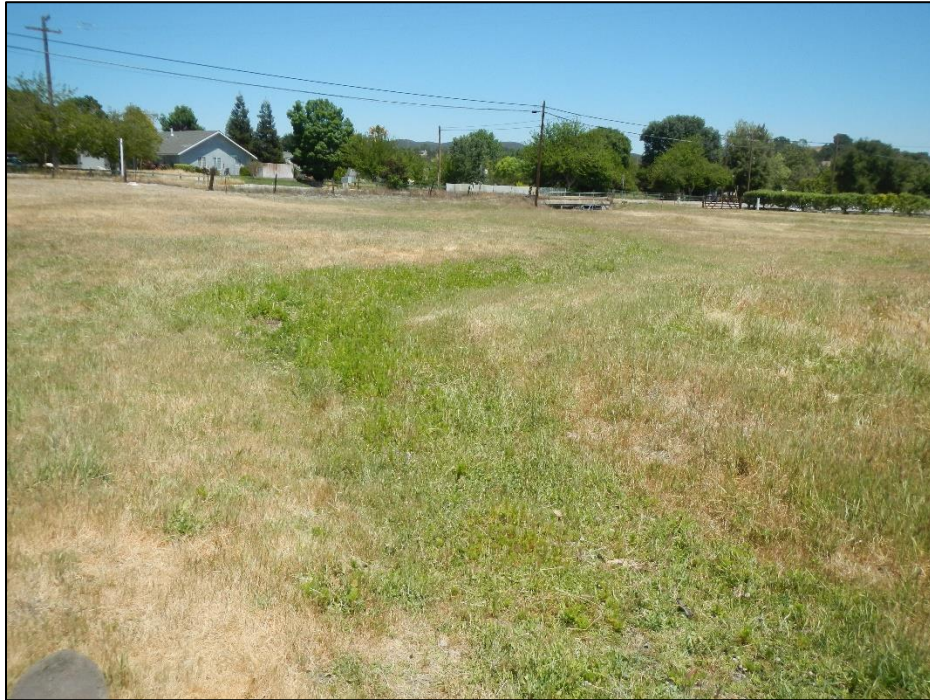
Soil test pits were excavated at each sampling point to classify the color and texture of the soil horizons down to at least 12 inches. Soil textures consisted of clay loam with a significant component of organic matter at all three sampling points. No hydric soils were identified on site. A soil color of 10YR 2/1 was documented at all three sampling points, with no redox features present (see Appendix D – Representative Site Photographs, Photo 1).

**Photo 1.** View southwest of ephemeral drainage bisecting the proposed development area.

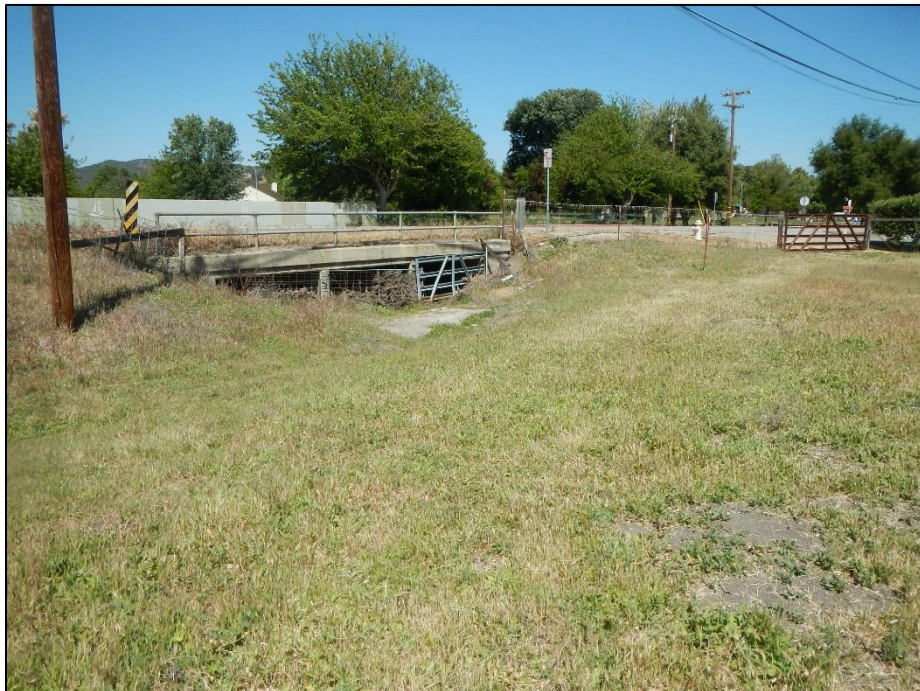
**Photo 2.** View northeast of the existing culvert under Viejo Camino.

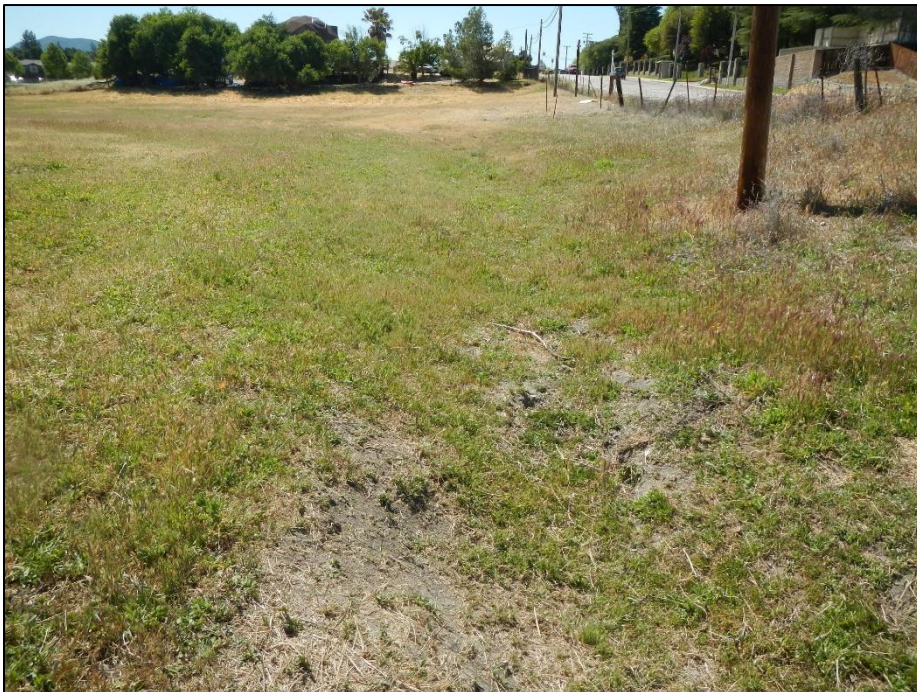
**Photo 4.** View north of the ephemeral drainage with evidence of scour, just upstream of the culvert under Viejo Camino.

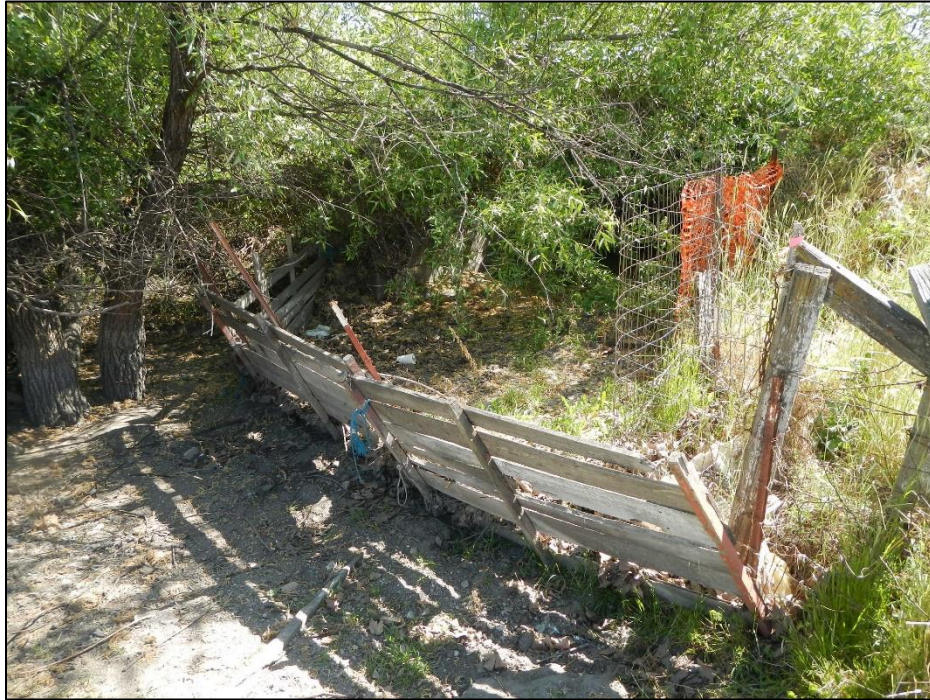
**Photo 5.** View west of the existing culvert under El Camino Real.

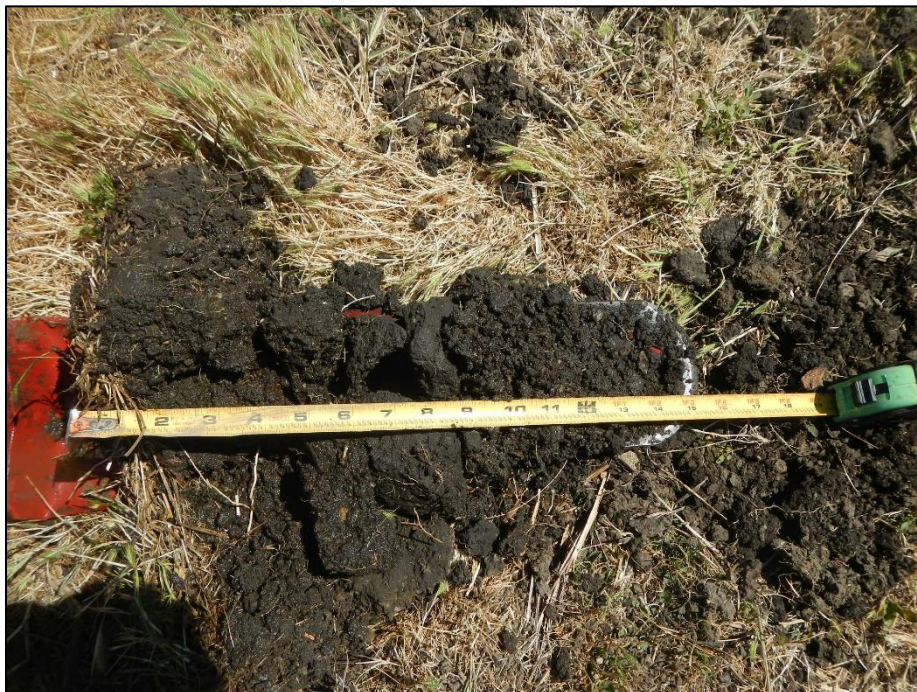
**Photo 6.** Soil plug excavated at SP-02 during the wetland delineation.
