Subject: Results of a Biological Reconnaissance Survey of LACFCD Soft-Bottom Channel Reaches 120 and 121 in the City of Santa Clarita, Los Angeles County, California

Los Angeles County Flood Control District – Soft-Bottom Channel Maintenance Program

Reach 120 – Jake's Way (PD 2496)

Reach 121 – San Francisquito Creek (PD 2271)

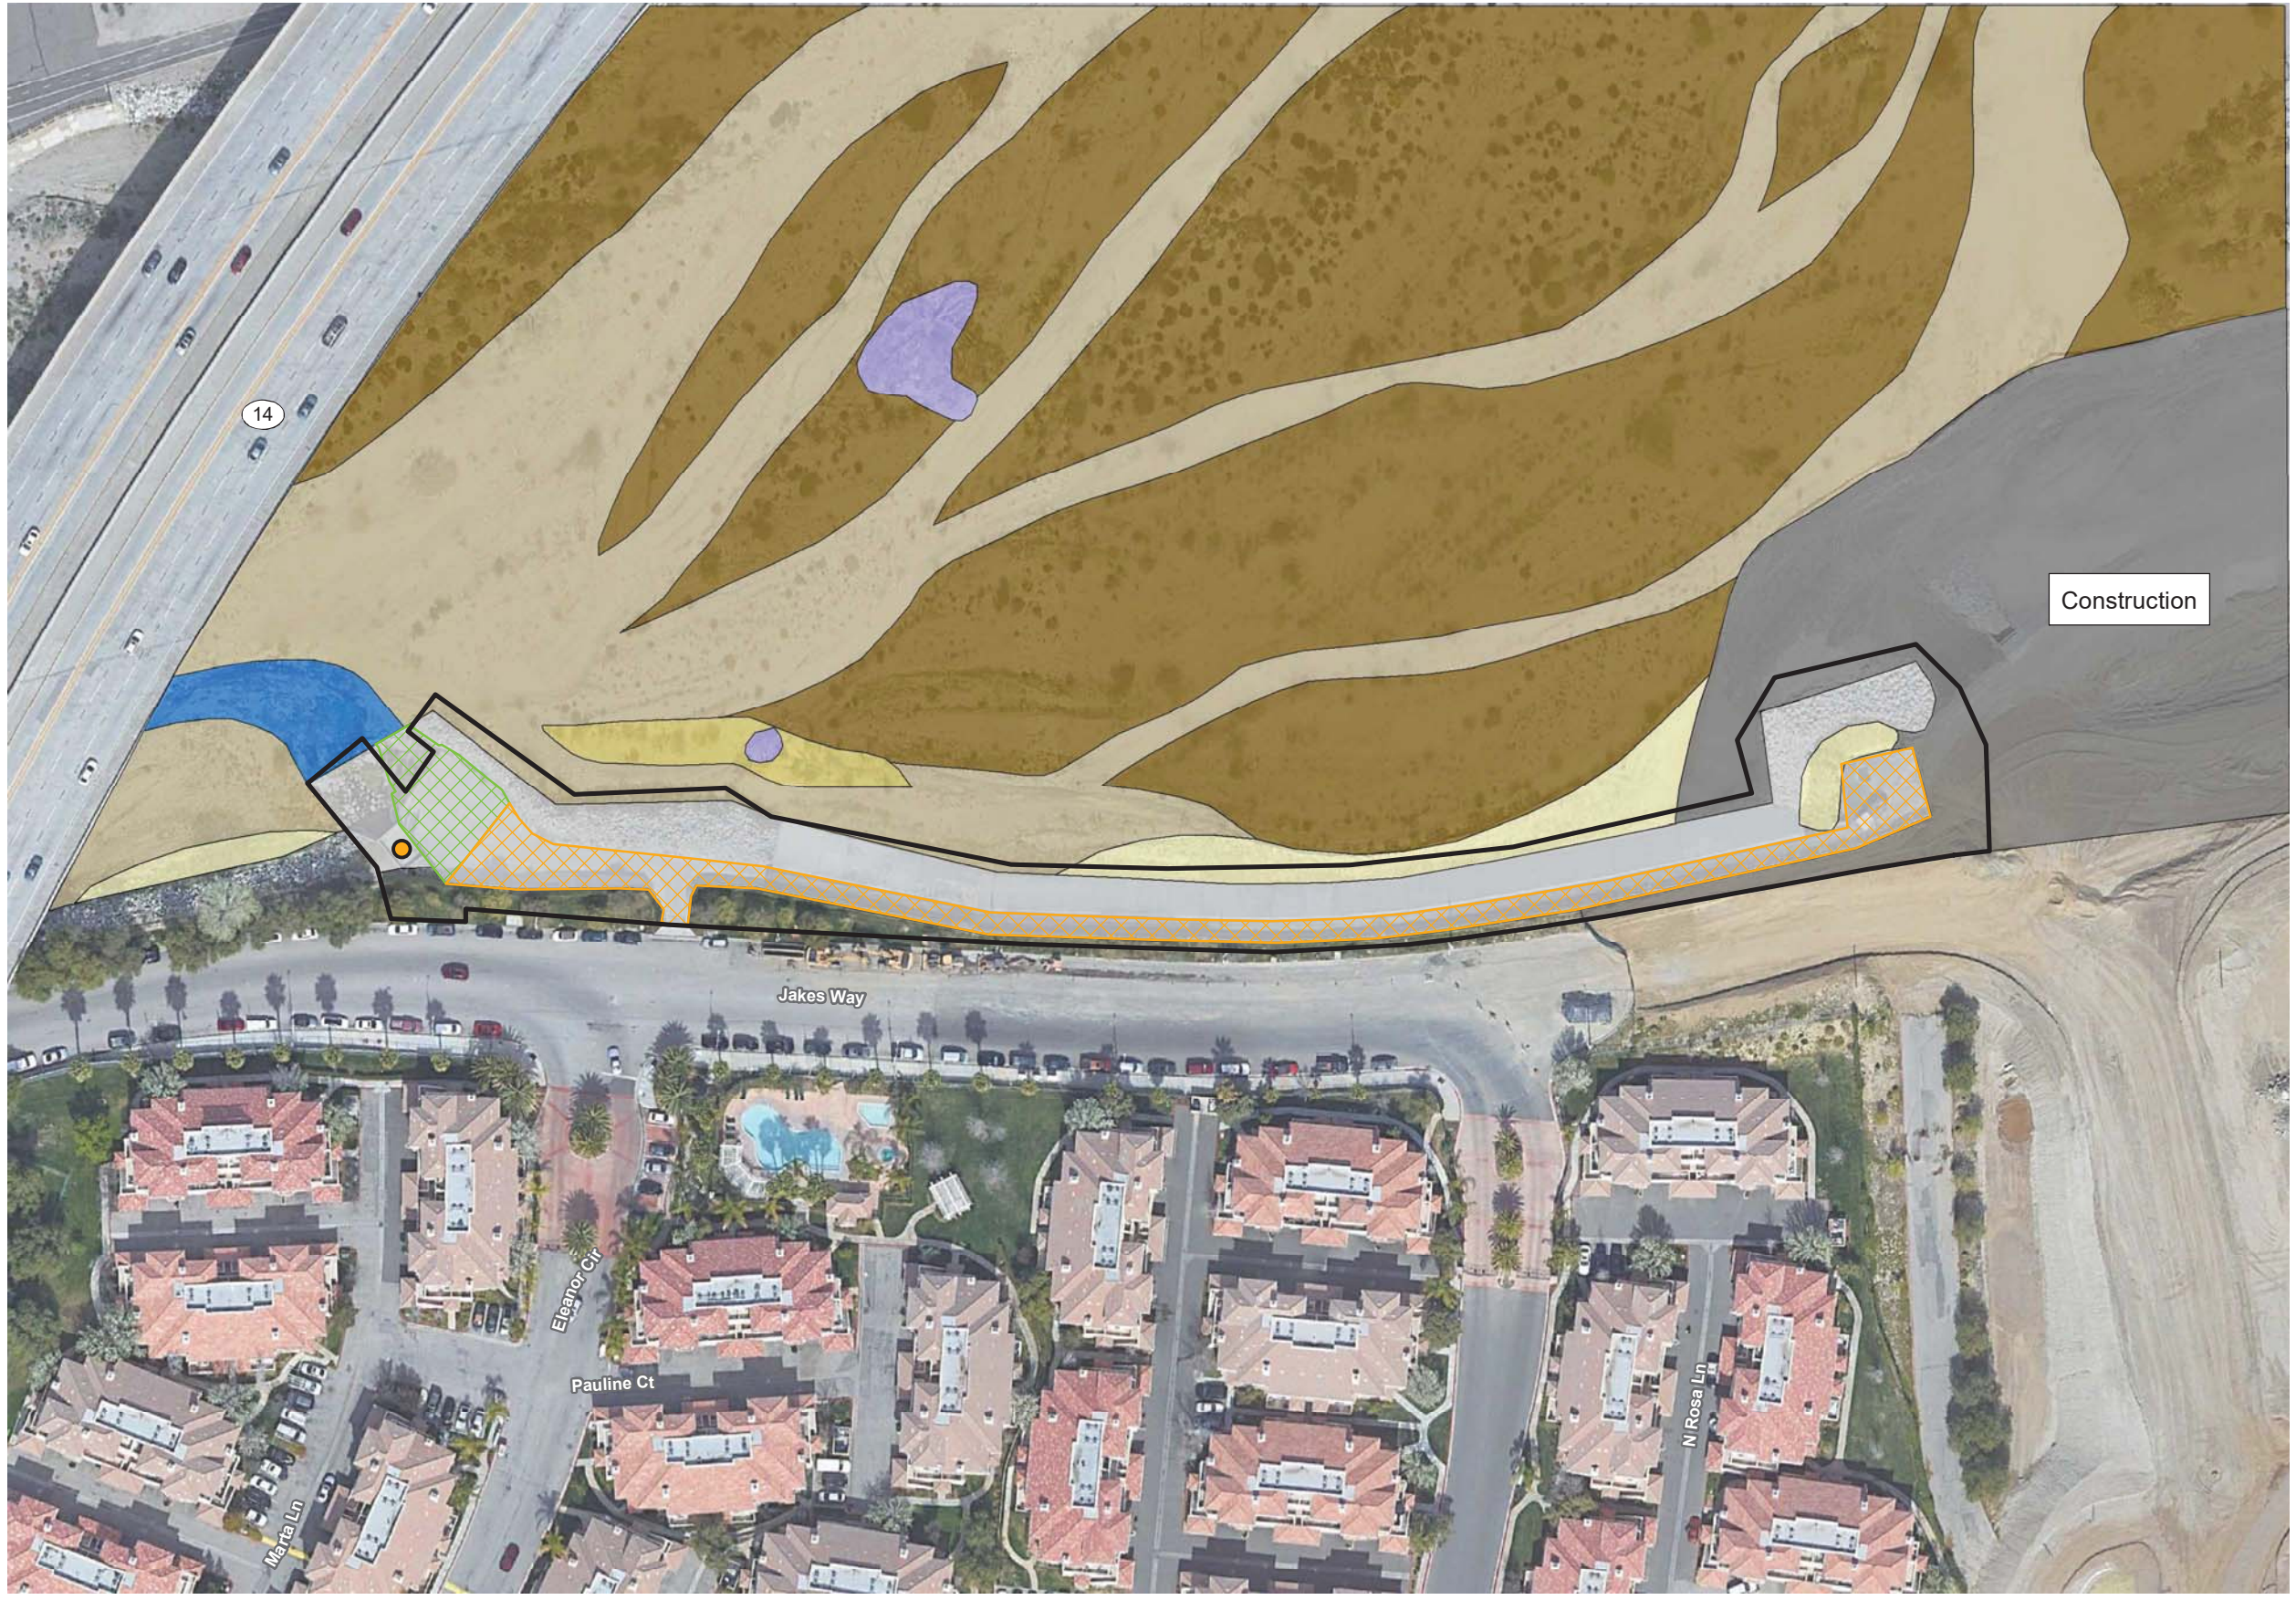
Exhibit 3a

This facility supports alluvial sage scrub (scale-broom-buckwheat alluvial shrubland), annual brome grassland, open water, and disturbed areas graded by adjacent construction. Individual Fremont cottonwood trees (*Populus fremontii*; cottonwood forest) are scattered throughout the adjacent riverbed, but do not occur within the project boundaries.

Alluvial sage scrub occurs throughout most of the riverbed outside the survey area. It is dominated by scattered scale-broom (*Lepidospartum squamatum*), California buckwheat (*Eriogonum fasciculatum*), California sagebrush (*Artemisia californica*), and mulefat (*Baccharis salicifolia*). Ephemeral scoured streambed takes up a large portion between the canopies of the dominant shrubs within this vegetation type. Several individuals of the invasive tree-of-heaven (*Ailanthus altissima*) shows evidence of cutting and resprouting. Scattered and infrequent invasive brome grasses occur throughout this vegetation type.

Annual brome grassland occurs in the project area near the existing construction. Cheatgrass (*Bromus tectorum*), red brome (*Bromus madritensis* var. *rubens*), and ripgut brome (*Bromus diandrus*) dominate this vegetation type. Species that are scattered, but not dominant, include invasive herbs like tocolote

(*Centaurea melitensis*) and native herbs like telegraphweed (*Heterotheca grandiflora*), annual bursage (*Ambrosia acanthicarpa*) and locoweed (*Acmispon glabra*). It is possible that a portion of area covered by this vegetation type was broadcast seeded by the most recent construction efforts.

Open water drains from the outlet in the project area. Saplings of arroyo willow (*Salix lasiolepis*) and cottonwoods occur within this area, but all individuals very recently died. It is likely the vegetation was sprayed with herbicide within the previous few months. A small patch of giant reed (*Arundo donax*) is resprouting from recent mowing of the above-ground material. One tamarisk (*Tamarix ramosissima*) plant remains healthy on the edge of the open water.

A vegetation map of Reach 120 and adjacent areas is attached as Exhibit 3a. Representative photographs are included as Exhibit 4a.

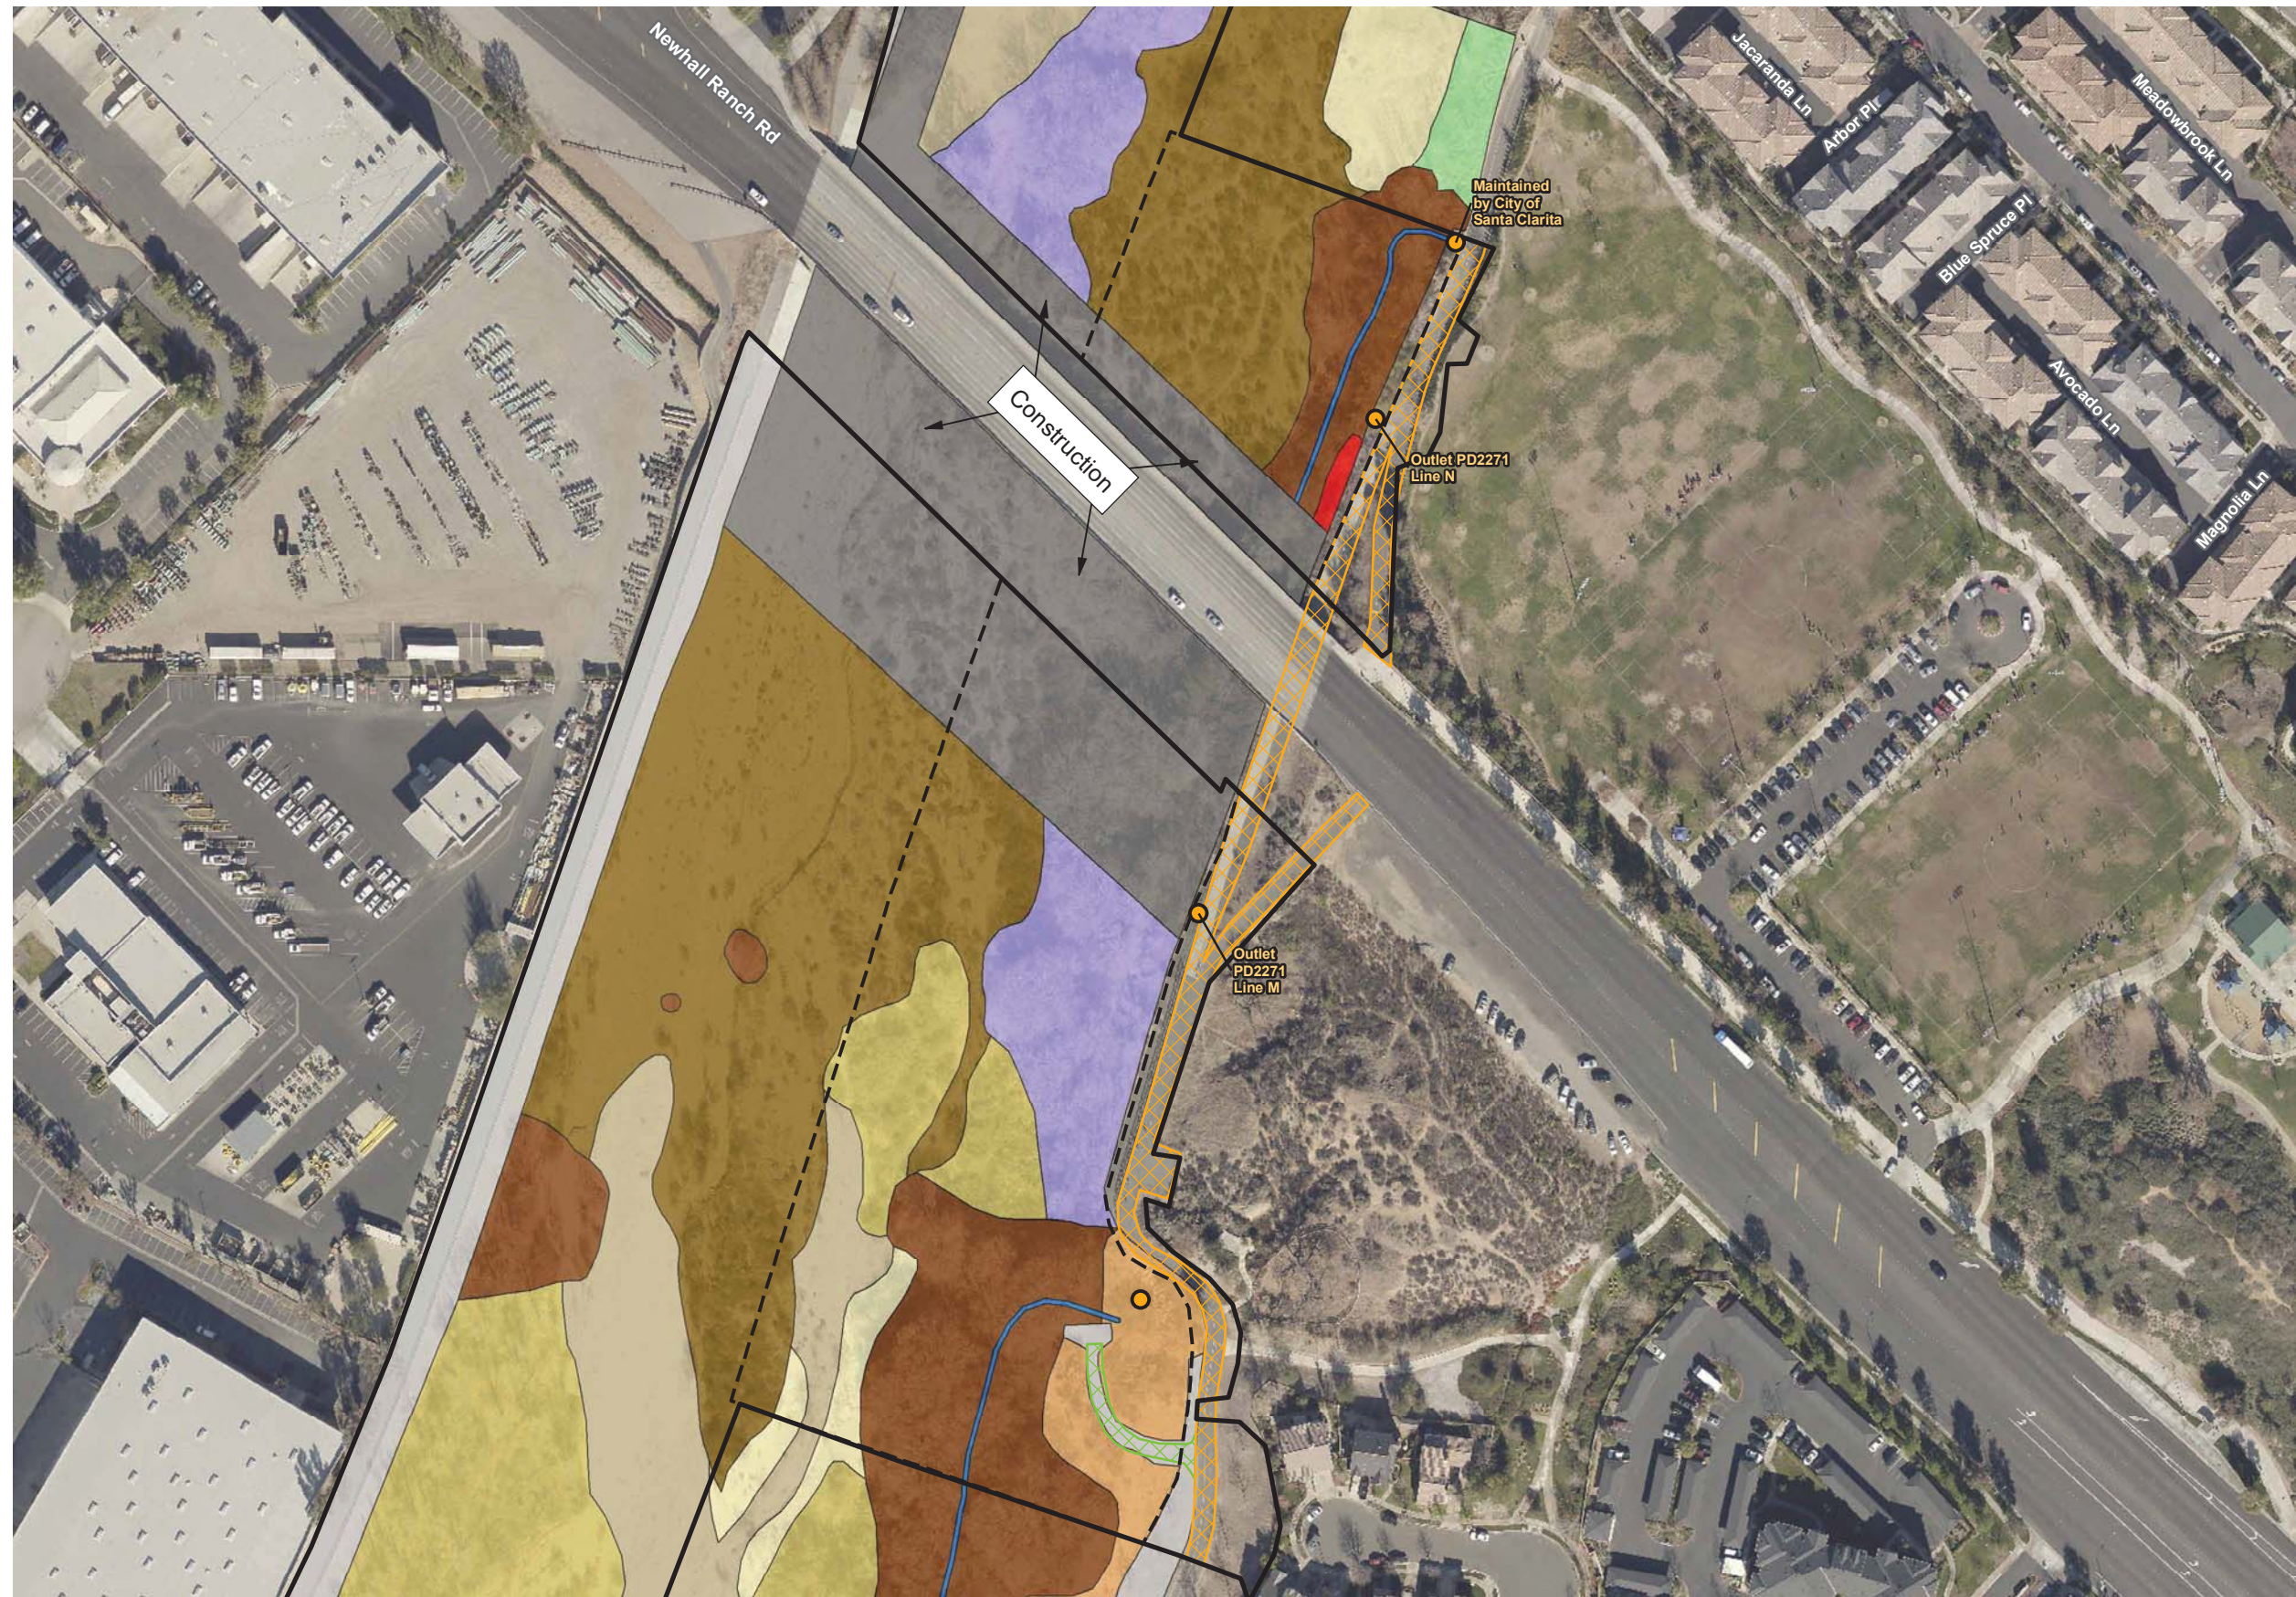
Exhibit 3b

This facility includes annual brome grassland, arroyo willow–giant reed shrubland, Fremont cottonwood–willow–mulefat woodland, ephemeral scoured streambed, open cottonwood–mulefat woodland, revegetated sagebrush–tamarisk shrubland, sandbar willow shrubland, alluvial sage scrub (scale-broom–buckwheat alluvial shrubland), open water, disturbed areas graded by adjacent construction, and developed concrete levees and access ramps. Revegetated–cottonwood–deer grass woodland occurs adjacent to the project area along the bike path, but does not occur within the project boundaries.

A vegetation map of Reach 121 and adjacent areas is attached as Exhibit 3b. Representative photographs of are included as Exhibit 4b.

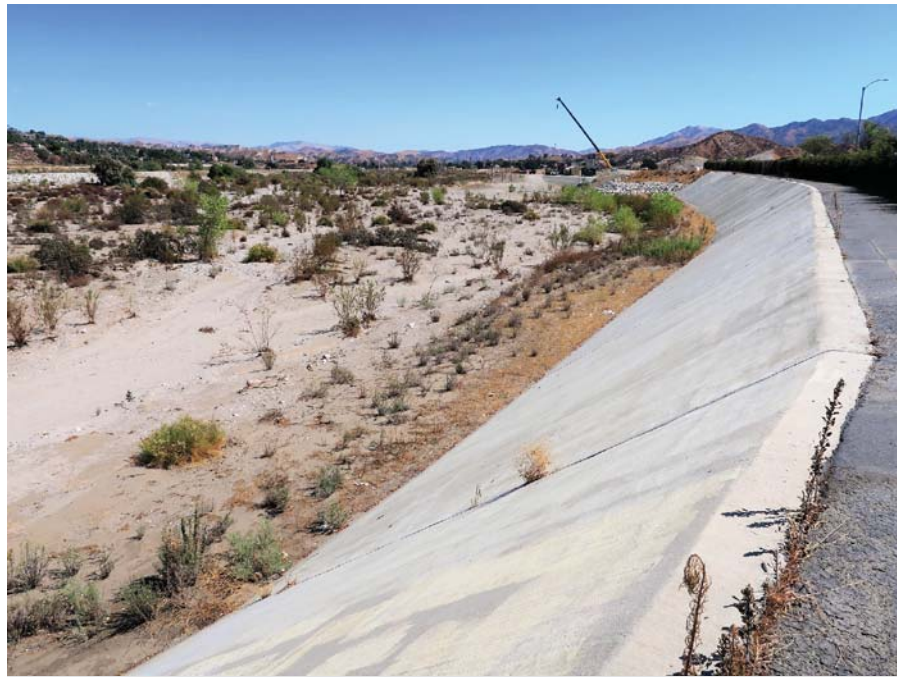
Exhibit 4a-1

September 22, 2017 - View upstream from left to right of alluvial sage scrub, ephemeral scoured streambed, and annual brome grassland from top of access ramp.

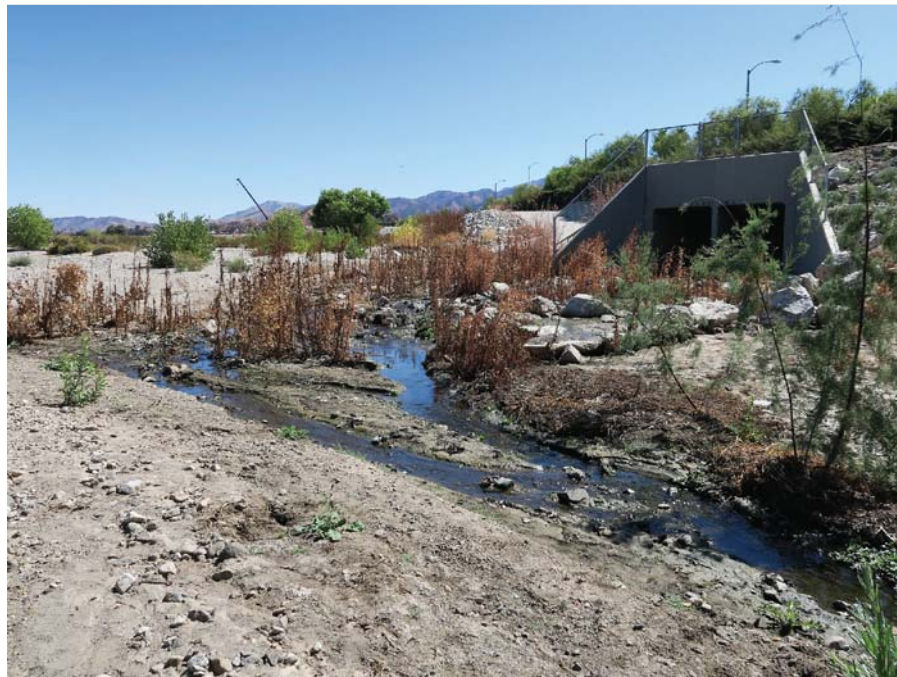
September 22, 2017 - View upstream of outlet and open water from nuisance flows. Dead vegetation exhibits evidence of possible herbicide usage.

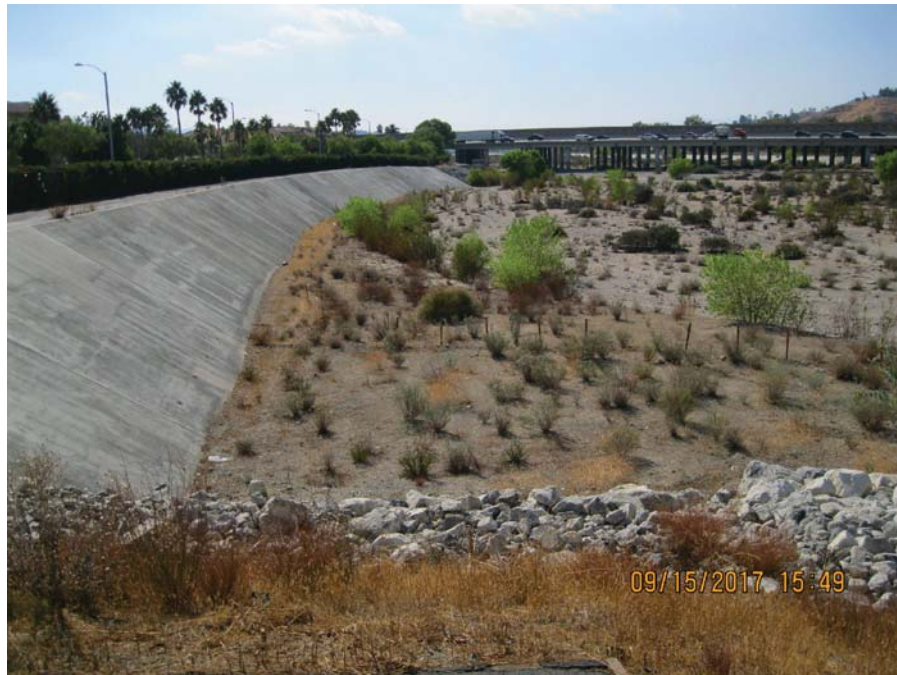
Exhibit 4a-2

September 15, 2017 - View downstream of disturbed habitat from previous construction activities and possible reseeding. Notice fenceline from construction boundary.

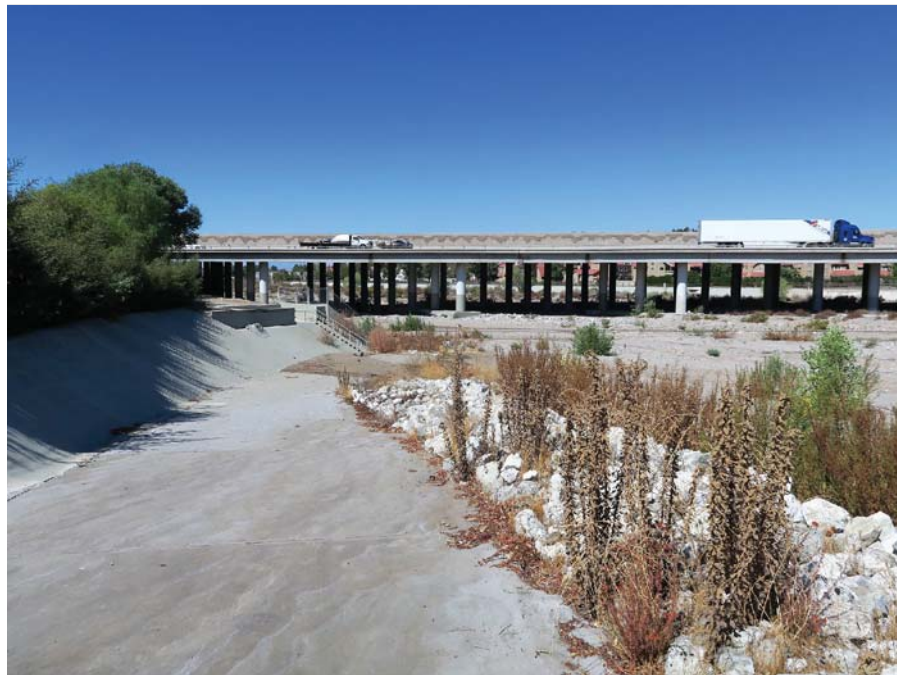
September 22, 2017 - View of access ramp and possible herbicide usage in riprap.

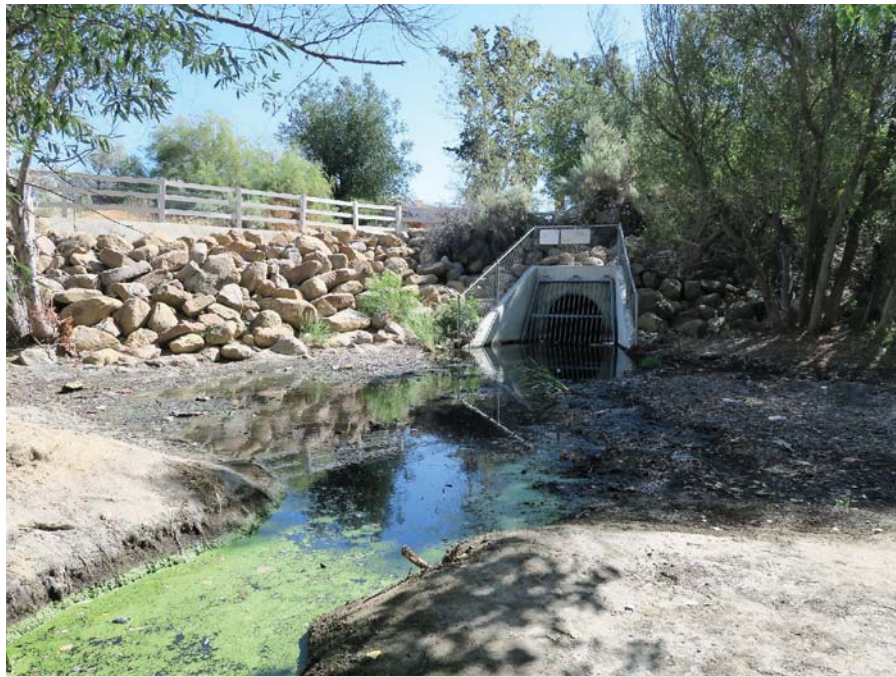
Exhibit 4b-1

September 22, 2017 - View of outlet and ponded nuisance flow at bottom of access ramp.

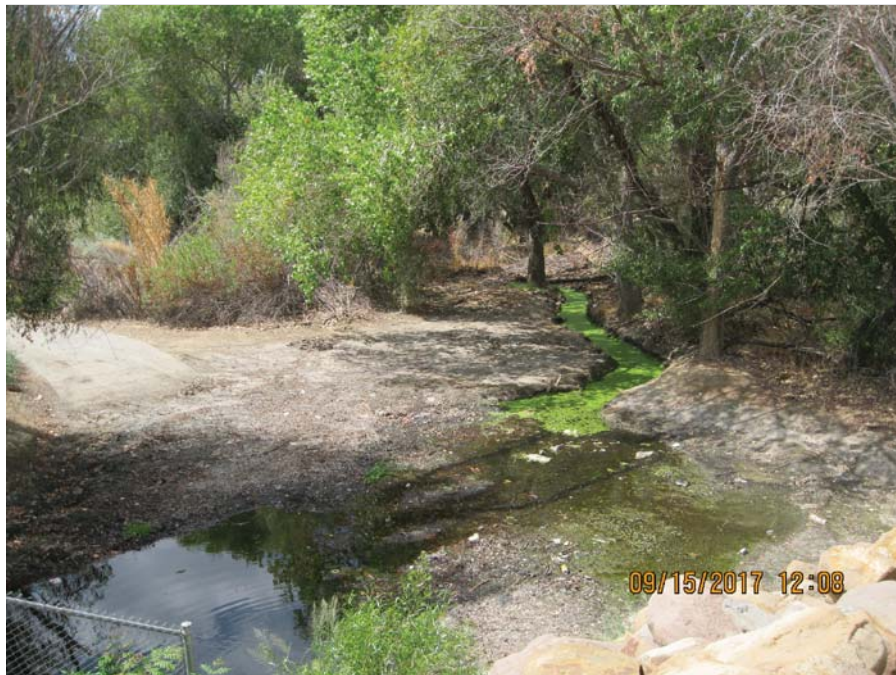
September 15, 2017 - View of entrainment channel from ponded water.

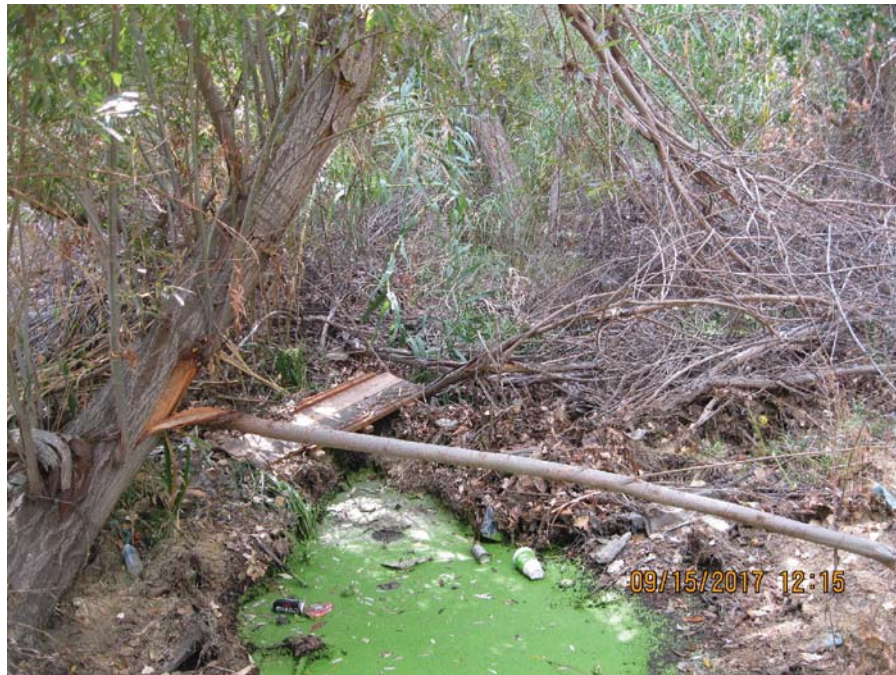
Exhibit 4b-2

September 15, 2017 - Entrainment channel is blocked by accumulated debris at 90-degree bend.

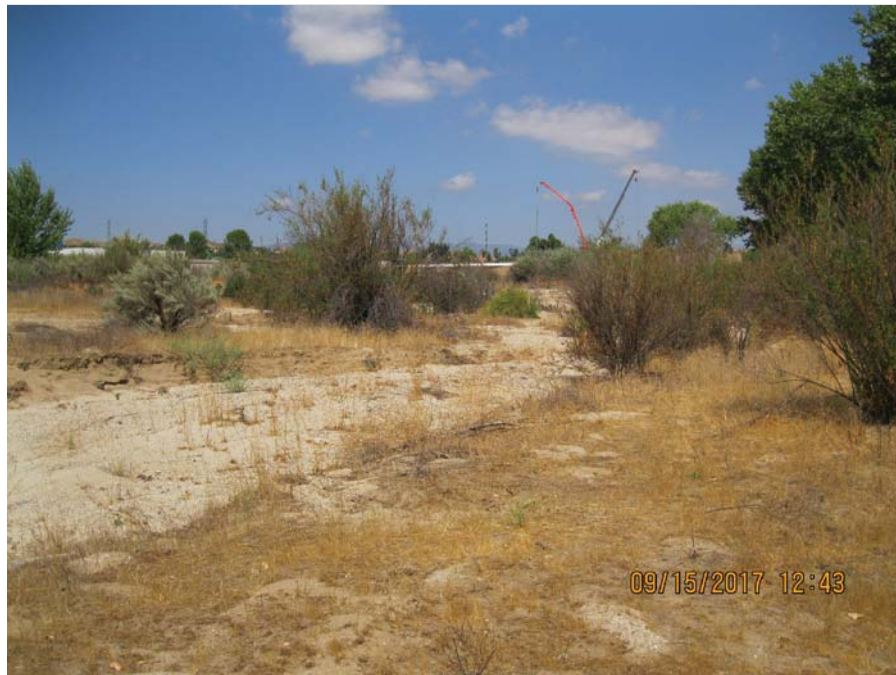
September 15, 2017 - View upstream in middle of riverbed of annual brome grassland and ephemeral scoured streambed.

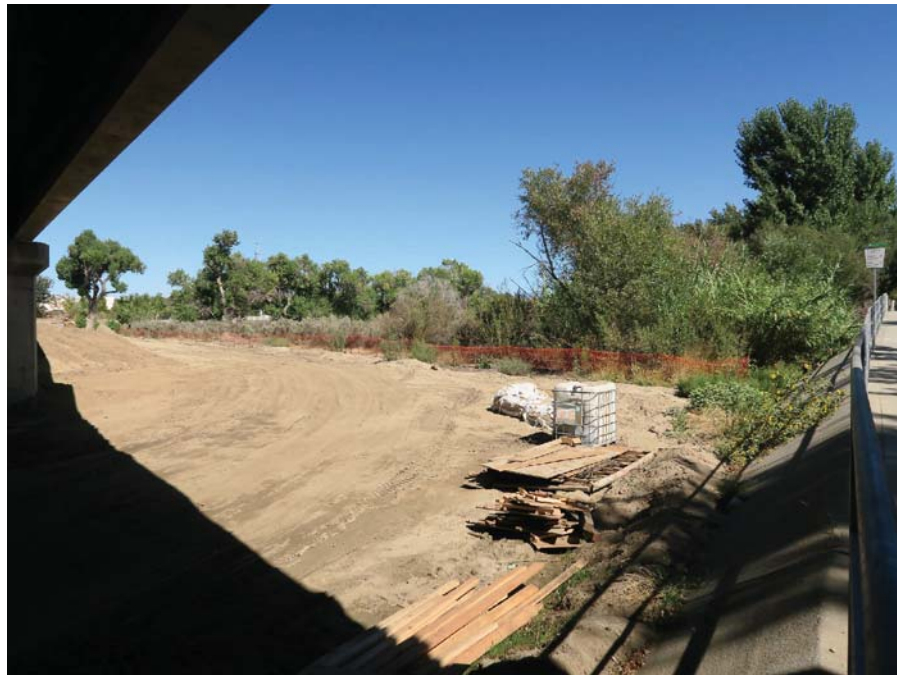
Exhibit 4b-3

Arroyo willow–giant reed shrubland occurs in one small location within roughly 30 feet of the east levee bank north of the Newhall Ranch Road bridge. The canopy of arroyo willow (*Salix lasiolepis*) and giant reed (*Arundo donax*) covers 100% of the area and is too thick to allow access underneath. Presumably there is no vegetative understory in the sandy bottom. The sunlit edge adjacent to the disturbed construction area contains a few mulefat and sandbar willow (*Salix exigua*) with short-pod mustard (*Hirschfeldia incana*), prickly lettuce (*Lactuca serriola*), and evening primrose (*Oenothera elata*) underneath.

September 22, 2017 - View upstream of arroyo willow-giant reed shrubland and disturbed ground from construction activities.

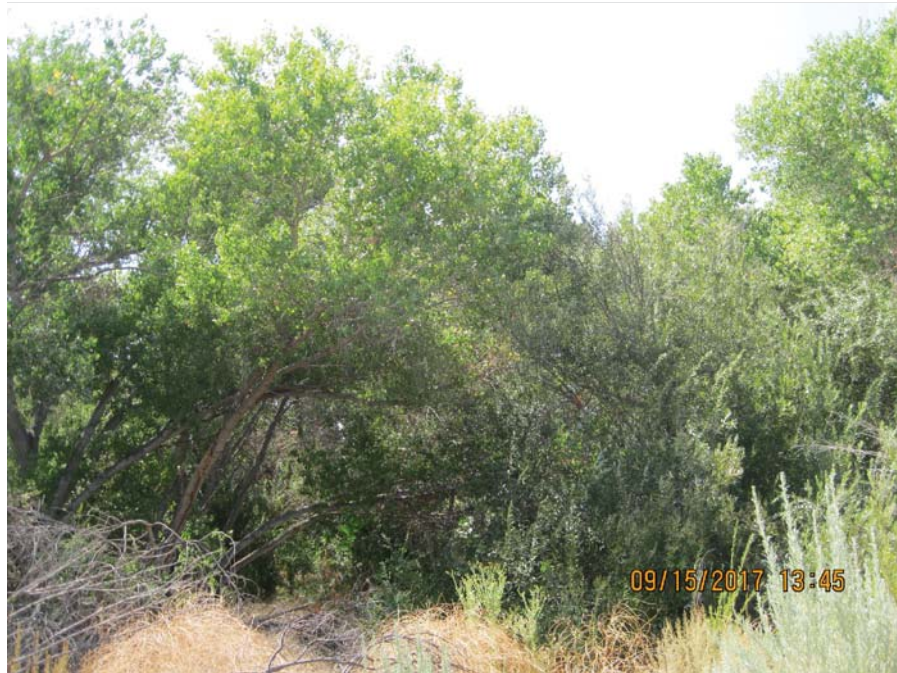
Fremont cottonwood–willow–mulefat woodland mostly follows high moisture levels from outlet entrainment channels. Two of the three outlets have perennial nuisance flows from the surrounding urban development. The entrainment channels contain stagnant open water under thick woodland canopy. The upper canopy is mostly cottonwood trees with scattered sandbar willows, arroyo willows, and mulefat in the midstory. The understory consists of exotic subshrubs and herbs including Mexican fan palm (*Washingtonia rubusta*), giant reed, and smilo grass (*Stipa millacea*)

September 15, 2017 - View of upper canopy of cottonwood-willow-mulefat woodland.

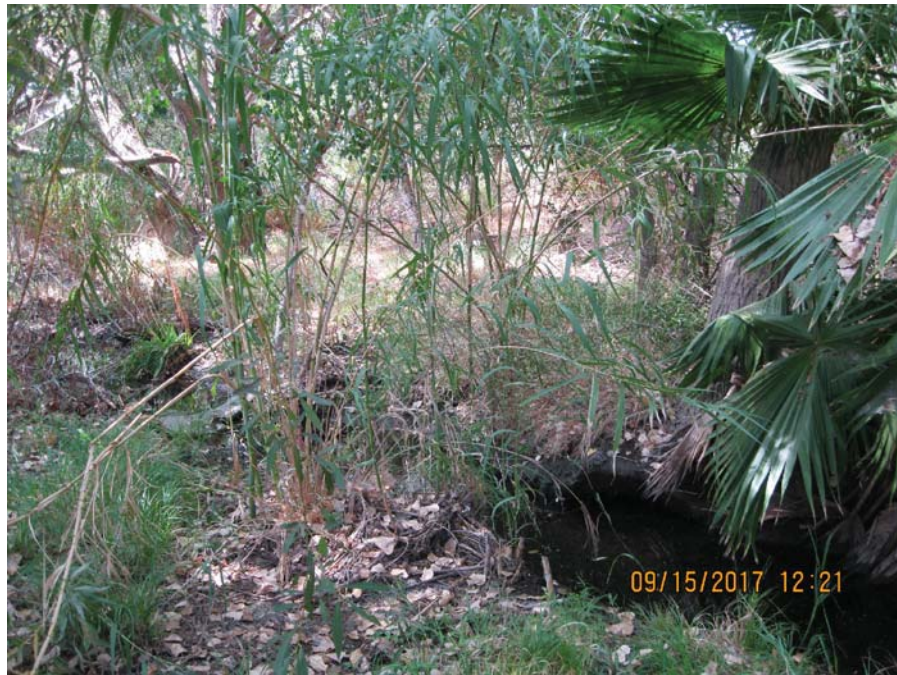
Exhibit 4b-4

September 15, 2017 - View of cottonwood-willow-mulefat woodland understory consisting of exotic species surrounding entrainment channel.

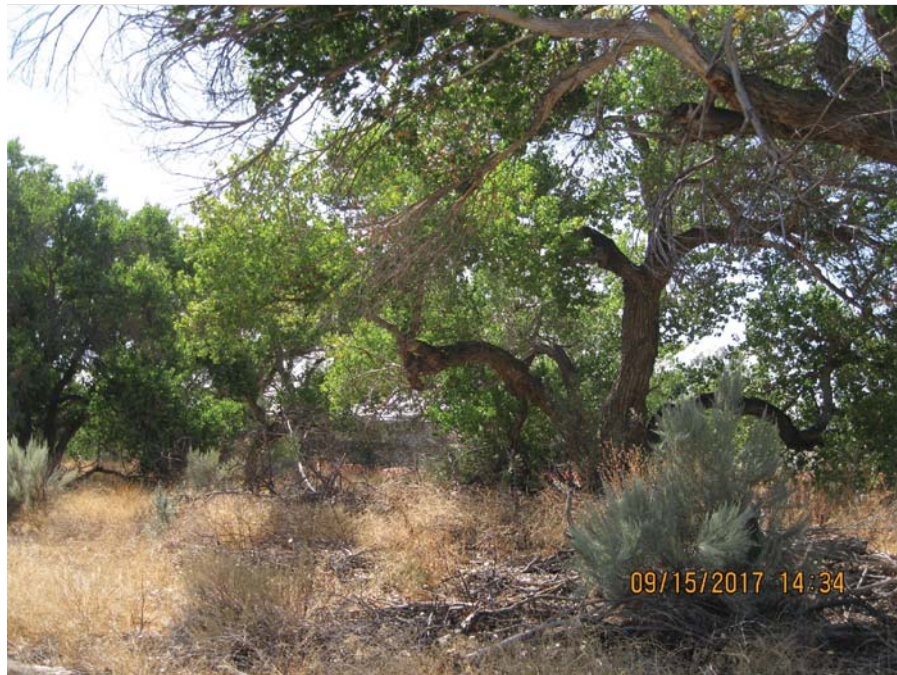
Open cottonwood–mulefat woodland occurs in two locations with low to medium moisture levels. The cottonwood canopy is very open, covering roughly 40% of the area. Between the scattered cottonwood canopy, there is a midstory canopy of coastal sage scrub (California sagebrush and mulefat) and an understory of mostly brome grasses and bare ground. The stand of open cottonwood–mulefat woodland upstream of the bridge contains mature cottonwood trees that naturally have an open canopy; however,

September 15, 2017 - View across riverbed of open cottonwood-mulefat woodland with understory of California sagebrush and brome grasses.

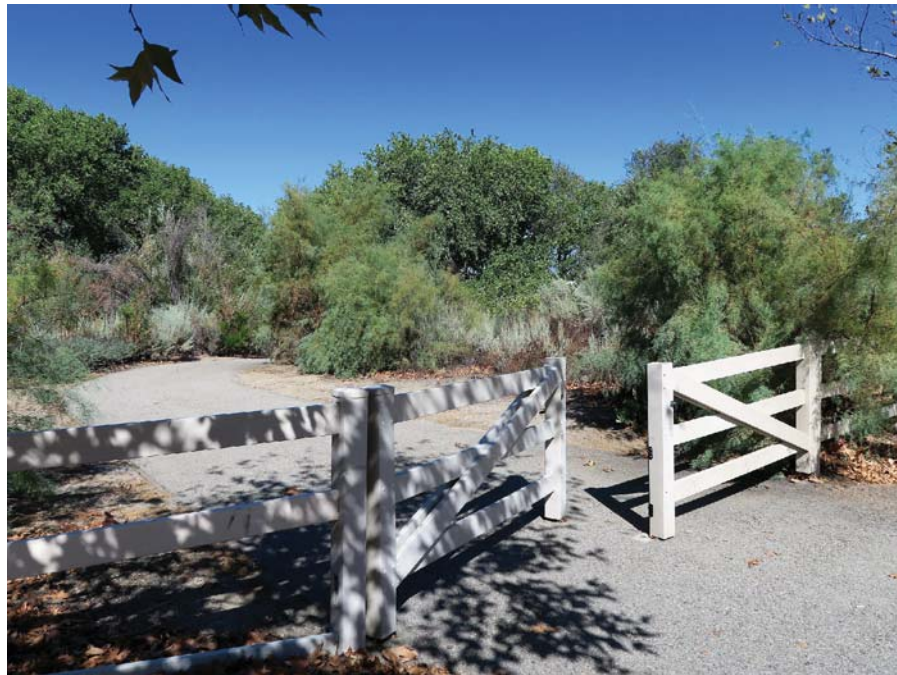
Exhibit 4b-5

Revegetated sagebrush-tamarisk shrubland surrounds the access ramp, adjacent to the bike path. Presumably, California sagebrush and California buckwheat were planted to revegetate the construction area with native species. Tamarisk and some vanilla-scented wattle (*Acacia redolens*) have since colonized and cover roughly 50% of the area. The planted native shrubs cover the remaining 50%. Exotic herbs such as brome grasses and tocolote are scattered throughout the canopy gaps.

September 22, 2017 - View of gate to access ramp from bike path with revegetated sagebrush-tamarisk shrubland in background.

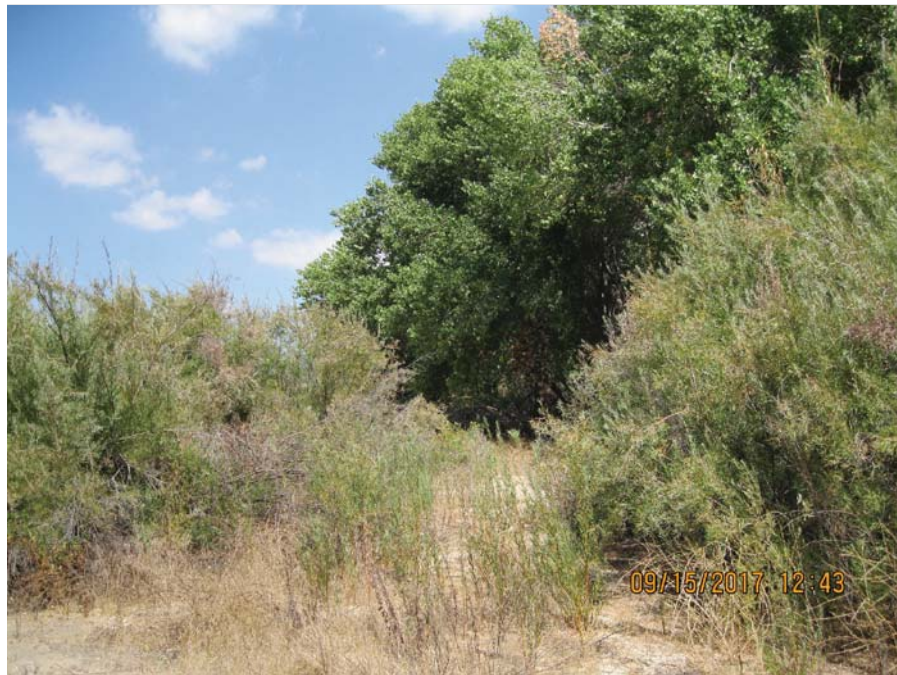
Sandbar willow shrubland (*Salix exigua*) tend to line the edges of the cottonwood–willow–mulefat woodland, taking advantage of the medium moisture levels from the downstream outlet entrainment channel where it can compete with cottonwood trees. Canopy gaps consist of equal parts mulefat to brome grasses and bare ground.

September 15, 2017 - View of sandbar willow shrubland lining edges of cottonwood-willow-mulefat woodland.

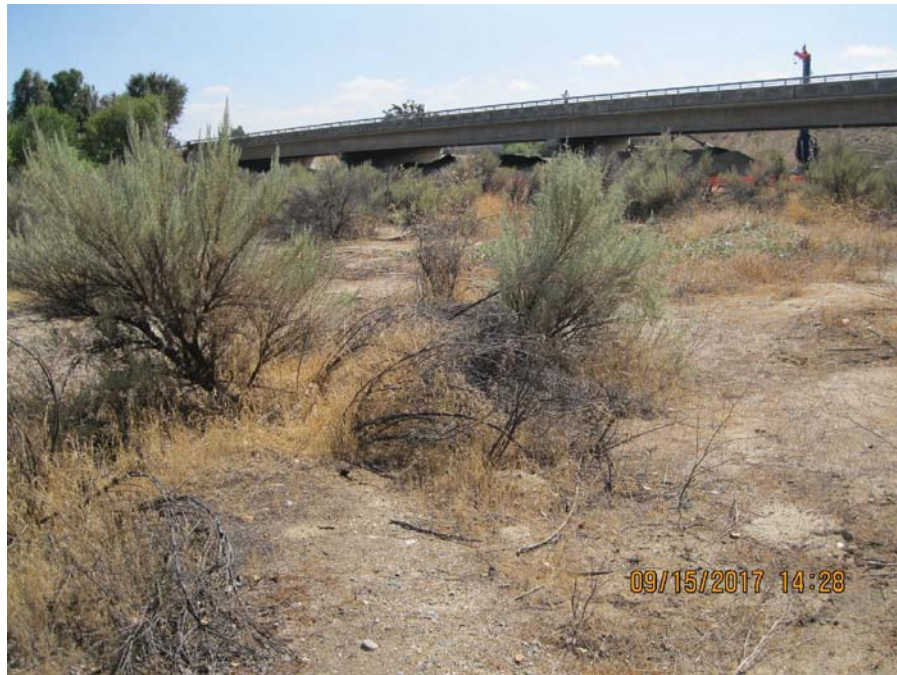
Exhibit 4b-6

Alluvial sage scrub (scale-broom-buckwheat alluvial shrubland) covered most of the dry open riverbed. It is dominated by scale-broom and California buckwheat with some scattered California sagebrush, mulefat and sandbar willow individuals. Ephemeral scoured streambed took up a large portion of the area between the canopies of the dominant shrubs within this vegetation type. Scattered and infrequent invasive brome grasses occurred throughout this vegetation type.

September 15, 2017 - View of alluvial sage scrub with brome grasses and bare ground in understory.
