July 31, 2014  
(20744)

**SUBJECT: RESULTS FROM THE NATIVE TREE ASSESSMENT FOR THE RIVAS CANYON REACH MAINTENANCE, LOS ANGELES COUNTY**

## Attachment 1 Rivas Canyon Reach Project Location and Vicinity Map

## Attachment 2 Rivas Creek Reach Tree Survey Results

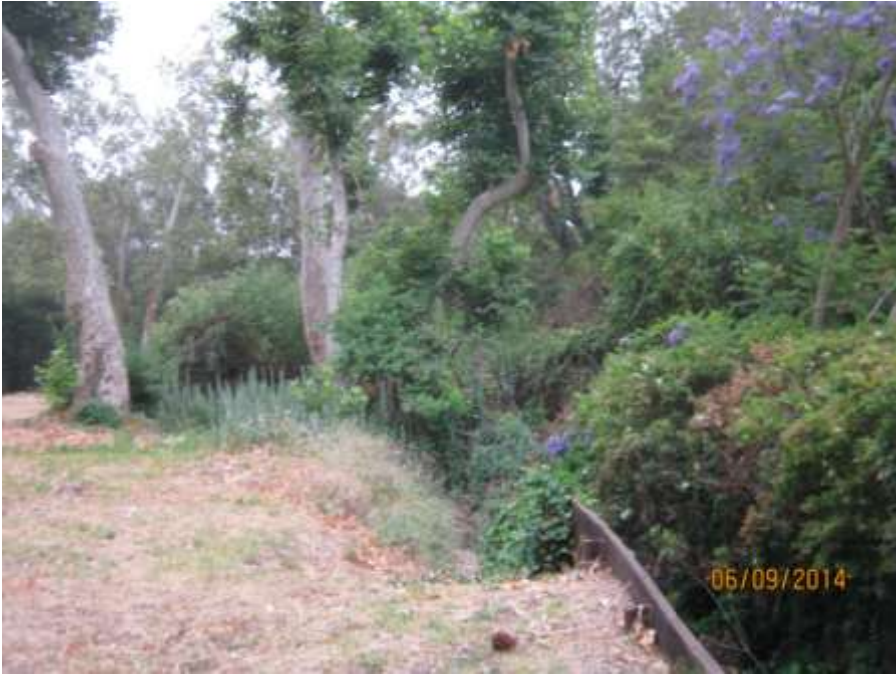
**Photo 1.** The upstream limit of Rivas Canyon Reach. Photo taken from Rustic Creek Lane, showing non-native vegetation and ornamental trees along the edge of the walls. Photo facing southeast.

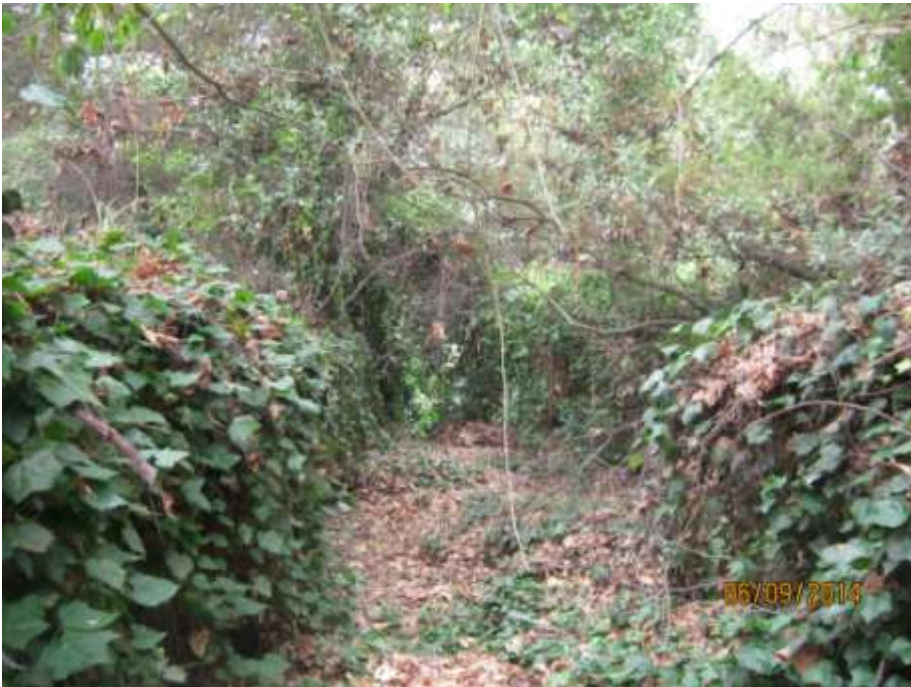
**Photo 2.** Section of the channel located just south of Rustic Creek Lane showing the thick leaf litter that was common throughout the Project site. Photo facing southeast.

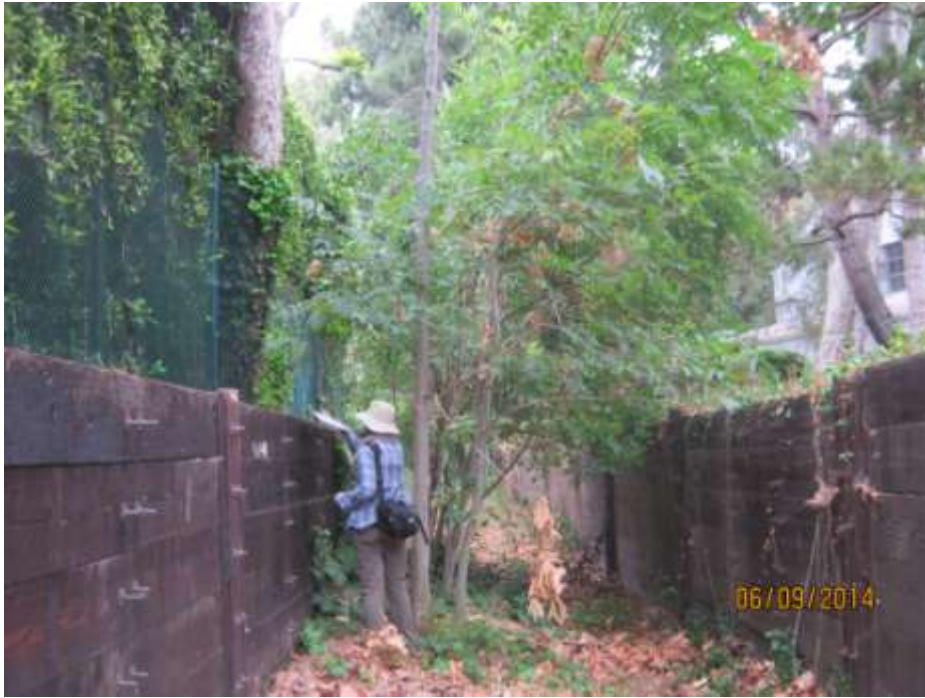
**Photo 3.** Section of the channel located by Rustic Creek Lane. Thick litter layer present on top of concrete lined channel. A small stand of native alders are present in the photo. Photo facing northwest.

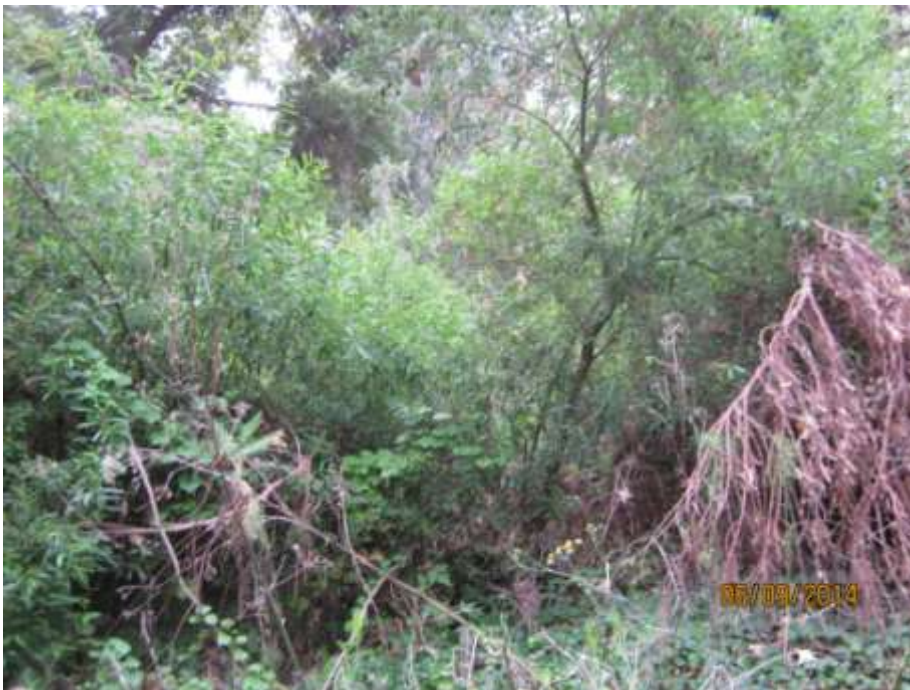
**Photo 4.** The downstream limit of Rivas Canyon Reach at the convergence of the Rivas Canyon Reach and Rustic Canyon Reach. Photo showing that this heavily vegetated area within the channels. Photo facing northwest.
