## BIOLOGICAL TECHNICAL REPORT FOR THE DOMINGUEZ SOFT BOTTOM CHANNEL REACH MAINTENANCE PROJECT LOS ANGELES COUNTY, CALIFORNIA

## COUNTY OF LOS ANGELES DEPARTMENT OF PUBLIC WORKS

## CHAMBERS GROUP, INC.

May 2014

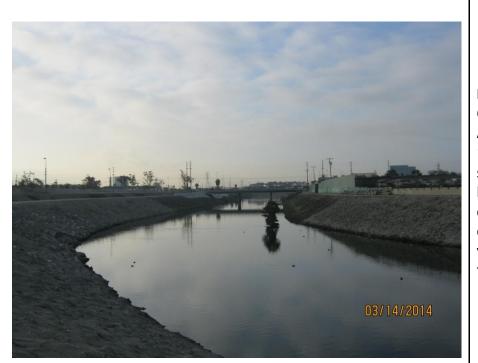
**Photo 1.** Dominguez Channel between Artesia Blvd and 182<sup>nd</sup> Street. A few small islands are located in the channel. Banks of channel are sparsely vegetated. Photo facing southeast.

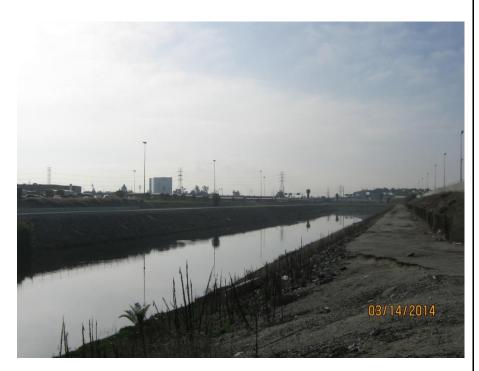
**Photo 2.** Dominguez SBC between 182<sup>nd</sup> Street and Victoria Street. Banks are sparsely vegetated. Photo facing southeast.

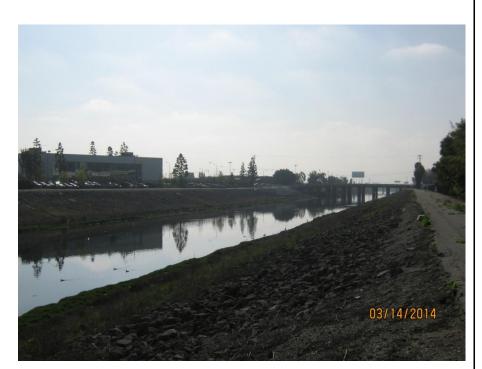
**Photo 3.** Photo showing the channel between Victoria Street and Figueroa Street. Pickleweed covers the lower portion of the banks. Photo facing southeast.

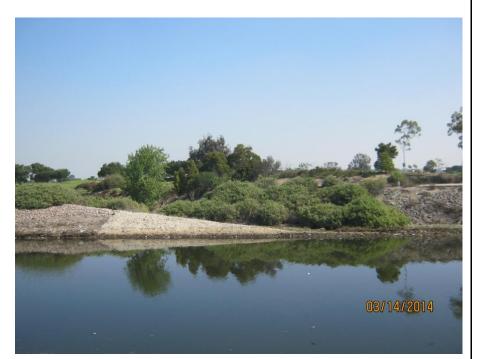
**Photo 5.** Photo showing a small area containing native vegetation between Del Amo Blvd and Carson Street. This area could provide potential habitat for nesting birds. Photo facing east.

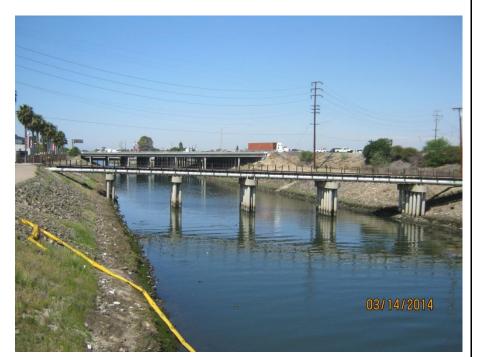
**Photo 6.** Photo showing the channel between Carson Street and 223<sup>rd</sup> Street. Banks along the west side of the channel are more evenly vegetated. The bridges located throughout the channel could provide potential nesting habitat for birds. Photo facing northwest.

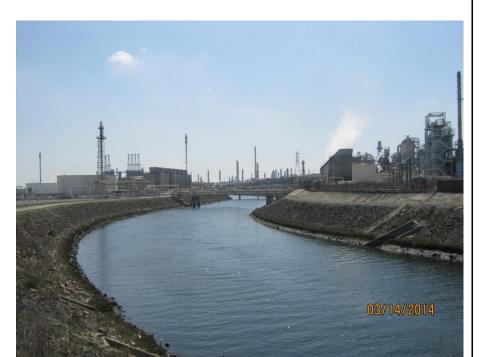
Photo 7. Dominguez SBC between 223<sup>rd</sup> Street and Alameda Street. The channel flows through a power plant and is sparsely vegetated along the banks. Photo facing southeast.

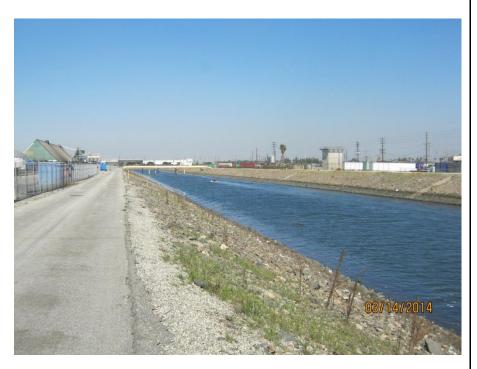
Photo 7. Photo showing Dominguez SBC between Alameda Street and Sepulveda Blvd. This portion of the channel is sparsely vegetated and is bordered by an oil refinery. Photo facing northwest.

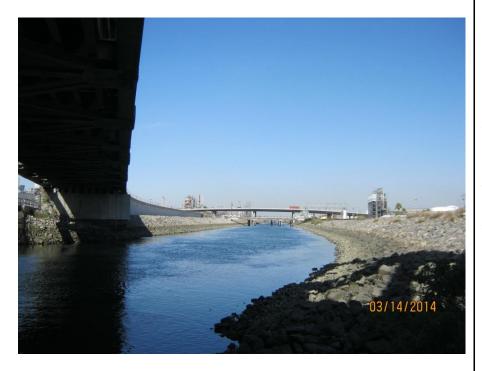
Photo 8. Photo showing the southern end of the channel where it opens to the Los Angeles Harbor. Banks are void of vegetation; however, several mollusks where observed attached to the rocks. Photo facing northwest.
