July 31, 2014
(20744)

SUBJECT: RESULTS FROM THE NATIVE TREE ASSESSMENT FOR THE RUSTIC CANYON REACH MAINTENANCE, LOS ANGELES COUNTY

Attachment 1 – Site Location Map

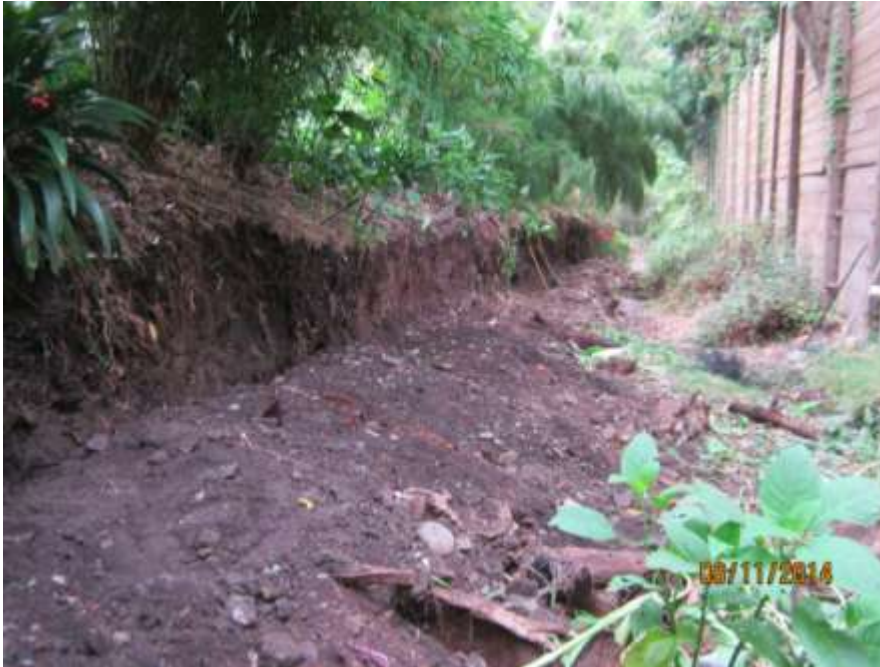
Photo 1. Photo showing removed wooden side wall on the east side of the channel, causing loose sediment to enter the channel. Photo facing south.

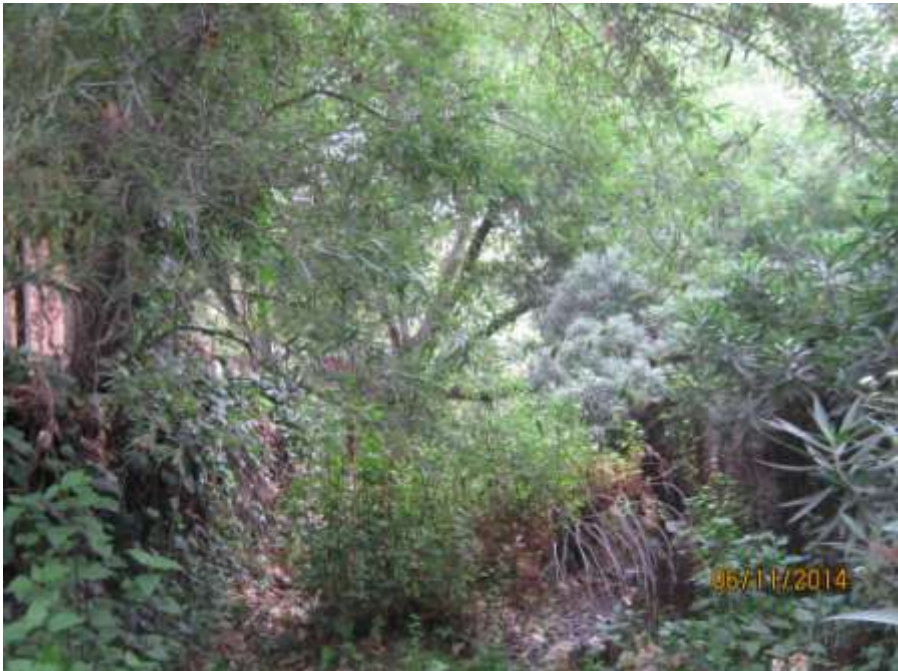
Photo 2. Near the upstream limit of Rustic Canyon Reach. Photo showing a section of riparian forest within the Project site. This area can provide potential habitat for nesting birds and sensitive species. Photo facing north.

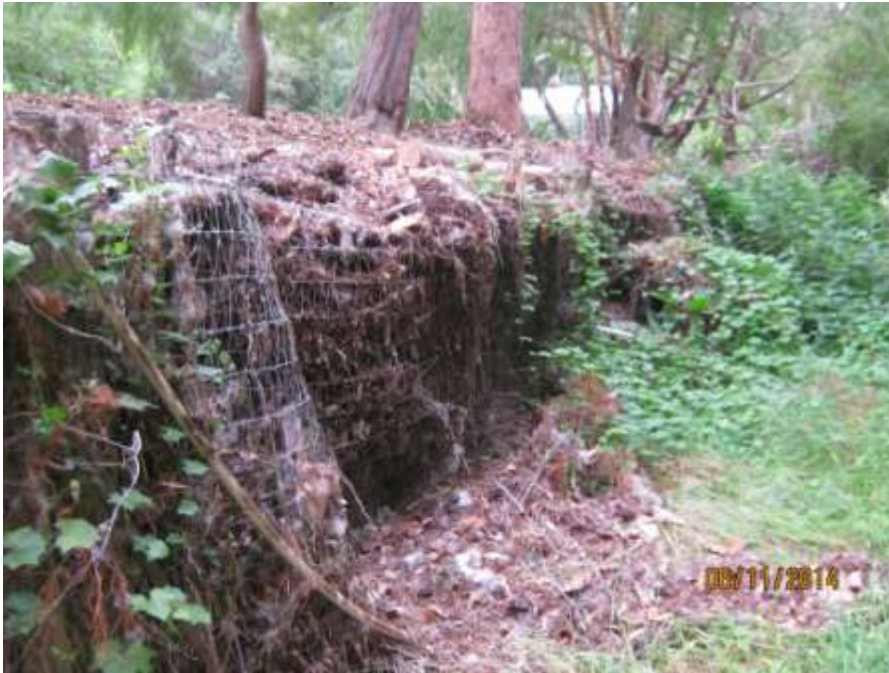
Photo 3. Photo showing a segment of the channel where the east side wall is degrading. Photo facing south.

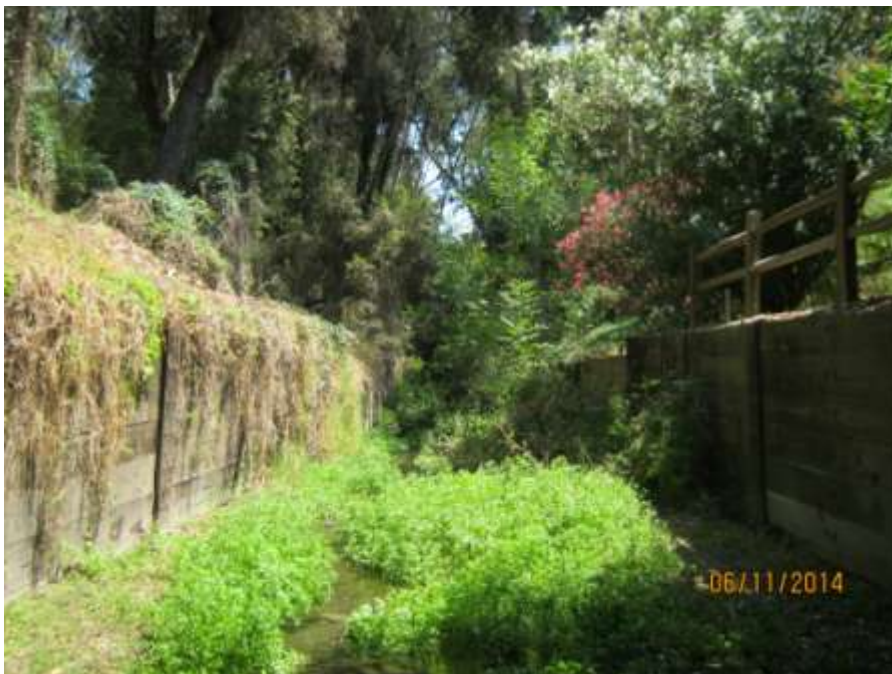
Photo 4. The southern end of Rustic Reach. Area is composed of sparse herbaceous vegetation. Photo facing north.

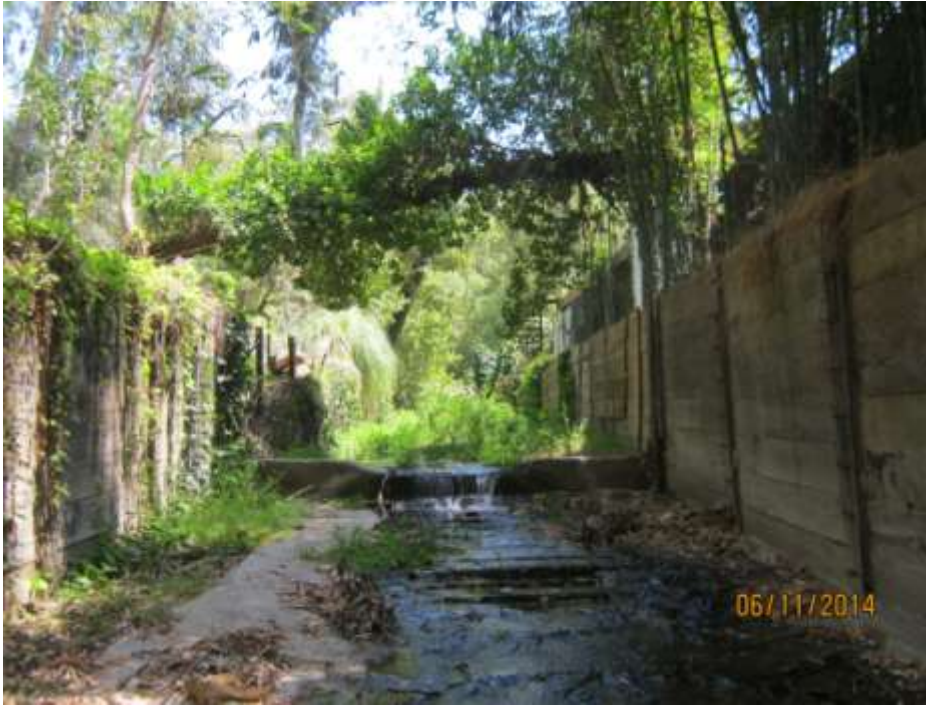
Photo 5. Southern end of the Project site. Wide section of the channel, lined with concrete. Photo showing a fallen tree across the channel. Photo facing north.

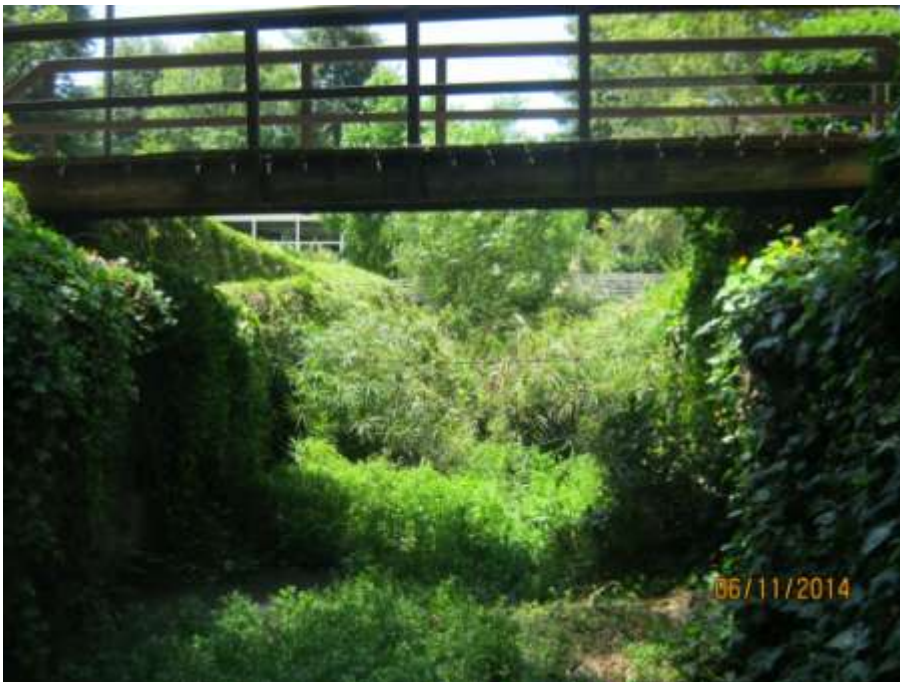
Photo 6. Dense non-native vegetation and ornamental vines along the walls, located south of Rustic Creek Lane. Photo facing south.

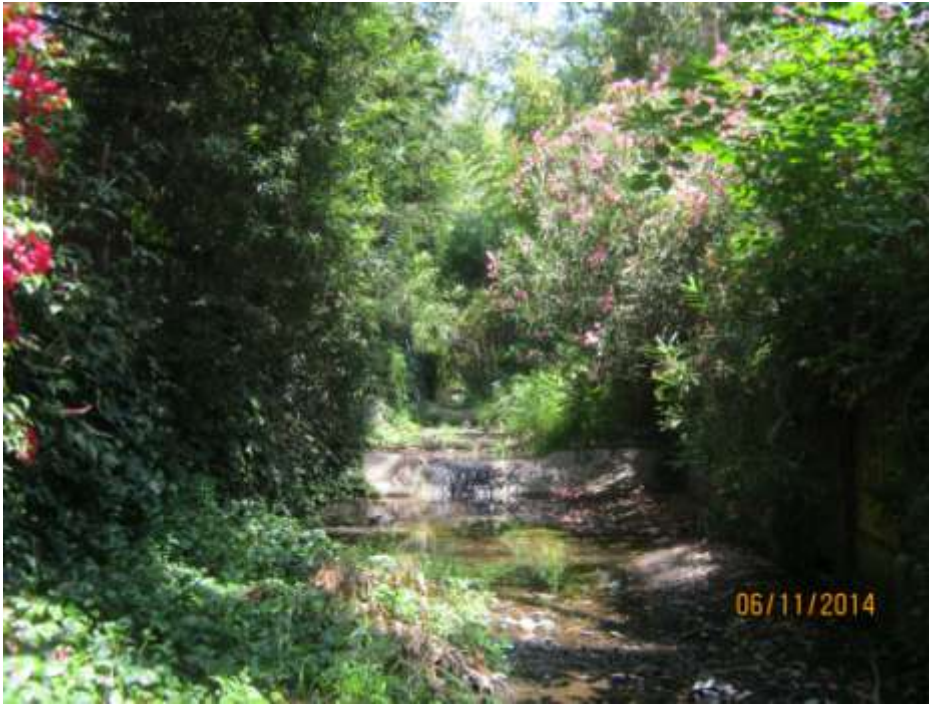
Photo 14. Photo showing vegetation within the channel and thick non-native vegetation along the sidewalls, located south of Rustic Creek Lane. Photo facing north.
