**BIOLOGICAL TECHNICAL REPORT FOR  
SOFT-BOTTOM CHANNEL REACH 118—  
RUSTIC CANYON CHANNEL  
MAINTENANCE PROJECT  
LOS ANGELES COUNTY, CALIFORNIA**

**LOS ANGELES COUNTY FLOOD CONTROL DISTRICT** 900 South Fremont Avenue  
Alhambra, California 91803

**CHAMBERS GROUP, INC.**  
5 Hutton Centre Drive, Suite 750  
Santa Ana, California 92707  
(949) 261-5414

**July 2014**

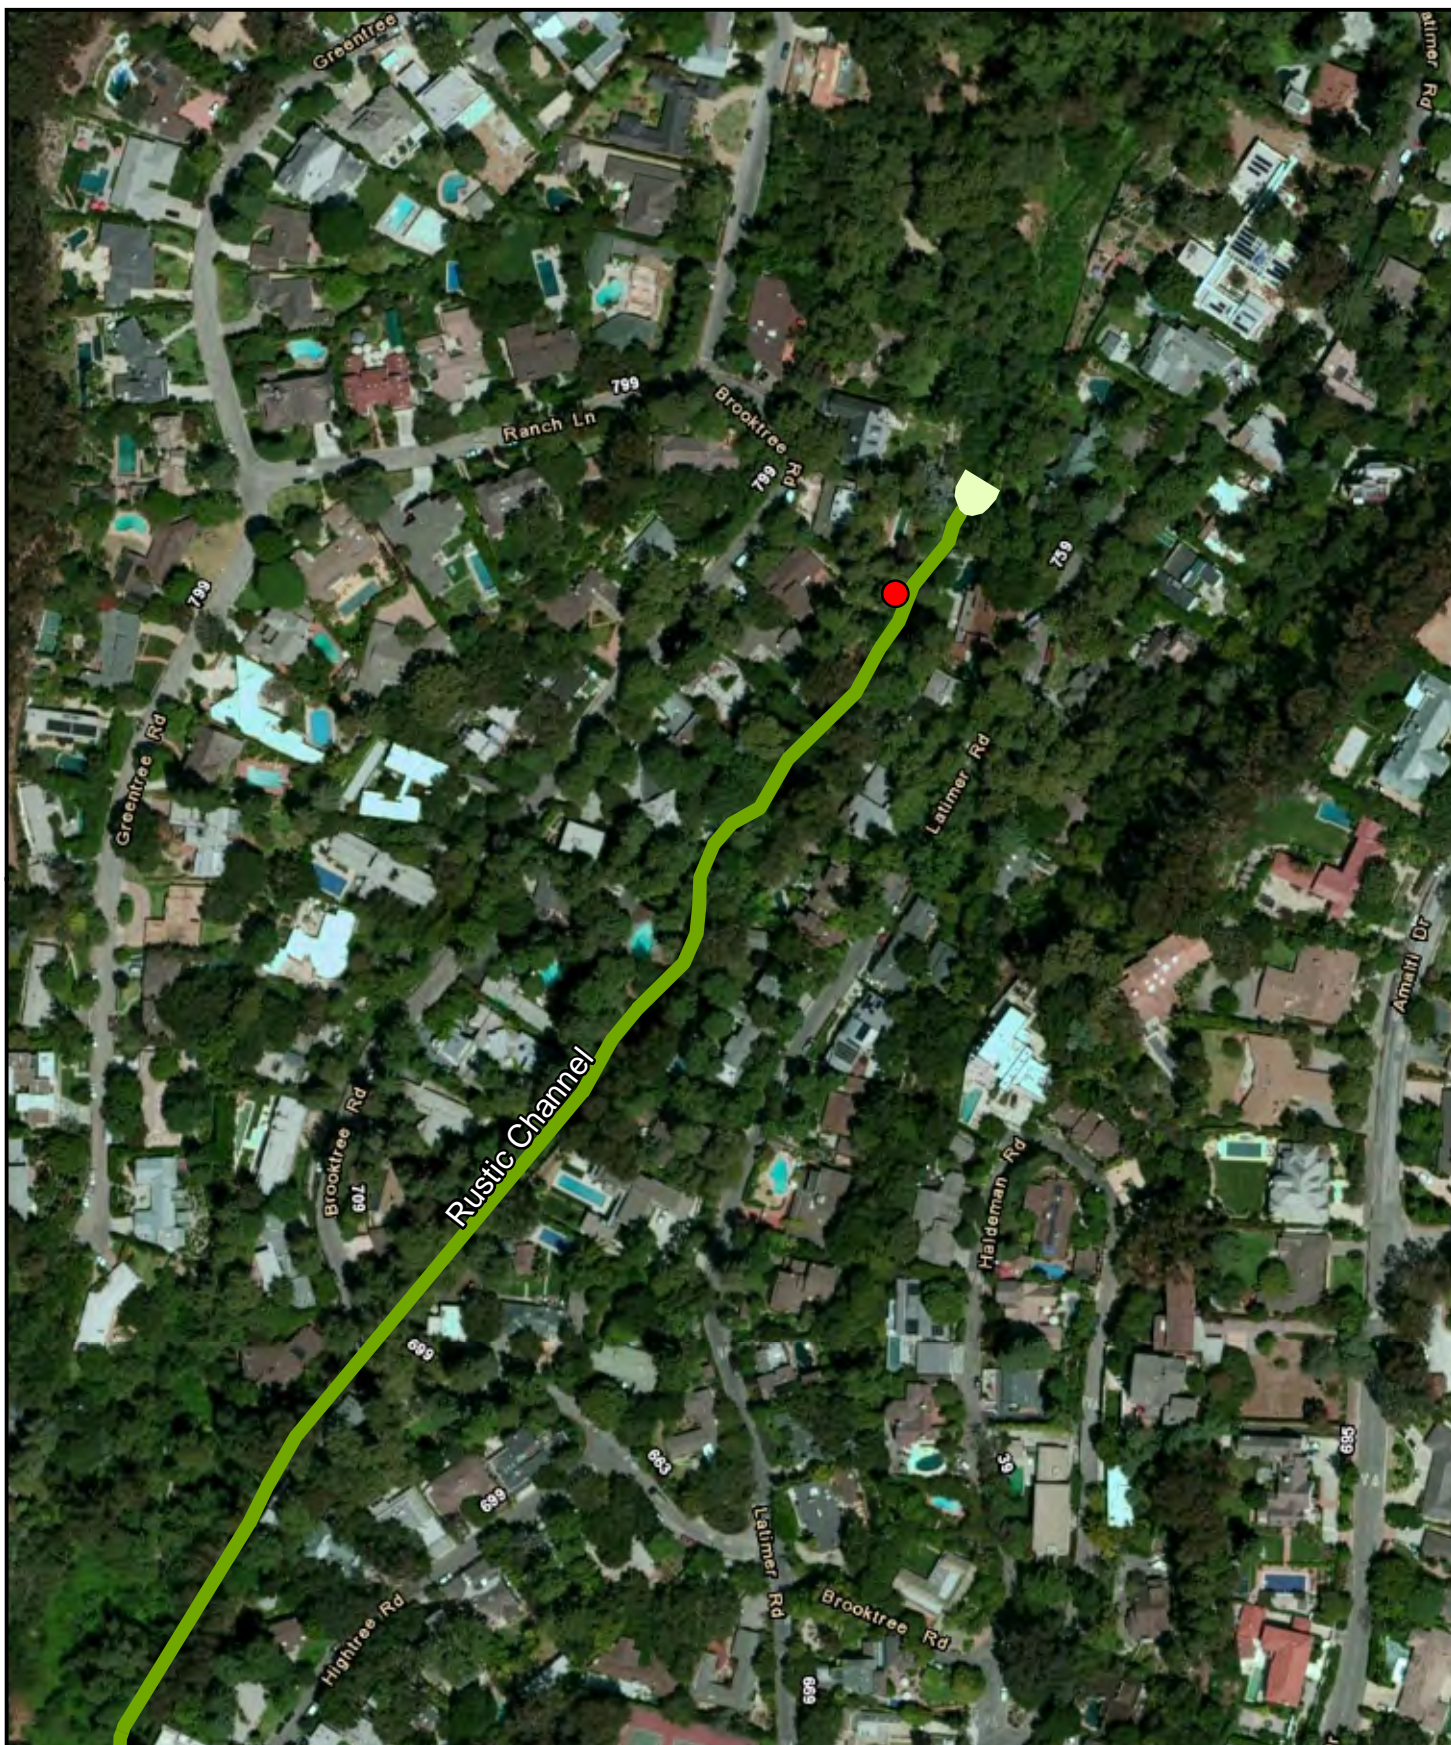
**Figure 2**  
Rustic Creek Reach  
Vegetation Communities Map

## Legend

### Vegetation Community

- Arroyo Willow Thickets
- Disturbed Riparian Species with Escaped Ornamental Species

### Structural Status

- Damage Observed

The Project site is approximately 0.69 river miles total in length. The Project area is located in a suburban area surrounded by private residences. Habitat in the survey area is composed primarily of red willow thickets, escaped ornamental species, and developed vegetation communities (Figure 2 Figure 2).

Biologists observed 80 plant species within the Project site during the time of the survey (Appendix B). Two vegetation communities, Arroyo Willow Thickets and Disturbed Riparian Species with Escaped Ornamental Species, were observed within the Project site. A map showing the vegetation communities observed within the Project site is provided as Figure 2. Representative site photographs were taken documenting the vegetation communities of the site (Appendix A). A brief description of the vegetation communities is provided in the following subsections.

Several locations along the sidewalls of Reach 118 Rustic have existing or potential structure problems caused by various trees from adjacent private properties. The locations and details can be found in the table below and in Table 2. Approximately 10 native willow trees have damaged the channel walls. These trees will need to be removed in an effort to restore the integrity of the channel and prevent potential flooding of adjacent residential properties. Once vegetation removal is complete, further assessment of the channel walls may provide additional structural problem areas.

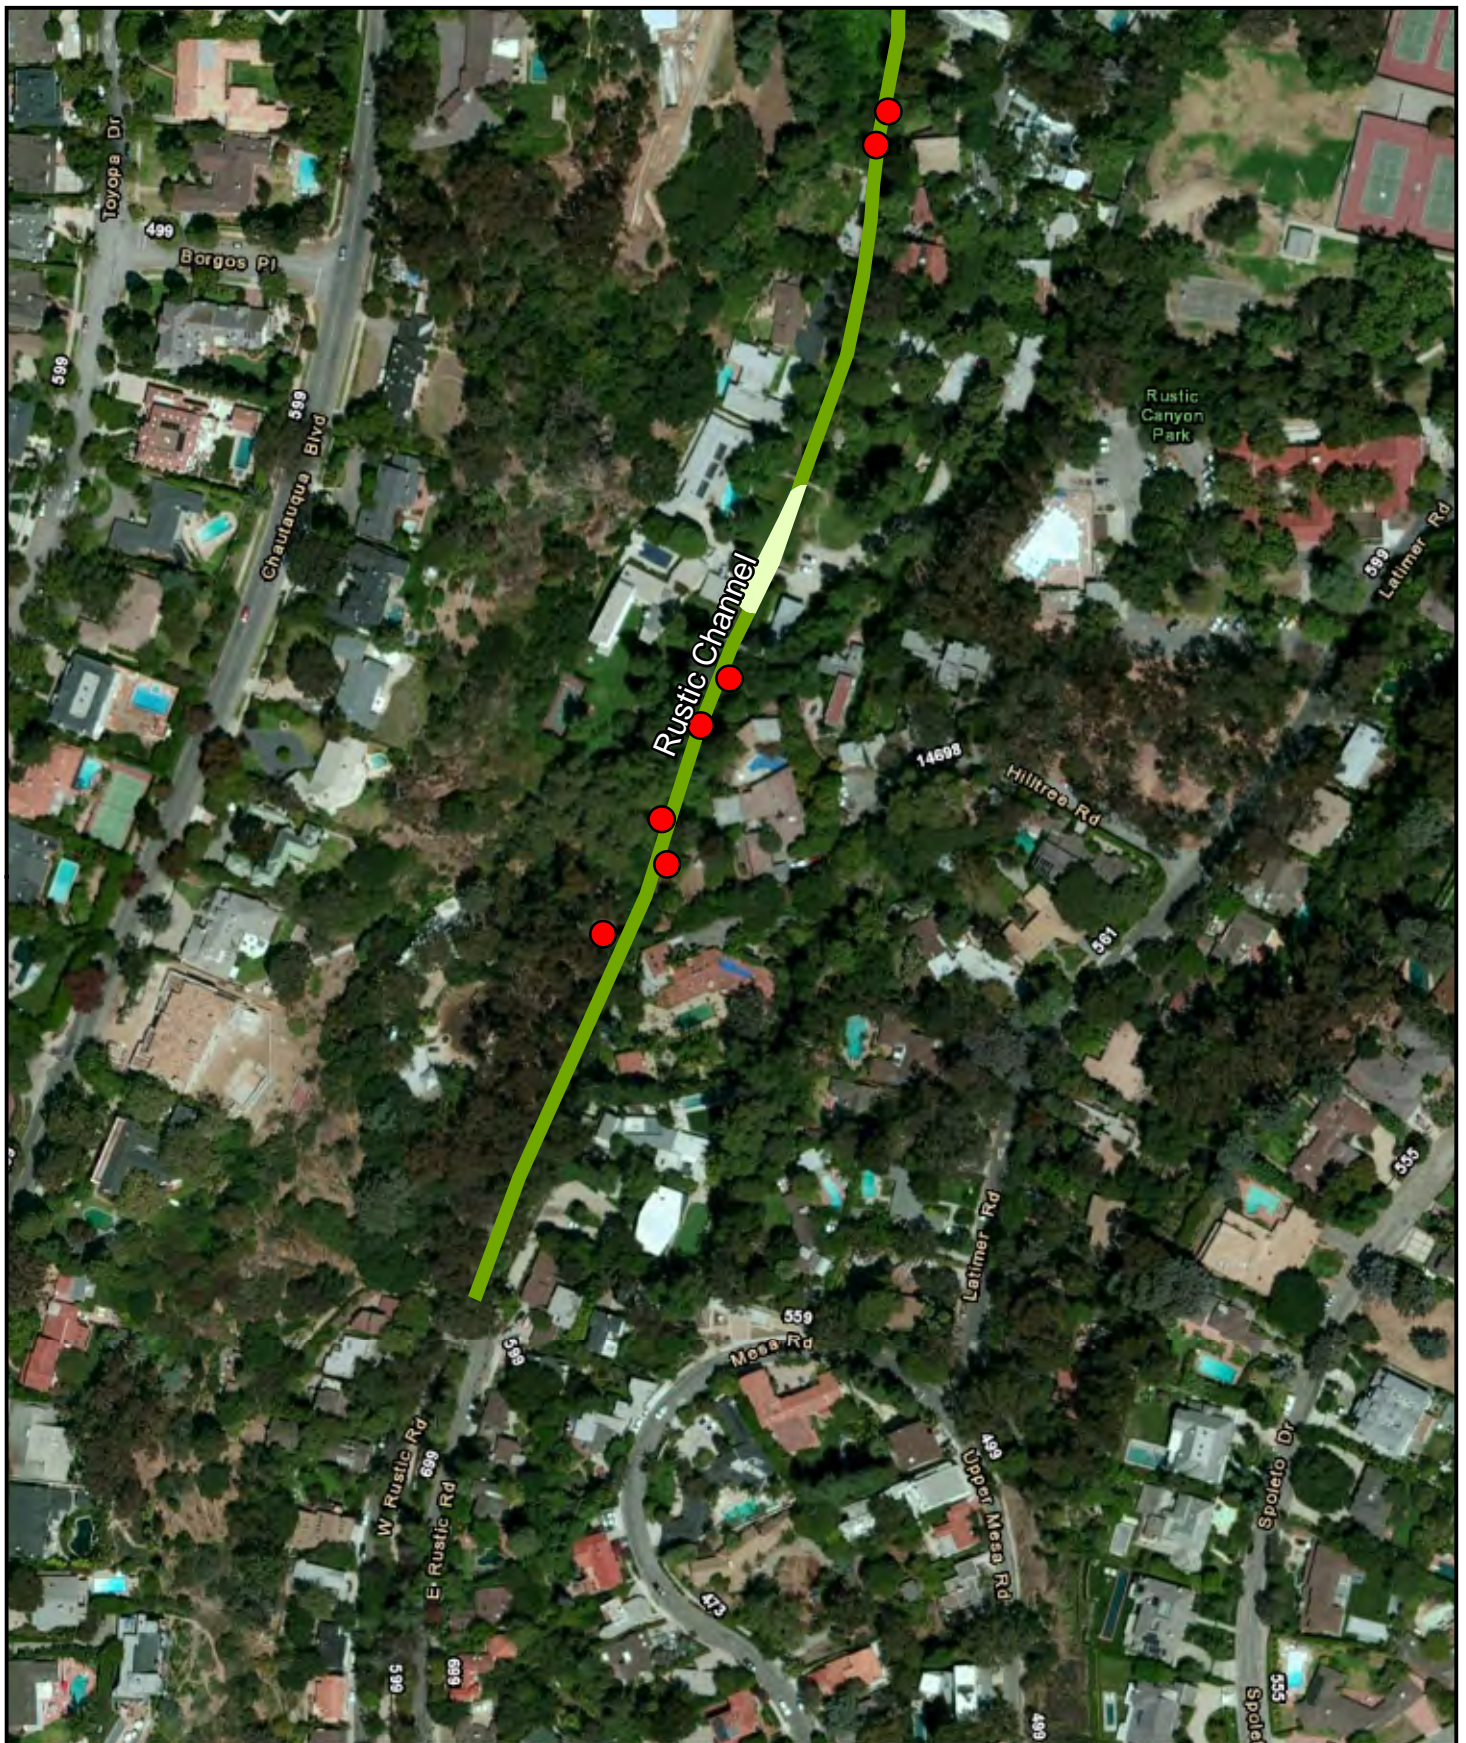
**Figure 2**  
Rustic Creek Reach  
Vegetation Communities Map

## Legend

### Vegetation Community

- Arroyo Willow Thickets
- Disturbed Riparian Species with Escaped Ornamental Species

### Structural Status

- Damage Observed

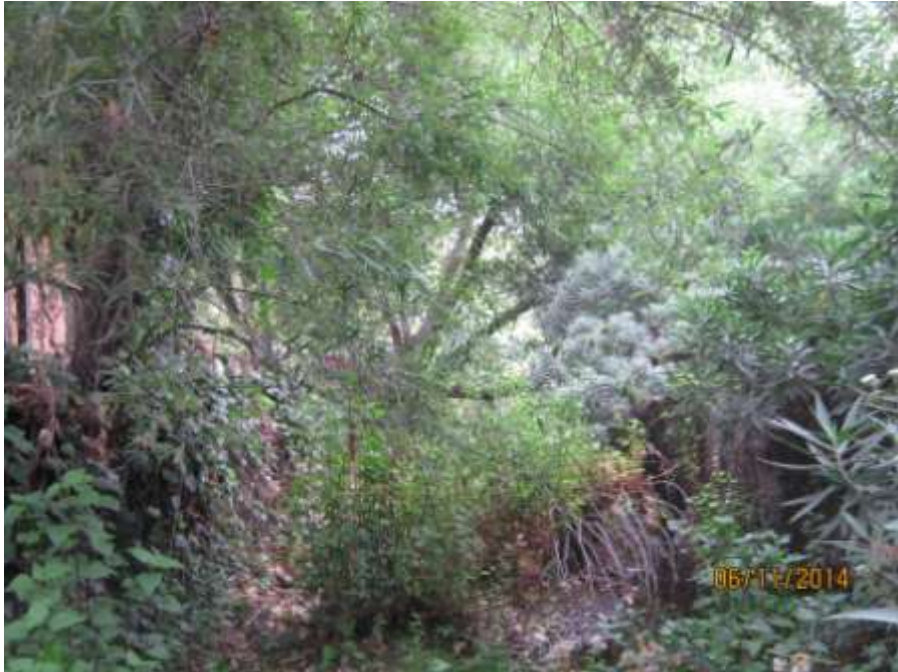
**Photo 1.** Upstream limit of Rustic Reach. Photo showing a section of riparian forest within the Project site. This area can provide potential habitat for nesting birds. Photo facing north.

In order to comply with the Migratory Bird Treaty Act, any vegetation clearing should take place outside the general bird-breeding season (March 15 to August 31), to the maximum extent practical. If this is not possible, prior to Project activities, a qualified biologist should conduct and submit a migratory nesting bird and raptor survey report. The survey should occur no more than three days prior to vegetation removal in the proposed work area, and any occupied passerine and/or raptor nests occurring within or adjacent to the Project area should be delineated. Additional follow-up surveys may be required by the resource agencies. To the maximum extent practicable, a biologist approved exclusionary buffer zone around occupied nests should be maintained during physical ground-disturbing activities. The buffer

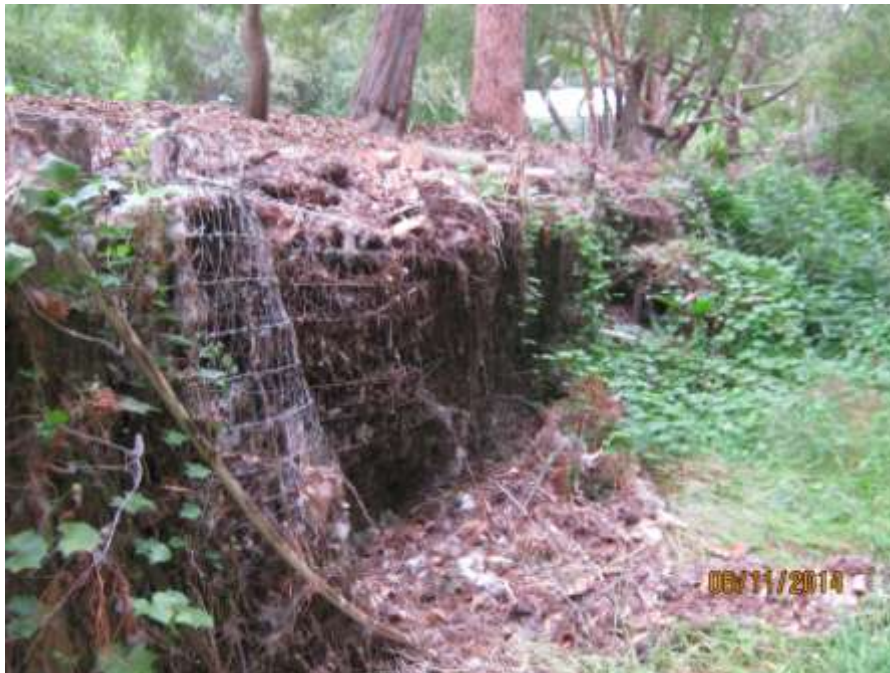
**Photo 2.** Photo showing a segment of the reach where the east side wall is degrading. Photo facing south.

Issue	Easting	Northing	Description
Tree of Heaven ( <i>Ailanthus altissima</i> *)	360566	3768710	Large tree of heaven growing through the fence-like side wall
Willow ( <i>Salix</i> sp.)	359936	3767246	Large willow tree from adjacent property growing onto side wall
Willow ( <i>Salix</i> sp.)	359957	3767269	Large willow tree from adjacent property growing onto side wall
Willow ( <i>Salix</i> sp.)	359968	3767315	Large willow tree from adjacent property growing onto side wall
Willow ( <i>Salix</i> sp.)	360026	3767507	Large willow tree from adjacent property growing onto side wall
Willow ( <i>Salix</i> sp.)	360290	3767934	Large willow tree from adjacent property growing horizontally onto side wall
arroyo willow	360030	3767518	Large arroyo willow from adjacent property growing onto side wall
trees	360357	3768091	Several trees causing structural damage to side wall
arroyo willow	360383	3768112	Arroyo willow causing structure damage to side wall

red willow	360324	3768001	Red willow causing structure damage to side wall
arroyo willow	359955	3767283	Arroyo willow growing through side wall causing structure damage
arroyo willow	359977	3767330	Arroyo willow overhanging onto side wall causing structure damage

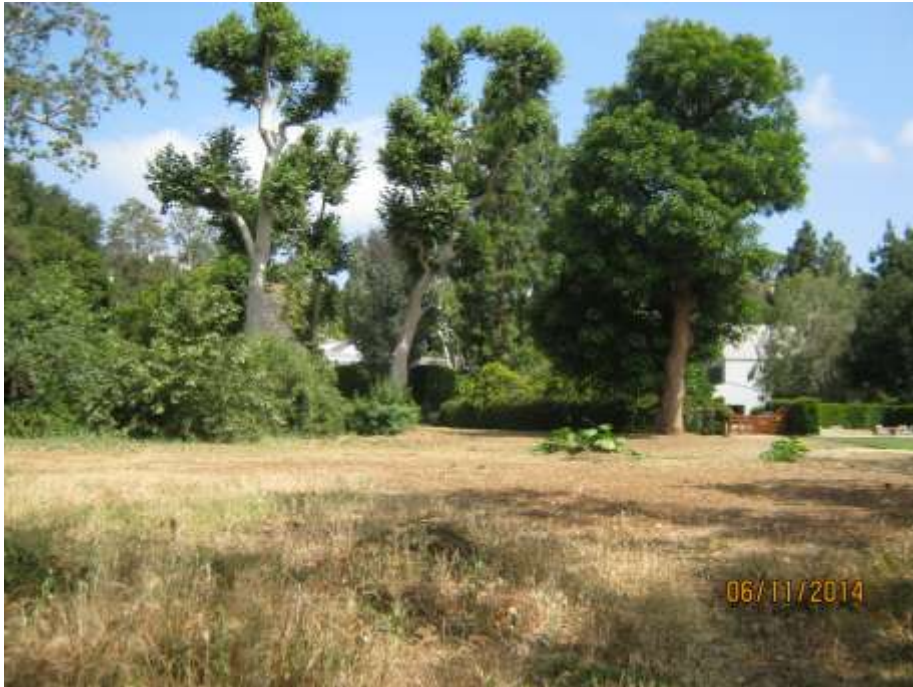
**Photo 3.**  
Proposed staging area at Rustic Creek Lane. Area is flat and comprised of weeds, grasses, and ornamental trees.

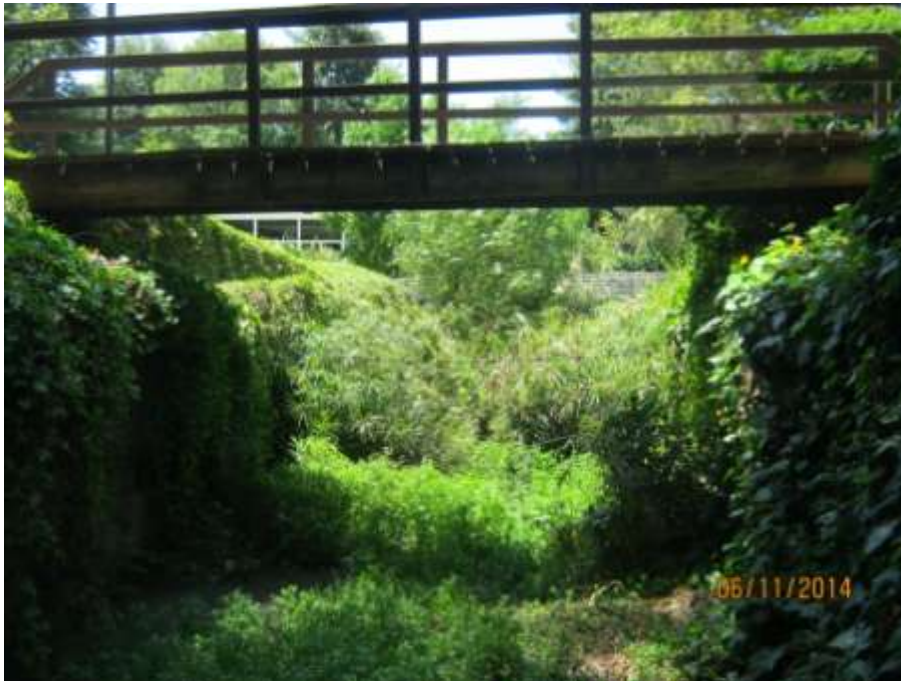
**Photo 4.** Dense non-native vegetation and ornamental vines along the walls, located south of Rustic Creek Lane. Photo facing south.

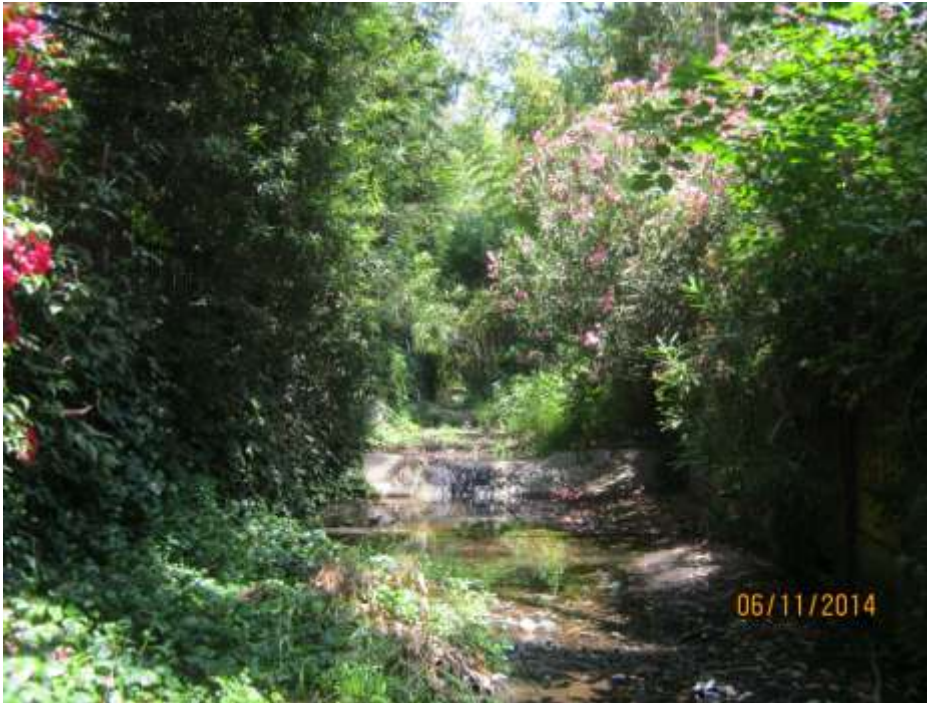
**Photo 5.** Photo showing vegetation within the channel and thick non-native vegetation along the sidewalls, located south of Rustic Creek Lane. Photo facing north.

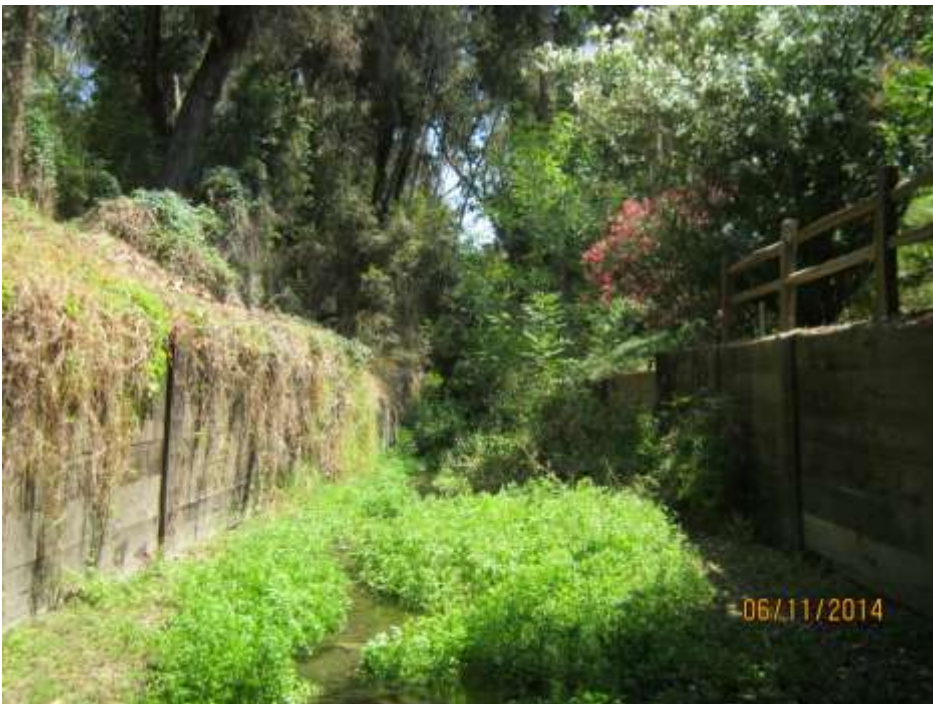
**Photo 6.** Near the southern end of Rustic Reach. Area is composed of sparse herbaceous vegetation. Large non-native trees outside channel walls provide potential habitat for nesting birds. Photo facing north.

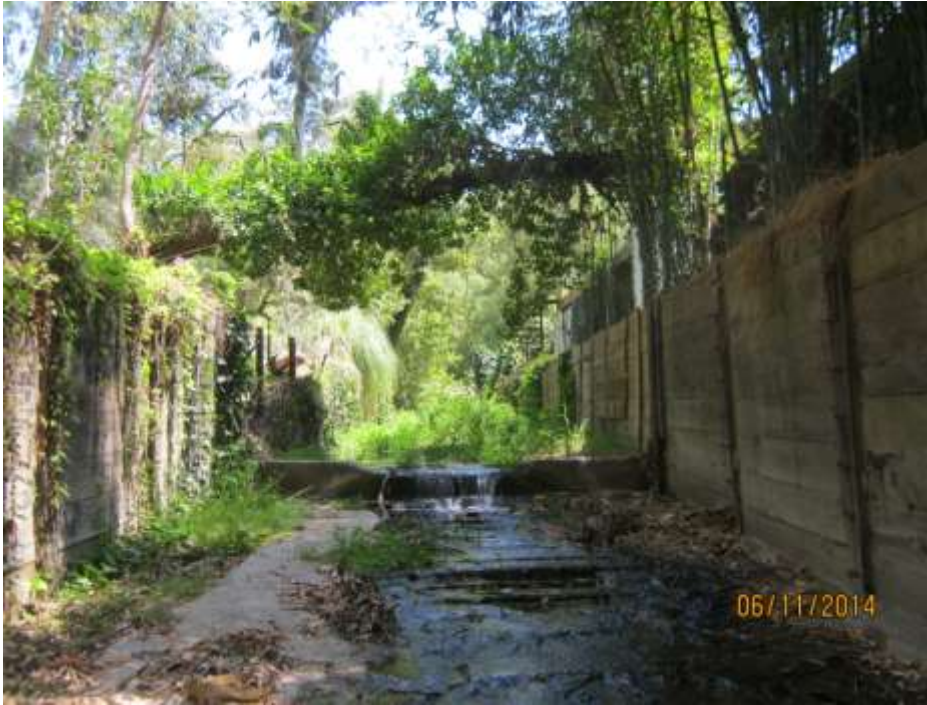
**Photo 7.**  
Downstream limit  
of the Project site.  
Wide section of  
the channel, lined  
with concrete.  
Photo facing  
north.
