Subject: Biological Assessment and Tree Inventory for Reach 103 (Bouquet Canyon Channel) and Reach 108 (Pico Canyon Channel), Los Angeles County, California

SBC Reaches 103/108 Biological Assessment . 120810

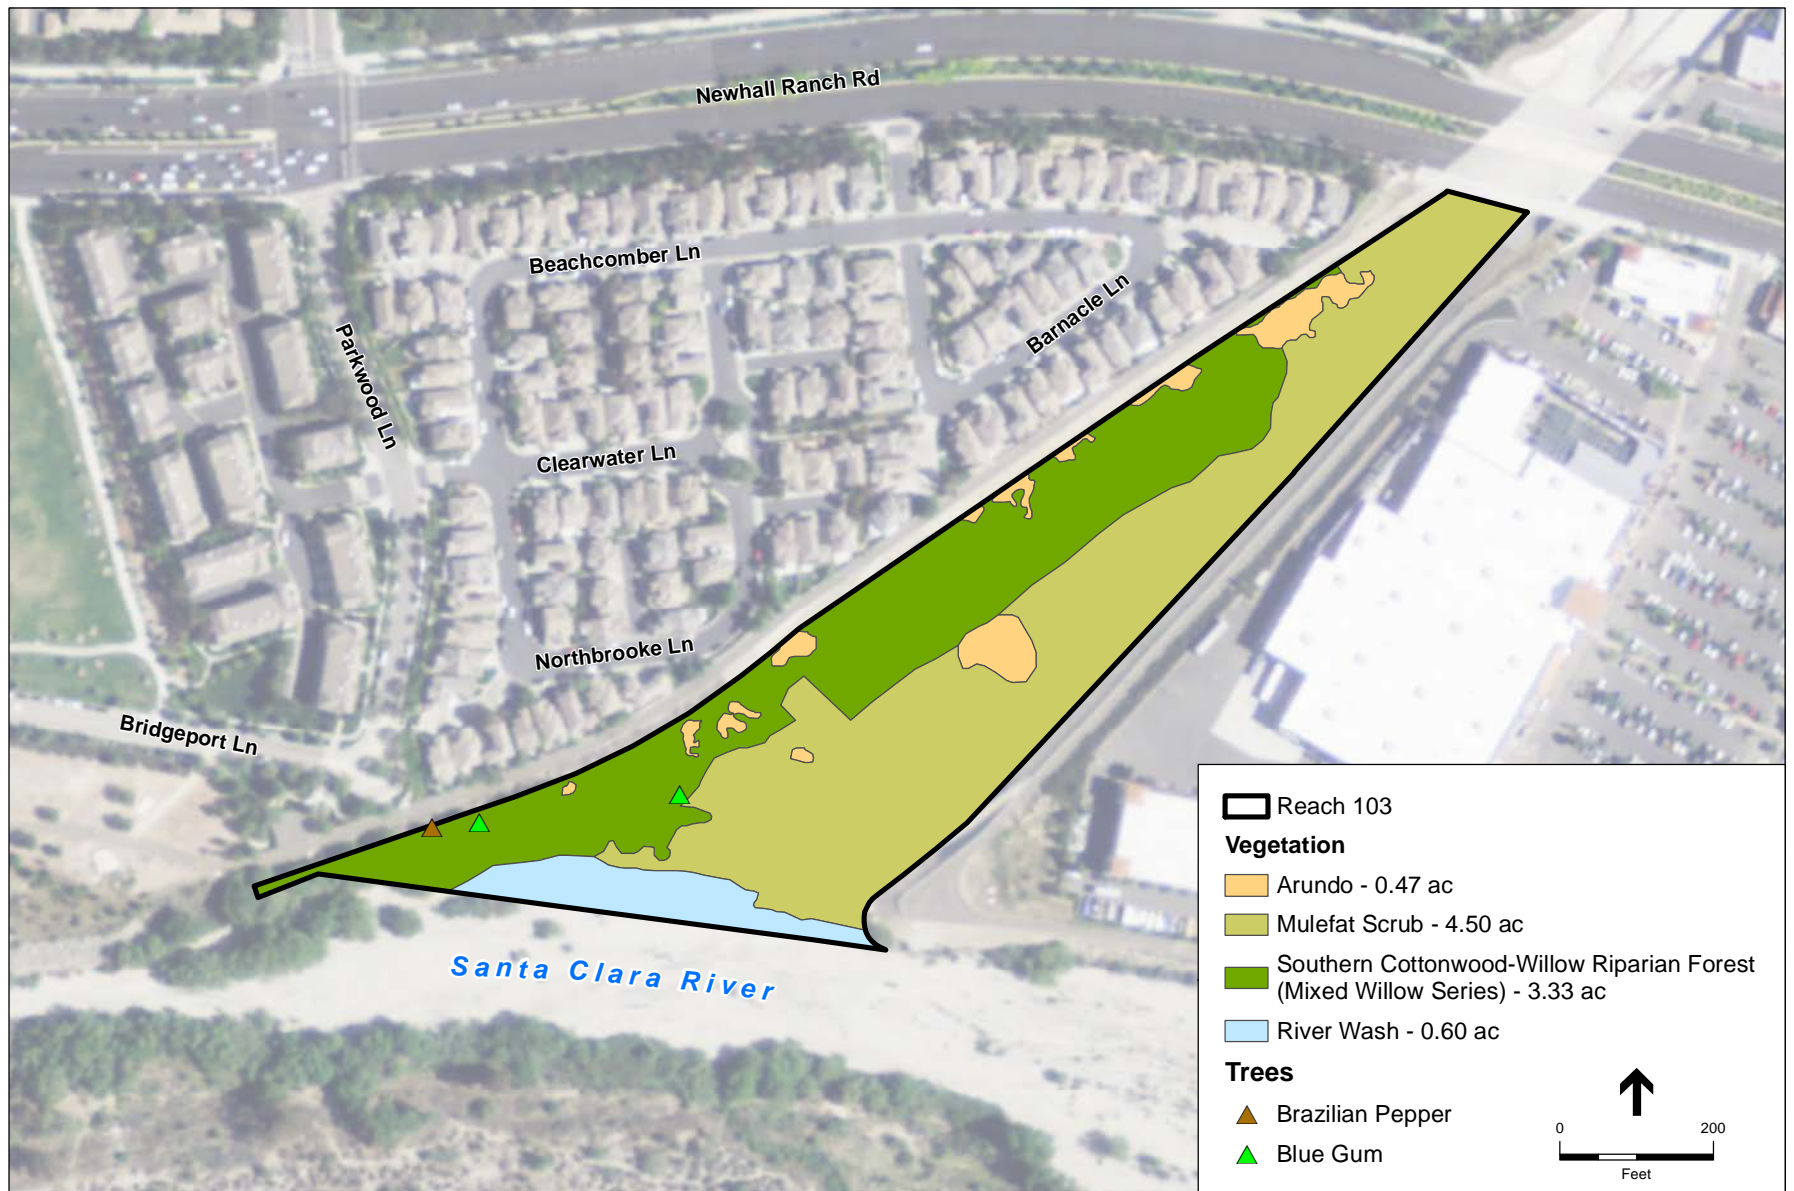
Figure 3
Bouquet Canyon Reach 103 Vegetation Map

Reach 103 is a natural soft-bottom channel, and its confluence with the Santa Clara River is at the southern boundary of the project site (Figure 3). Four vegetation communities were characterized and mapped within the Reach 103 project boundary as described below.

Southern Cottonwood-Willow Riparian Forest (Mixed Willow Series). Southern cottonwood and willow riparian habitat is dominated by mixed willow (*Salix* spp.) trees and shrubs and cottonwoods (*Populus* spp.). Understory species may include mugwort (*Artemisia douglasiana*), stinging nettle and wild cucumber (*Marah macrocarpus*) (Holland 1986). Dominant species observed in this community include red willow (*Salix laevigata*), narrowleaf willow (*Salix exigua*), and Freemont cottonwood (*Populus fremontii*). Other species observed include Pacific willow (*Salix lasiandra*), mulefat (*Baccharis salicifolia*), giant reed (*Arundo donax*), tamarisk (*Tamarix* spp.), and elderberry (*Sambucus mexicana*). Southern cottonwood-willow riparian forest comprises 3.33 acres within the Reach 103 project site (Figure 3).

Arundo. The arundo vegetation community is a monoculture of giant reed (*Arundo donax*). Arundo comprises 0.47 acre within the Reach 103 project site (Figure 3).

Mulefat Scrub. Mulefat scrub is dominated by mulefat, but also may include willows (*Salix* spp.), sedges (*Carex* spp.) and stinging nettle (*Urtica dioica*) (Holland 1986; Sawyer and Keeler-Wolf 1995). In addition to mulefat, other native species found in this community included red willow, narrowleaf willow, and Fremont cottonwood saplings or small trees; common sagebrush, California sagebrush (*Artemisia californica*), California buckwheat (*Eriogonum fasciculatum*), and mugwort. Non-native species observed included red brome (*Bromus madritensis* ssp. *rubens*), milk thistle (*Silybum marianum*), ripgut brome (*Bromus diandrus*) soft chess (*Bromus hordeaceus*), black mustard (*Brassic nigra*), redstem filaree (*Erodium cicutarium*) and tree tobacco (*Nicotiana glauca*). Tree tobacco saplings consist of a few individuals and are scattered throughout the vegetation community. Mulefat scrub comprises 4.5 acres within the Reach 103 project site (Figure 3).

River Wash. River wash includes areas within Reach 103 that are generally void of vegetation. This area includes the active channel that is periodically scoured by seasonal flows. River wash comprises 0.6 acre within the Reach 103 project site (Figure 3).

In Reach 103, the biologists accessed the vegetation within the channel on foot. The inventory consisted of counting each trunk from the base of the tree or from the nearest vantage point when immediate access was not achievable due to dense vegetation. All large non-native trees, such as blue gum (*Eucalyptus globulus*) were mapped and are identified in **Figure 3**.

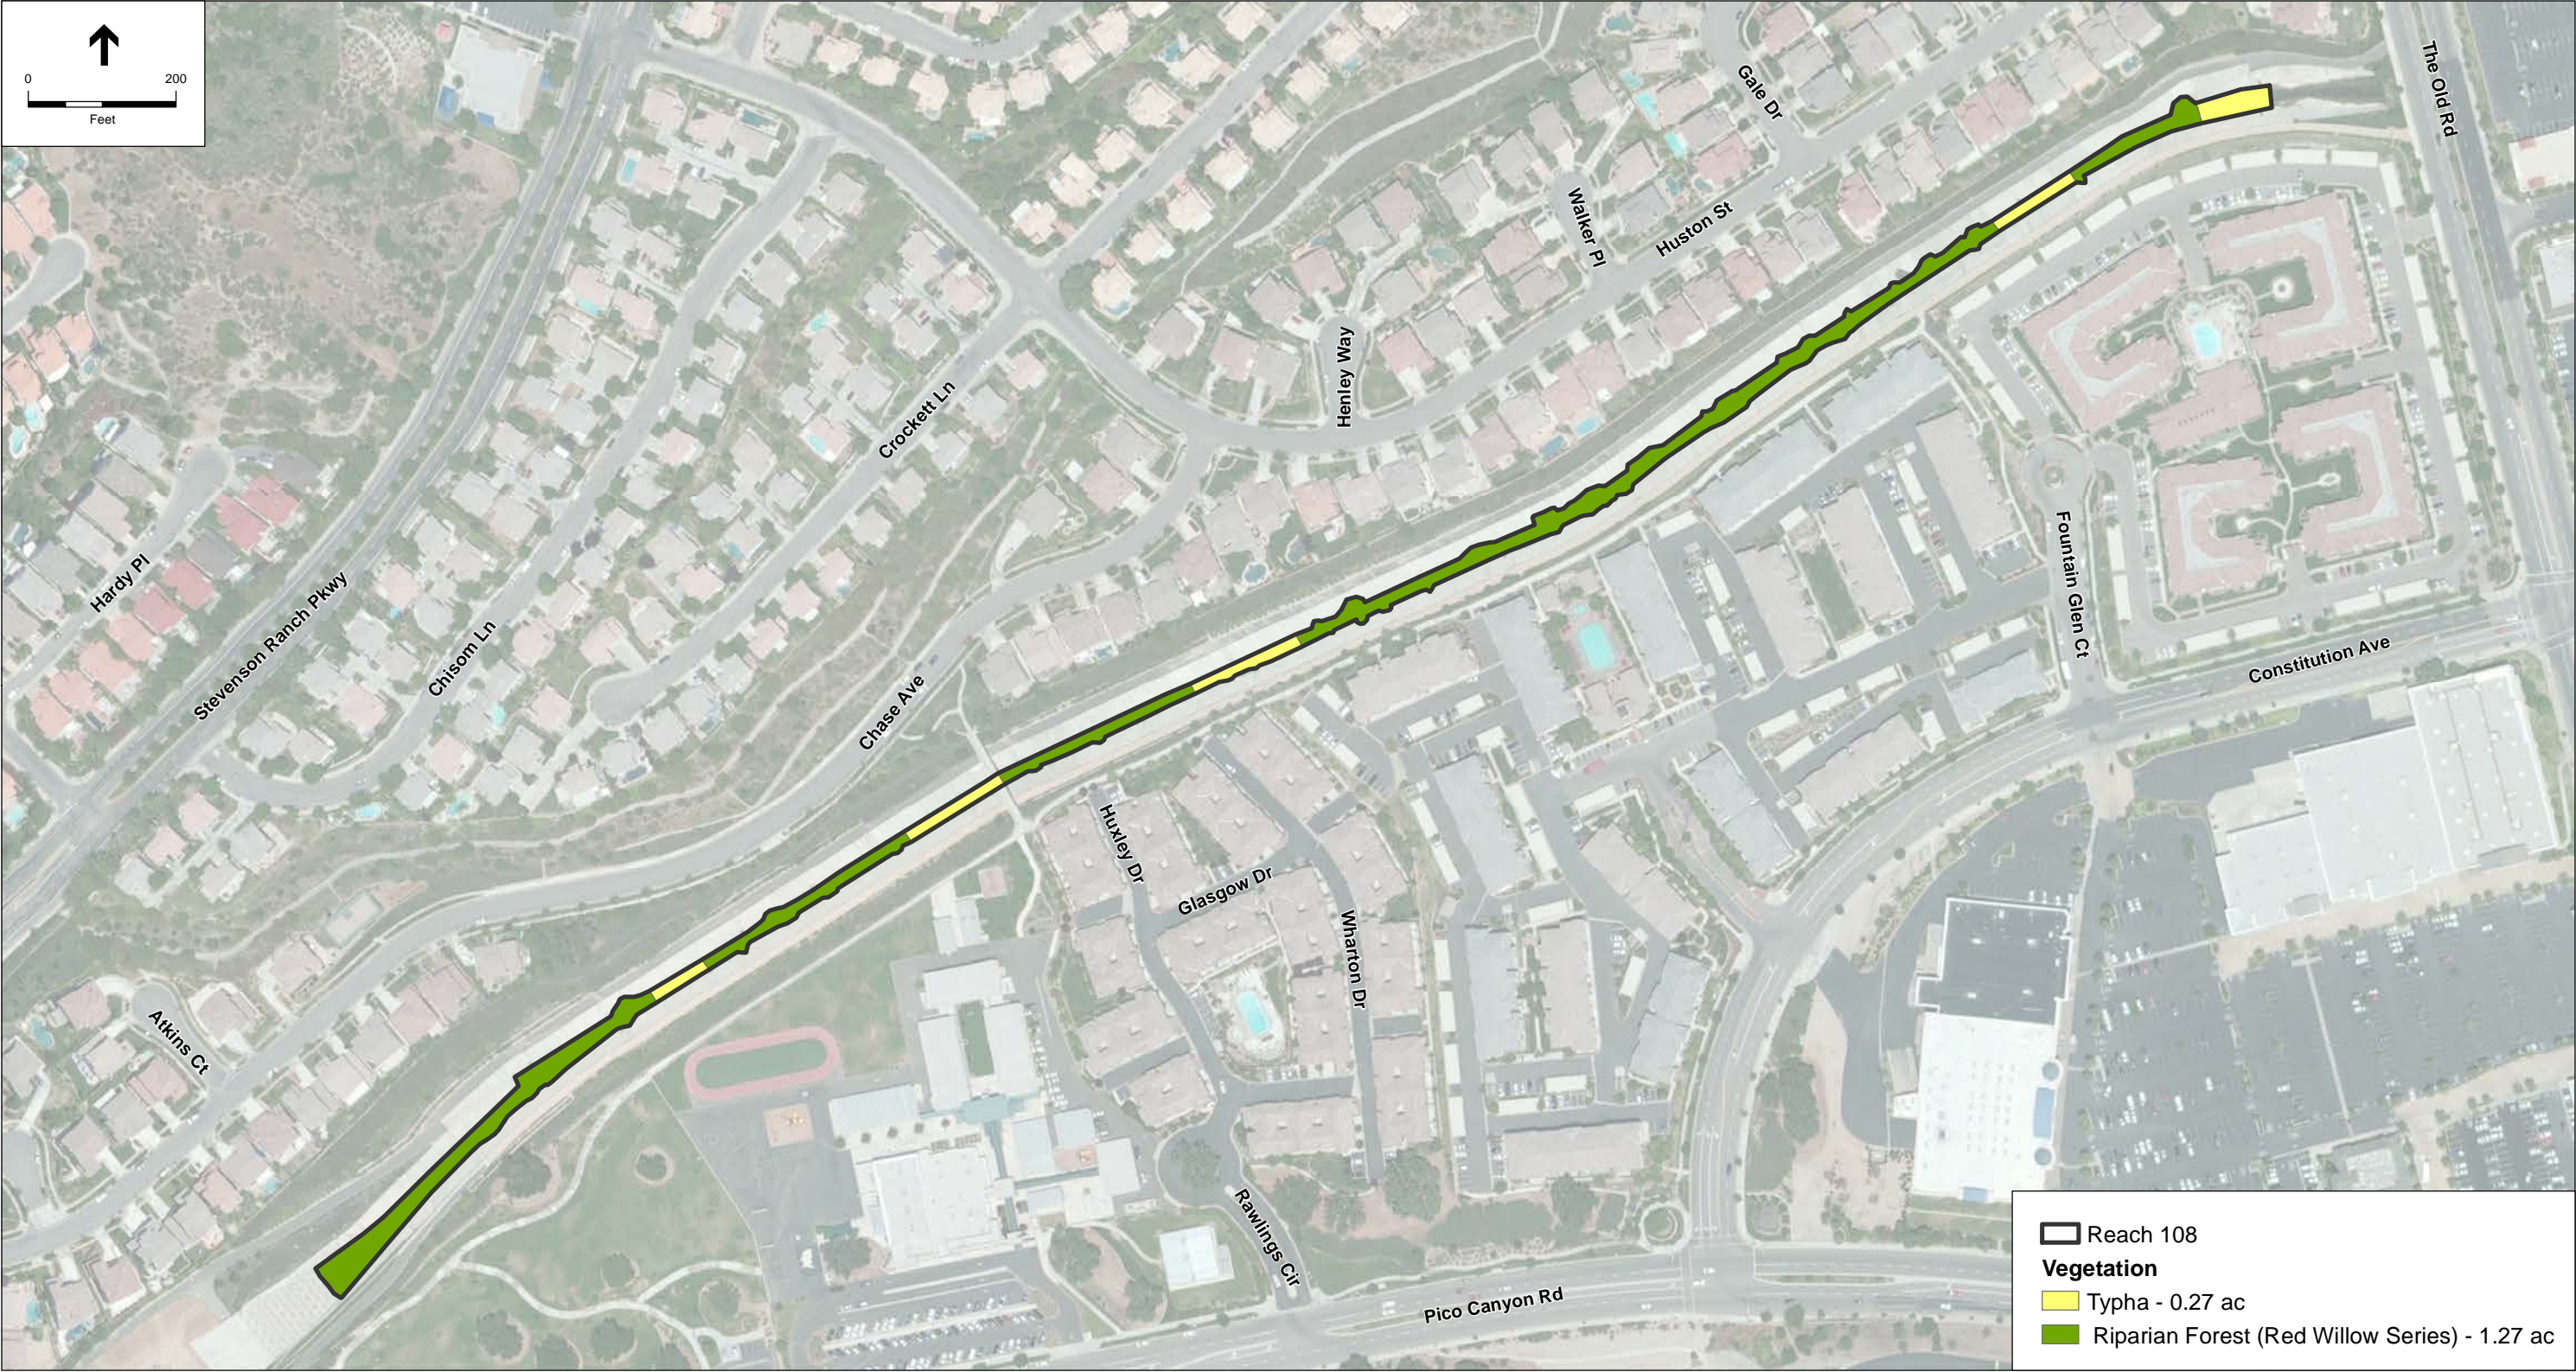
Figure 4

Reach 108 is a soft-bottom channel that drains from the Stevenson Ranch Debris Basin (**Figure 4**). Two vegetation communities were mapped within the Reach 108 project boundary as described below.

Riparian Forest (Red Willow Series). The riparian forest habitat in Reach 108 is dominated by willow species. Dominant species observed include red willow and narrowleaf willow. Other native species observed, but at a much lesser extent, include arroyo willow (*Salix lasiolepis*), Fremont cottonwood, California sycamore (*Platanus racemosa*), Pacific willow, mulefat, and common cattail (*Typha latifolia*). Non-native species observed include tree tobacco, horseweed (*Conyza* spp.). Riparian forest comprises 1.27 acres within the Reach 108 project site (Figure 4).

Typha. The typha community is a monoculture of common cattail. Other species observed around the fringes of this community include mulefat, tamarisk, coyote brush (*Baccharis pilularis*), and two small Mexican fan palms (*Washingtonia robusta*). The typha community comprises 0.27 acre within the Reach 108 project site (Figure 4).

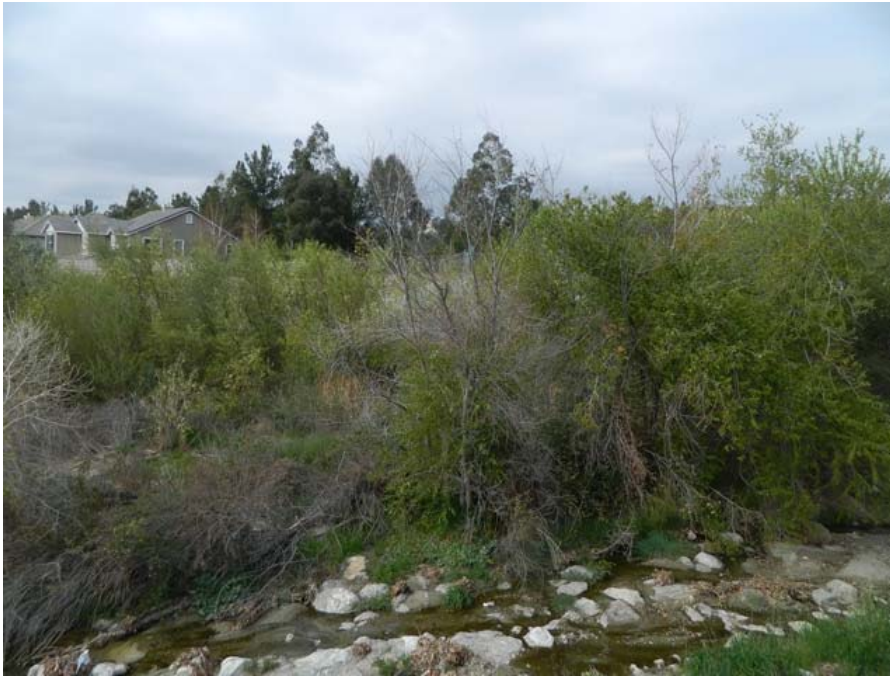
Photo 1. Facing northwest from an adjacent public walkway, immediately southwest of Newhall Ranch Road. Photo depicts dense willow vegetation present within Bouquet Canyon Creek, along Reach 103.

As shown in Photos 1-4 (Appendix A), the riparian forest in both reaches is too dense to collect attribute data for each tree, such as height and canopy spread. Therefore, under the supervision of the certified arborist, all trees with a trunk diameter of two-inches or greater were inventoried. Trunk diameters were approximated at 4.5 feet above the natural grade (also referred to as diameter at breast height [dbh]), and separated into three size classes: 2-5 inches, 6-10 inches and greater than 10 inches. For multiple trunked trees, the largest trunk diameter was measured (**Table 1**).

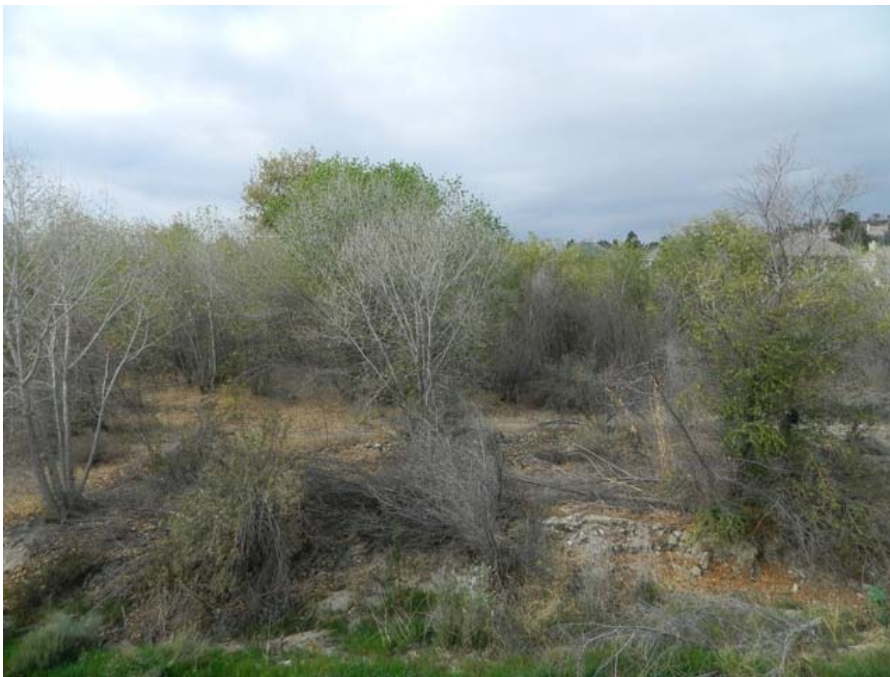
Photo 2. Facing northwest from an adjacent public walkway. Photo depicts dense cottonwood-willow riparian vegetation present within Bouquet Canyon Creek, along Reach 103.

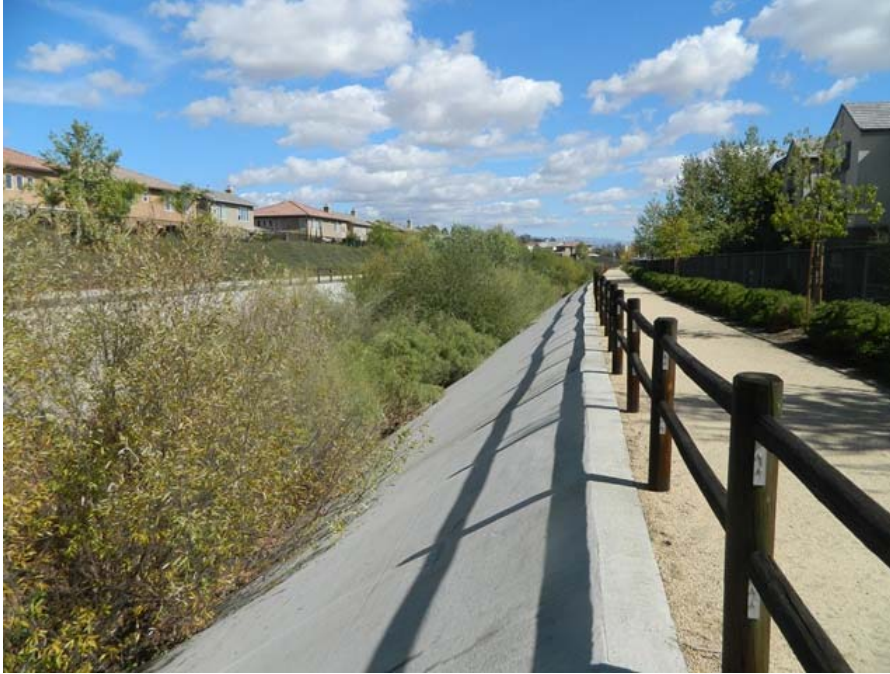
Photo 3. Facing northeast from an adjacent public walkway. Photo depicts dense riparian forest vegetation present within the Pico Canyon Channel, along Reach 108.

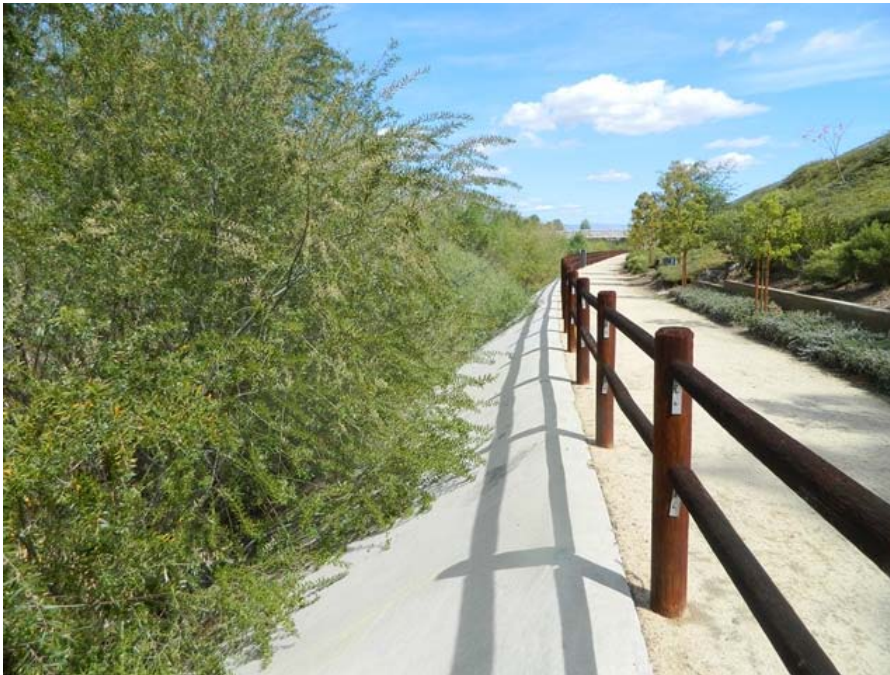
Photo 4. Facing northeast from an adjacent public walkway. Photo depicts dense riparian forest vegetation present within the Pico Canyon Channel, along Reach 108.
