**Initial Study  
and Mitigated Negative Declaration  
for the  
Parrott Phelan Restoration and Maintenance Project  
December 2020**

Butte County Department of Development Services  
7 County Center Drive, Oroville, CA 95965

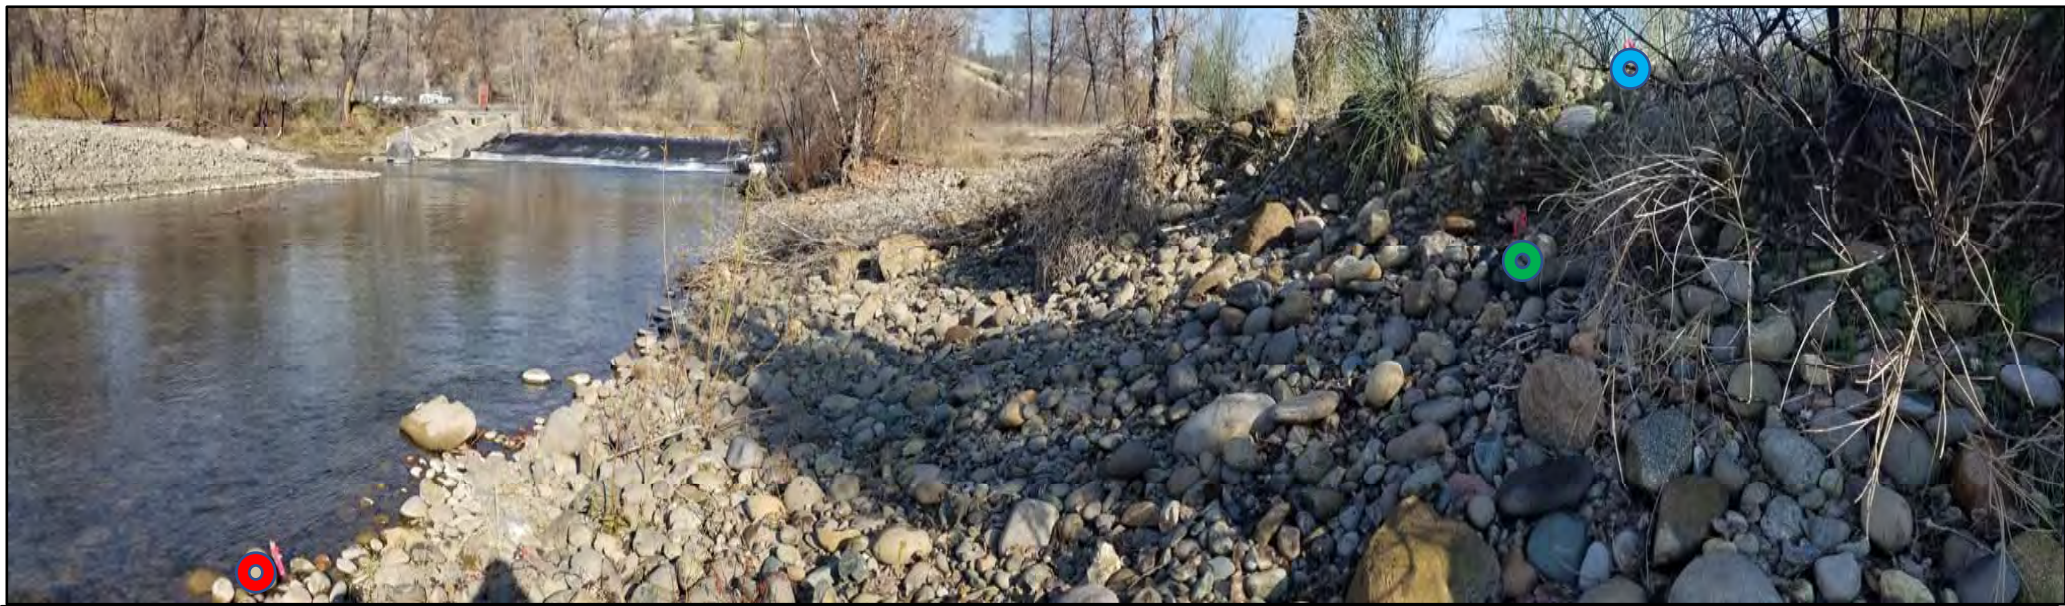
PHOTO 13 - Parrott-Phelan Restoration – Transect 2, River Left  
Standing on the southern bank of Butte Creek facing east.

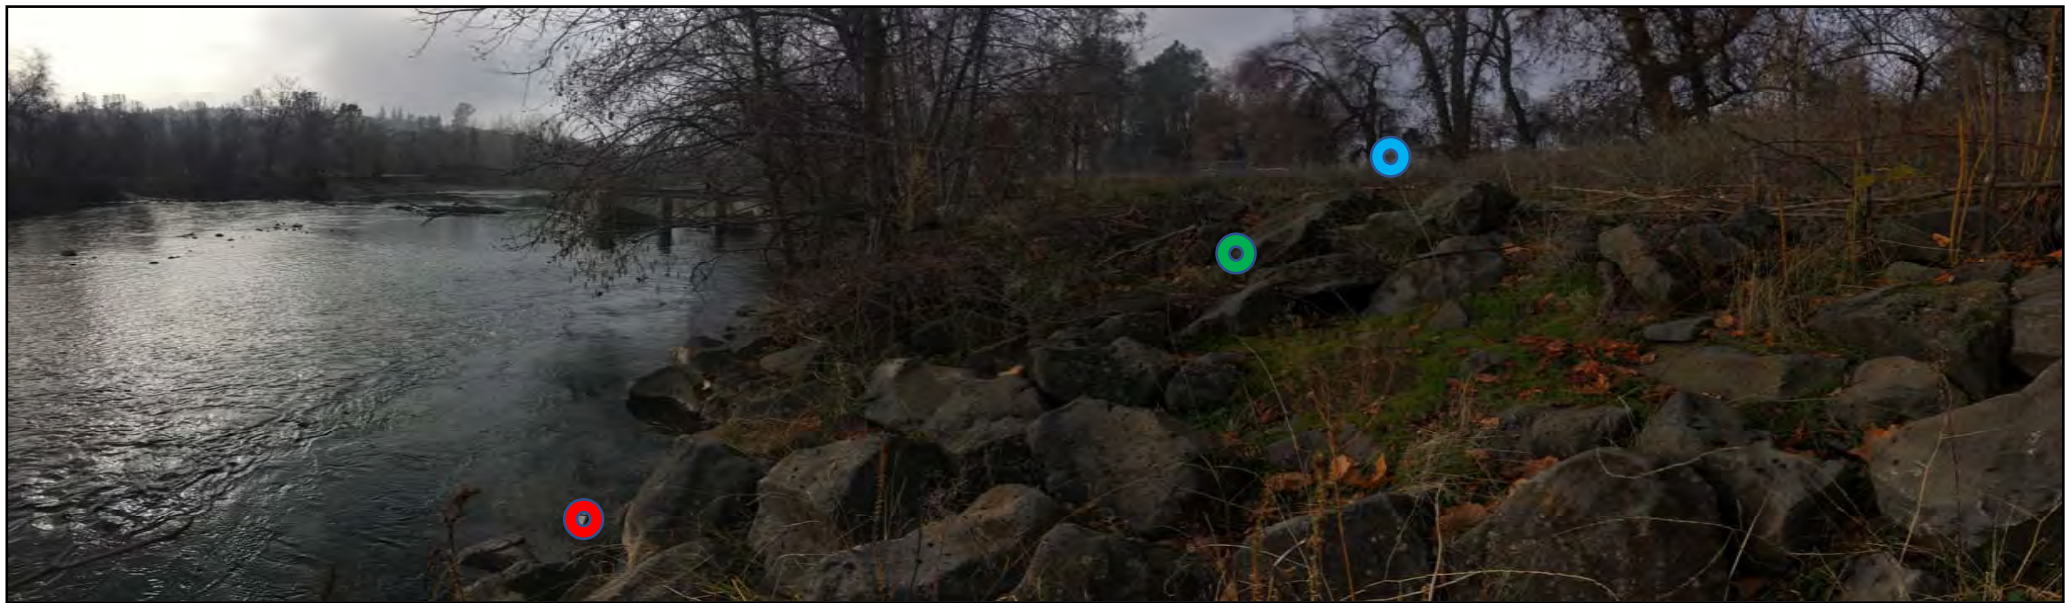
PHOTO 14 - Parrott-Phelan Restoration – Transect 5, River Right  
Standing on the northern bank of Butte Creek facing west.

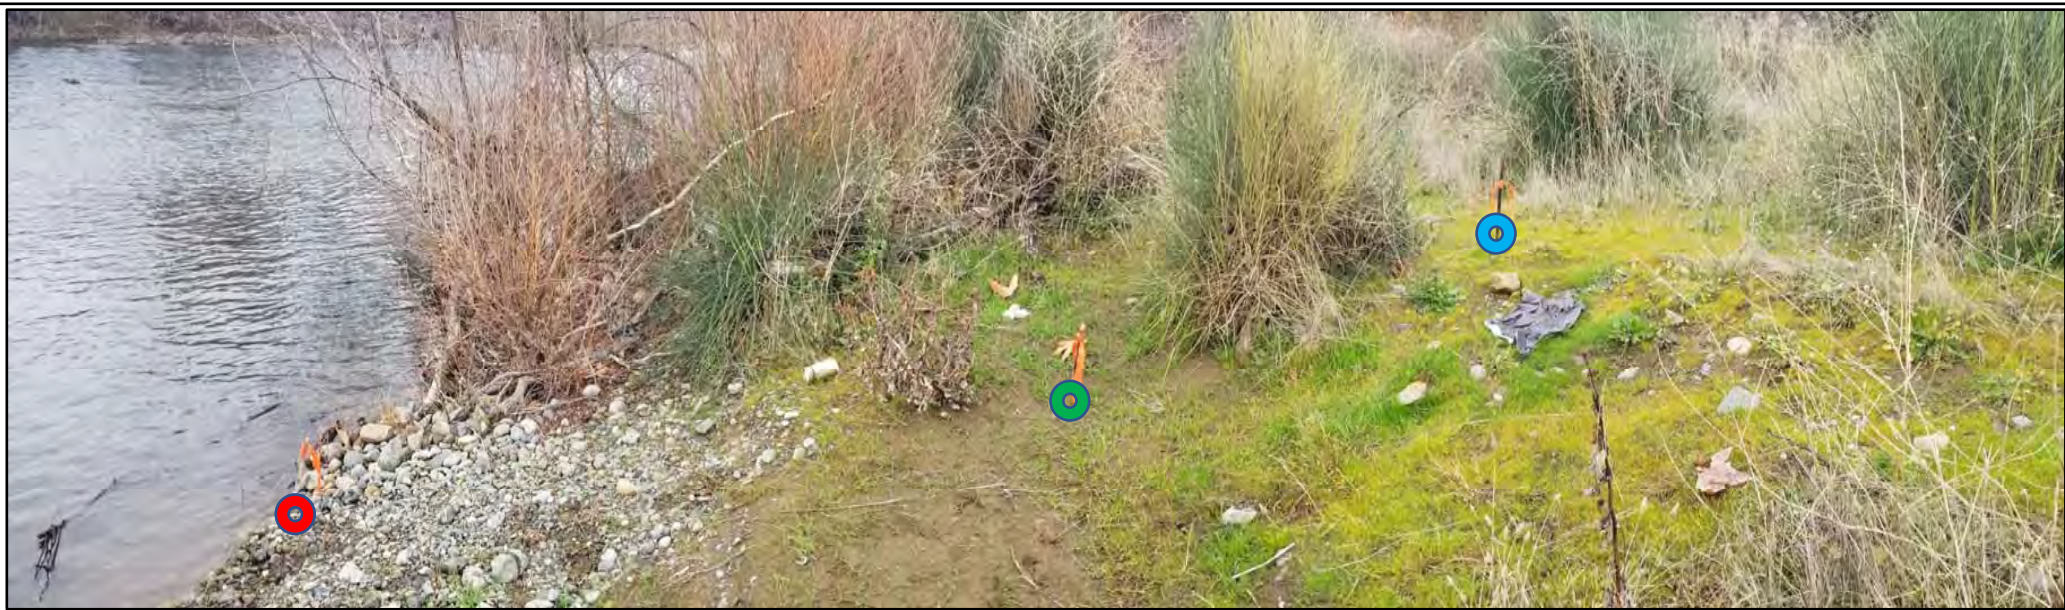
PHOTO 15 - Parrott-Phelan Restoration – Transect 6, River Right  
Standing on the northern bank of Butte Creek facing west.

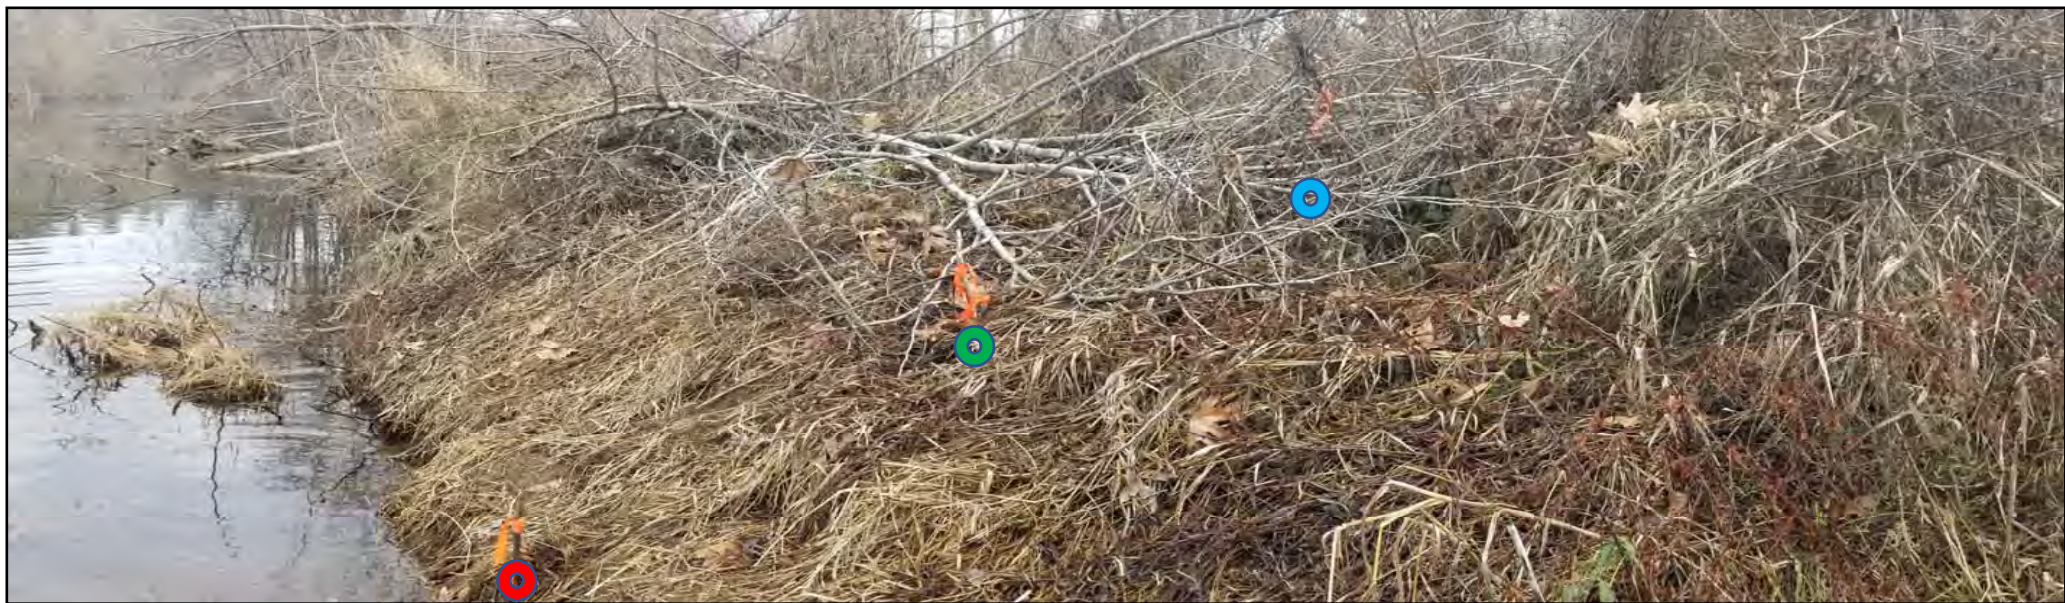
PHOTO 16 - Parrott-Phelan Restoration – Transect 8, River Left  
Standing on the southern bank of Butte Creek facing east.

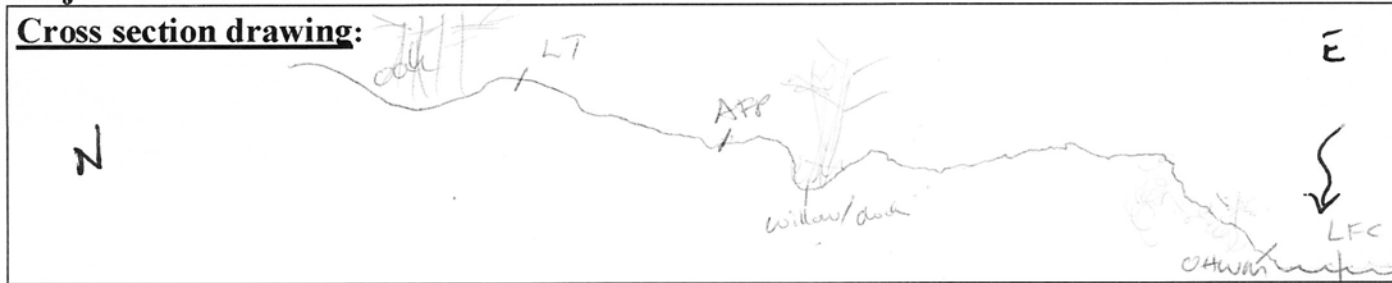
**Cross section drawing:**

**OHWM**

GPS point: T1-RR-OHWM

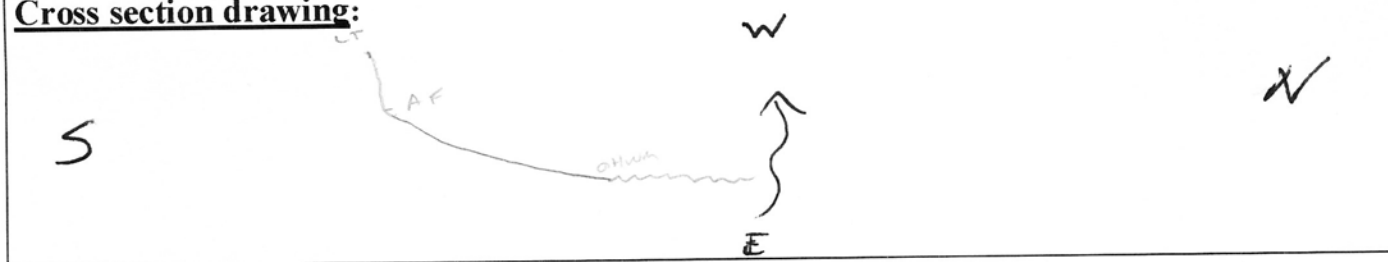
Cross section drawing:

OHWM

GPS point: T1-RL-OHWM
