**PRELIMINARY GEOTECHNICAL ENGINEERING
INVESTIGATION
RICHMOND ELEMENTARY SCHOOL RELOCATION
PROJECT
RIDGECREST, CALIFORNIA**

BSK PROJECT G20-078-11B

**PREPARED FOR:
SIERRA SANDS UNIFIED SCHOOL DISTRICT
113 W. FELSPAR AVENUE
RIDGECREST, CALIFORNIA 93555**

APRIL 28, 2020

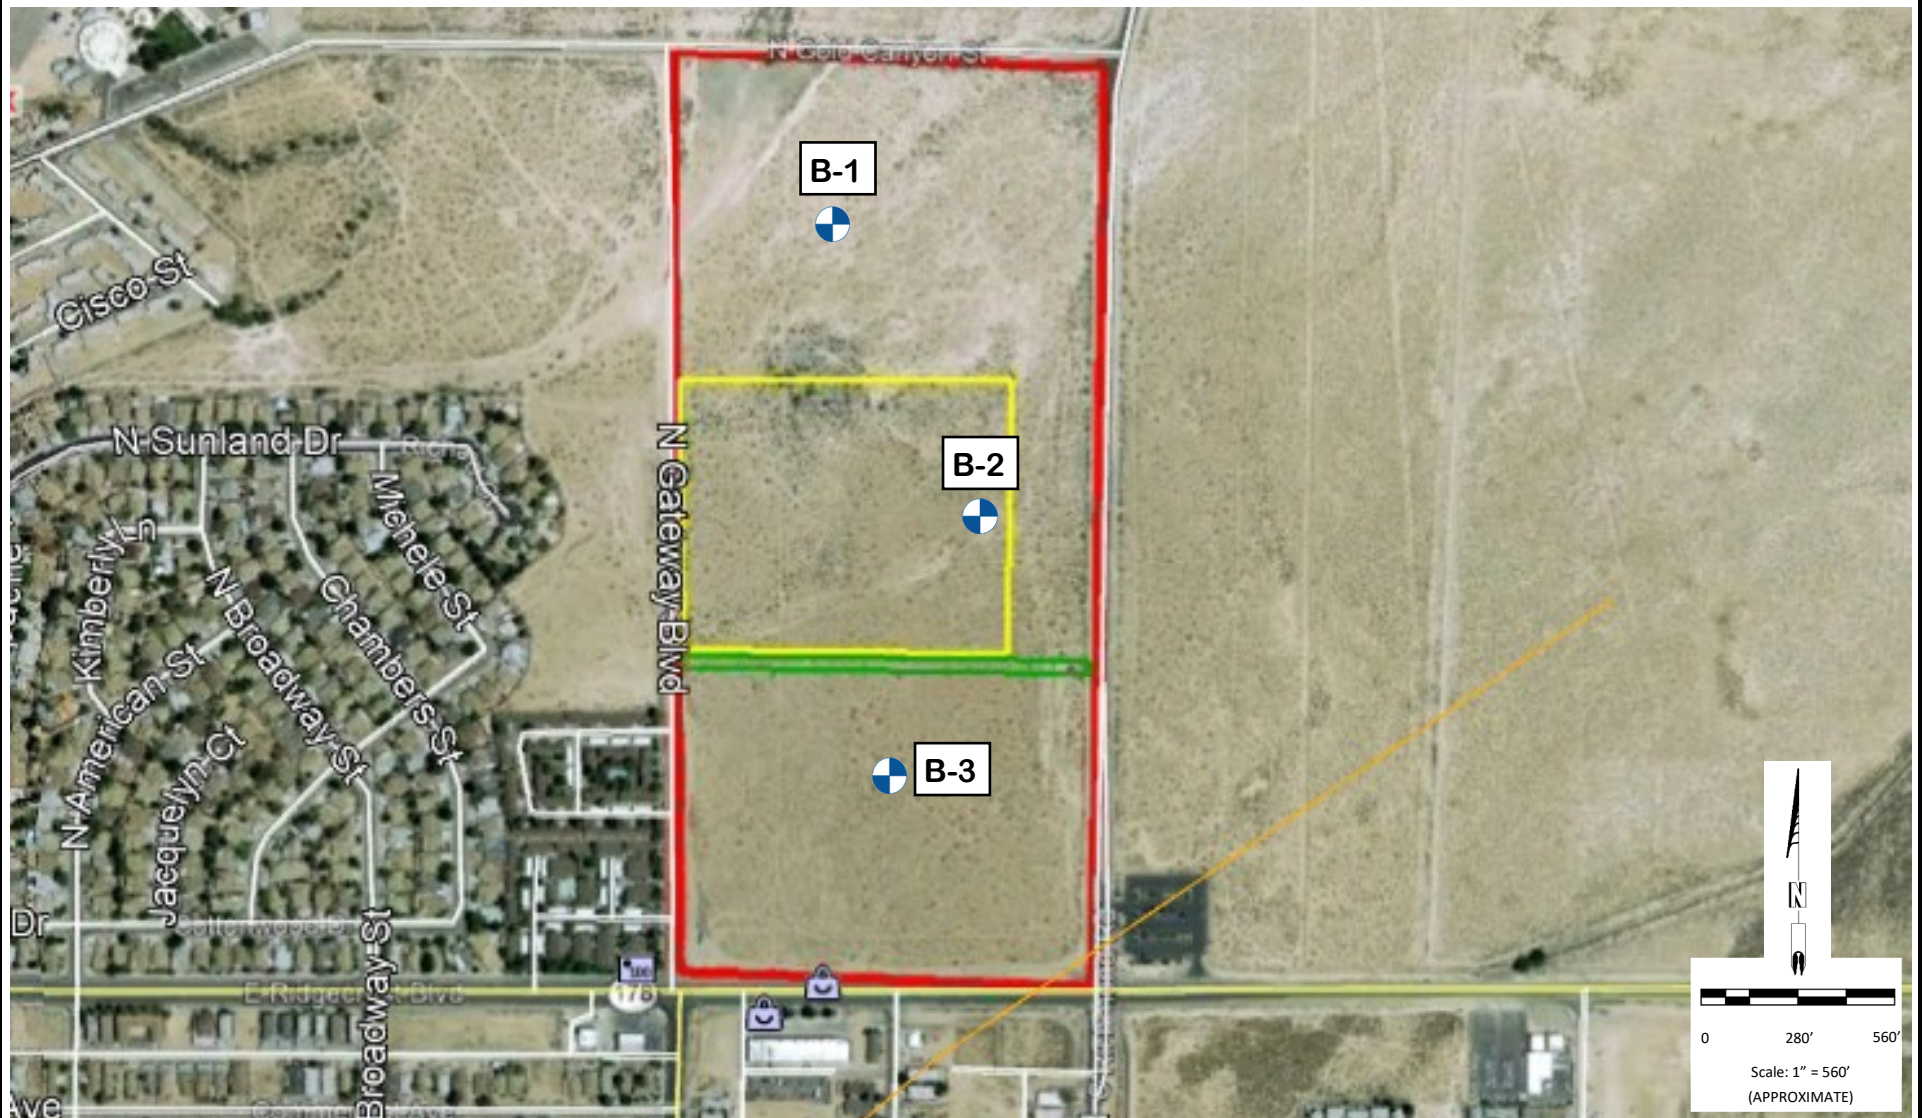
The analyses and recommendations submitted in this report are based upon the data obtained from the Borings performed at the locations shown on the Boring Location Map, Figure A-2. The report does not reflect variations which may occur between or beyond the Borings. The nature and extent of such variations may not become evident until construction is initiated. If variations then appear, a re-evaluation of the recommendations of this report will be necessary after performing on-Site observations during the excavation period and noting the characteristics of the variations.
