Phillipsville Community Services District  
Water Quality, Supply, and Distribution Improvements  
Preliminary Engineering Report

# Phillipsville Community Services District Water Quality, Supply and Distribution Improvements Preliminary Engineering Report

Date: February 19, 2021  
Prepared by: Sheila Magladry, P.E.  
Checked by: Tim Durbin, P.E.  
Sami Kader, P.E.

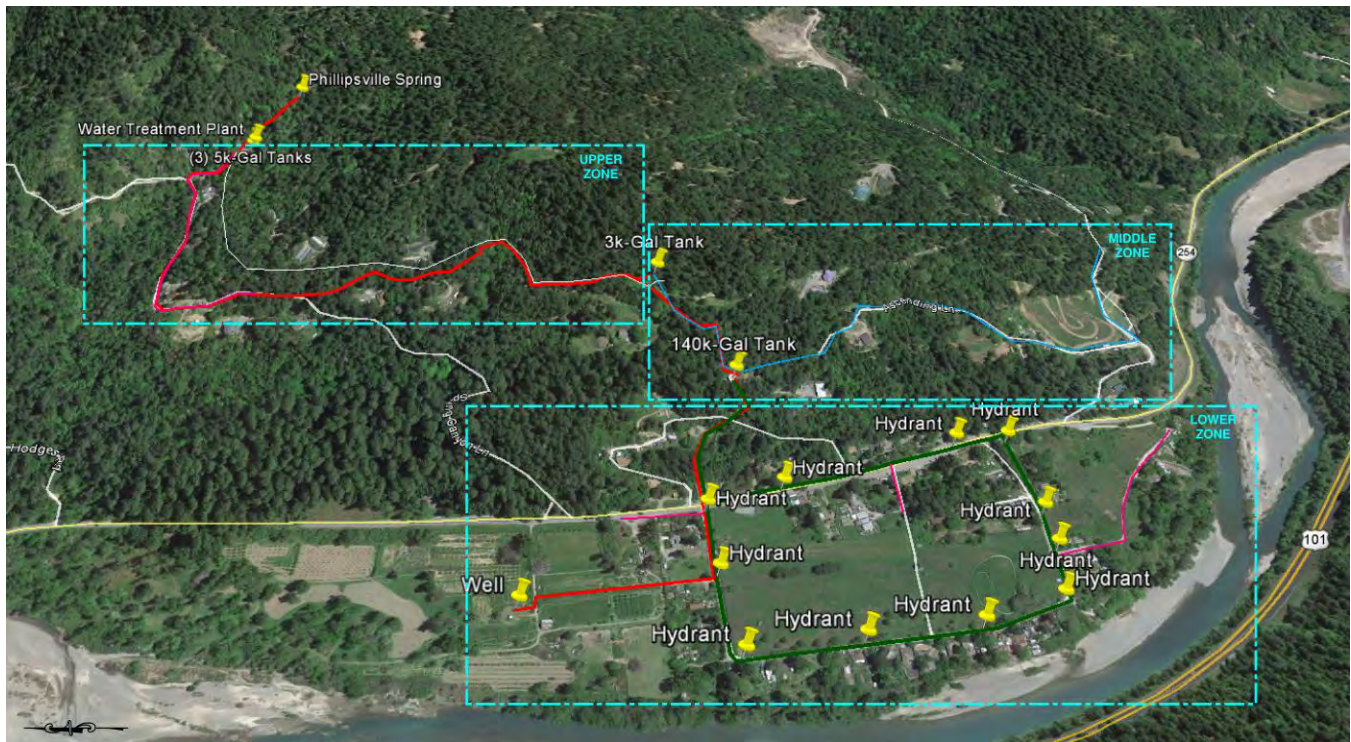
**Figure 2: PCSD Facilities**

Figure 2 shows a map of the existing service area, facilities, and approximate distribution pipeline alignments. The pipelines are color coded by size: 6" is green, 3" is red, 2" is pink, and 1.5" is blue.

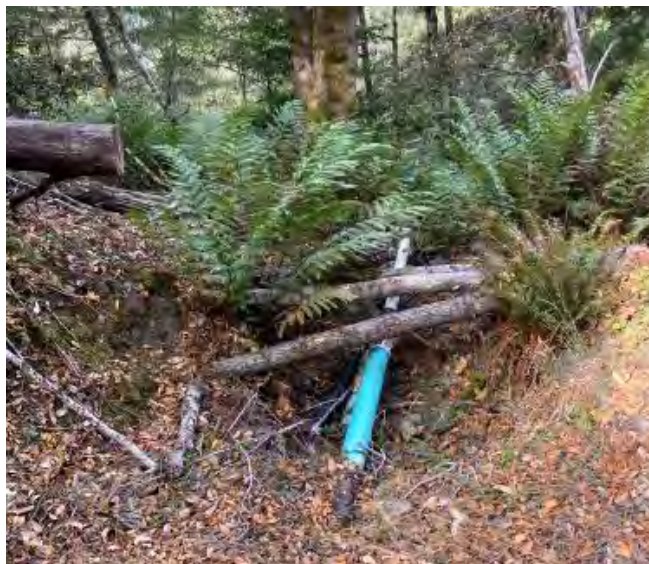
**Figure 4: Spring Discharge Piping**

After the 2009 Improvements Project, a second 6" collection pipe was added above the original 6" collection pipe to improve the water collection from the spring. The two C900 PVC collection pipes join at an overflow tee and then transition down to 2" HDPE pipe. The spring effluent piping where the 6" combined piping transitions to the 2" HDPE piping is shown in Figure 4. The spring area is just beyond the ferns in the photograph.

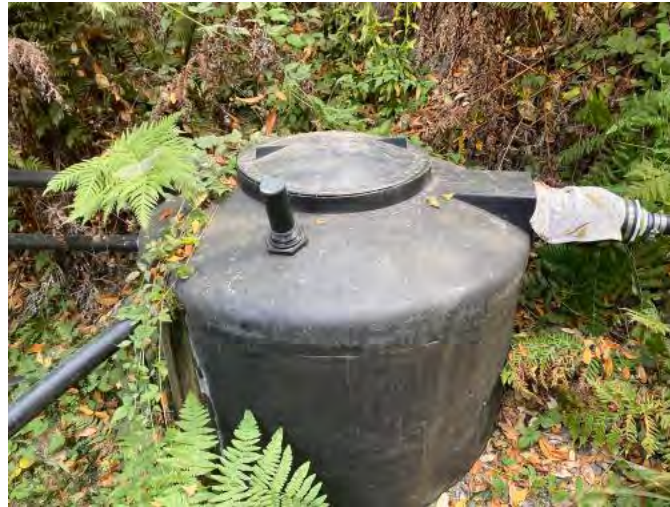
**Figure 5: Spring Overflow Tank**

A tank is located along the 2" HDPE pipeline between the spring and the spring WTP. The tank is shown in Figure 5. The tank was installed to settle out small rocks and gravels entrained into the spring source water by the spring collection area materials. The tank bypasses spring flows when the hydraulic grade line reaches the tank overflow elevation. According to Google Earth elevations, the tank is located at approximately the same elevation as the

spring, so it is unclear if the overflow elevation of the tank prevents over-pressurization of the filters at the spring WTP.

The above grade pipeline between the spring and the WTP will not be improved. The tank below the spring site will be bypassed, and the wye-strainer housings on the influent line near the WTP will be removed and replumbed with 2" HDPE pipe. It is recommended the District demolish the tank following the completion of the project. The raw water sampling location will be moved just upstream of the flow meter into the spring WTP. The sampling site will be from a sample tap inside of the spring WTP.

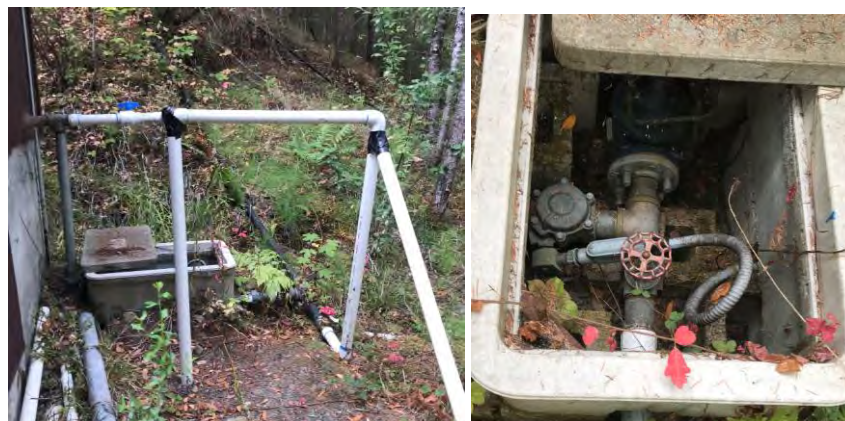
**Figure 6: WTP Influent Plumbing and Bypassed PRV**

The influent piping enters the spring WTP through haphazard PVC piping on the rear side of the WTP building (Figure 6). There are no pipe supports, and the connections are held together with duct tape. This piping arrangement was installed after the 2009 improvements project to bypass the pressure reducing valve (PRV) located in the valve box in Figure 6. The 2009 construction drawings show the PRV was designed to reduce pressure into the filters and bypass excess flows to Tank C.

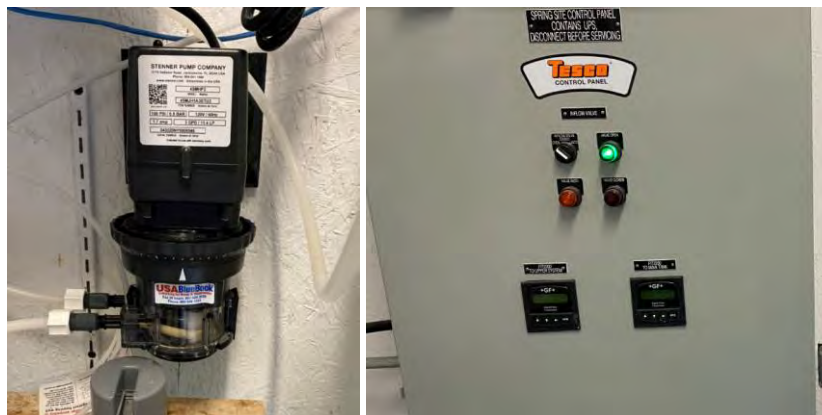
**Figure 8: Chlorine Feed Pump and Tesco Panel**

The chlorine source is sodium hypochlorite. The chlorine solution tank is stored in the spring WTP building. There is no secondary containment for the solution tank. The feed pump is a peristaltic pump, shown in Figure 8.

The control panel mounted on the wall in Figure 8 contains a flow totalizer and control modes for the bypassed PRV. This panel is not used.

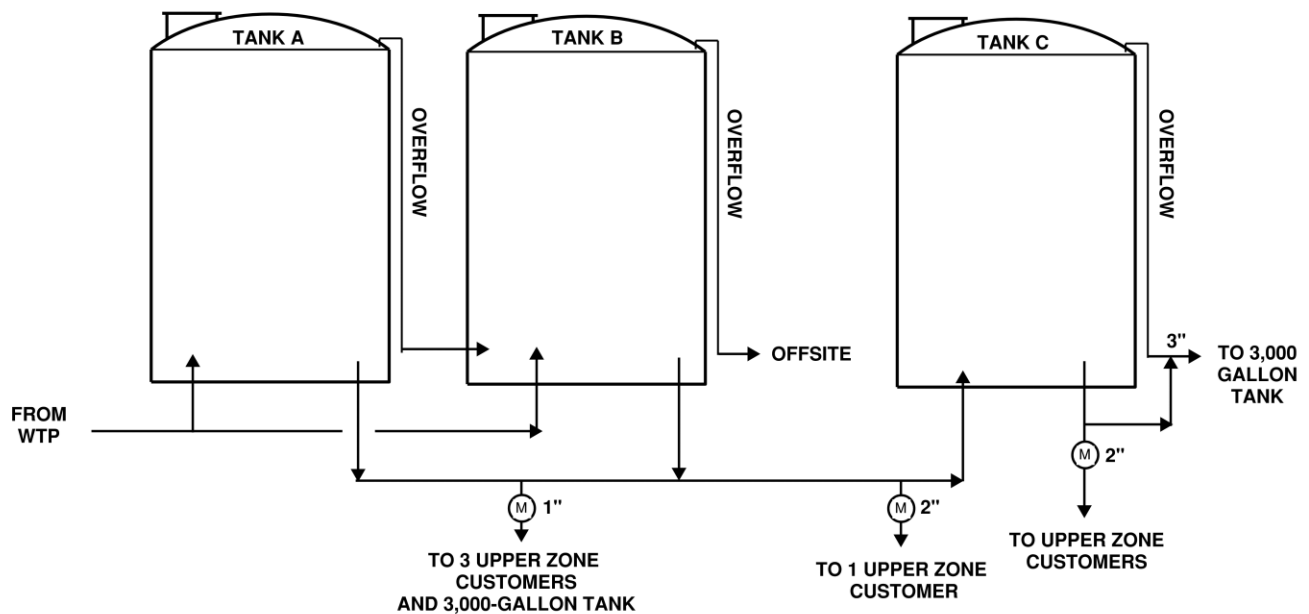
**Figure 10: Current Upper Zone Tank Operation for Storage**

In response to system needs for storage serving the upper zone, the site plumbing has been modified to eliminate the overflow tank connections; instead, the tanks are operated in parallel to maximize storage. The current piping arrangement for the tank site is shown in Figure 10.

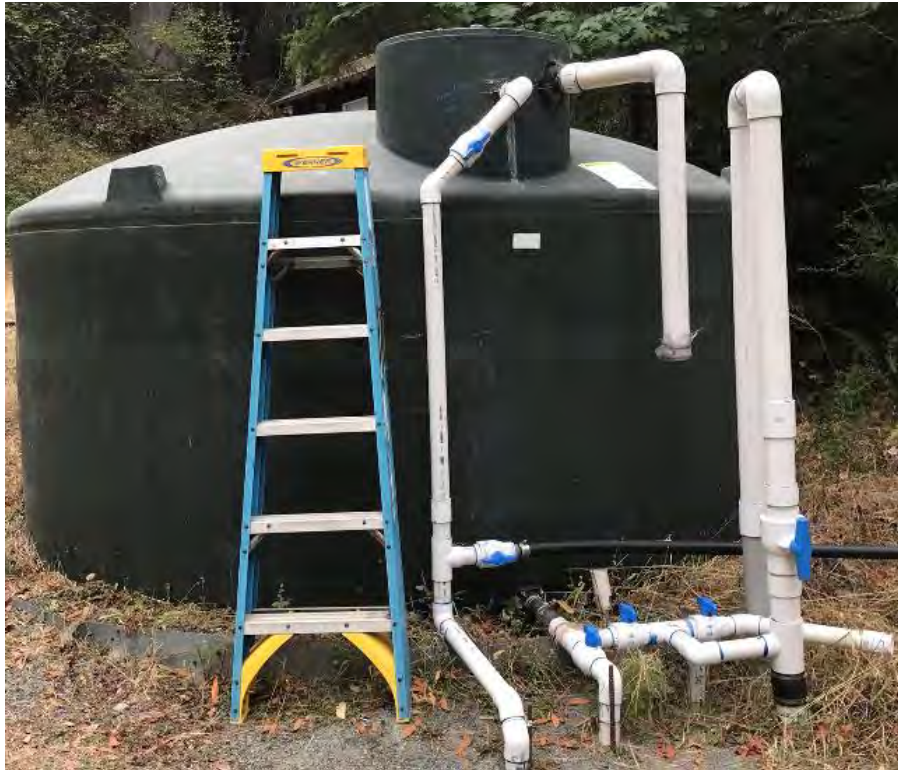
**Figure 11: Tank C Plumbing**

Tanks A and B are operated in parallel, not in series. The tank draw lines exit from the bottom of the tanks and connect to a common header that supplies Tank C. Because the overflow connection arrangement between Tank A and B is bypassed, the disinfection volume required for GWUDI post-filtration disinfection is not maintained at the spring WTP. Two distribution lines are connected to Tank C's fill line. Tank C supplies the 2" distribution main and the 3" dedicated 3,000-gallon tank fill line. Flow is metered on the 1" , 2" and 3" HDPE lines existing the site. Overflow from Tank B is discharged just offsite down a hillside. There is no dechlorination of the overflow. Figure 11 shows the plumbing of Tank C. Each tank in the upper and middle zones have similar installation and plumbing arrangements.

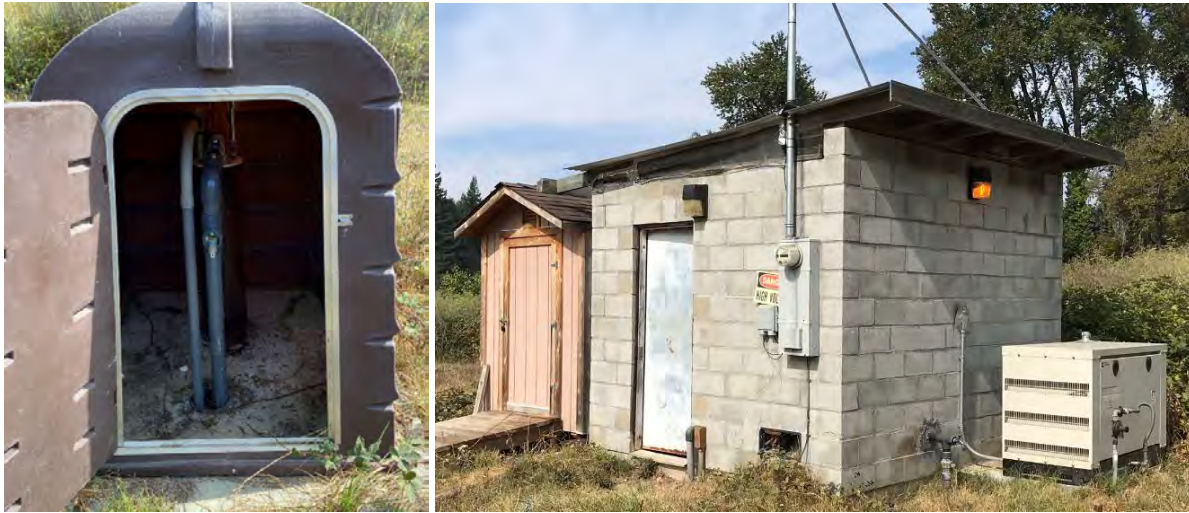
**Figure 12: Wellhead, Well WTP and Chlorine Storage Shed**

The original well source for PCSD was a 50-foot deep agricultural well. A 140-foot deep well with a 29-foot sanitary seal was drilled in 2017 to replace the agricultural well. The well completion report is included as Appendix C. The well water treatment plant (WTP) and the chlorine storage shed are shown in Figure 12. The well WTP serves as a storage room and contains the well pump discharge flow meter, raw water sample point, and the chlorine injection point. There is a chlorine analyzer in the building, but it is broken and is offline. The district chlorinates the well source for precautionary reasons as recommended by the SWRCB DDW.

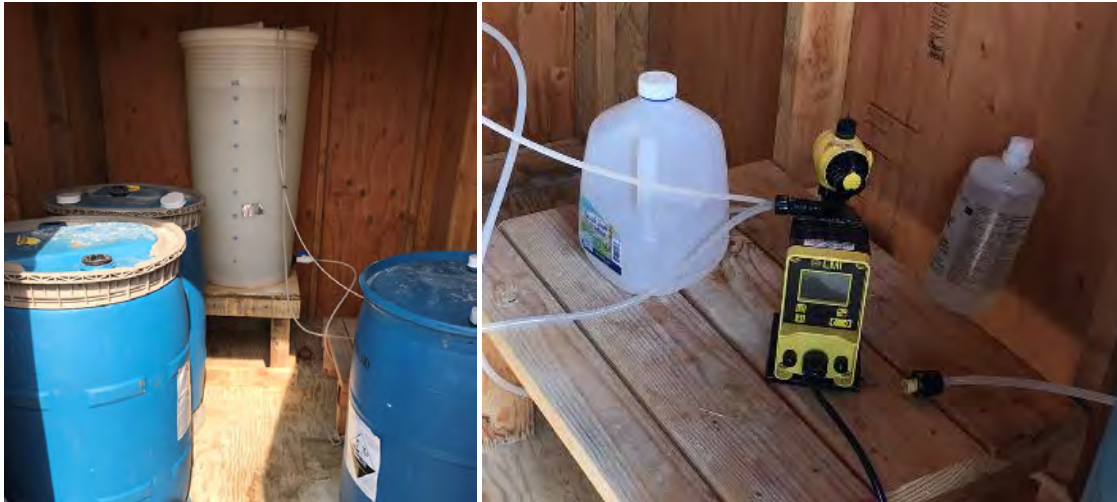
**Figure 14: Chlorine Injection Equipment**

The shed adjacent to the well house contains the sodium hypochlorite storage drums in 55-gallon capacities, the chlorine solution tank, and the injection pump for the well discharge chlorination. There is no secondary containment for the chlorine storage. The District prefers to use a Stenner brand peristaltic pump for chlorine

injection, as previous experience with diaphragm injection pumps was poor. The chlorine equipment is shown in Figure 14.

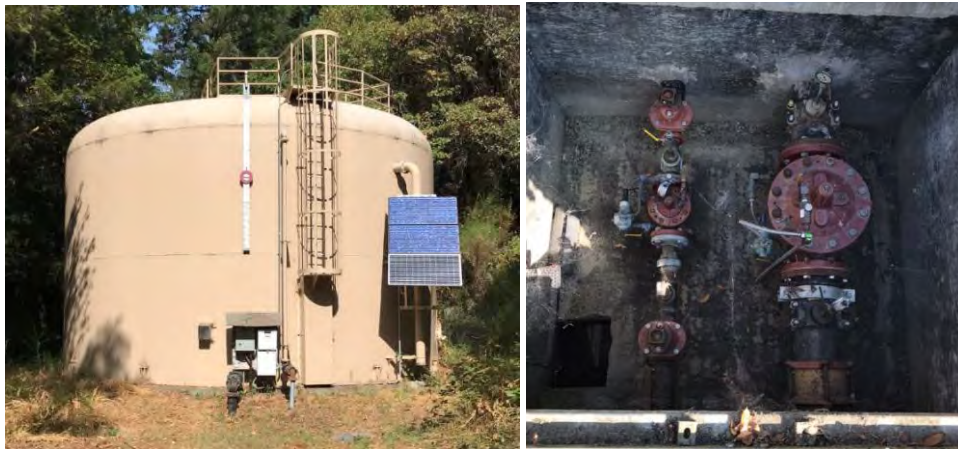
**Figure 15: 140,000-Gallon Tank and PRV Vault**

The 140,000-gallon welded steel tank was constructed in 2009 as part of the improvements project. The tank is located on a public easement on private property. The tank is supplied by the well pump and serves the lower zone customers. High and low-level floats in the tank control the well pump. The tank is shown in Figure 15.

The lower zone PRV vault is shown in Figure 15, also. Two PRVs are located on the 6" distribution piping to the lower zone; a 2" valve is sized for low flow and a 6" valve is sized for high flow. The 6" valve is out of service and is valved off. This prevents adequate flow into the lower zone for fire suppression and high flow demands. The inlet and outlet pressure gauges show 80 psi and 60 psi, respectively. The 2" PRV is serving to reduce pressure into the lower zone by 20 psi.

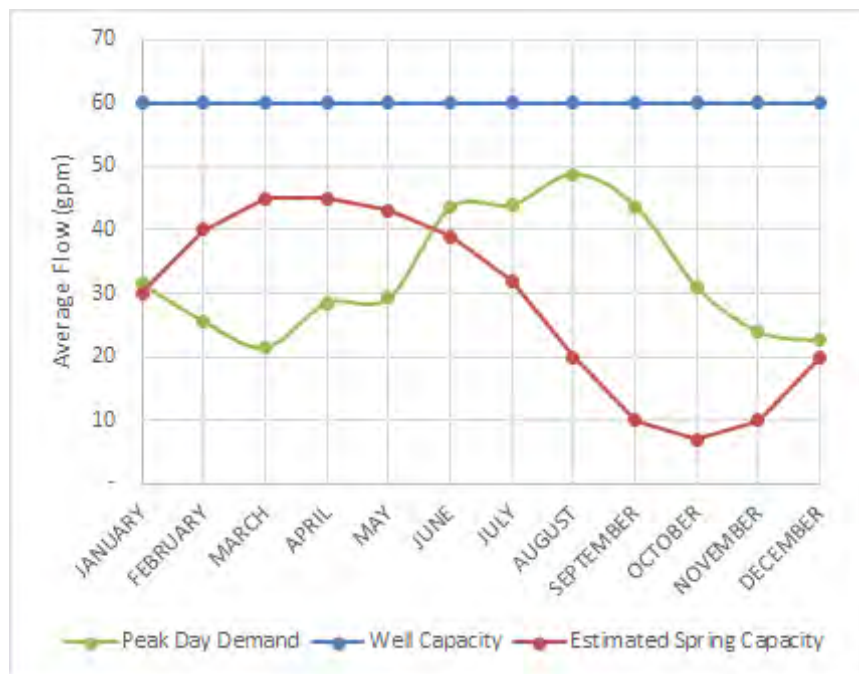
**Figure 18: System Peak Day Demand and Source Capacities**

The annual ADD to peak day peaking factor of 3.5 from the Redway Report was applied to the peak month (August) to determine the monthly to peak day peaking factor of 2.4. The 2.4 peaking factor was applied to the combined monthly ADD curve to create a monthly peak demand curve for the system. This curve was compared to the well production capacity of 60 gpm and the estimated spring capacity in Figure 18. The spring source flow rates reportedly vary from 35 gpm in the wet weather months to 5 gpm in the dry weather months. However, a peak spring capacity of 45 gpm is shown in the graph because it is assumed the spring has a greater capacity than what is recorded at the spring WTP.

From December to June, the spring has adequate flow to supply the entire system demand. From July to November the spring capacity is inadequate to serve the whole system. It is expected during the June to November time frame the well will be used to supplement the spring supply. The extent of the well use will be dependent on the specific demands and spring capacity during the low spring flow months. The spring capacity curve and the peak day demand curve intersect at 40 gpm, therefore the design flow rate of the spring WTP will be 40 gpm.

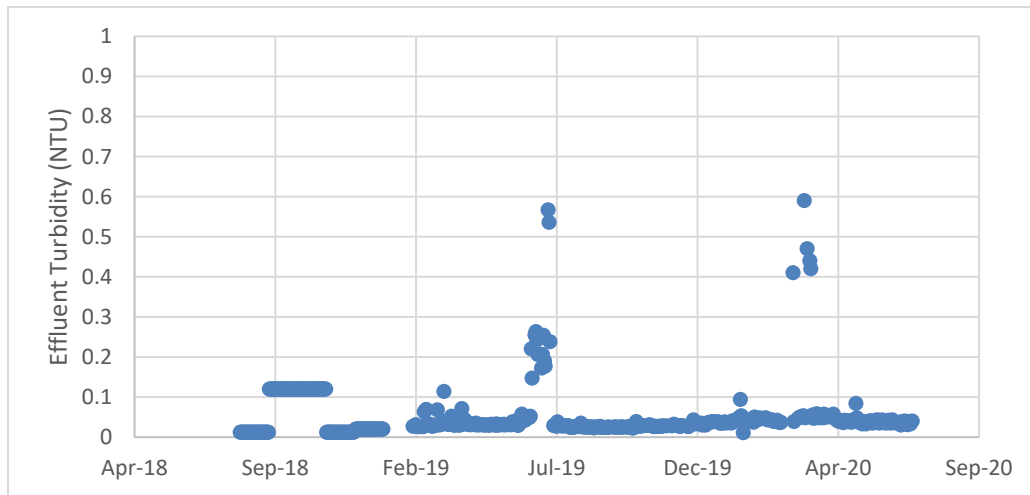
**Figure 20: Spring Finished Water Turbidity**

The turbidity data from 2018 to 2020 are graphed in Figure 20. Typically, effluent turbidity is less than 0.1 NTU. The regulatory limit for turbidity is 1 NTU. The samples have not exceeded the regulatory limit in the last 3 years.

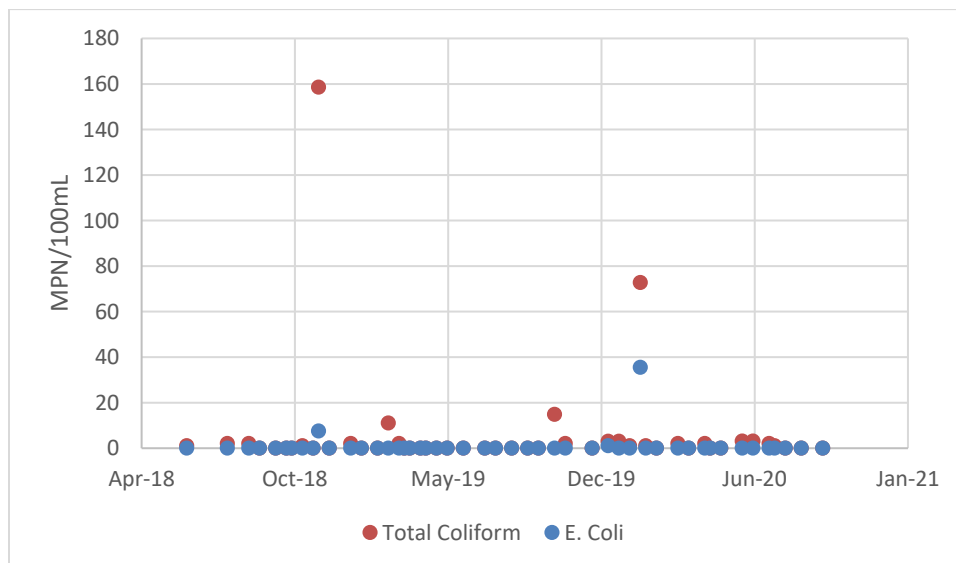
**Figure 21: Spring Source Raw Water Total Coliform and E. Coli Results**

Figure 21 presents total coliform and E. Coli sample results from the spring source raw water. The E. Coli sample result for the sample taken on January 21, 2020 was determined to be influenced by improper sampling methods, and not a true indication of the raw water quality. The presence of total coliform in the spring raw water at various points over the period of inspection shows that the spring is GWUDI.

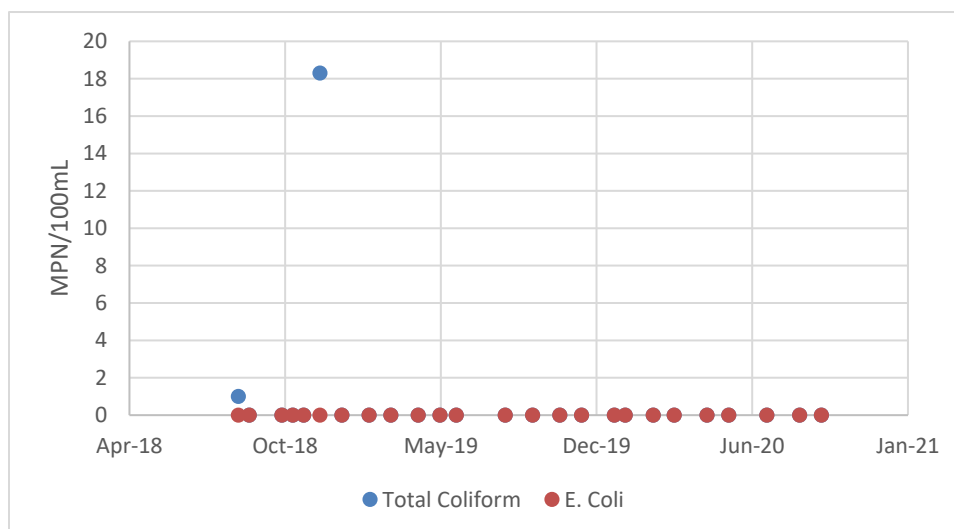
**Figure 24: Well Source Finished Water Total Coliform and E. Coli Results**

Figure 24 presents the total coliform and E. Coli sample results from the well source raw water. Figure 25 presents the present or absence test results for well source finished water samples.

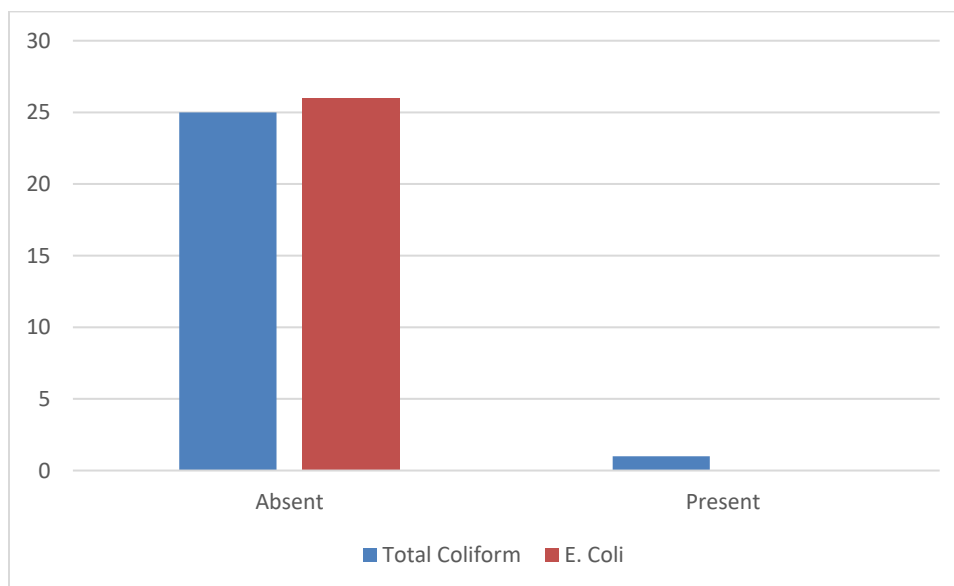
**Figure 25: Well Source Finished Water Coliform Present/Absent Test Results**

There were two positive total coliform results in the past 3 years from the well raw water source. These samples were determined to be influenced by improper sampling methods, and not a true indication of the raw water quality. The well water has no positive E. Coli results.

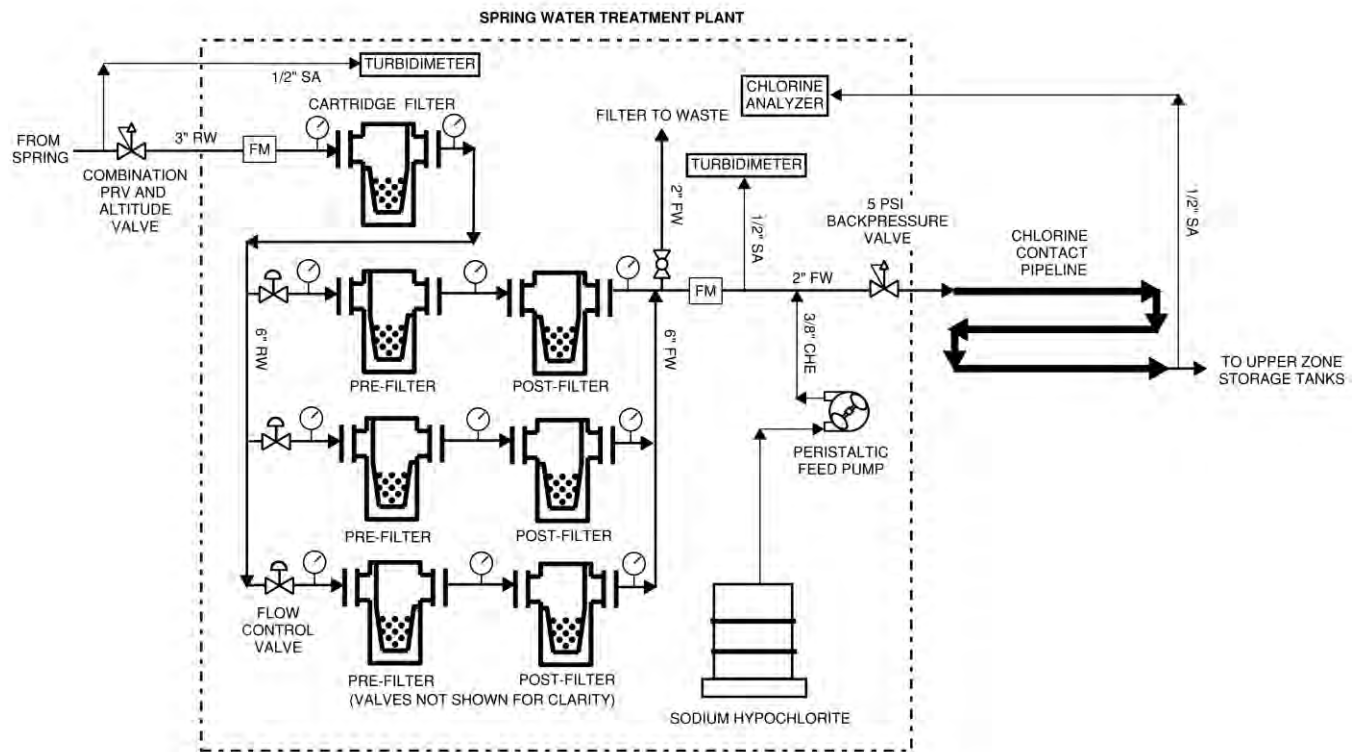
**Figure 27: Spring WTP Schematic**

The raw water sample line, filtered effluent sample line, and point of entry (POE) chlorine residual sample line will all be run to a single sampling station in the WTP. The two turbidimeters and the chlorine analyzer will be mounted in this location for the continuous sampling. The influent sample line will be tapped upstream of the flow meter. The effluent sample will be tapped downstream of the combined filter effluent. The POE sample line will be tapped at the outlet of the contact pipeline. A schematic of the WTP improvements is shown in Figure 27.

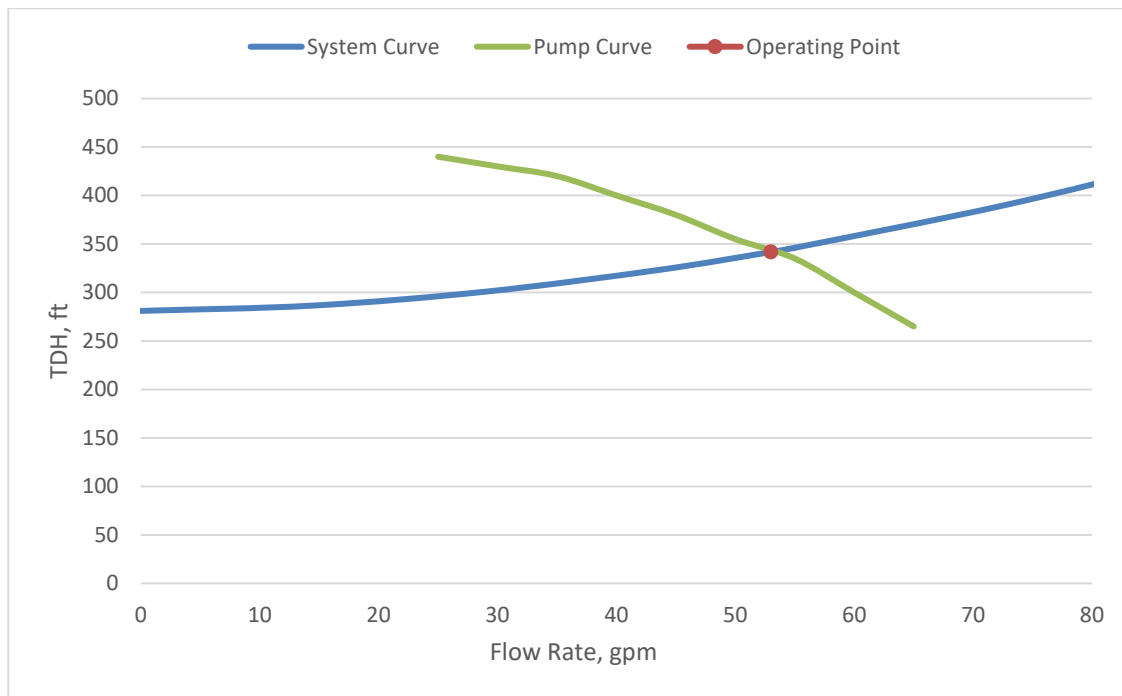
**Figure 30: System and Supply Pump Curve**

The booster pump station capacity will be 50 gpm to balance the fill time for the upper zone tanks (8 hours) while not drawing down the volume in the lower zone tank faster than the well pump can refill the tank (60-gpm). The system and pump curve are shown in Figure 30. The selected pump details are shown in Table 24.

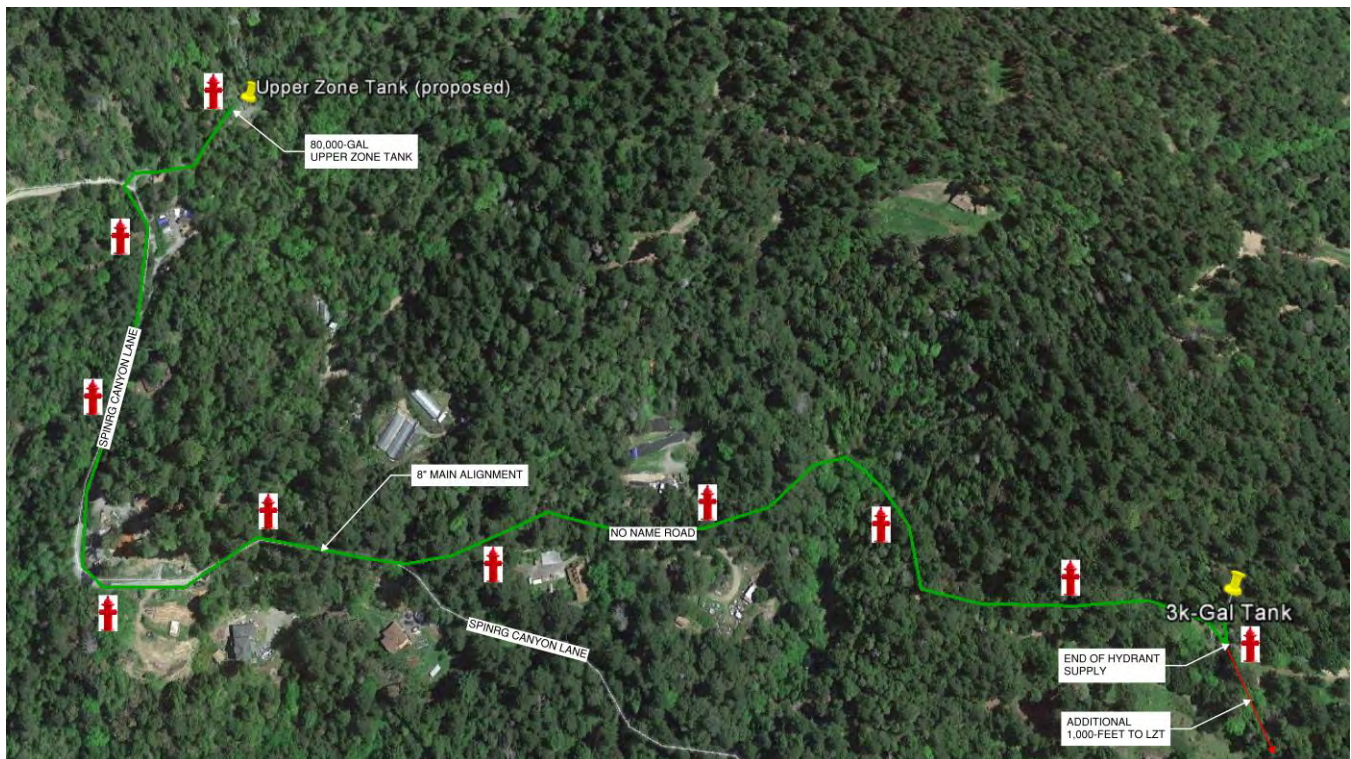
**Figure 31: Upper Zone Fire Suppression Map**

along the 3" main alignment. Trenching for this alignment will also allow for a fiber optic cable to be installed from the upper zone tank site to the booster pump station to transmit level signals from upper zone tanks for the booster pump station control. The gravel road will be restored to pre-construction conditions following the pipeline installation and other system improvements. Ten fire hydrants will be located at approximately 500-foot intervals along the 8" HDPE fire suppression service pipeline, targeting driveway locations and including one at the upper and middle tank locations. The section of pipeline between the middle zone tank and the lower zone tank is not along a road or near service connections, so no fire hydrants are required in that section. The main alignment and fire hydrant locations are shown in Figure 31.

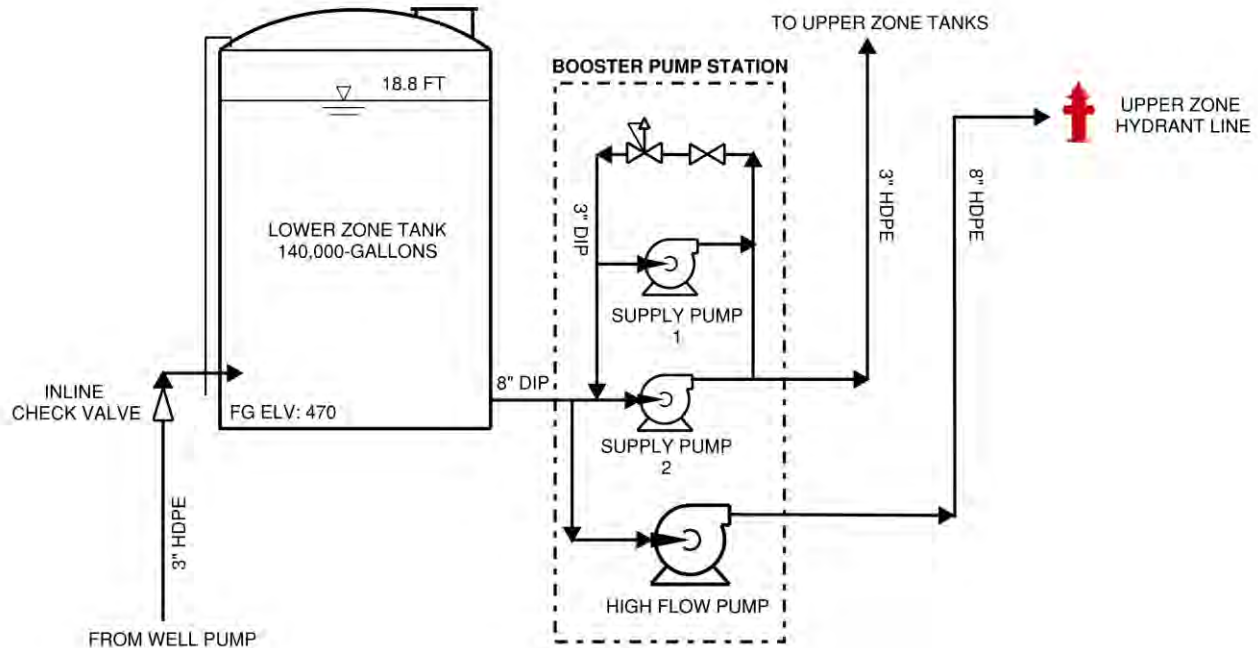
**Figure 33: Booster Pump Station Piping**

A bypass line will be installed between the supply pump suction and the pump discharge lines. The bypass line will have a gate valve and an altitude valve. The gate valve will be closed when the pump station is in manual or automatic operation. When the gate valve is open, flows from the spring site can be transmitted to the lower zone tank. The altitude valve will close when the lower zone tank is at the maximum operating level. The pump station piping arrangement is shown in Figure 33.

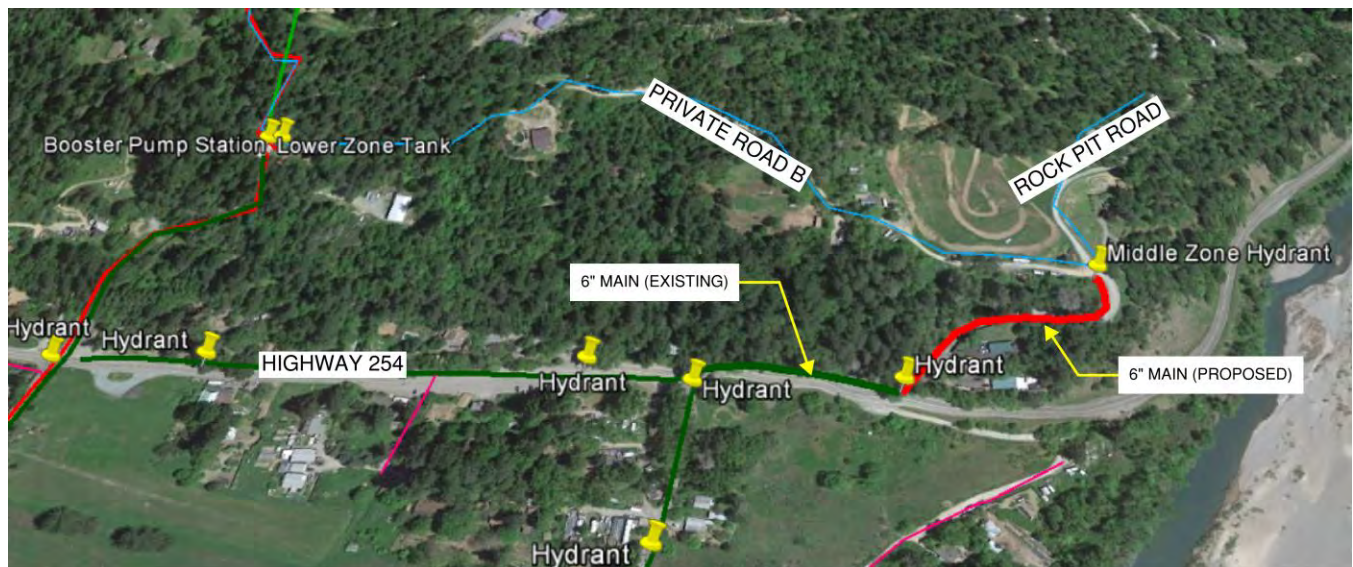
**Figure 35: Middle Zone Hydrant Location**

The middle zone customers have no fire suppression, and they cannot be served by the new 8" HDPE main. A hydrant will be installed on Rock Pit Road at the south end of town which is in the vicinity of the middle zone customer properties. The hydrant line will be connected to the 6" lower zone distribution main along Highway 254. The hydrant location will be within 500-feet of the surrounding customers and will be located at an elevation to provide a minimum service pressure of 20 psi. The hydrant and 6" main alignment is shown in Figure 35.

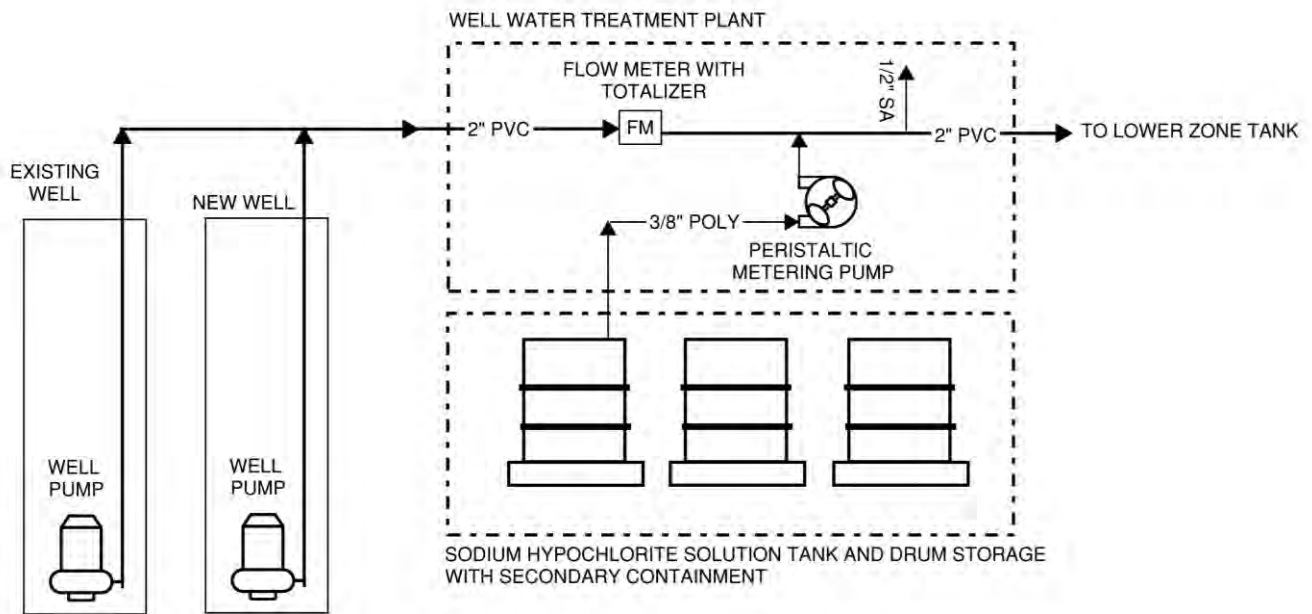
**Figure 36: Well House Schematic**

The well water treatment plant plumbing will be demolished and replumbed to be supported off the ground. The well water treatment plant piping arrangement will be replaced with new PVC piping. A flow meter with automatic flow totalizer will be installed. A schematic of the piping arrangement is shown in Figure 36.

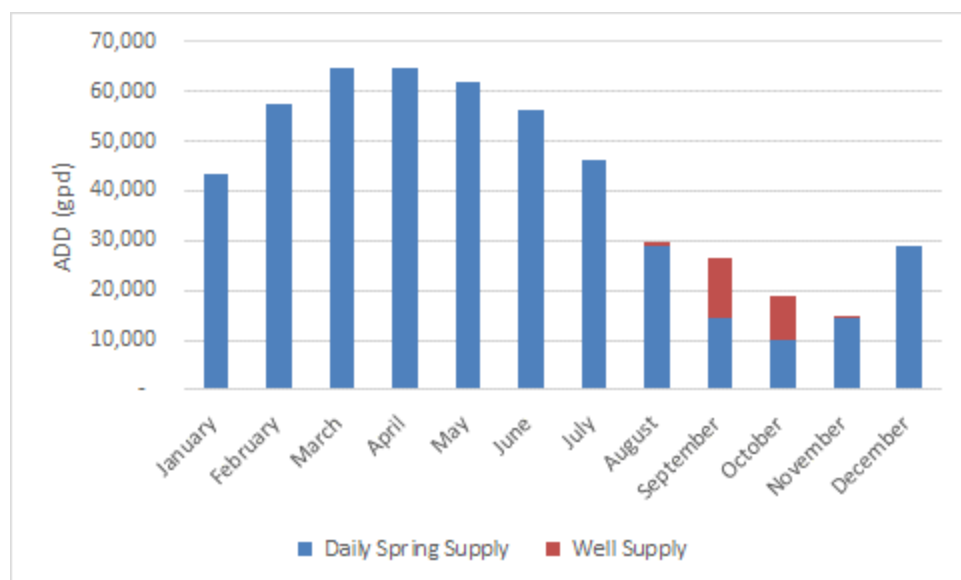
**Figure 38: Average Daily Supply by Each Source**

The future operating costs of the spring WTP were estimated based on average day demand estimates presented in Figure 17, and the resulting supply requirement from either the spring or well source. The ADD estimates for each source are shown in Figure 38. The well pump will likely only operate in the summer months when the spring source is inadequate to supply the total system demand. The spring operating costs includes hypochlorite dosing. The well operating costs include hypochlorite dosing and pump operation.

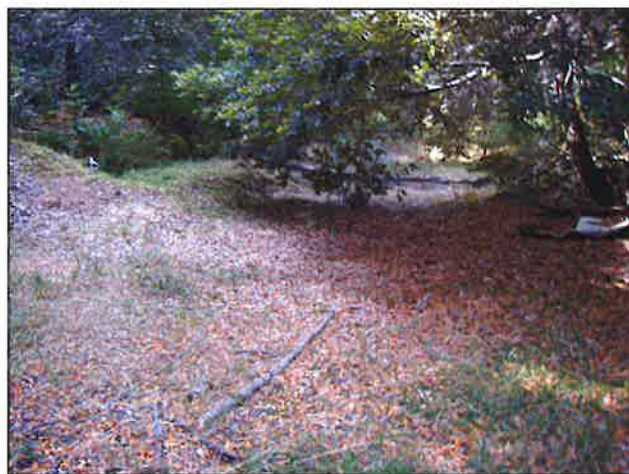
Photo 1. PCSD Spring Head Source

The spring head development (Photos 1) consists of two, 20-foot lengths of 18-inch diameter PVC pipe, with 1-inch perforations, set end to end in a trench. The collectors are set in 24-inch wide ditches and backfilled with 2-inch drain rock to cover over the top of the pipe approximately 2 feet. Natural fill was used to cover the drain rock an additional 3 feet.

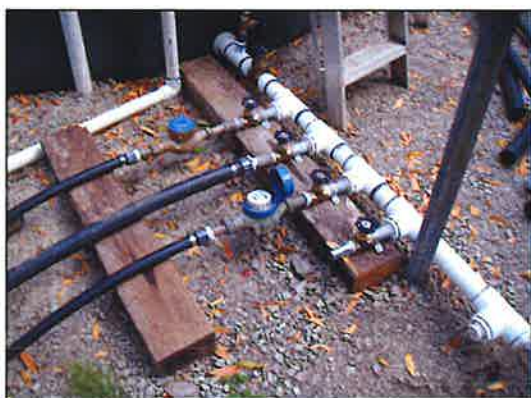
Downstream from the fiberglass tank, the PEP passes another small (500-gallon) wooden tank that services a couple of homes. The 2-inch pipeline then goes into the existing deteriorated 10,000-gallon redwood storage tank above the town.

Photo 2. Service Lines Discharge

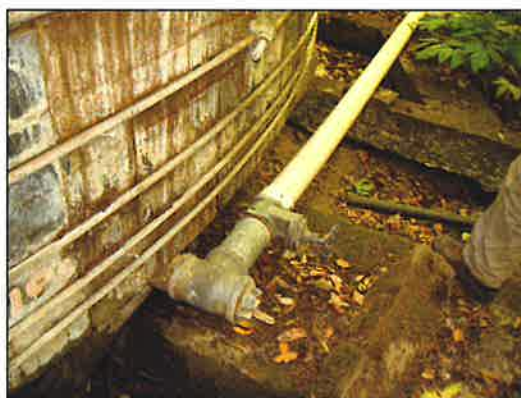
Photo 3. Deteriorating 60,000-Gallon Redwood Tank

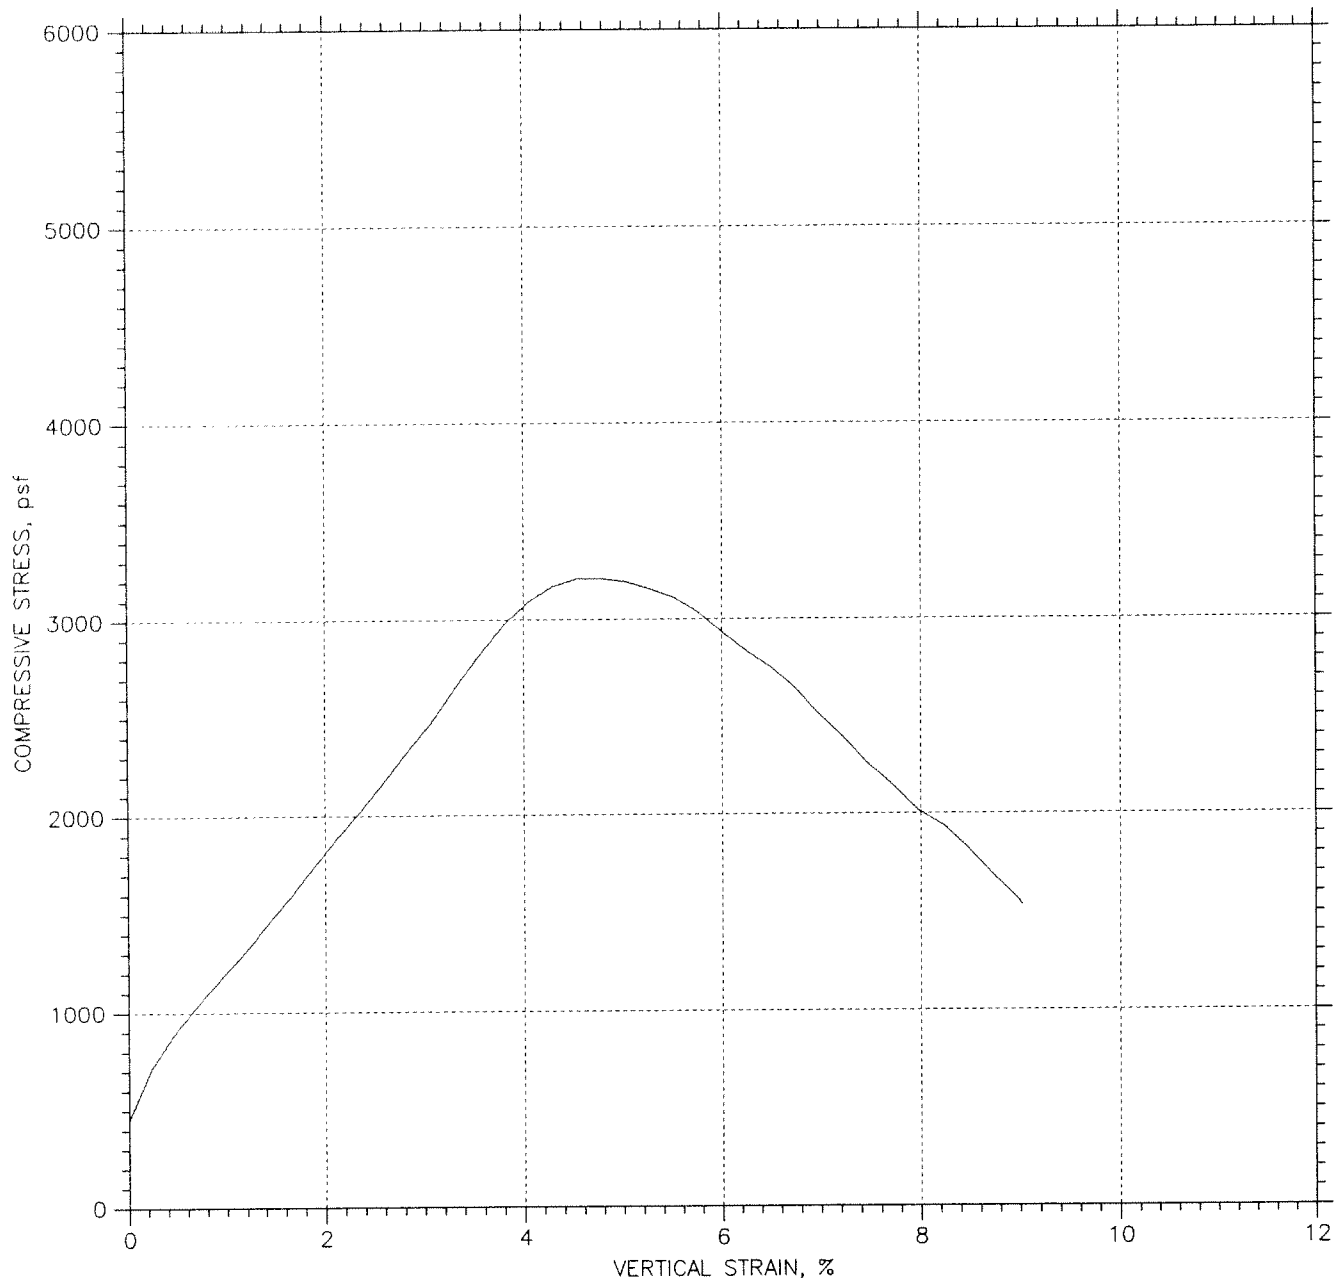
Project: Phillipsville Tank	Location: Phillipsville	Project No.: 006167
Boring No.: BH1	Tested By: JMA	Checked By: <b>JB</b>
Sample No.: 7-1248	Test Date: 10/15/07	Depth: 11-11.5
Test No.: 7-1248	Sample Type: 2.5" tube	Elevation:
Description: Brown Clayey Gravel		
Remarks:

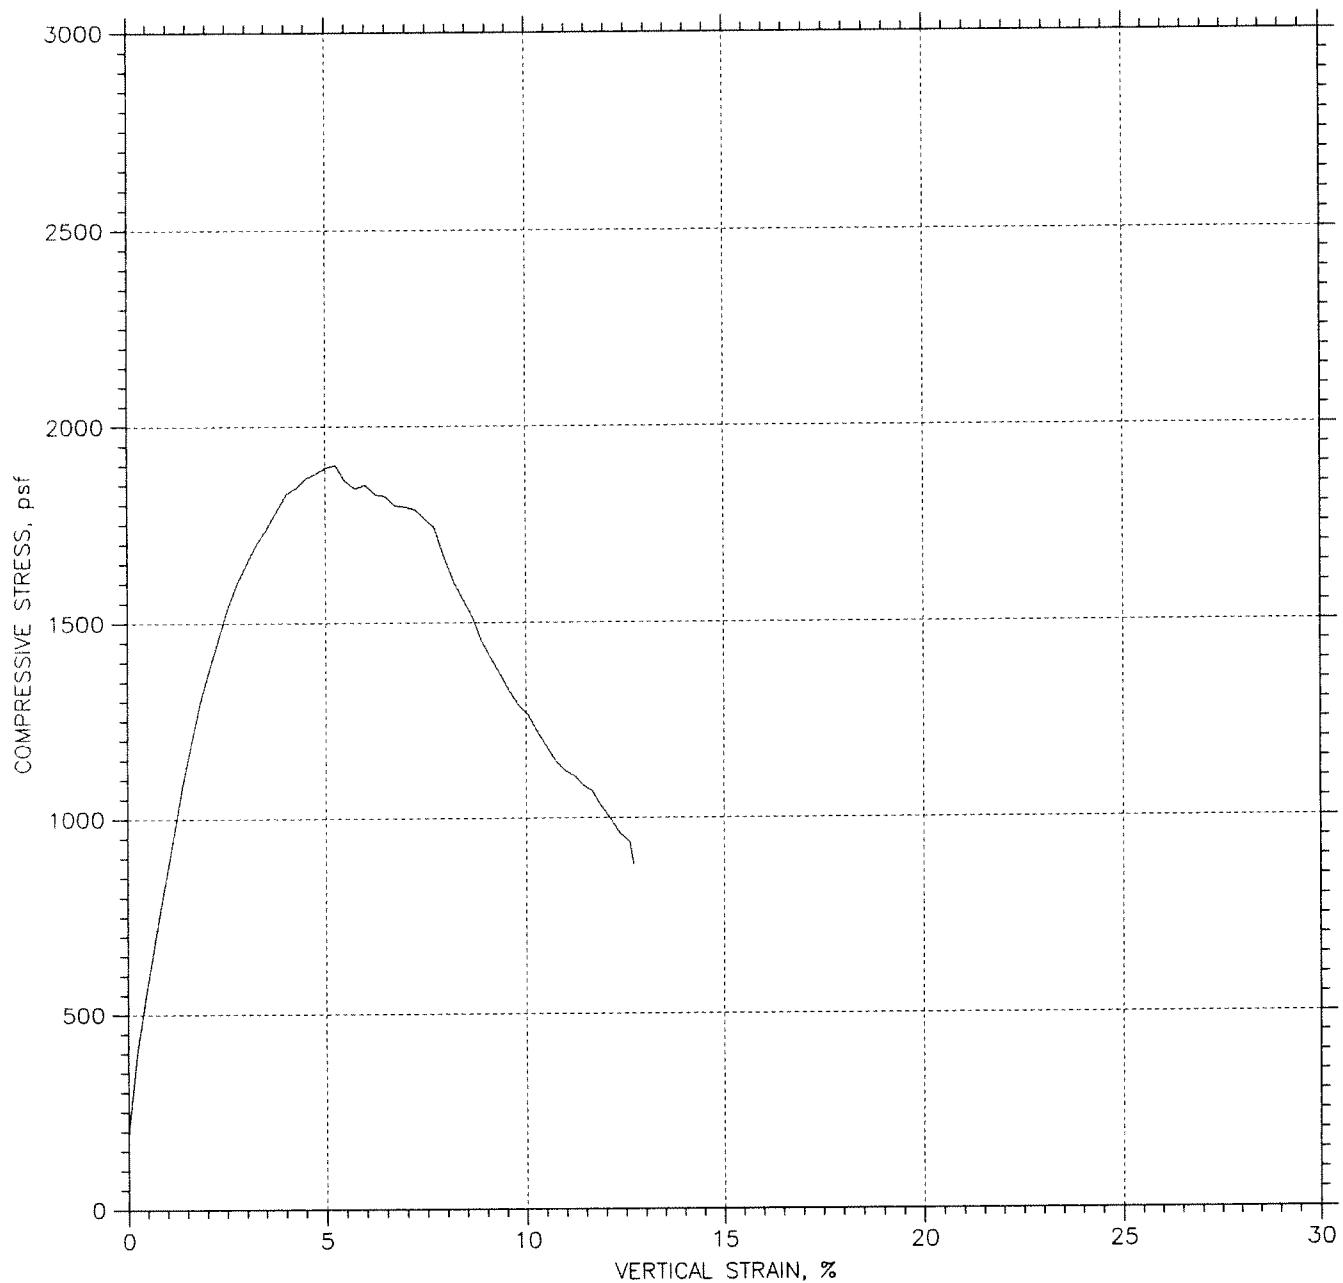
Project: Phillipsville Tank	Location: Phillipsville	Project No.: 006167
Boring No.: BH1	Tested By: JMA	Checked By: <i>JL</i>
Sample No.: 7-1249	Test Date: 10/15/07	Depth: 15.5-16
Test No.: 7-1249	Sample Type: 2.5" tube	Elevation:
Description: Brown Clayey Gravel		
Remarks:

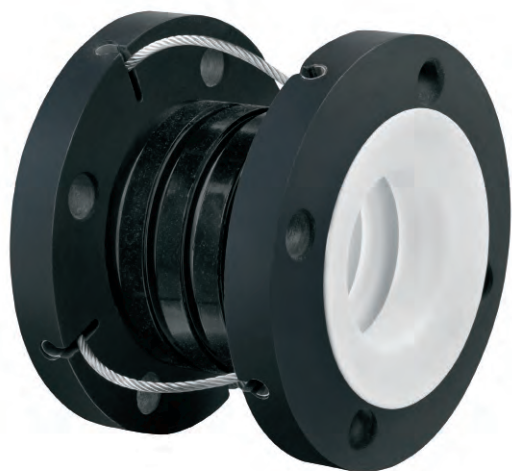
## FLEXIJOINT® EXPANSION JOINT

These flexible PTFE connectors and tremor barriers are designed to compensate for expansion and contraction, and isolate the vibration and shock that could damage a tank. Their low spring rate protects stress-sensitive connections.

- Made of pure 100% virgin PTFE resin
- Ethylene's exclusive Fluorforming™ process guarantees multiple convolution walls of consistently uniform thickness for any size.
- Features T-Band™ root and sidewall support and protection from over-compression
- LimitLinks™ stainless steel cables protect from over-expansion.
