Phillipsville Community Services District  
Water Quality, Supply, and Distribution Improvements  
Preliminary Engineering Report

# Phillipsville Community Services District Water Quality, Supply and Distribution Improvements Preliminary Engineering Report

Date: February 19, 2021  
Prepared by: Sheila Magladry, P.E.  
Checked by: Tim Durbin, P.E.  
Sami Kader, P.E.

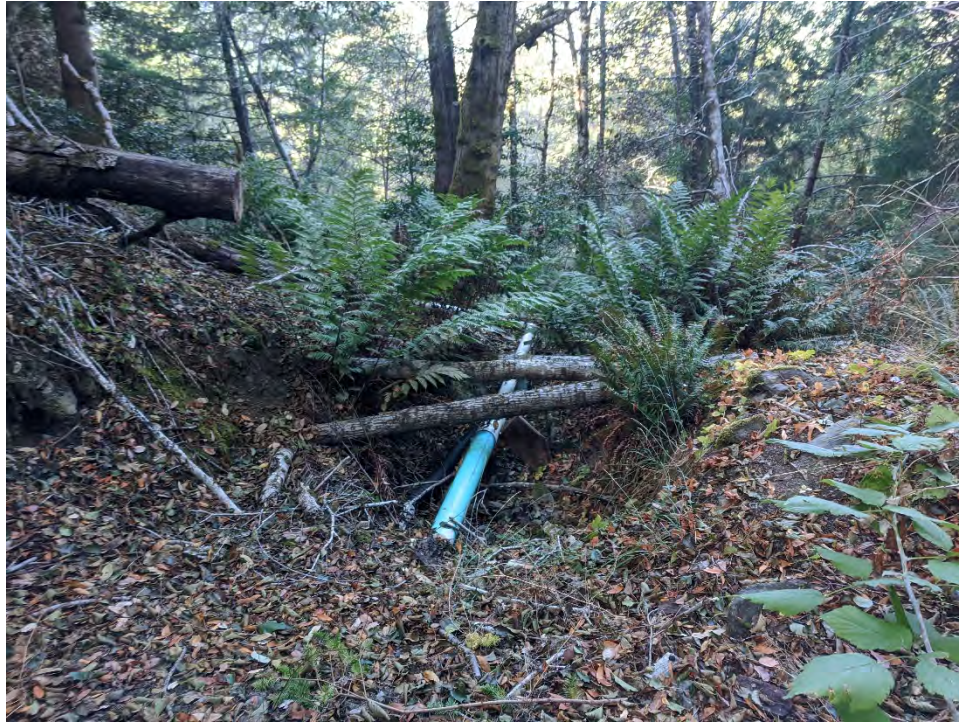
**Photo 1:** View of the existing spring source collection system and associated pipe gallery.  
Photo taken November 11, 2020.

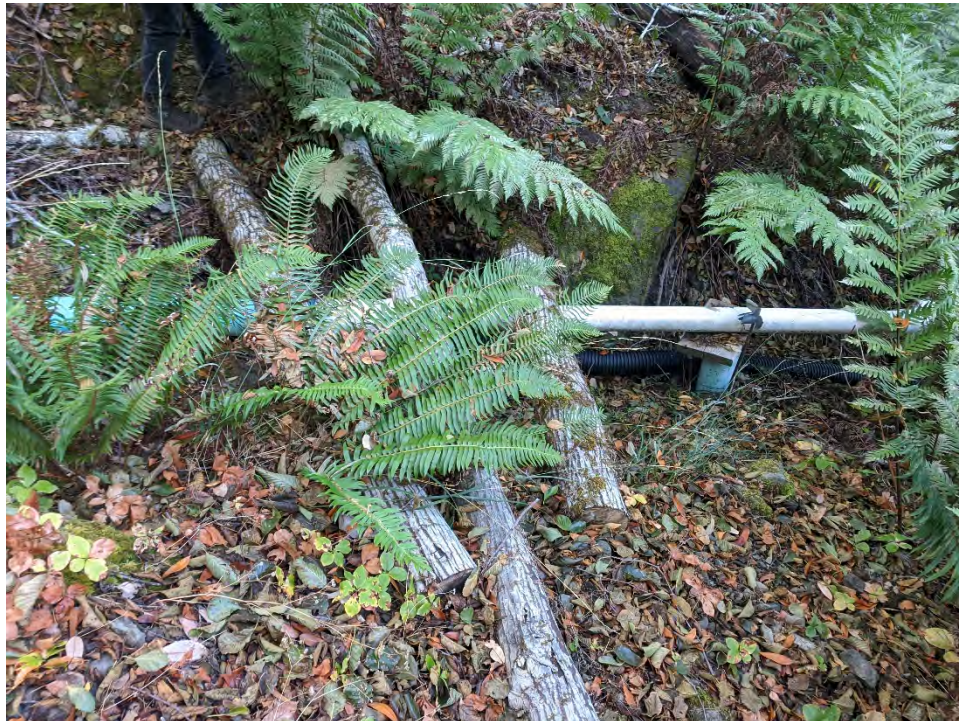
**Photo 2:** View of the existing spring source collection system and associated pipe gallery.  
Photo taken November 11, 2020.

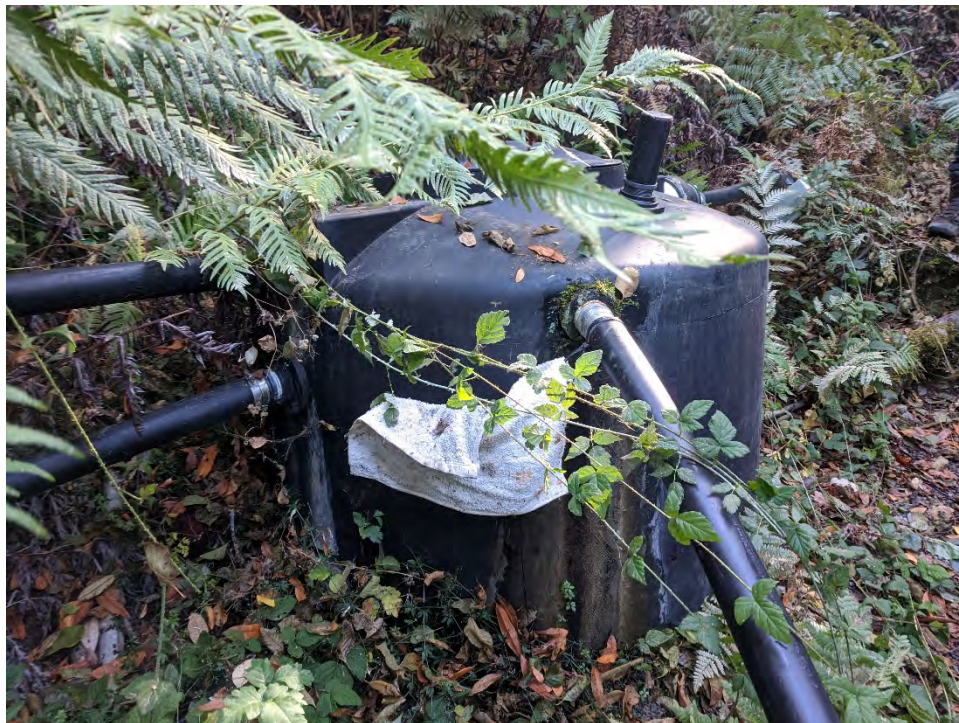
**Photo 3:** View of the overflow tank as part of the spring source collection system. Photo taken November 11, 2020.

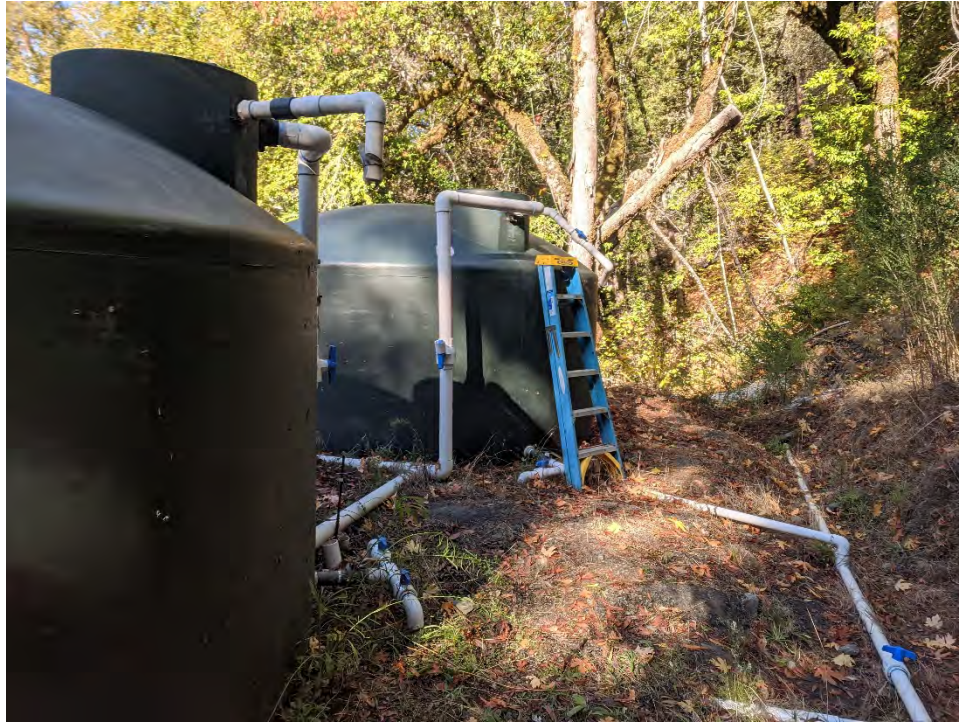
**Photo 7:** View of two 3,000 gallon water storage tanks and associated infrastructure at the WTP. Photo taken November 11, 2020.

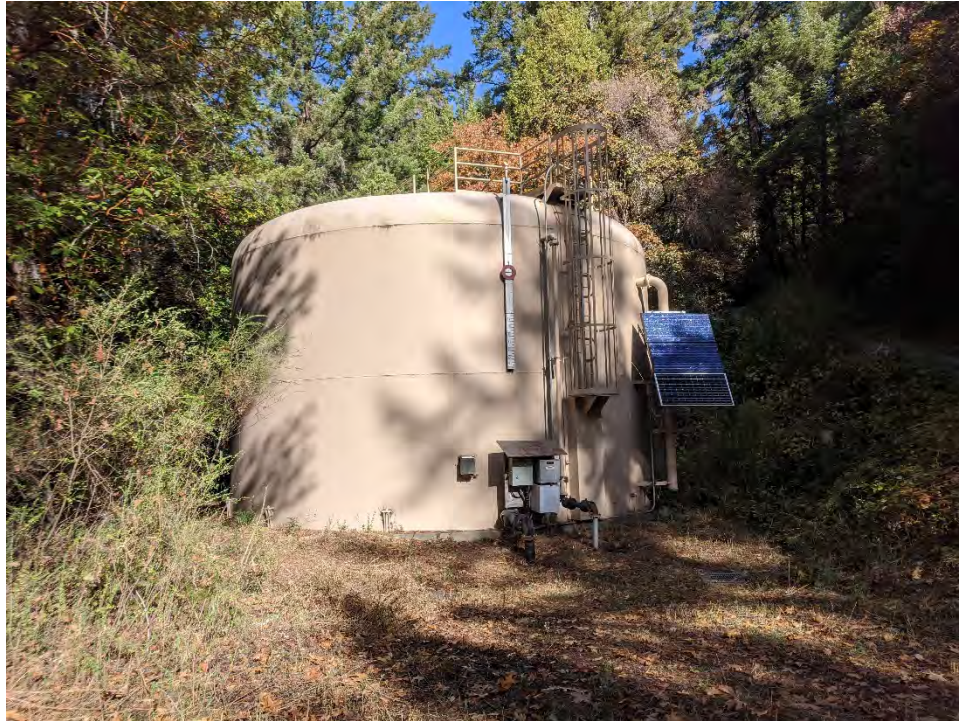
**Photo 9:** View of the 140,000-gallon water storage tank and associated infrastructure. It is proposed that a booster pump station be installed in the foreground. Photo taken November 11, 2020.

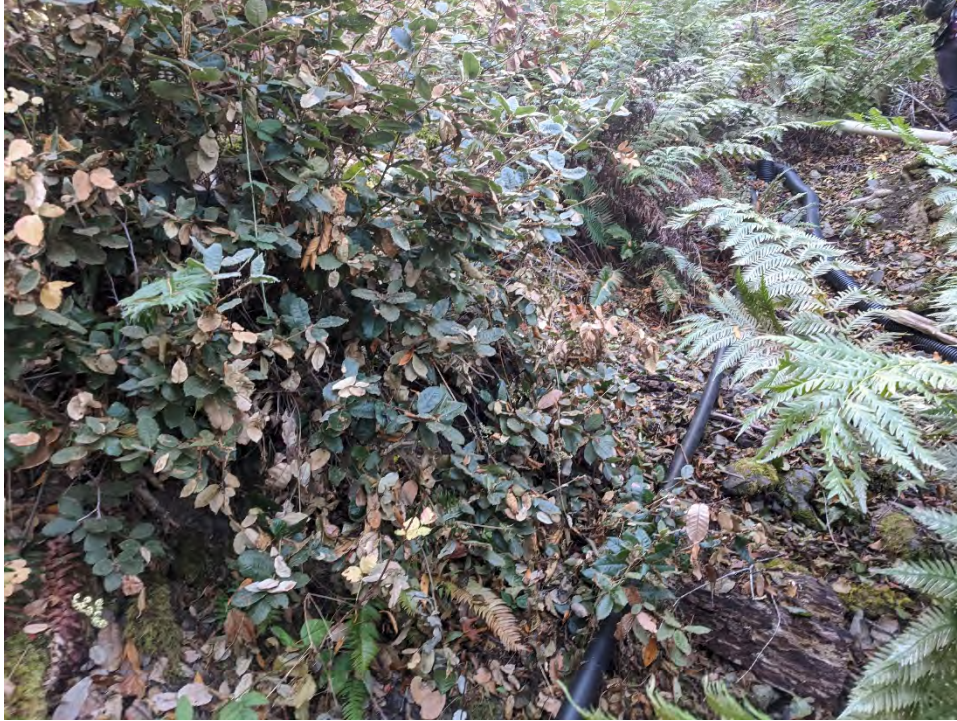
**Photo 13:** Water is transported to Phillipsville CSD residents via existing HDPE pipes installed above ground. Photo taken November 11, 2020.

Four customers in the upper zone are served by above grade small diameter high density polyethylene (HDPE) piping. This exposed piping is subject to damage. Leaks resulting from damage in the wooded area where the exposed pipeline is located are very difficult to inspect. Customers in the upper and lower zones have issues with inadequate flows and pressure.
