DRAFT ENVIRONMENTAL ASSESSMENT (DEA) FOR OPERATIONS AND MAINTENANCE (O&M) BREAKWATER REPAIRS PORT SAN LUIS HARBOR SAN LUIS OBISPO COUNTY, CALIFORNIA

U.S. Army Corps of Engineers South Pacific Division Los Angeles District 915 Wilshire Blvd. Los Angeles, California 90017

April 2021

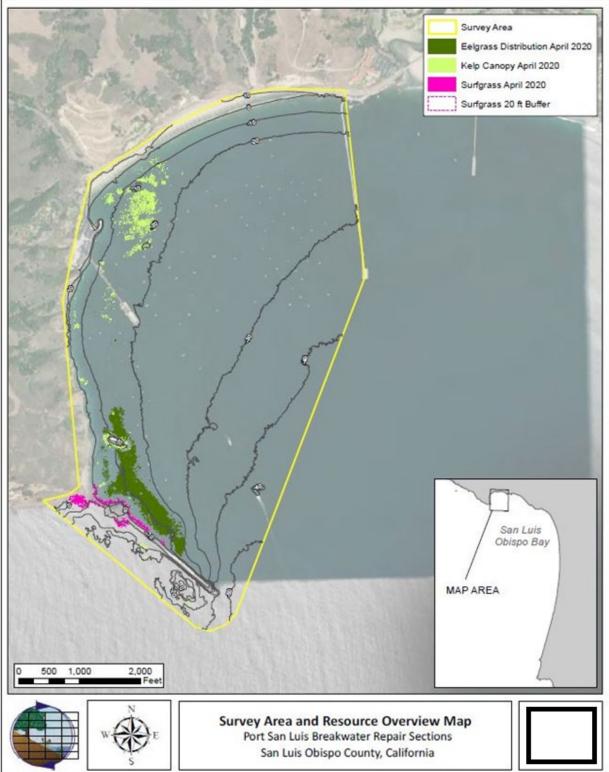
Figure 5. PSL Harbor April 2020 Seagrass and Canopy Kelp Surveys (Merkel & Assoc. 2021).

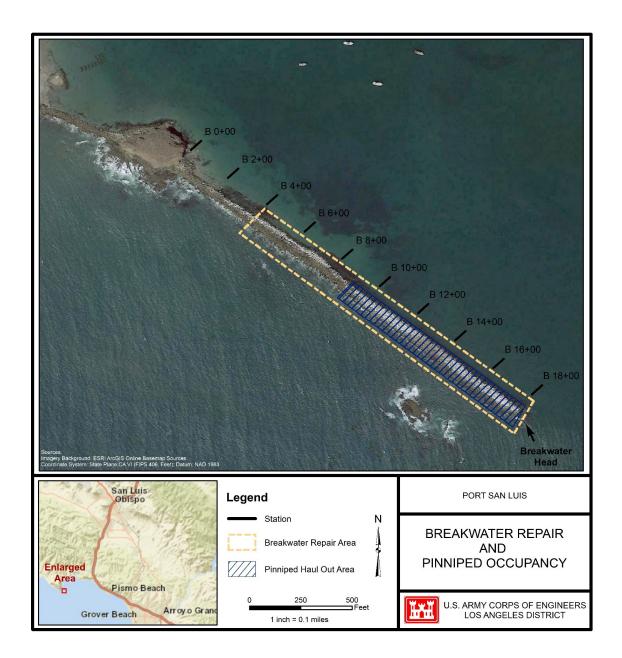
Figure 7. Pinniped Breakwater Images

PSL Breakwater: Head Section, Leeward. 6NOV2019

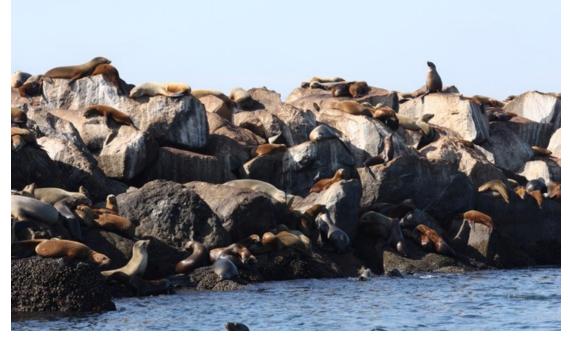
PSL Breakwater: South Eastern Section looking north towards Whaler's Rock, Leeward. 6NOV2019

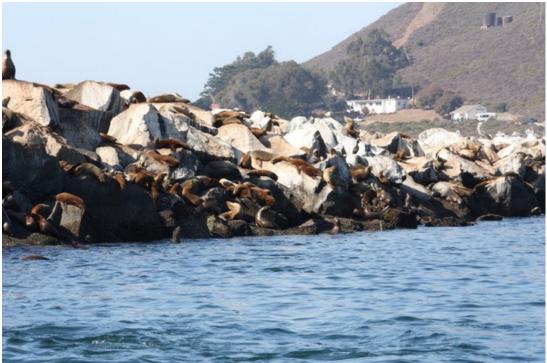
PSL Breakwater: South Eastern Section, Seaward. 3JUNE2019

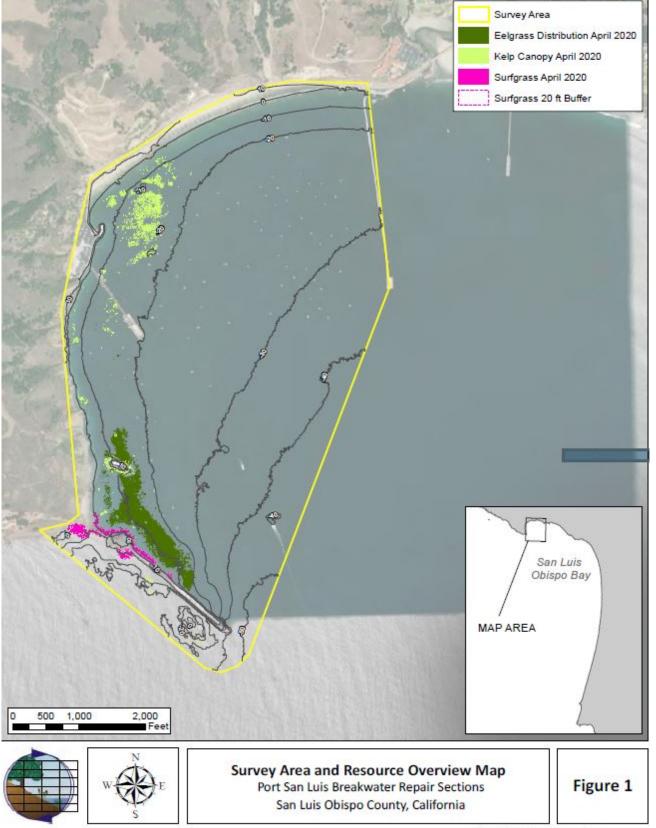
Figure 10. Eelgrass, Surfgrass, and Kelp Canopy Distribution in Port San Luis (Merkel & Associates)

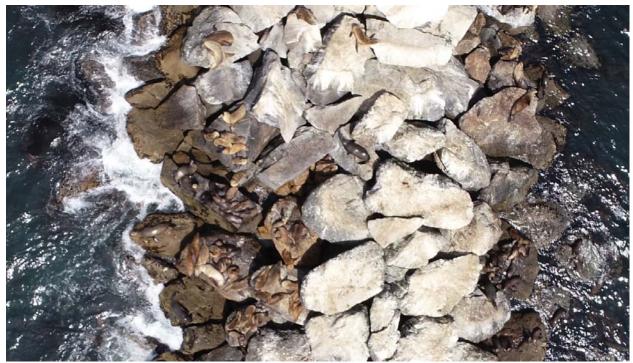
Sea lions photographed in June 2018 using high resolution low altitude UAV aerial photography. Overflights provided an opportunity to map individual animals hauled out by species, gender, and age class.

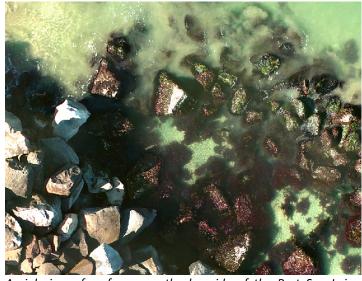
Aerial view of surfgrass on the lee side of the Port San Luis breakwater is principally found on the displaced rock that persists interspersed with sand at the lower intertidal margins of the breakwater.

Surfgrass at Port San Luis has been documented both on the outside and inside of the breakwater. The majority of the surfgrass occurs on the natural rock of Point San Luis and Whaler's Island; however, additional surfgrass extends along the breakwater within area where the breakwater rock is exposed to sand scour and burial. It does not occur on the rock in cleaner water, where it likely is precluded by competition with macroalgae. As a result of its presence in areas that are influenced by sanding, the presence of surfgrass on the breakwater is predominantly focused on the inner portions of the breakwater where intertidal and shallow subtidal sand deposits occur. On the outer segment B

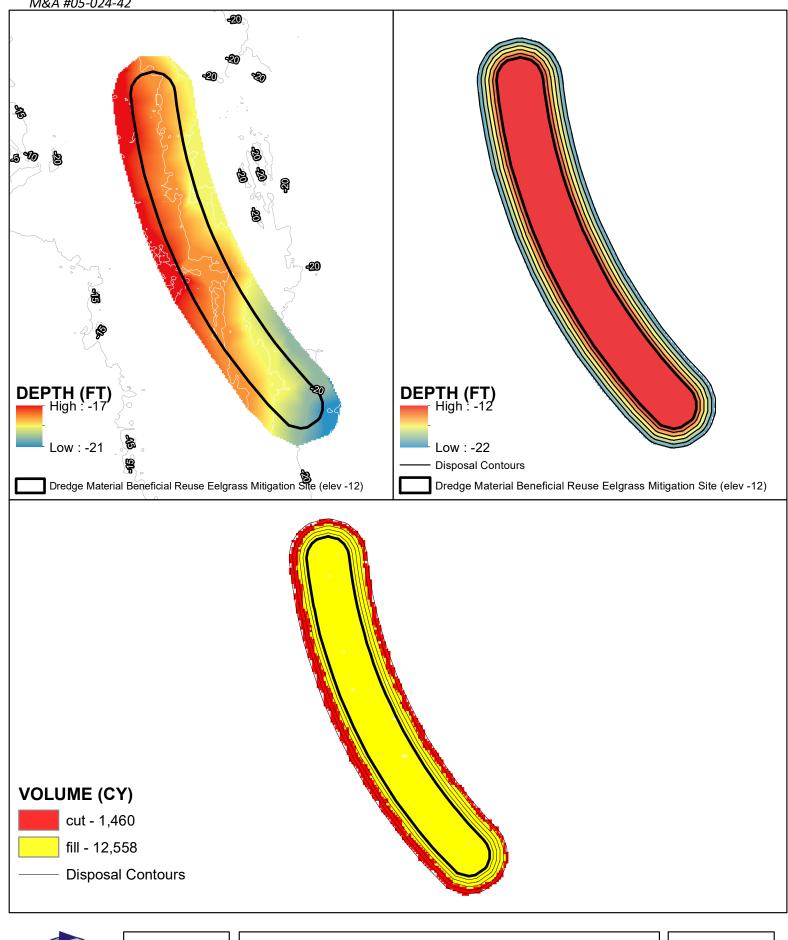
Eelgrass Mitigation Site Volume Calculations Will be Adjusted to Balance Cut Volume

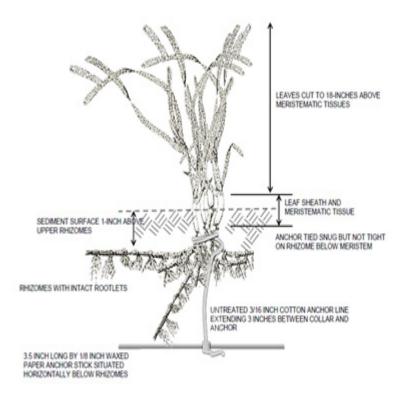
The Merkel Anchored Bare-root Eelgrass Planting Unit consists of a bundle of turions with intact rhizomes with a minimum of 3 nodes and internodes held on a biodegradable anchor consisting of a cotton twine collar that connects to a wax impregnated paper stick anchor situated horizontally below the planting unit.

The proposed mitigation will utilize anchored bare-root transplant units. Bare-root transplants are the preferred means of transplanting eelgrass in most situations, and anchored bare- root units are the principal planting units used in largescale restoration projects at the current time. The survival of such planting units has been shown to be quite high when properly prepared (Fonseca et al. 1982; Merkel 1987, Similarly, bare-root units 1990a). have shown an ability to rapidly expand and colonize bare substrate (Merkel 1990b). In addition to offering high unit survival and rapid expansion rates, bare-root units can be prepared with limited damage to the donor bed. Unlike plug extractions, bare-root units can be prepared using materials collected without substantial sediment disturbance. Each transplant unit for the project work will consist of 6-8 turions.

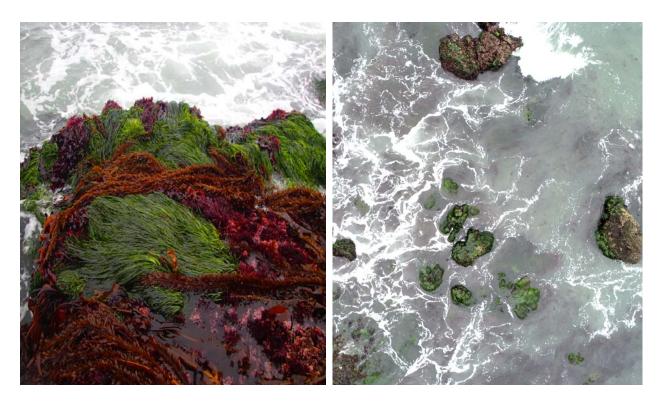
Surfgrass on bedrock (left) and within orthorectified UAV aerial image of surfgrass January-February 2019 (right). Surfgrass also occurs on what appears to be remnants of a prior breakwater roadway on the lee of the the breakwater (bottom).

Of particular note to the proposed breakwater repairs is the presence of the limited extent of surfgrass extending along the breakwater between Stations B 0+00 and B 8+00 (Figure 5). All of the surfgrass in this area is located between 0 and -3 feet MLLW. As a result, the surfgrass in this area should be outside of the elevation range within which repairs would take place, however well within the work area limits.

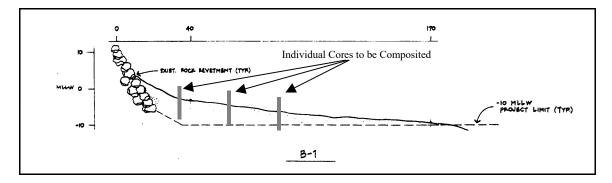
Figure 3. Profile of core sampling technique.

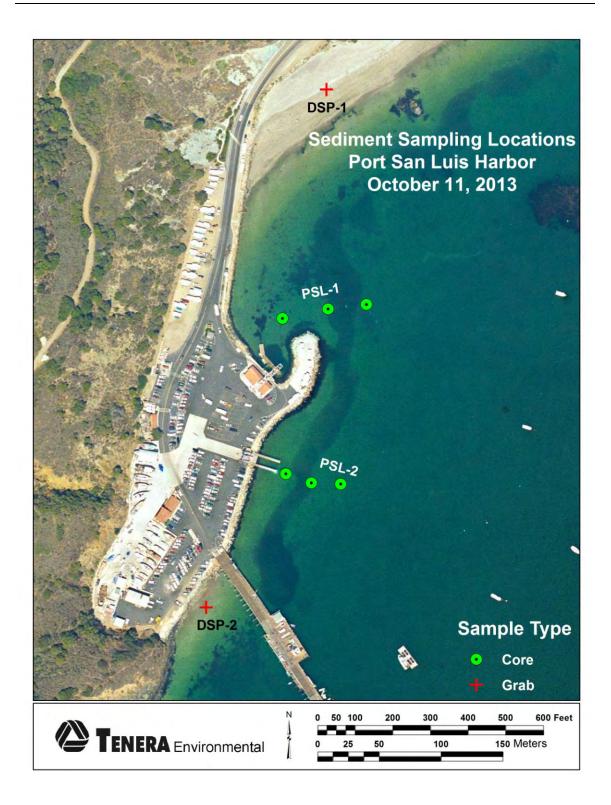
Figure 4. Locations of individual sediment cores and grab samples collected in the Port San Luis Harbor dredge and disposal areas on October 11, 2013.
