Appendix for Darrell Water Tanks Replacement Project Draft IS/MND

Darrell Water Tanks Replacement Project

RE: Darrell Water Tank Replacement Project Air Quality, Greenhouse Gas and Energy Analysis Technical Memorandum

Biological Habitat Evaluation Report

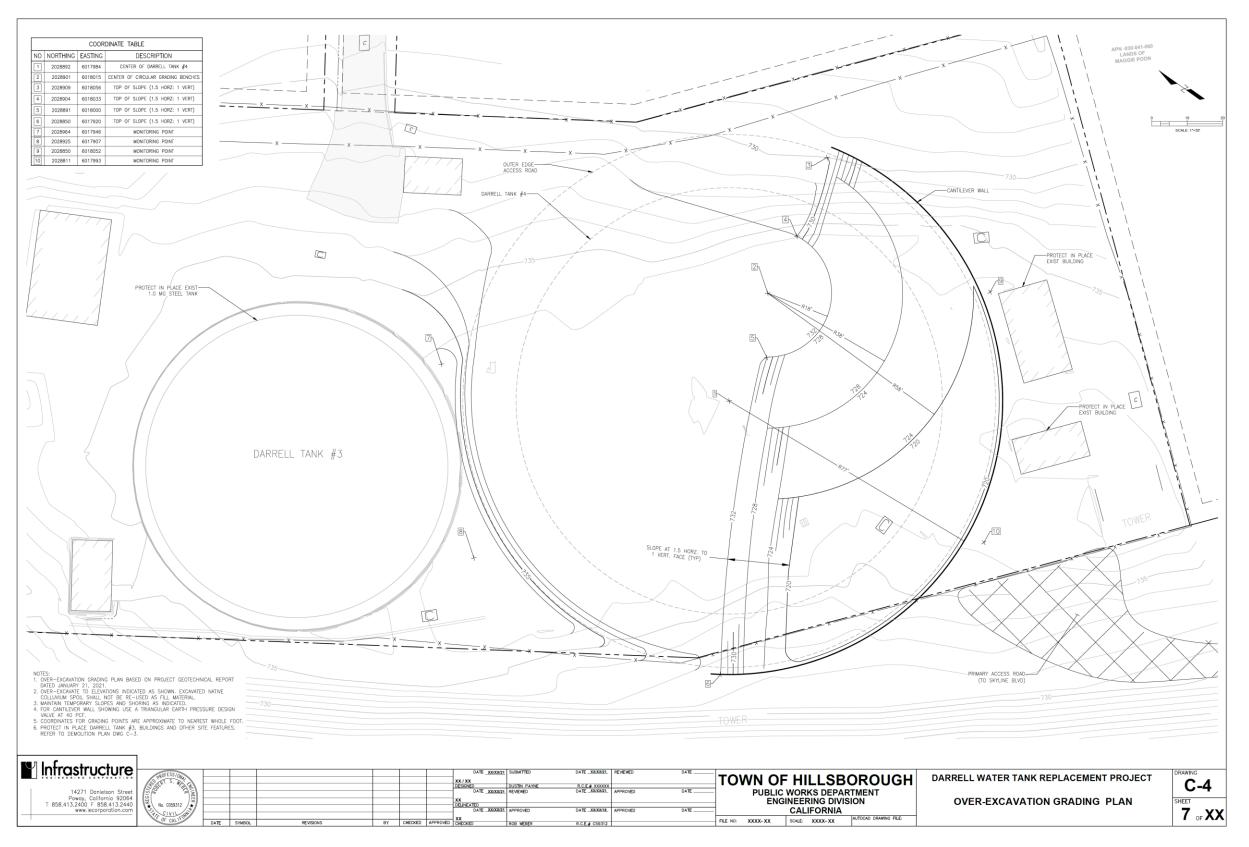
Figure 7. Planned areas of excavation and over-excavation

Based on the current over-excavation plan (Figure 7) and the Project geology (Figure 4), the Project will be excavating approximately 16 feet into the Jurassic serpentinite. Grading impacts to the late Pliocene to early Pleistocene Merced Formation will be low to very low.

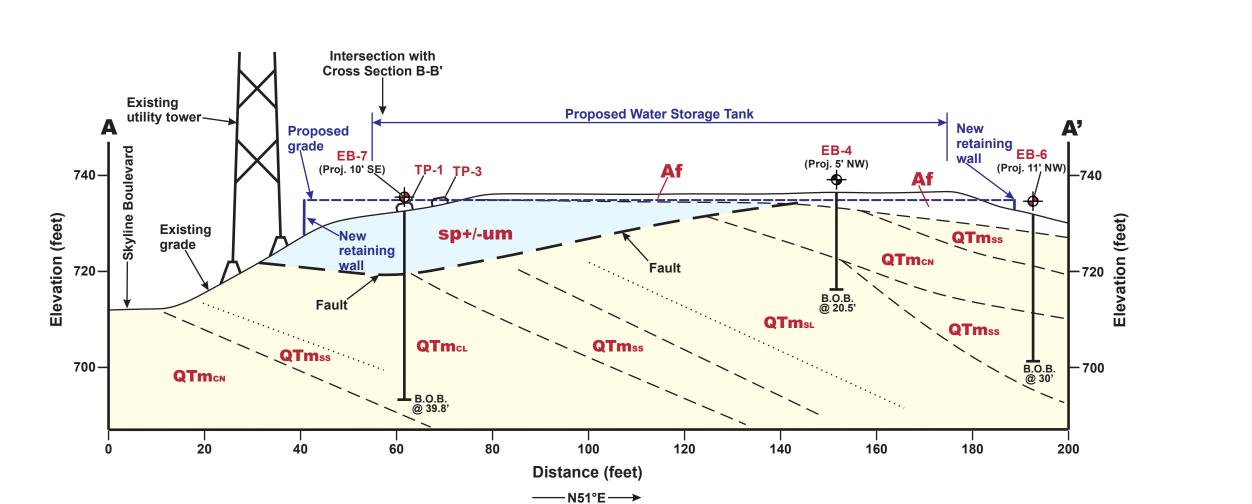
Section A-A'

(View Looking Northwest) 1"=20' H:V

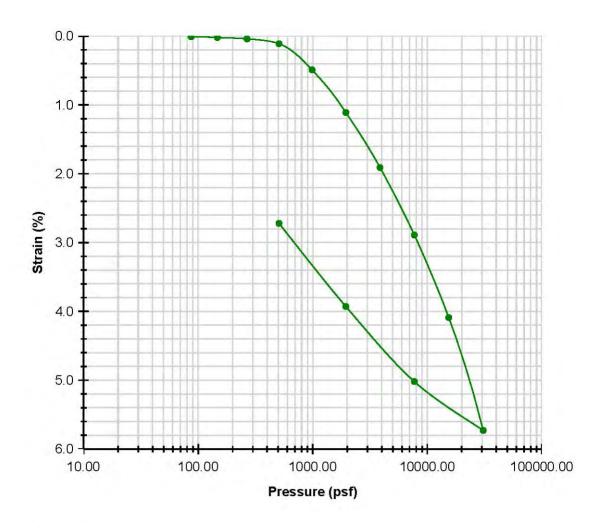
Boring: EB-7 Sample: 12B Depth: 22.4'

Description: Sandy Claystone [QTm]

BEFORE	AFTER
Moisture (%)	18.6	20.0
Dry Density (pcf)	107.9	109.9
Saturation (%)	88.3	100.0
Void Ratio	0.57	0.55

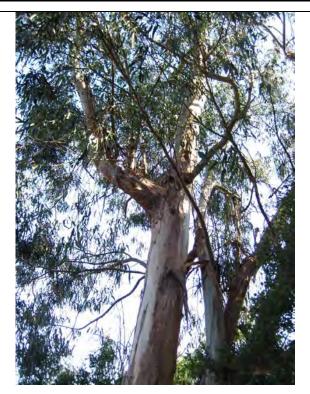
Tree recommended for removal, due to threat of stem failure and impact with PG&E facilities.
