# **Appendix C-1**

## **Bat Habitat Assessment**

## **BAT HABITAT ASSESSMENT, REPORT, RECOMMENDATIONS – SAMOA PENINSULA LAND-BASED AQUACULTURE PROJECT – SAMOA, CA**

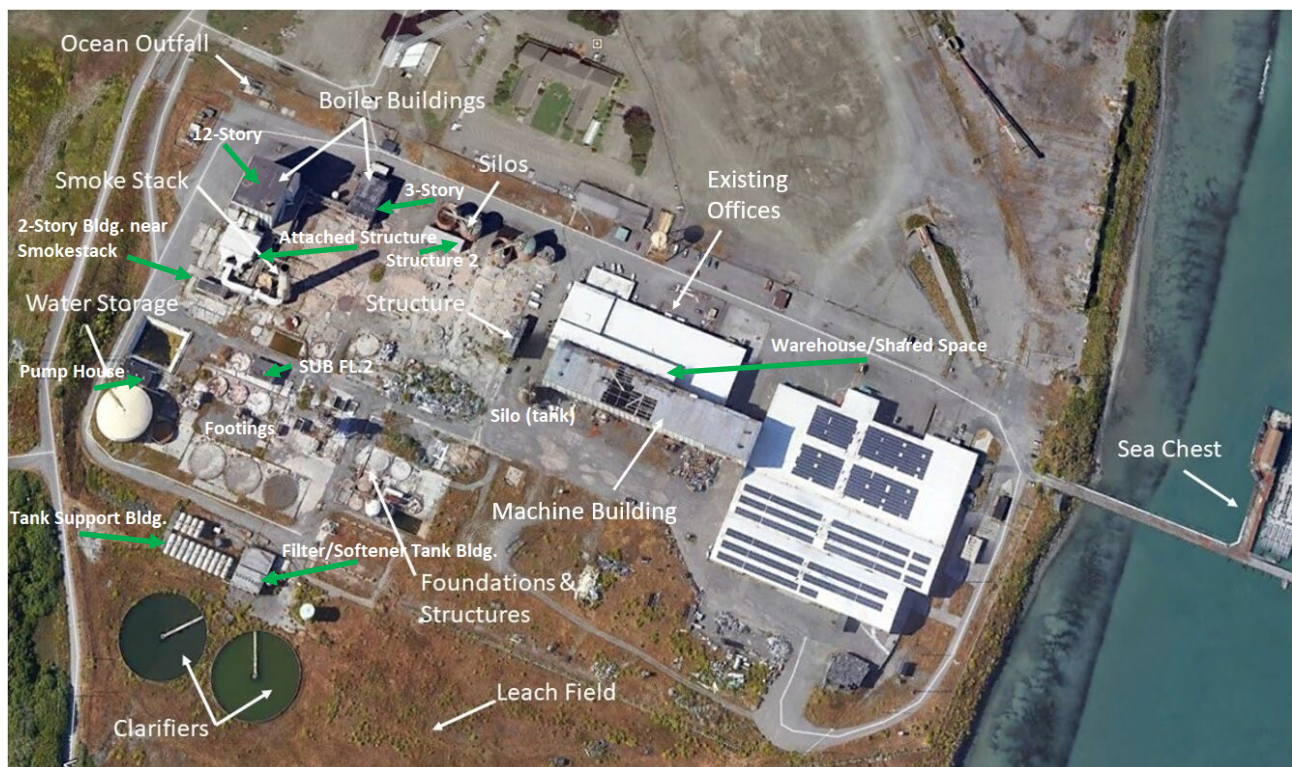
Figure 1. Structure names referenced in this report. White labels and arrows, GHD; white labels and green arrows, Wildlife Research Associates.

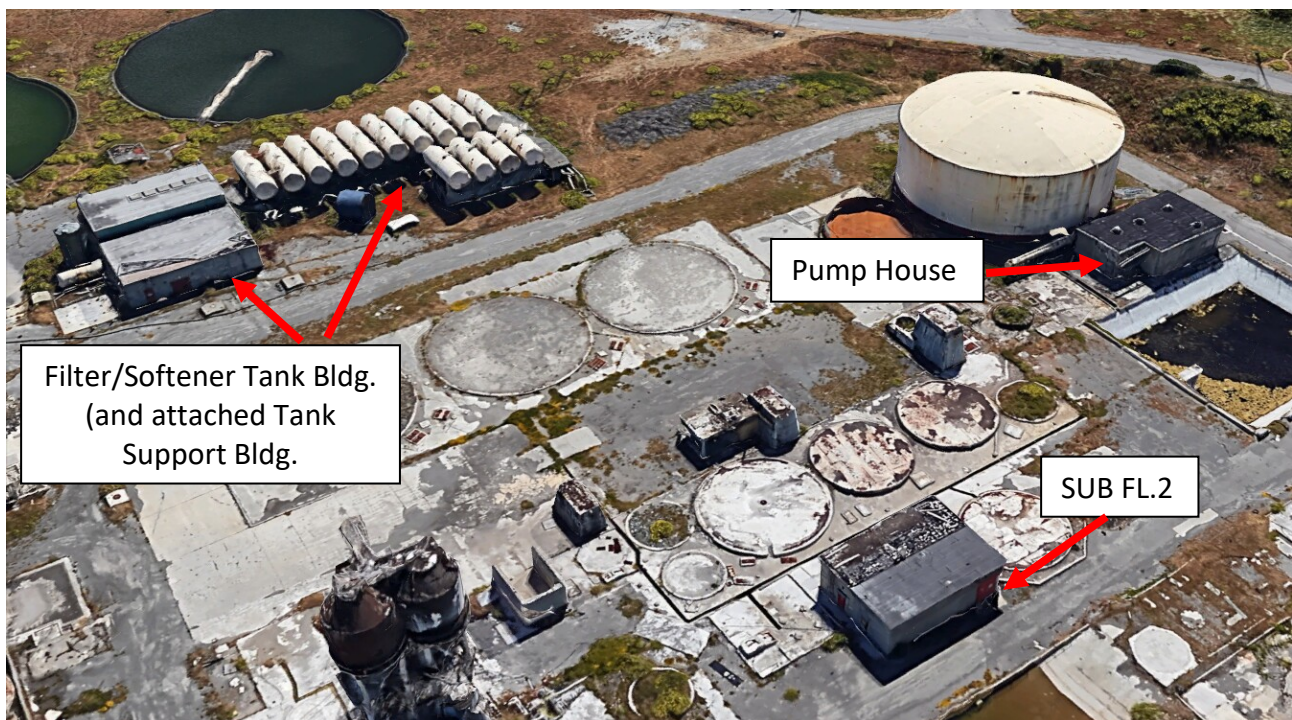
Bat activity was observed in three buildings - **Pump House (SUB BF2), SUB FL.2, and Filter/Softener Tank Building**. Evidence suggests roosts are not used during winter months when bats are in seasonal torpor. The likelihood of maternity roost usage appears to be minimal but could not be confirmed by the results of this winter season survey. The amount and distribution of bat fecal pellets, fur staining at roosts and openings, and urine staining, do not support the conclusion that large numbers of bats have been using the structures, nor is there any indication that the only two SSC bat species, *C. townsendii* and *A. pallidus*, have been roosting in any of the structures. The evidence suggests the roosts are used as night roosts, or daytime roosts for males and non-reproductive females, however, there is always a possibility that small maternity colonies may have occurred in the past or could do so in the future.

Figure 2. Three buildings with evidence of roosting bats.

Based on the results of this survey, it is reasonable to presume presence of bats during maternity season and potentially during winter months in the Pump House (SUB BF2), SUB FL.2, and Filter/Softener Tank Building, and to conduct partial dismantling and/or deterrence measures to cause bats to abandon the roosts during seasonal periods of bat activity when there are no non-volant young during maternity season, or non-volant bats of any age class during winter torpor.

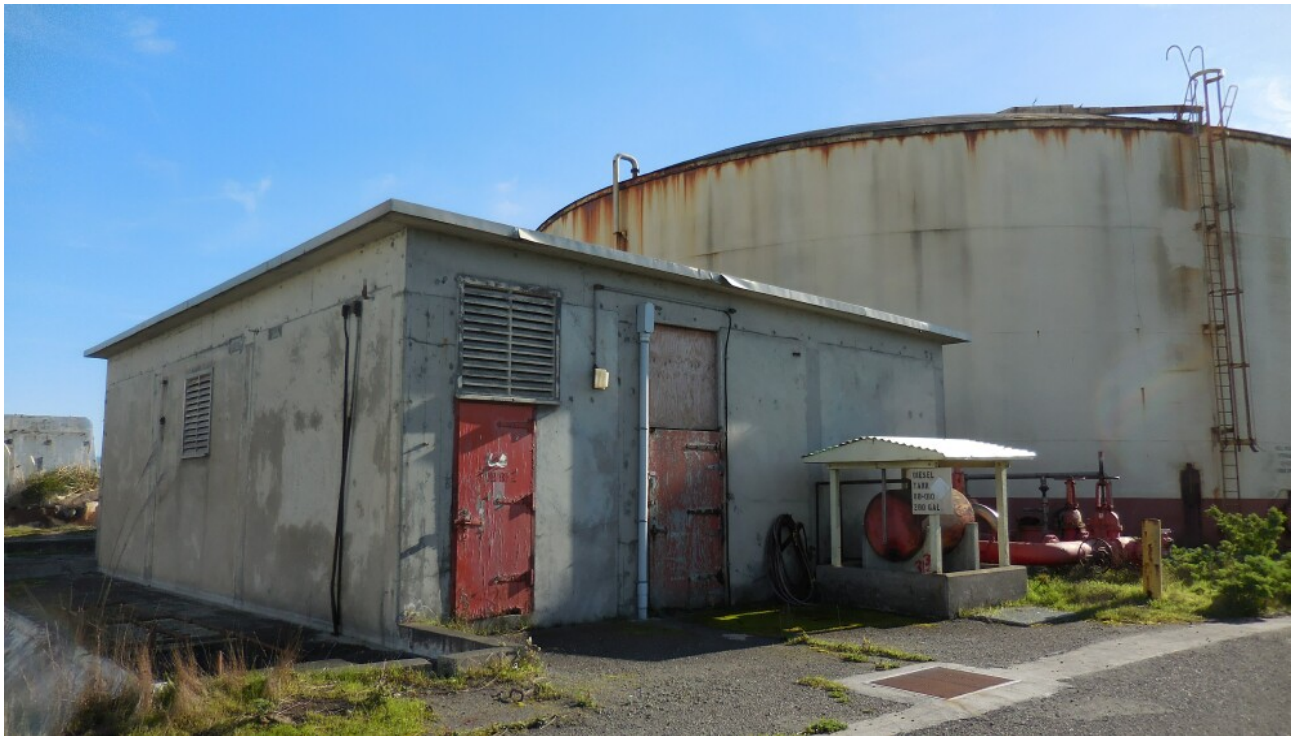
Figure 3. Pump House. Bat activity noted throughout. Remove only during seasonal periods of bat activity after conducting partial dismantling/deterrence measures as detailed in text.

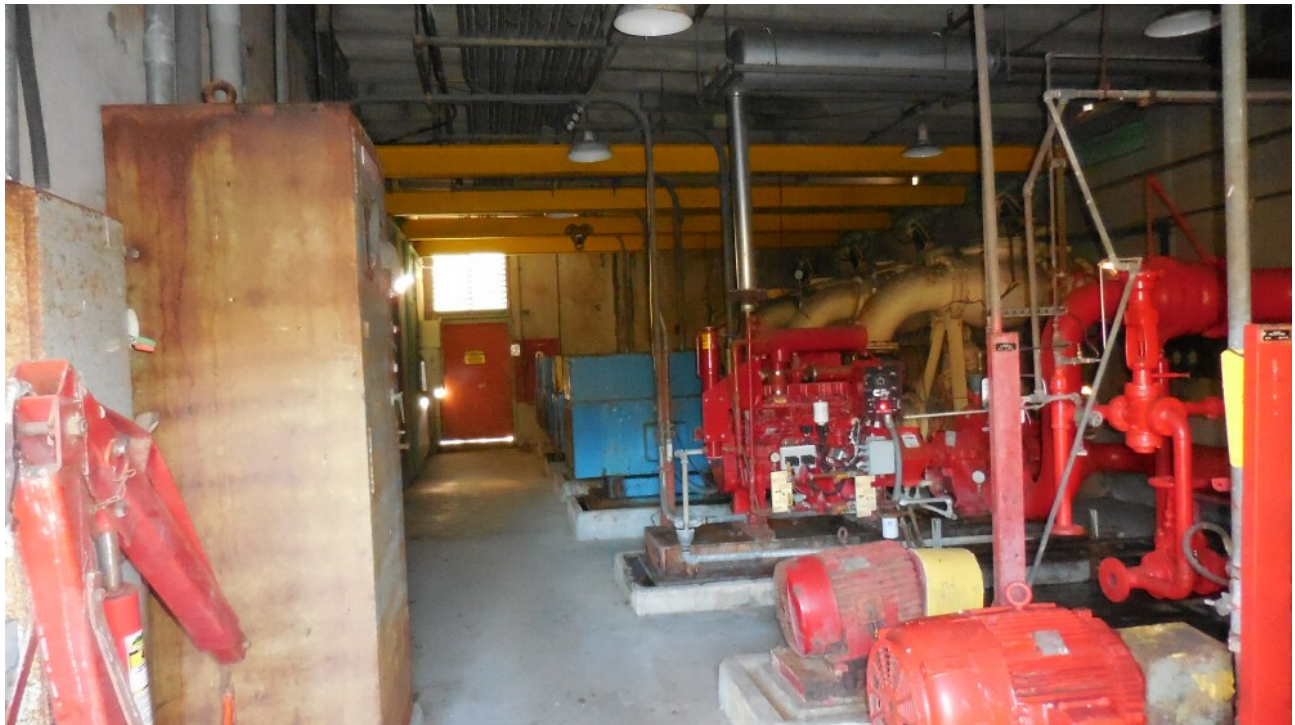
Figure 4. Interior of Pump House. Bat activity noted throughout. Remove only during seasonal periods of bat activity after conducting partial dismantling/deterrence measures as detailed in text.

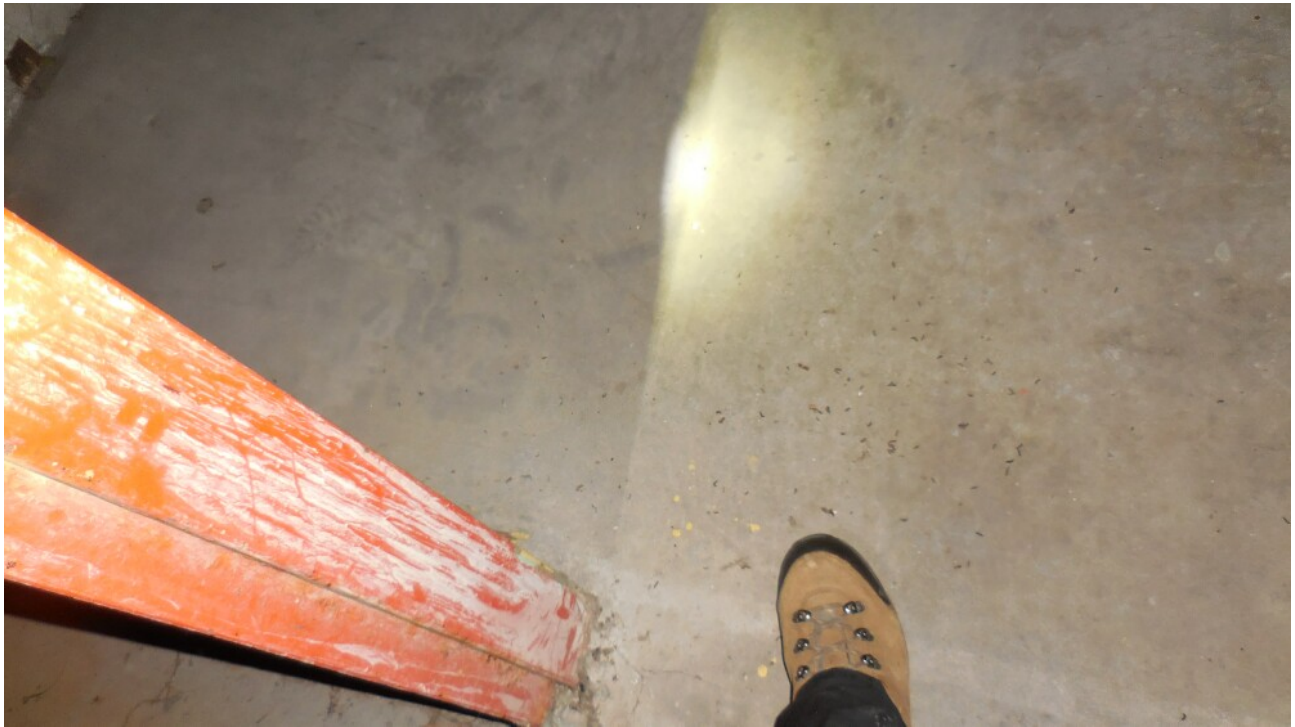
Figure 5. Bat fecal pellets noted in several locations throughout Pump House.

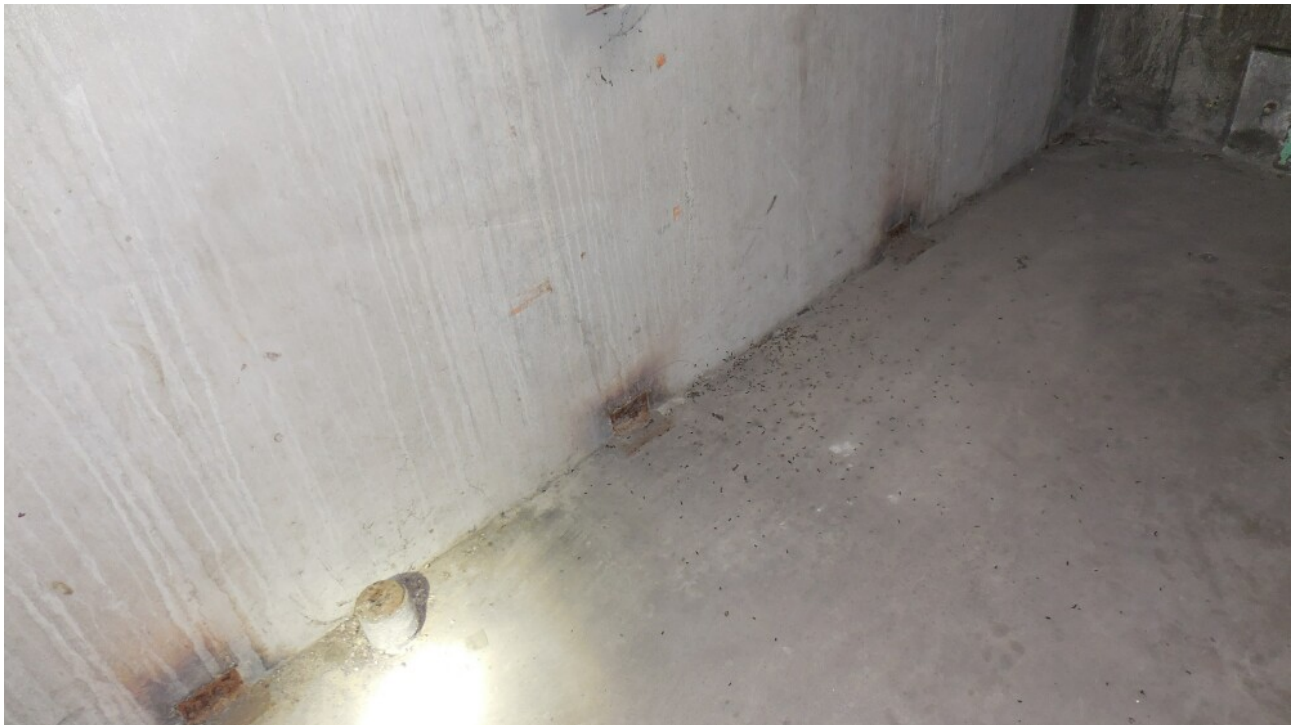
Figure 6. Bat fecal pellets noted in several locations throughout Pump House.

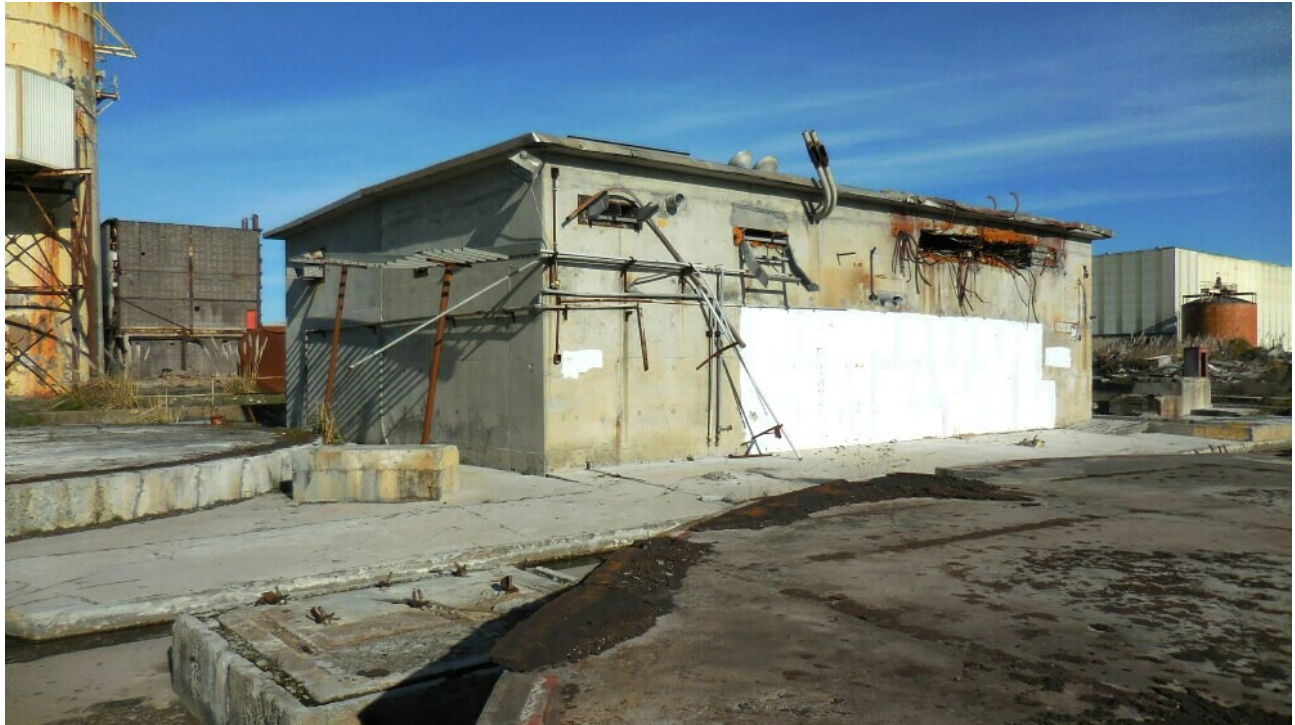
Bat fecal pellets were present in several different locations throughout the interior of the structure; however, no large accumulations of fecal pellet or urine streaking or staining were present, and no evidence of large populations such as a maternity colony was noted.

Figure 7. Building SUB FL.2. Bat activity noted in several interior locations.

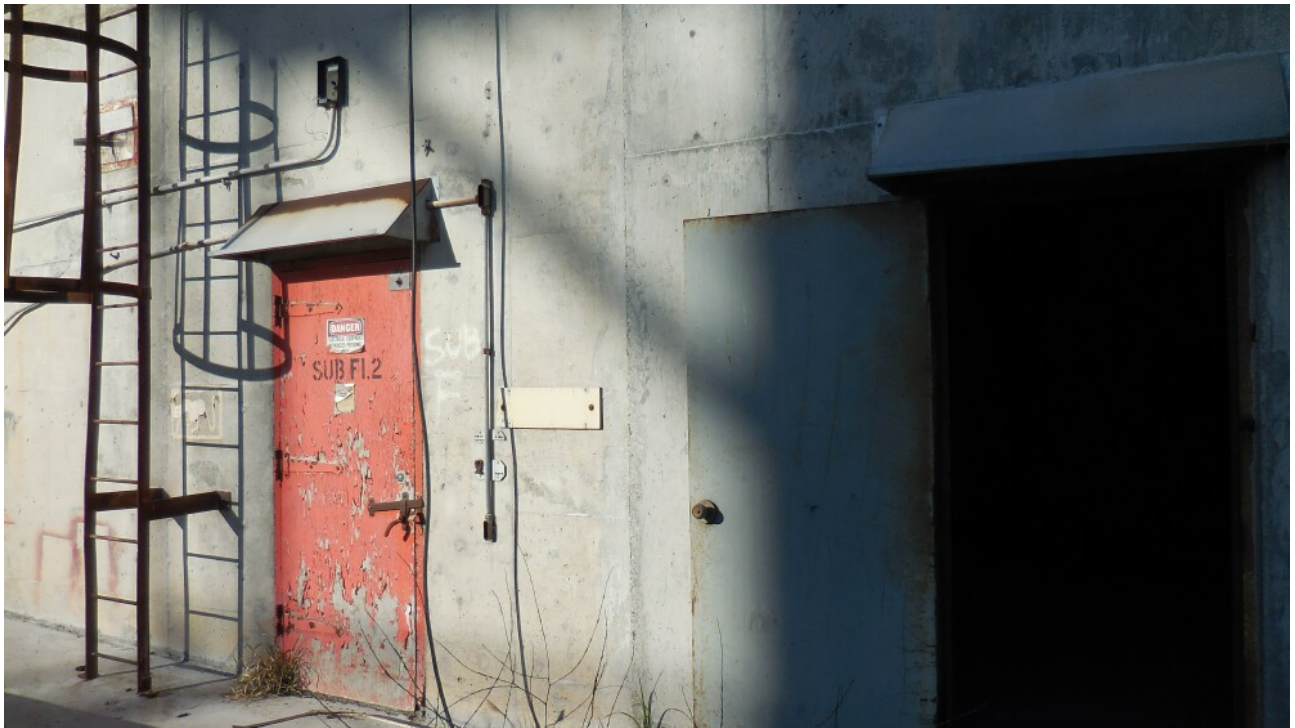
Figure 8. Building SUB FL.2. Bat activity noted in several interior locations.

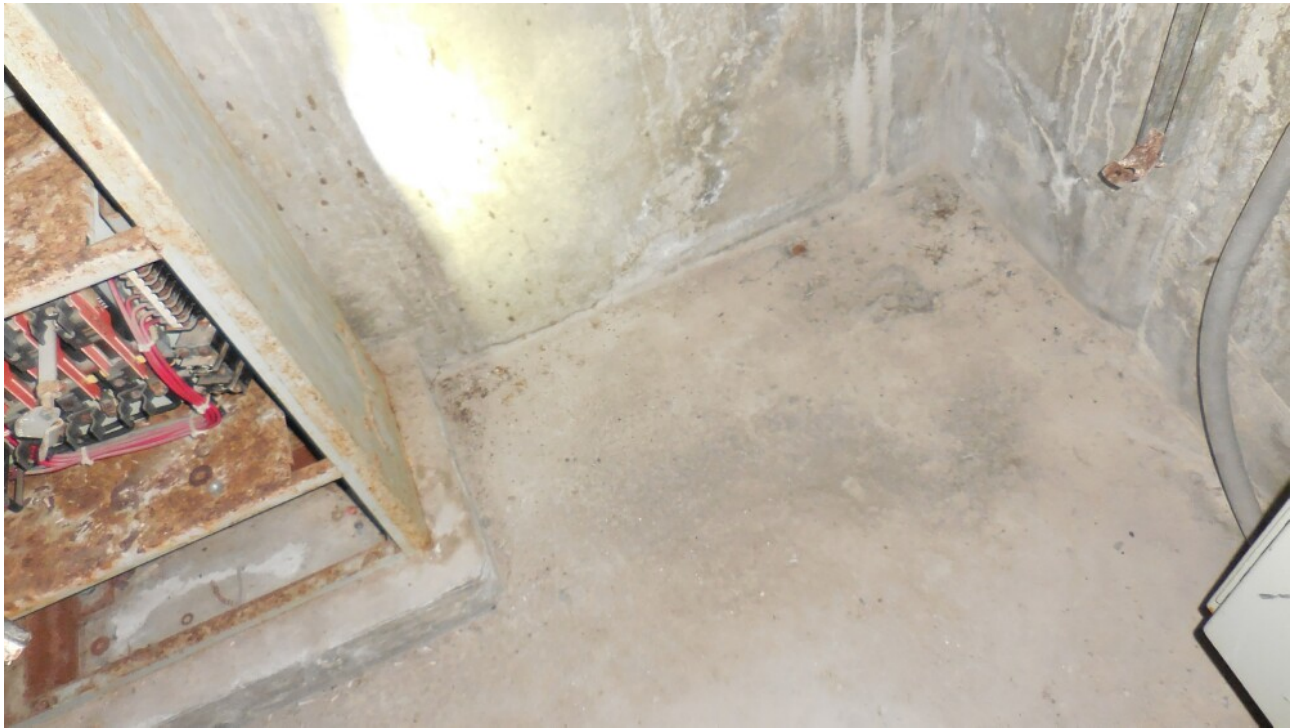
Figure 9. Building SUB FL.2. Bat activity noted in several interior locations.

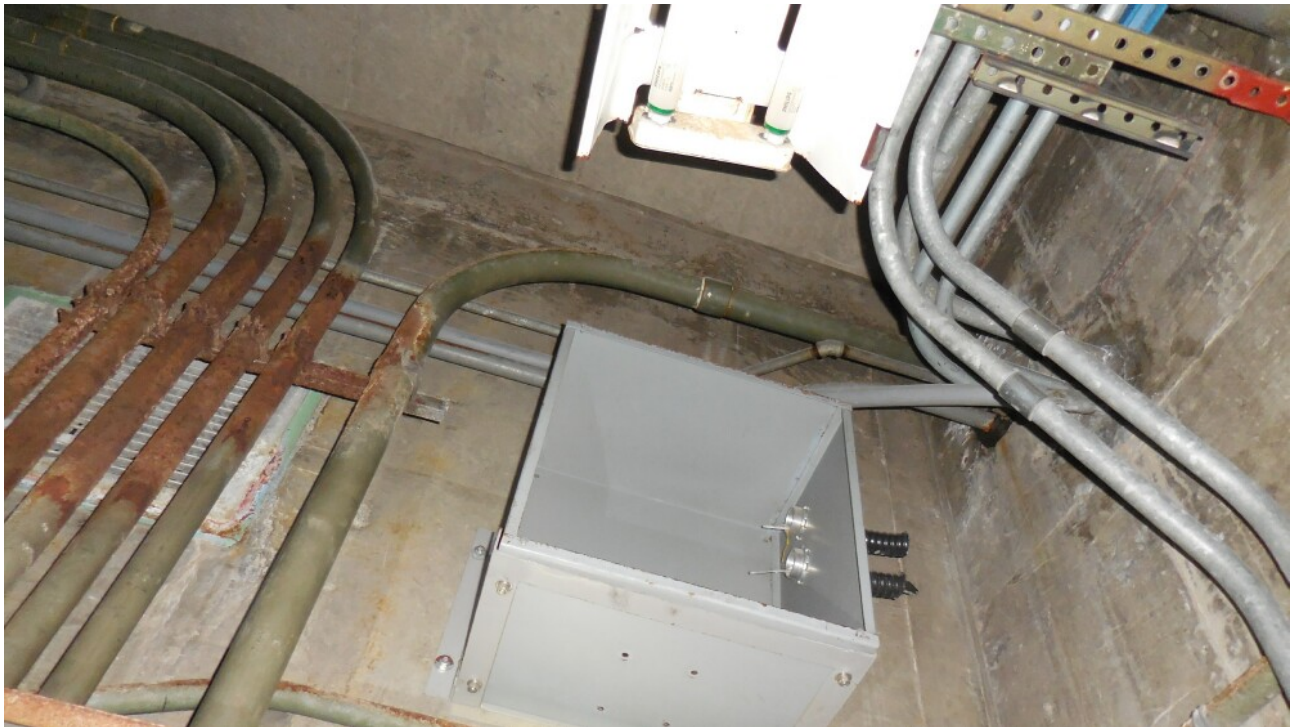
Figure 10. Building SUB FL.2. Bat activity noted in several interior locations.

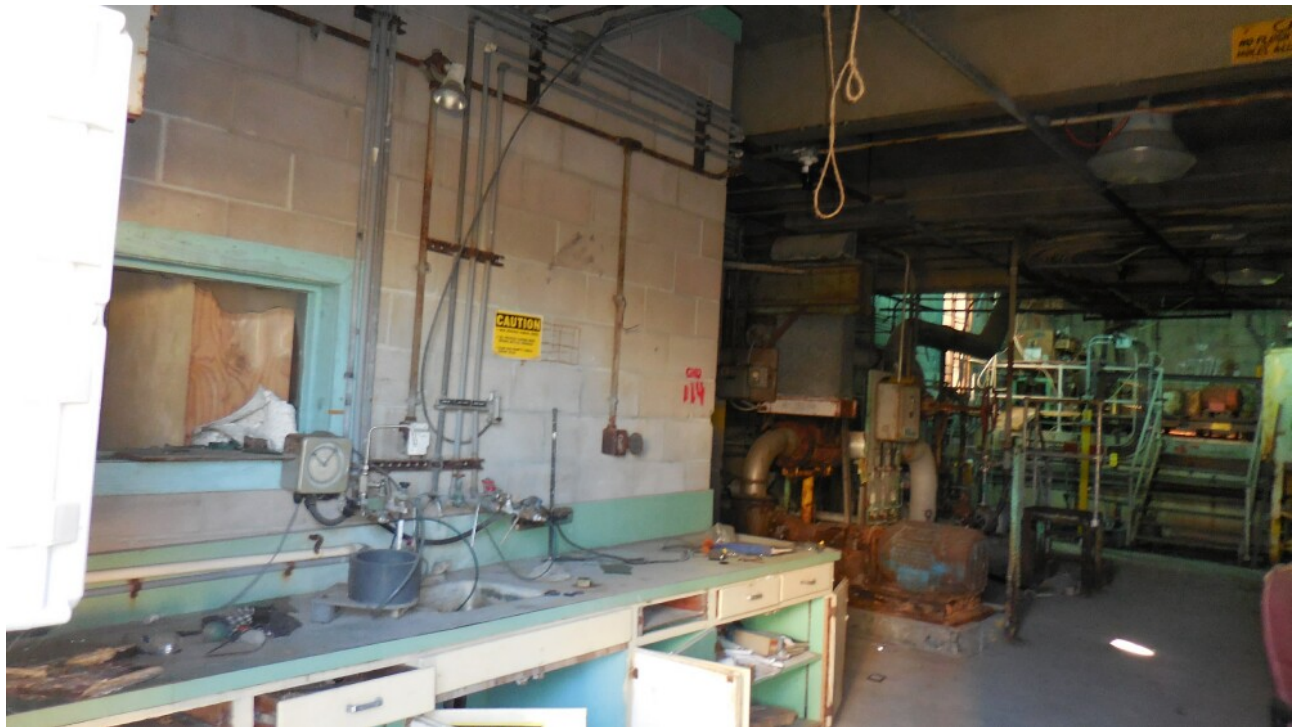
Figure 12. Interior of Filter/Softener Tank Building. Evidence of use by bats inside this structure, but not present in the attached, J-shaped Tank Support Building.

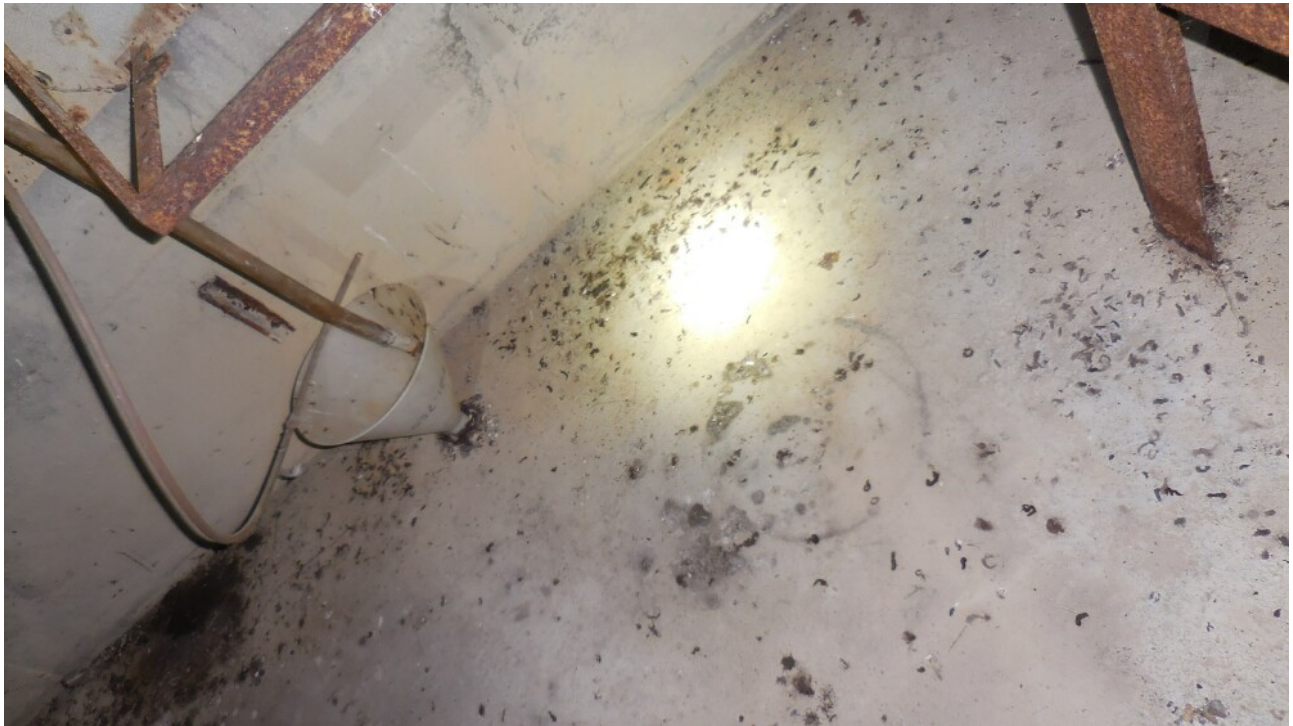
Figure 13. Bat fecal pellets observed in Filter/Softener Building. Some rodent activity also noted.

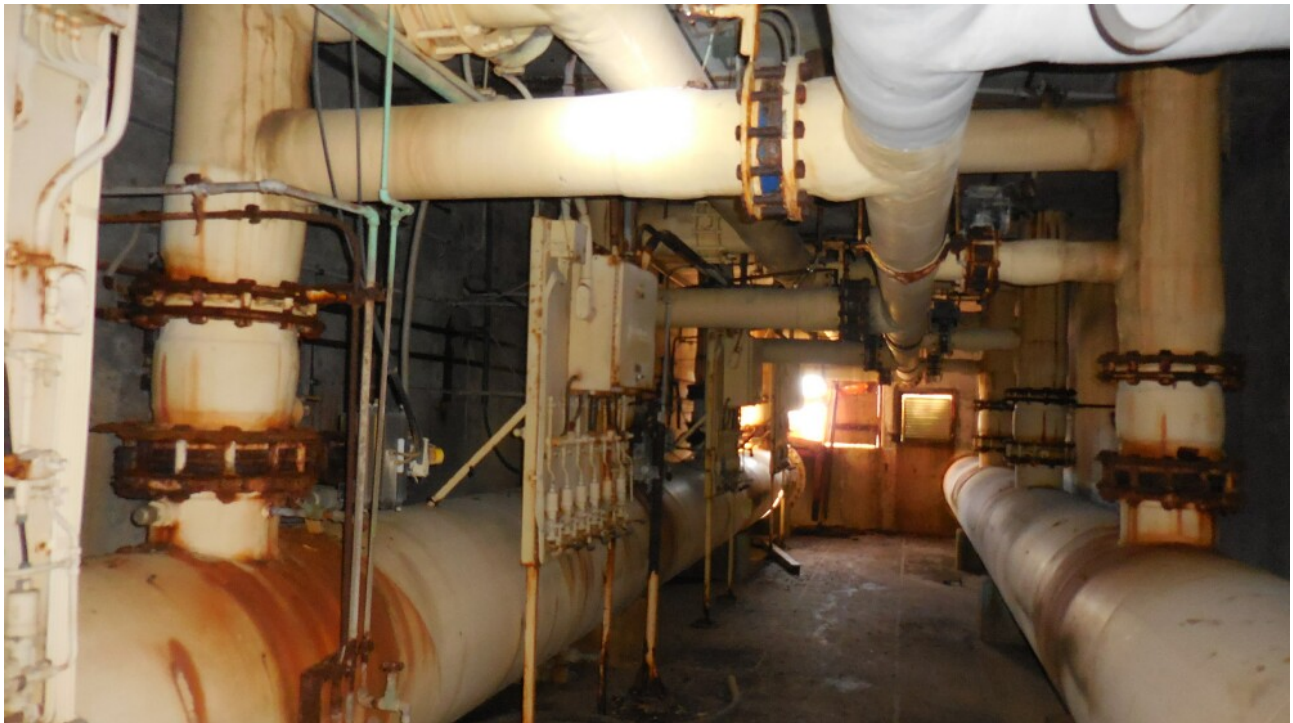
Figure 14. Interior of J-shaped Tank Support Building attached to Filter/Softener Tank Building. No signs of use by bats, but suitable potential habitat.

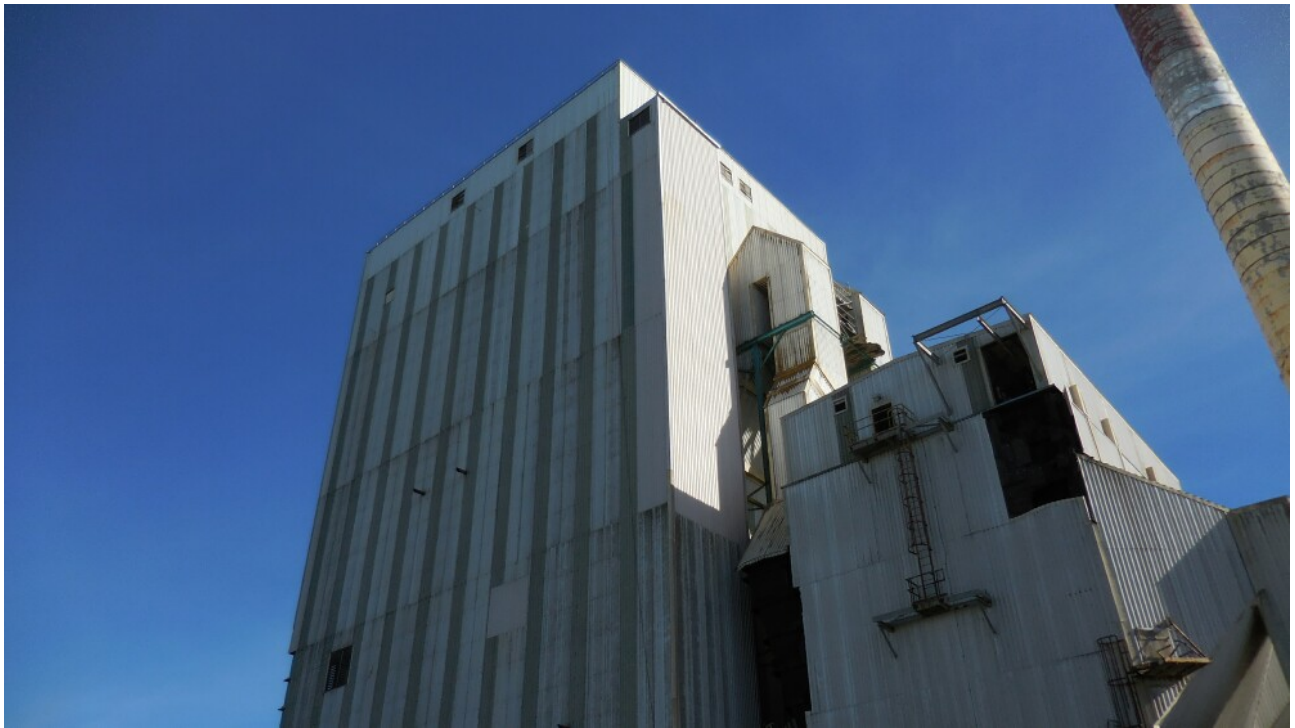
Figure 15. West-facing portion of 12-Story Boiler Building and attached structure. No signs of past or present use by bats around exterior or interior.

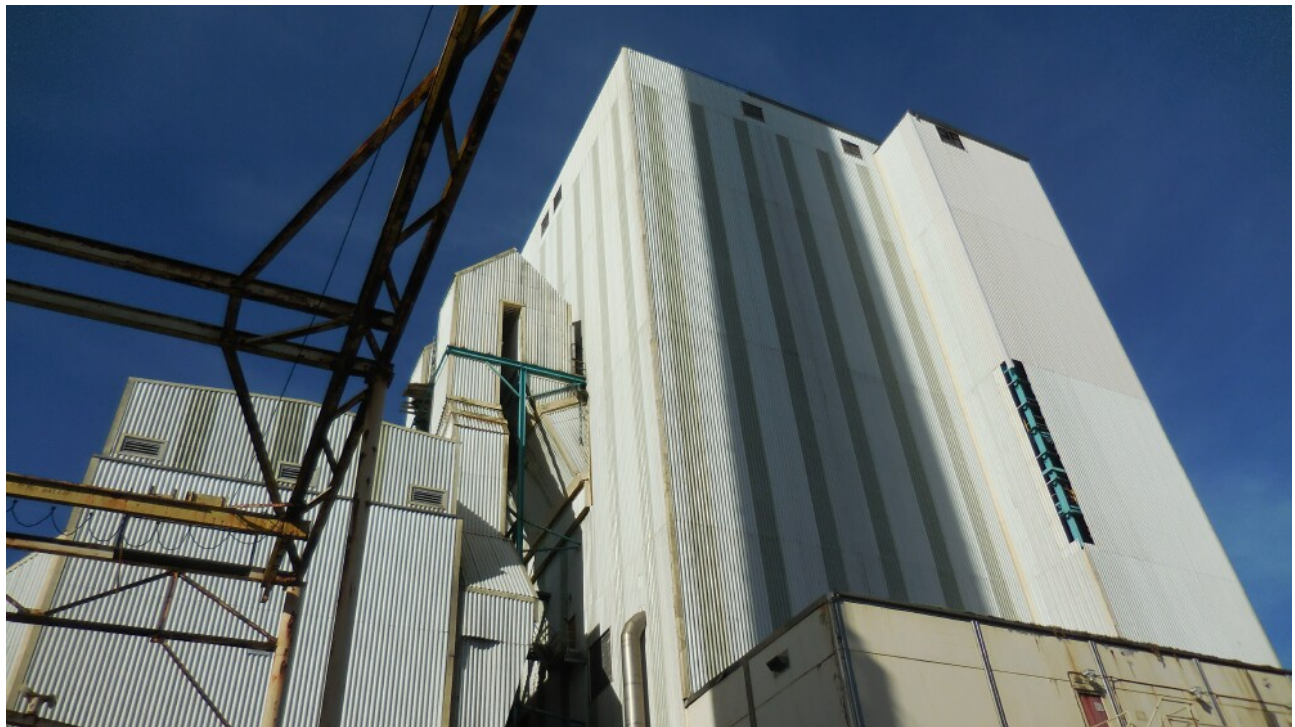
Figure 16. East-facing portion of 12-Story Boiler Building and attached structure. No signs of past or present use by bats.

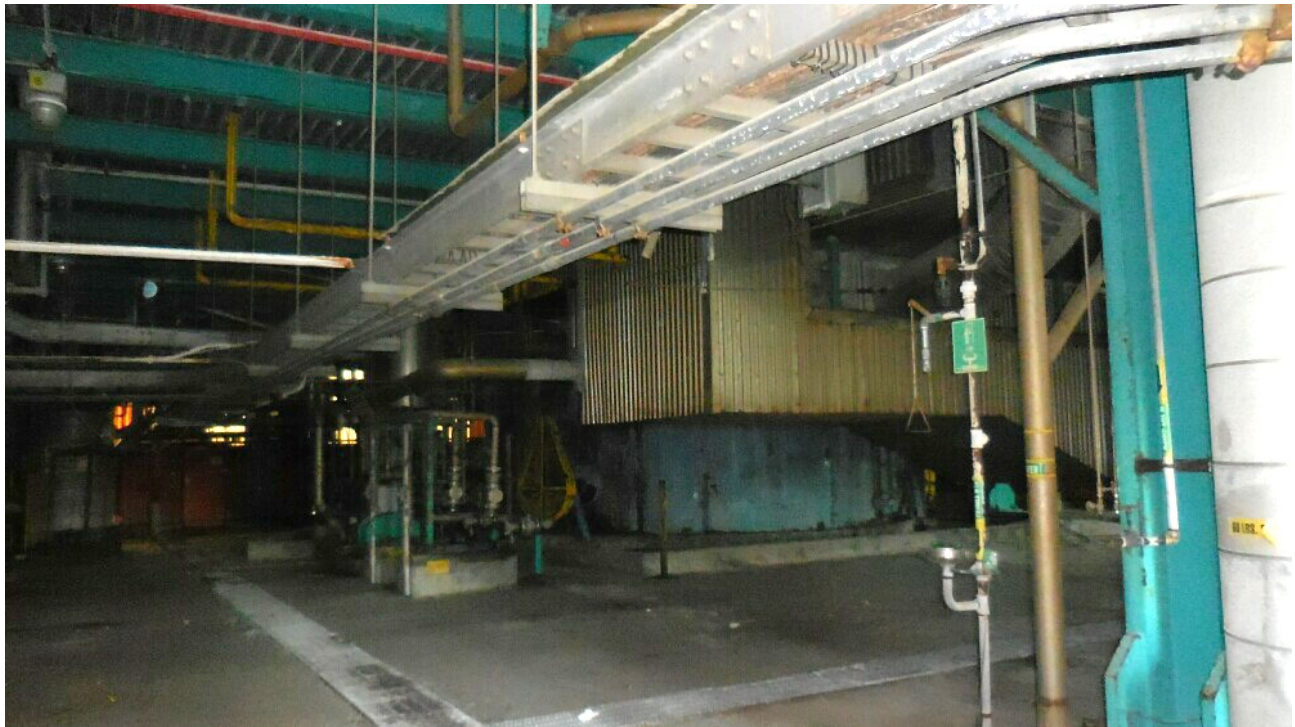
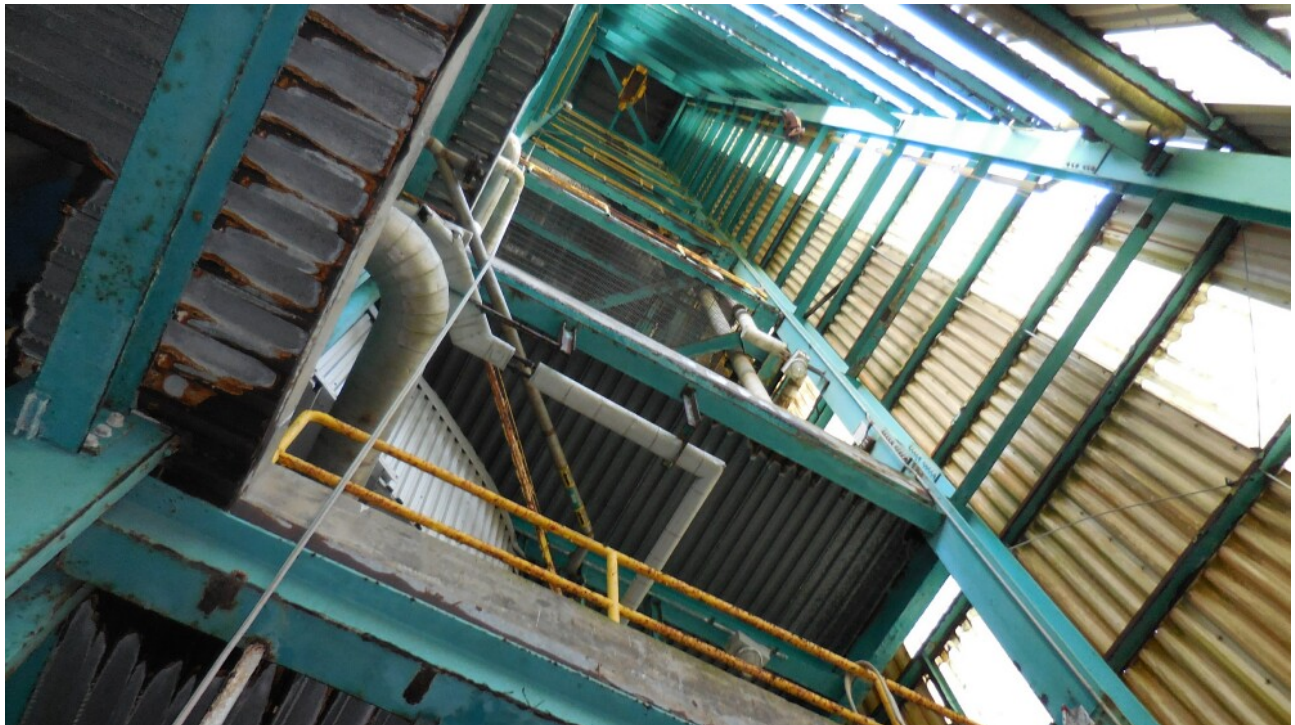
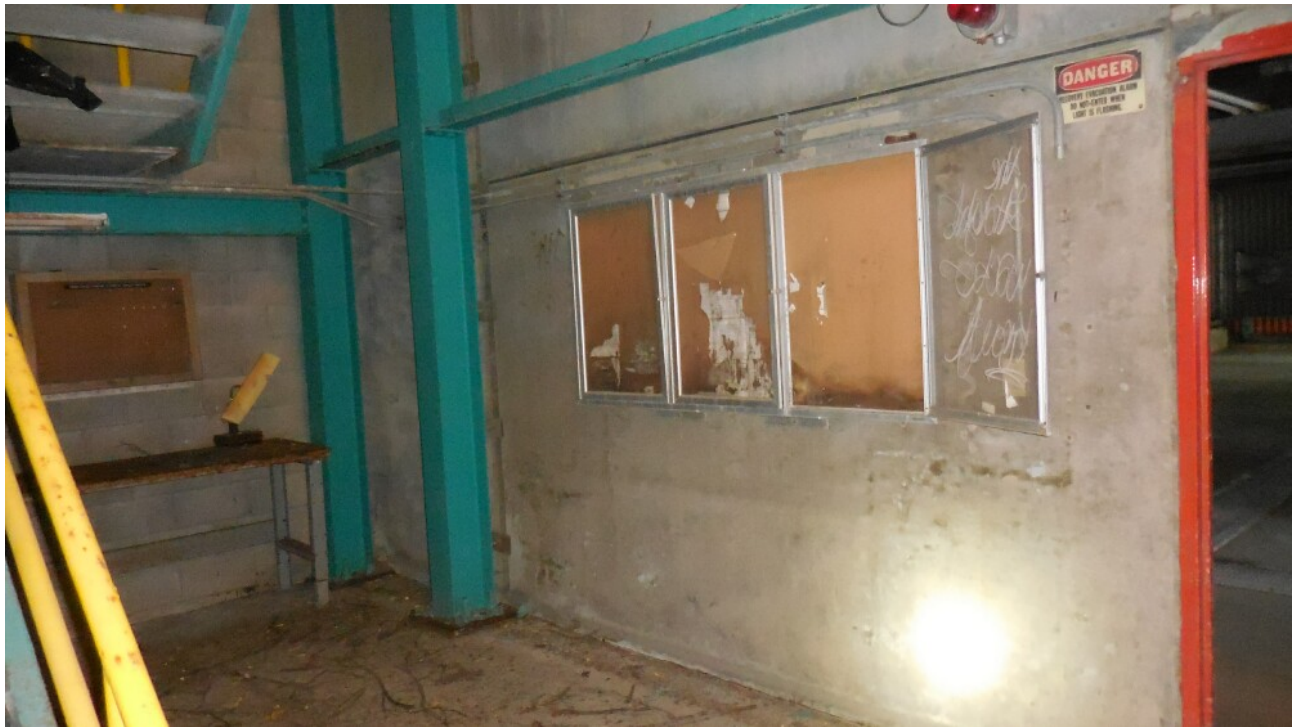
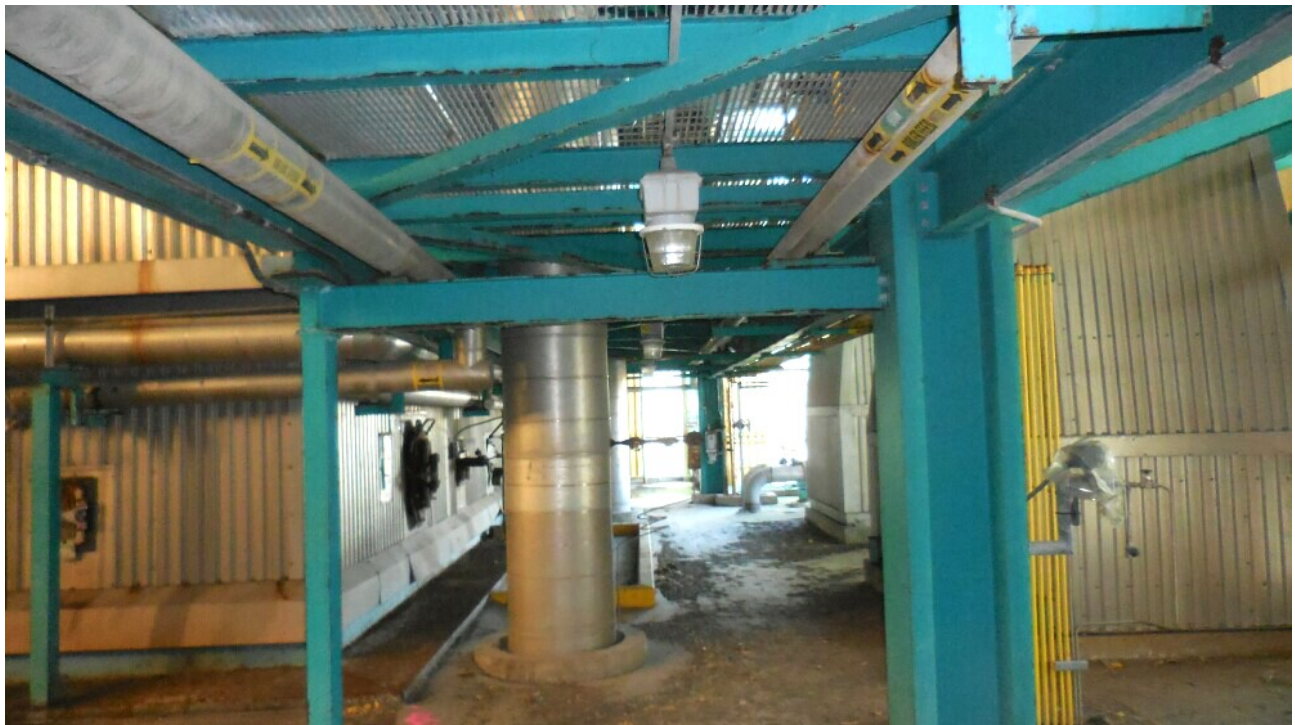
The interior of the 12-story structure is filled in most areas with ambient light, due to the opaque fiberglass wall panels. There are large sections of siding that have fallen from the building. Louvered vents also admit light and airflow. Several dead birds and nests were present in the structure, but no bat fecal pellets, urine, fur staining, live or dead bats were present in the structure. As a result of these observations along with the building conditions, roost habitat suitability is extremely low in this structure.

Figure 17. Interior of 12-Story Boiler Building. Large amounts of light and in some locations, airflow, not conducive to bat roosting activity. No signs of past or present use found.

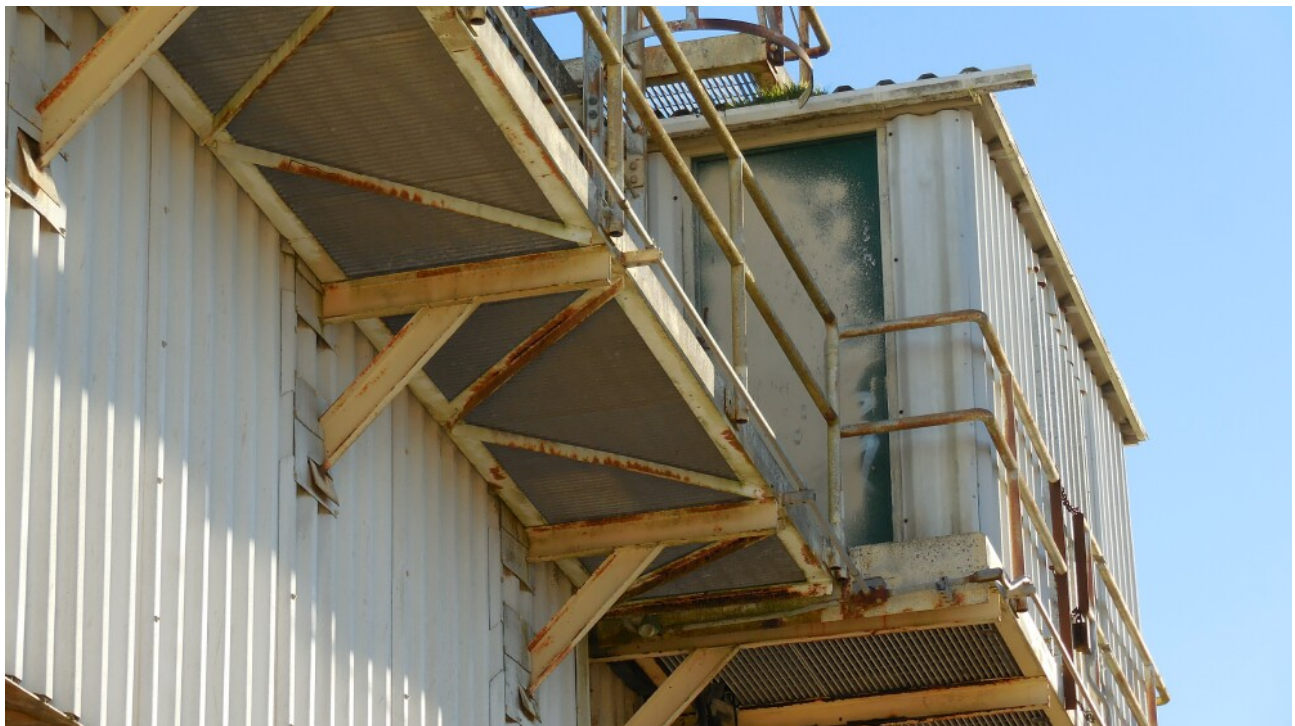
Figure 21. No signs of past or present bat activity in connected structure.

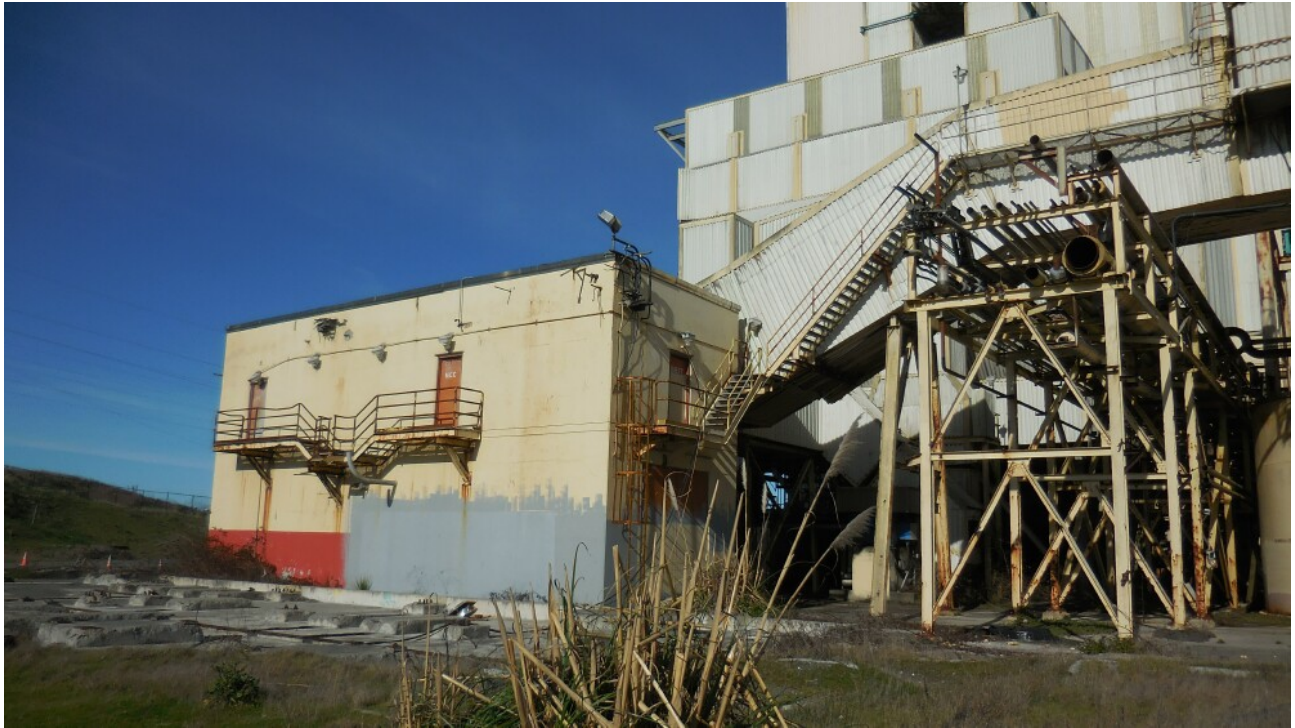
Figure 23. 2-Story Building near Smokestack and 12-Story Boiler Building. No signs of use by bats around exterior or interior.

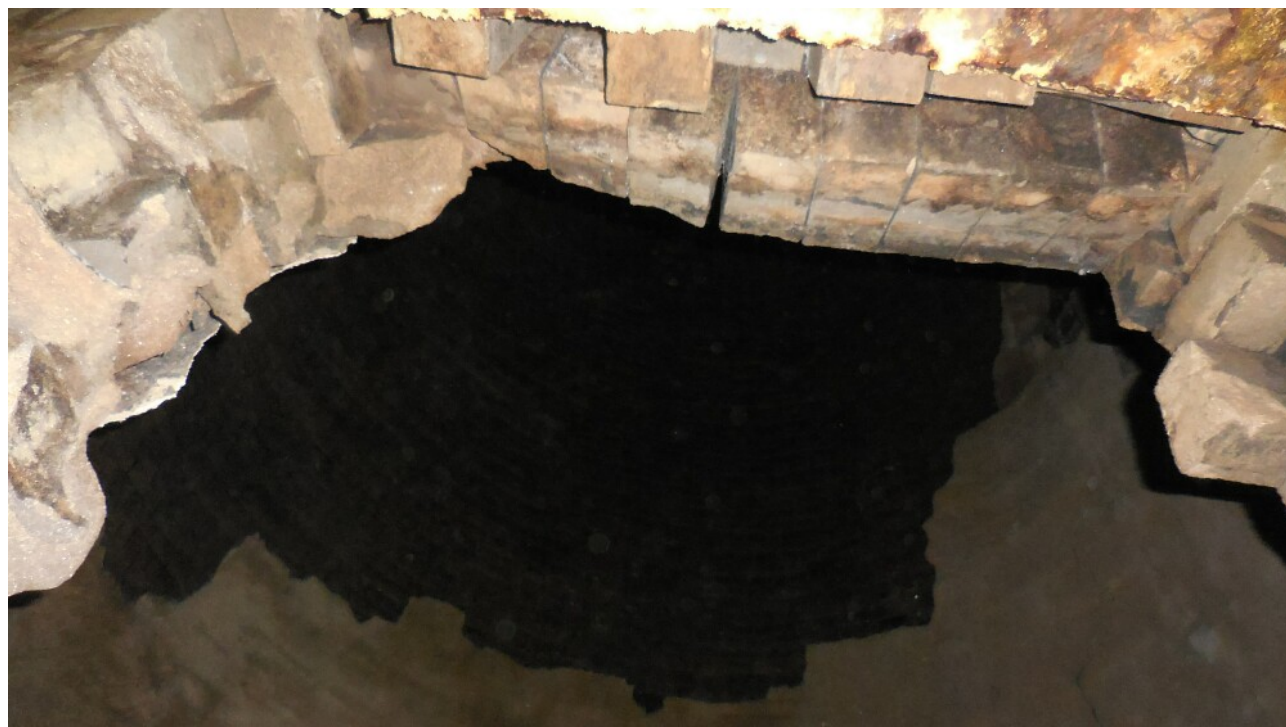
view up to the top opening. No urine staining, adhered fecal pellets, or accumulated fecal pellets on the floor of the Smokestack were observed. Based on the open top admitting light and moisture from above, lack of protected roost crevices or cavities observed, and lack of bat fecal pellets or urine/fur staining, visible from the base opening up about 100 feet, the Smokestack likely provides poor habitat suitability.

Figure 26. Interior lower portion of Smokestack. No signs of roosting bats.
