# **Appendix C-1**

## **Bat Habitat Assessment**

## **BAT HABITAT ASSESSMENT, REPORT, RECOMMENDATIONS – SAMOA PENINSULA LAND-BASED AQUACULTURE PROJECT – SAMOA, CA**

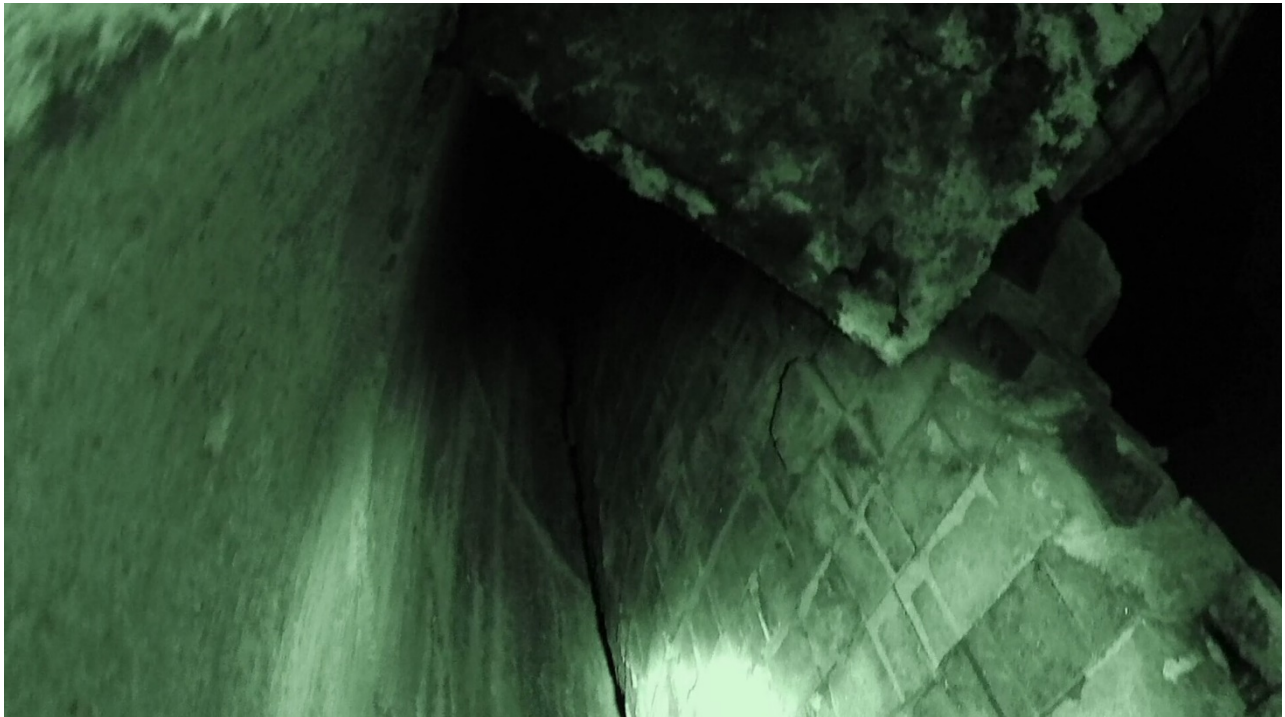
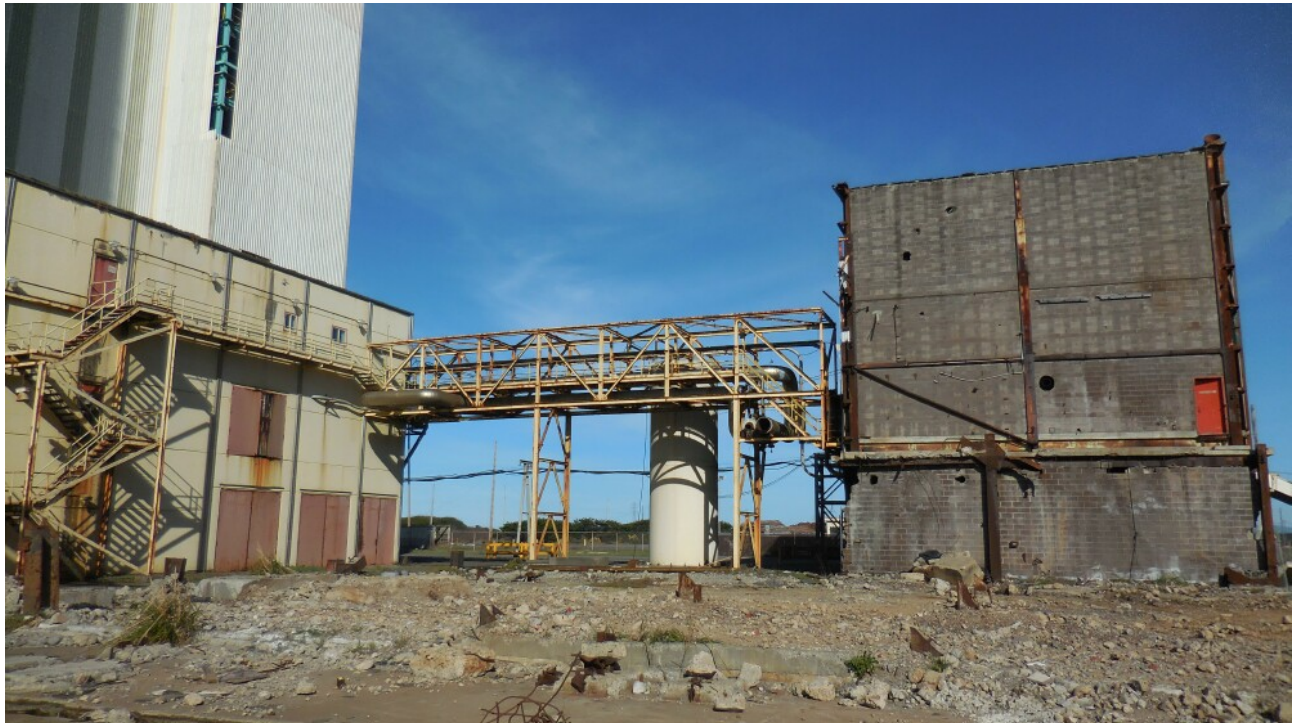
Figure 28. South-facing portion of 3-Story Boiler Building just east of 12-Story Boiler Building. No signs of bat activity, exterior or interior.

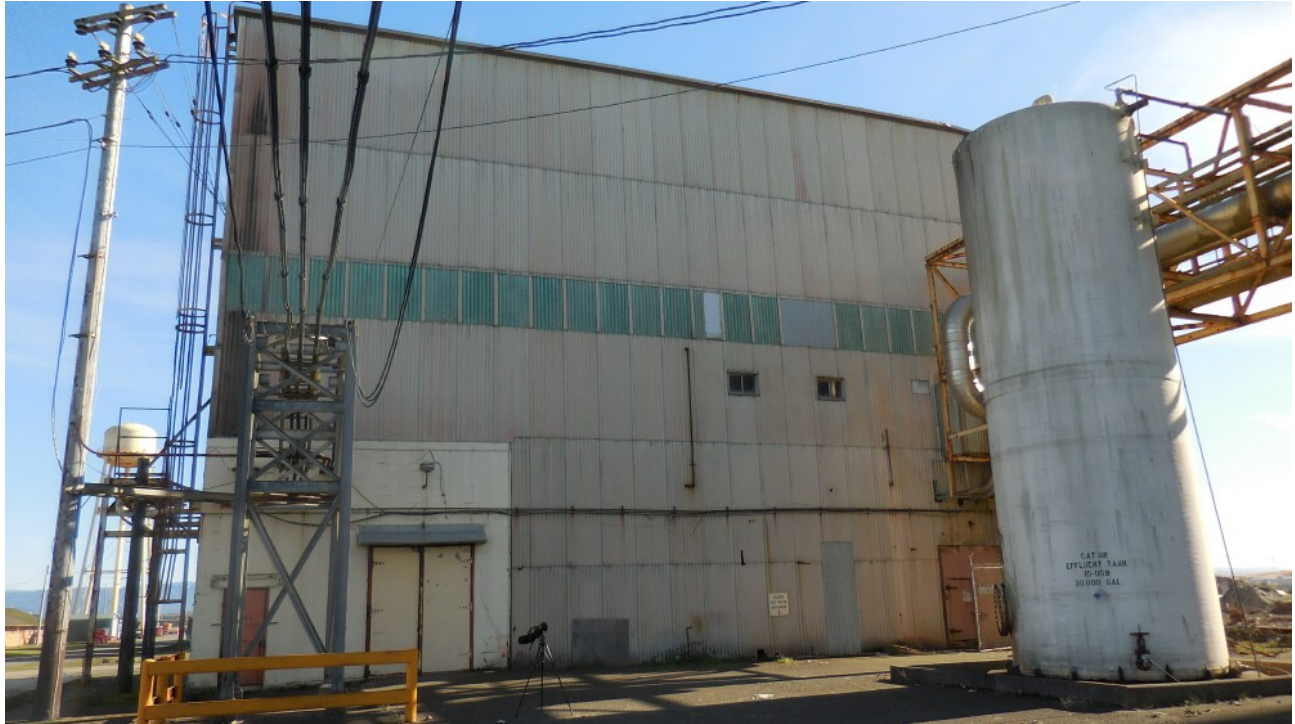
Figure 31. West-facing portion of 3-Story Boiler Building just east of 12-Story Boiler Building. No signs of bat activity, exterior or interior.

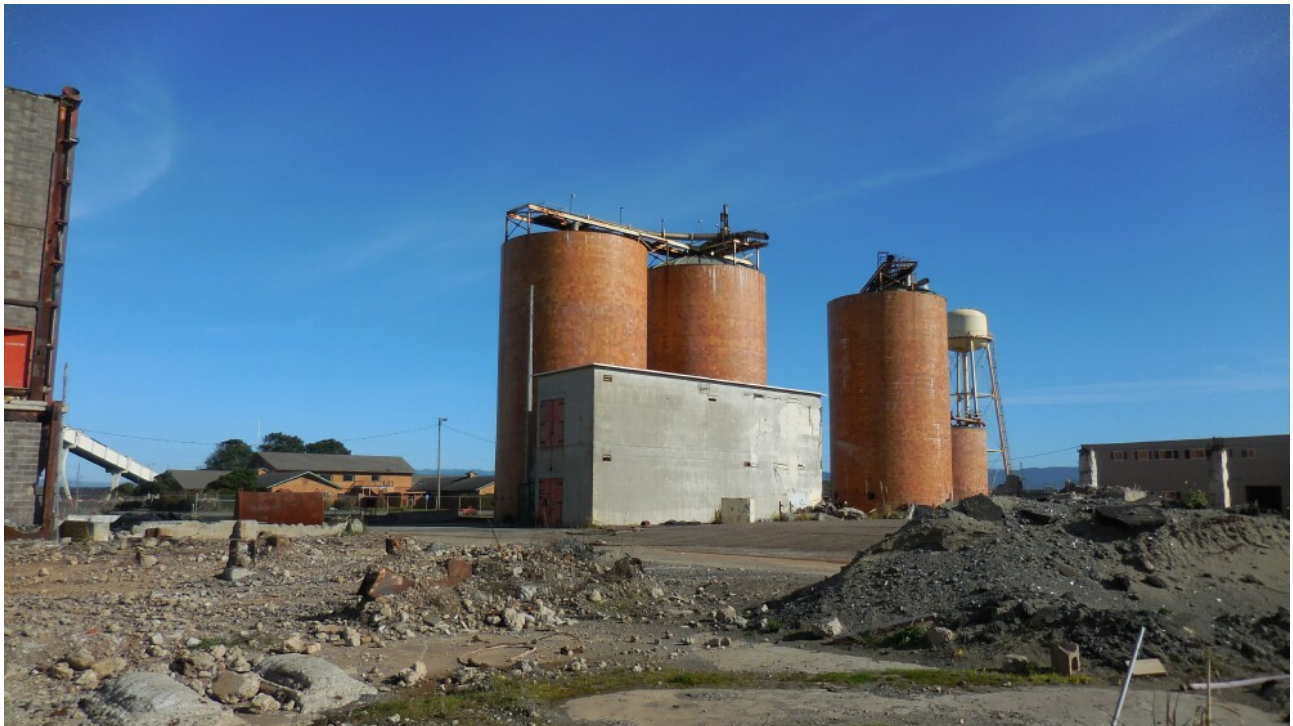
These roughly 3-story high brick silos, or tanks were not safe to enter, however one was viewable through an open hatch at the base. Aerial UAV photographs provided by Nordic Aquafarms show several of the tanks with totally or mostly missing roofs, and three tanks still with roofs that had small openings a few inches in diameter. Bats prefer protected roost locations that provide cover from above; the three tanks with no roofs provide no suitable day-roost habitat for bats. The three tanks with roofs had openings too small and not oriented properly for bats to enter and exit those tanks. As a result, tanks with no roof have no habitat suitability for bats; those with intact roofs with small openings have extremely low habitat suitability.

Figure 35. Brick Silos (tanks) located at north-central portion of site. Structure 2 is visible in foreground. No signs of past or present use by bats in Structure 2, tanks not safe to survey interiors, but 2 have open tops, no suitable habitat; remainder have no suitable openings for bats.

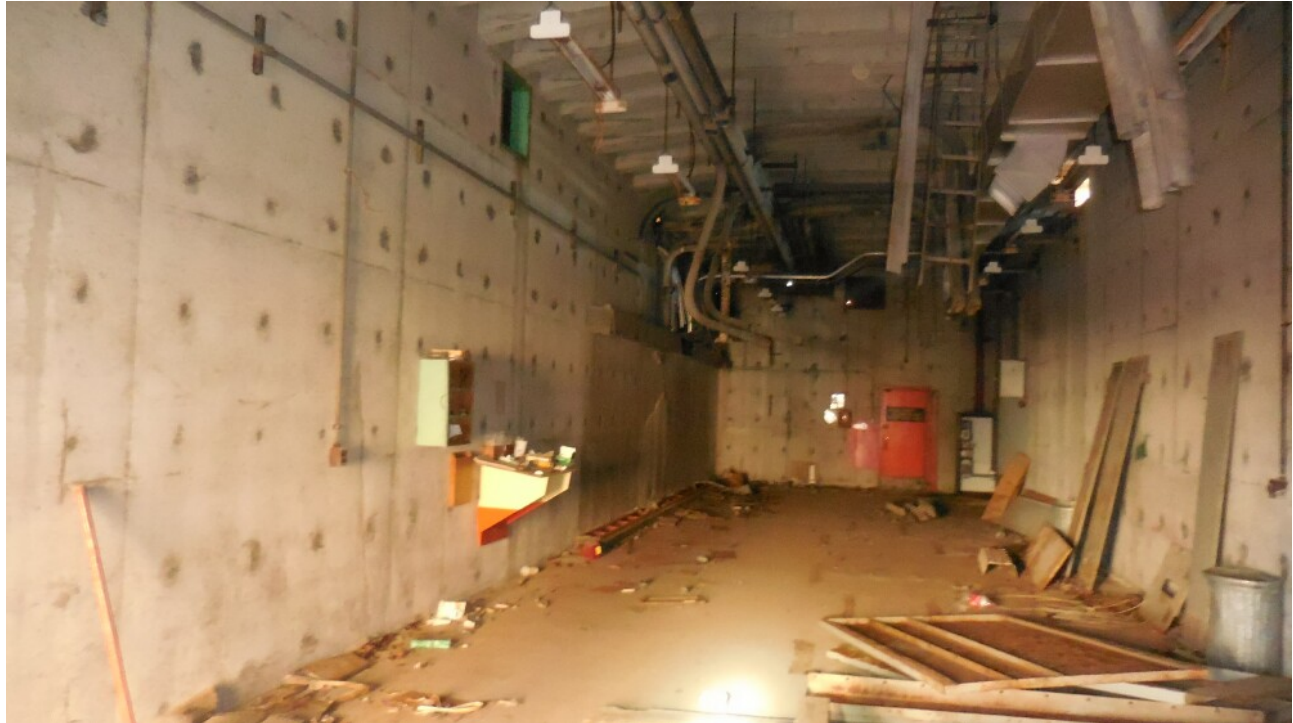
Figure 36. Interior – Structure 2. No signs of bats, but suitable habitat present in upper floor.

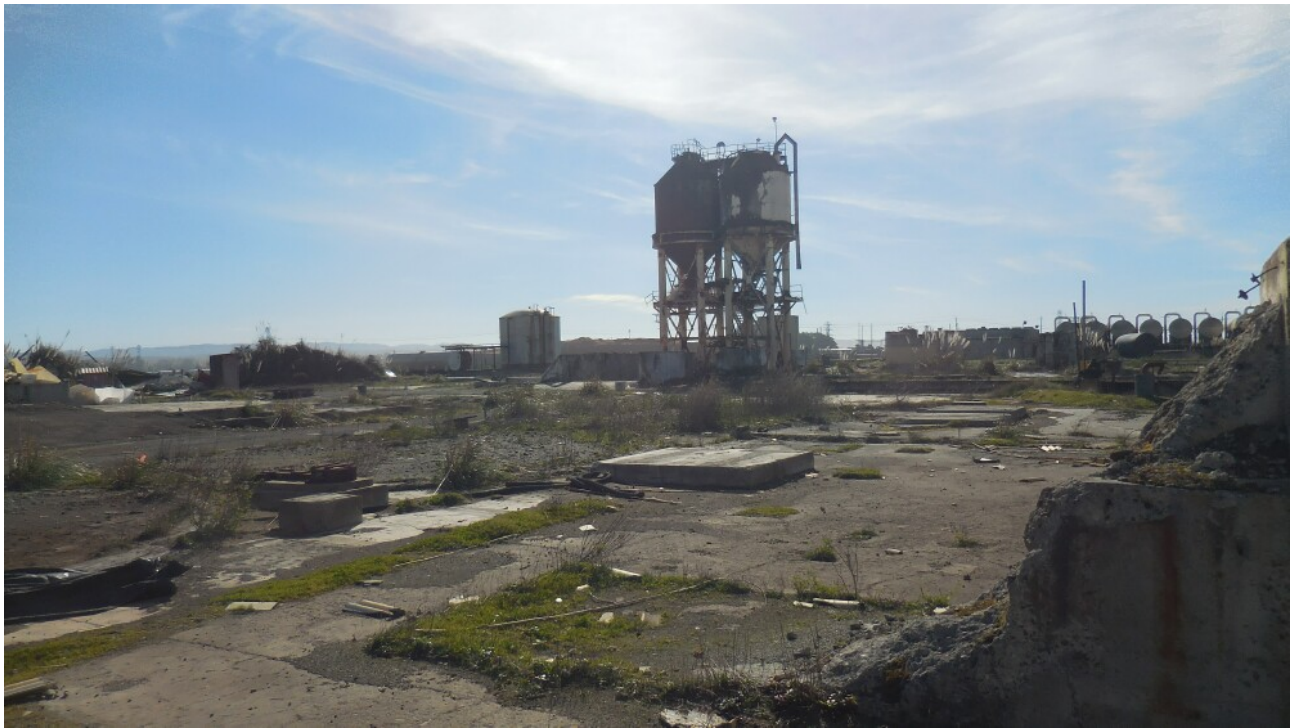
Figure 37. Steel tanks in interior of site. No suitable bat habitat.

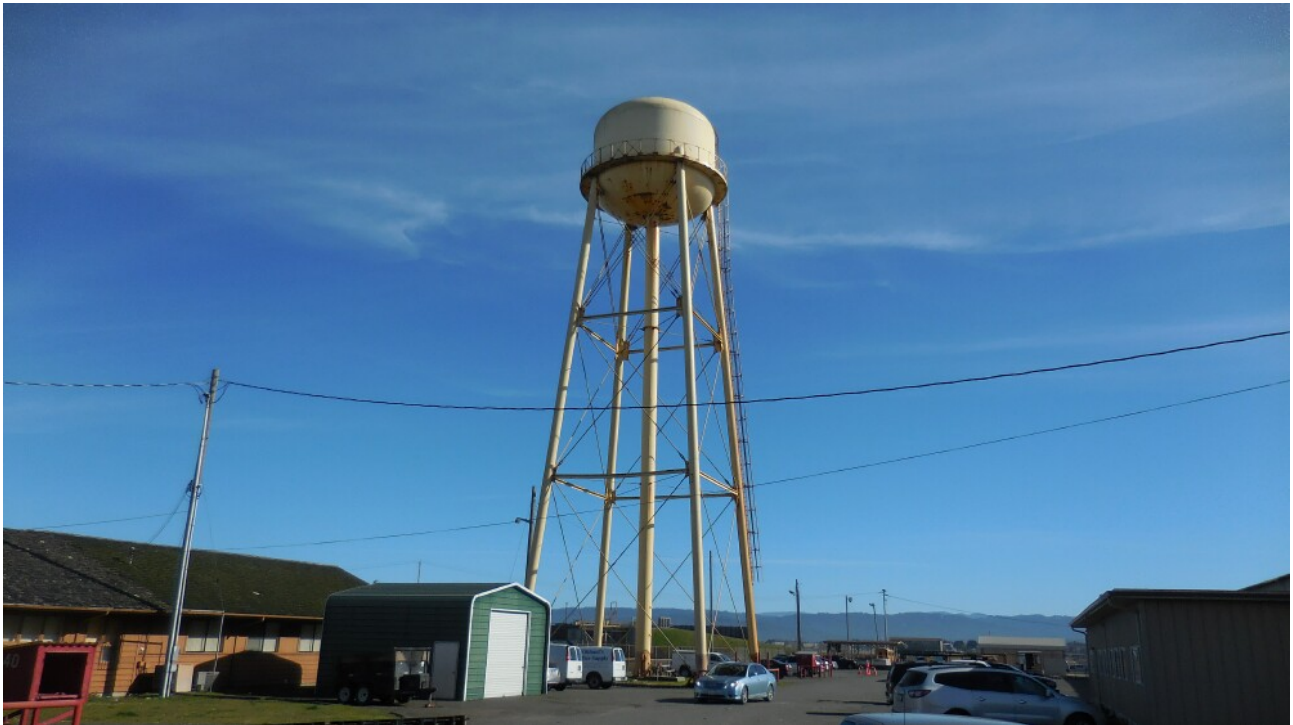
Figure 38. Elevated water tank, north portion of site just outside boundary, but may be removed. No suitable bat habitat.

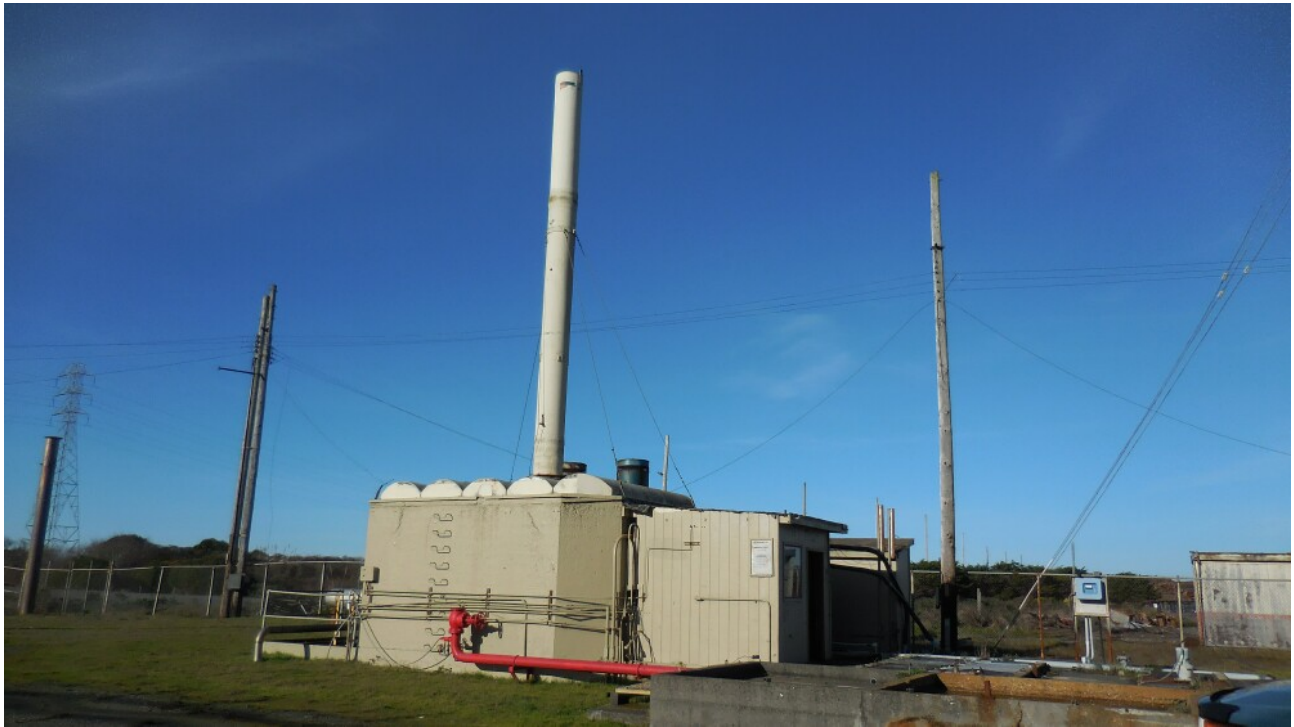
Figure 39. Unmarked building outside north boundary – no signs of use by bats.

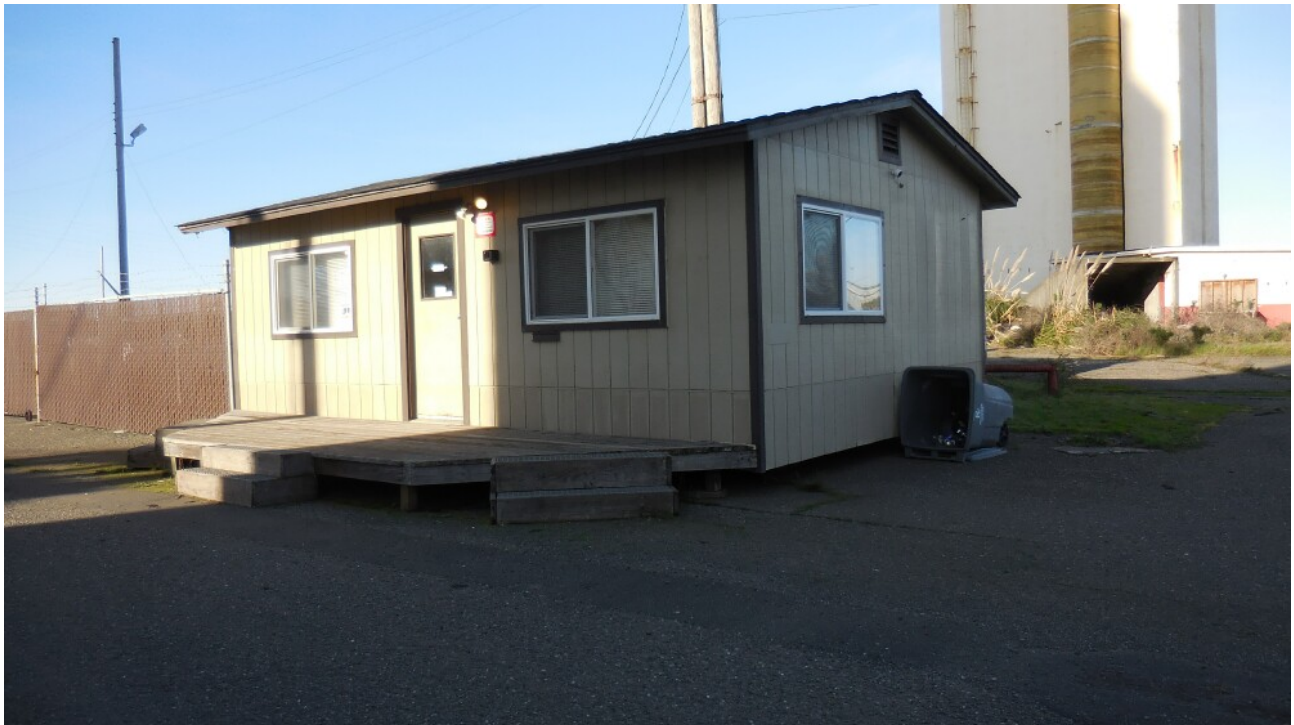
Figure 40. Portable building outside north boundary – no signs of use by bats, no suitable entry points.

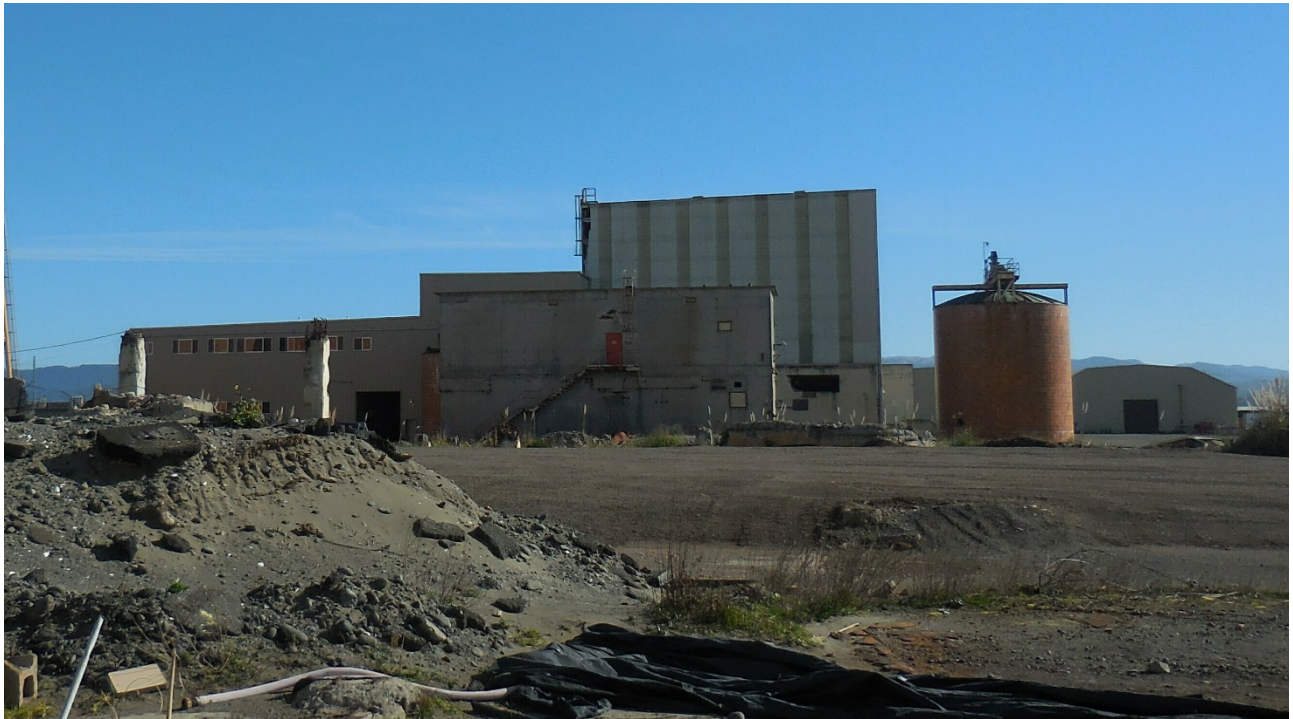
Figure 41. Structure – 2-story building in foreground, Existing offices at left side of large structure, Warehouse and Shared Spaces in central part of building behind Structure, and Machine Building and Silo at right.

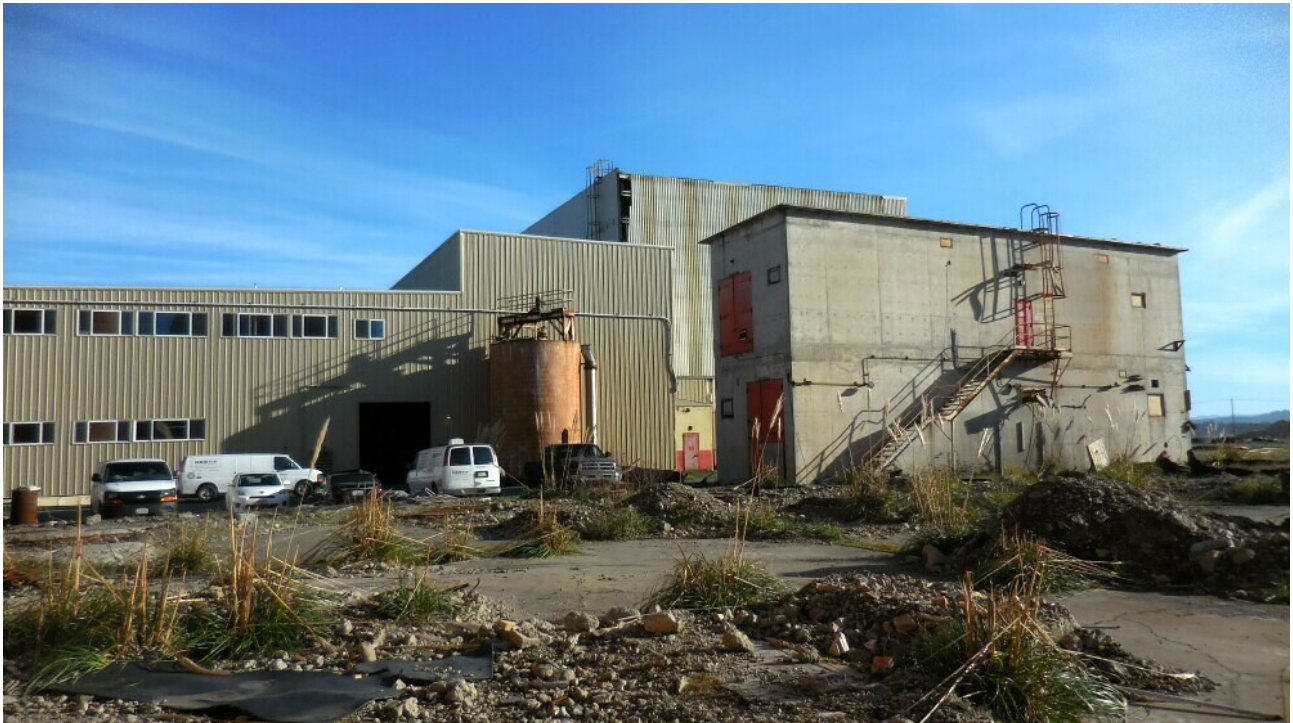
Figure 42. Existing Offices at left, Silo (tank), Warehouse and Shared Spaces in middle portion of large structure, and Structure (2-story, concrete) in foreground at right. No signs of past or present use by bats in any of these structures.

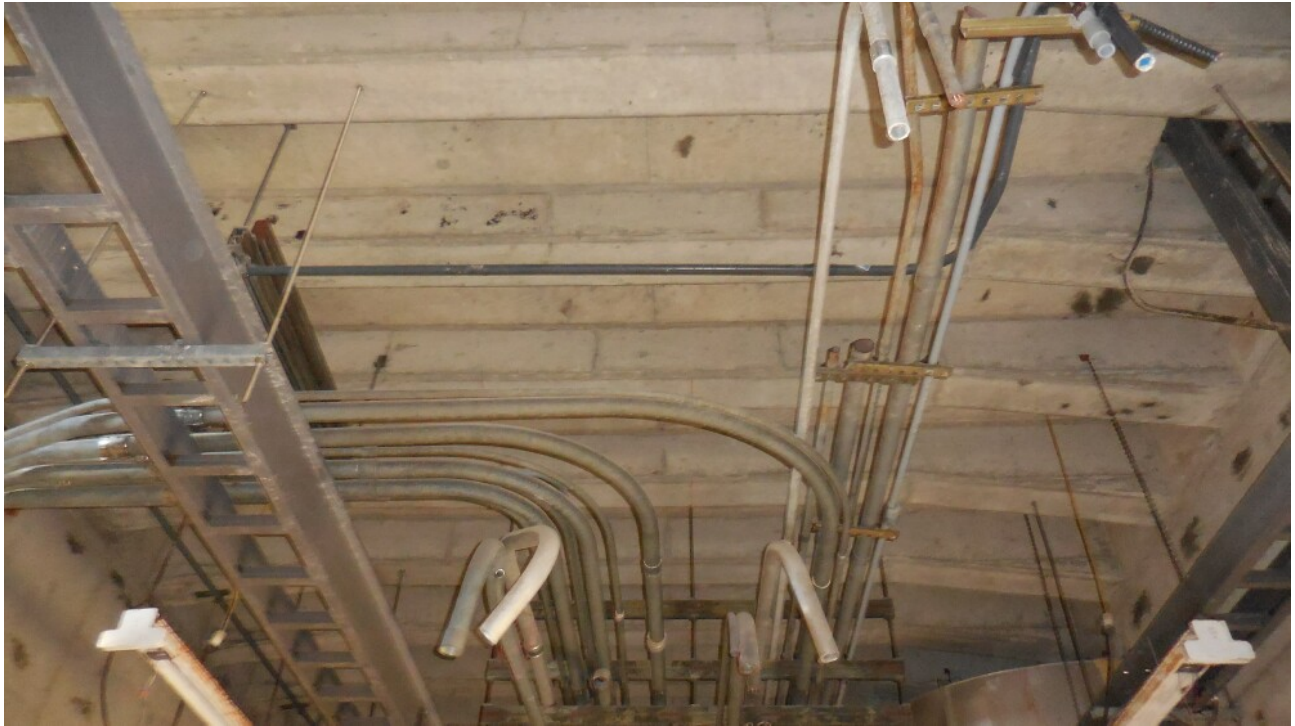
Adjacent to and immediately south of a row of brick Silos at the north-central portion of the site is a two-story concrete structure almost identical to the Structure (concrete) noted above. A window in the front doors and other smaller openings around the exterior walls provide suitable entry for bats. The interior was warmer than the other structures inside, and provides highly suitable potential bat roost habitat; although no signs of past or present use by bats were present around the exterior or in the interior of this structure, bats could easily begin to occupy the structure either spontaneously, or due to being caused to abandon other occupied roosts.

Figure 49. T-beam ceiling girders provide good suitable habitat for bats, although no signs of use were present. However, Structure and Structure 2, identical in construction, should be removed prior to removal of bat-occupied structures to prevent bats abandoning those buildings from moving into these structures.

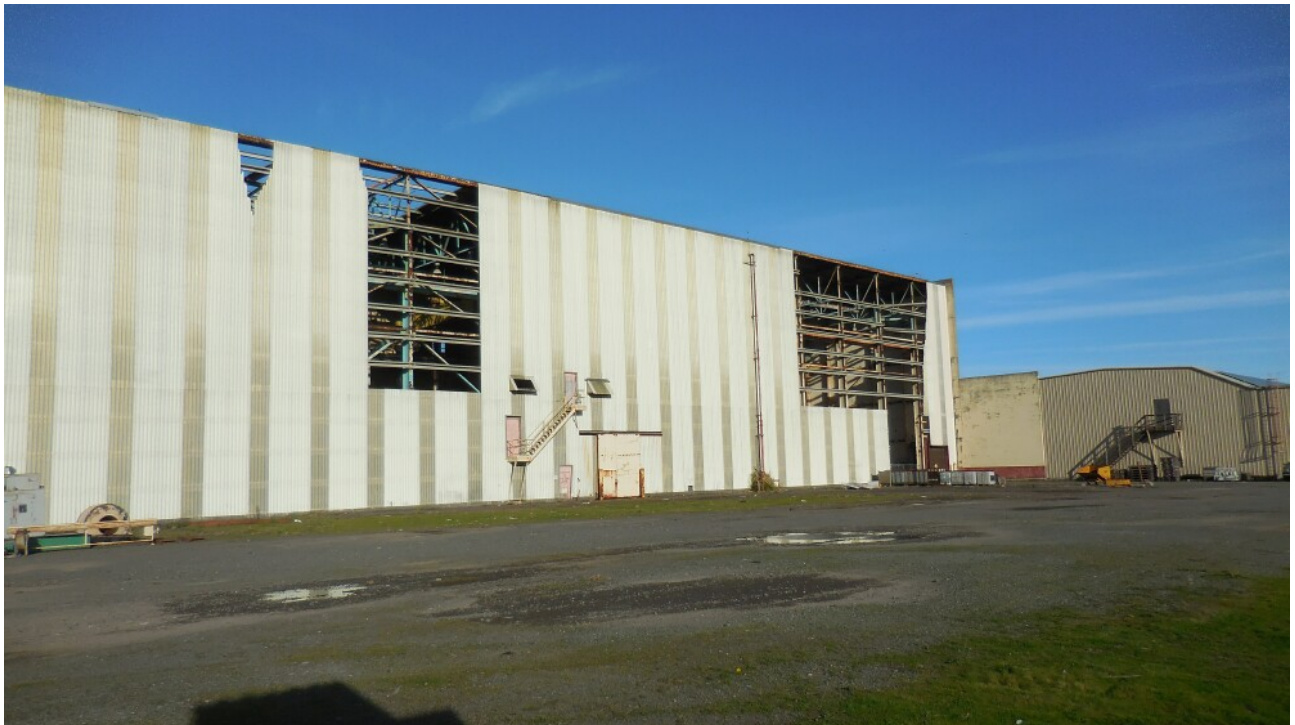
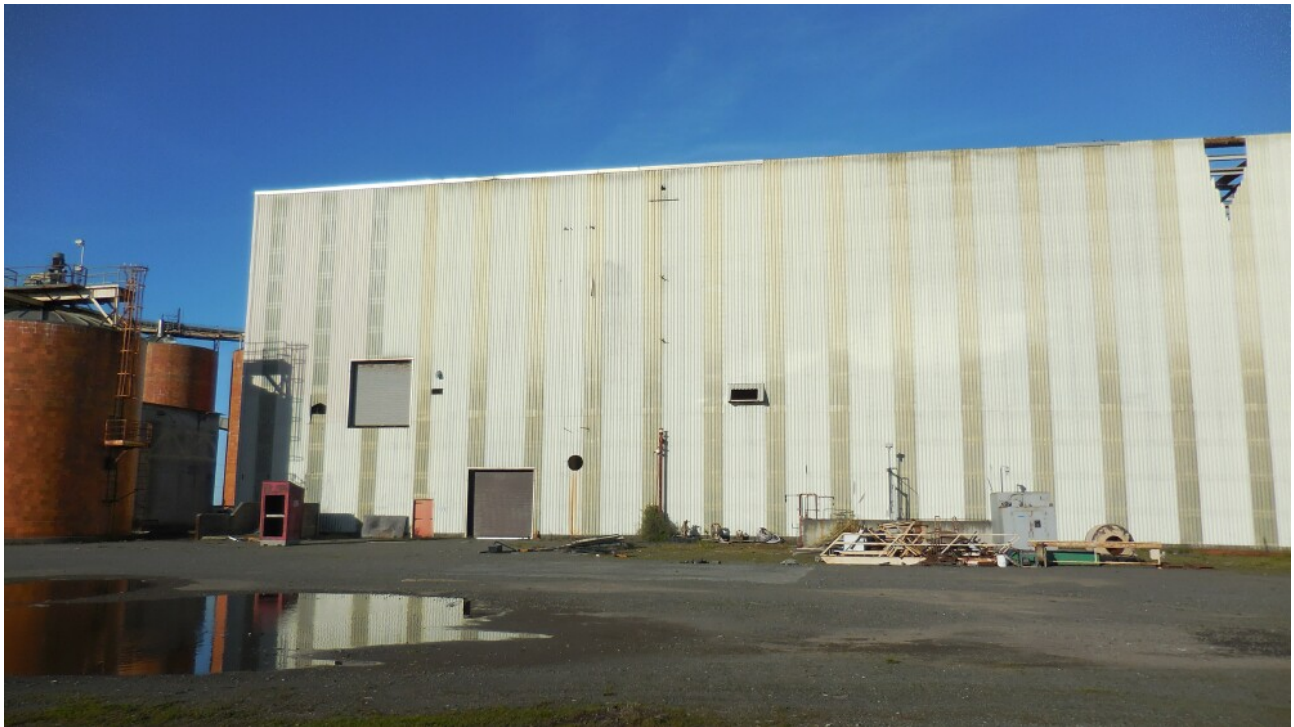
The Machine Building is a long, tall structure located immediately south and attached to the Existing Offices (Office Building) and is attached at the east end of the building to the newer, actively utilized aquaculture building at the eastern portion of the site. This structure is constructed of steel girders covered with alternating panels of corrugated metal and corrugated translucent fiberglass panels. Very large portions of the roof and exterior walls are missing.

Figure 50. Machine Building. Extremely large structure has many large openings in walls and roof. No signs of past or present use by bats observed around exterior, or in interior large open spaces or enclosed rooms.

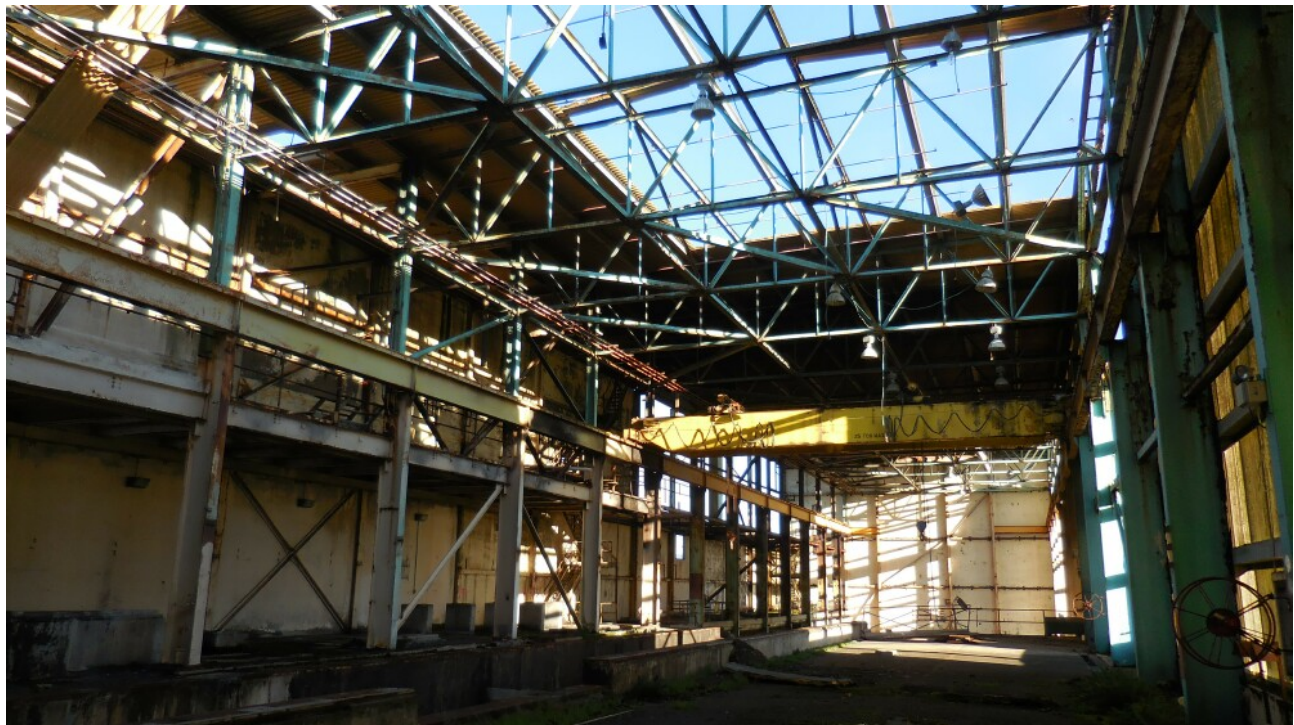
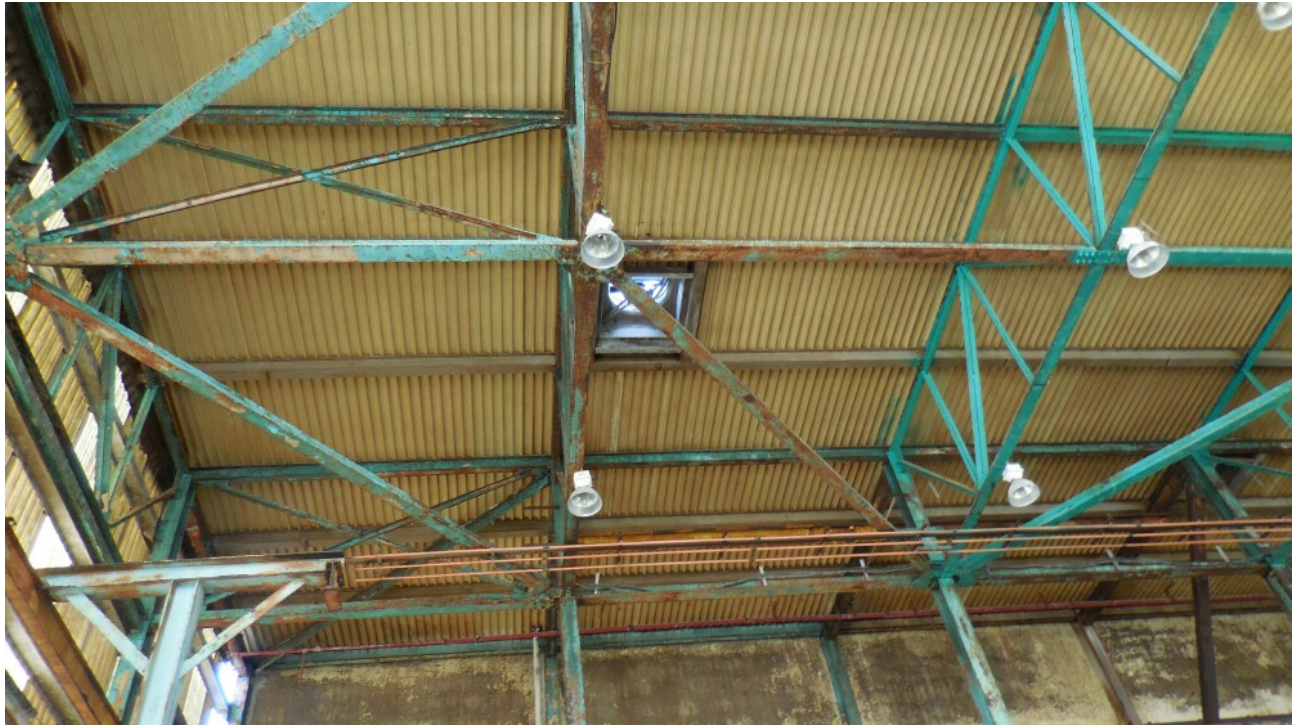
Figure 52. Interior of Machine Building – large amounts of light and airflow, not conducive to bat roosting activity.

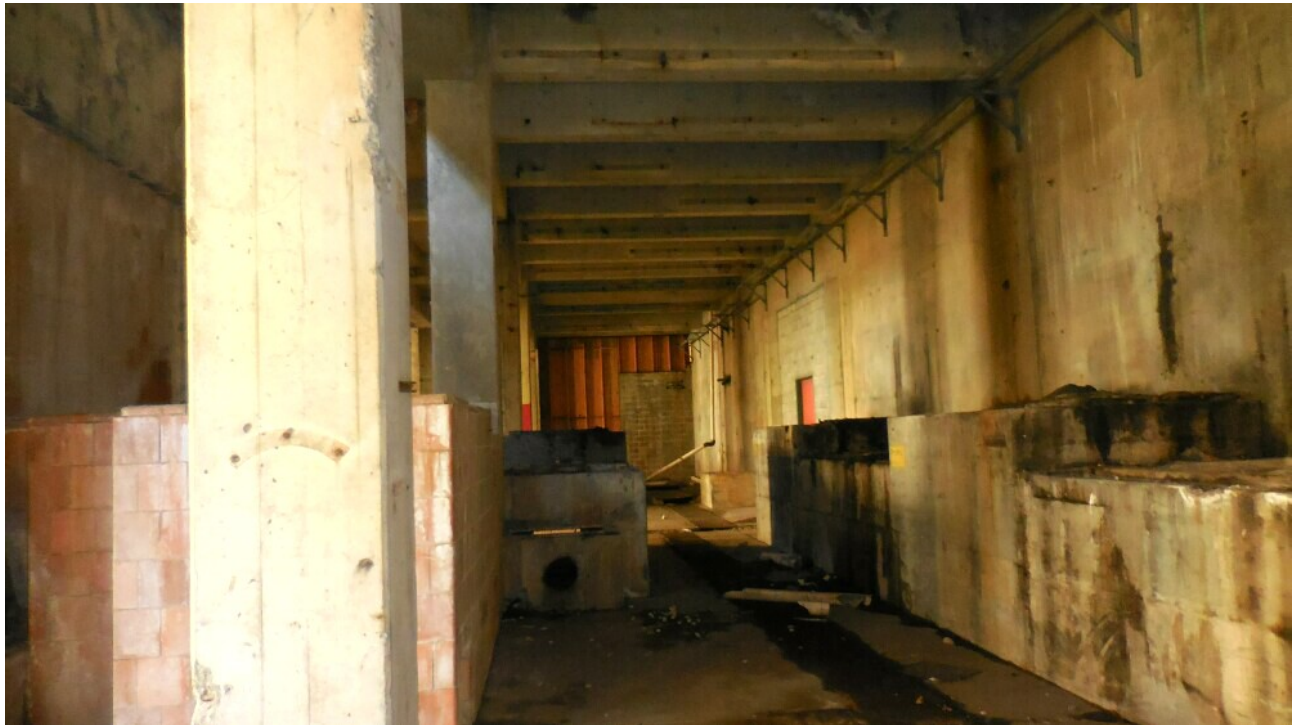
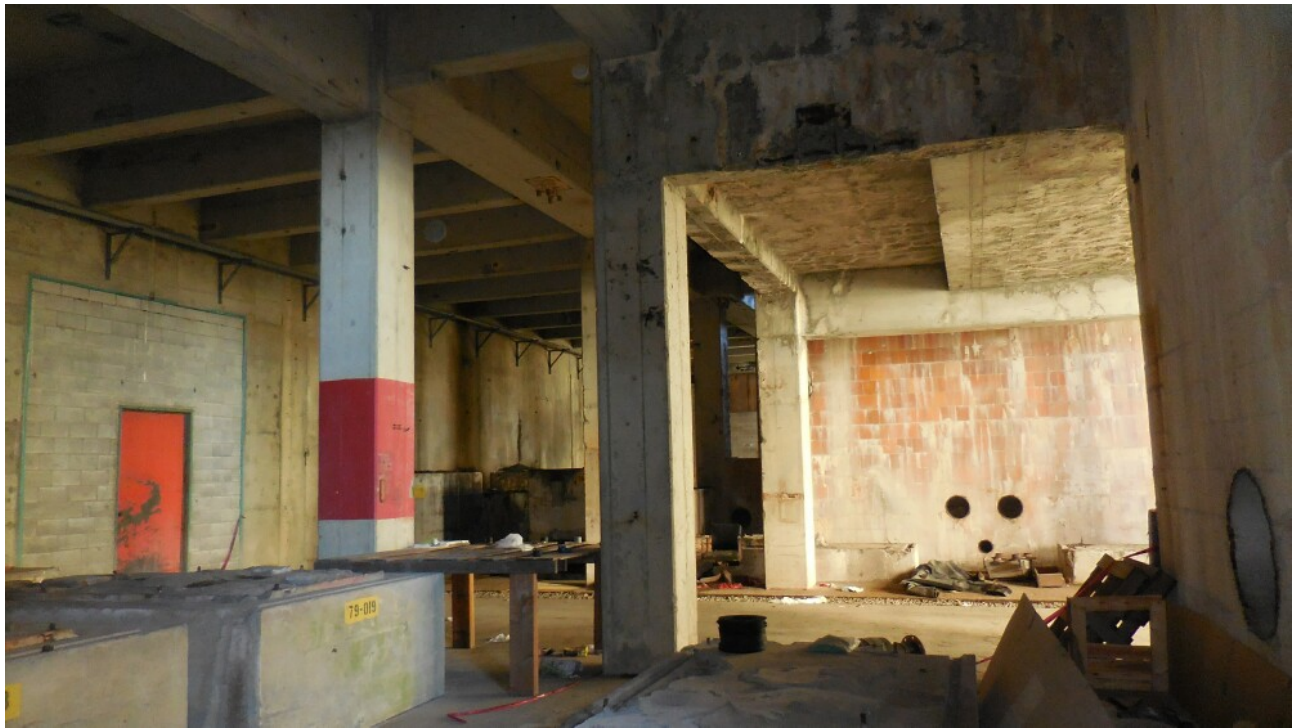
Figure 54. Interior of Machine Building – large amounts of light and airflow, not conducive to bat roosting activity, even in more protected locations such as this concrete wall and girder ceiling area.

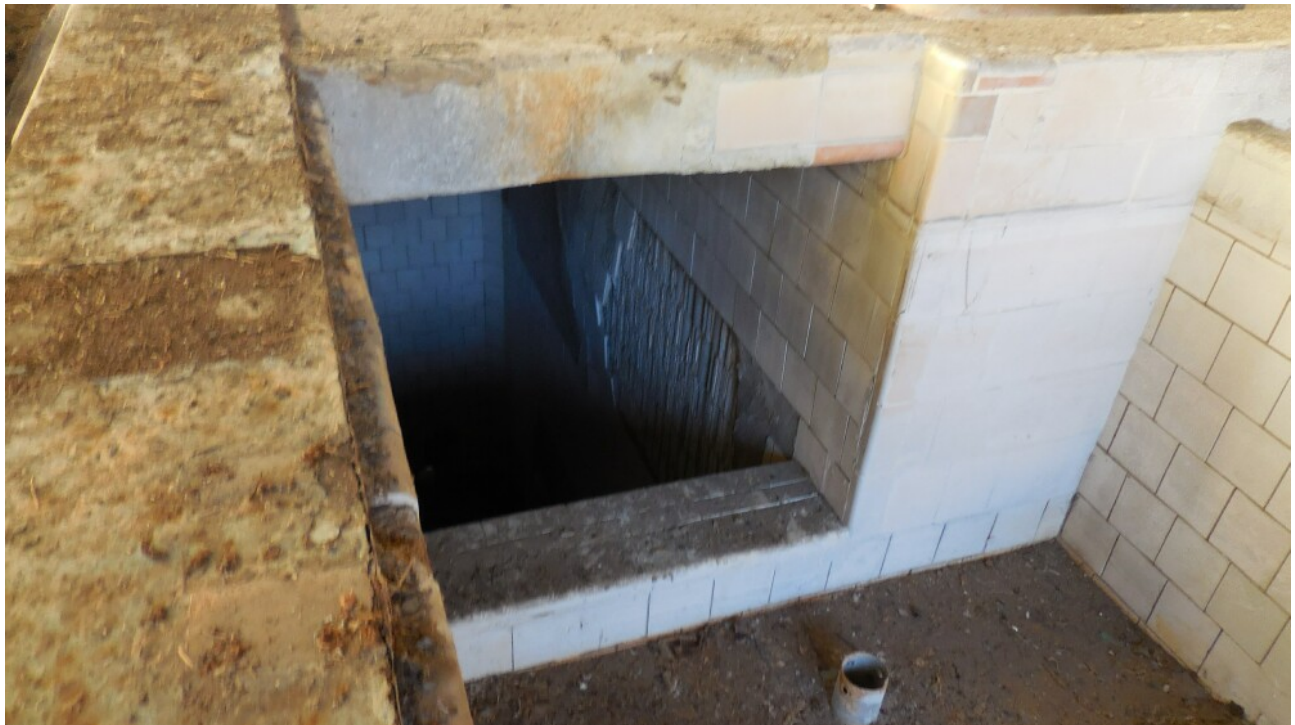
Figure 56. Enclosed and partially-enclosed rooms inside Machine Building – no signs of past or present use by bats.
