Aquatic Resources Delineation

Vega SES 5 Solar Project

Imperial County, California

February 2021, revised October 2022

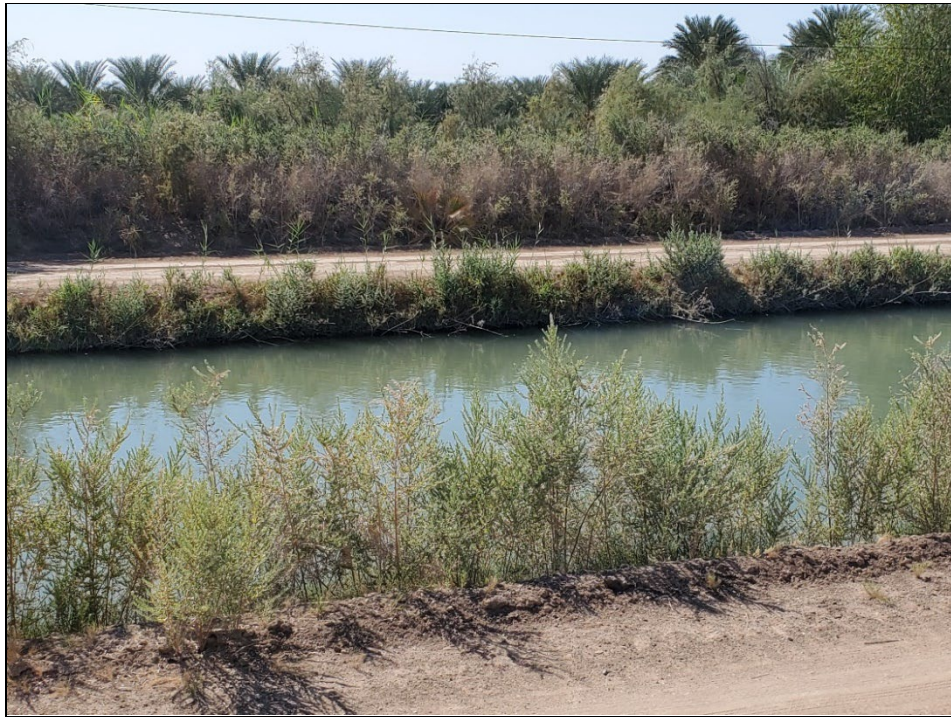
Photo 1. View of the N Lateral canal within the southwestern portion of the buffer of the Project Area; photo facing south. September 29, 2020.

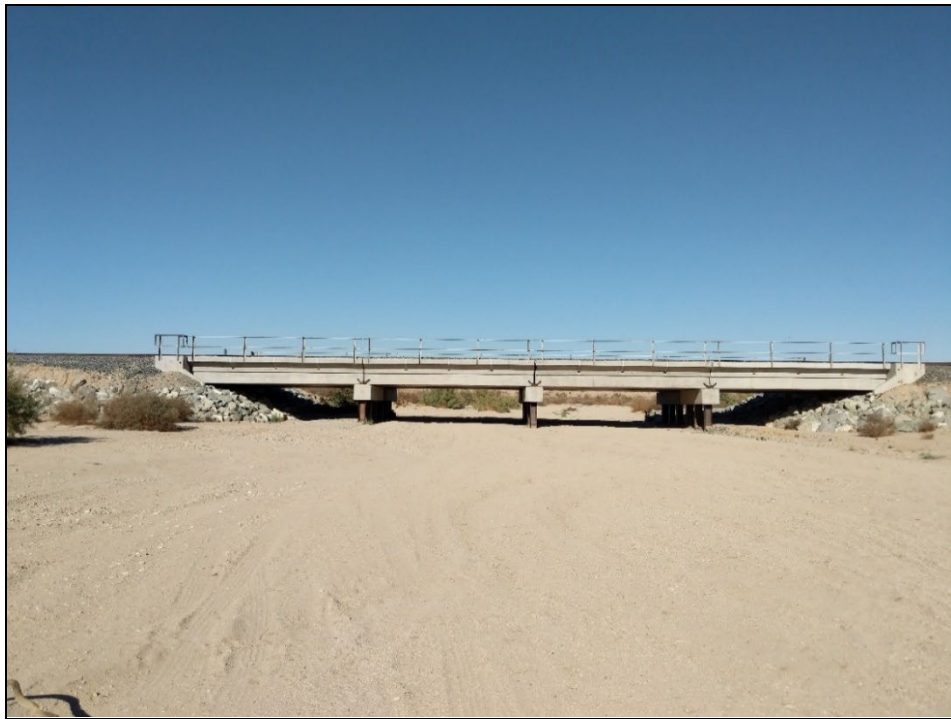
Photo 2. View of the railroad right-of-way within the northeast portion of the Project Area. ED-3001 drainage crosses the railroad via an underpass; photo facing northeast. November 11, 2020.

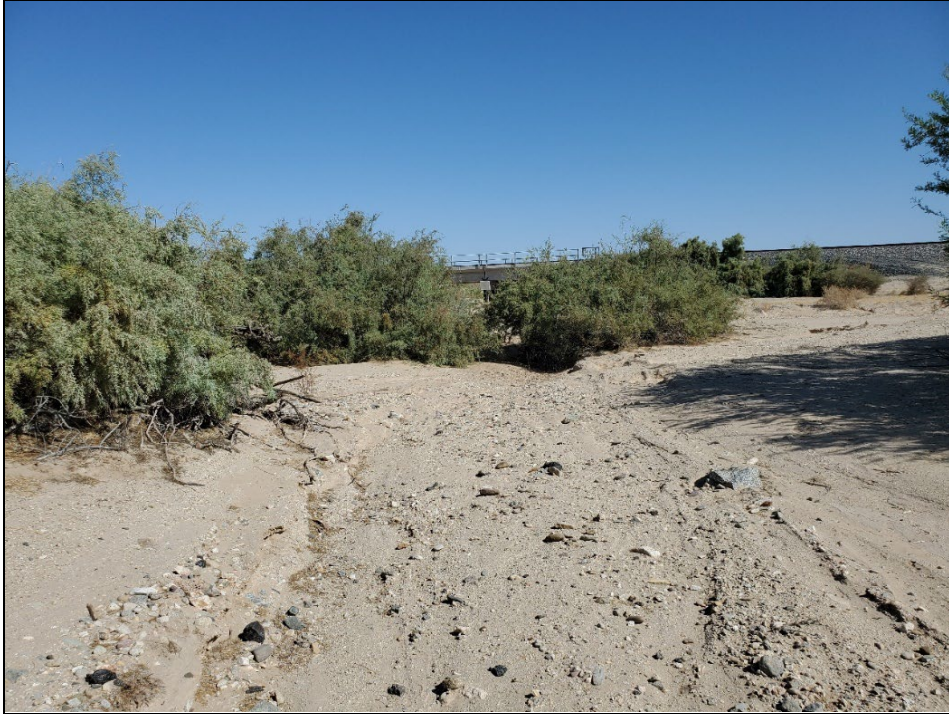
Photo 3. View of a braided portion of ED-3001 taken at OHWM Cross Section 200 near the railroad right-of-way within the Project Area; photo facing northeast. September 29, 2020.

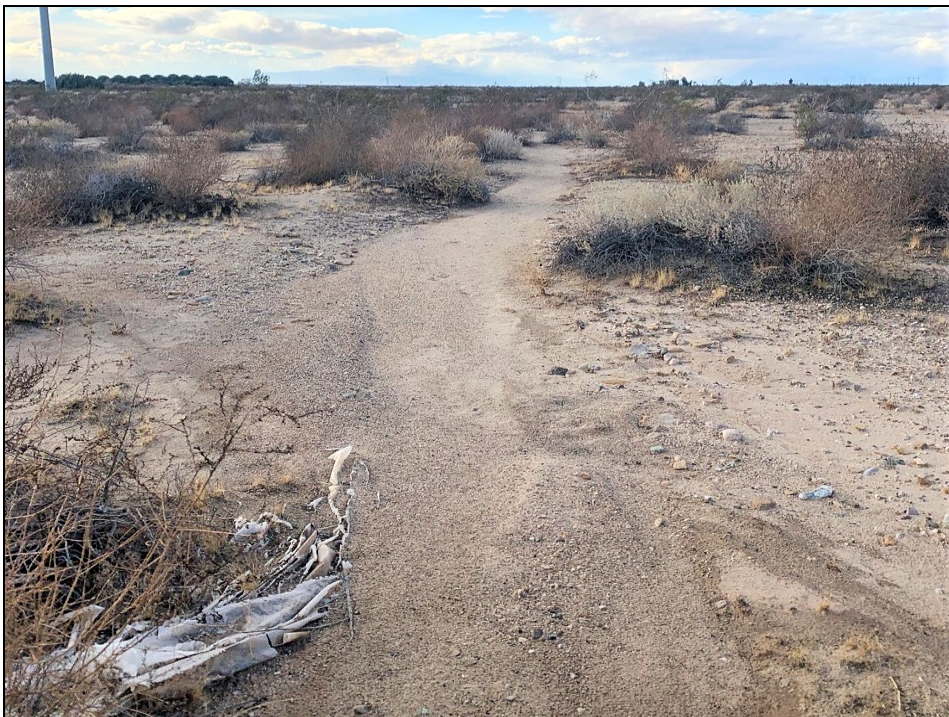
Photo 4. View of an ephemeral drainage determined to be inactive within the northeastern portion of the Project Area; photo facing northeast. January 25, 2021.

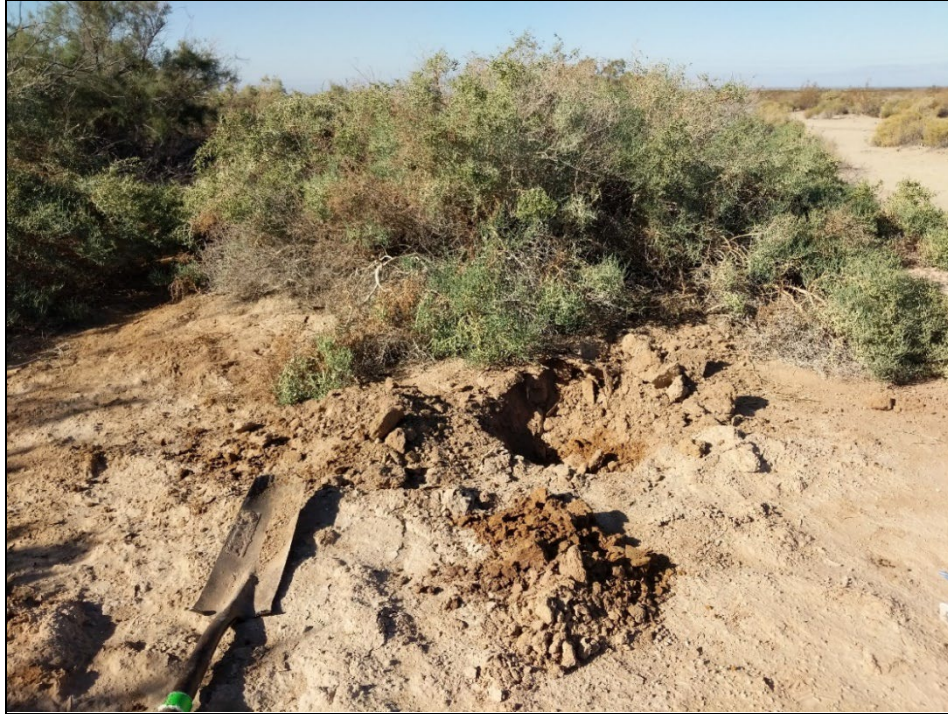
One freshwater pond was identified and mapped within the northeast portion of the Project Area, outside of the Impact Area. This feature is documented by Sampling Point 500 (Attachment B) and Photo 5 (Attachment C). At the time of the aquatic resource delineation in 2020 and 2021, this Sampling Point was inside the Project impact limits. The Impact Area was revised in 2022 and it now no longer includes the location of the Sampling Point 500. Plant species observed within the wetland included tamarisk and iodine bush. The matrix color at a depth of 0 to 6 inches was 7.5YR 4/4 with 5 percent redox features colored 7.5R 5/8; and at a depth of 6 to 15 inches the matrix color was 7.5YR 4/3 with 30 percent redox features colored 7.5R 5/8. Texture and the percentage of redox features were the primary differences between these horizons. The A horizon was clay loam, and the B horizon was silty clay. It was determined that the redox depressions (F8) hydric soil indicator was met at this sampling location. Wetland hydrology indicators met included the surface soil cracks (B6) primary indicator and FAC-neutral test (D5) secondary indicator.

Photo 5. View of Sampling Point 500 taken within the freshwater pond at the northeast portion of the Project Area; photo facing southeast. November 9, 2020.

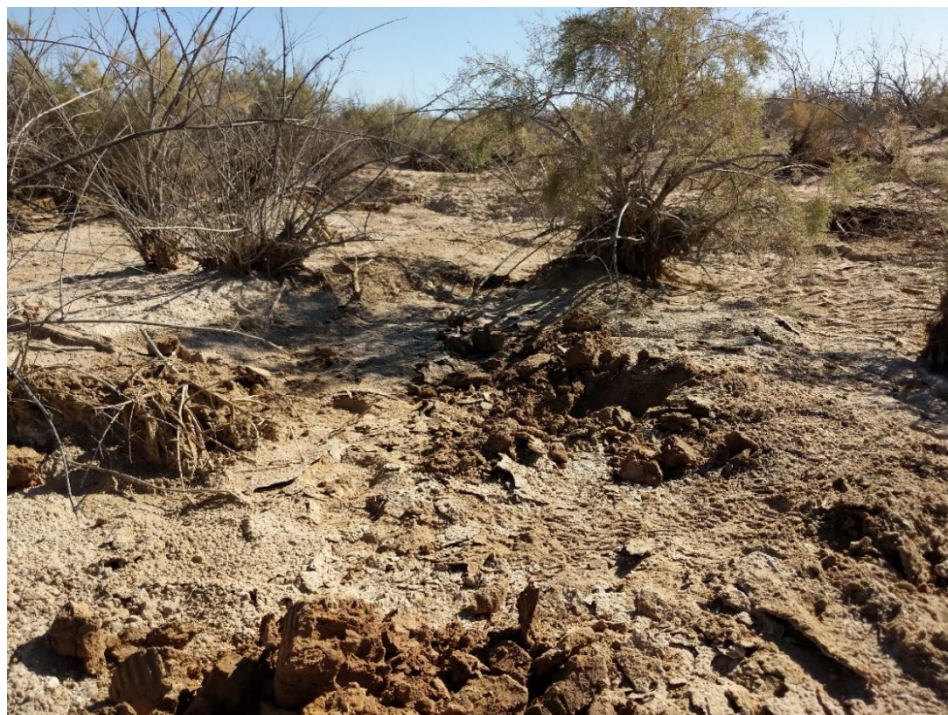
Photo 6. View of Sampling Point 543 taken within the freshwater forested/shrub wetland at the northeast portion of the site; photo facing west. November 11, 2020.

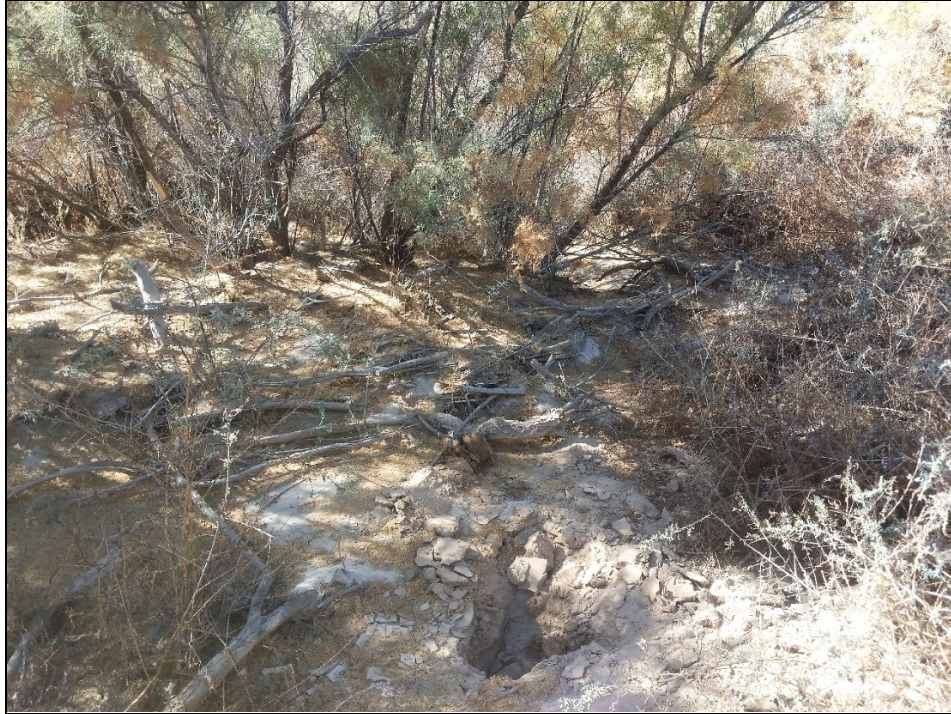
At Sampling Point 525, the matrix color at a depth of 0 to 4 inches was 10YR 4/4 with no redox features; and at a depth of 4 to 12 inches the matrix color was 10YR 4/3 with 5 percent redox features colored 5YR 5/8. Texture was the primary difference between these horizons. The A horizon was loamy sand, and the B horizon was silty clay loam. The soil was moist at a depth of approximately four inches, indicating possible ground water connection to the adjacent East Highline Canal at the time of the assessment. It was determined that the redox depressions (F8) hydric soil indicator was met at this sampling location. Wetland hydrology indicators observed included the surface soil cracks (B6) primary indicator and the sediment deposits (B2), drift deposits (B3), drainage patterns (B10), and FAC-neutral test (D5) secondary indicators.

Photo 7. View of Sampling Point 525 taken within the freshwater forested/shrub wetland along the east side of the East Highline Canal; photo facing west. November 10, 2020.

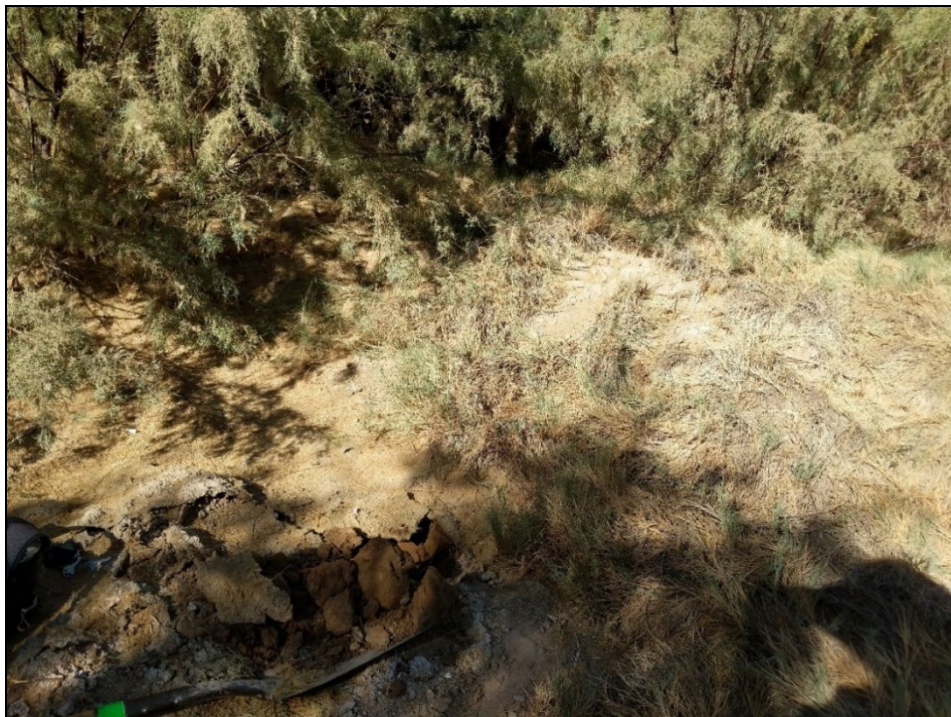
Photo 8. View of Sampling Point 603 taken within the freshwater forested/shrub along the west side of the East Highline Canal; photo facing north. November 13, 2020.

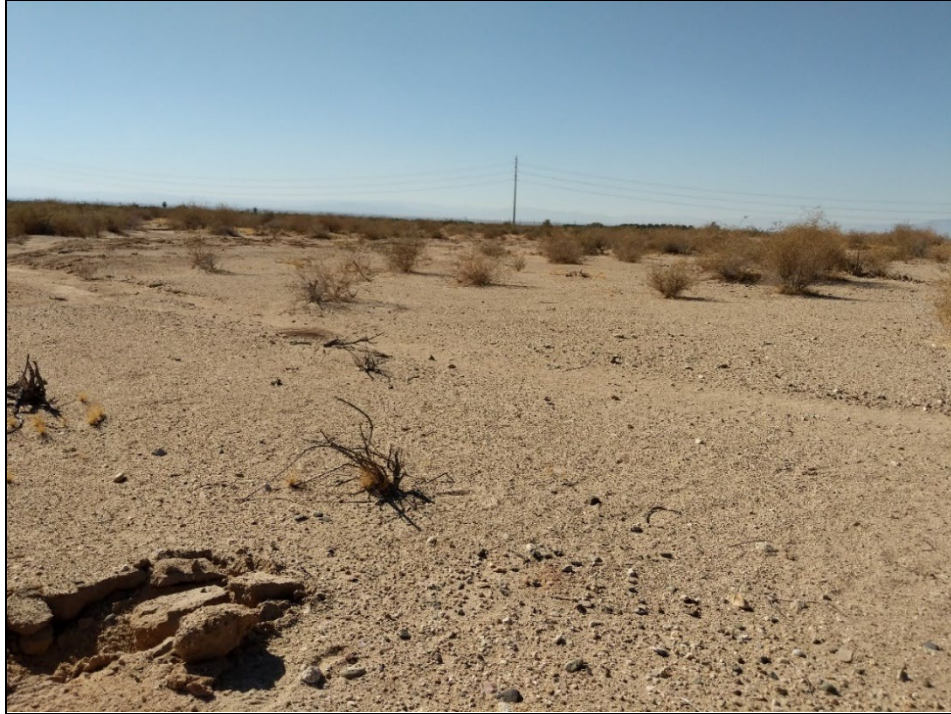
present within the revised Impact Area and is subject to direct impacts. Sampling Points 501, 522, 524, 545, and 547 are representative of the alkali sink habitat of the Project Area as a whole. Sparse hydrophytic vegetation was present at all sampling point locations within the alkali sink habitat, including iodine bush, arrow weed, bush seepweed, and big saltbush. Indicators of wetland hydrology were observed at multiple upland sampling points within the alkali sinks, including primary indicator surface soil cracks (B6) and secondary indicators sediment deposits (B2), drift deposits (B3), and drainage patterns (B10). All sampling points within the alkali sink habitat lacked hydric soil indicators. Upland Sampling Points 522 and 545 document locations which had hydrophytic vegetation but lacked wetland hydrology and hydric soils. Upland Sampling Points 524 and 547 document locations which had hydrophytic vegetation and wetland hydrology but lacked hydric soils.

Photo 9. Sampling Point 547 taken within alkali sink habitat at the northeastern portion of the Project Area; photo facing southeast. November 11, 2020.

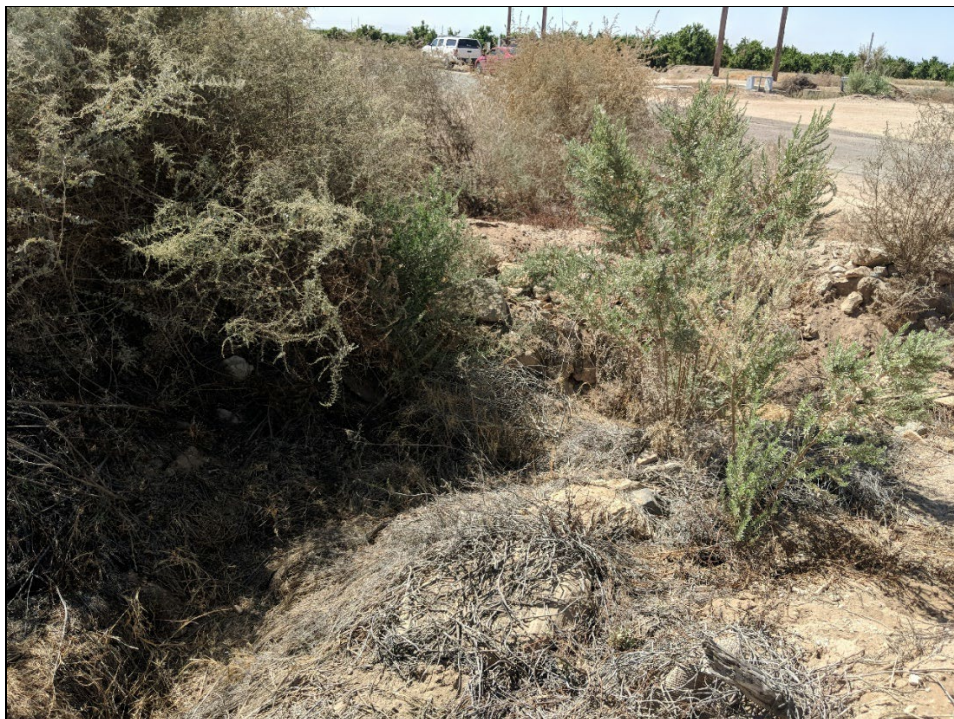
Riparian habitat associated with the drainage systems throughout the Project Area consists of tamarisk thickets, which is characterized by a weedy, monoculture of tamarisk. This habitat is typically in ditches, washes, rivers, arroyo margins, lake margins, and other watercourses. Throughout the Project Area, other species observed included four-wing saltbush and arrow weed. There is additional riparian habitat within the southwest portion of the Impact Area near the N Lateral canal that is not associated with an active aquatic feature. This habitat likely established opportunistically in areas that were recently left fallow and consists of tamarisk thickets. This area was determined to be remnant of a relic unlined irrigation channel that is no longer in use.

Photo 10. View of unassociated riparian habitat within the southwestern portion of the Project Area. Habitat is likely remnant of a relic unlined irrigation channel that is no longer in use; photo facing southwest. September 30, 2020.
