## Aquatic Resources Delineation Report

**Aquatic Resources Delineation Report for the Cloverdale Unified  
School District South Fields Project, Sonoma County, California**

JUNE 2021

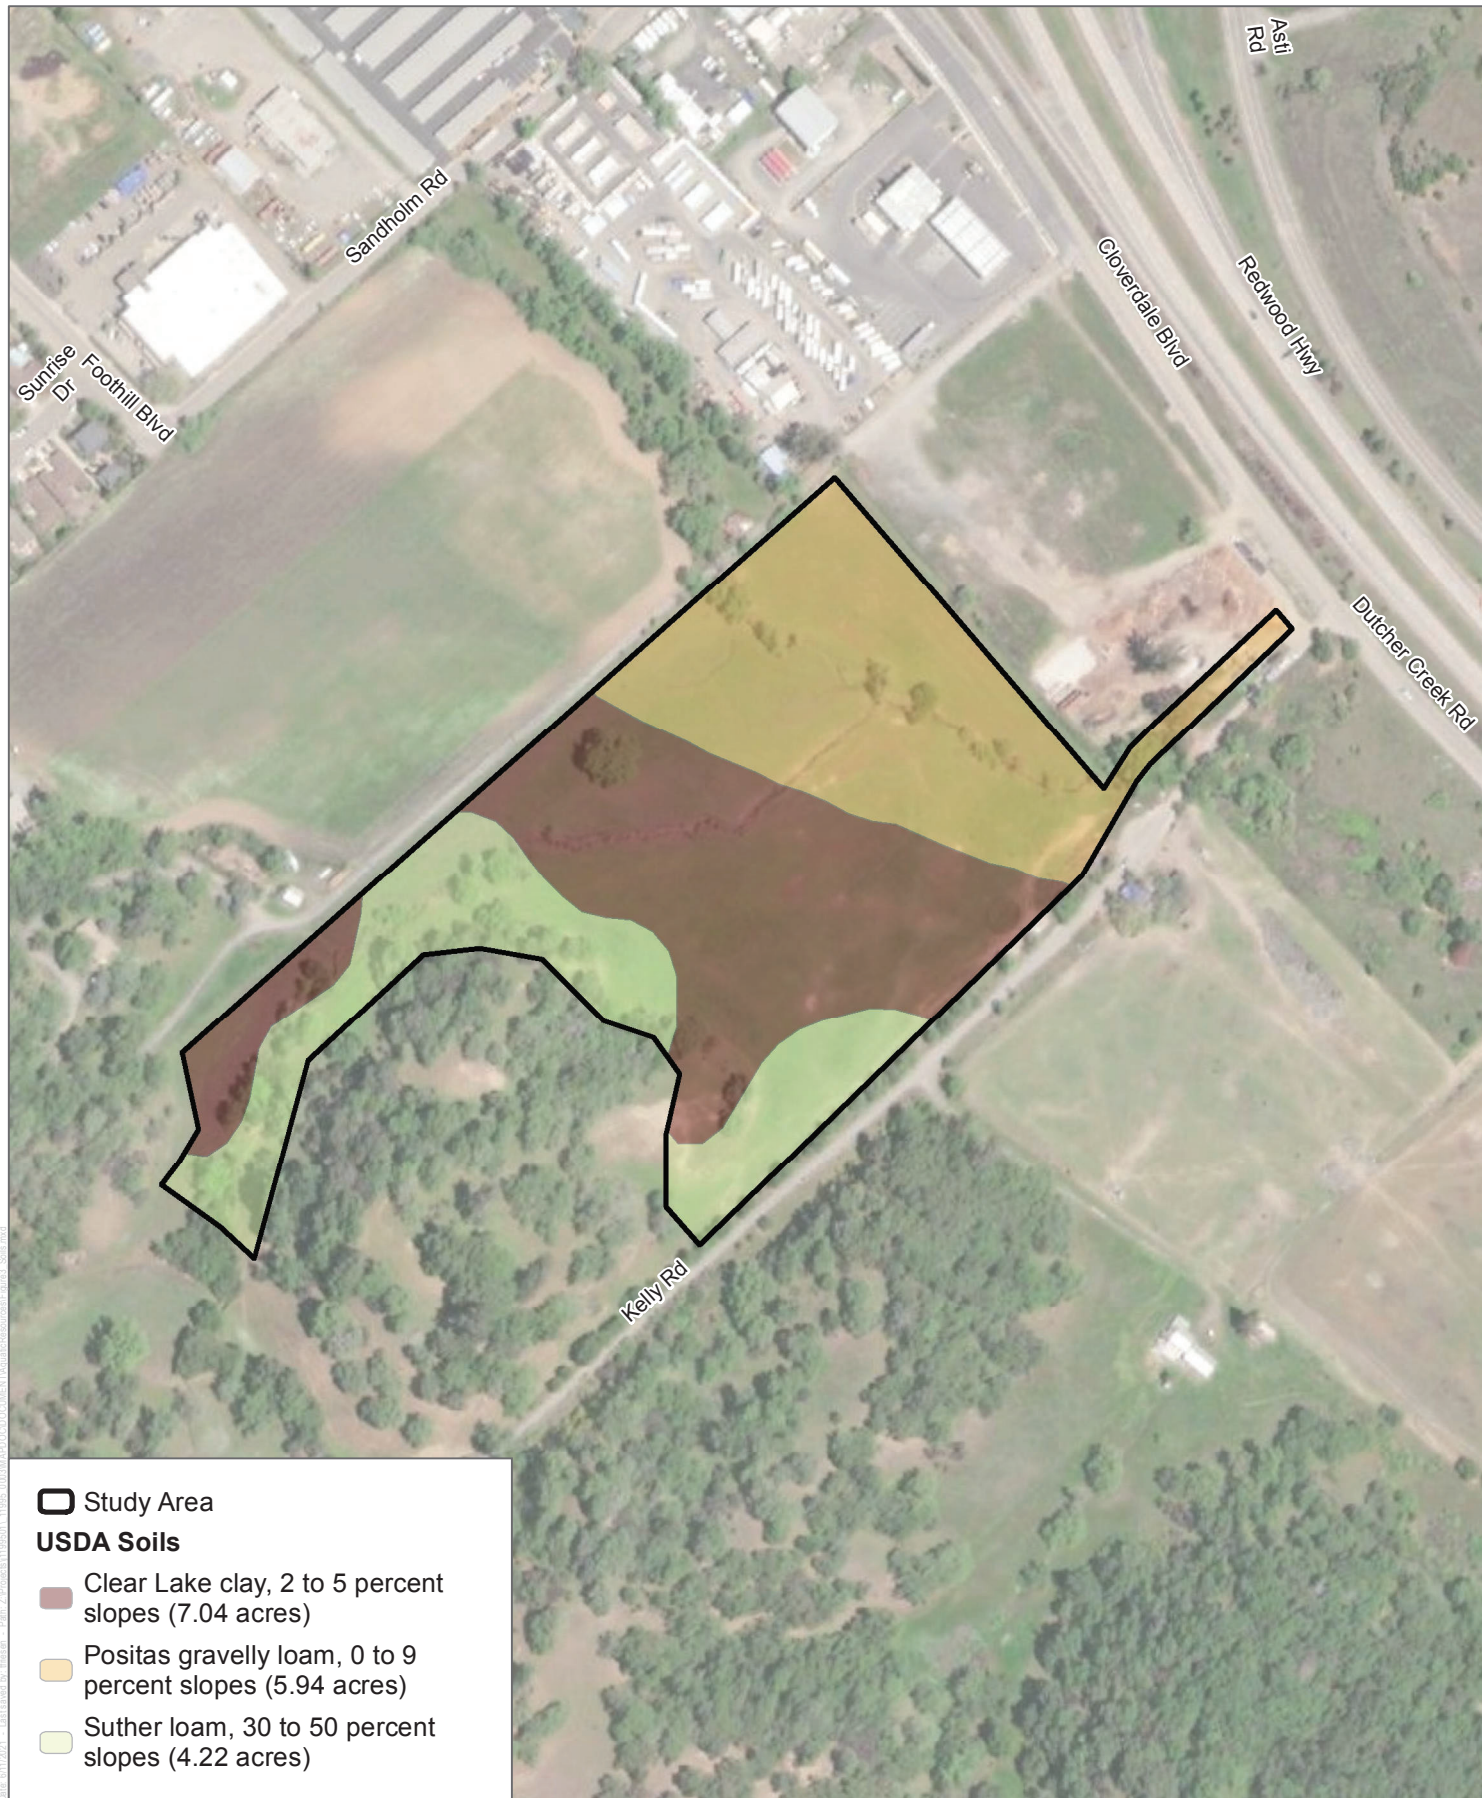
**FIGURE 3**  
Project Soils

The Natural Resources Conservation Service (USDA 2021b) maps three soil units in the study area: Clear Lake Clay, drained, 2 to 5 percent slopes, MLRA 14; Positas gravelly loam, 0-9 percent slopes; and Suther loam, 30 to 50 percent slopes. Each soil unit, its proportion of hydric soils, drainage class (i.e., frequency and duration of wet periods in conditions similar to those in which it was developed), and typical landform or geomorphic position within the landscape is detailed in Table 2, Summary of Soil Units in the Project Study Area below. Figure 3, Project Soils, provides the geographic extent of each soil unit in the study area (USDA 2021b).

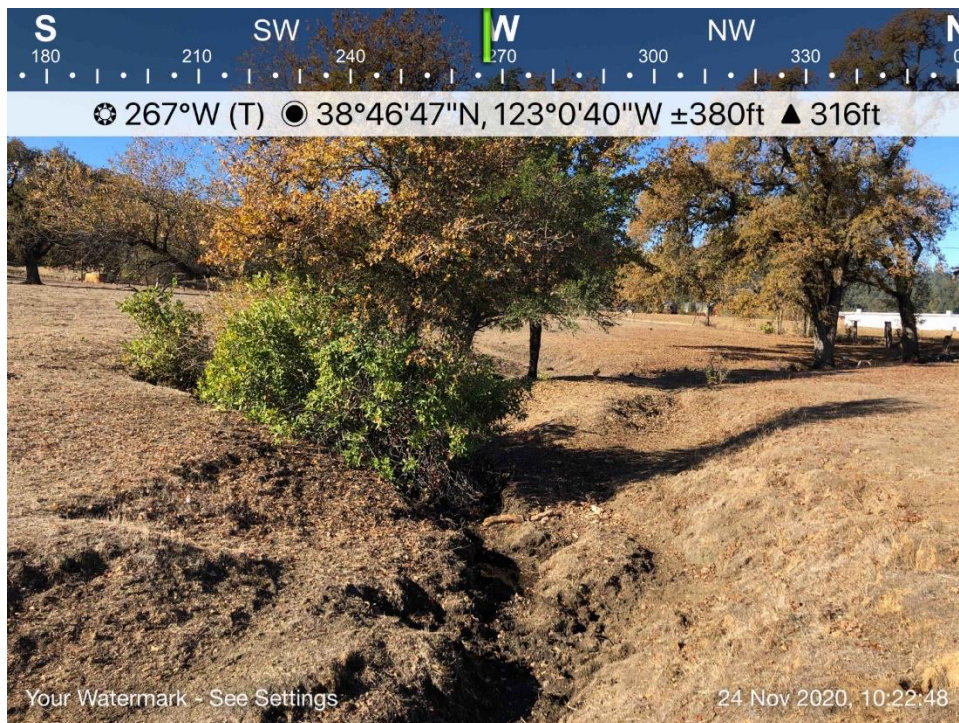
There are two unnamed intermittent drainages comprising approximately 2,421 linear feet (0.96-acre) within the study area (see Attachment A, Photos 3, 6, and 7). Intermittent drainages generally have flowing water during certain times of the year, when groundwater provides water for stream flow, and receive supplemental water from rainfall runoff. Both drainages contained standing water in places at the time of the November 2020 and May 2021 fieldwork, and evidence of OHWM included bed and bank, shelving, sediment sorting, water staining, and a change in plant community and cover. Vegetation along these drainages consisted of mixed oak woodland and forest, coyote brush scrub, and non-native grassland (see Section 5.1.4.1). Herbaceous vegetation was heavily disturbed by horse grazing. The intermittent drainages flow in a southeasterly direction through the study area, with Intermittent Drainage-01 receiving flows indirectly or directly from the other drainages on-site. Intermittent Drainage-01 outlets off-site into a ditch along the eastern margin of the property which connects downstream to Icaria Creek, a tributary to the Russian River.

**Photo 3.** Mixed oak woodland within Intermittent Drainage-01.

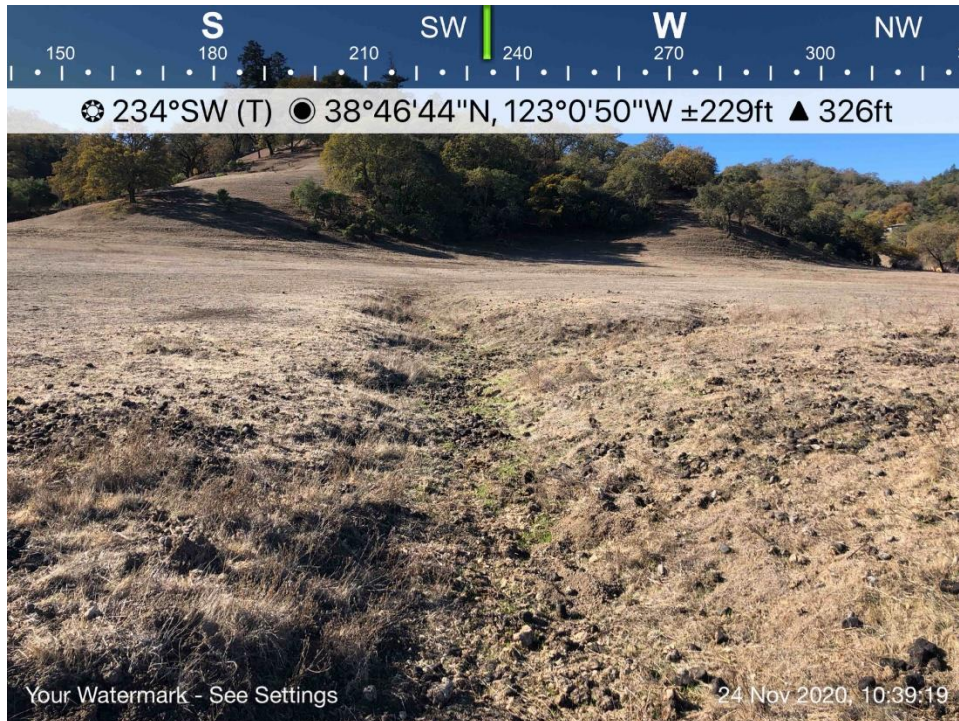
**Photo 4.** Ephemeral Drainage-01. November 24, 2020.

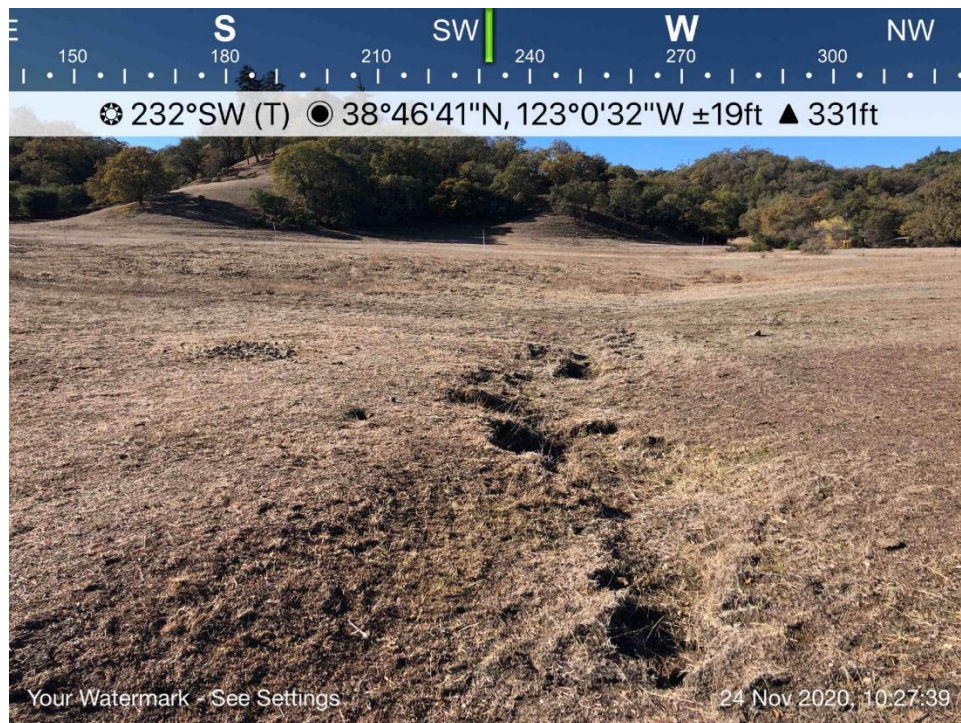
**Photo 5.** Seasonal Wetland Swale-01. November 24, 2020.

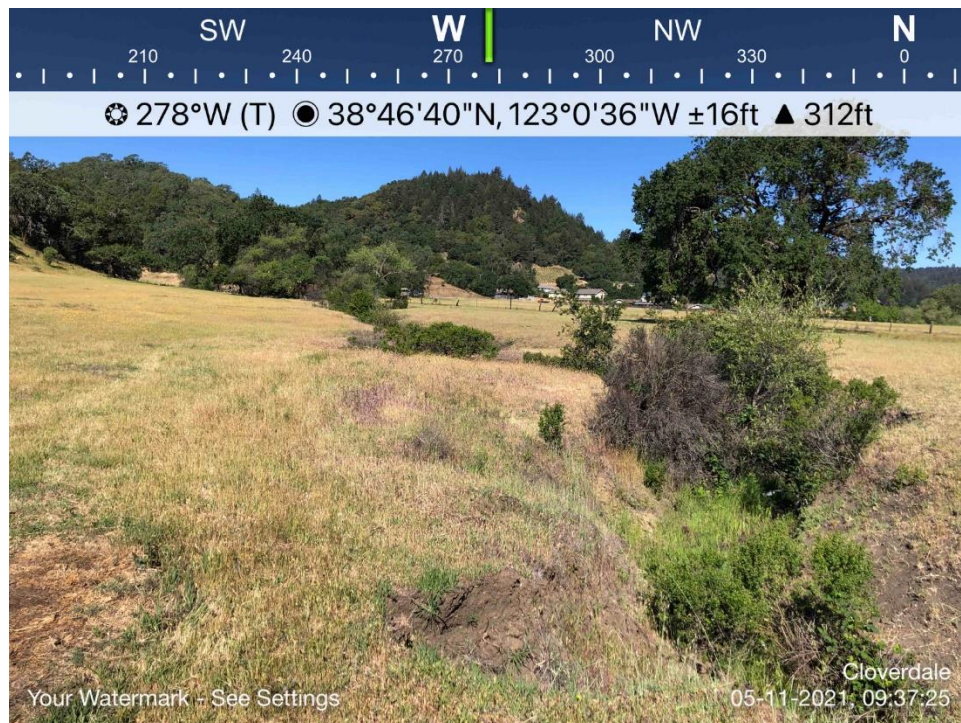
**Photo 6.** Coyote brush scrub within Intermittent Drainage-02. May 11, 2021.

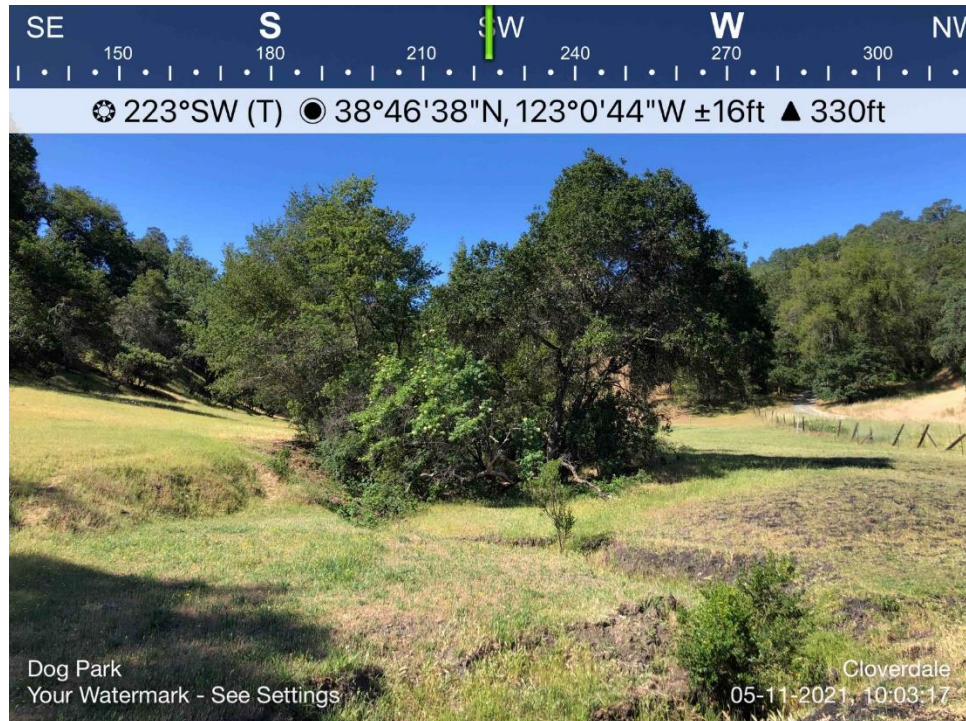
**Photo 7.** Mixed oak woodland within Intermittent Drainage-02. May 11, 2021.

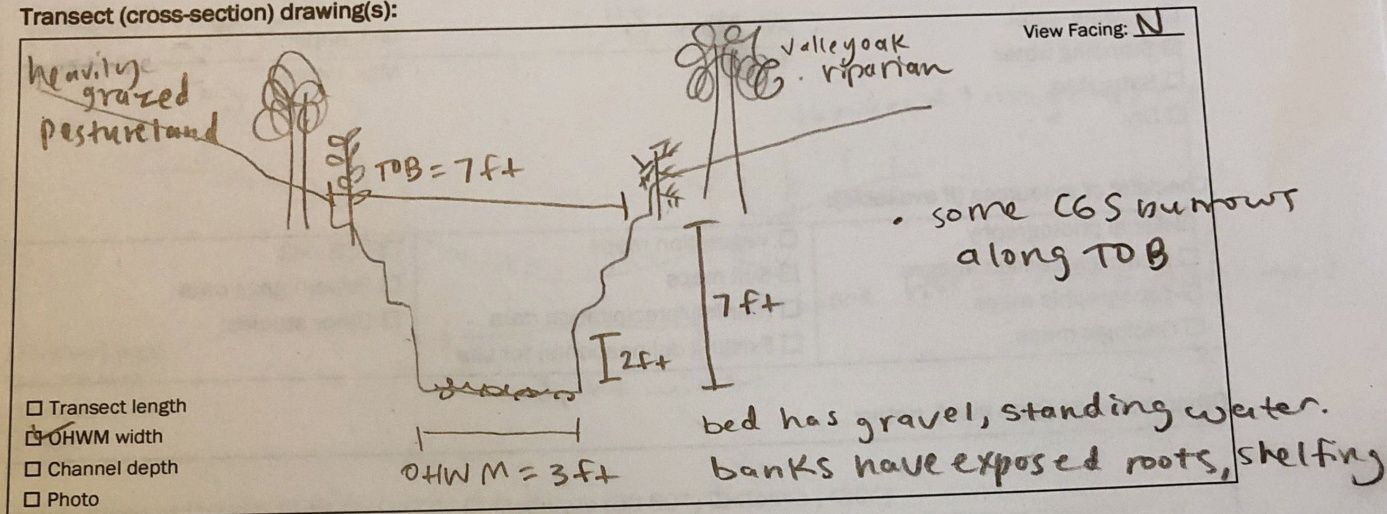
Transect (cross-section) drawing(s):

Feature Type: ☐ Ephemeral ☒ Intermittent ☐ Perennial ☐ Other

Break in Slope at OHWM: ☒ Sharp ( $>60^\circ$ ) ☐ Moderate ( $30-60^\circ$ ) ☐ Gentle ( $<30^\circ$ )

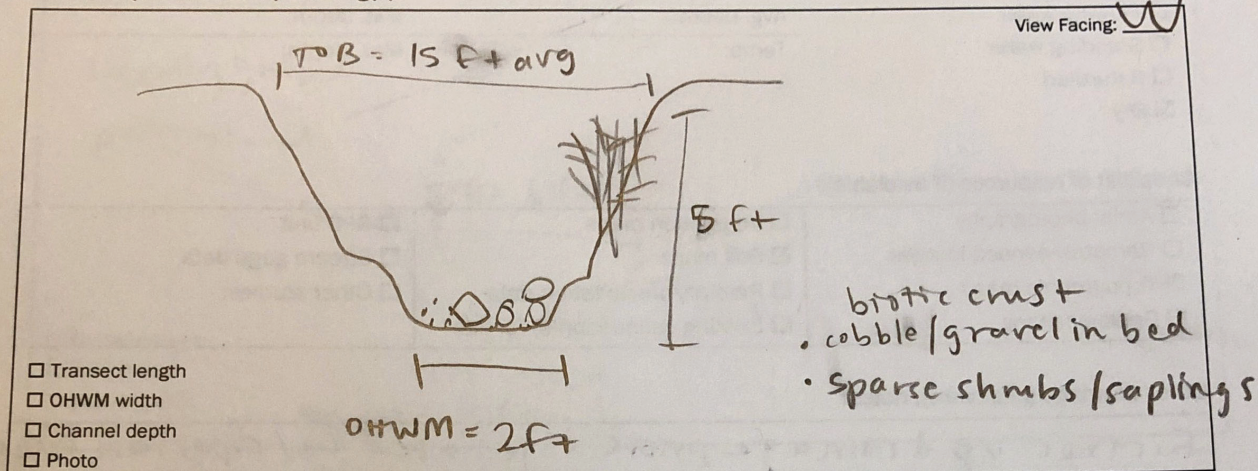
Transect (cross-section) drawing(s):

Feature Type: ☐ Ephemeral ☒ Intermittent ☐ Perennial ☐ Other

Break in Slope at OHWM: ☒ Sharp ( $>60^\circ$ ) ☐ Moderate ( $30-60^\circ$ ) ☐ Gentle ( $<30^\circ$ )

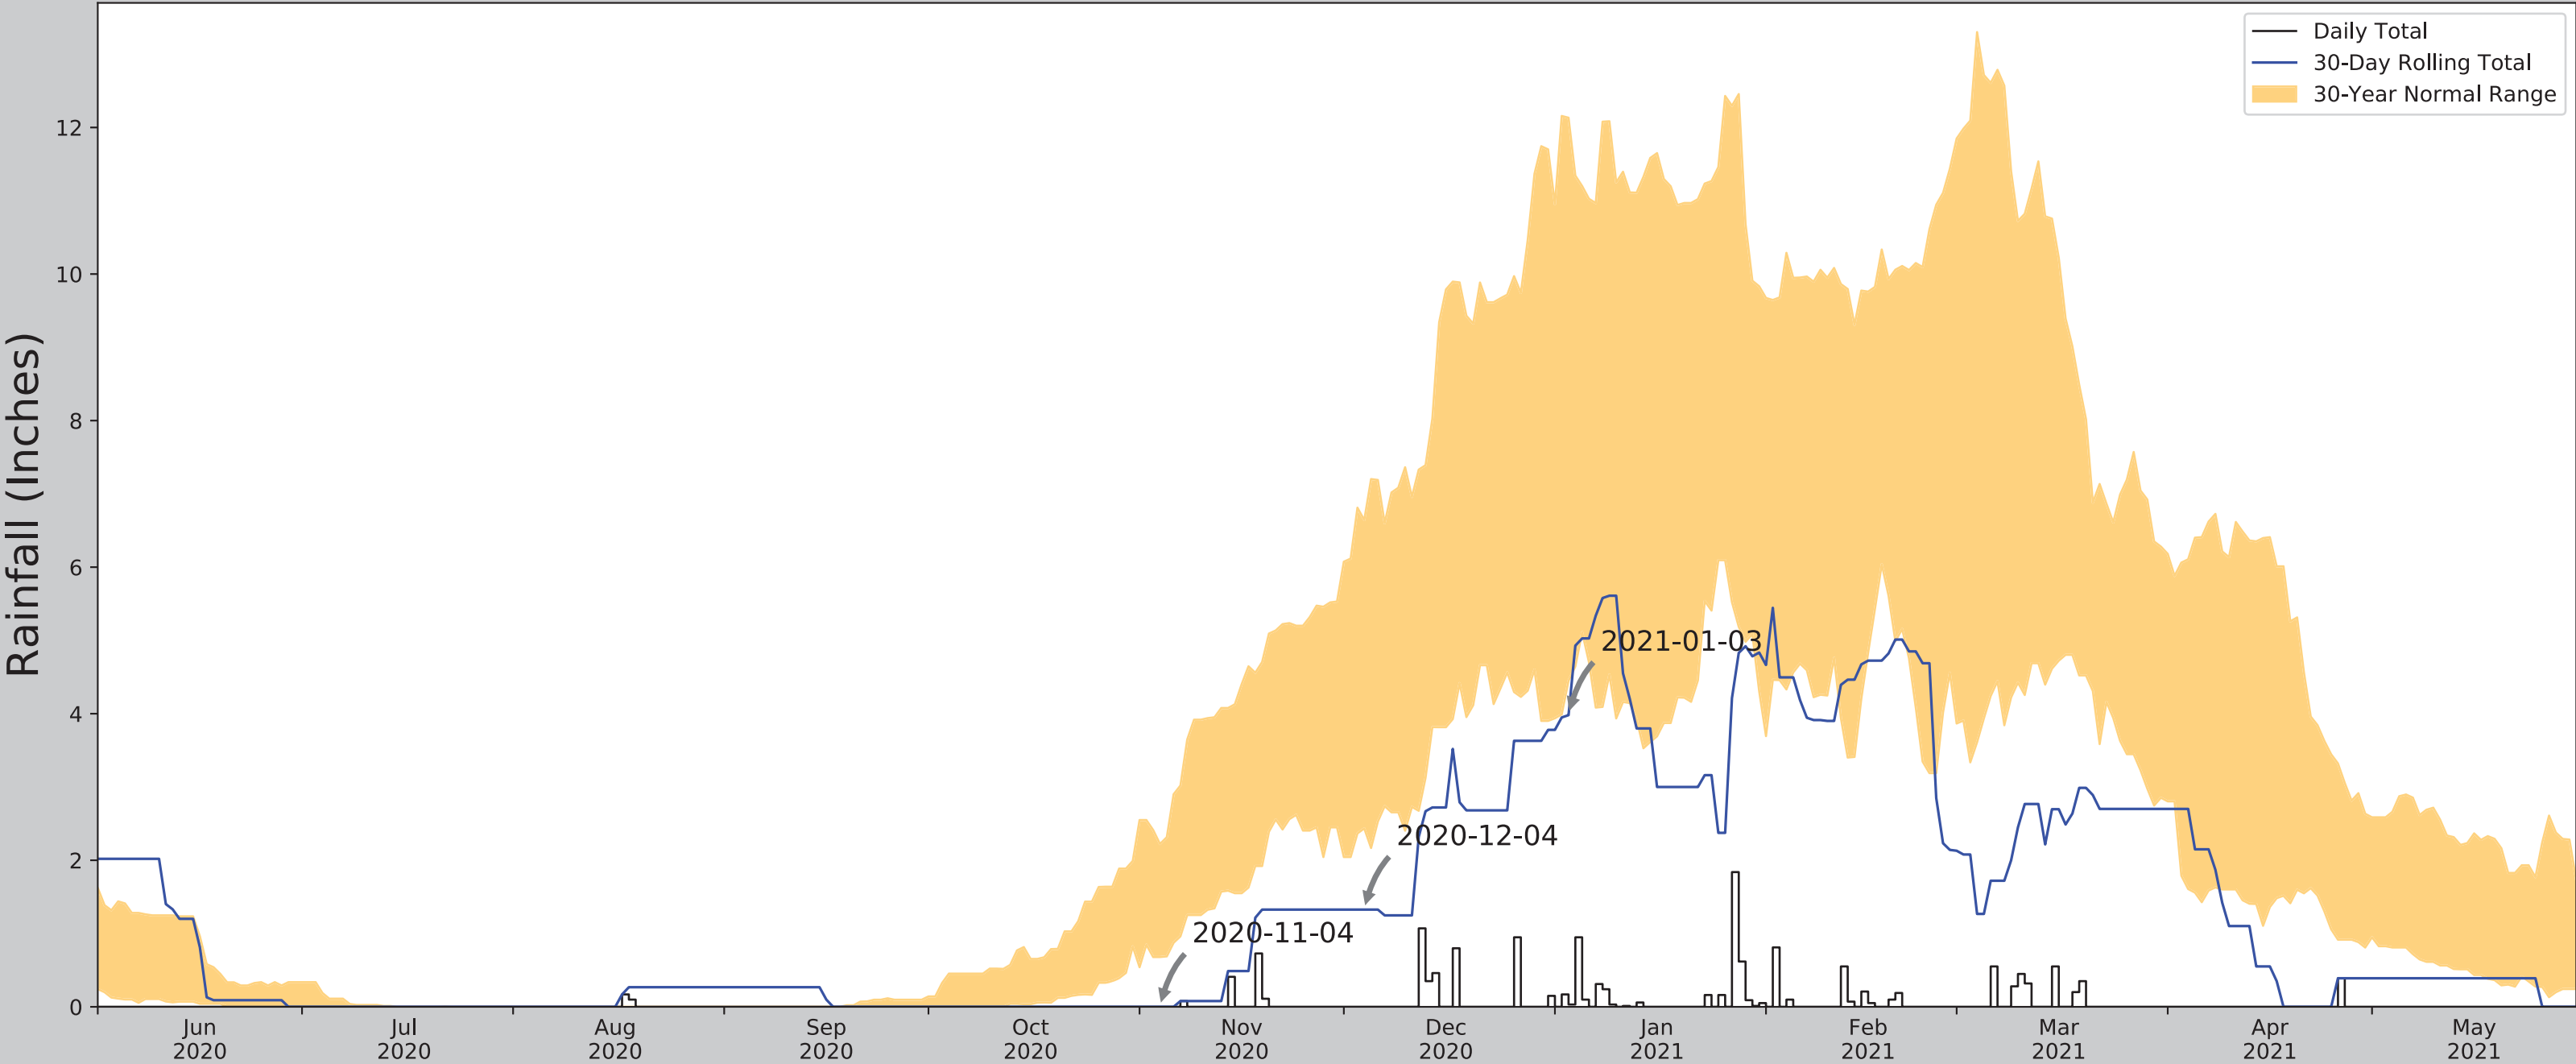
The USACE Antecedent Precipitation Tool (APT) was used to assess the amount of precipitation received in the study area during the delineation period (USACE 2021). The tool calculated that the coordinates of the geographic center of the study area experienced, on average, drier than normal antecedent precipitation conditions (below 30-Year Normal Range) during the period between November 24, 2020 and May 11, 2021, during which the delineation was conducted. The complete results of the APT query can be found in Attachment D.

Antecedent Precipitation vs Normal Range based on NOAA's Daily Global Historical Climatology Network

Coordinates	38.777672, -123.010295
Observation Date	2021-01-03
Elevation (ft)	335.8
Drought Index (PDSI)	Moderate drought
WebWIMP H <sub>2</sub> O Balance	Wet Season
