11.6 Hazardous Materials Documentation

Subject: Draft Phase I Environmental Site Assessment Report, 26126 Victoria
Boulevard, APN 668-361-01, Capistrano Beach, California

PHASE I ENVIRONMENTAL
SITE ASSESSMENT REPORT
26126 VICTORIA BOULEVARD
APN 668-361-01
CAPISTRANO BEACH, CA 92624

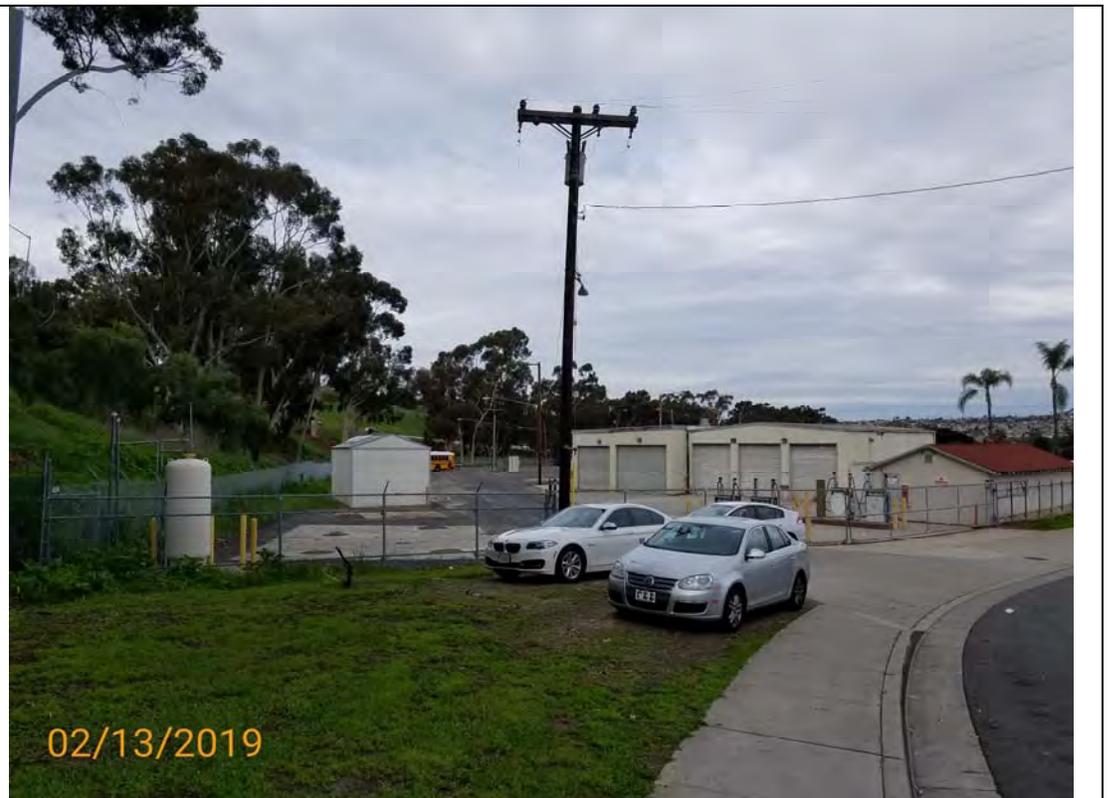
Photo No.4

View of the eastern corner of the subject site. This area houses two underground fuel tanks, two dispenser islands, and an above-ground clean air separator.

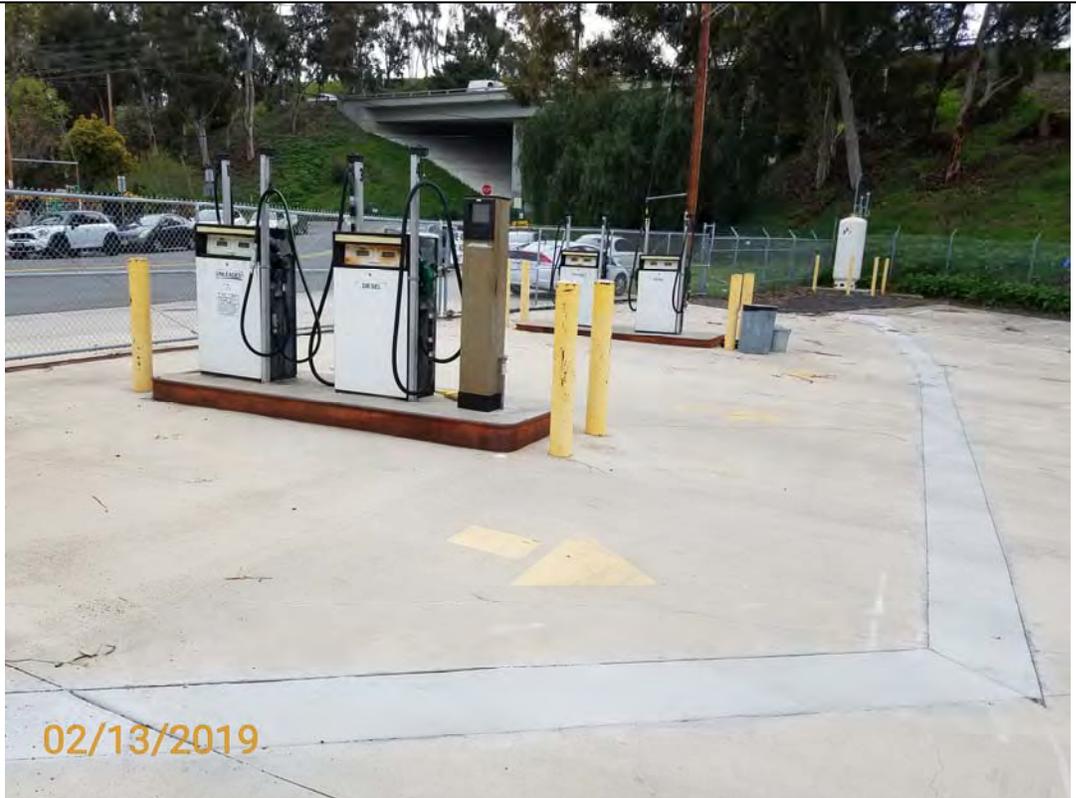
Description:
Two dispenser islands for refueling gasoline and diesel equipment. Above-ground clean air separator is visible in the background.

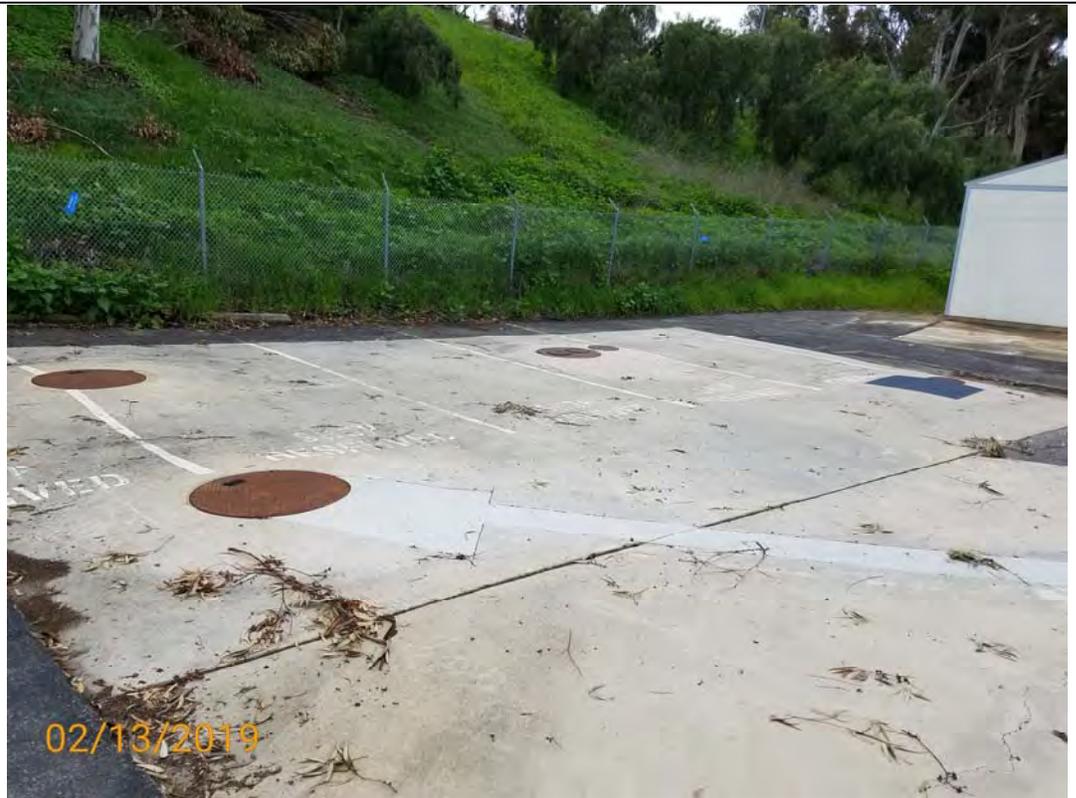
Description:
Location of two underground storage tanks (gasoline and diesel).

Two underground storage tanks (USTs) were identified during the site reconnaissance in the western corner of the site (see Photo No. 6 in Appendix B). The USTs contain unleaded gasoline and diesel and associated product and vapor lines connect the USTs to two dispenser islands located near the western exit off Victoria Boulevard (see Photo No. 5 in Appendix B). According to the Grounds Manager, Kent Smith, the two USTs are periodically used via onsite dispensers to fuel school district vehicles. An aboveground clean air separator is located between the USTs and fuel dispensers. An underground hydraulic fluid reservoir is suspected in association with the hydraulic vehicle lifts identified in the former Vehicle Maintenance Building.

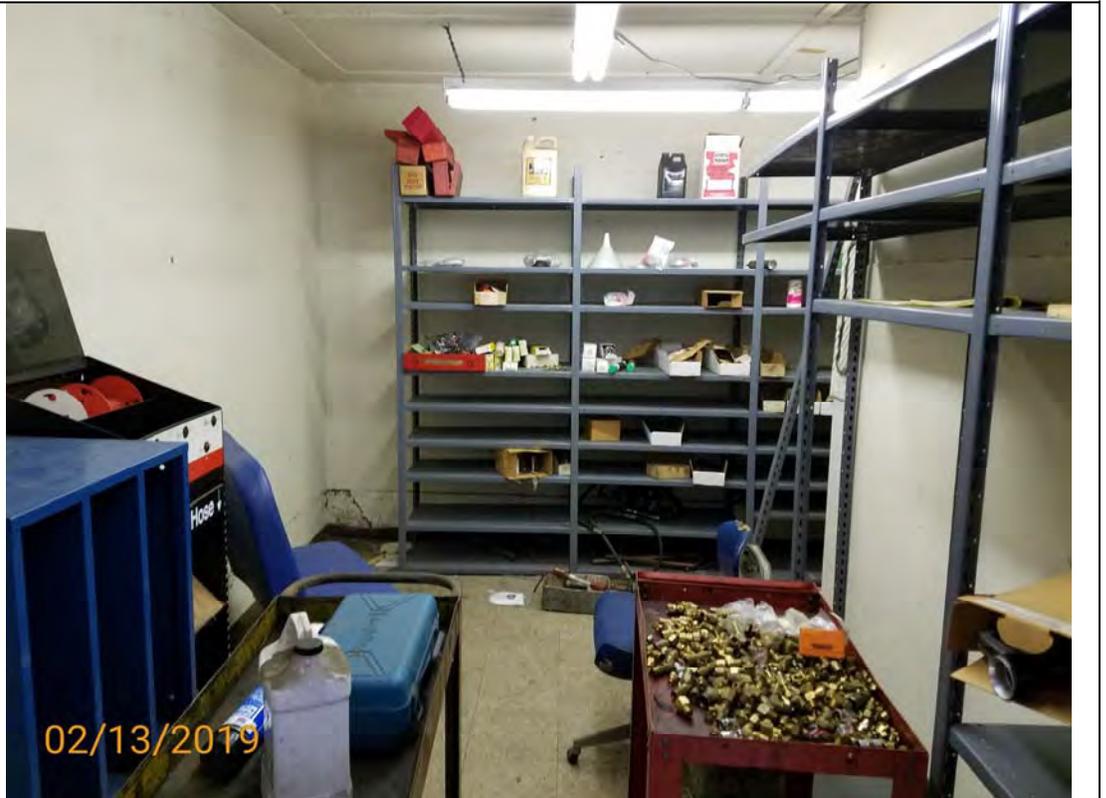
Description:
Assorted parts and small quantities of lubricants identified in the former Tire Storage Building.

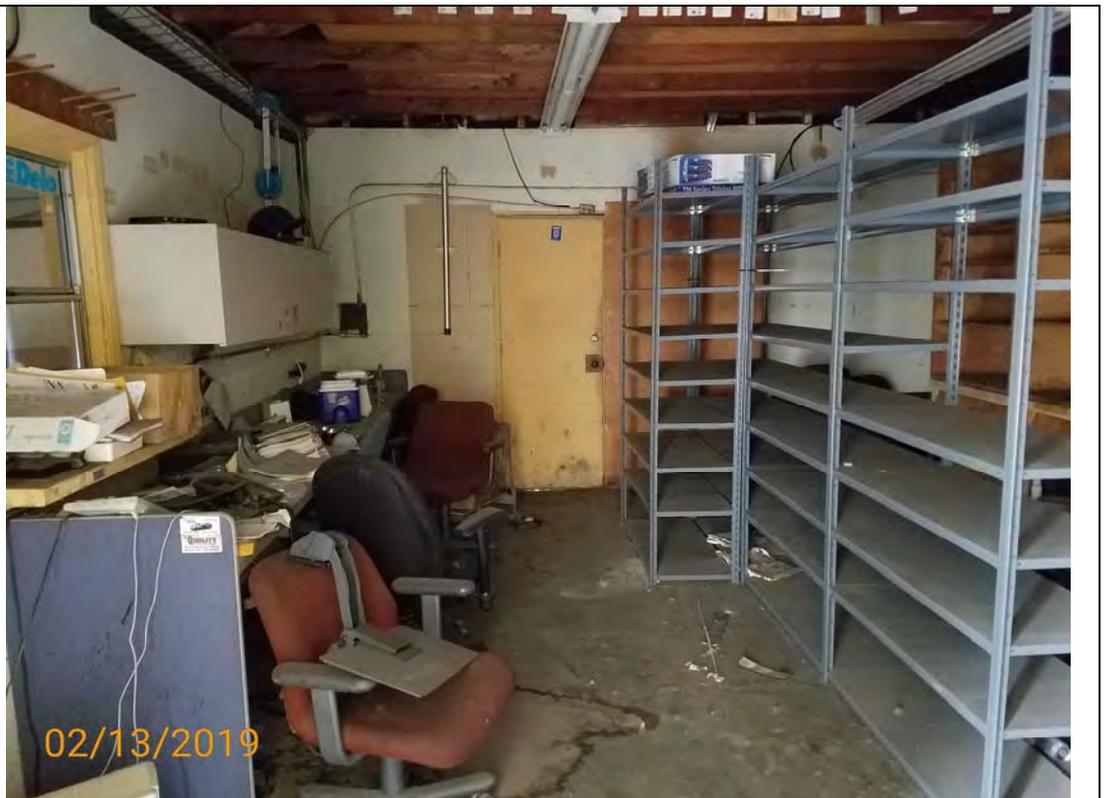
Description:
Storage racks and office equipment observed in the former Tire Storage Building.

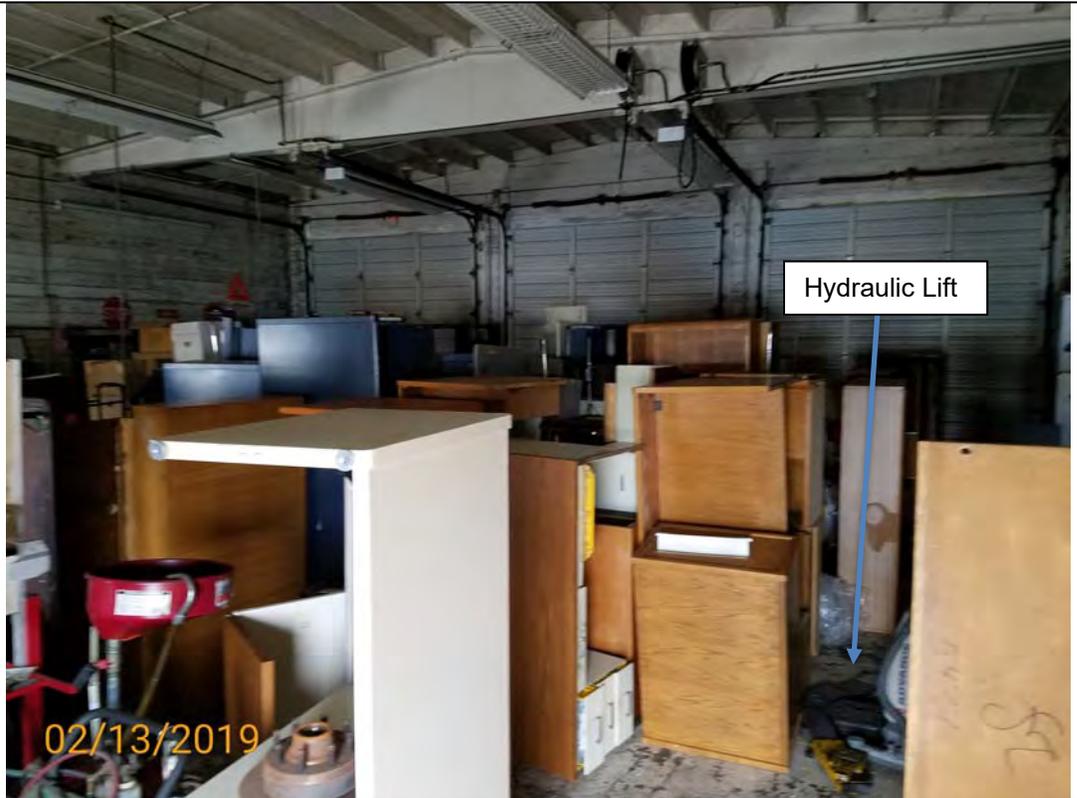
Description:
Equipment/furniture storage in northernmost room of the former Mechanic Shop. At least one in-ground hydraulic lift was identified in this room.

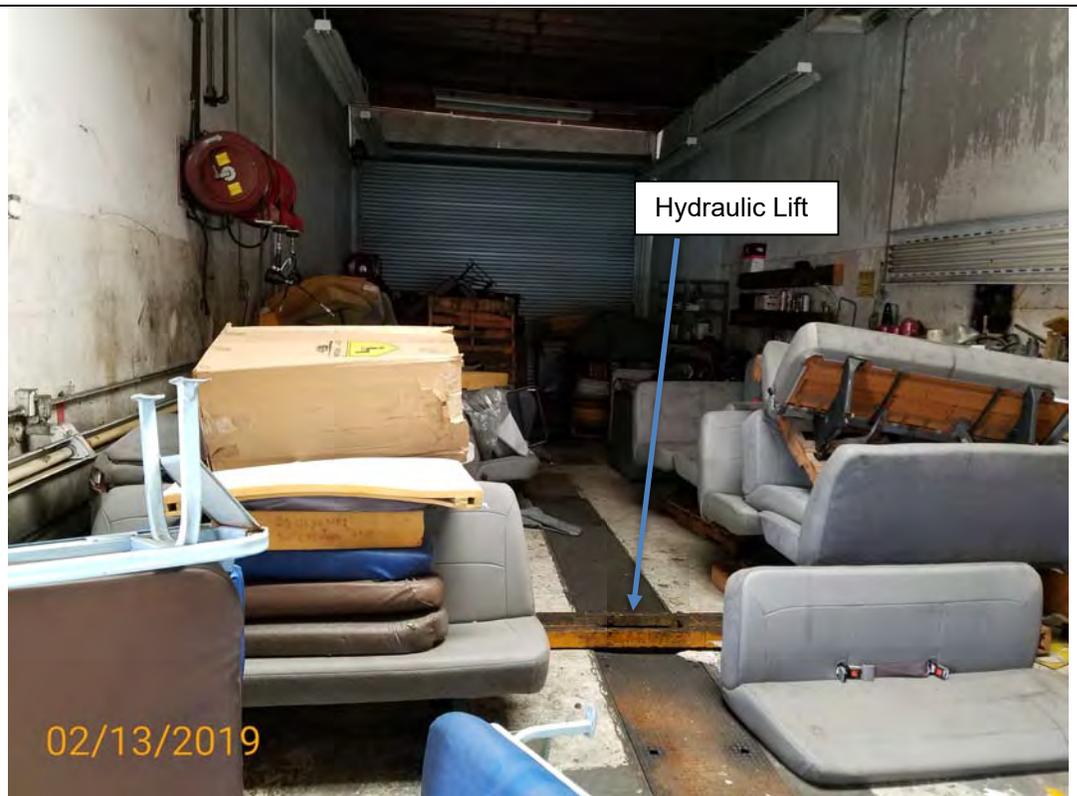
Photo No. 10

Description:
Middle room of the former Mechanic Shop contained a hydraulic lift and trench.

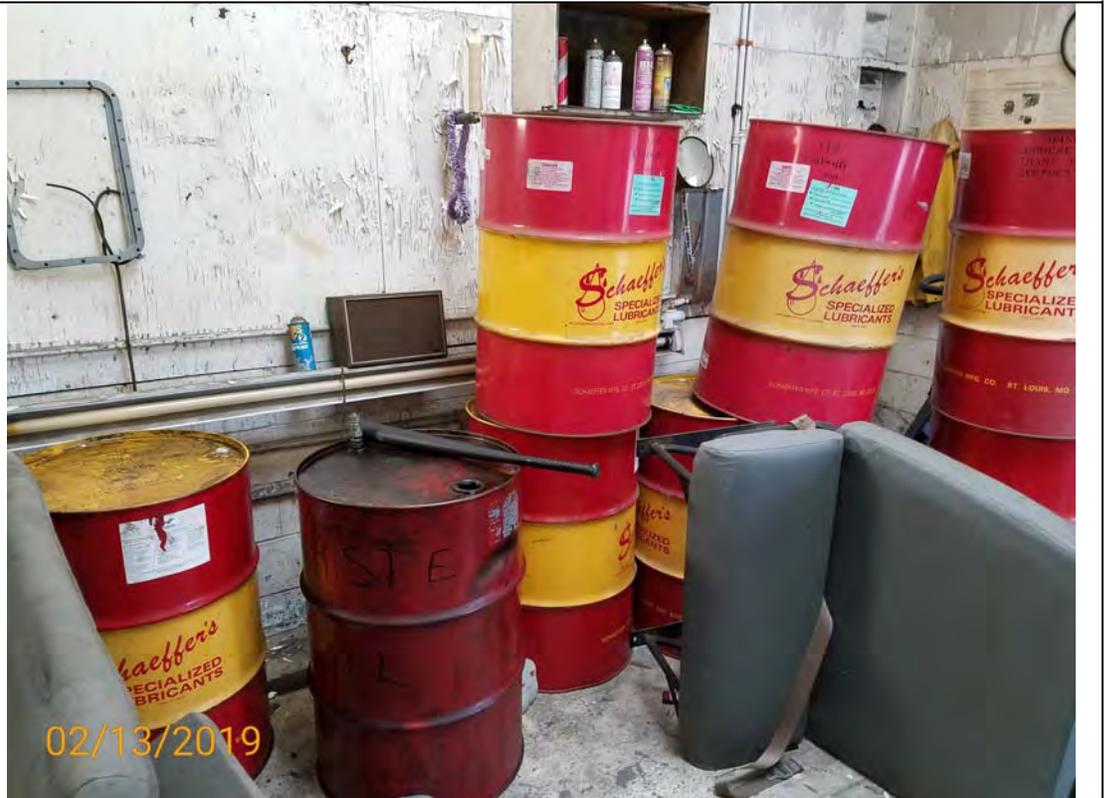
Photo No. 12

At least twelve (12), 55-gallon drums were stored in the middle room of the former Mechanic Shop. Many of these drums were noted to be empty or near-empty. No significant stains were observed on the concrete adjacent to the drums.

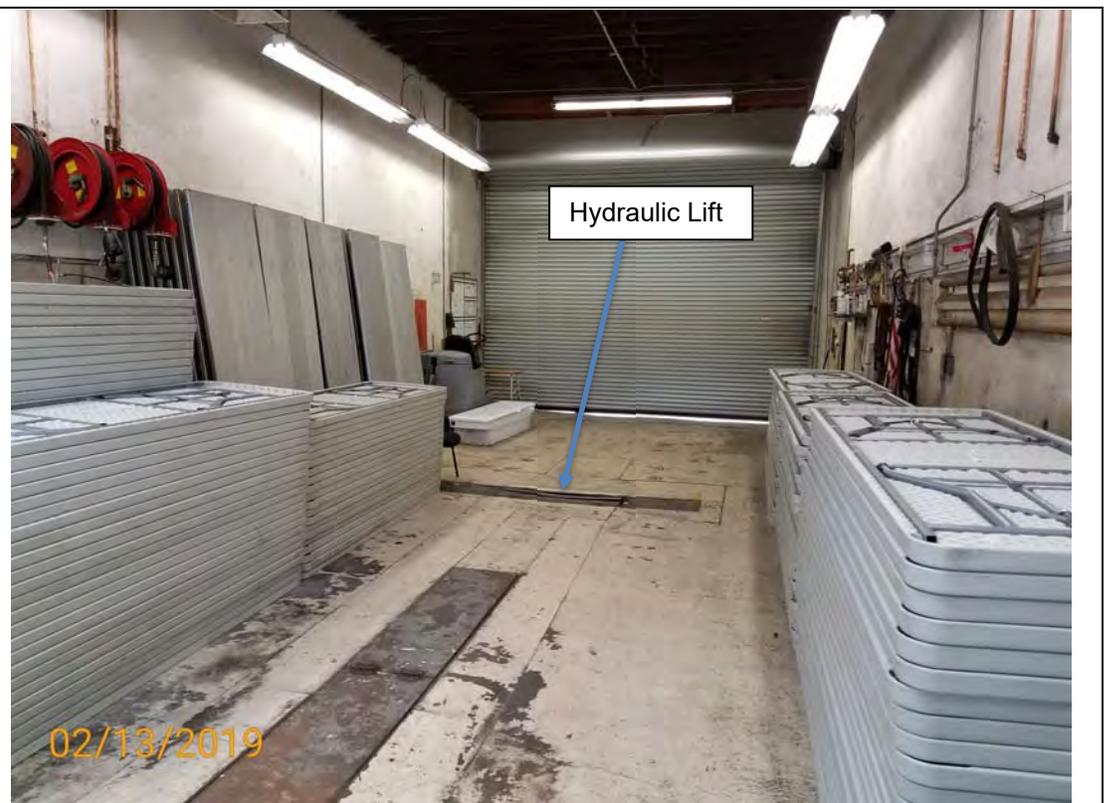
Southernmost room of the former Mechanic Shop. Storage of folding tables and small quantities of paints, cleaners, and lubricants. Hydraulic lift identified in center of room.

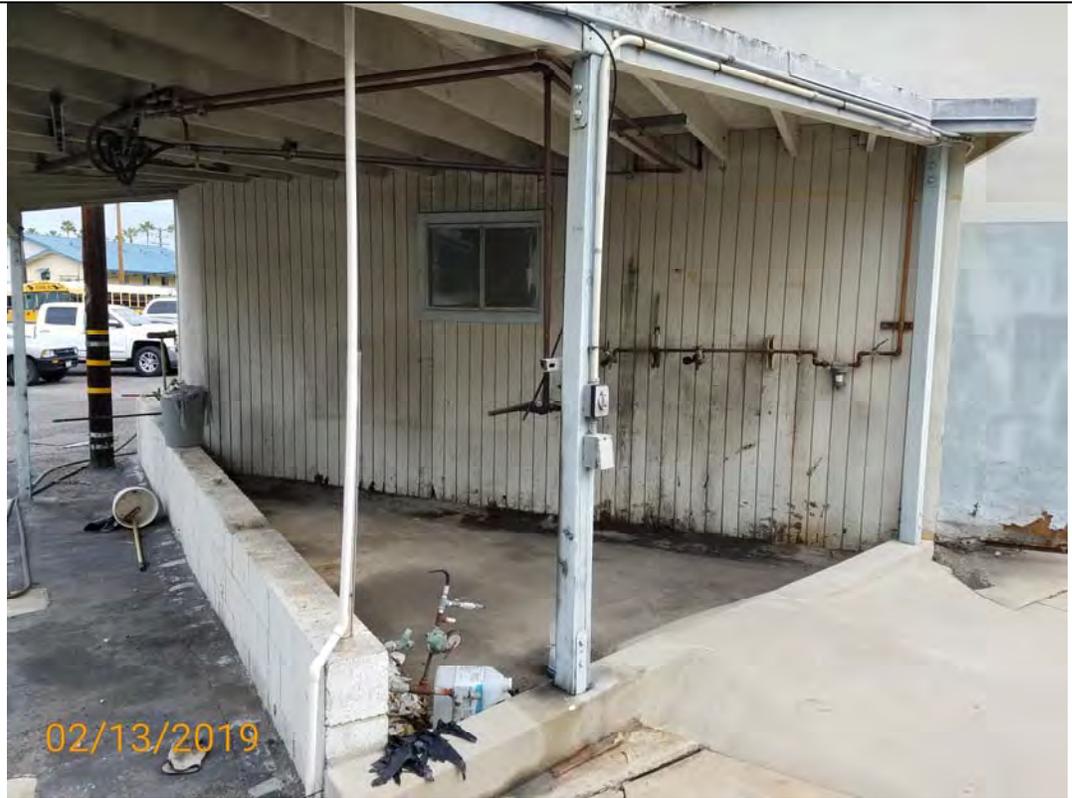
Photo No. 14

Description:
Former drum storage area adjacent to the former Mechanic Shop. No significant stains or damaged concrete were identified.

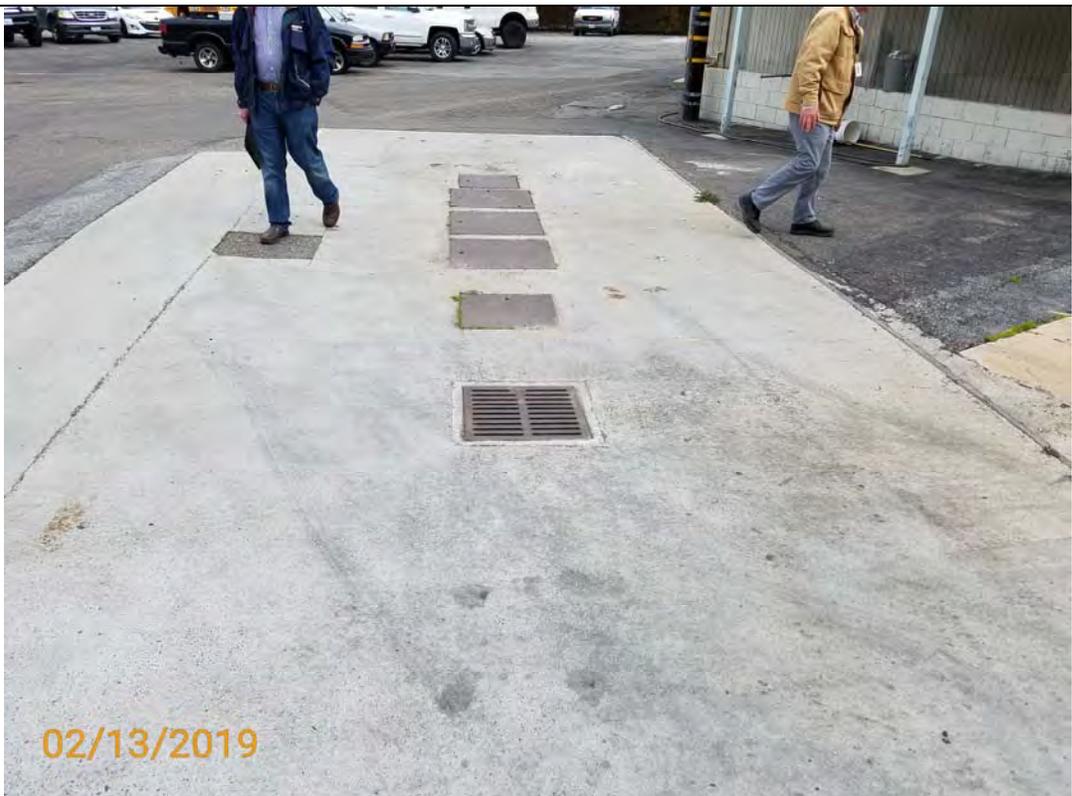
Description:
Former bus/vehicle wash area. Drain leads to a 3-stage clarifier (pictured) before discharging to sewer system.

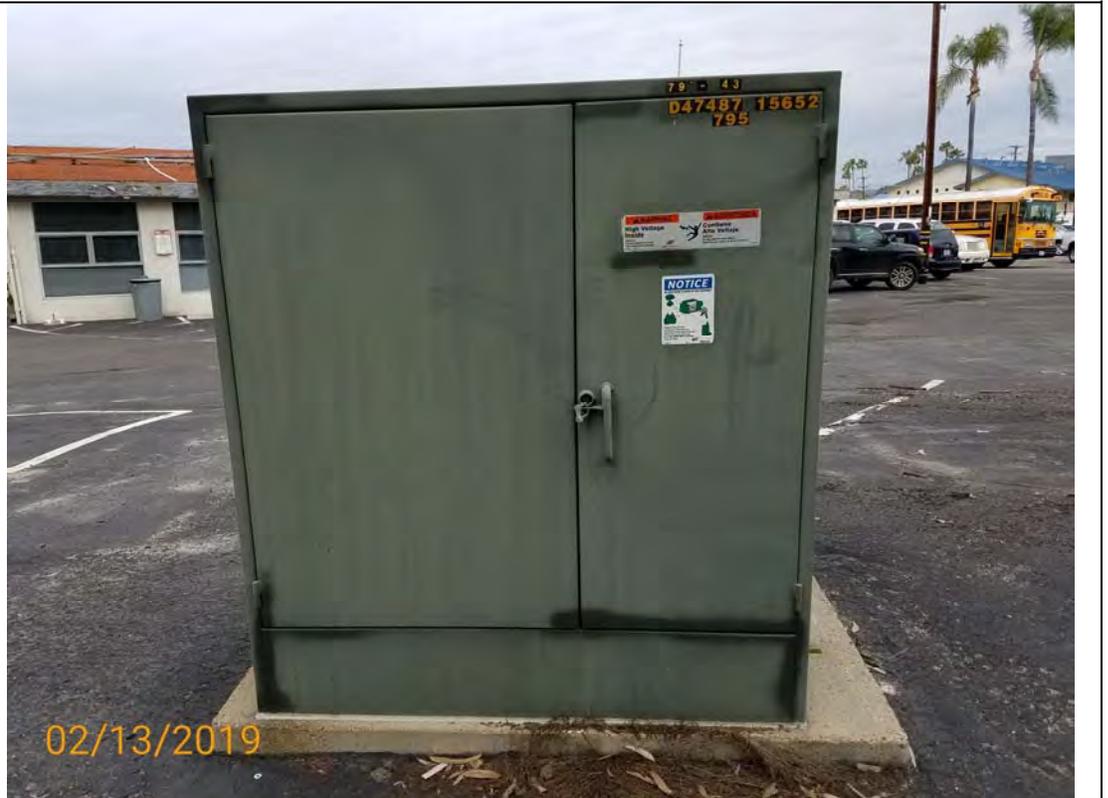
Photo No. 16

Description:
Pad-mounted transformer noted in the southeast portion of the subject site. No staining was noted on the concrete pad.

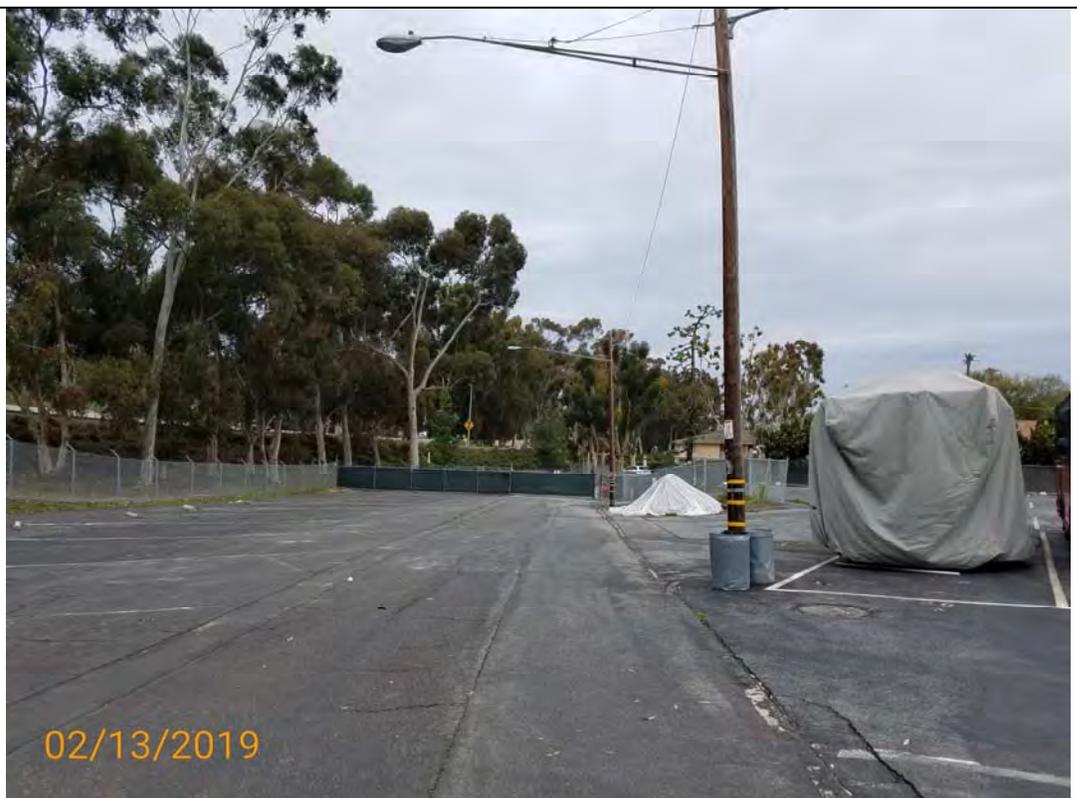
View of the southern margin of the subject property. Possible stockpile covered with plastic observed near the southwestern corner of the Site. According to onsite personnel, this stockpile contains material used as excess backfill at school sites, as needed.

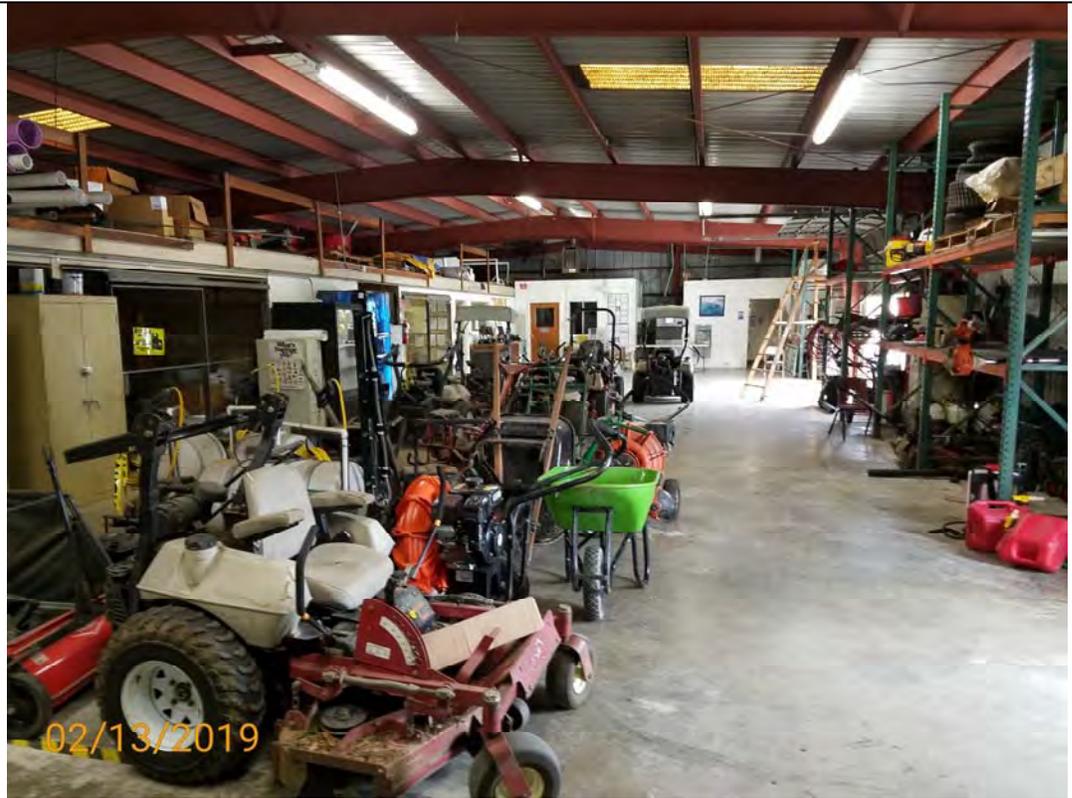
Description:
Interior of the Grounds Dispatch Building. Gardening equipment and supplies are stored within this building.

Portable fuel containers (approximately 2-gallon capacity) were noted inside the Grounds Dispatch Building, presumably used for fueling the motorized grounds-keeping equipment parked inside (Appendix B, Photo #21). Pesticide chemicals are currently stored within a fenced enclosure inside the Grounds Dispatch Building (Appendix B, Photograph 22). The concrete floor observed within the Grounds Dispatch Building appeared to be in good condition and no significant staining was observed.

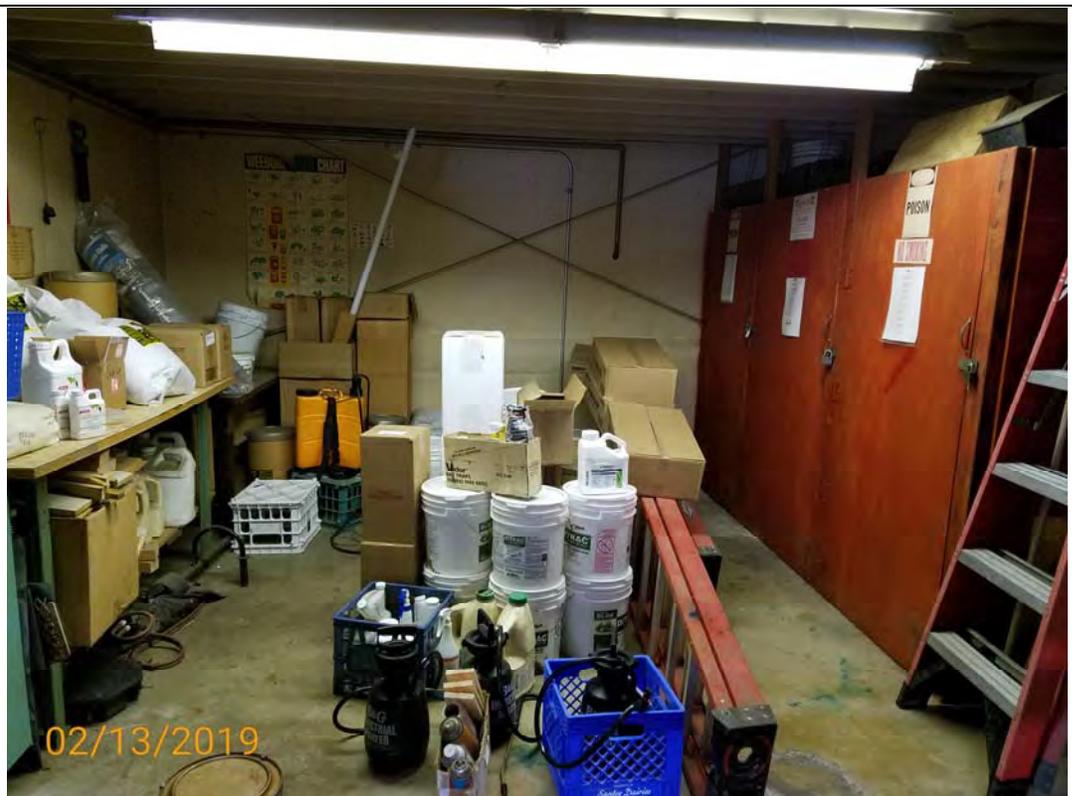
Description:
Pesticides/herbicide storage within one of the caged areas inside the Grounds Dispatch Building.

Evidence of pesticide use was not observed on the subject site. Various pesticides are stored on site within the Grounds Dispatch Building (see Photo No. 22 in Appendix B). Based on a review of aerial images, agricultural activities may have taken place at the subject site prior to 1946 (see Section 4.3.1).

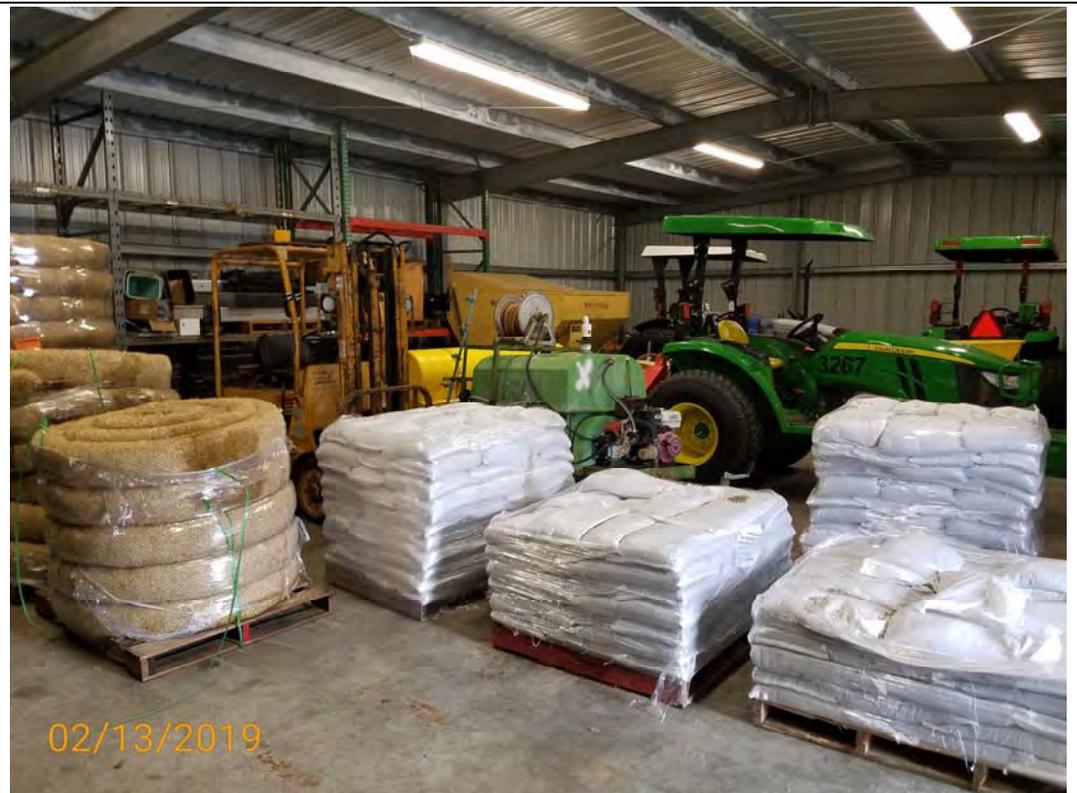
Photo No. 24

Description:
Interior of the "Buttler Building." Building serves as tractor/equipment parking and storage for straw waddle and sand bags.

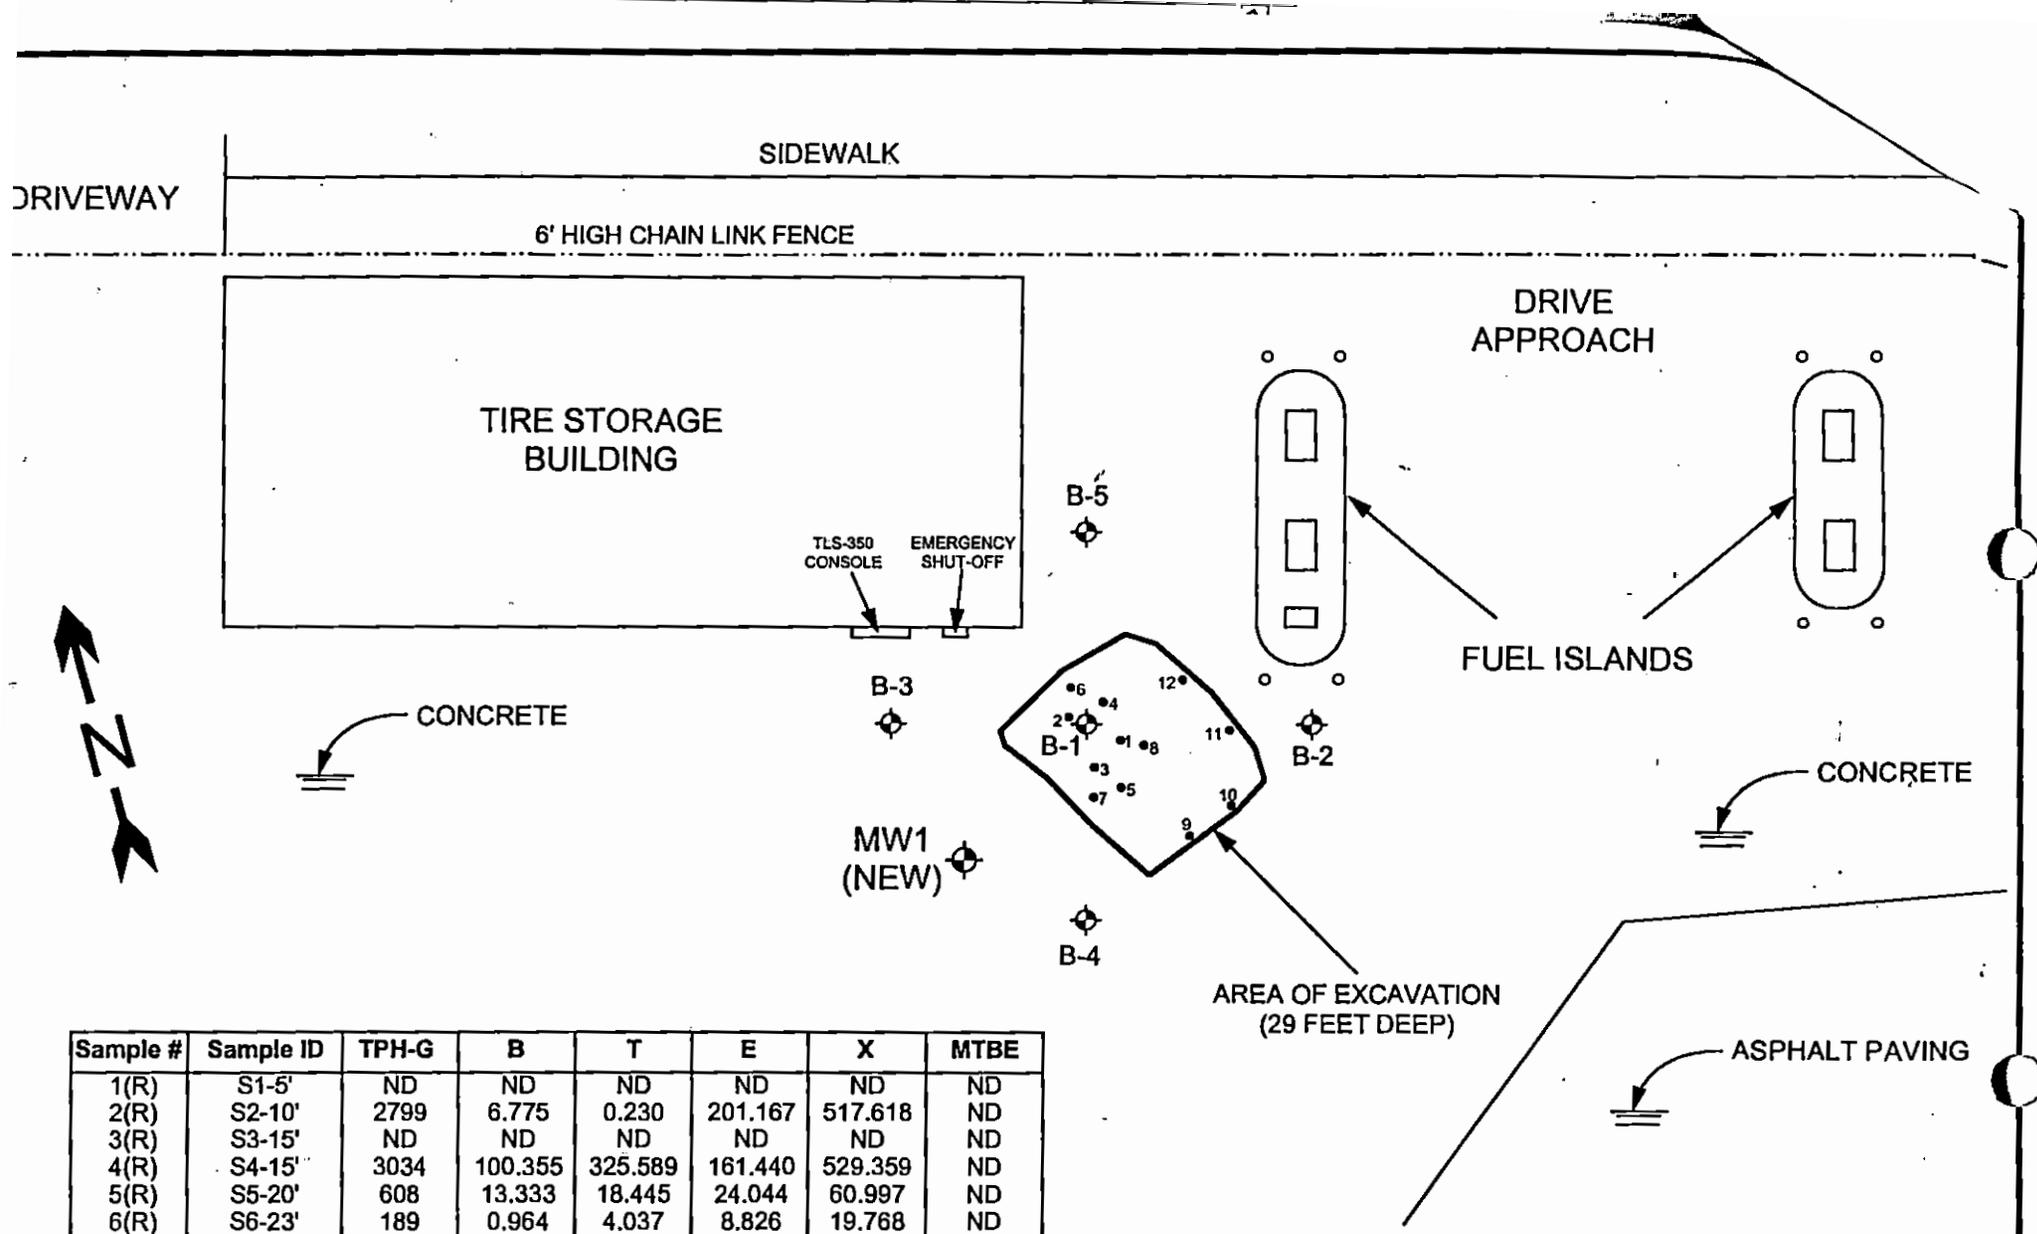
Sample #	Sample ID	TPH-G	B	T	E	X	MTBE
1(R)	S1-5'	ND	ND	ND	ND	ND	ND
2(R)	S2-10'	2799	6.775	0.230	201.167	517.618	ND
3(R)	S3-15'	ND	ND	ND	ND	ND	ND
4(R)	S4-15'	3034	100.355	325.589	161.440	529.359	ND
5(R)	S5-20'	608	13.333	18.445	24.044	60.997	ND
6(R)	S6-23'	189	0.964	4.037	8.826	19.768	ND
7(R)	S7-25'	24	2.744	6.173	1.276	5.129	ND
8(R)	S8-29'	12	0.106	0.196	0.627	0.444	ND
9	SW-10'	ND	ND	ND	ND	ND	ND
10	SW-20'	ND	0.121	ND	0.160	ND	ND
11	EW-10'	ND	ND	ND	ND	ND	ND
12	EW-20'	ND	0.014	ND	0.026	ND	ND

(R) SOIL REMOVED DURING EXCAVATION
 ⊕ B-3 LOCATION OF BORINGS PERFORMED IN 1992

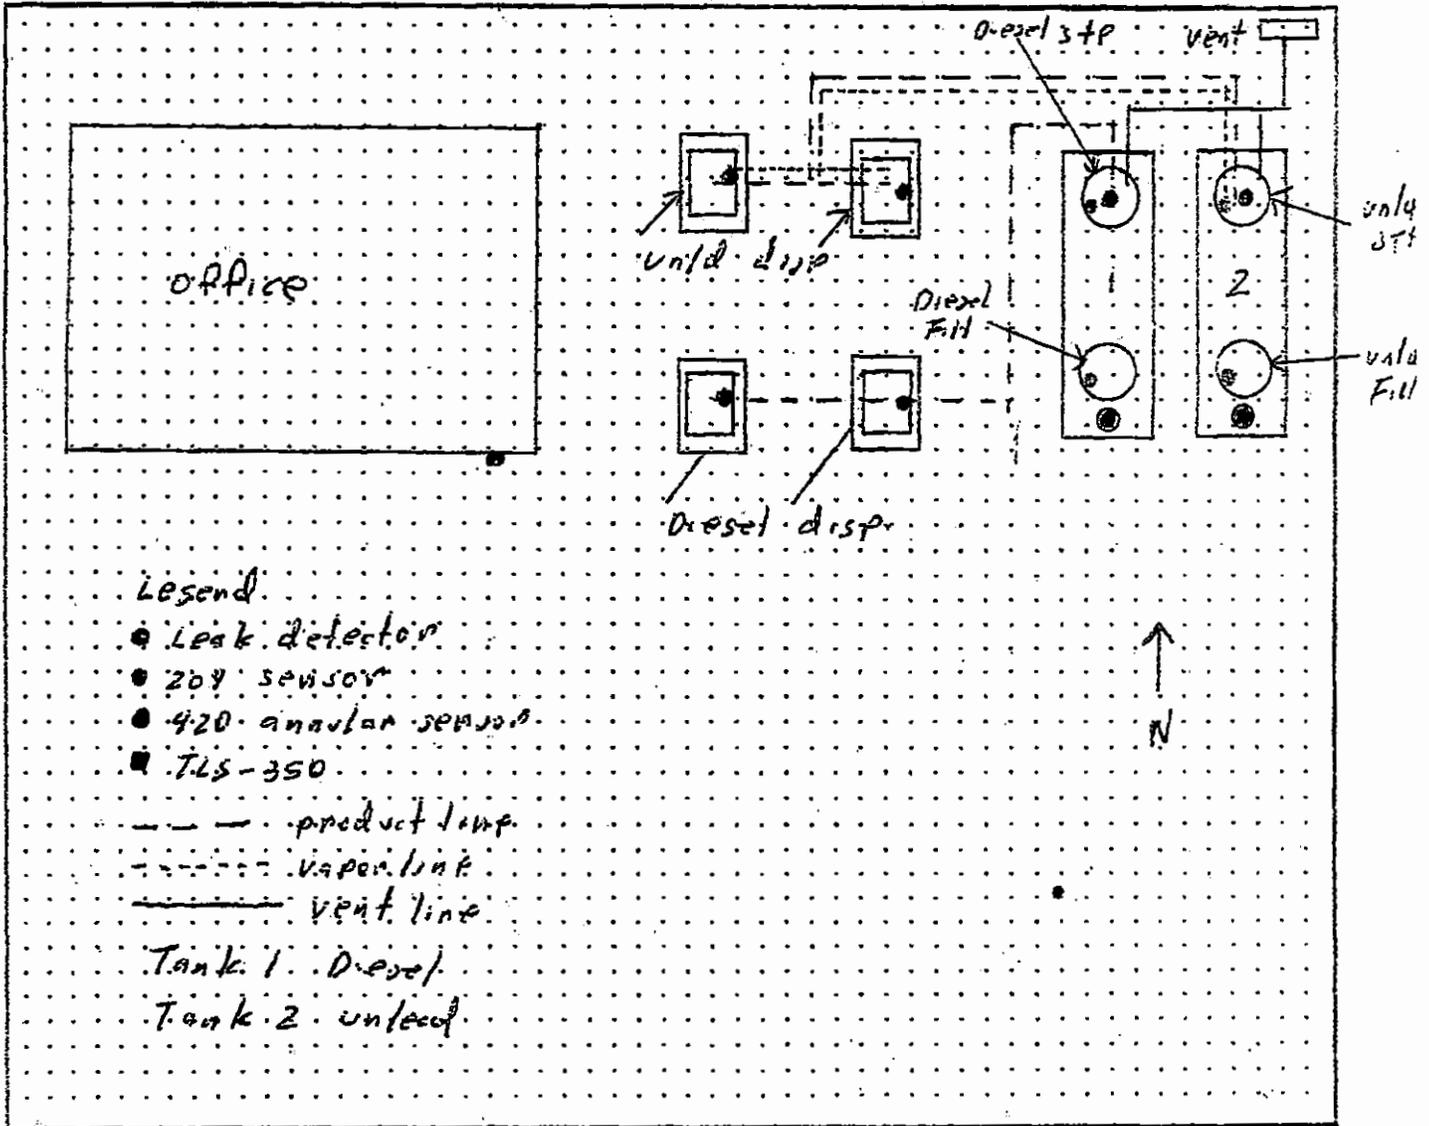
- Leak detector
- 209 sensor
- 420 analog sensor
- TLS-350
- product line
- - - vapor line
- · - vent line
- Tank 1 Diesel
- Tank 2 unleaded

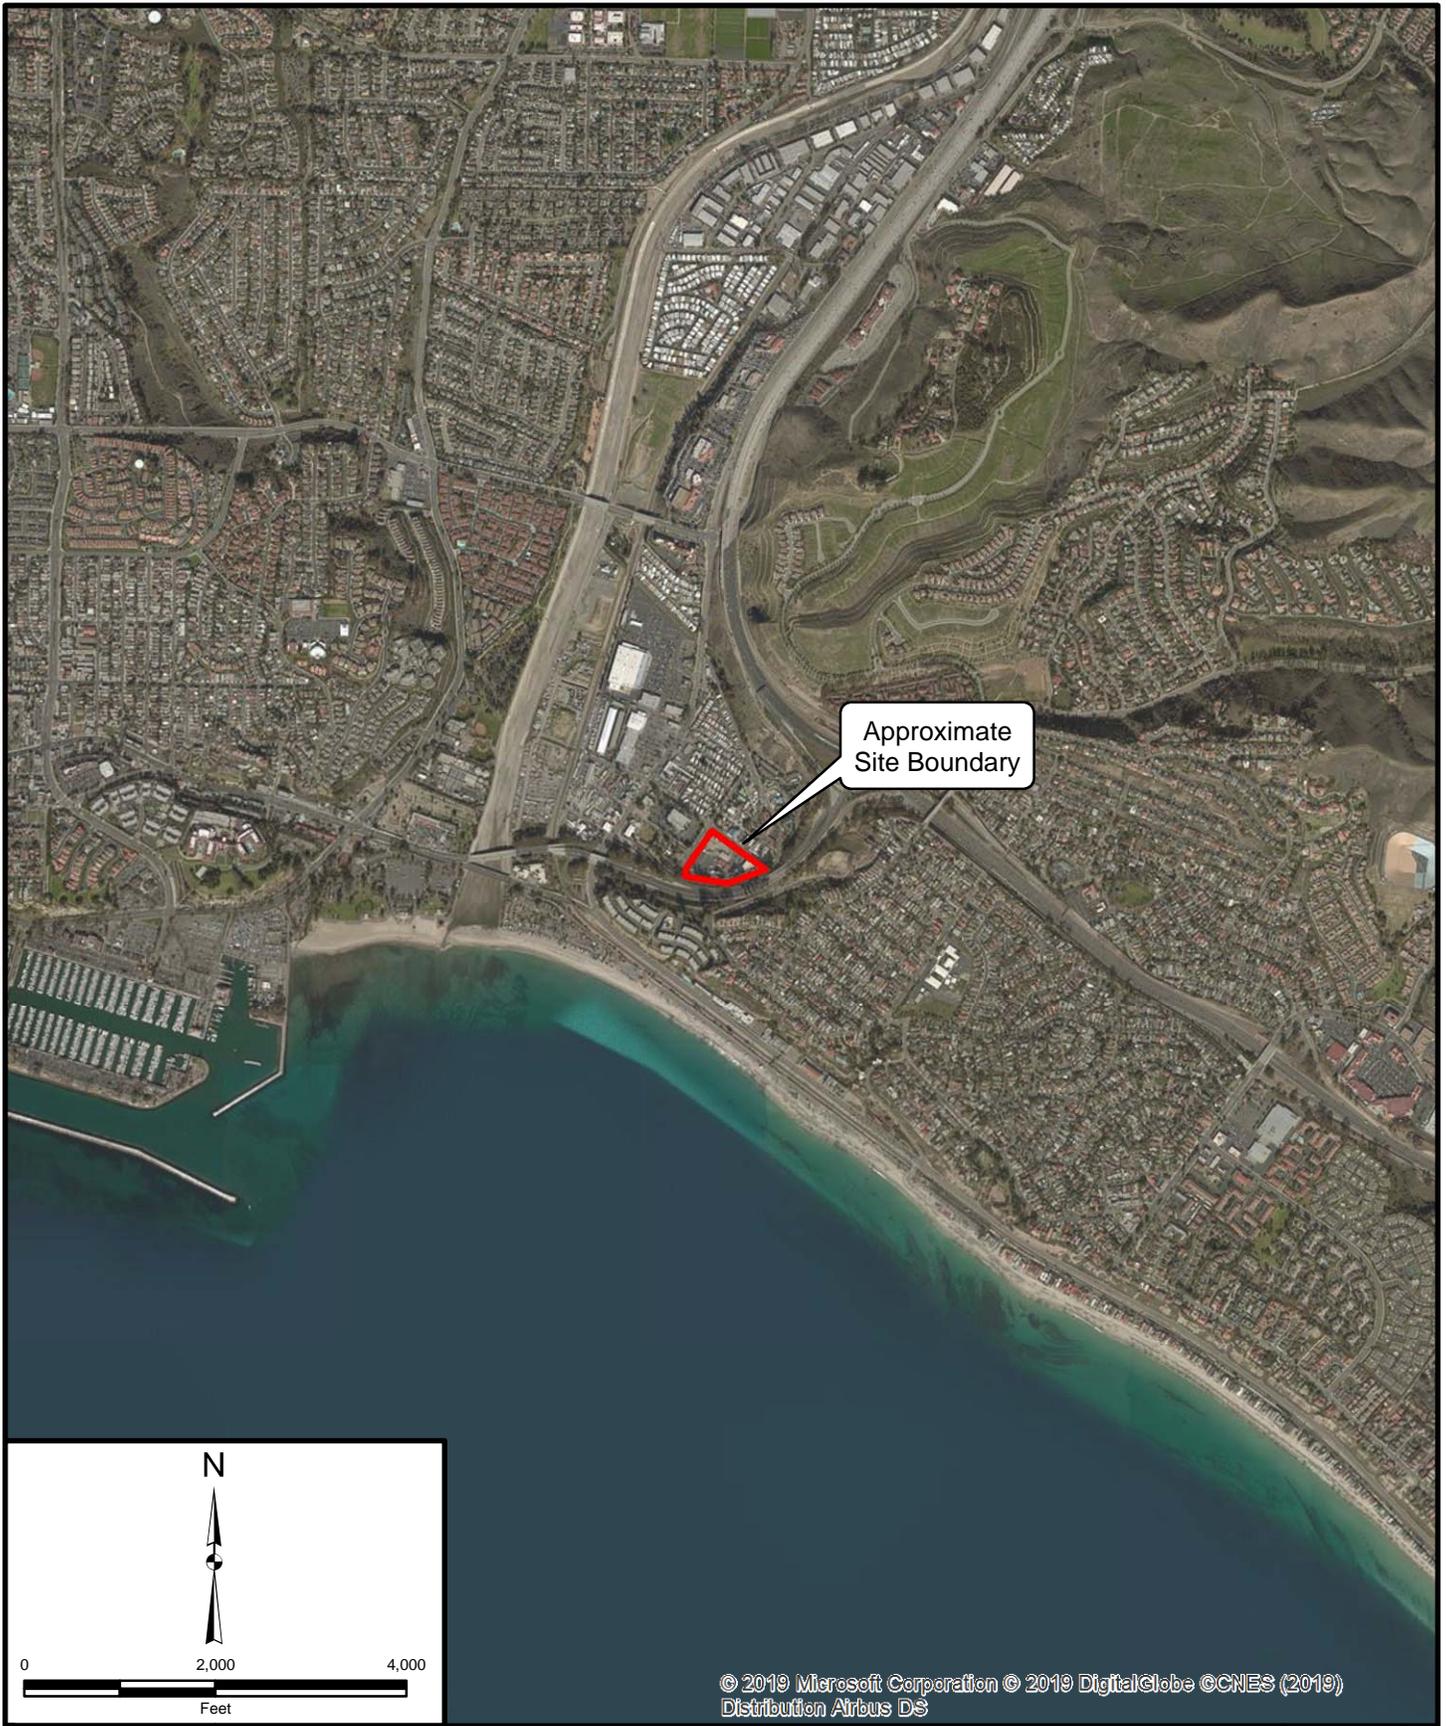
Figure 1

Approximate Site Boundary
