11.6 Hazardous Materials Documentation

Subject: Draft Phase I Environmental Site Assessment Report, 26126 Victoria
Boulevard, APN 668-361-01, Capistrano Beach, California

PHASE I ENVIRONMENTAL
SITE ASSESSMENT REPORT
26126 VICTORIA BOULEVARD
APN 668-361-01
CAPISTRANO BEACH, CA 92624

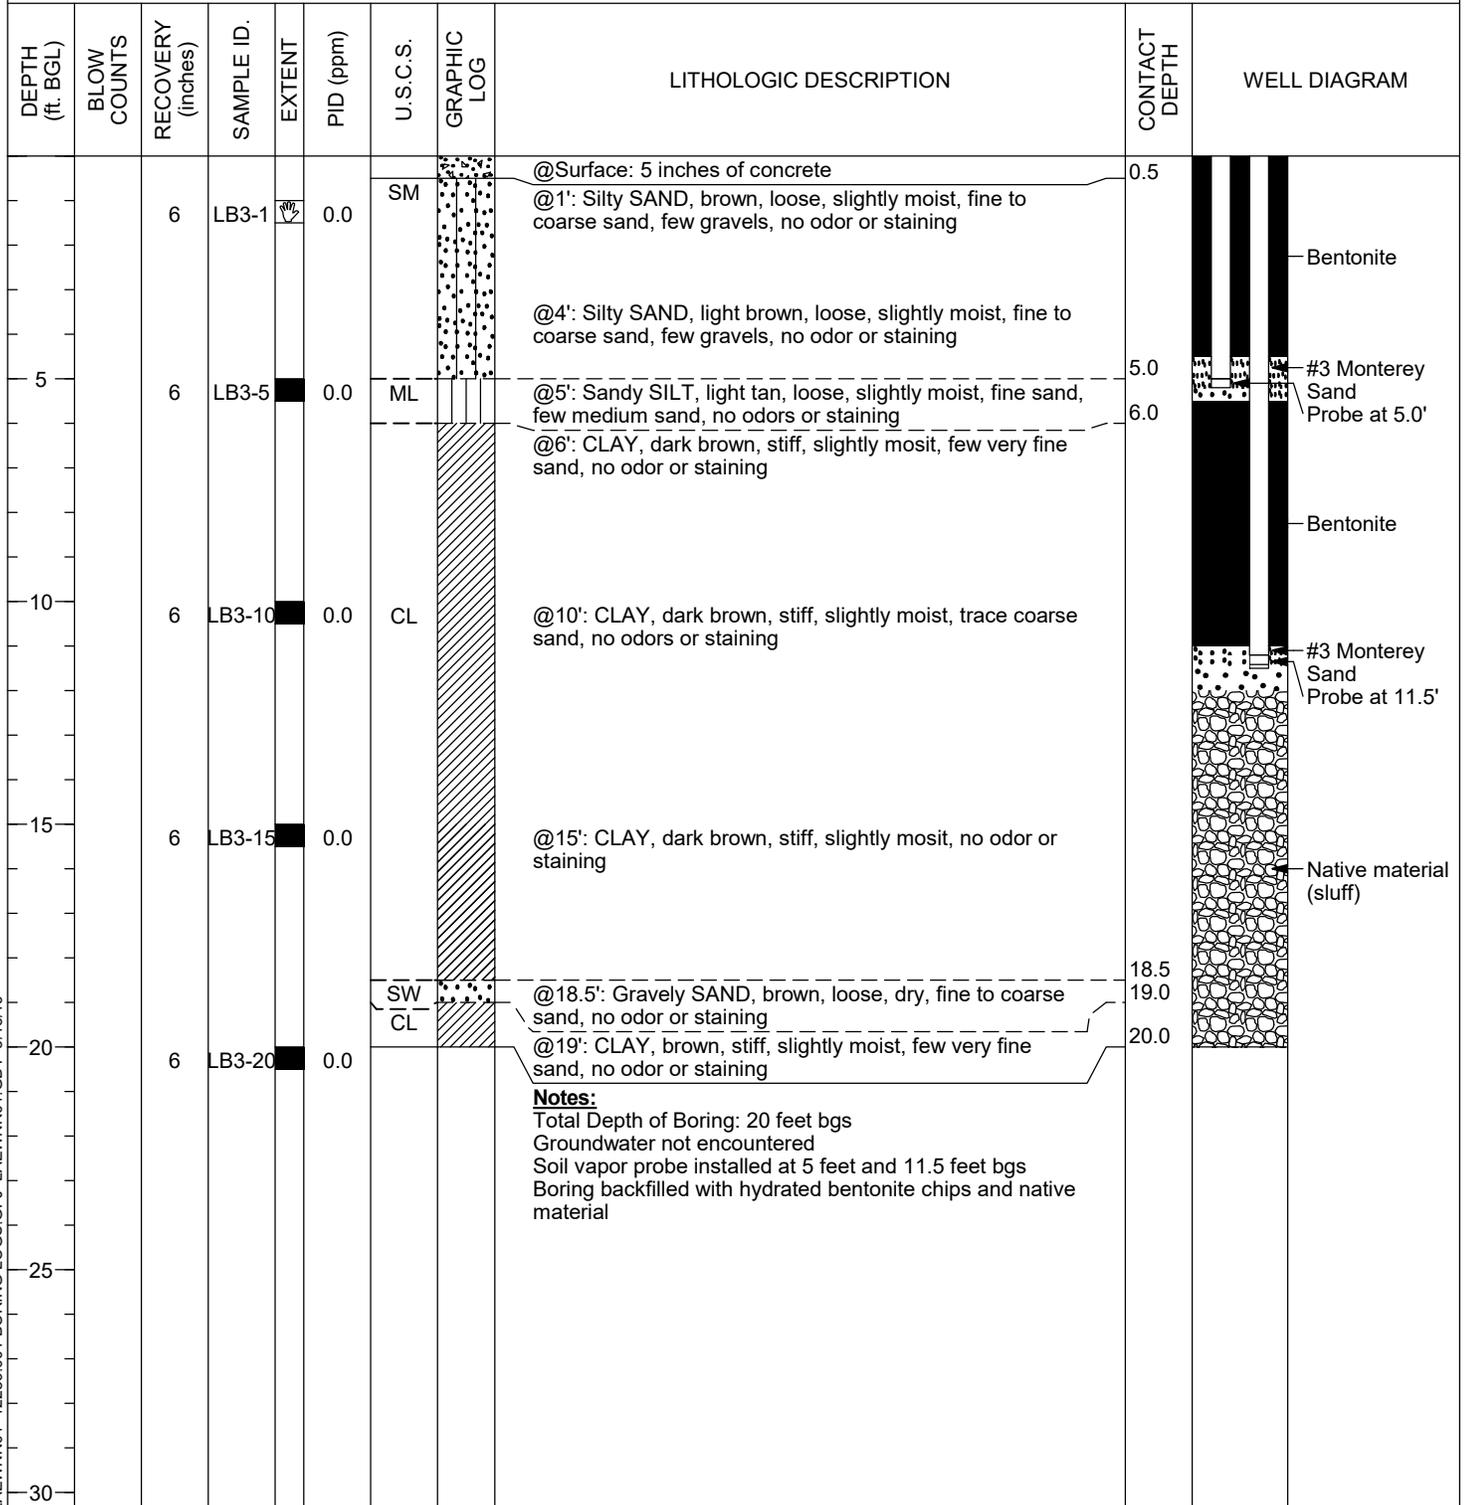
PROJECT NUMBER 12289.001	BORING/WELL NUMBER LB3
PROJECT NAME Toll Bros. Apartment Living - Phase II ESA	DATE DRILLED 2/27/2019
LOCATION 26126 Victoria Blvd., Capistrano Beach, CA	CASING TYPE/DIAMETER 1/4" Nylaflo
DRILLING METHOD Hand Auger to 4.5 feet, then Direct Push	SCREEN TYPE/SLOT Polyethylene Implant / N/A
SAMPLING METHOD Glass Jar/Sleeve	GRAVEL PACK TYPE #3 Monterey Sand
GROUND ELEVATION ft.	GROUT TYPE/QUANTITY Hydrated Bentonite
TOP OF CASING ft.	DEPTH TO WATER N/Aft.
LOGGED BY SAG	GROUND WATER ELEVATION ft.
REMARKS Boring completed by Millennium Environmental, Inc. using Geoprobe6600.
