Appendix F: Hazards and Hazardous Materials Supporting Information

PHASE I ENVIRONMENTAL SITE ASSESSMENT

Canine Companions Expansion Project 2965 Dutton Avenue Santa Rosa, California 95407 Sonoma County

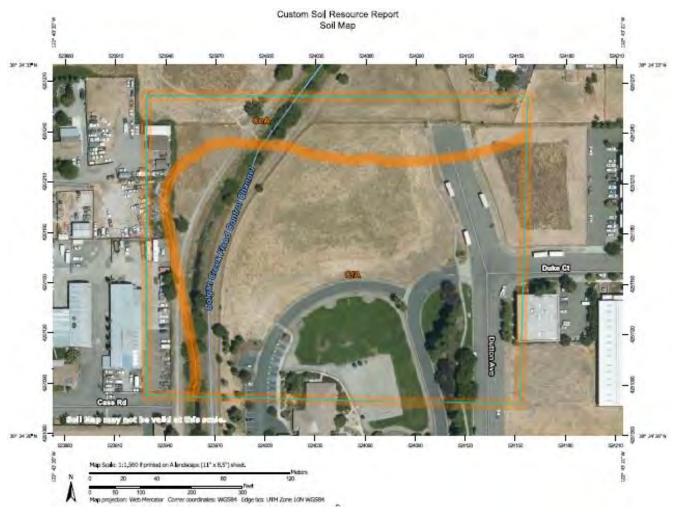
Soils within the Study Area are mapped as Clear Lake clay, ponded 0-2% slopes (CfA) and sandy substratum, drained 0-2% slopes (CeA) (NRCS 2020; see below map).

Clear Lake clay, ponded is alluvium derived from sedimentary rock. The typical profile is clay from 0 to 60 inches. Clear Lake clay, sandy substratum, drained is basin alluvium derived from volcanic and sedimentary rock over fan alluvium derived from volcanic and sedimentary rock. The typical profile is clay from 1 to 52 inches, clay loam from 52 to 60 inches, and fine sandy loam to 72 inches. Clear Lake clay is poorly drained and the runoff class is high. The depth to the water table is 36 to 60 inches. The soil is subject to frequent ponding. Clear Lake clay is considered a hydric soil. Within the Study Area, Clear Lake clay, ponded occupies most of the site. Clear Lake clay, sandy substratum drained occurs along the northern edge of the Study Area.

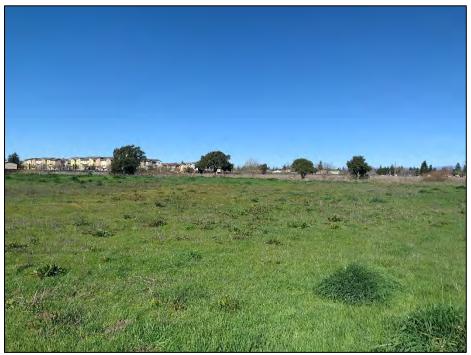
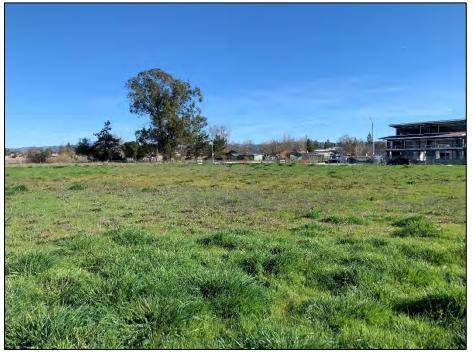
Looking northwest (above) and northeast (below) at delineated wetland. Light orange plant is common spikerush, a wetland obligate plant.

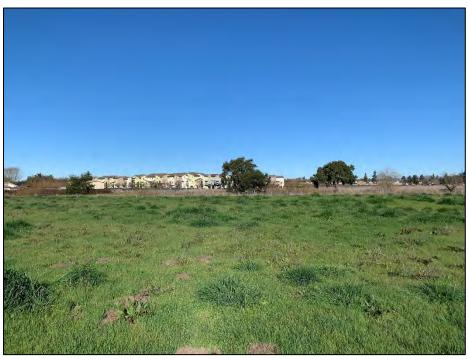
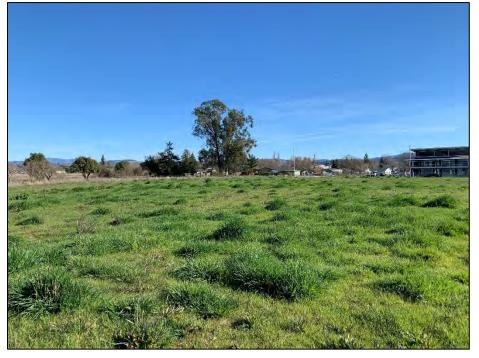
Upland areas along western edge (above) and central portion (below) of the Study Area.

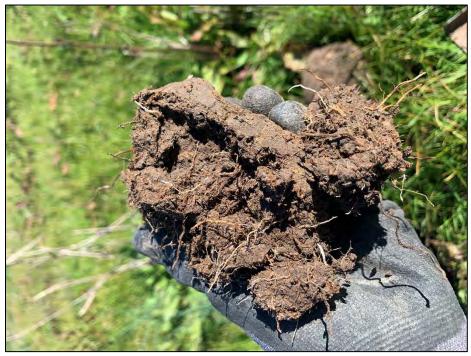
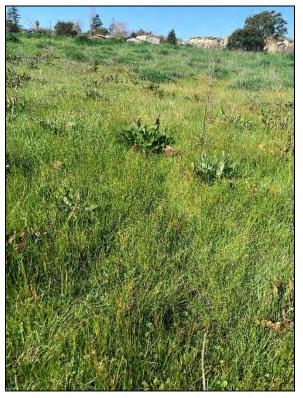
Wetland soils with oxidized rhizopheres along living root channels (above) and common spikerush dominated wetland (below).

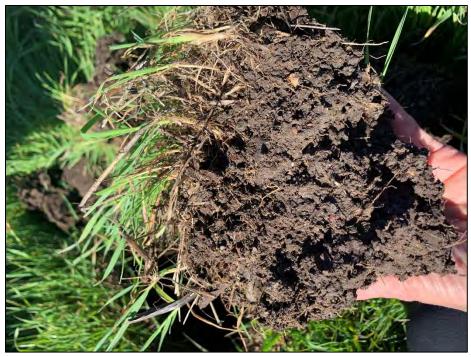
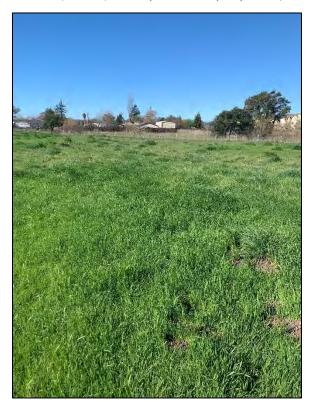
Upland soil (above) and upland sample point (below).
