California Environmental Quality Act
Initial Study and Negative Declaration
for the
East Weaver Creek Dam Removal
and Intake Relocation Project

Weaverville, CA
July 15, 2021

Prepared for:
Weaverville Community Services District
716 Main Street
Weaverville, California 96093
(530) 623-5051

Prepared by:
Northwest California Resource Conservation & Development Council
Five Counties Salmonid Conservation Program
40 Horseshoe Lane
Weaverville, California 96093
(530) 623-3967

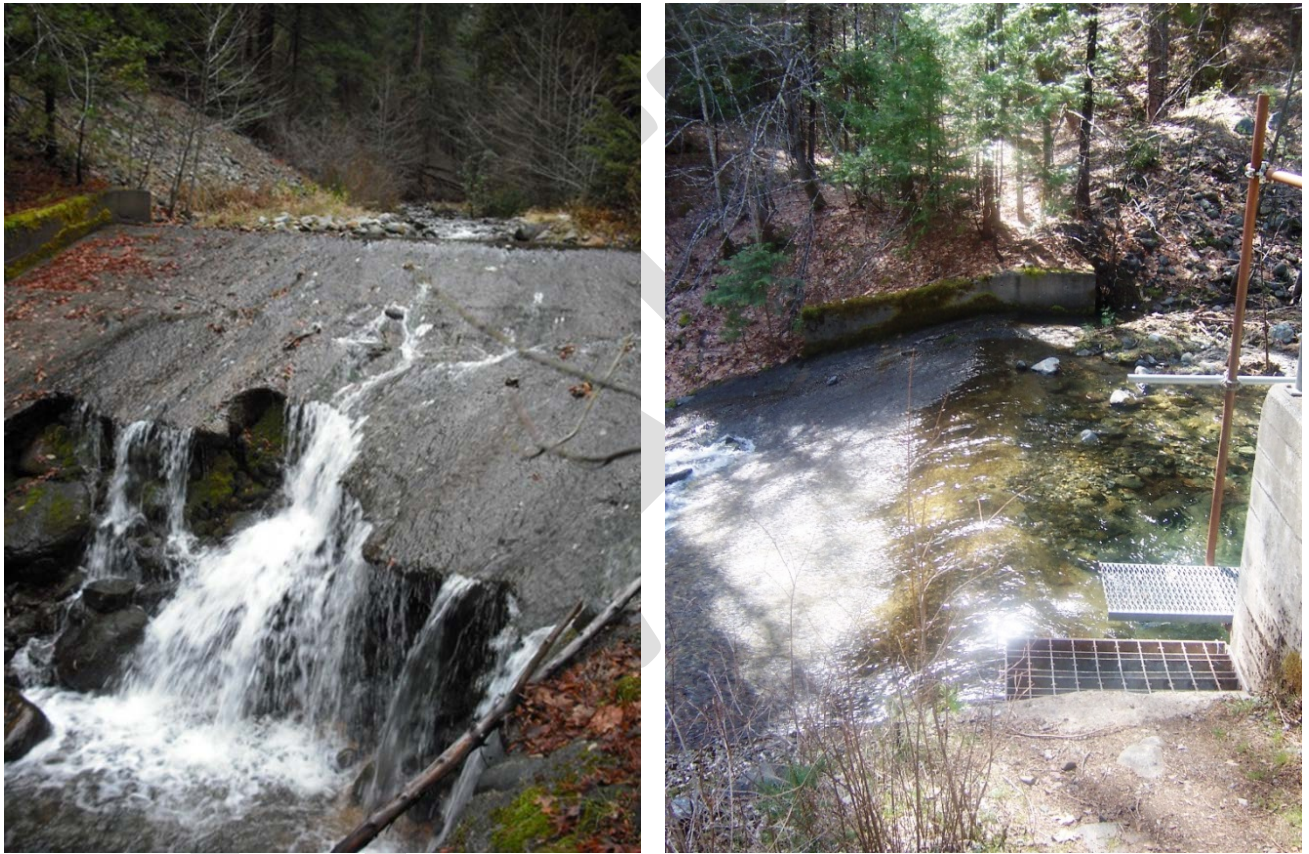
Figure 2-3. Dam showing concrete cap (left) and stilling basin to the EWF (right).

A dam condition assessment was completed using the Bureau of Land Management (BLM) Dam Condition Assessment Checklist (BLM, 2006). The EWD is rated in poor condition due to repairs or modifications required to maintain the structure operationally. Deficiencies are evident on visual inspection of the dam including: loss of concrete apron segments, concrete spalling, exposed rebar, water flows interstitially through the dam’s rock structure, sediment filling upstream, and bed scour below the base of the dam (Figure 2-3). Major repairs to the dam will be necessary in the reasonably foreseeable future.

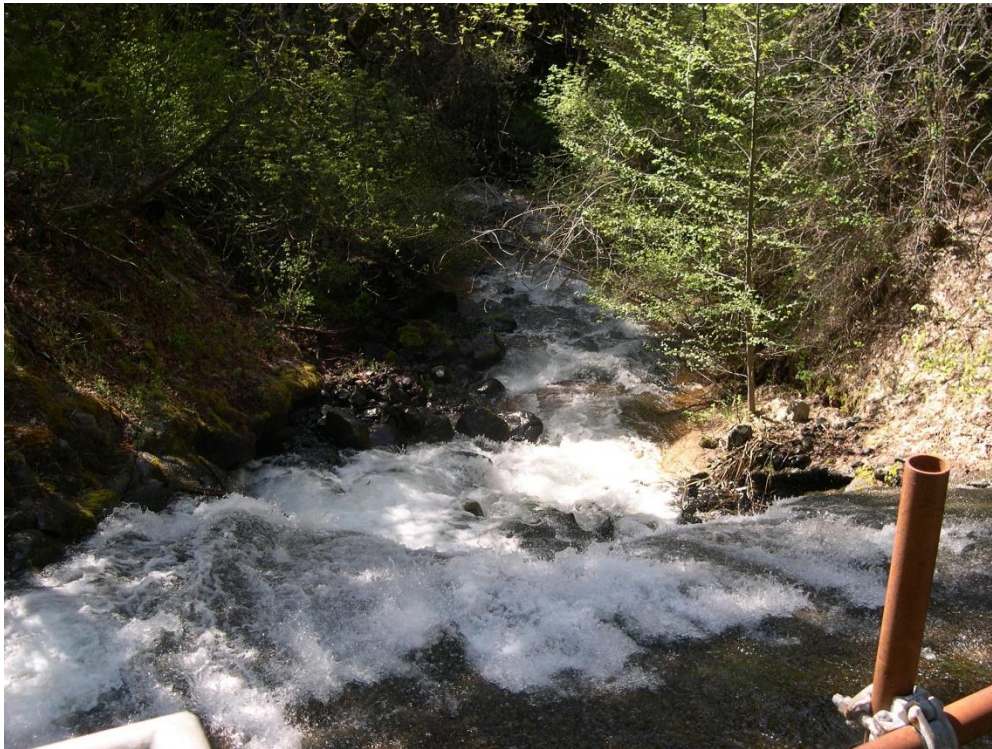
ii: East Weaver Dam- photo taken from the intake structure near the crest of the dam, looking downstream.

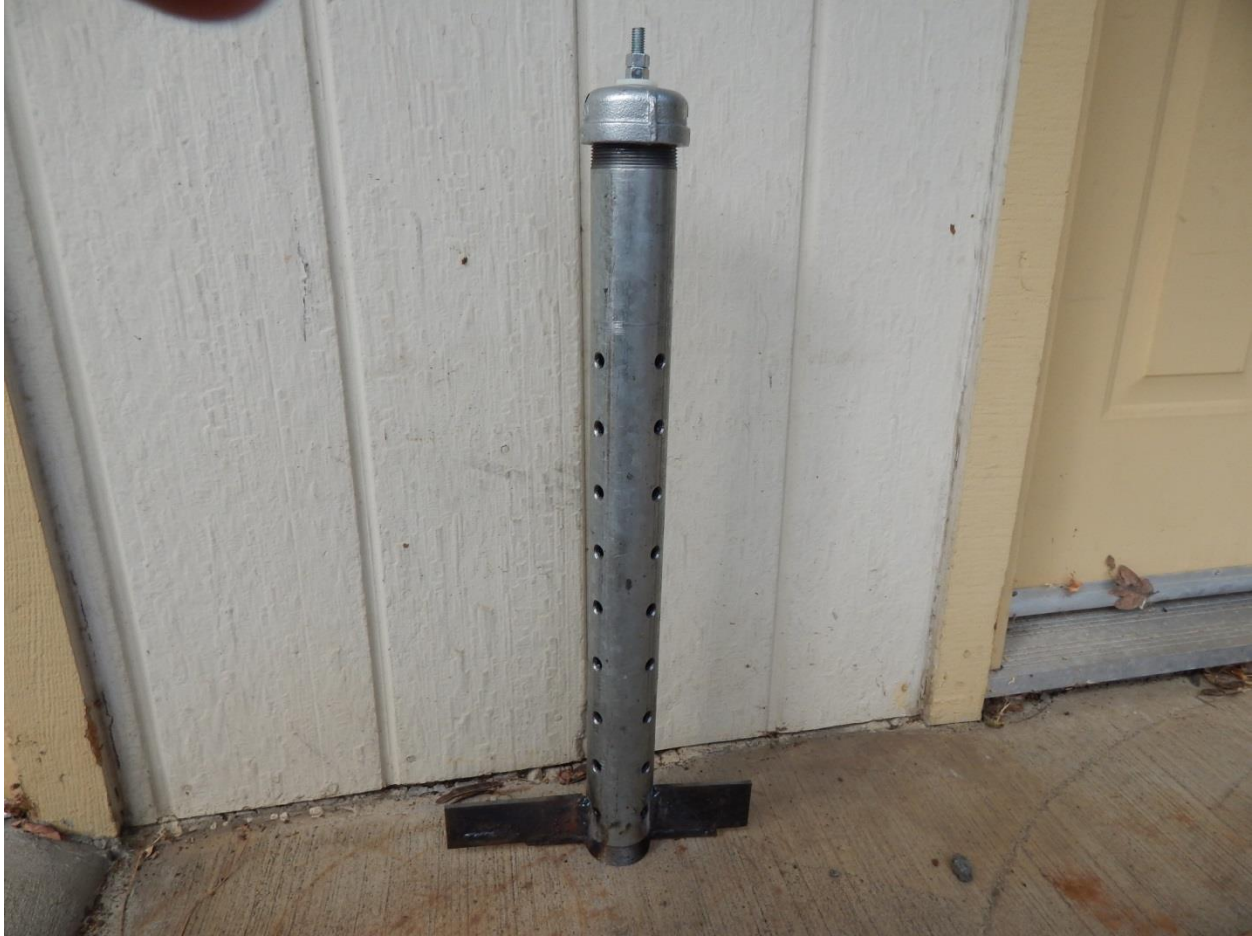
Figure 4. HOBOT container for Monitoring Sites #2 and #3.
