# PHASE I ENVIRONMENTAL SITE ASSESSMENT 505 East Bayshore Road Redwood City, California

9 July 2019 770655201

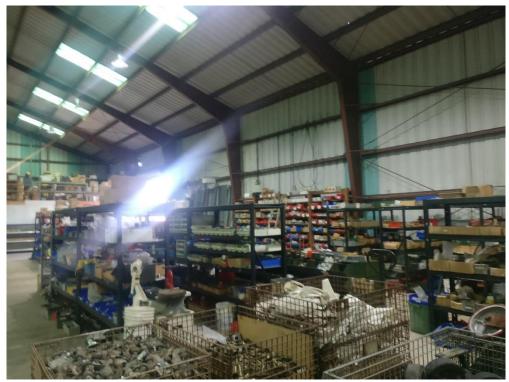
Building 1 contains an office and a restroom. The remainder of the building is used for storage of steel products such as bolts, metal sheeting, pipes, and other small metal items. No use of hazardous substances or petroleum products were observed in this building.

Photograph 3: Interior of Building 1, shelves used to store small metal pieces.

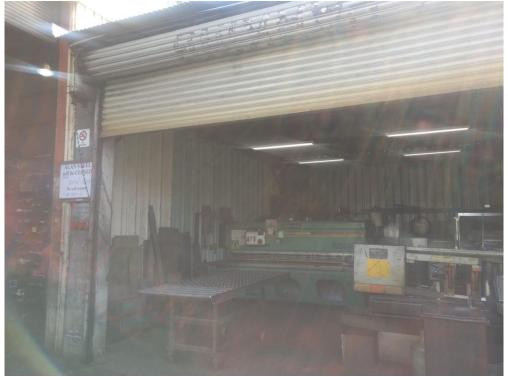
Building 2 is used to store metal and steel products. In a small shed attached to Building 2 steel saw was observed and the storage of water, coolants, water soluble lubrication oils, and compressed gas cylinders (oxygen and acetylene).

Photograph 4: Steel saw in shed south of Building 2 (facing east).

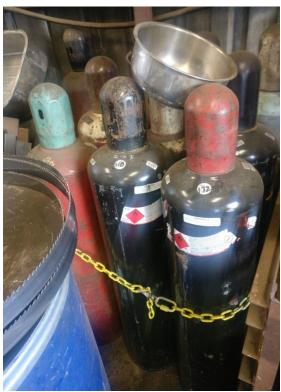
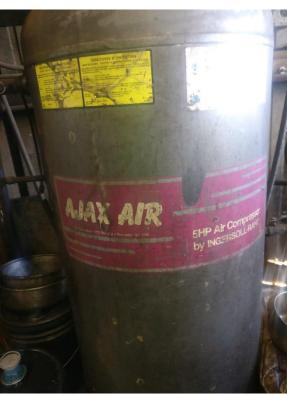
Photograph 5a and 5b: Gas cylinders stored in shed south of Building 2.

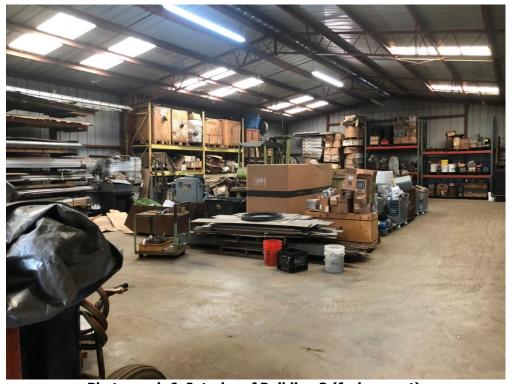
Building 3 was used to store ladders, metal pipes, forklifts, and metal sheeting. In addition a portion of Building 3 contains a small machine shop. In the machine shop storage of lubricant bottles and a grease bucket were observed. Some minor surface stains were observed on the concrete floor of the machine shop. Also, a small storage shed attached to the machine shop was used to store waste and lubrication oil.

Photograph 6: Interior of Building 3 (facing west).

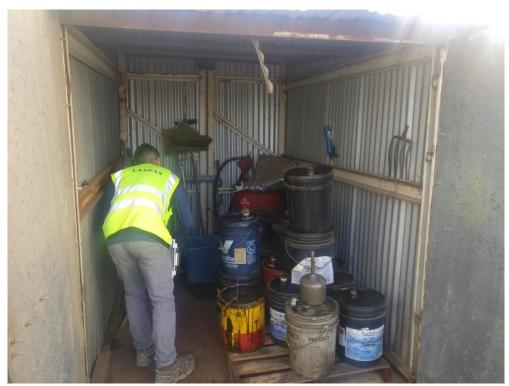
Photograph 7: Storage shed that contains used oil and lubricants west of Building 3 (facing south).

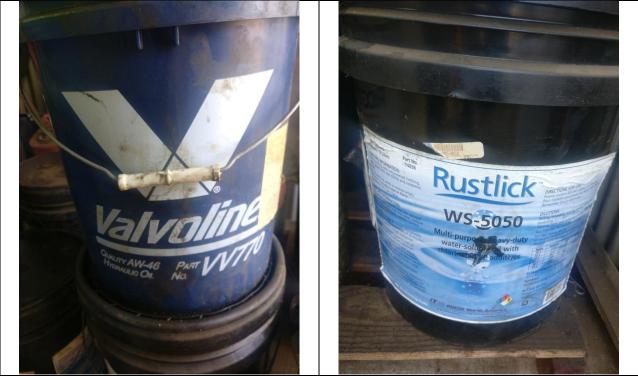
Langan did observe the following hazardous substances and/or petroleum products in connection with identified uses at the site. Chemicals stored on site included new and recycled hydraulic oils, water soluble lubricants, coolants and batteries. These products were stored in cabinets and appropriately labeled.

Photograph 8a and 8b: Used hydraulic oil water soluble lubricant in storage shed west of Building 3.

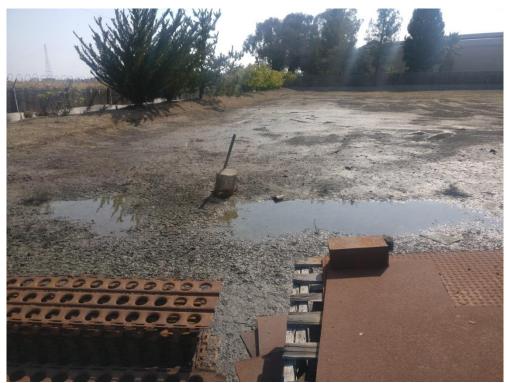
Langan observed a storm drain in the northeastern portion of the site. This storm drain collects surface water from this area during low tide and during periods of rain and drains into the ditch north of the site (Figure 2).

Photograph 10: Undeveloped area, shows surface water ponding due to high tide. Surface water drain in the center of the picture (facing northeast).

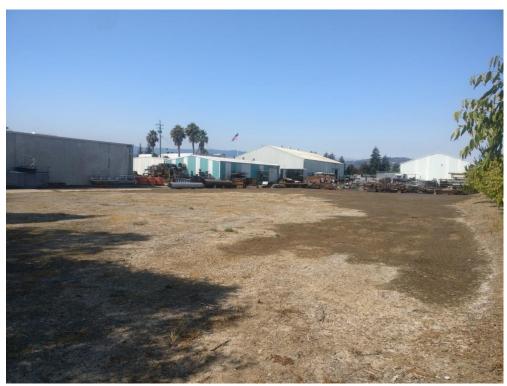
The site is occupied by Alan Steel and Supply Company and is comprised of four single-story warehouse-like structures, with no basements. The outside yard contains storage structures for metal products such as pipes, sheets and other pieces of scrap metal of various sizes. Salt water intrusion was observed in the northeastern portion of the site.

Photograph 11: View of undeveloped land in the northeastern portion of the site (facing southwest).

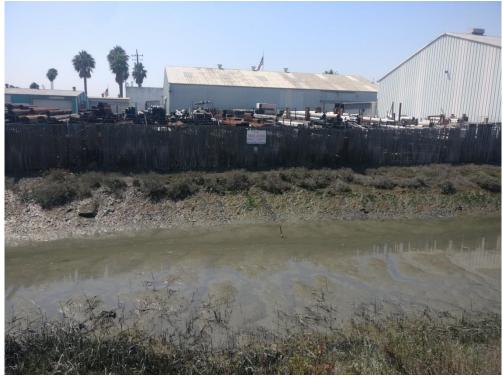
Photograph 12: View of the ditch north of the site during low tide (facing south).

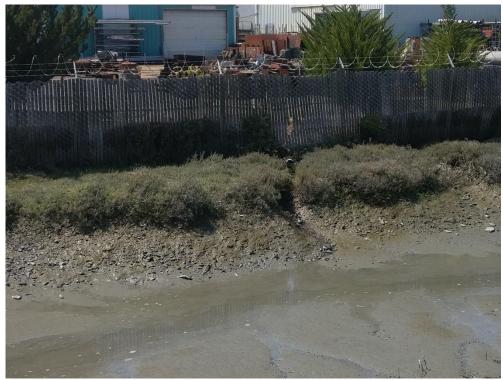
Photograph 13: Close up of the drain PVC pipe outfall in the ditch (facing south).
