**WETLAND DELINEATION
FOR THE
±3.52-ACRE MORROW LANE STUDY AREA
CITY OF CHICO, BUTTE COUNTY, CALIFORNIA**

APRIL 2020

WETLAND DELINEATION FOR THE ±3.52-ACRE MORROW LANE STUDY AREA

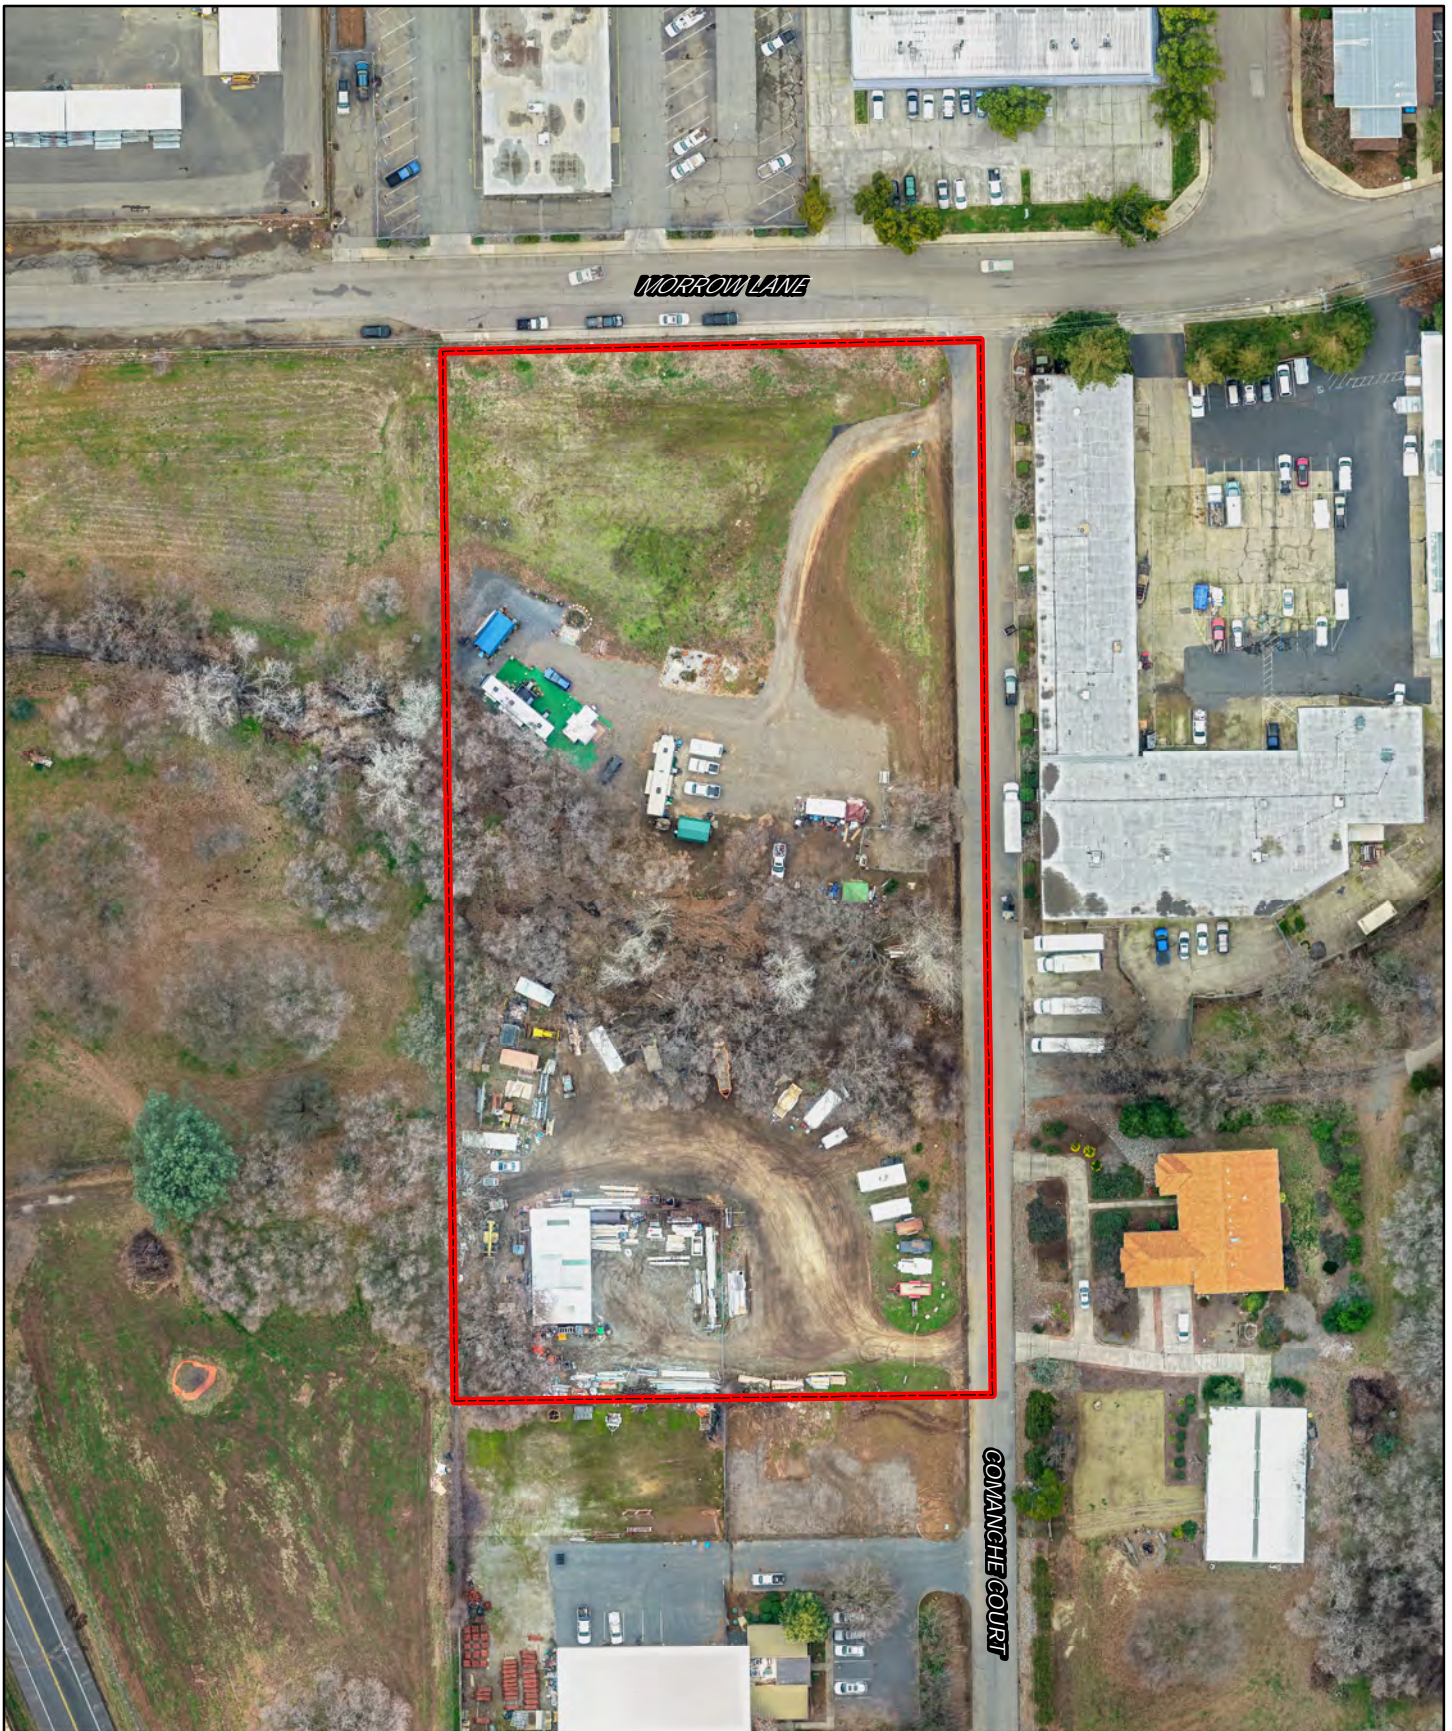
Study Area
(±3.52 acres)

The site occurs on the valley floor of the northeast edge of Sacramento Valley, directly west of the northern Sierra Nevada mountain range. It is situated near the southeastern edge of the City of Chico, approximately 400 feet northeast of Highway 99 (HWY 99). The site is in a suburban extension surrounded by agricultural land to the southwest and undeveloped land to the northeast. Warehouses and commercial/industrial properties are located north, south, and west of the site within the immediate vicinity, while property directly to the east is mainly suburban residential. The site is mostly flat, with elevations ranging from approximately 220 feet near the northwest corner to 225 feet at the southwest corner (Figure 2).

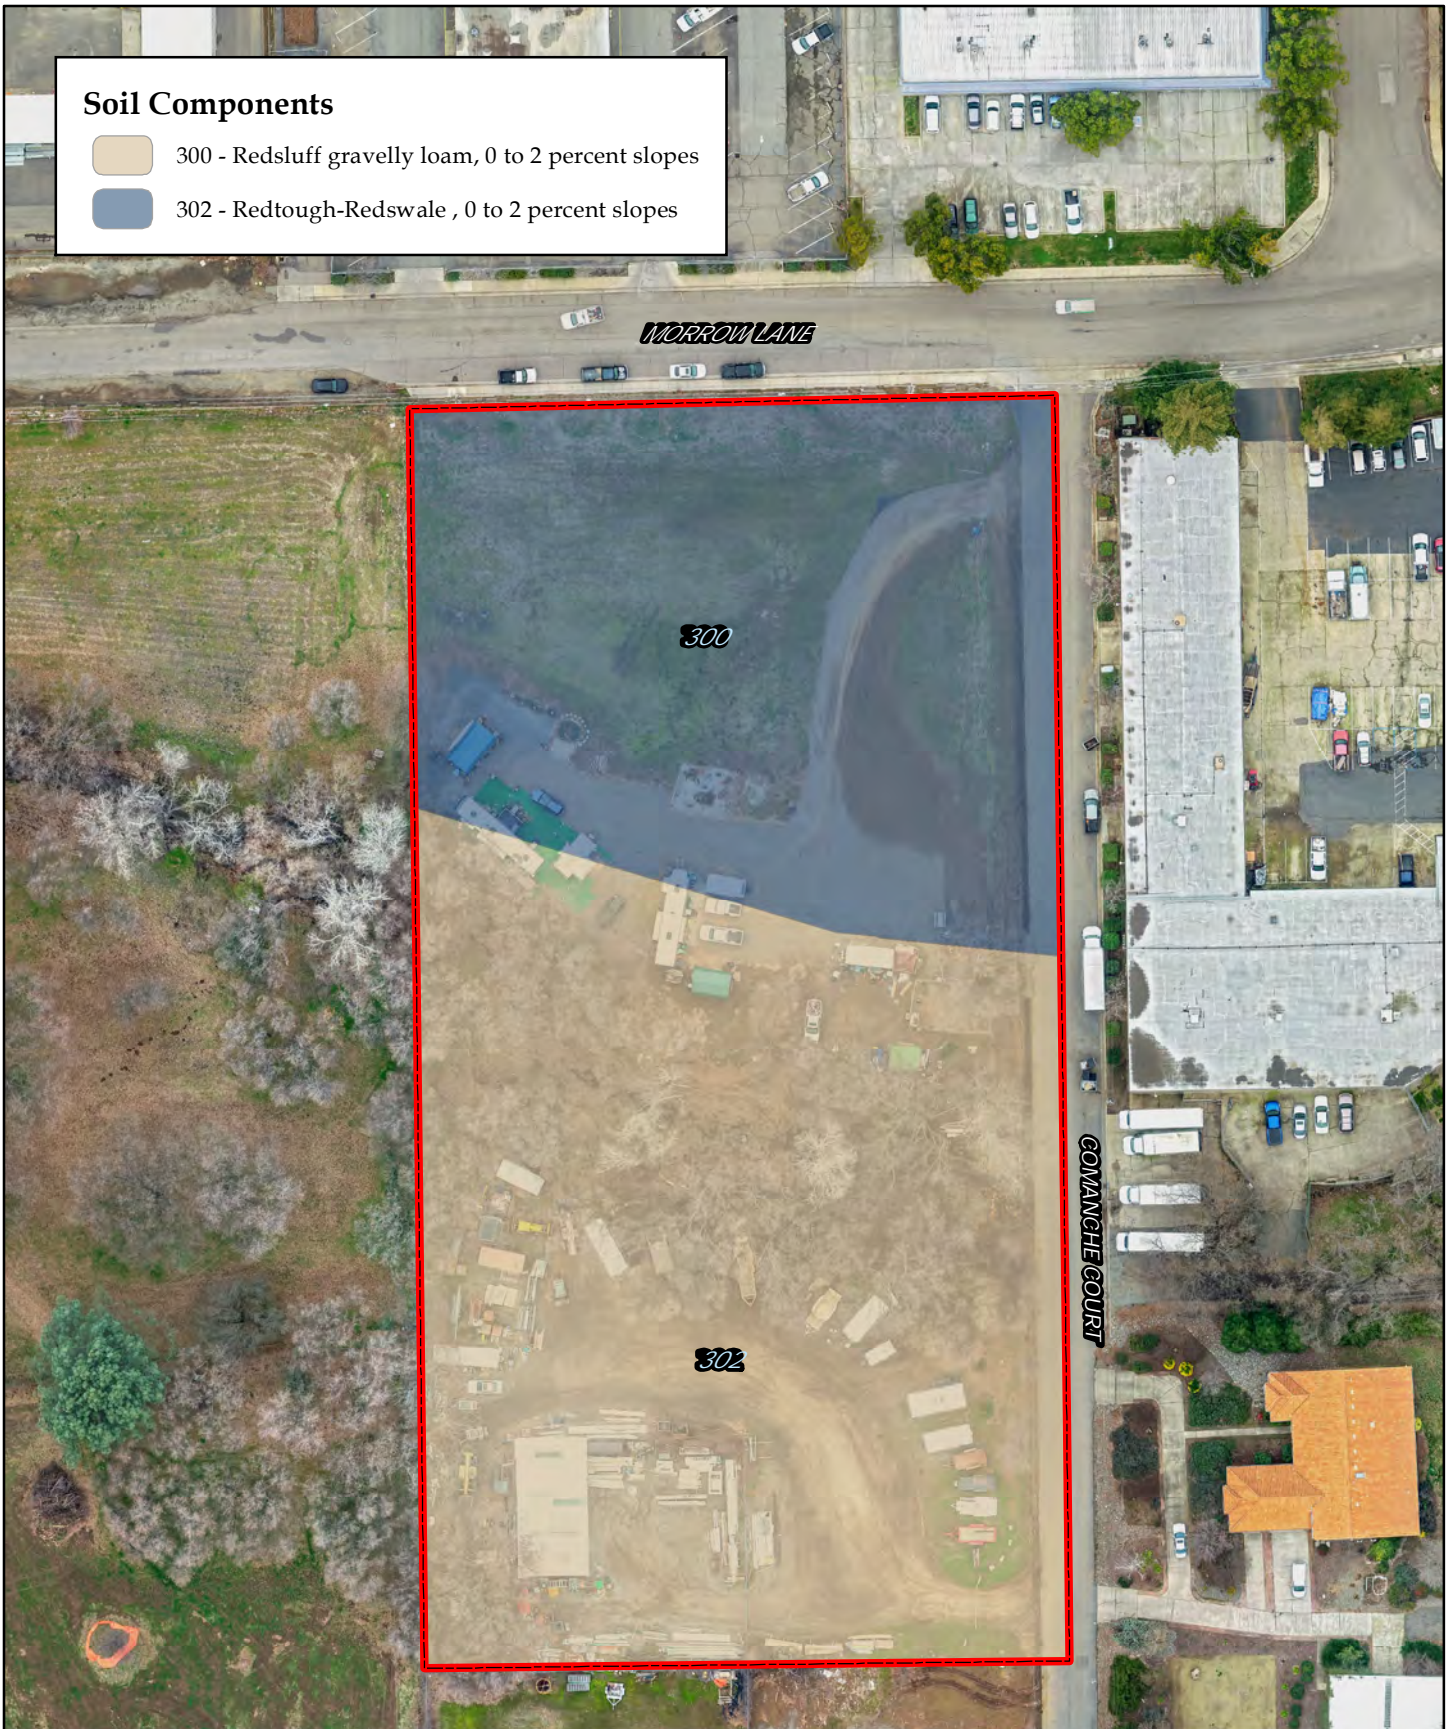
Figure 3

Two soil units have been mapped within the study area: Redsluff gravelly loam, 0 to 2 percent slopes, and Redtough-Redswale, 0 to 2 percent slopes. The components of each complex are described below.

300 - Redsluff gravelly loam, 0 to 2 percent slopes
-

302 - Redtough-Redswale, 0 to 2 percent slopes

SOIL COMPONENTS

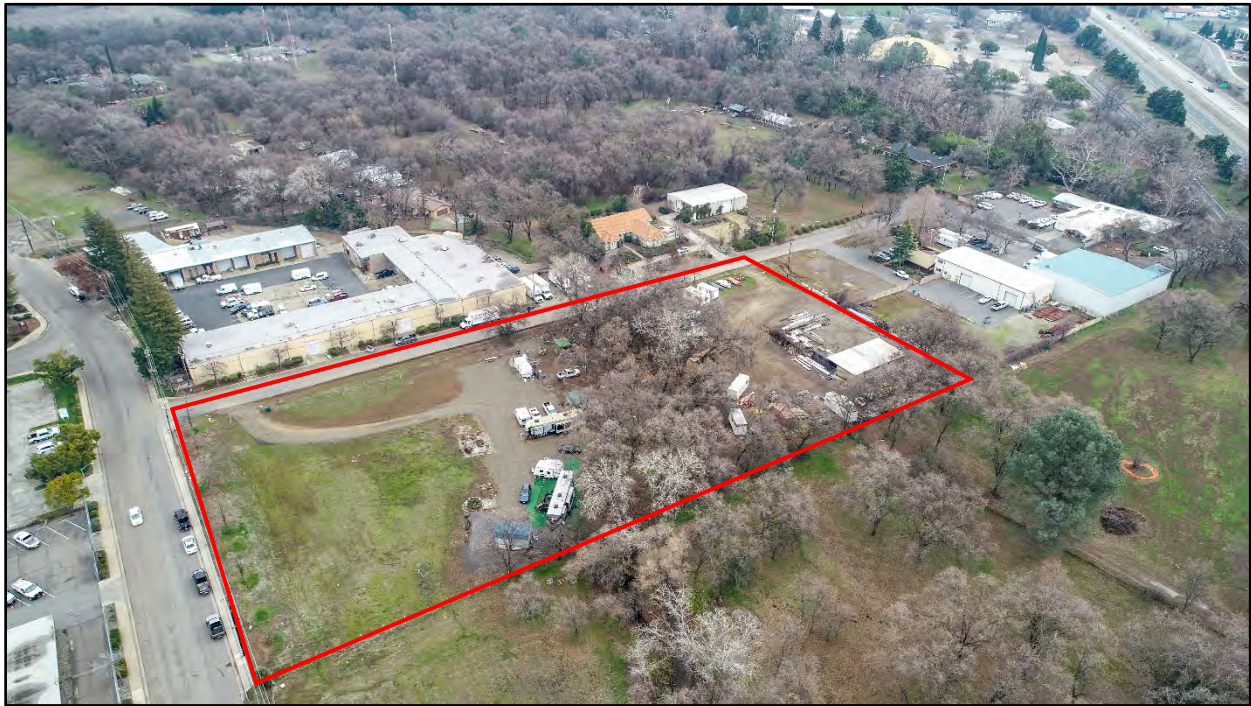
Looking southeast over study area and wetland swale. *Photo Date 01-20-20.*

A majority of the study area (approximately 2.5 acres in the northern and southern portions) is ruderal. Ruderal habitats are areas of ongoing disturbed ground (such as dirt roads, areas of general vehicular use, and residential and storage areas) dominated by weedy annual species adapted to disturbance. Common species throughout the ruderal areas include Italian ryegrass (*Festuca perennis*), ripgut grass (*Bromus diandrus*), soft chess (*Bromus hordeaceus*), rose clover (*Trifolium hirtum*), dove’s foot geranium (*Geranium molle*), turkey mullein (*Croton setiger*), curly dock (*Rumex crispus*), prickly lettuce (*Lactuca serriola*), ruby sand-spurrey (*Spergularia rubra*), and yellow starthistle (*Centaurea solstitialis*) (Figure 4a).

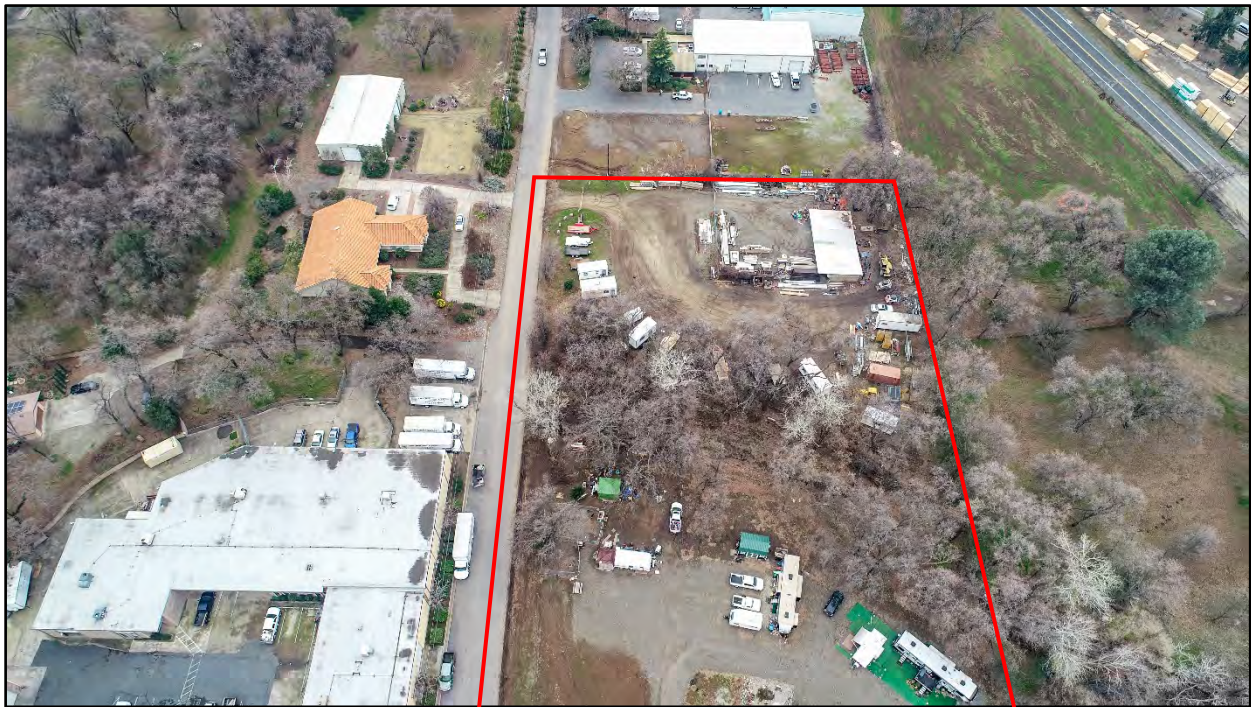
Looking south over study area and wetland swale. *Photo Date 01-20-20.*

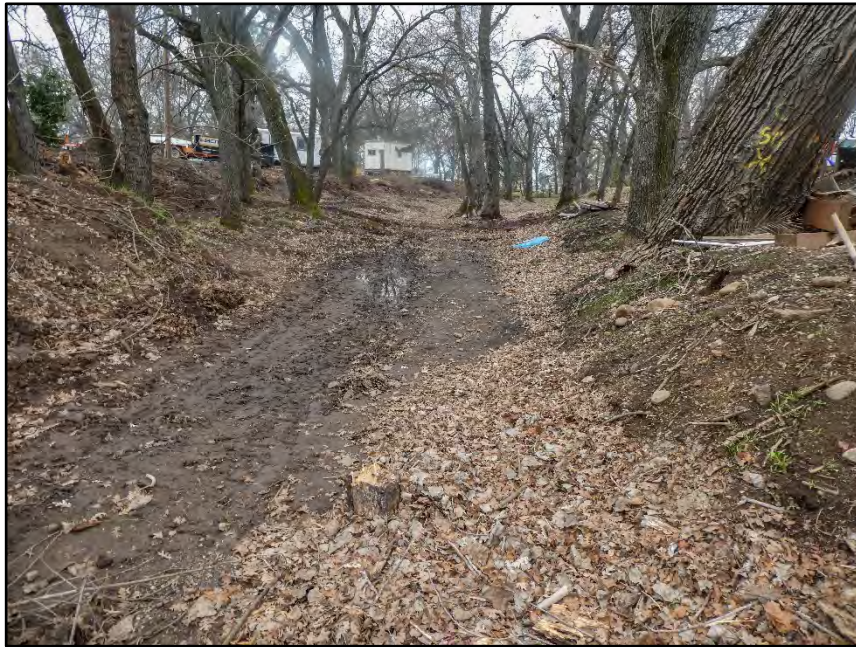
Looking west along the wetland swale and oak woodland from Comanche Court. *Photo Date 01-20-20.*

Approximately 0.083 acre of potential waters of the U.S. have been identified on the site in the form of an ephemeral stream. This feature bisects the center of the study area from east to west. The drainage is part of a minor tributary to Comanche Creek that begins approximately 0.6 mile east of the study area. Water enters the swale through two culverts under Comanche Court at the study area's eastern boundary. Water moves northwesterly across the study area and to the west.

The drainage is a remnant of a larger stream that existed before the area was developed decades ago. There is still a minimal amount of water that flows through it during high precipitation events but appear to be dry for most of the time. During the delineation in January, there was no evidence of recent flows although some shallow puddling was present from recent rains. The surface of the drainage is dense with decaying leaf litter and fine sediment. Digging through the litter reveals a very rocky substrate. Soils do not show redoximorphic features and there was virtually no vegetation growing in the channel. This feature therefore does not meet the three criteria for a wetland and is considered an ephemeral stream. The thalweg of the drainage is just under 300 feet long (Figures 4b and 4c).

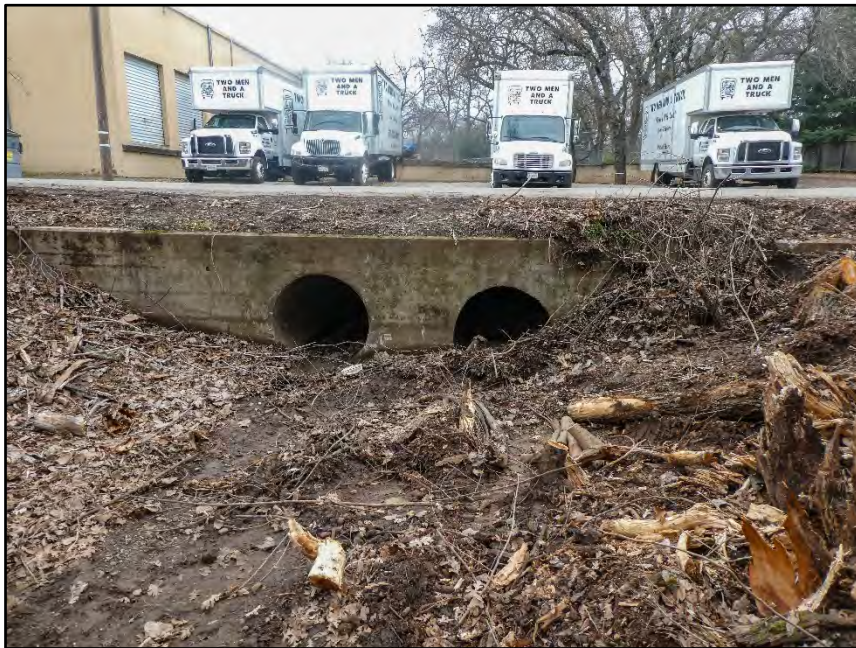
Water enters the swale through two culverts underneath Comanche Court at the study area's eastern boundary. *Photo Date 01-20-20.*

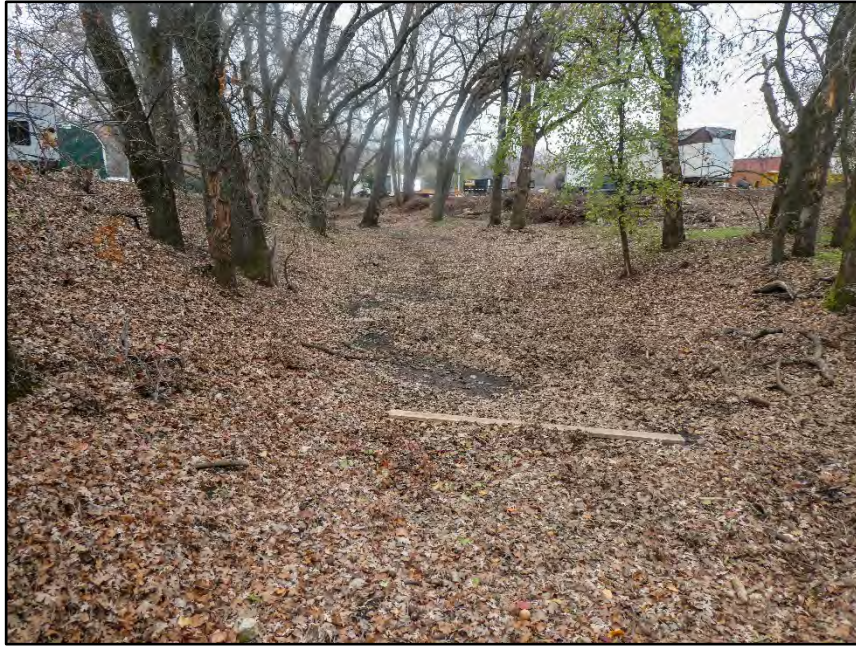
Looking east along the wetland swale and oak woodland from the western boundary. *Photo Date 01-20-20.*

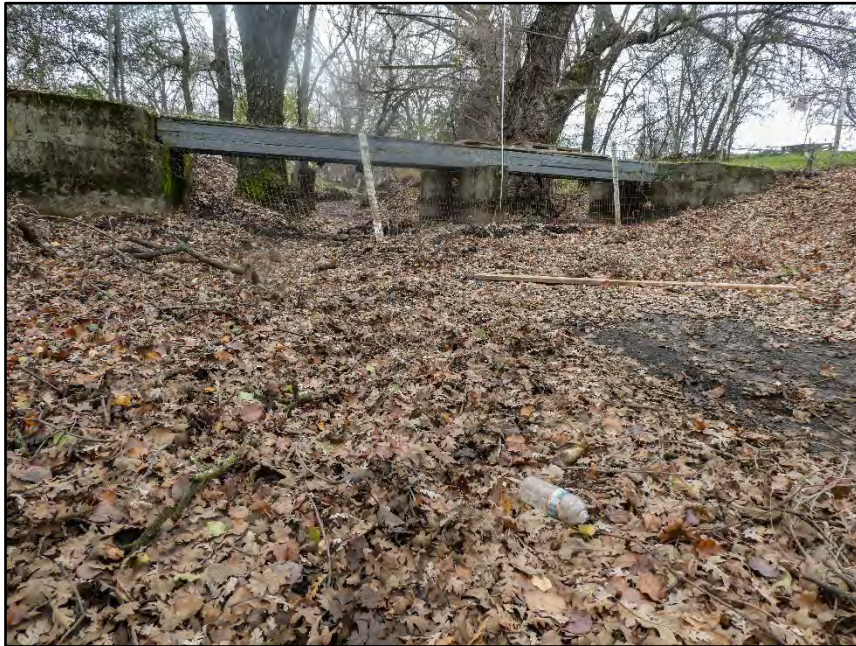
View of a remnant pedestrian crossing where the wetland swale exists the study area along the western boundary. *Photo Date 01-20-20.*

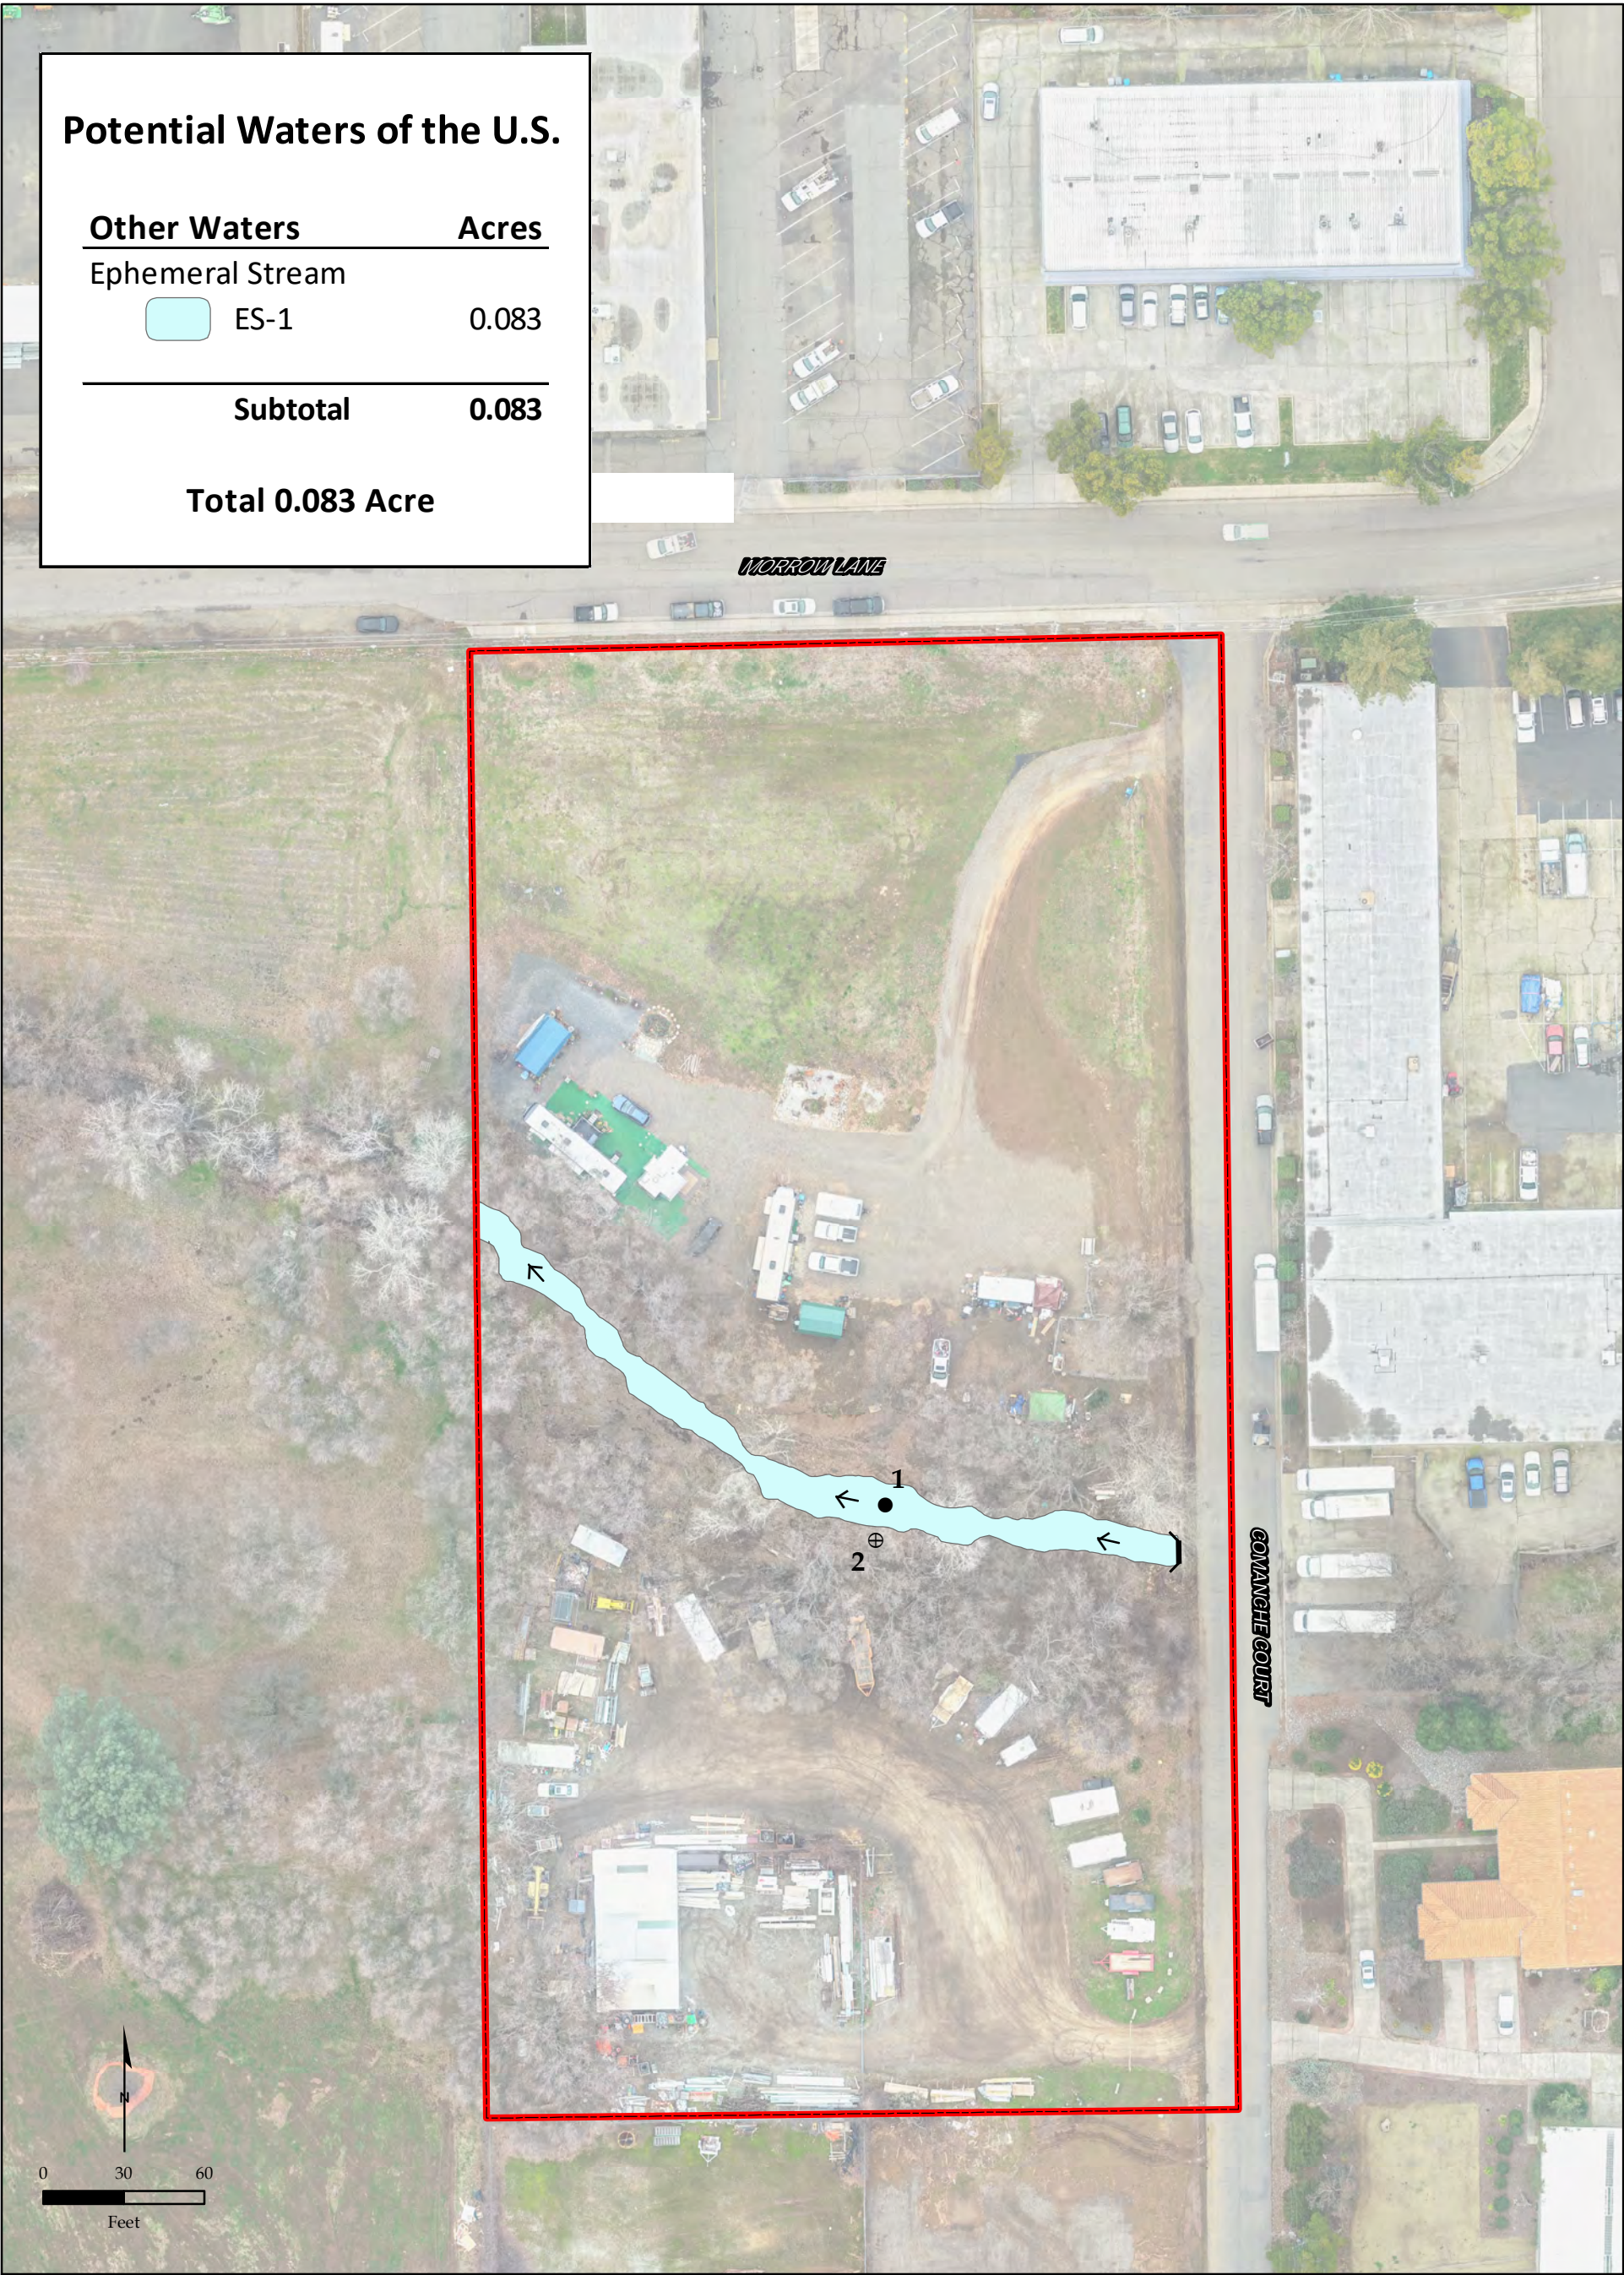
One category of potential waters of the United States have been mapped on the study area: ephemeral stream. Figures 4b and 4c show representative site photographs; Figure 5 is the wetland delineation map.

Potential Waters of the U.S.	
Other Waters	Acres
Ephemeral Stream	
<div>ES-1</div>	0.083
<hr/>	
Subtotal	0.083
<hr/>	
Total 0.083 Acre
