## FINAL INITIAL SITE ASSESSMENT

**Road 66B over Colusa Drain Bridge Replacement**  
**Glenn County, California**  
Existing Bridge 11C-0068  
Federal ID BRLO-5911(063)

13 June 2019  
Job No. 16-322.1

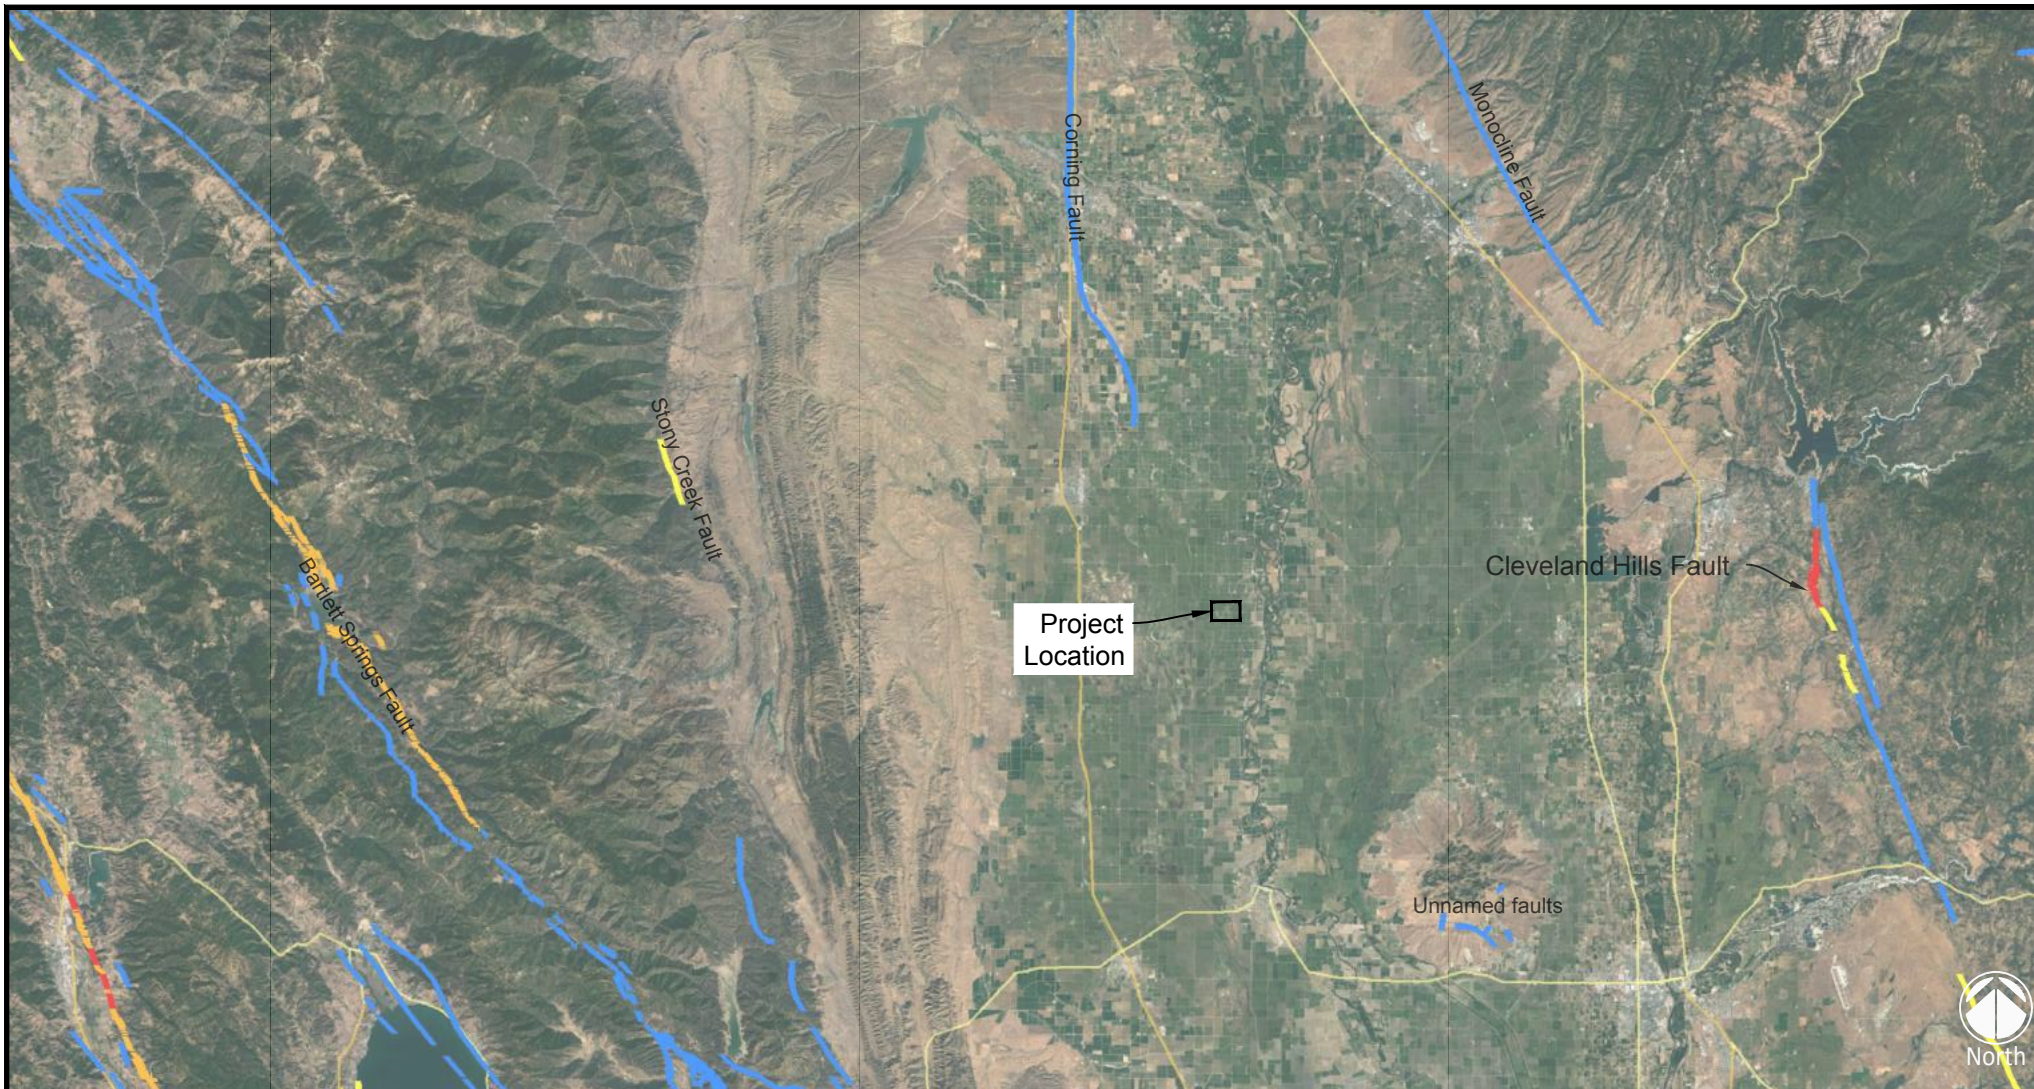
Figure 3  
Fault Activity Map

No faults have been mapped in the project site vicinity. Based on mapping from the US Geological Survey<sup>3</sup> the nearest faults are the Great Valley Thrust Fault system 12.8± miles to the west and the Corning Fault 10.8 to the north-northwest, both of undifferentiated Quaternary age. The site is not included within an Alquist-Priolo Special Studies Zone.<sup>4</sup> A Fault Map (Figure 3) is included in Appendix A.

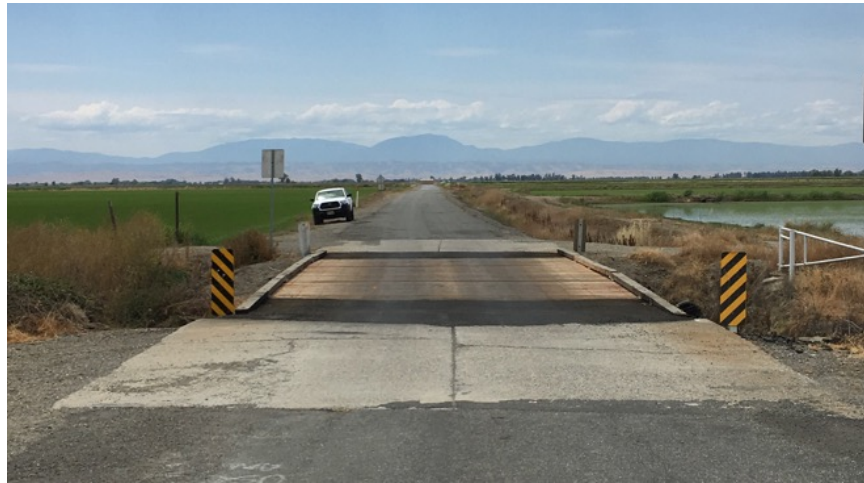
Mr. Carter observed that the bridge comprises a three-span timber structure supported by concrete abutments and piers on concrete piles (photos 1 through 5 and 8). Water in the canal was flowing toward the south. Steel jackets are visible at the base of the piles above the water line (photo 5). The bridge deck is constructed of wooden structural members, wooden decking, and a wooden curb. This wood appears new and lacks the color and dimpling typical of pressure-treated wood (photos 8 and 9). No guard rails are present on the bridge or bridge approaches. Concrete approach aprons are present on both sides of the bridge. CR 66B is asphalt-paved on both sides of the bridge. There is no centerline or fog line striping present.

**Photo 1 – CR 66B bridge over Colusa Drain. Viewed west.**

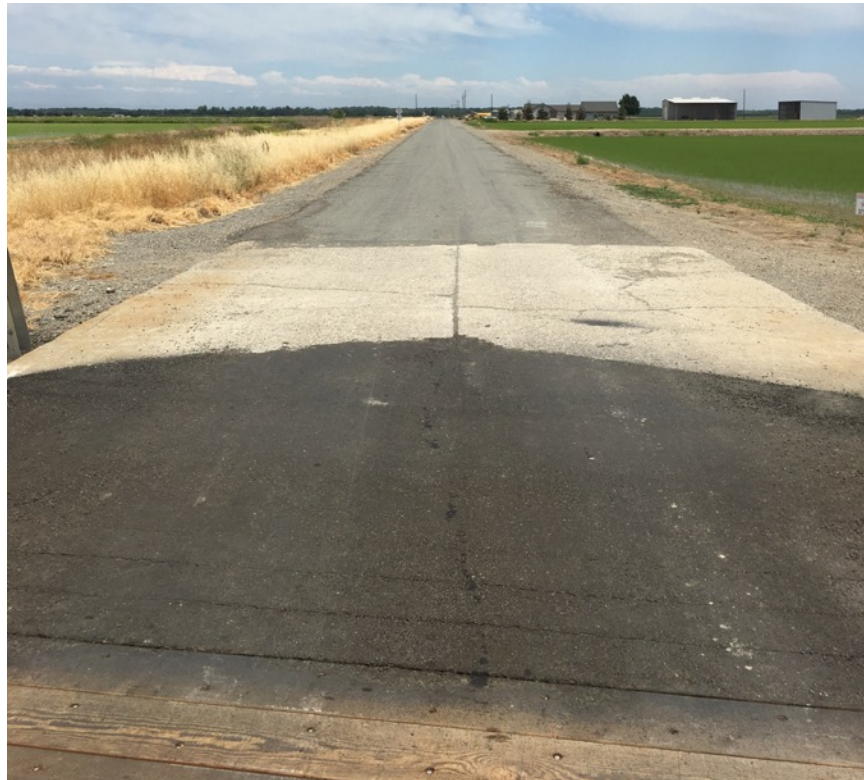
**Photo 2 – CR 66B looking east from Colusa Drain bridge.**

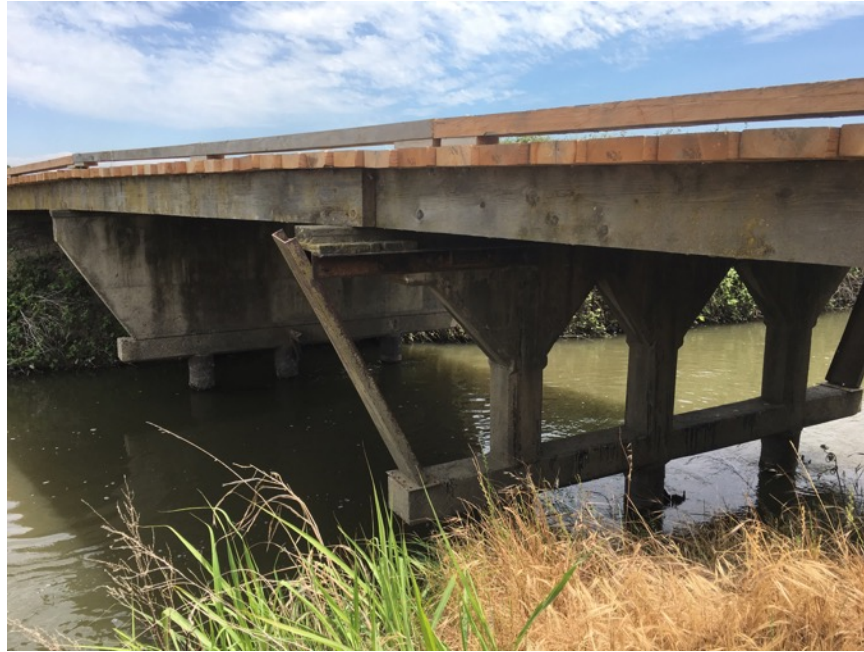
**Photo 3 – View of bridge from the north side. Viewed southeast.**

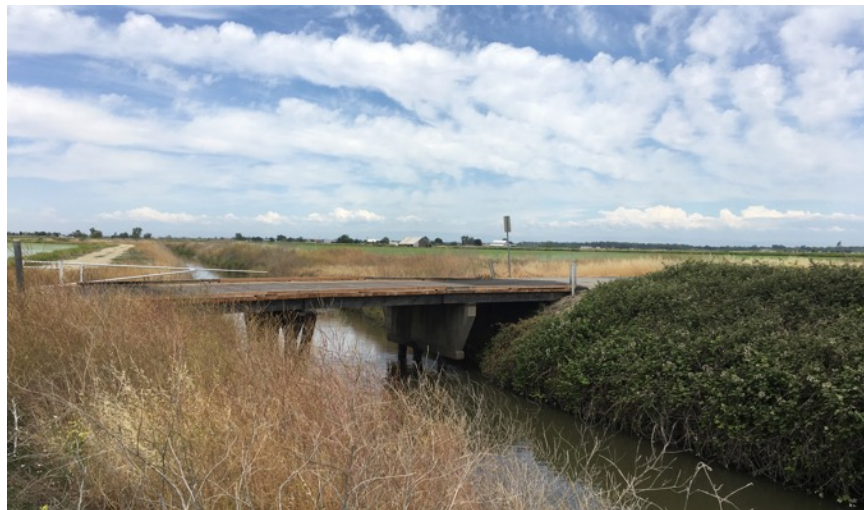
**Photo 4 – View of bridge from the south side. Viewed north-northeast.**

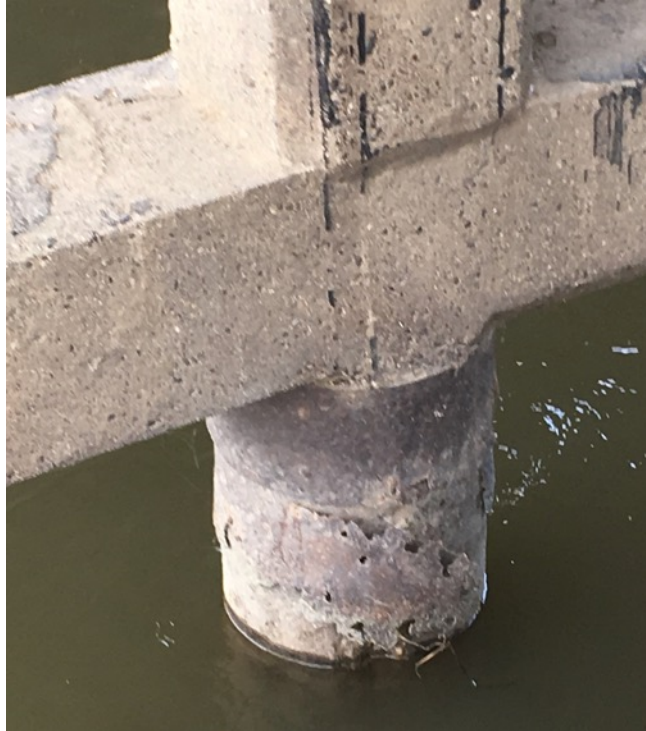
The existing bridge, built in 1940, is a three-span structure comprising a timber deck with timber girders on framed reinforced concrete bents founded on cast-in-steel-shell piles with reinforced concrete sill abutments. The bridge is approximately 54 feet long, 20 feet wide, and skewed about 10 degrees to the channel. The steel shell piles are severely corroded and the bridge is deemed Structurally Deficient by Caltrans.

**Photo 5 – Corroded steel jacketing on pile (western pier).**

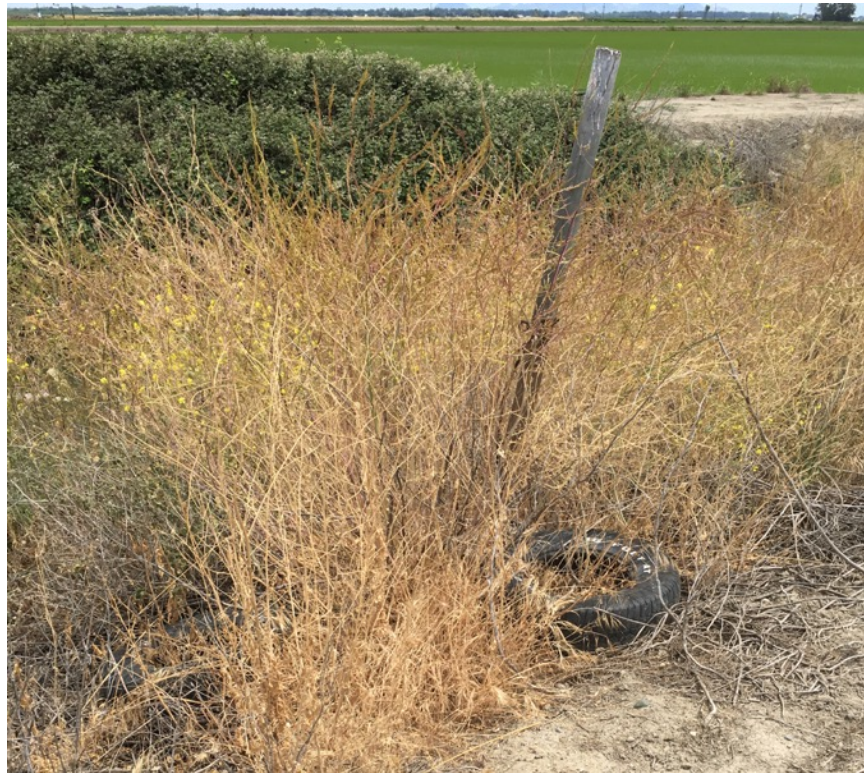
Vegetation observed in Colusa Drain (weeds and vines) and adjacent to CR 66B (weeds) appeared seasonally healthy. Several tires were observed near the southwest corner of the bridge on APN 013-250-037 adjacent to Colusa Drain (photo 6). No utility boxes, wires, pipes, subgrade vaults, or manhole covers were observed in the project site vicinity. Wells, mining activities, oil and gas drilling and production equipment, pits, lagoons, hazardous materials containers, wells, rock outcrops, or indications of NOA were not observed within or in the vicinity of the APE. Evidence of vehicle repair operations or storage of petroleum motor fuels or agricultural chemicals

**Photo 6 – Tires at southwest corner of bridge (APN 013-250-037).**

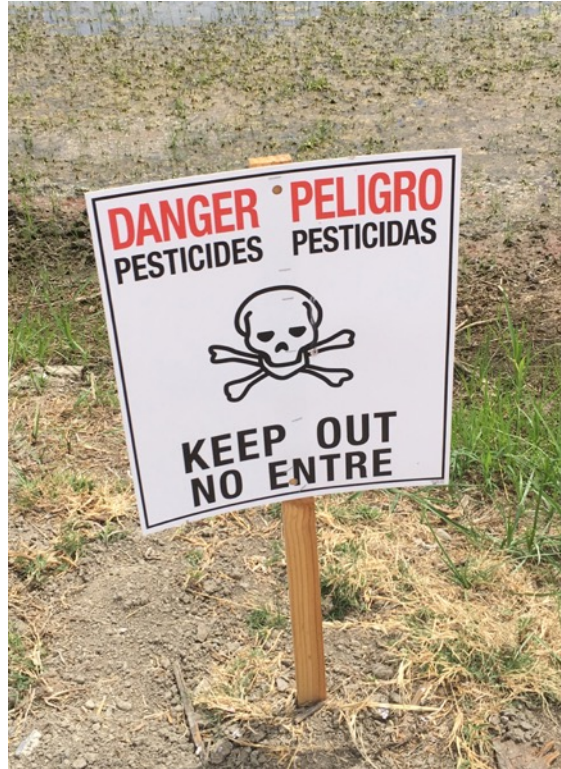
A new sign indicating the presence of pesticides in the rice field was observed at the southwest corner of the bridge (APN 013-250-021; photo 7).

Properties surrounding the project site are currently utilized for rice cultivation and have been throughout the historical period examined for this assessment. Agricultural chemicals are typically applied to rice fields; a sign indicating the presence of pesticides was observed within the APE. Discussion with the University of California Agricultural Extension indicated applied agricultural chemicals were likely herbicides, although may also have included pesticides and/or fungicides. The likely herbicide application method of the herbicide would have been granules applied by aircraft; this application method may have resulted in impact to the project site. The potential for agricultural chemicals in the soil and surface water within the APE constitutes a REC.

Photo 7 – Sign at southeastern corner of bridge (APN 013-250-021).

CAInc recommends that soil within the proposed construction limits be screened for the presence of agricultural chemicals at concentrations sufficient to be an exposure hazard. Water from the rice fields is carried by the adjacent drainage canals and Colusa Drain. Surface water within the APE should also be screened for agricultural chemicals as workers within Colusa Drain are likely to come in contact with Colusa Drain water during demolition and construction activities. Percolation of impacted surface water may also have impacted shallow groundwater; if excavation for the new bridge abutments encounters groundwater, this should also be screened for agricultural chemicals. If soil generated by excavation activities will be hauled for off-site disposal, the receiving facility may also require analysis of the spoils for agricultural chemicals as part of the disposal characterization process.

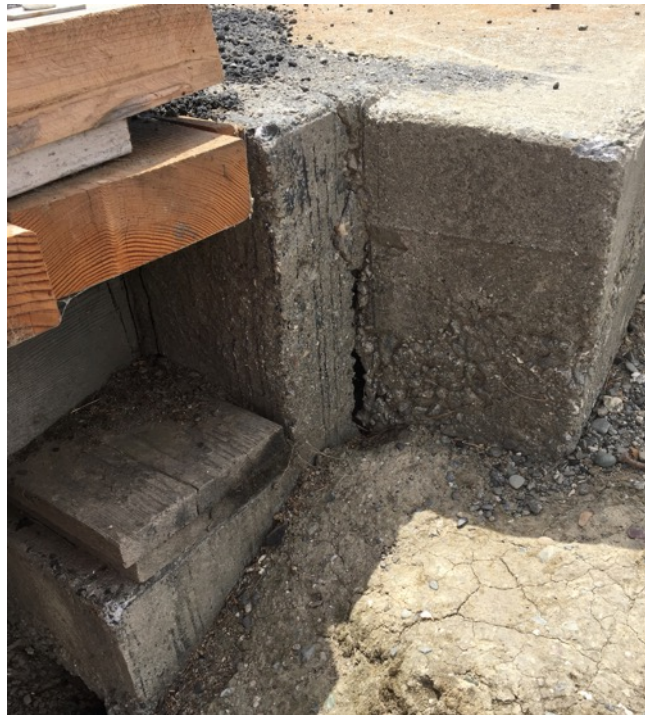
Photo 8 – Abutment, northwest corner of bridge.

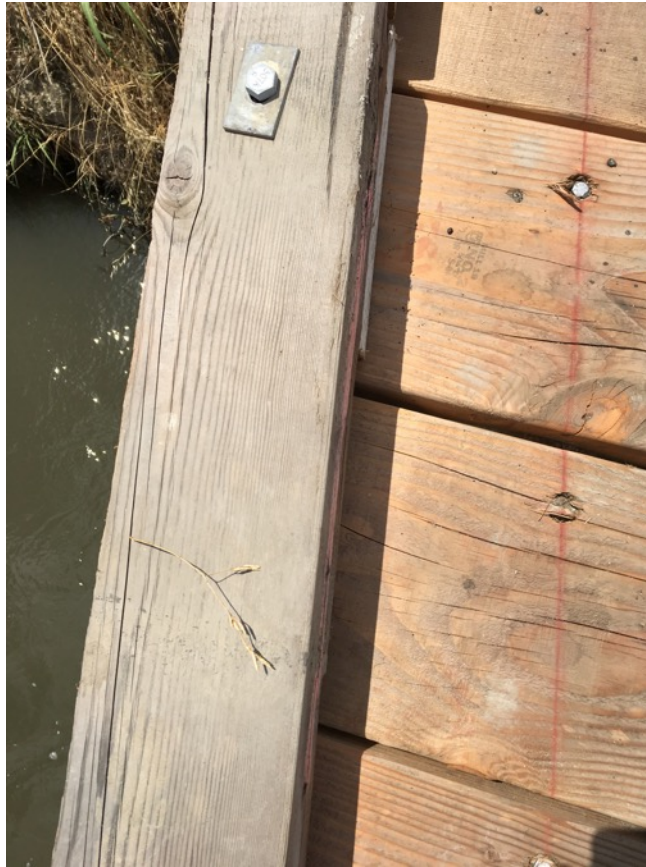
Chemically treated wood was not observed at the project site. Wood used for the bridge decking and support beams appeared new and does not have the dimpling and green color typical of pressure-treated wood. Special handling and disposal of this wood is not required. If chemically treated wood is encountered in parts of the bridge that could not be observed during site reconnaissance (e.g. sole plates on the piers or abutments), this would will need to be handled and disposed of as TWW.

**Photo 9 – Wooden decking and curb rail.**
