**GEOTECHNICAL INVESTIGATION
MAPLE CANYON SEDIMENT PLACEMENT SITE
BIG TUJUNGA RESERVOIR SEDIMENT REMOVAL PROJECT**

**GEOTECHNICAL INVESTIGATION
MAPLE CANYON SEDIMENT PLACEMENT SITE
BIG TUJUNGA RESERVOIR SEDIMENT REMOVAL PROJECT
PROJECT ID WRDD000028 (PROJECT NO. HF00710003)**

**GEOTECHNICAL INVESTIGATION
MAPLE CANYON SEDIMENT PLACE SITE
BIG TUJUNGA RESERVOIR
SEDIMENT REMOVAL PROJECT**

**ANGELES NATIONAL FOREST
UNINCORPORATED LOS ANGELES COUNTY**

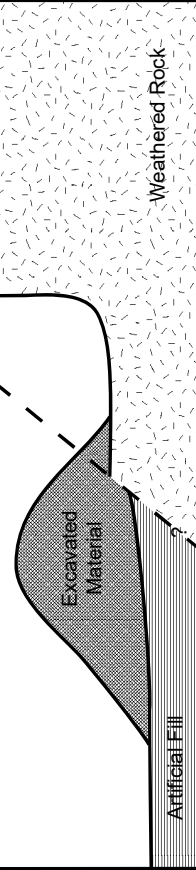
Trench 17

Weathered Rock: Granitic, light brown, small gravel- to cobble-sized clasts, moderately hard, breaks in hand, highly fractured.
