Aquatic Resource Delineation Report

99W/South Main Street Reconstruction Project Tehama County, California

Tehama County Public Works

99W/South Main Street Reconstruction Project Aquatic Resource Delineation Report

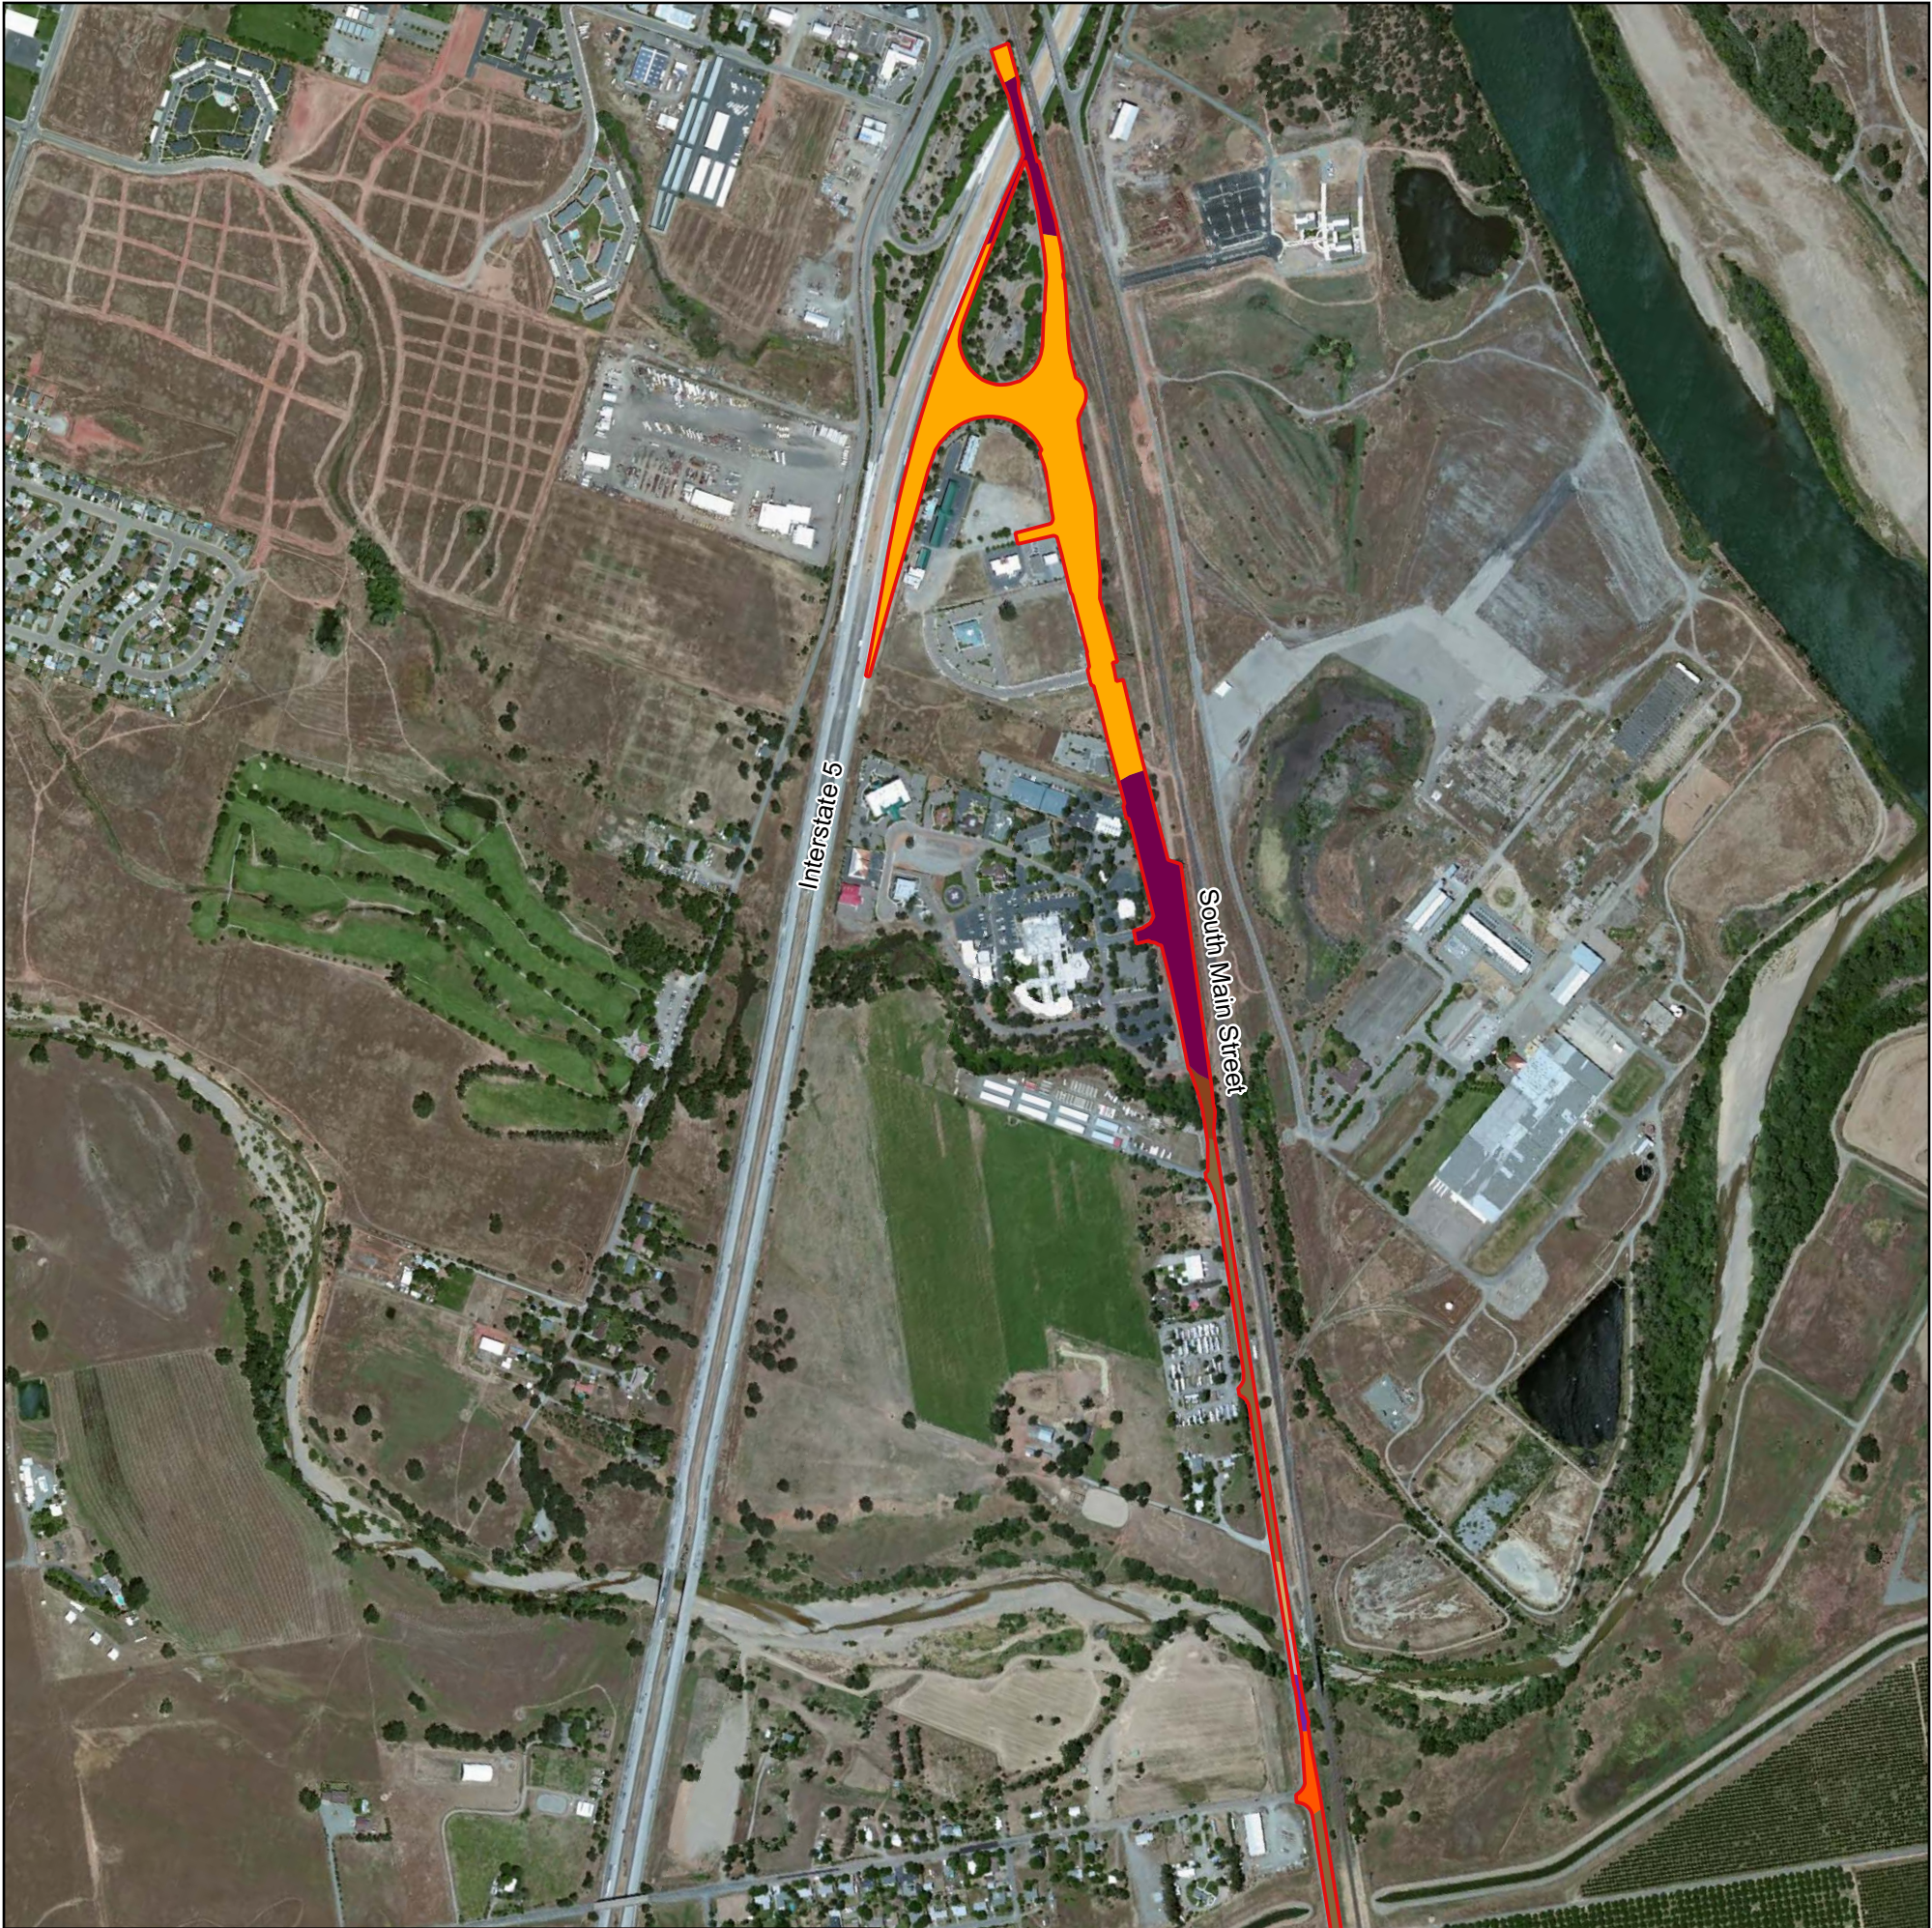
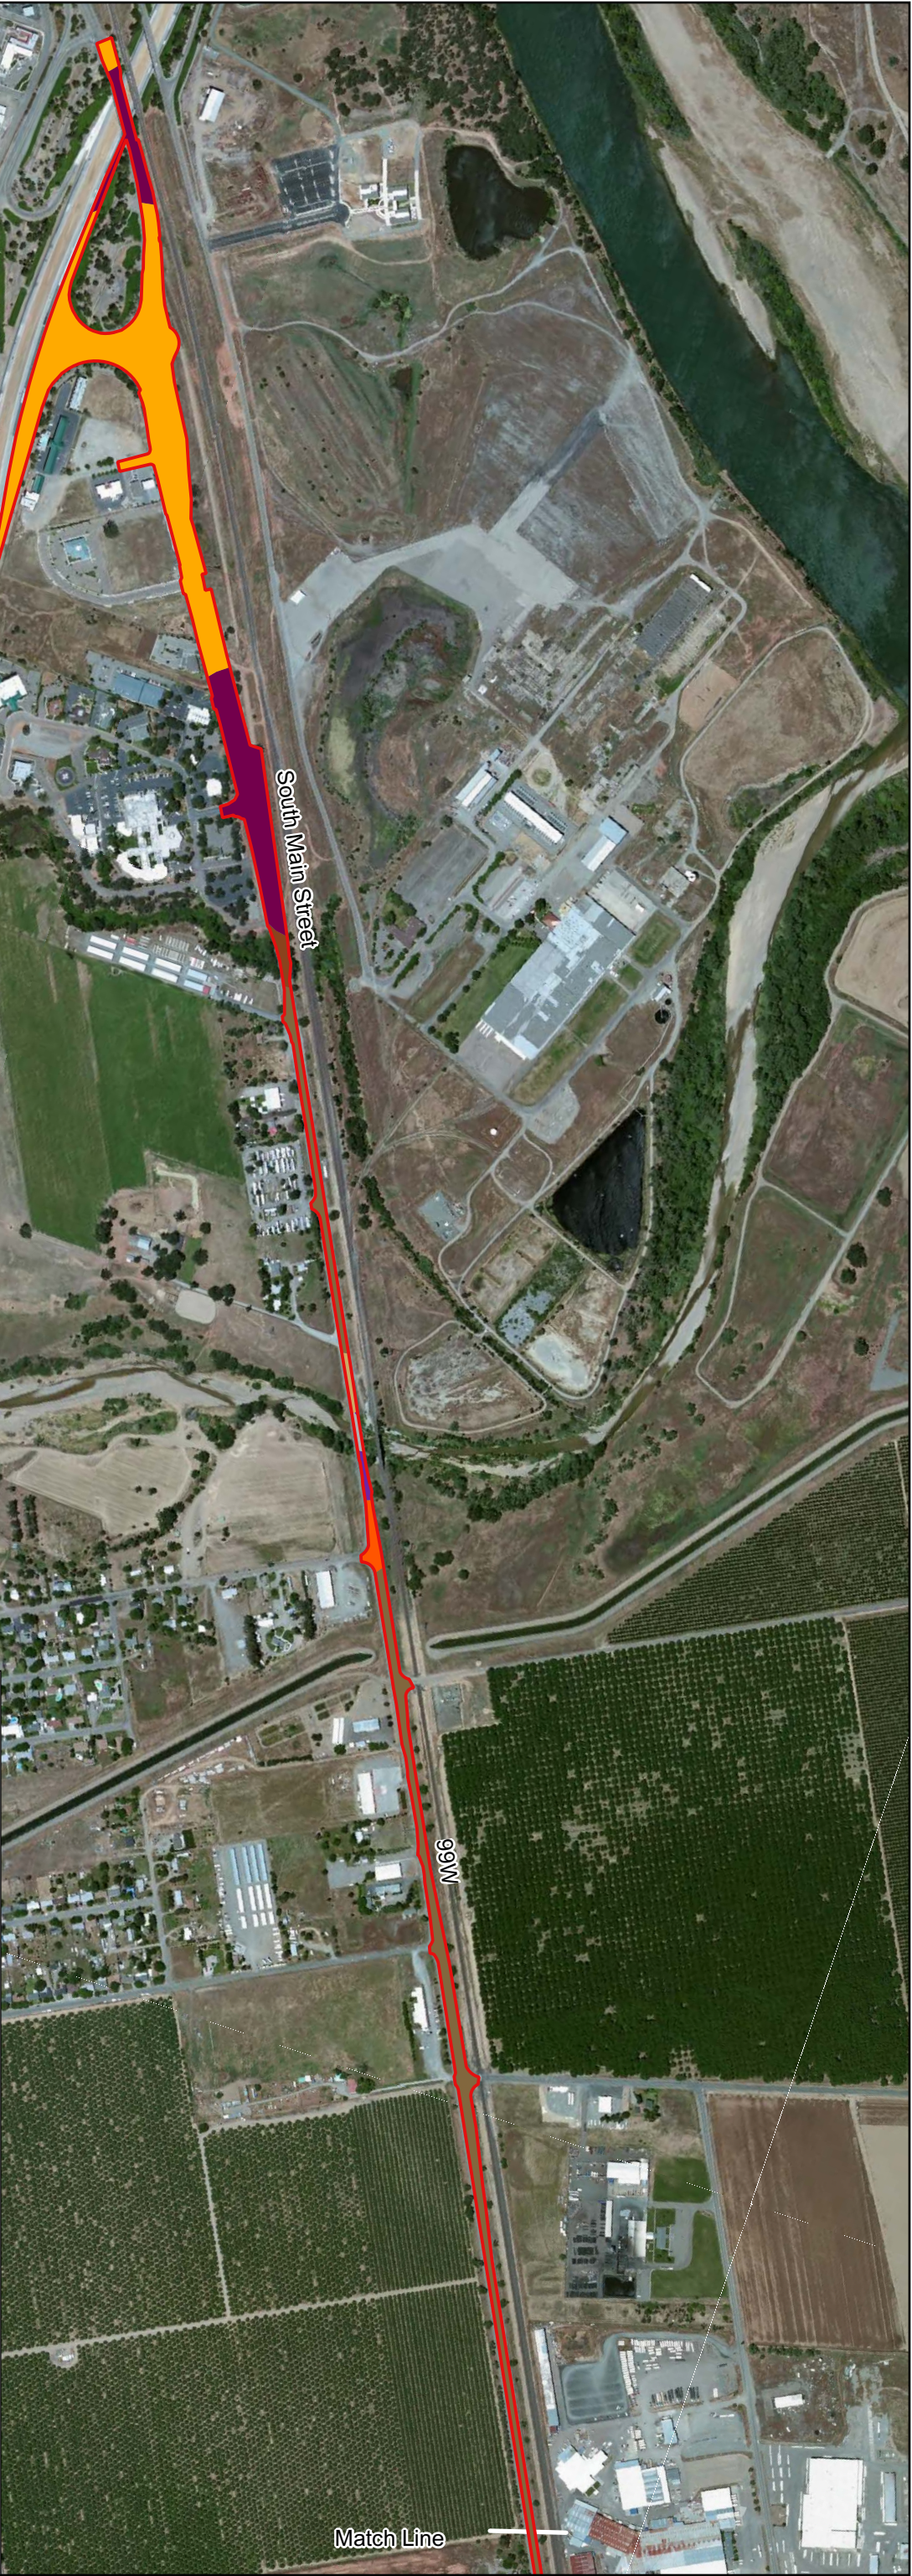
Figure 2
Project Soils

According to the U.S. Department of Agriculture, Natural Resources Conservation Service (NRCS, 2020), 27 soil units have been mapped within the study site (**Table 1**). Two soil units, Clear Lake clay and riverwash are considered hydric, while ten soil units may contain hydric inclusions. A soils map is provided in **Figures 2-4 (Appendix A)**.

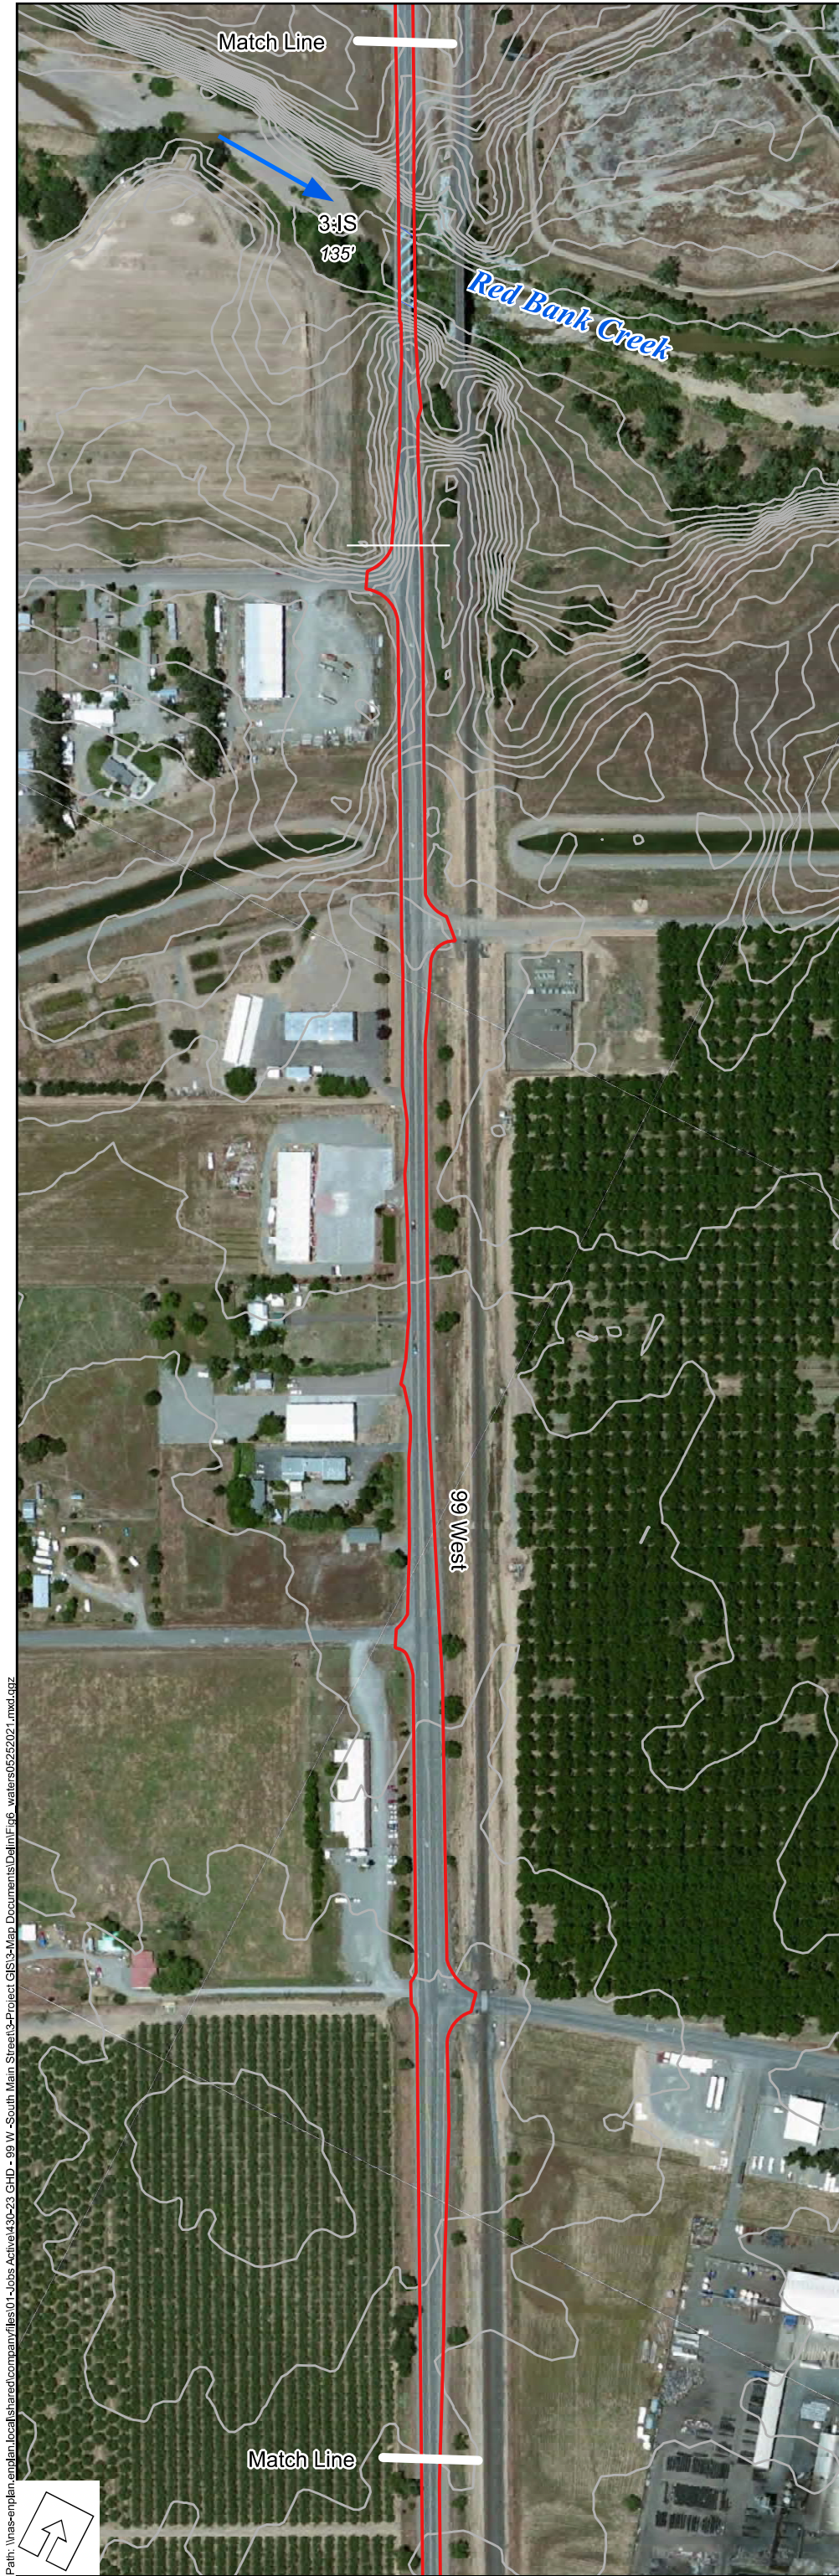
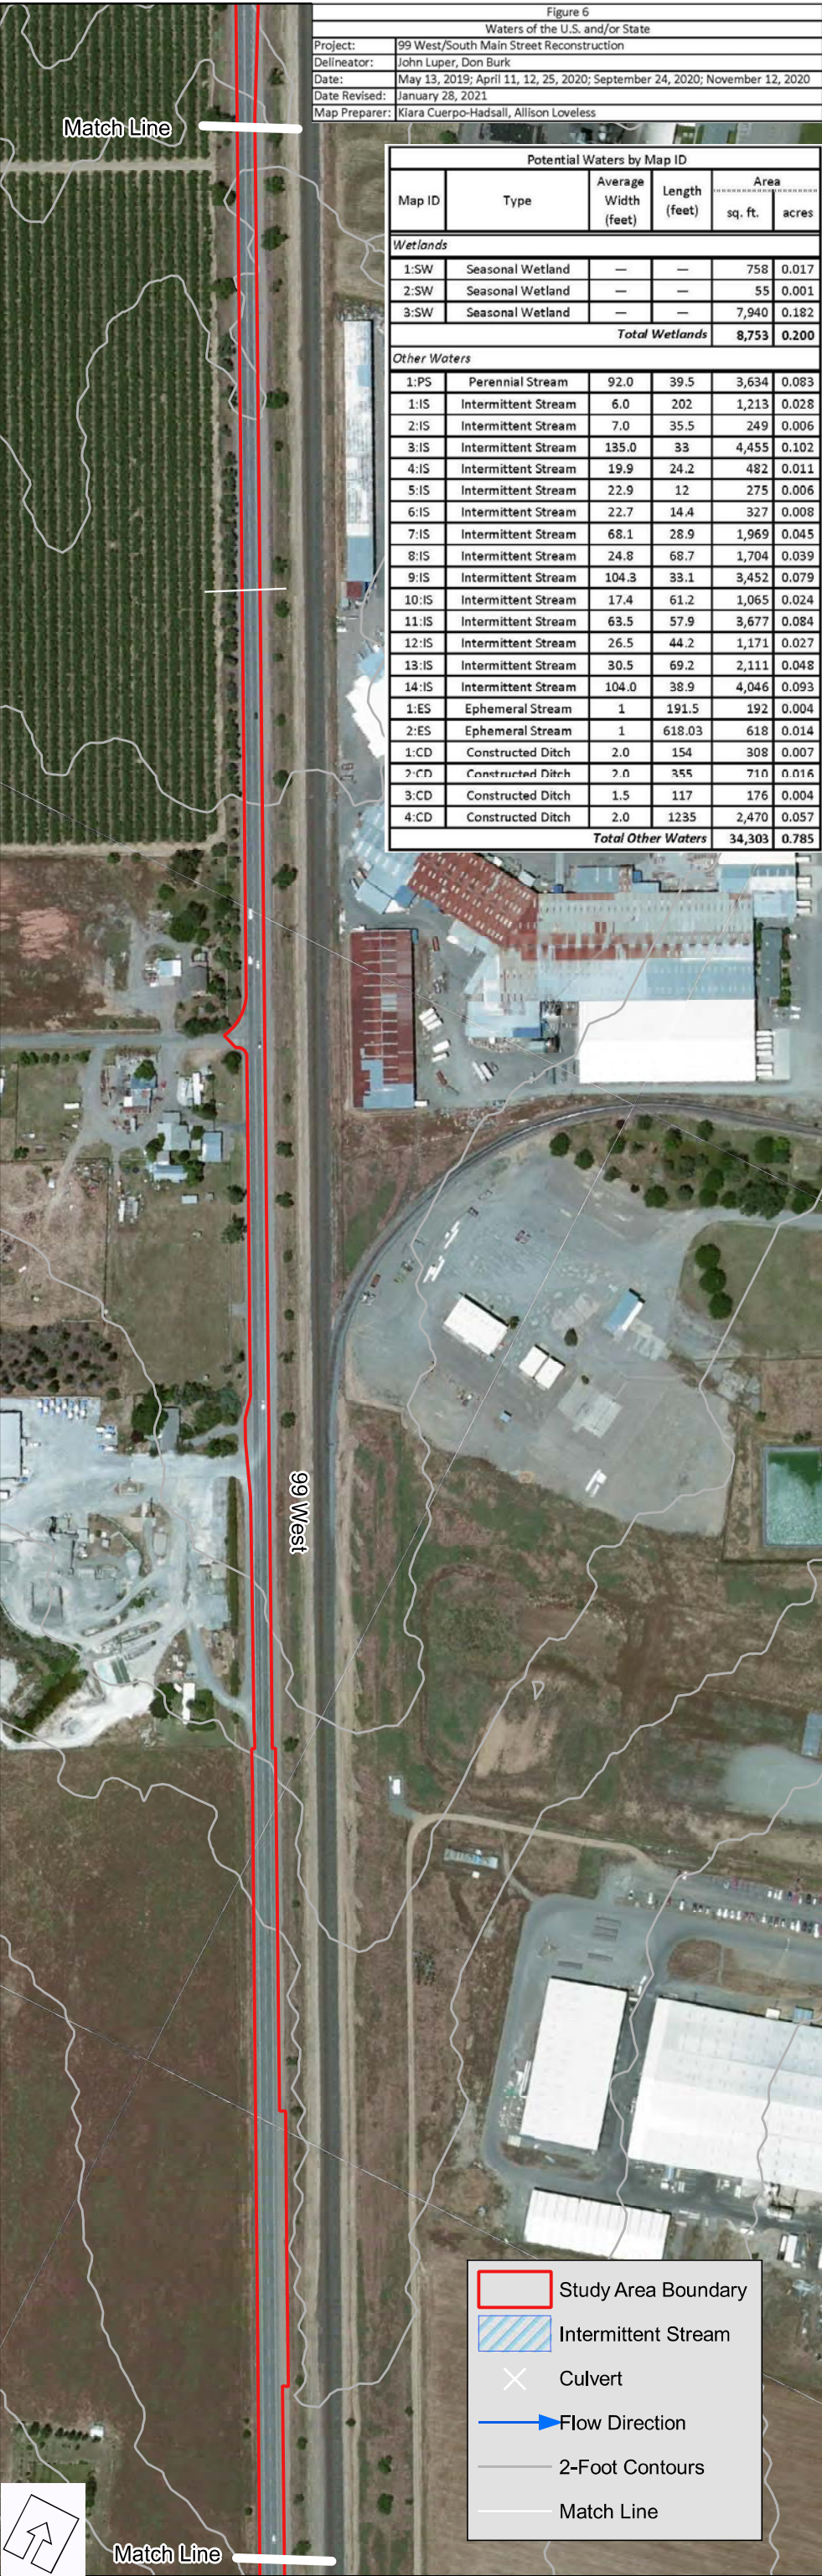
Figure 7	
Waters of the U.S. and/or State	
Project:	99 West/South Main Street Reconstruction
Delineator:	John Luper, Don Burk
Date:	May 13, 2019; April 11, 12, 25, 2020; September 24, 2020; November 12, 2020
Date Revised:	January 28, 2021
Map Preparer:	Klara Cuerpo-Hadsall, Allison Loveless

Potential Waters by Map ID					
Map ID	Type	Average Width (feet)	Length (feet)	Area sq. ft.	acres
Wetlands					
1:SW	Seasonal Wetland	—	—	758	0.017
2:SW	Seasonal Wetland	—	—	55	0.001

3:SW	Seasonal Wetland	—	—	7,940	0.182
Total Wetlands				8,753	0.200
Other Waters					
1:PS	Perennial Stream	92.0	39.5	3,634	0.083
1:IS	Intermittent Stream	6.0	202	1,213	0.028

2:IS	Intermittent Stream	7.0	35.5	249	0.006
3:IS	Intermittent Stream	135.0	33	4,455	0.102
4:IS	Intermittent Stream	19.9	24.2	482	0.011
5:IS	Intermittent Stream	22.9	12	275	0.006

6:IS	Intermittent Stream	22.7	14.4	327	0.008
7:IS	Intermittent Stream	68.1	28.9	1,969	0.045
8:IS	Intermittent Stream	24.8	68.7	1,704	0.039
9:IS	Intermittent Stream	104.3	33.1	3,452	0.079

10:IS	Intermittent Stream	17.4	61.2	1,065	0.024
11:IS	Intermittent Stream	63.5	57.9	3,677	0.084
12:IS	Intermittent Stream	26.5	44.2	1,171	0.027
13:IS	Intermittent Stream	30.5	69.2	2,111	0.048

14:IS	Intermittent Stream	104.0	38.9	4,046	0.093
1:ES	Ephemeral Stream	1	191.5	192	0.004
2:ES	Ephemeral Stream	1	618.03	618	0.014
1:CD	Constructed Ditch	2.0	154	308	0.007

2:CD	Constructed Ditch	2.0	355	710	0.016
3:CD	Constructed Ditch	1.5	117	176	0.004
4:CD	Constructed Ditch	2.0	1235	2,470	0.057
Total Other Waters				34,303	0.785

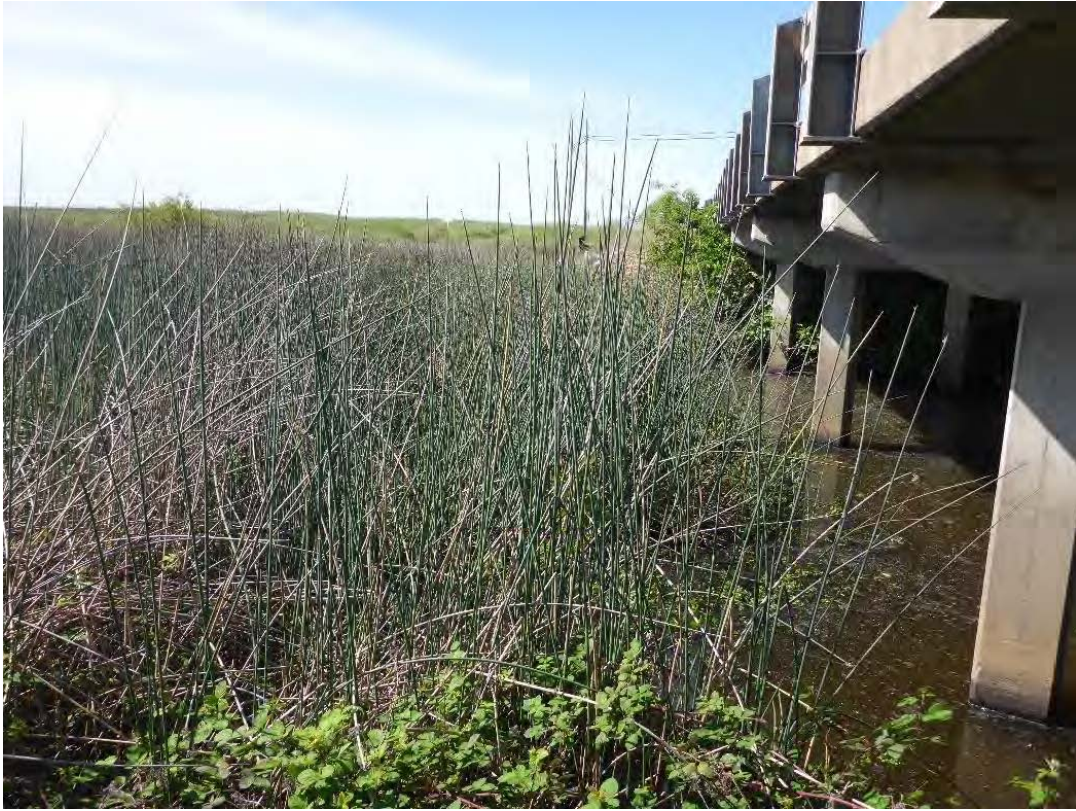
Perennial Stream; 1:PS

perennial stream, Coyote Creek, supports freshwater emergent vegetation including tules and waterweed.

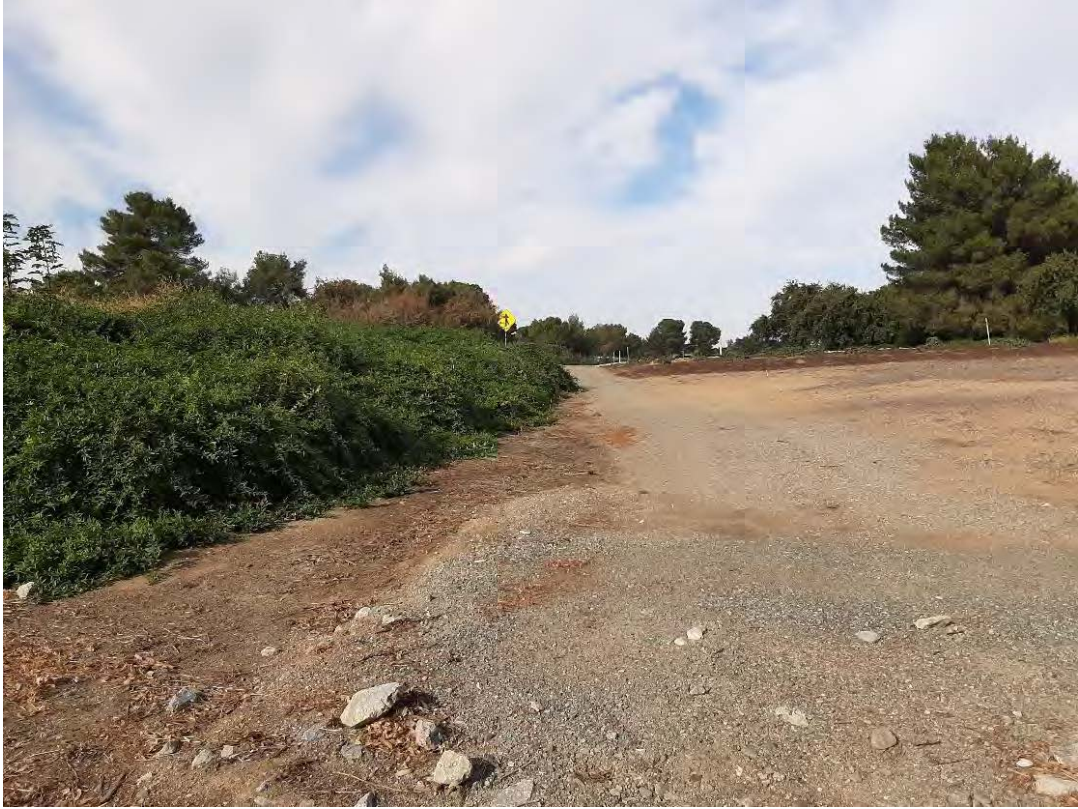
Ephemeral Stream; 1:ES

Ephemeral Stream: Ephemeral streams are characterized by defined bed and bank features that hold water for only a short time following rain events. Sources of water are general precipitation and runoff. The two on-site ephemeral streams drain runoff from Interstate 5 to an intermittent stream within the project boundary.

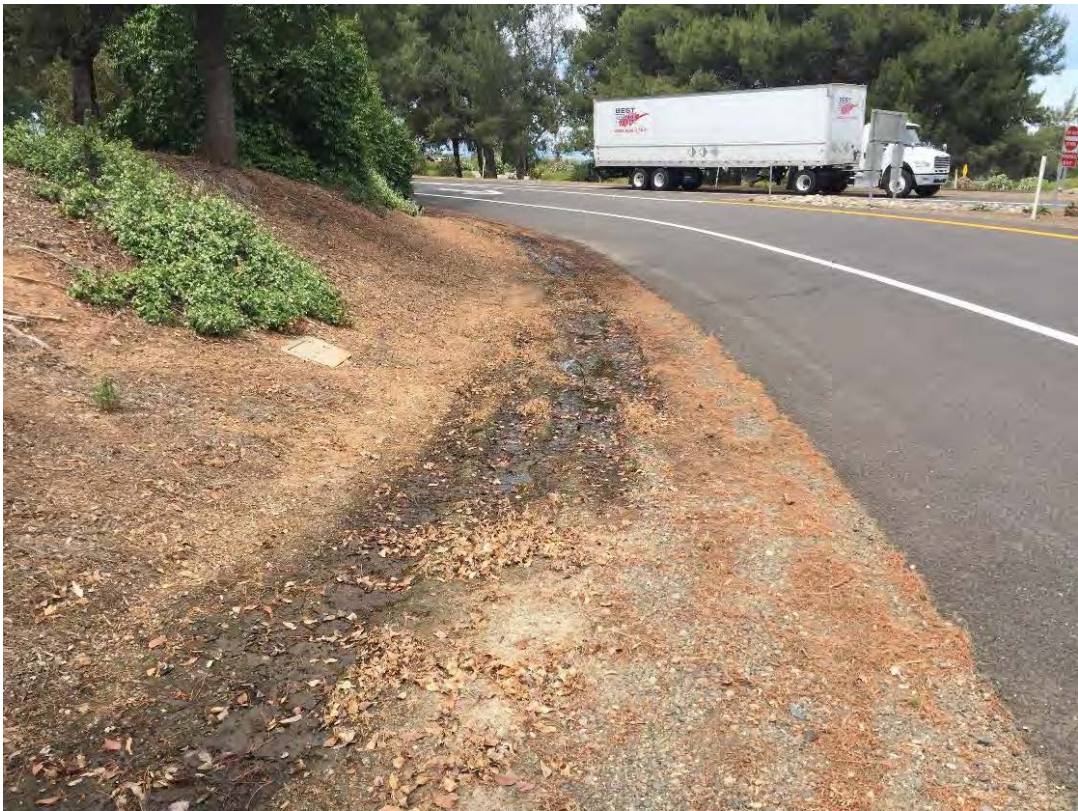
Constructed Ditch; 2:CD

Constructed Ditch: Constructed ditches are excavated features that may be located in either wetlands or uplands, and may convey water collected from sheet flow or diverted from other water bodies. The jurisdictional status of constructed ditches depends in part on these characteristics and flow duration. The on-site constructed ditches were constructed in uplands and drain roadside runoff.

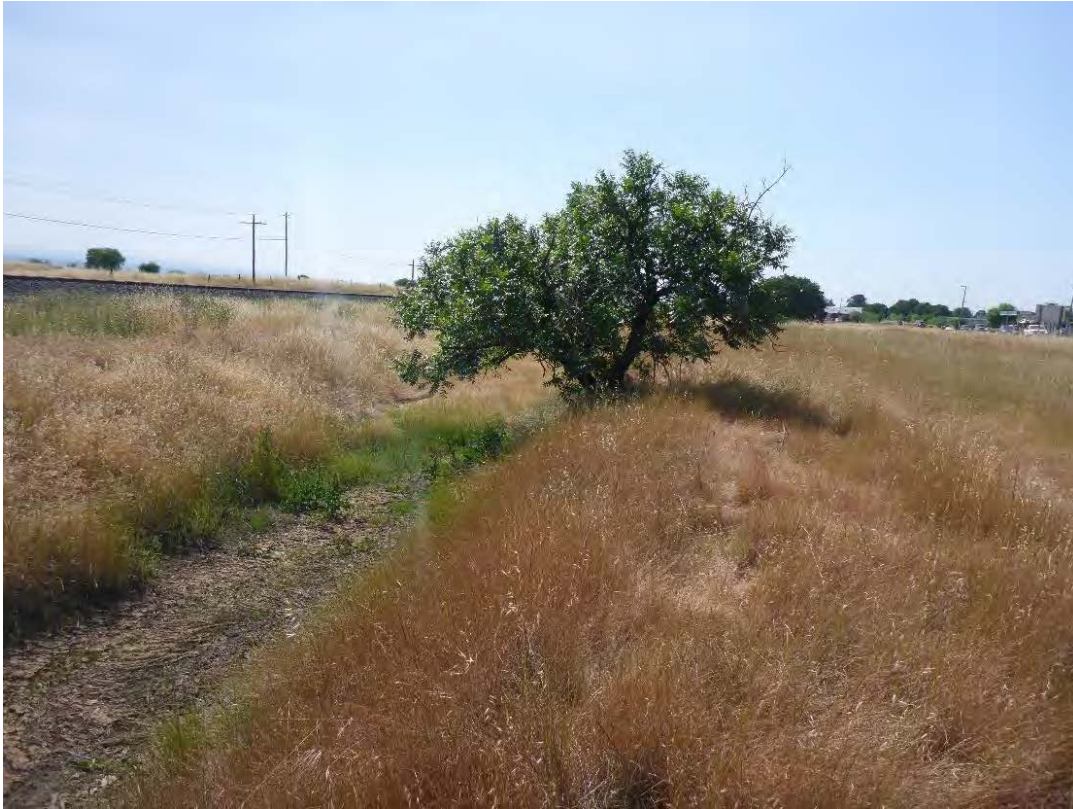
Seasonal wetland; 1:SW

Seasonal Wetland: Seasonal wetlands are saturated or inundated during the winter wet season and dry during the dry season. Seasonal wetlands can be created naturally or as a result of human activity. Representative plant species include Greene's popcorn flower (*Plagiobothrys greenei*), annual hairgrass (*Deschampsia danthonioides*), and Mediterranean barley (*Hordeum marinum*).
