Booster Station 5513 and Tank 5514 Project

Biological Resources Technical Study

August 2020

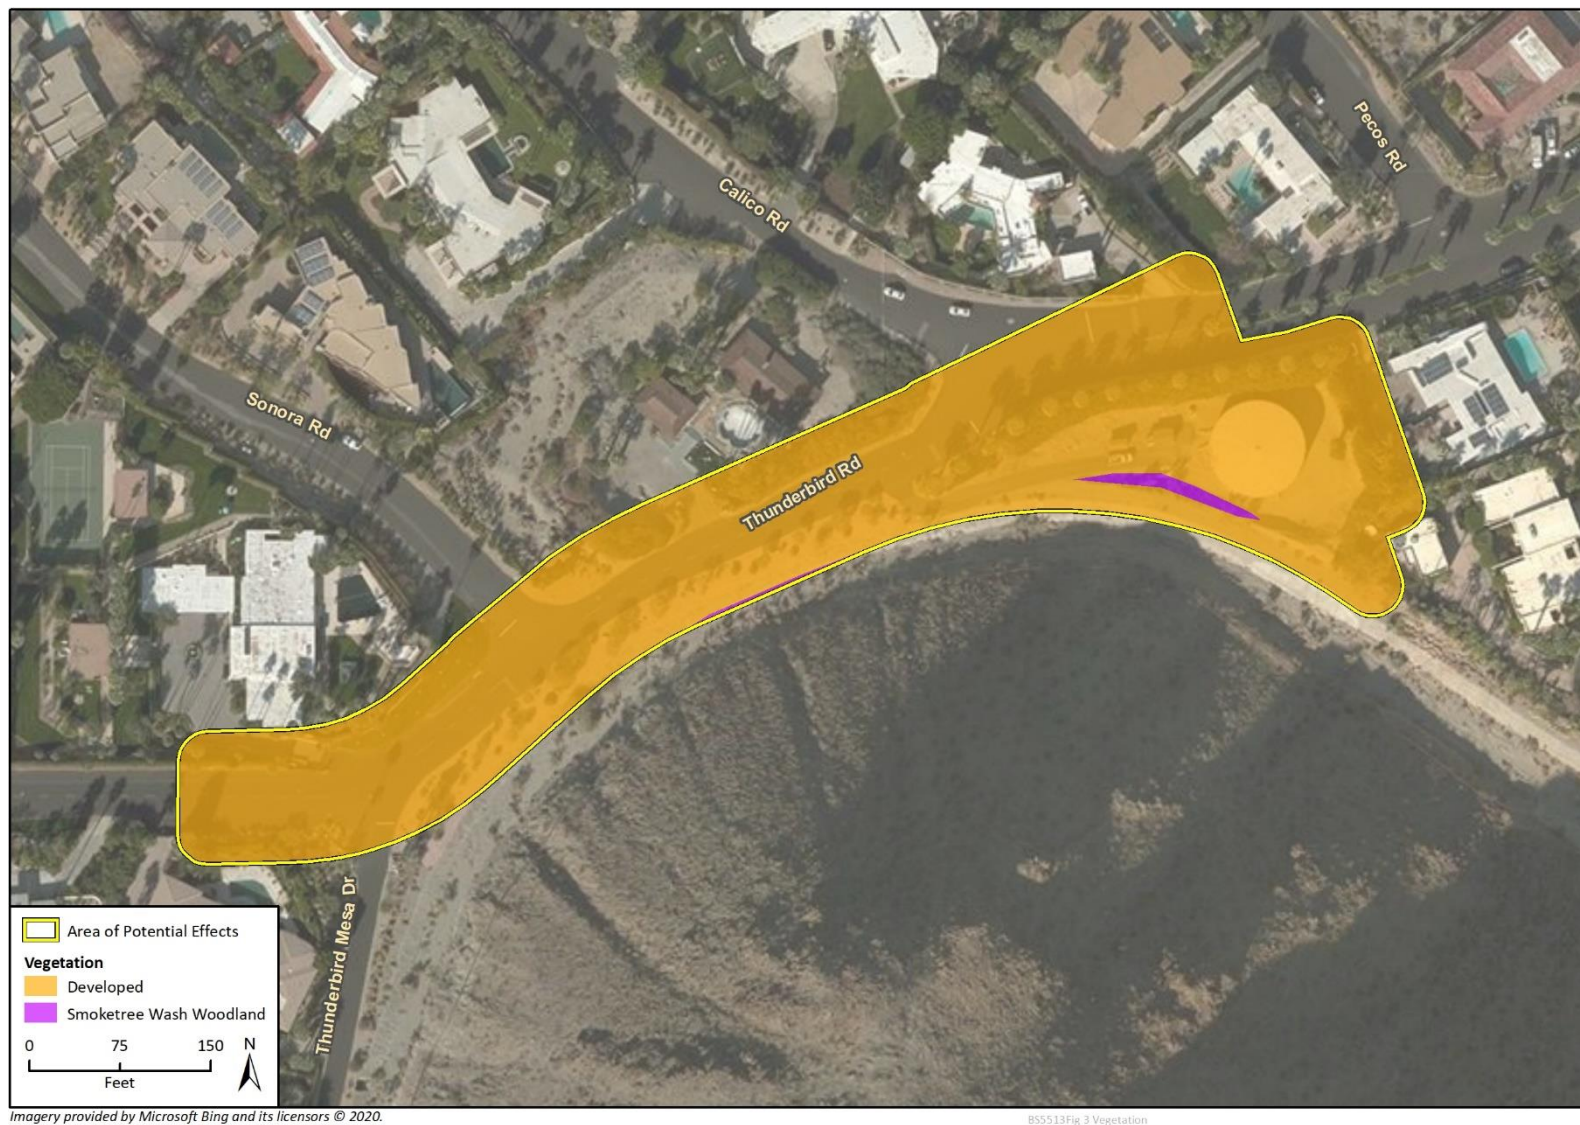
Figure 3a Land Cover and Vegetation

The APE is within the lower Colorado desert which is a subdivision of the Sonoran Desert Region (DSon) geographic subdivision of California. The DSon subdivision is a component of the larger Desert Province (D) geographic region, which occurs within the larger California Floristic Province (Baldwin et al. 2012). While both project sites are located entirely within a developed residential area, additional vegetation communities are present within the APE adjacent to the project sites. One land cover type and two vegetation communities occur within the APE and are discussed in more detail below: developed, creosote bush-brittle bush scrub, and smoketree wash woodland (Figure 3a and Figure 3b).

Developed land includes areas that have been constructed upon or otherwise physically altered to an extent that native vegetation is no longer supported. It is characterized by permanent or semi-permanent structures, pavement or hardscape, and landscaped areas that often require irrigation (Oberbauer et al. 2008). Developed land comprises the entirety of the two project sites (approximately 5.08 acres), which includes irrigated residential lots, water conveyance facilities, paved roads, and other buildings. Ornamental trees and shrubs in these areas include Mexican fan palm (*Washingtonia robusta*), oleander (*Nerium oleander*), date palm (*Phoenix dactylifera*), palo verde (*Parkinsonia* sp.), mesquite (*Prosopis* sp.), and chitalpa (*Chitalpa tashkentensis*).

The creosote bush and brittle bush scrub habitat in the APE corresponds to natural shrubland stands more recently described by Sawyer et al. (2009). Creosote bush and brittle bush scrub is dominated by native species including creosote (*Larrea tridentata*) and brittlebush (*Encelia farinosa*). Within the APE, this plant community has varying levels of disturbance. It occupies approximately 0.19 acre and primarily exists along the adjacent rocky slopes outside of the disturbance limits of the Tank 5514 project site.

The smoketree wash woodland habitat in the APE corresponds to natural shrubland stands more recently described by Sawyer et al. (2009). Smoketree wash woodland is dominated by the native species smoketree (*Psoralea argophylla*). Within the APE, this plant community has varying levels of disturbance. It occupies approximately 0.04 acre and primarily exists along the adjacent dry wash outside of the disturbance limits of the BS05513 project site. Additionally, this vegetation community within the APE contains a large occurrence of invasive fountain grass (*Pennisetum setaceum*).

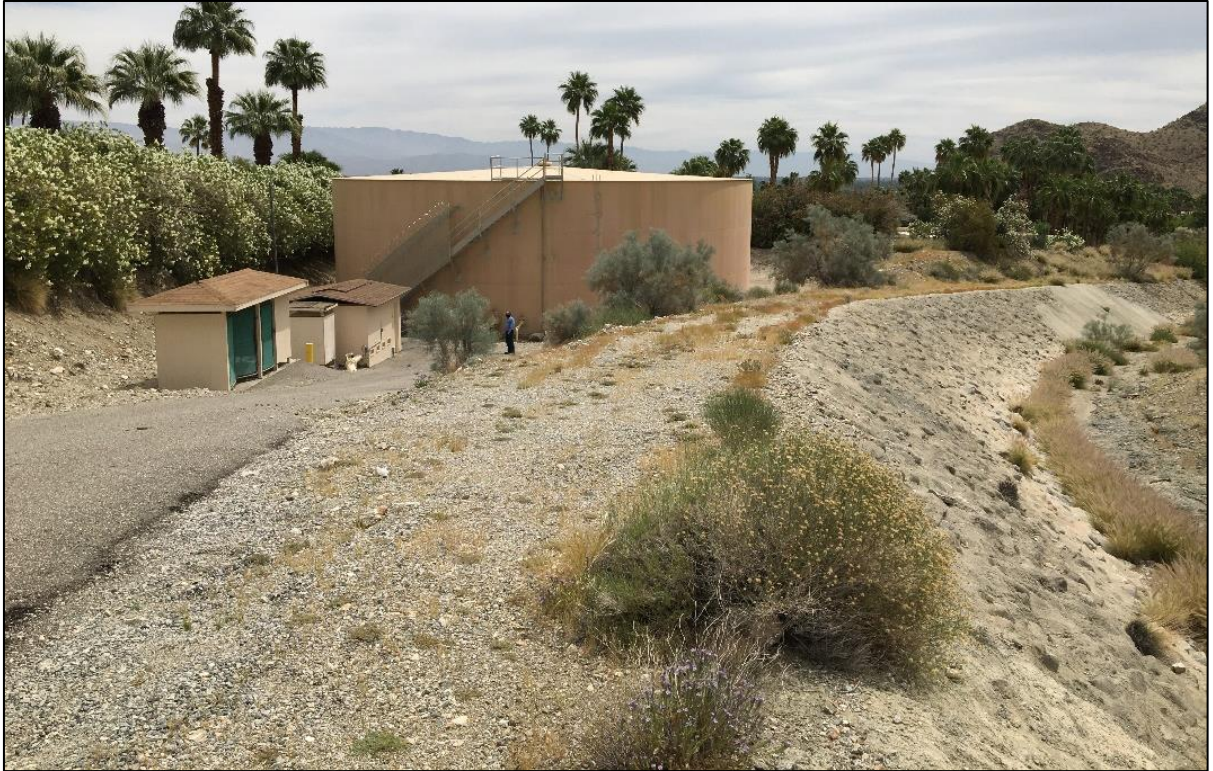
Photograph 1. View looking east at BS05513.

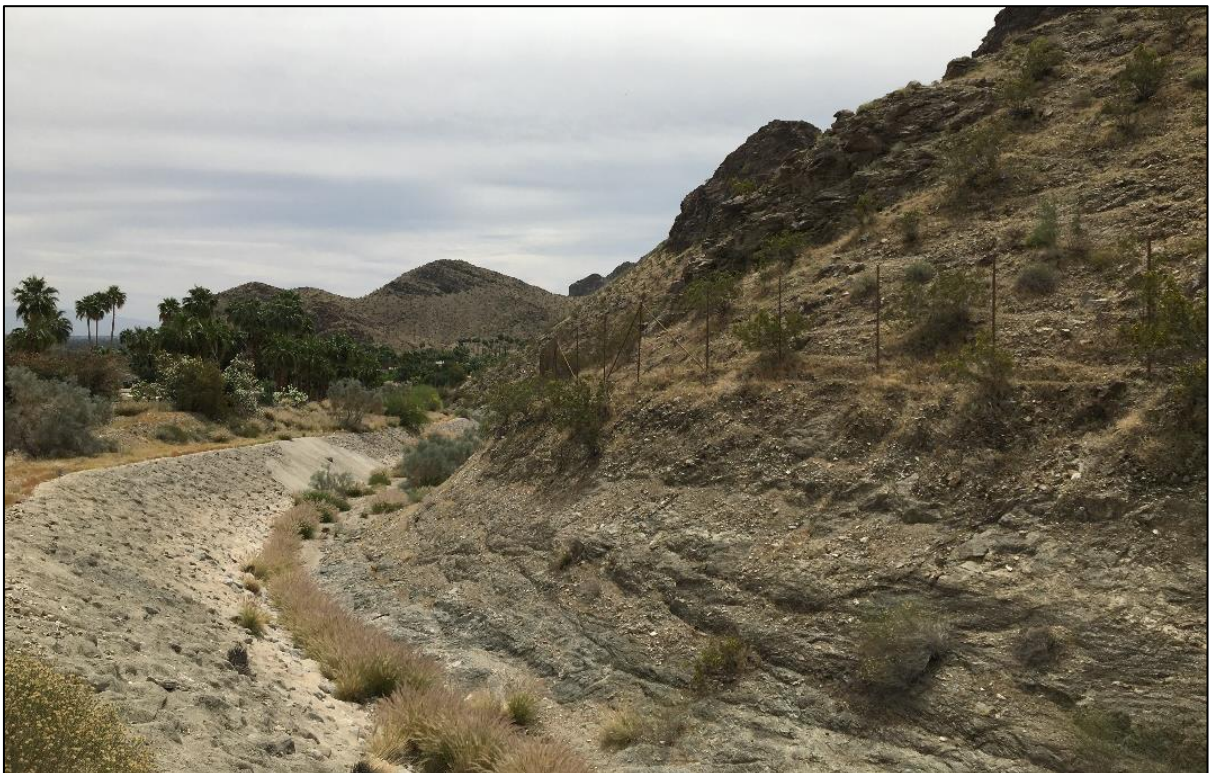
Photograph 2. View looking east at dry wash adjacent BS05513.

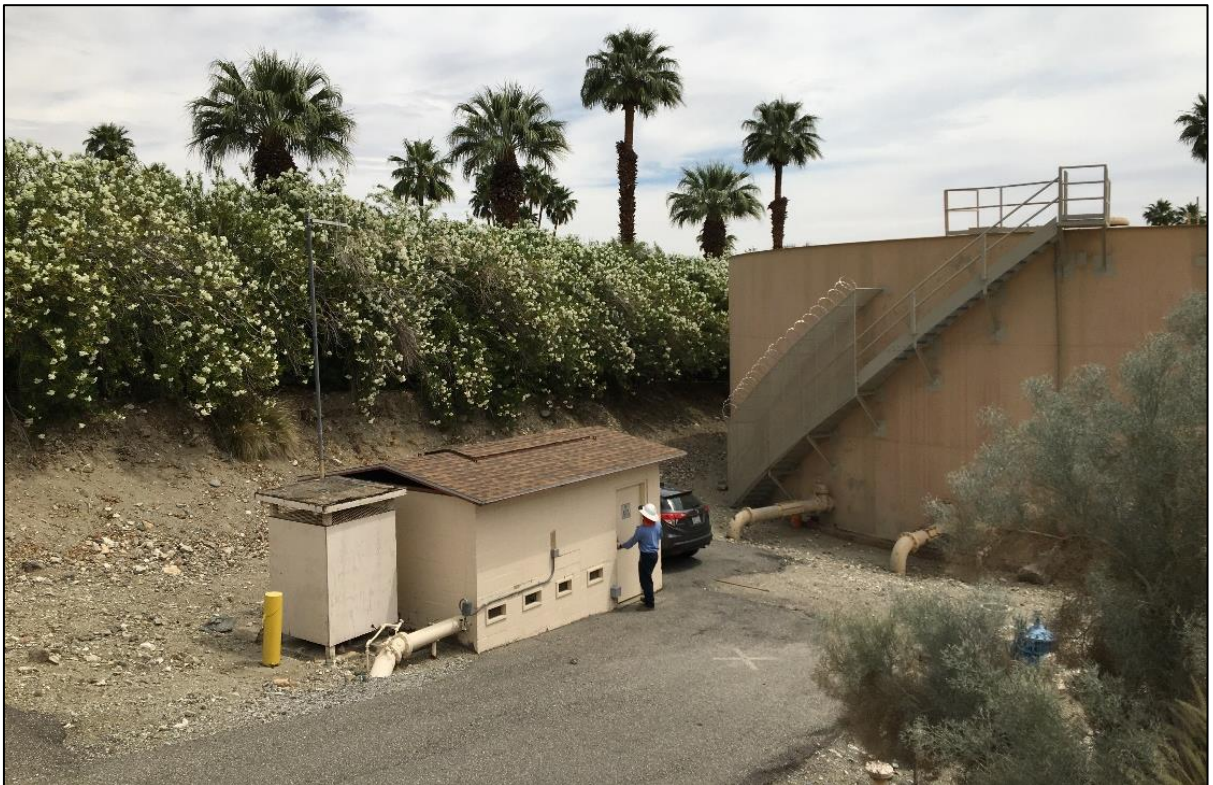
Photograph 4. View looking northeast at BS05513. Note ornamental screening vegetation.

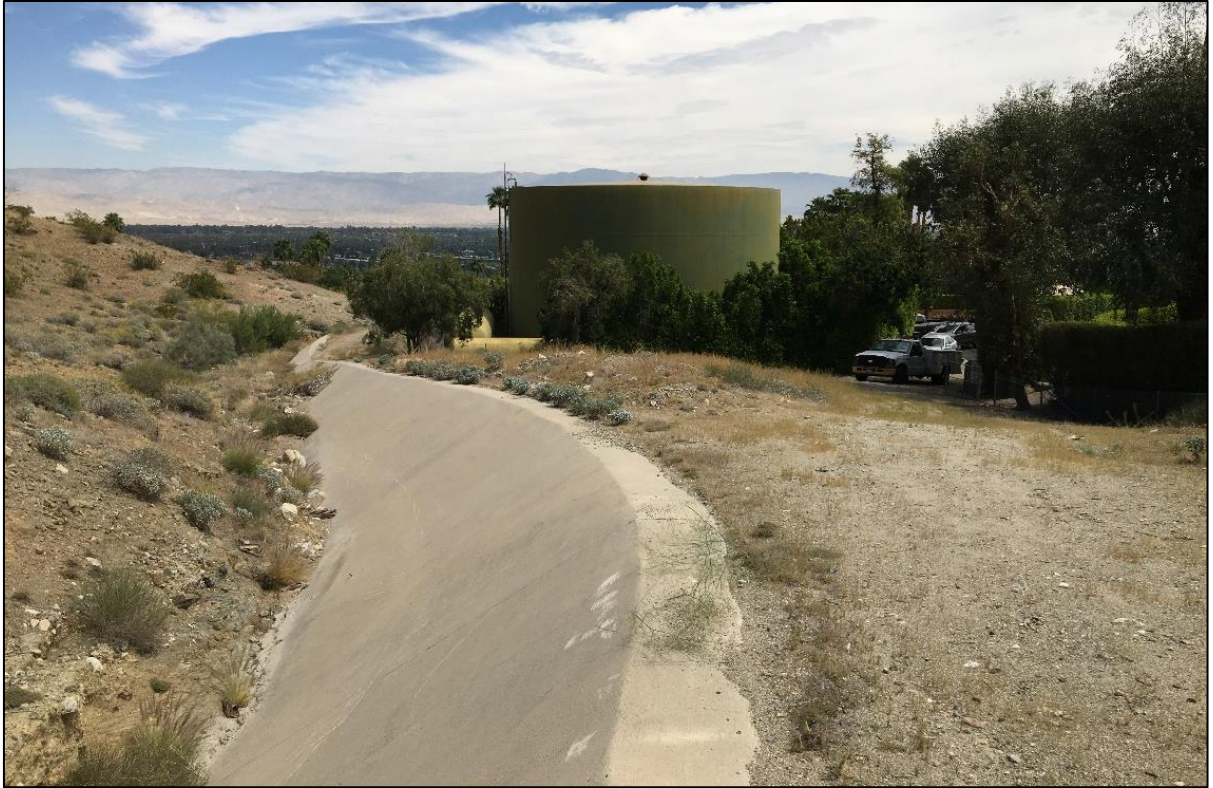
Photograph 7. View looking northeast at Tank 5514-1. Note the dry wash adjacent to the project site.

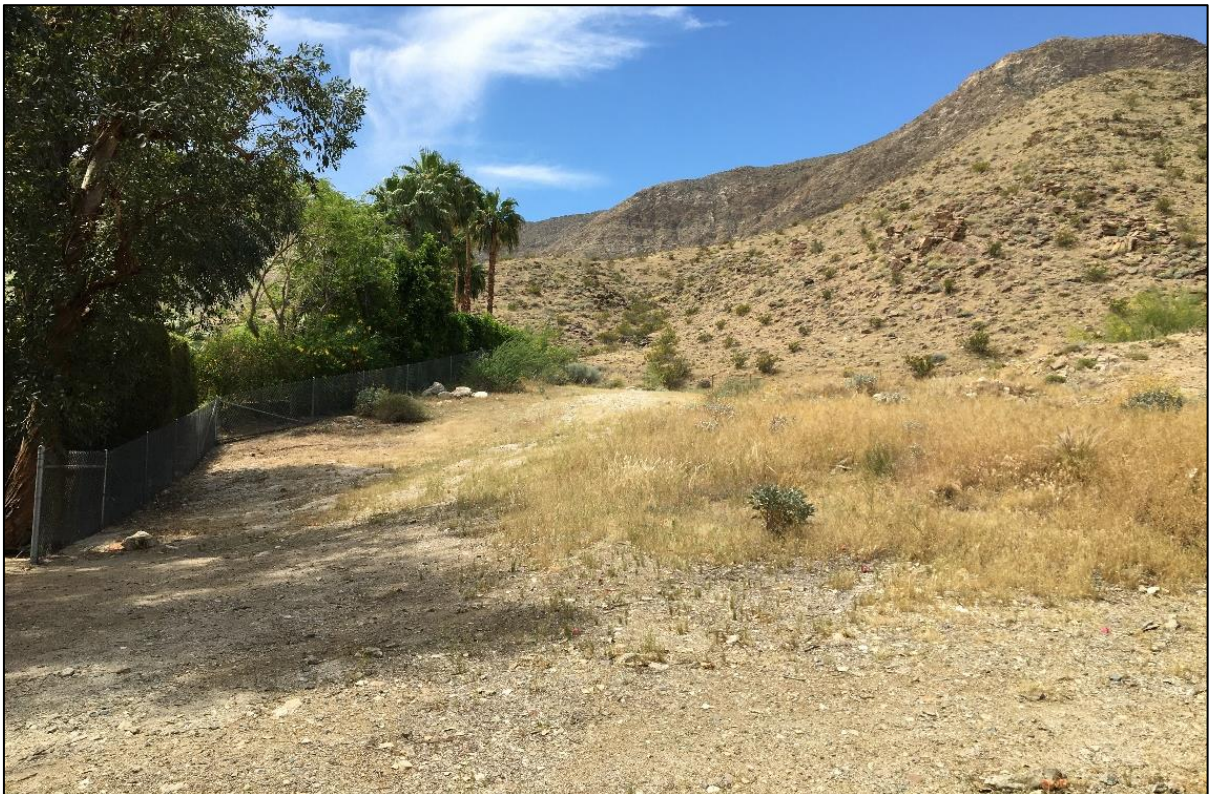
Photograph 8. View looking southwest from Tank 5514-1. Note adjacent mountain side with creosote scrub.

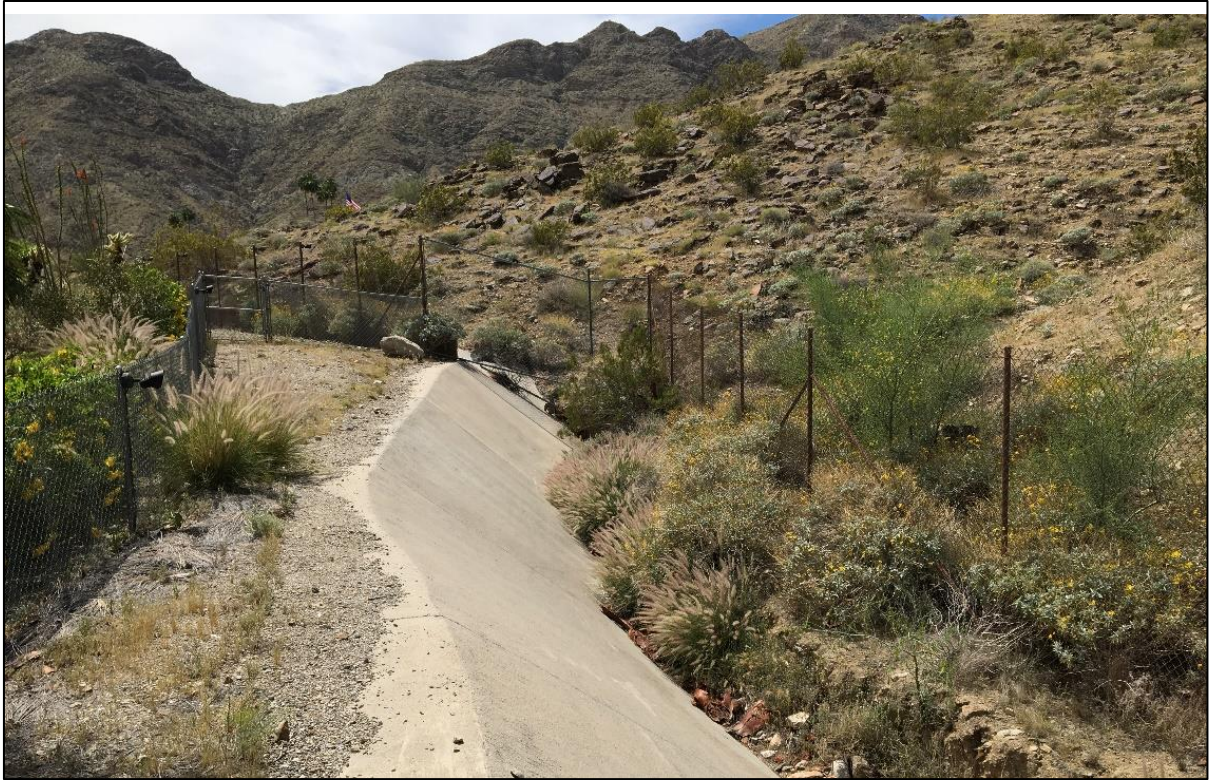
Photograph 9. View looking southwest along dry wash to southern edge of the Tank 5514-1 project site.

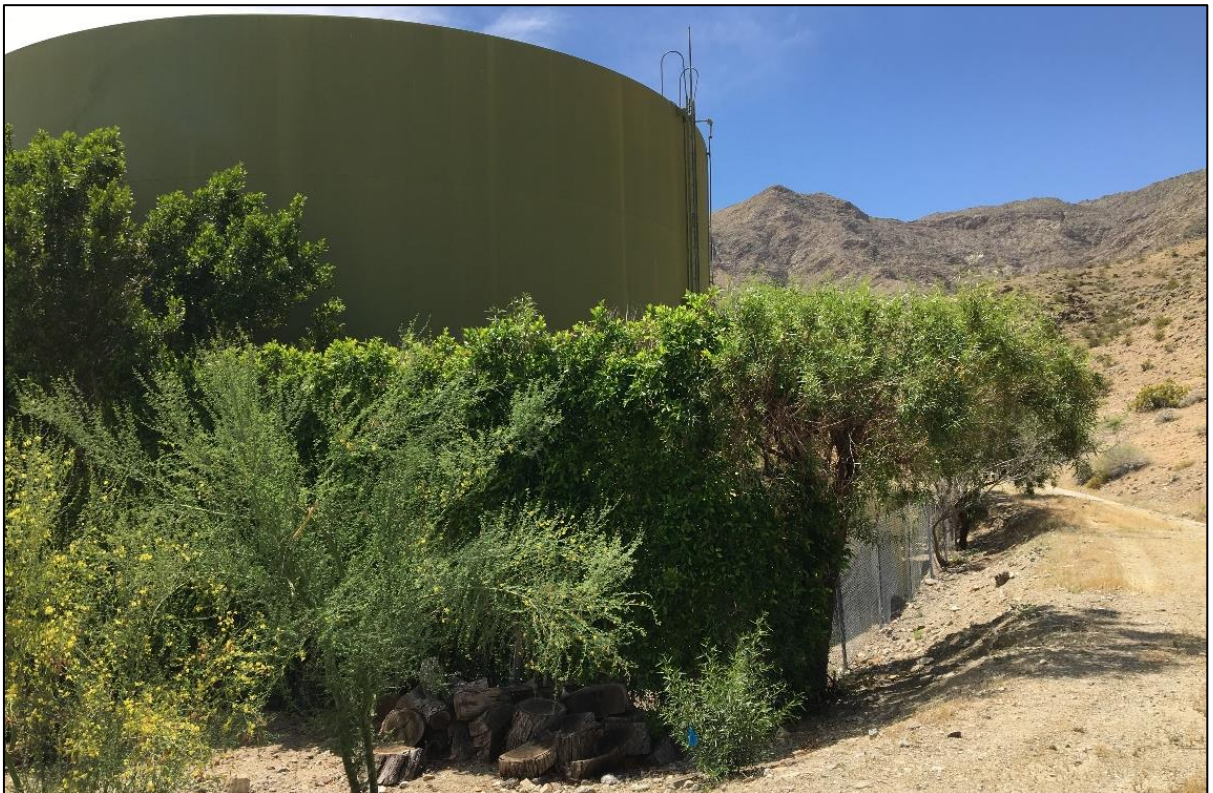
Photograph 10. View looking south at Tank 5514-1. Note ornamental screening vegetation.

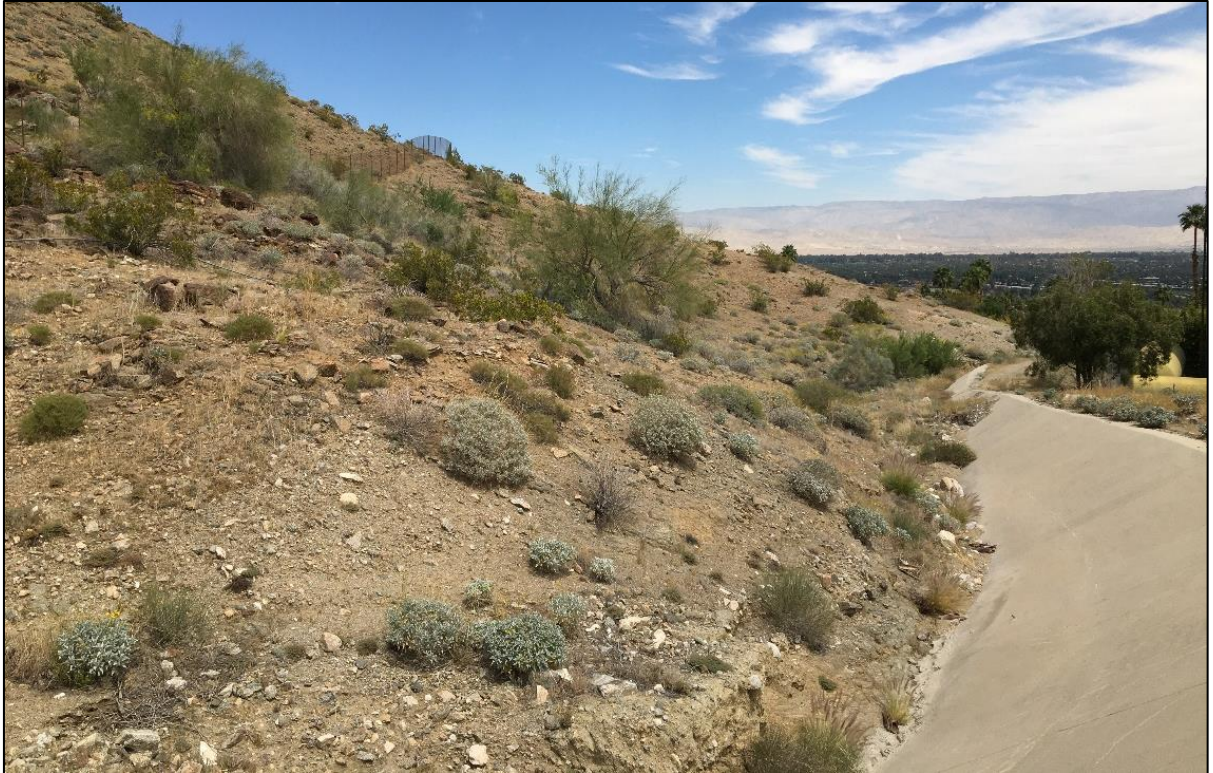
Photograph 11. View looking north along dry wash with creosote scrub habitat on hillside opposite the Tank 5514-1 project site.
