# TECHNICAL MEMORANDUM

**To:** Jackie McCloud, Environmental Sustainability Manager, City of Watsonville Public Works Department  
**From:** Sarah Faraola, Environmental Analyst  
**Subject:** Memorandum in Support of a CEQA Categorical Exemption for the City of Watsonville Middle Struve Slough Water Quality and Habitat Enhancement Project  
**Date:** October 29, 2021  
**CC:** Jonathan Pilch, Watsonville Wetlands Watch  
**Att:** A, 100% Design Plans; B, Habitat Enhancement Plan; C, Biotic Report; D, Wetland Delineation; E, Cultural Resources Report; F, Hazardous Waste Sites Database Search Results

## Project Overview

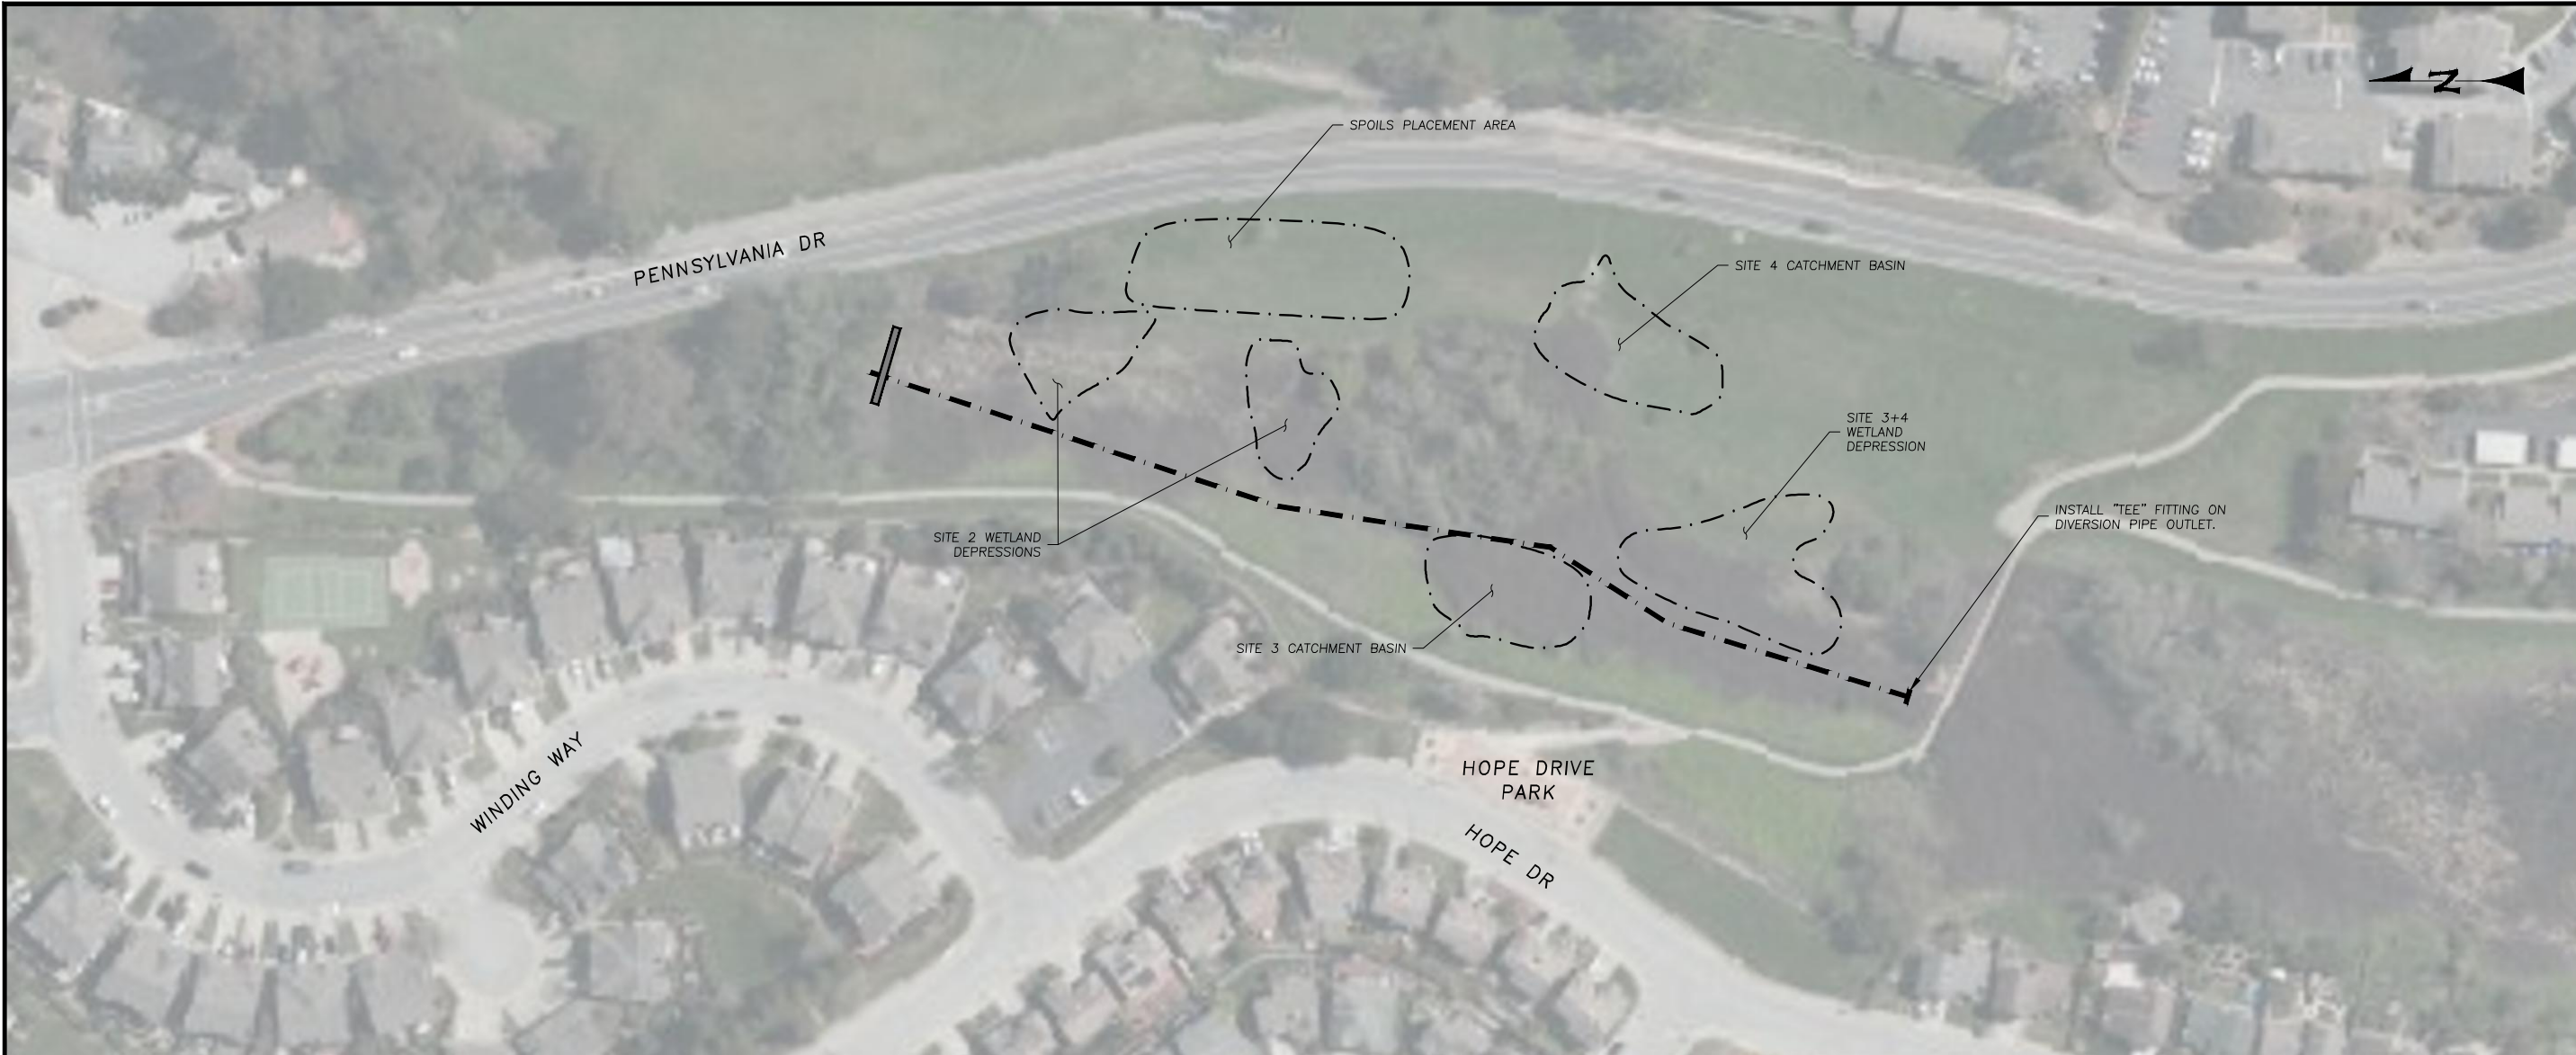
**DIVERSION AND DEWATERING PLAN**  
SCALE: 1" = 60'

- IMPLEMENT DIVERSION AND DEWATERING MEASURES IN COMPLIANCE WITH PROJECT PERMIT REQUIREMENTS.
  - CONFIRM THAT A FAVORABLE LONG TERM WEATHER FORECAST (1 WEEK, MIN.) IS OBSERVED PRIOR TO PLACEMENT OF DIVERSION STRUCTURES.

- THE DIVERSION STRUCTURE SHALL BE CONSTRUCTED AS SHOWN ON DETAIL 1, THIS SHEET OR AS DIRECTED BY THE ENGINEER IN THE FIELD.
  - IN THE EVENT OF A SIGNIFICANT STORM, THE CONTRACTOR SHALL BE PREPARED TO TAKE NECESSARY MEASURES TO INSURE SAFE PASSAGE OF STORM WATER FLOW THROUGH THE PROJECT AREA, WITHOUT DAMAGE TO EXISTING STRUCTURES, OR INTRODUCTION OF EXCESSIVE SEDIMENT. THE CONTRACTOR SHALL BE RESPONSIBLE FOR ALL TEMPORARY EROSION CONTROL B.M.P.'S.

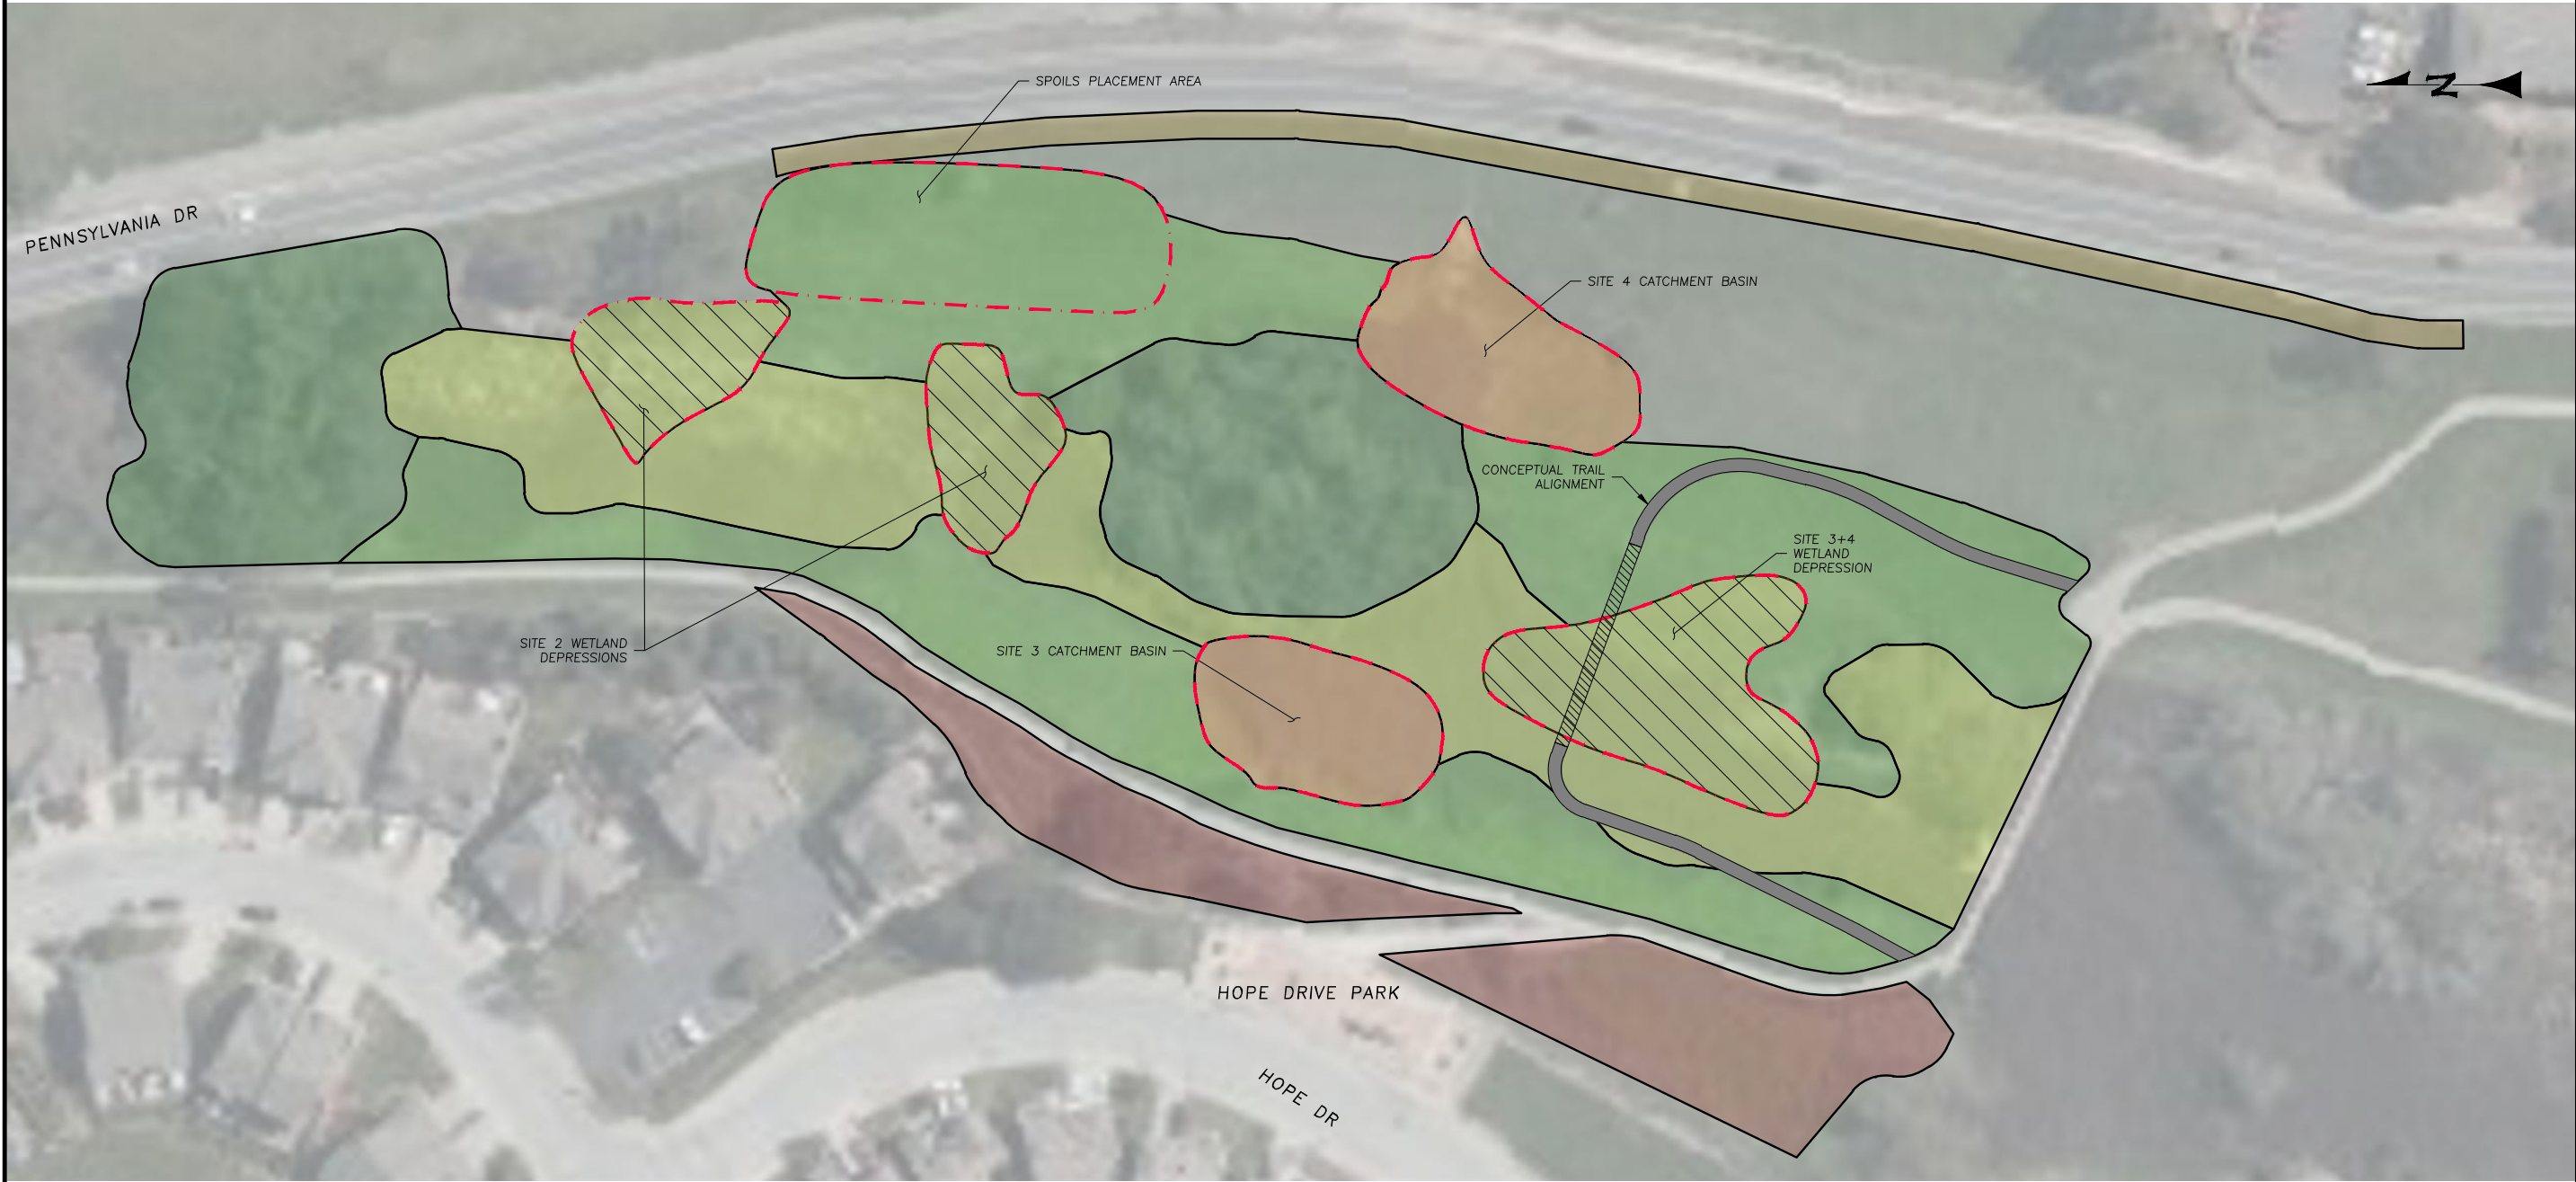
SEEDING AND REVEGETATION NOTES:  
1. SEED AND MULCH ALL AREAS DISTURBED DURING CONSTRUCTION.  
2. SEED MIX AND REVEGETATION DETAILS TO BE PROVIDED BY OTHERS.

**HABITAT ENHANCEMENT AND PUBLIC ACCESS IMPROVEMENT AREA OVERVIEW**

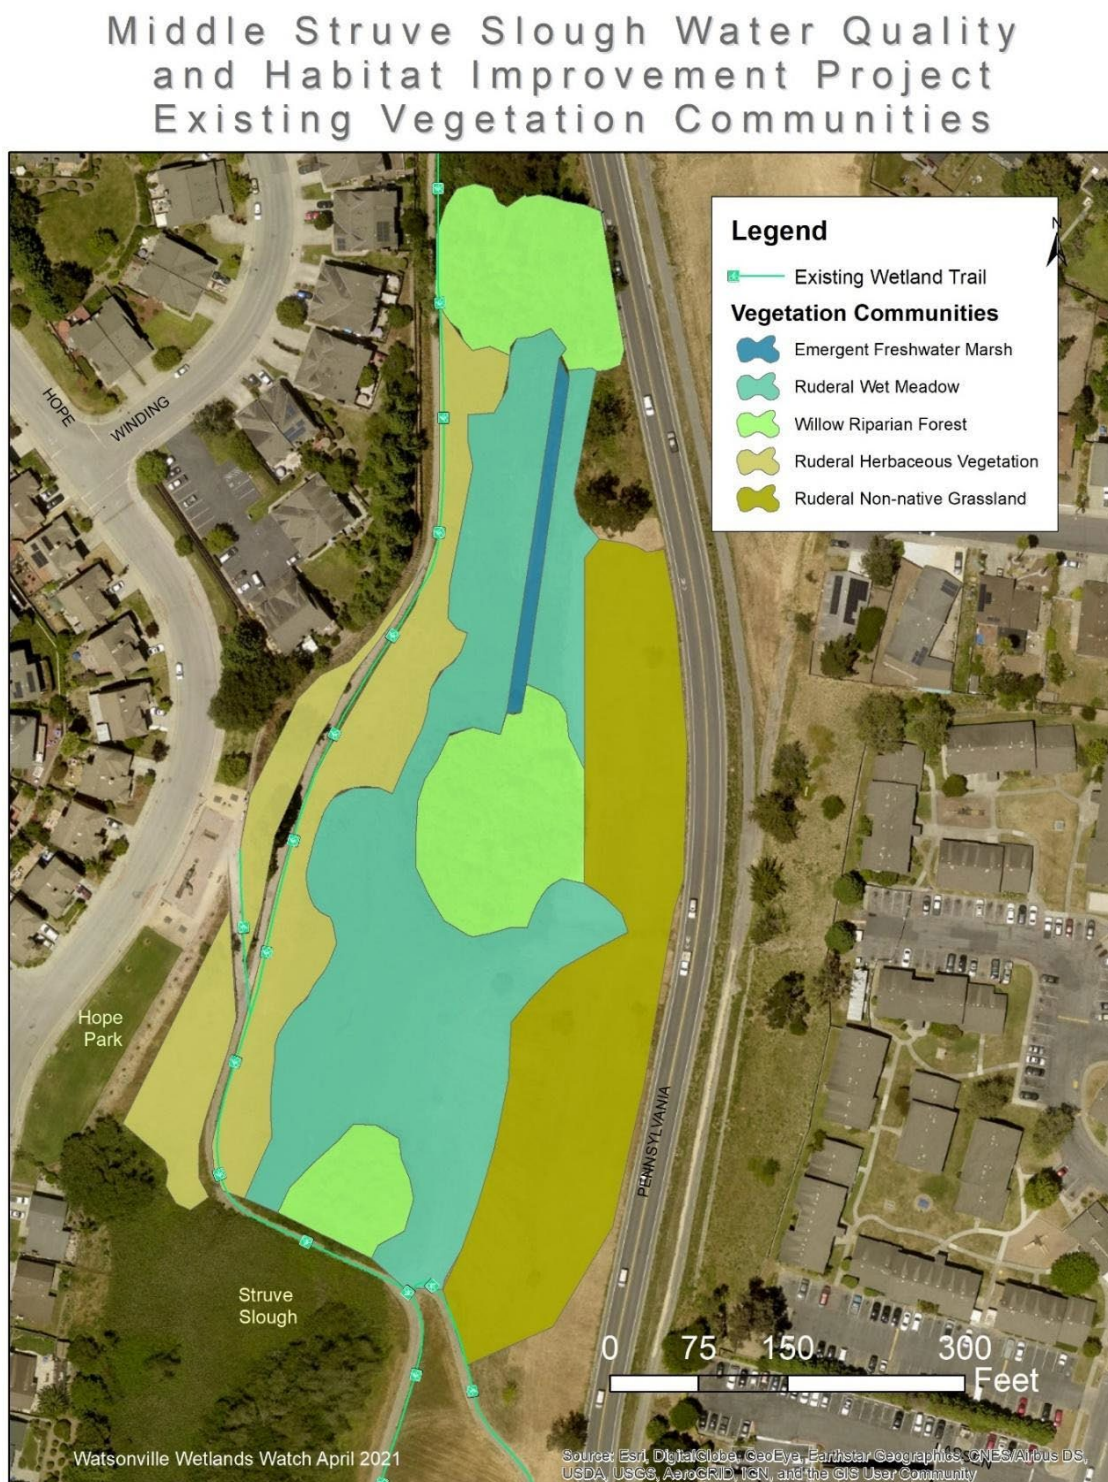
Figure 2. Map of Middle Struve Slough, Vegetation Communities Map

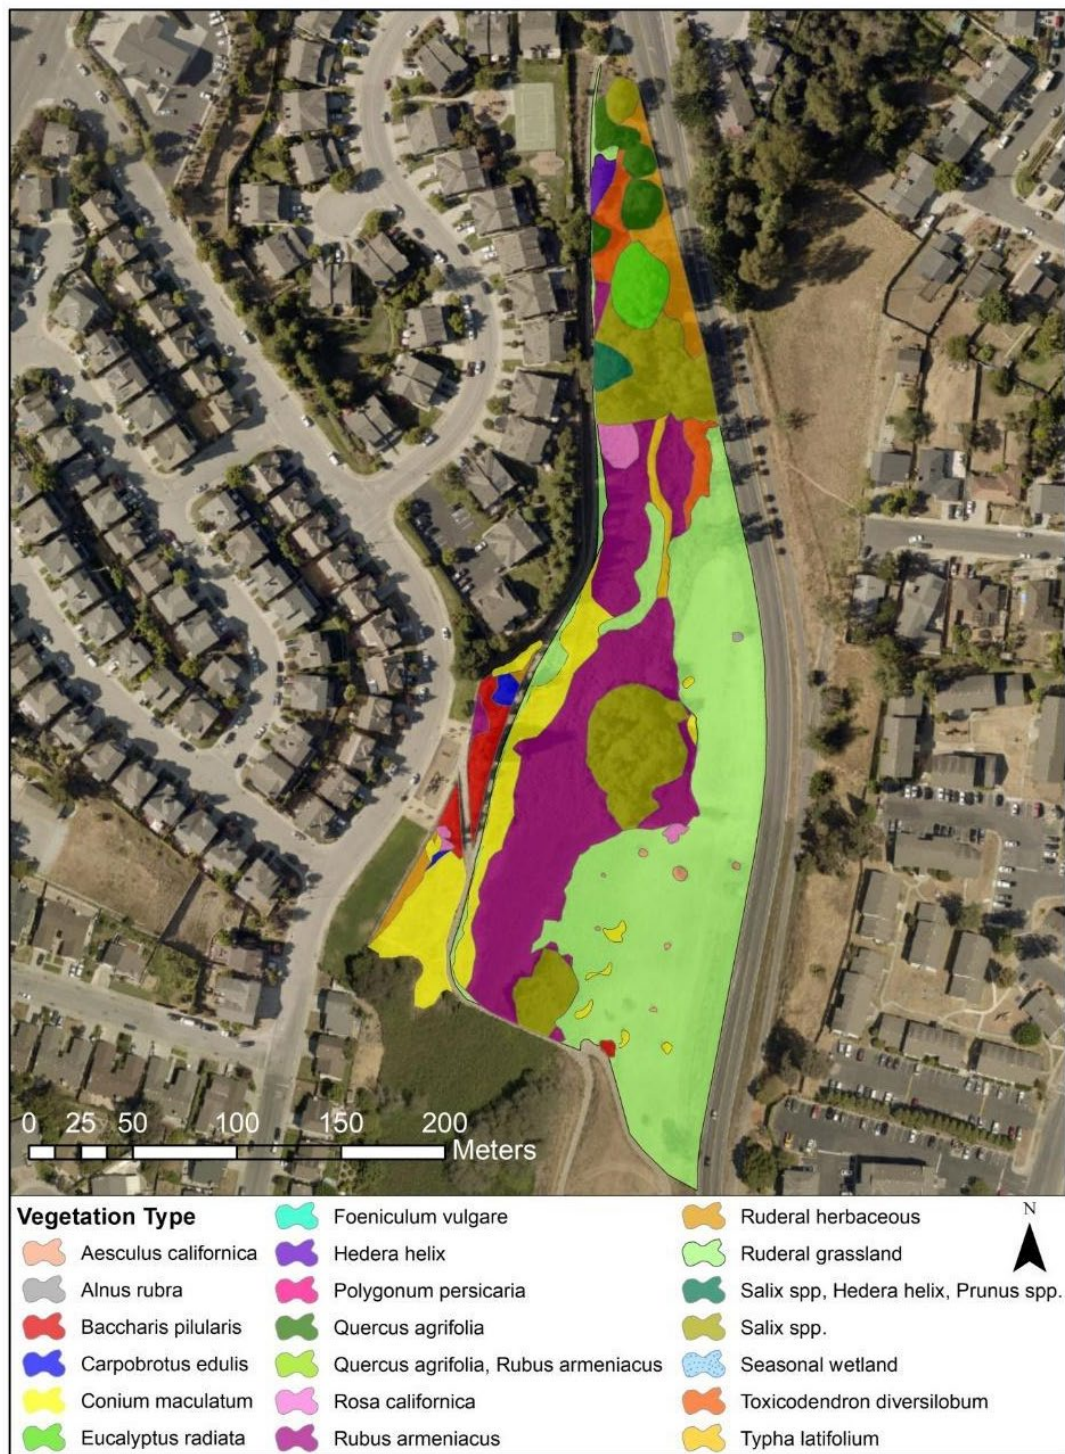
Figure 3. Middle Struve Slough, Plant Species Composition Map, Spring 2019

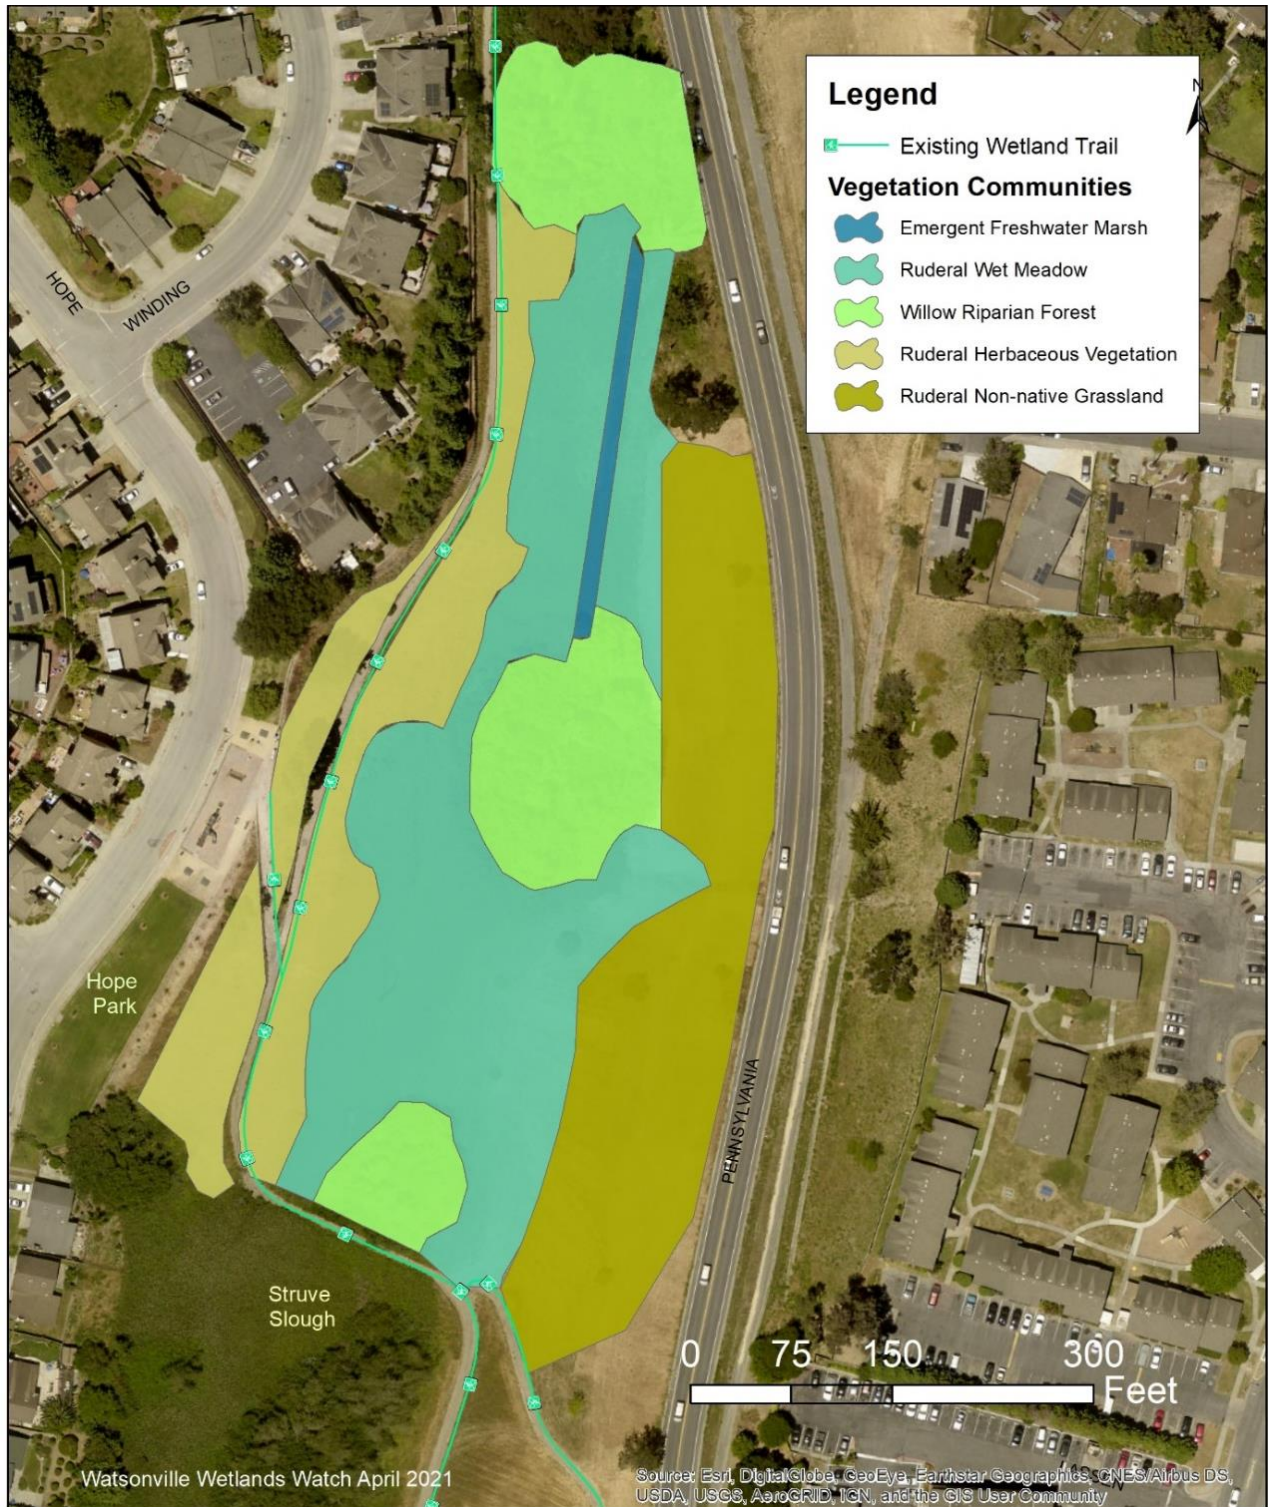
Figure 3. Vegetation Communities (Watsonville Wetlands Watch 2021)  
Middle Struve Slough Habitat and Water Quality Improvement Project

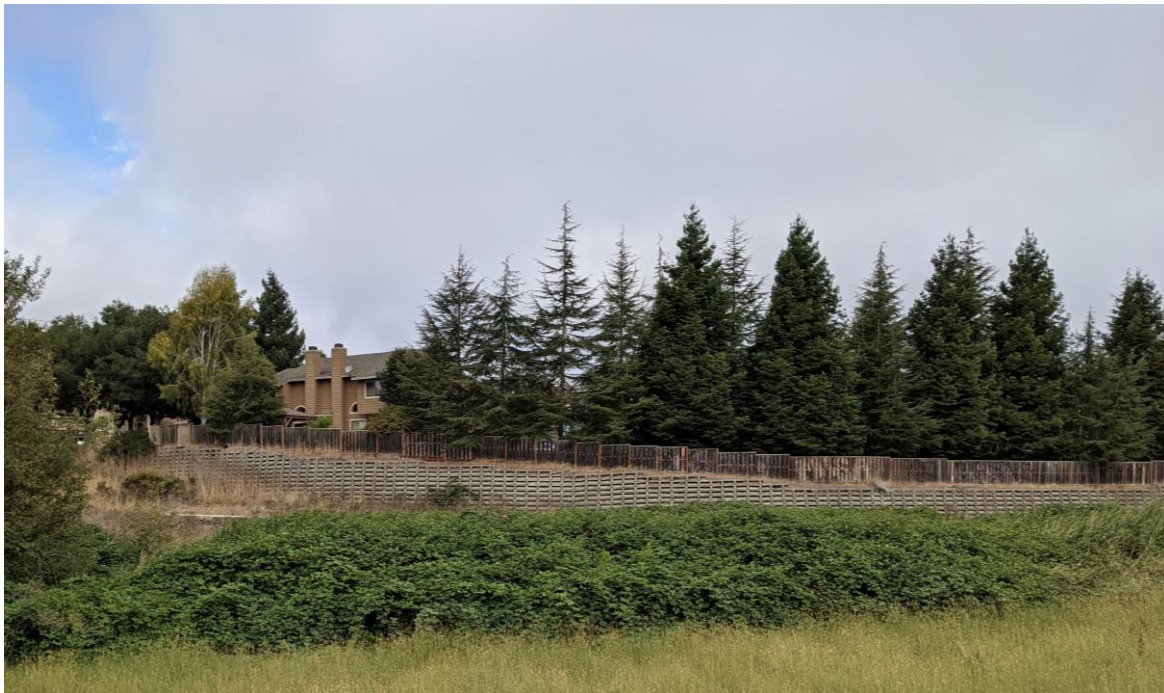
**Photo 1. Ruderal Wet Meadow dominated by Himalayan blackberry.**

This portion of the property was drained for agricultural production in the beginning in the second half of the nineteenth century, until the 1960's. Ruderal wet meadows, include seasonally flooded areas outside of the freshwater emergent marsh. This area is dominated by large and dense stands of Himalayan blackberry (*Rubus armeniacus*). The character of the blackberry, which dominates the project area, is depicted in Photo 1.

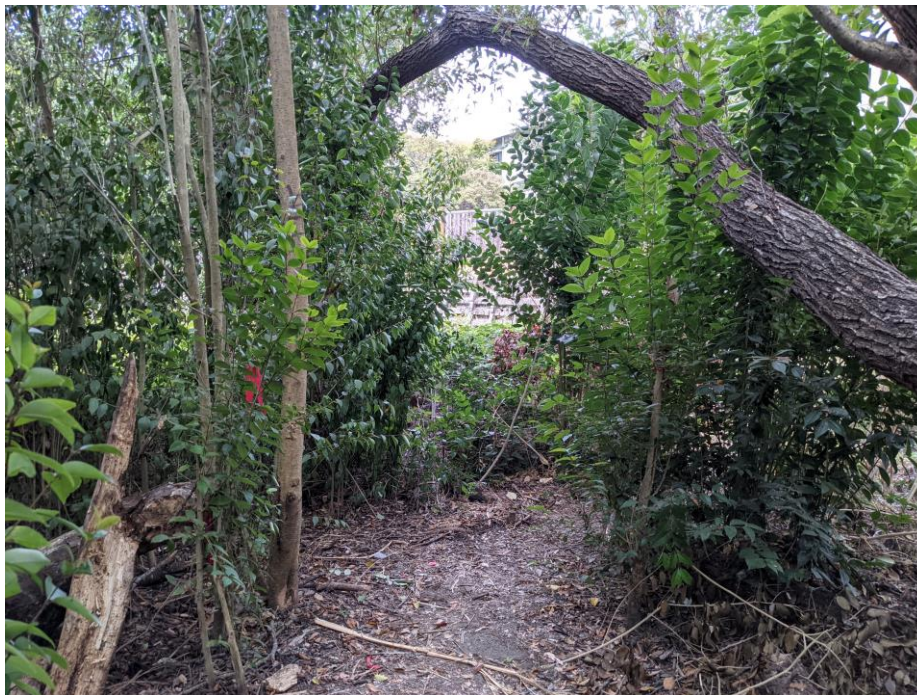
**Photo 2. Willow Riparian Habitat in the northern portion of the property.**

The character of the Arroyo Willow Thicket is depicted in Photo 2.

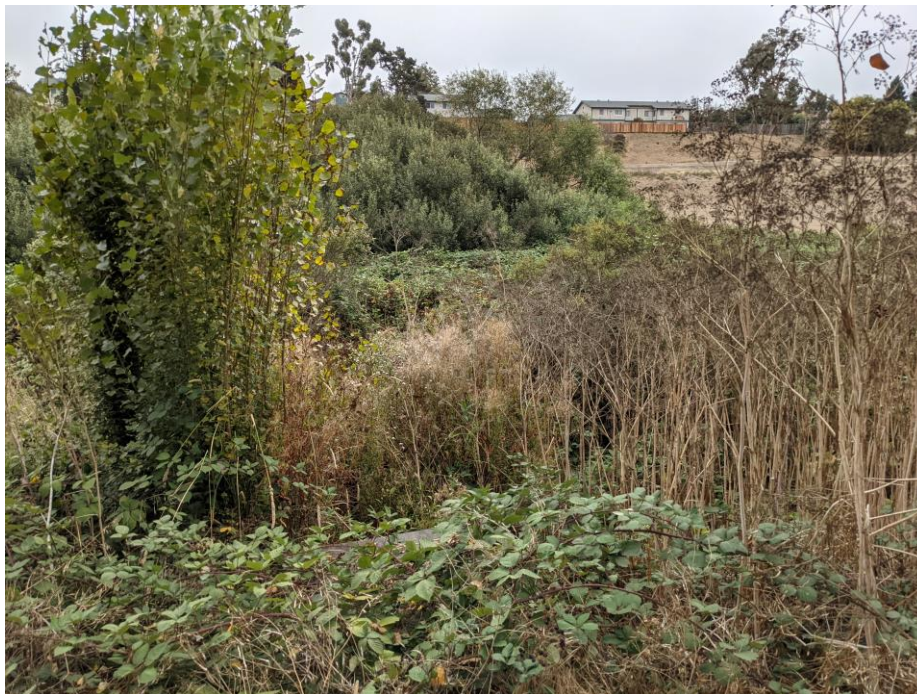
**Photo 3. Poison Hemlock and Fennel Patches dominated by aggressive, opportunistic species.**

The character of the Poison Hemlock and Fennel Patches is depicted in Photo 3.

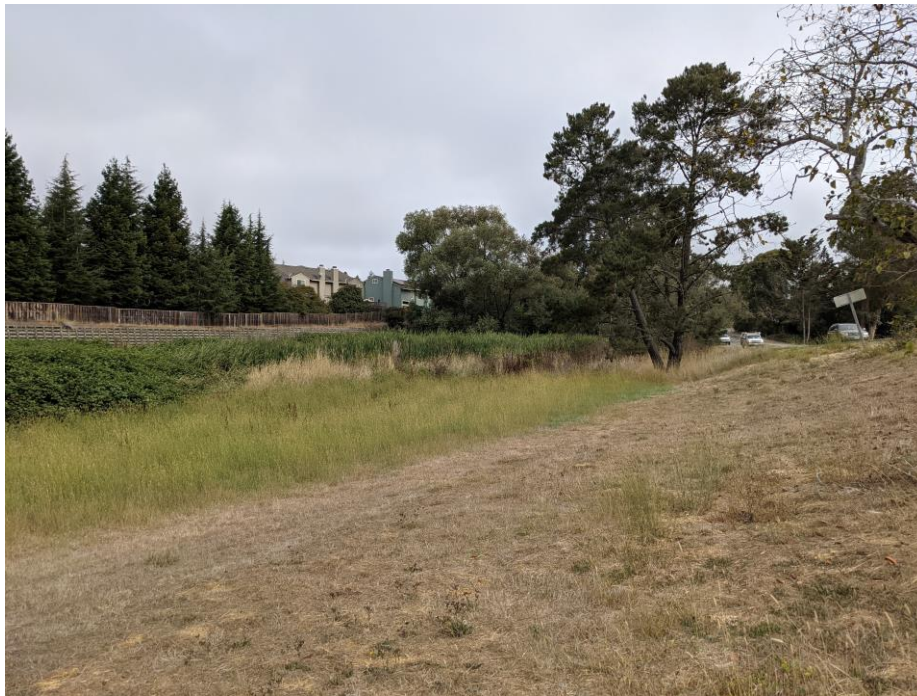
**Photo 4. Perennial Ryegrass habitat.**

The character of the Perennial Ryegrass habitat is depicted in Photo 4.

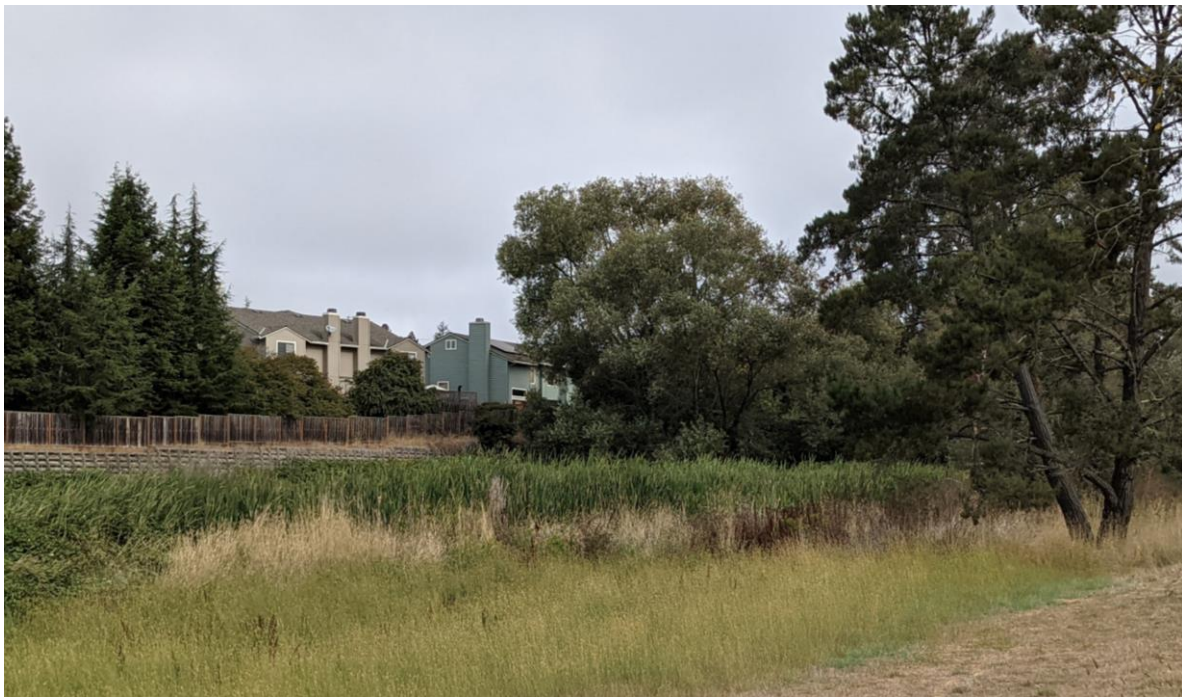
**Photo 5. Emergent Freshwater Marsh habitat dominated by broadleaf cattail.**

The character of the Emergent Freshwater Marsh is depicted in Photo 5.

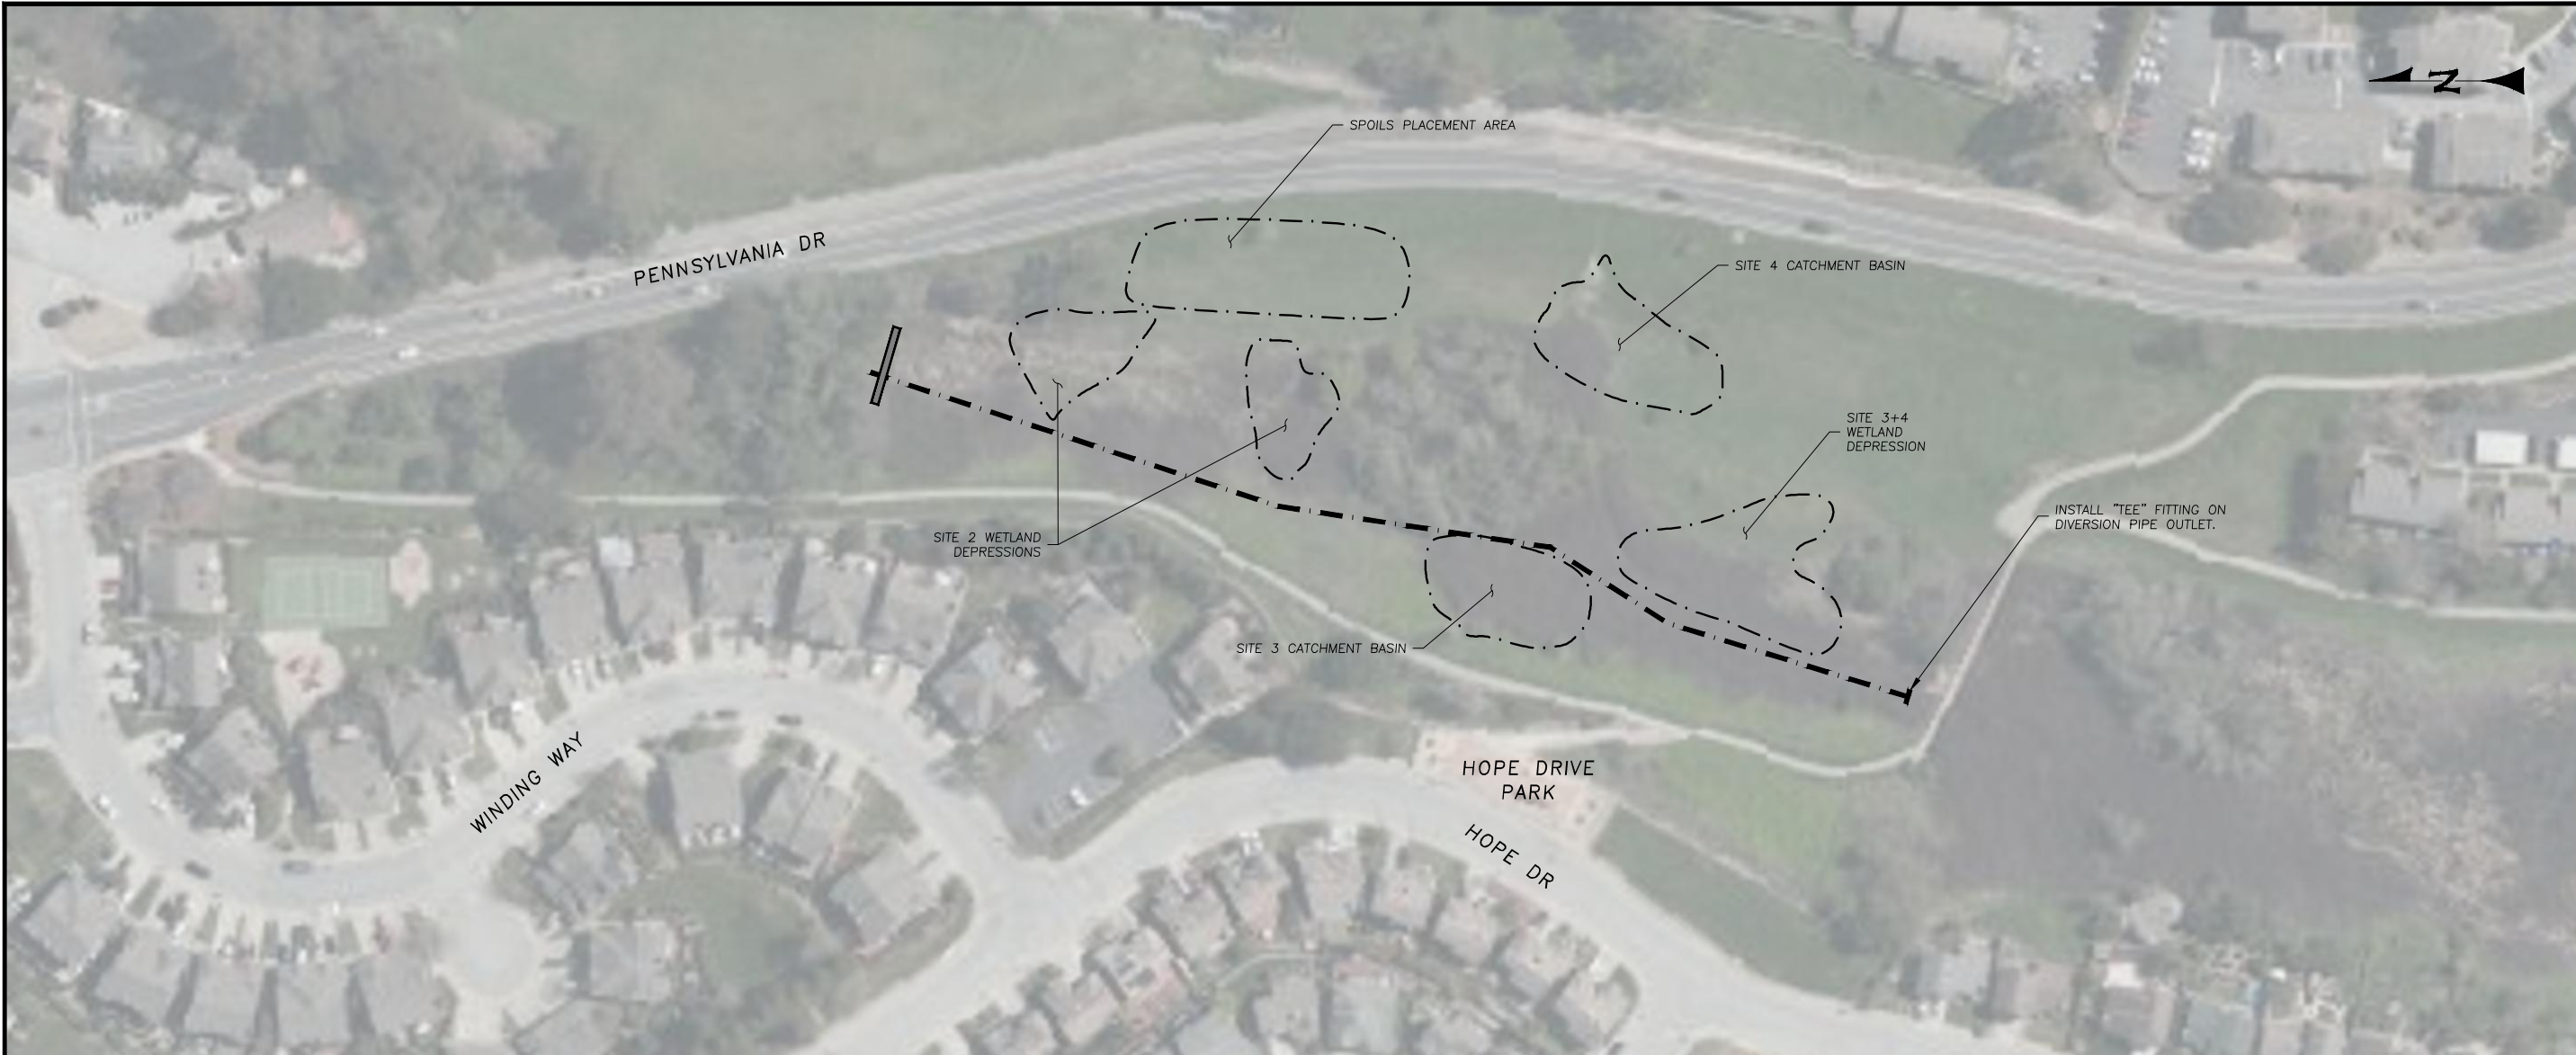
**DIVERSION AND DEWATERING PLAN**  
SCALE: 1" = 60'

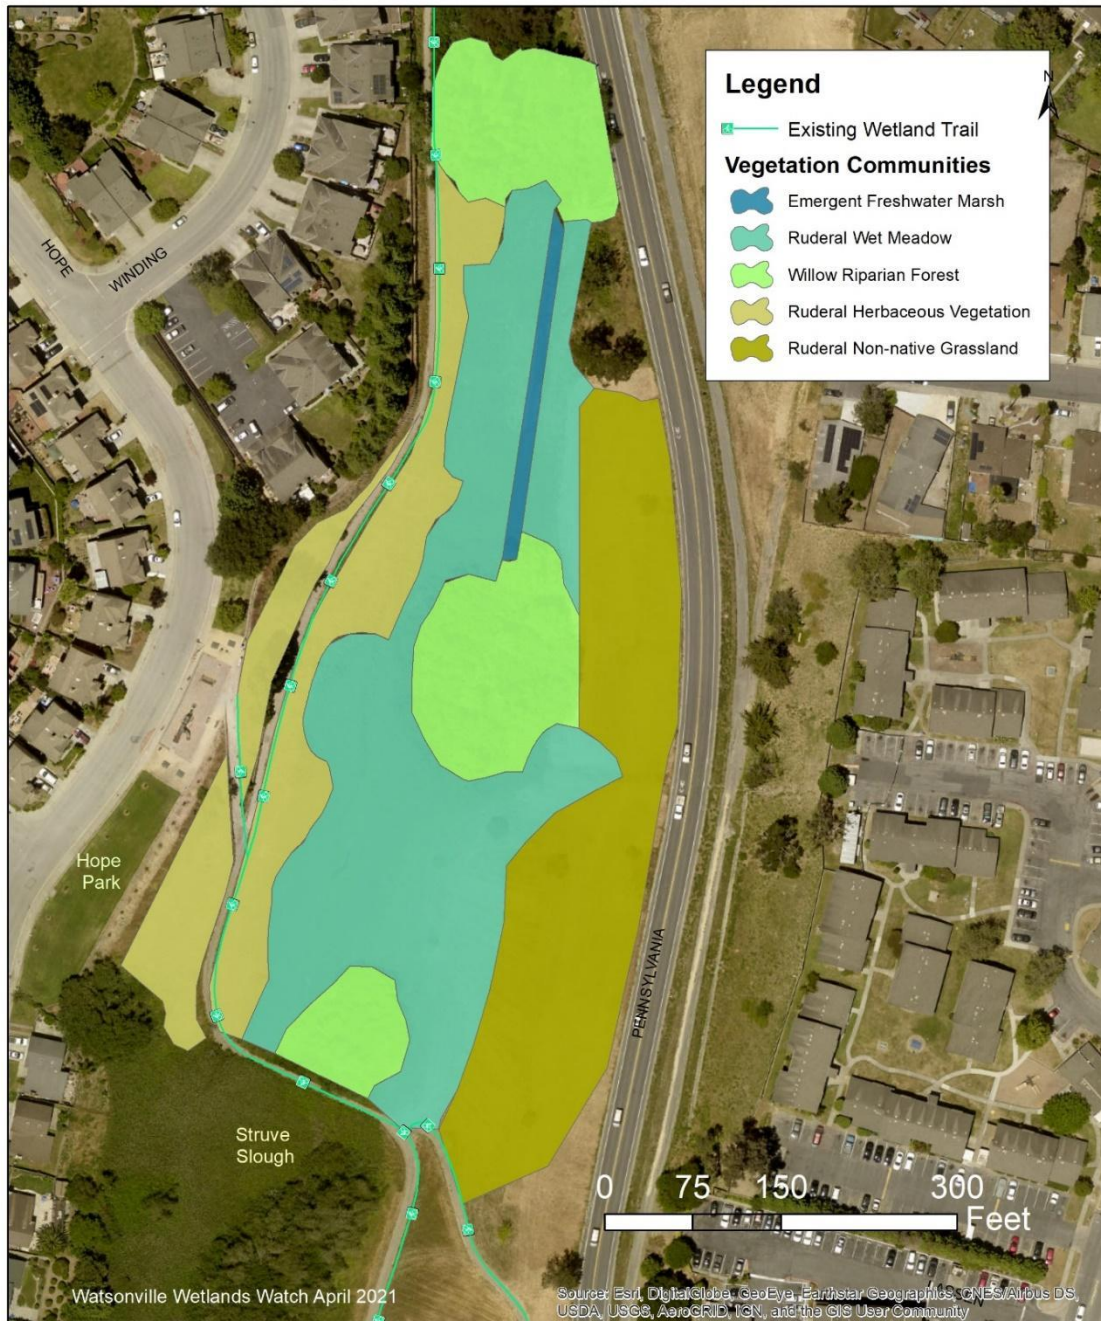
Figure 2. Map of Middle Struve Slough, Vegetation Communities Map

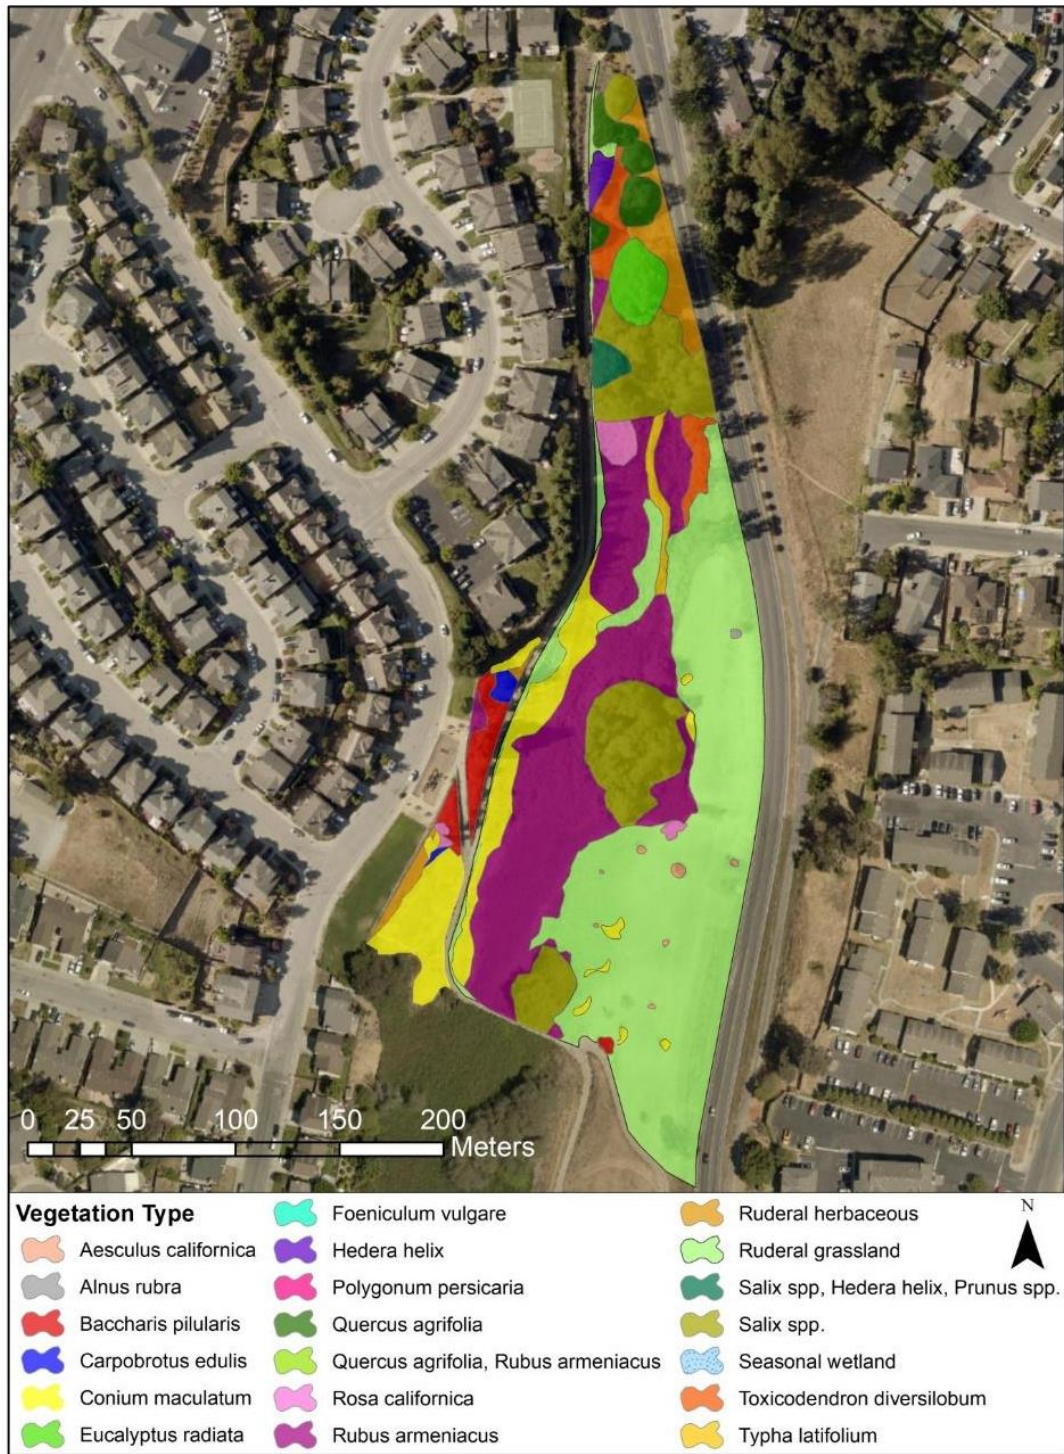
Figure 3. Middle Struve Slough, Plant Species Composition Map, Spring 2019
