# TECHNICAL MEMORANDUM

**To:** Jackie McCloud, Environmental Sustainability Manager, City of Watsonville Public Works Department  
**From:** Sarah Faraola, Environmental Analyst  
**Subject:** Memorandum in Support of a CEQA Categorical Exemption for the City of Watsonville Middle Struve Slough Water Quality and Habitat Enhancement Project  
**Date:** October 29, 2021  
**CC:** Jonathan Pilch, Watsonville Wetlands Watch  
**Att:** A, 100% Design Plans; B, Habitat Enhancement Plan; C, Biotic Report; D, Wetland Delineation; E, Cultural Resources Report; F, Hazardous Waste Sites Database Search Results

## Project Overview

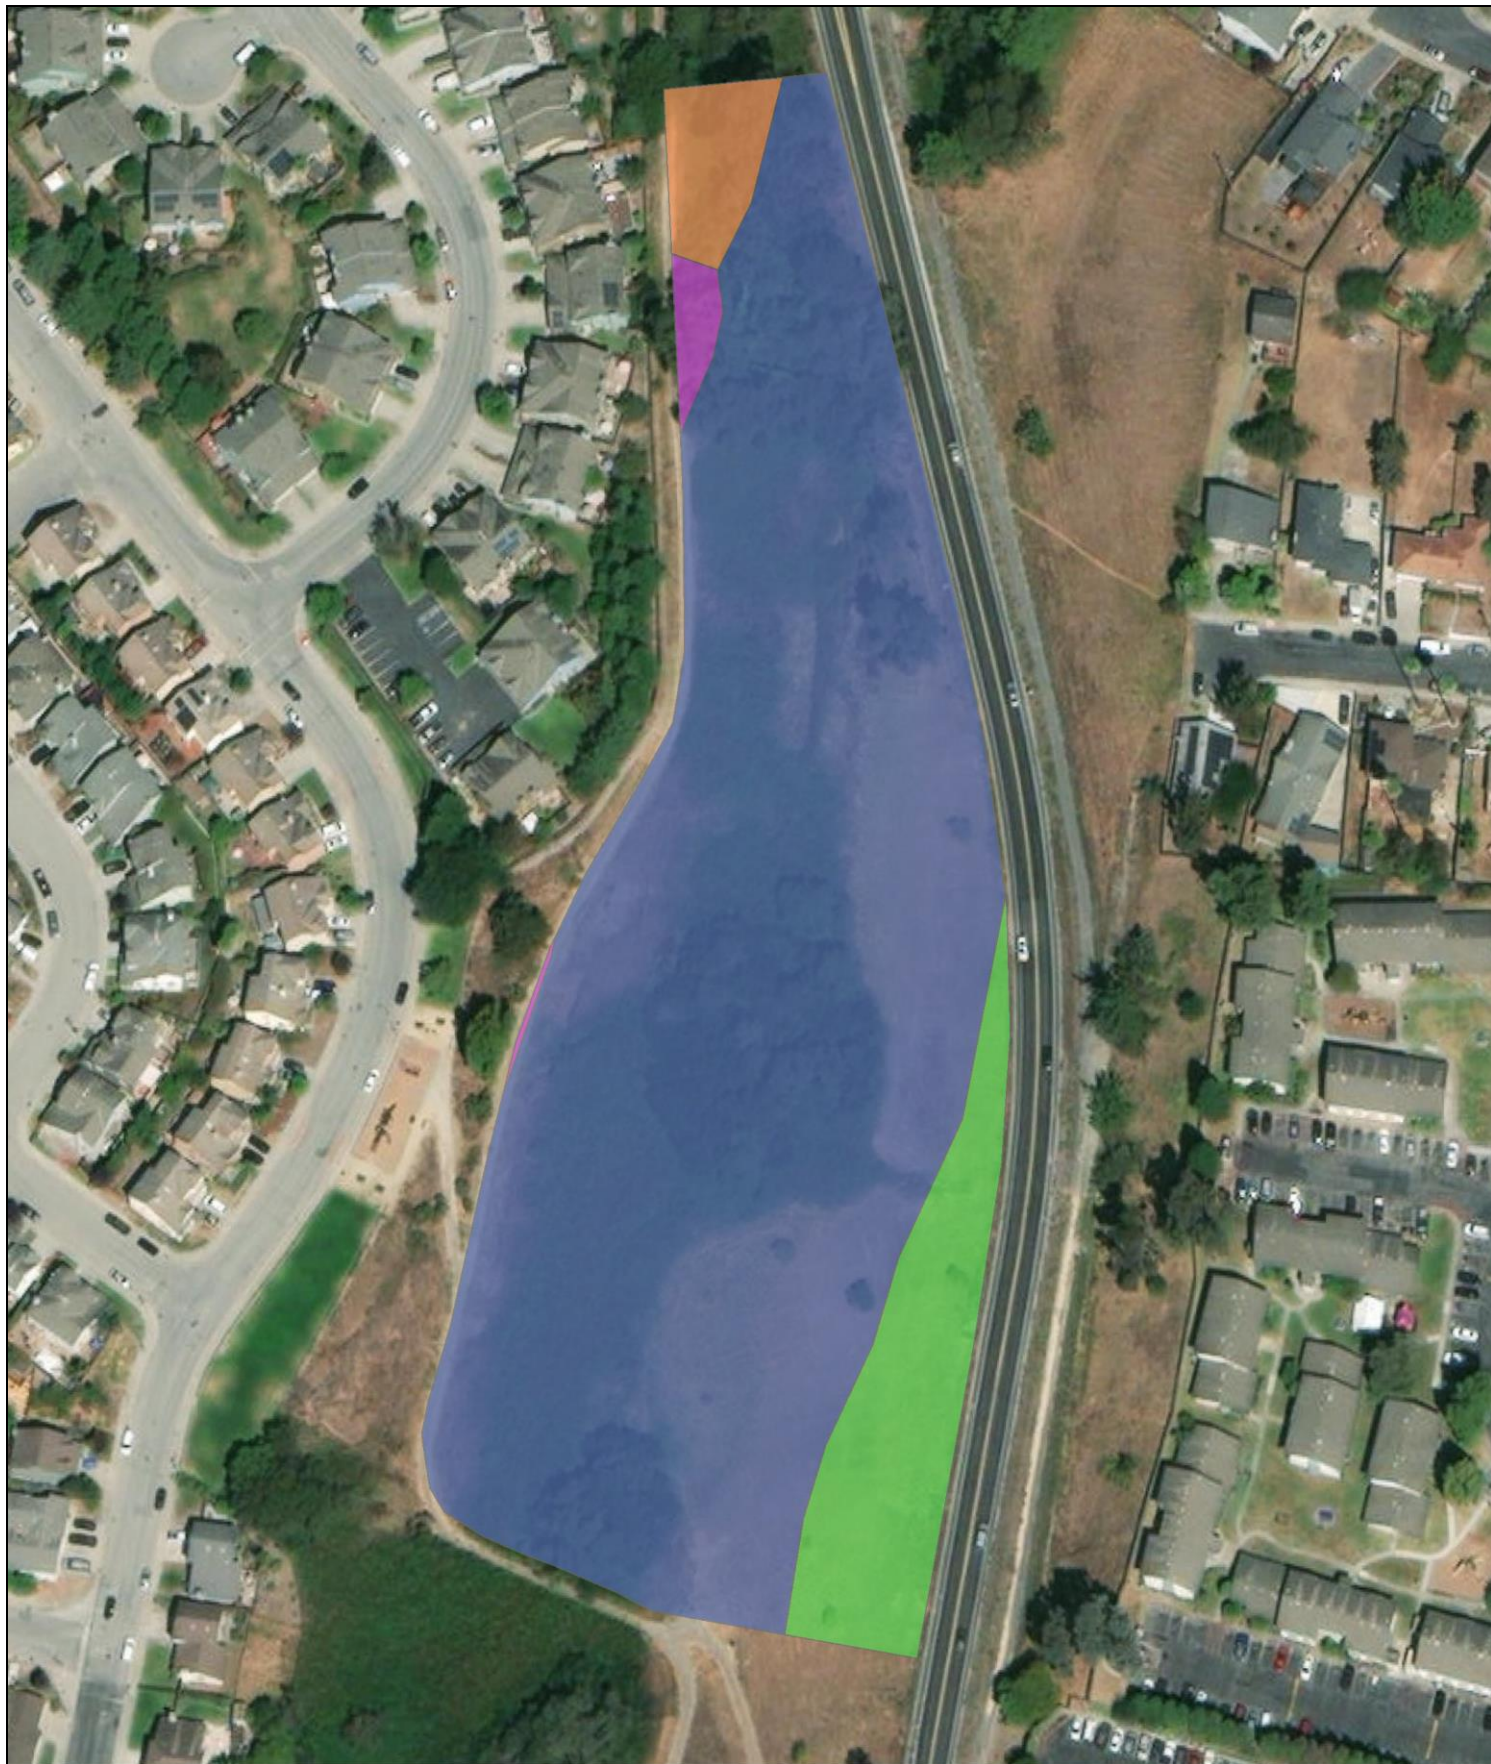
**Figure 3.**

**Soils Mapped within  
Middle Struve Slough  
Wetland Enhancement  
Project Area**

Cropley silty clay is a very deep, moderately well drained soil formed in alluvium from mixed rock sources and found on alluvial fans, floodplains and in small basins. In natural areas this soil type supports grassland and scattered live oak woodland. Cropley clay is commonly used for irrigated row crops, pasture, and fruit trees. The surface layer is typically a very dark gray hard, sticky clay extending to approximately 11 inches. Below this surface layer, soils are dark gray to black with coarse, blocky structure and very fine tubular pores. The shrink-swell potential is very high with cracks up to 2.5 inches extending up to 25 inches deep during the dry summer and fall months. This soil type is considered a hydric soil type by the NRCS in Santa Cruz County. Within the Study Area, this soil type is limited to a band of non-native grassland along the eastern perimeter of the site but likely occurs in non-flooded areas mapped as Aqueuts due to changes in the historic hydrologic regime of the slough.

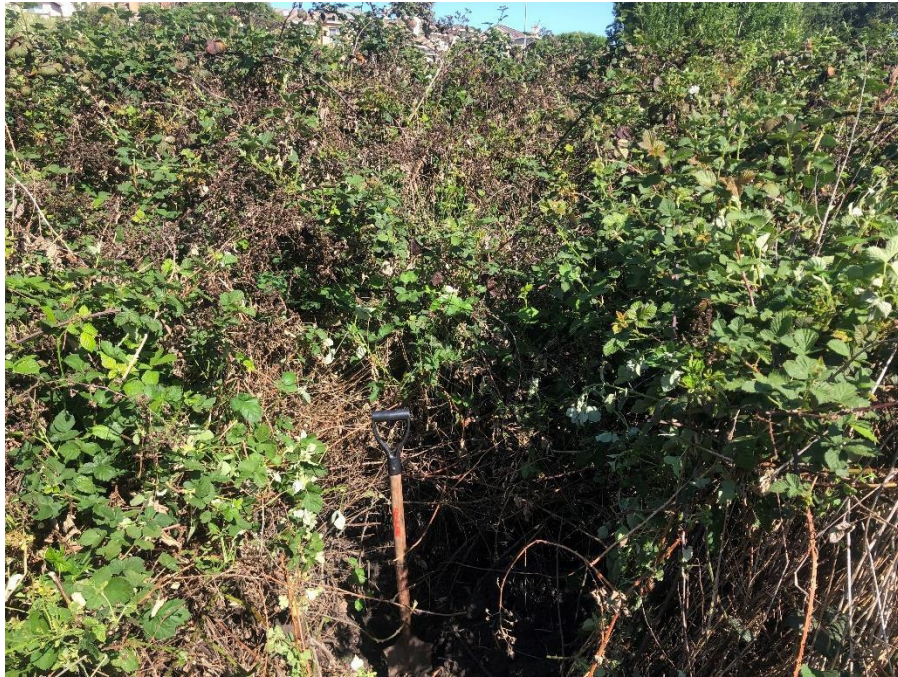
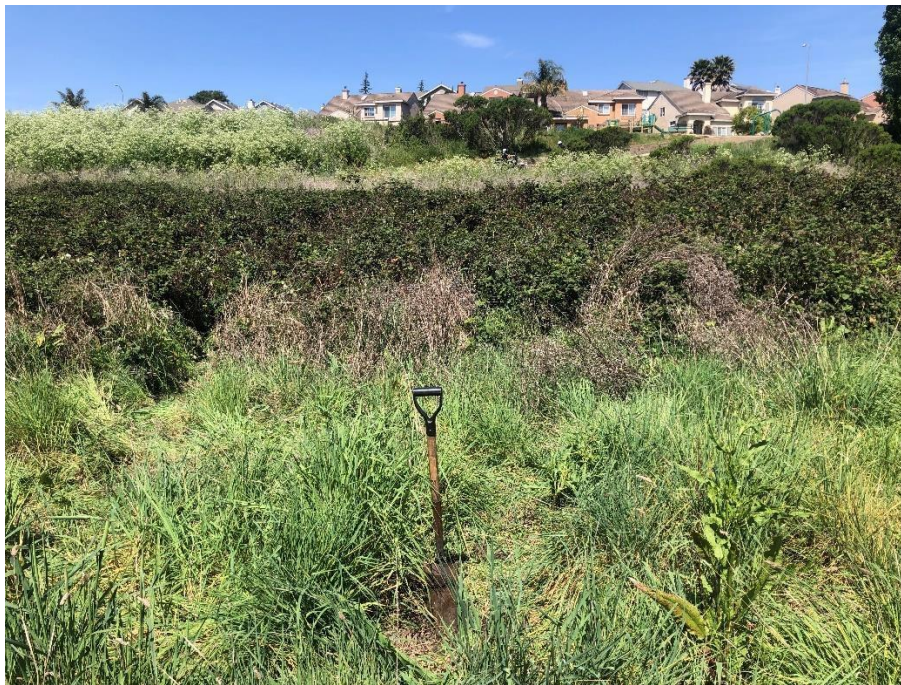
**Above.** Himalayan blackberry wetland sample point (SP-1) looking west (330°) in the southernmost portion of Middle Struve Slough.

**Below.** Paired upland sample point (SP-2)( 290°) immediately east of SP-1 dominated by Harding Grass and other weedy species.

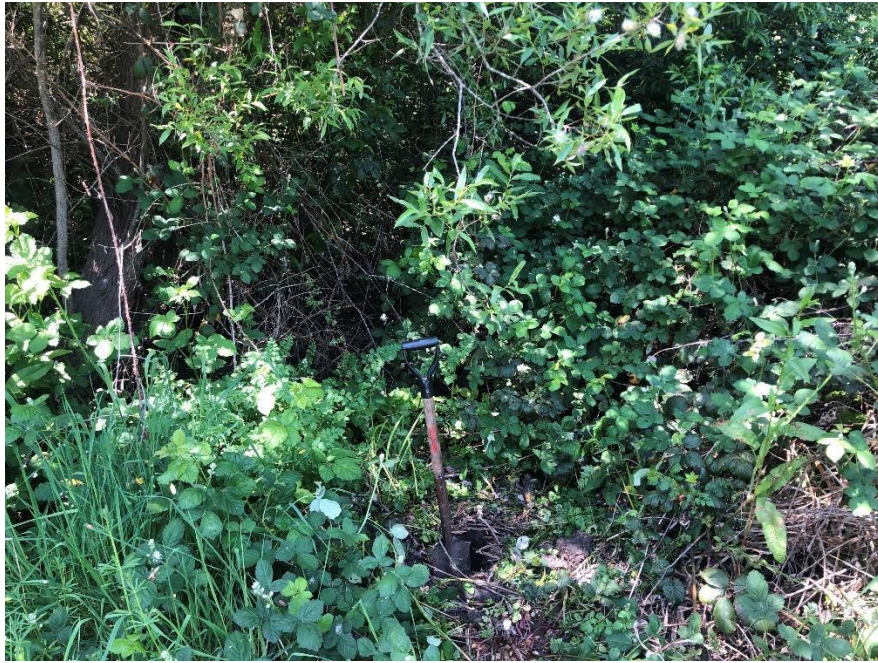
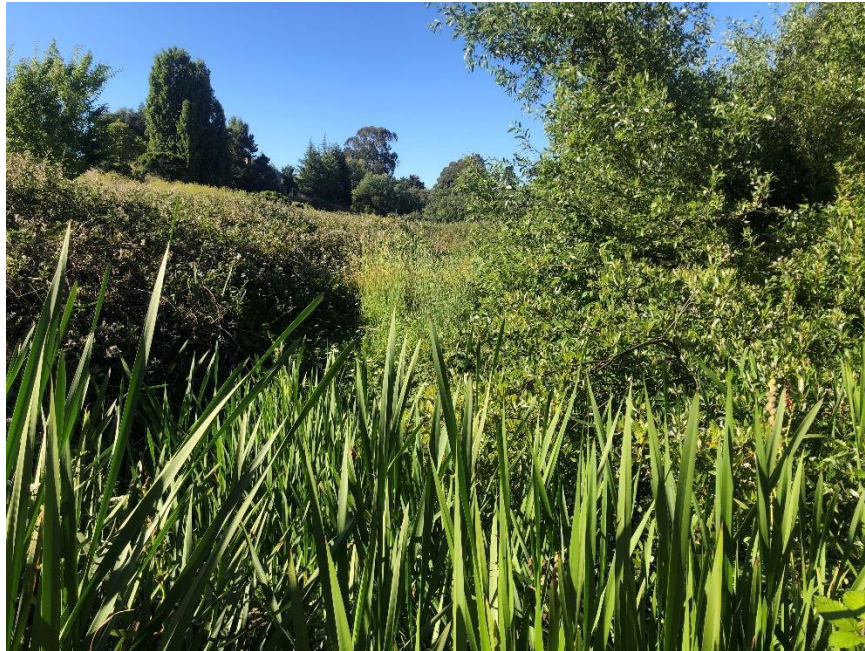
**Above.** Wetland sample point (SP-3)(245°) at edge of mixed willow thicket wetland adjacent to low-flow channel in central portion of the Project Area.

**Below.** Freshwater emergent wetland dominated by cattails along low flow channel immediately south of non-wetland riparian forest.

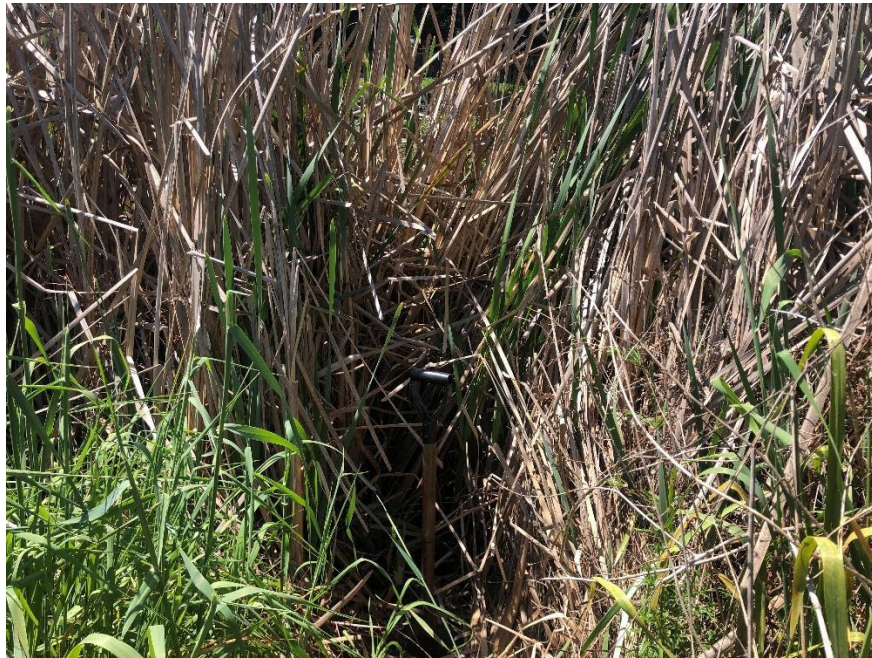
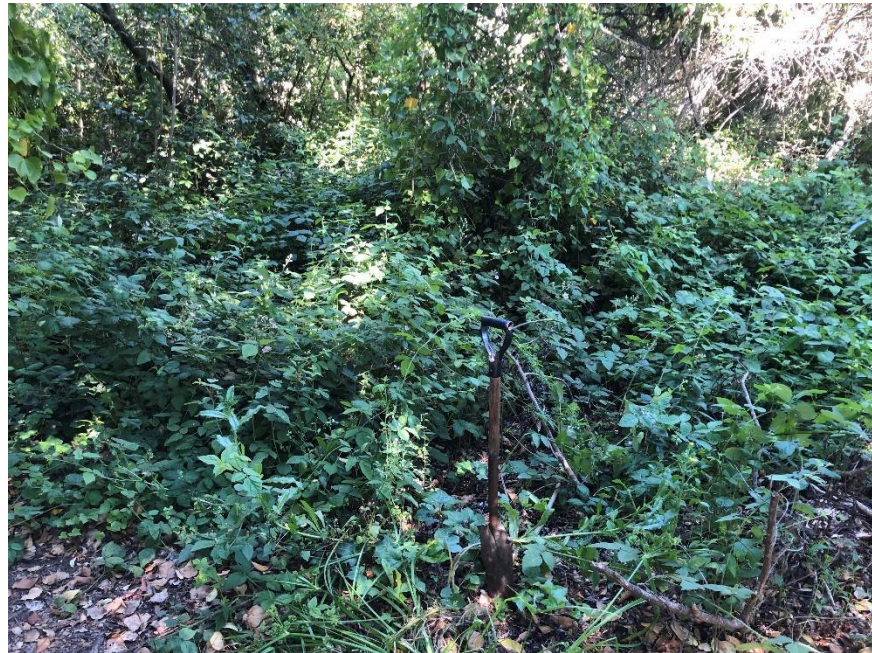
**Above.** Freshwater emergent marsh sample point (SP-5)(280°) along the east edge of cattails along low-flow channel.

**Below.** Non-wetland riparian sample point (SP-9) (90°) in Himalayan blackberry with willow and eucalyptus overstory in northernmost portion of the Project Area.

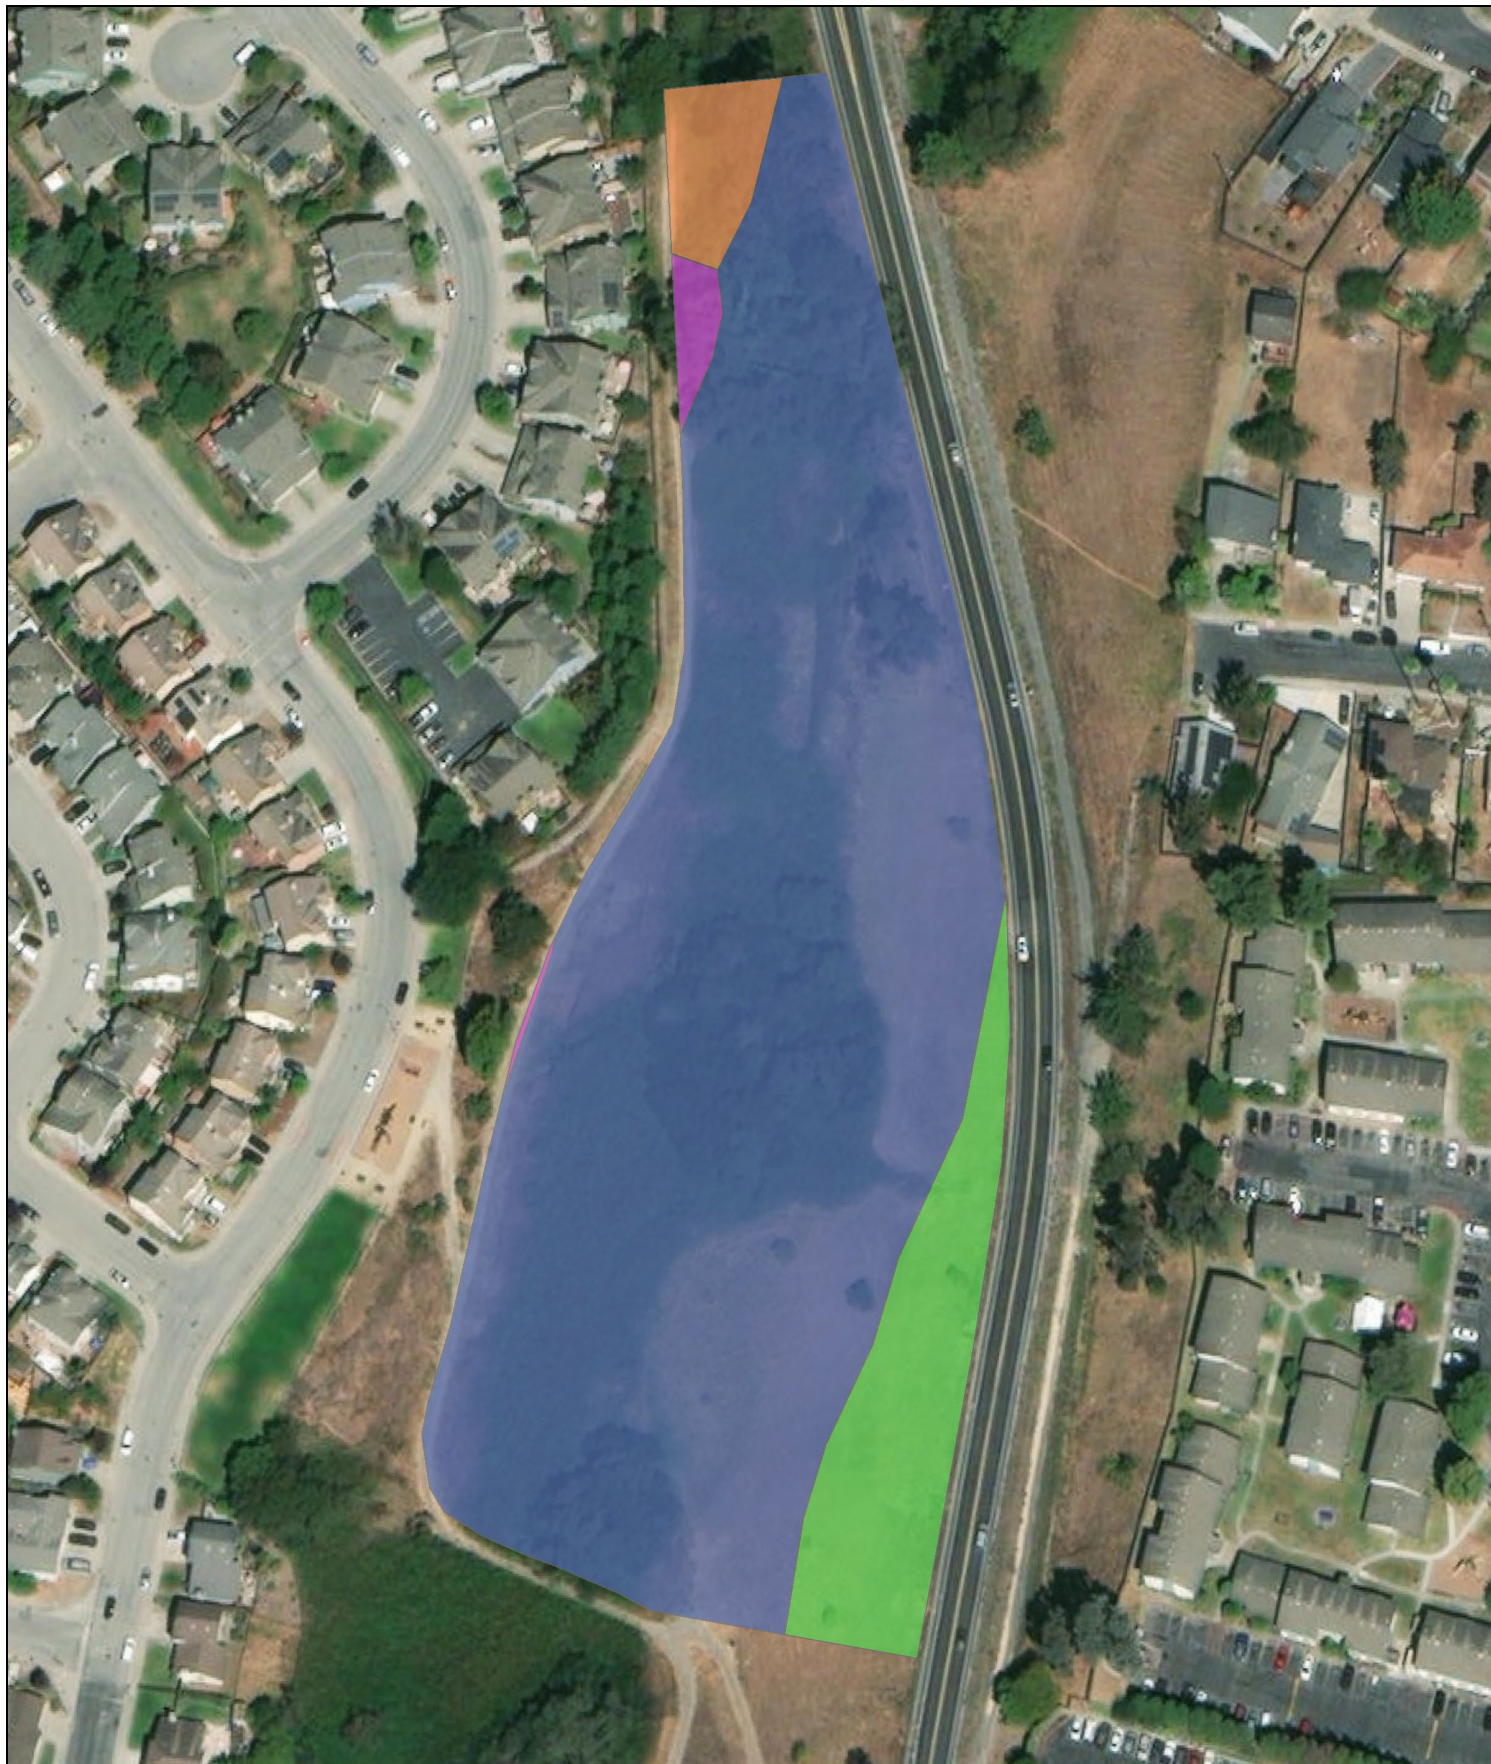
**Figure 3.**

**Soils Mapped within  
Middle Struve Slough  
Wetland Enhancement  
Project Area**

Cropley silty clay is a very deep, moderately well drained soil formed in alluvium from mixed rock sources and found on alluvial fans, floodplains and in small basins. In natural areas this soil type supports grassland and scattered live oak woodland. Cropley clay is commonly used for irrigated row crops, pasture, and fruit trees. The surface layer is typically a very dark gray hard, sticky clay extending to approximately 11 inches. Below this surface layer, soils are dark gray to black with coarse, blocky structure and very fine tubular pores. The shrink-swell potential is very high with cracks up to 2.5 inches extending up to 25 inches deep during the dry summer and fall months. This soil type is considered a hydric soil type by the NRCS in Santa Cruz County. Within the Study Area, this soil type is limited to a band of non-native grassland along the eastern perimeter of the site but likely occurs in non-flooded areas mapped as Aquents due to changes in the historic hydrologic regime of the slough.

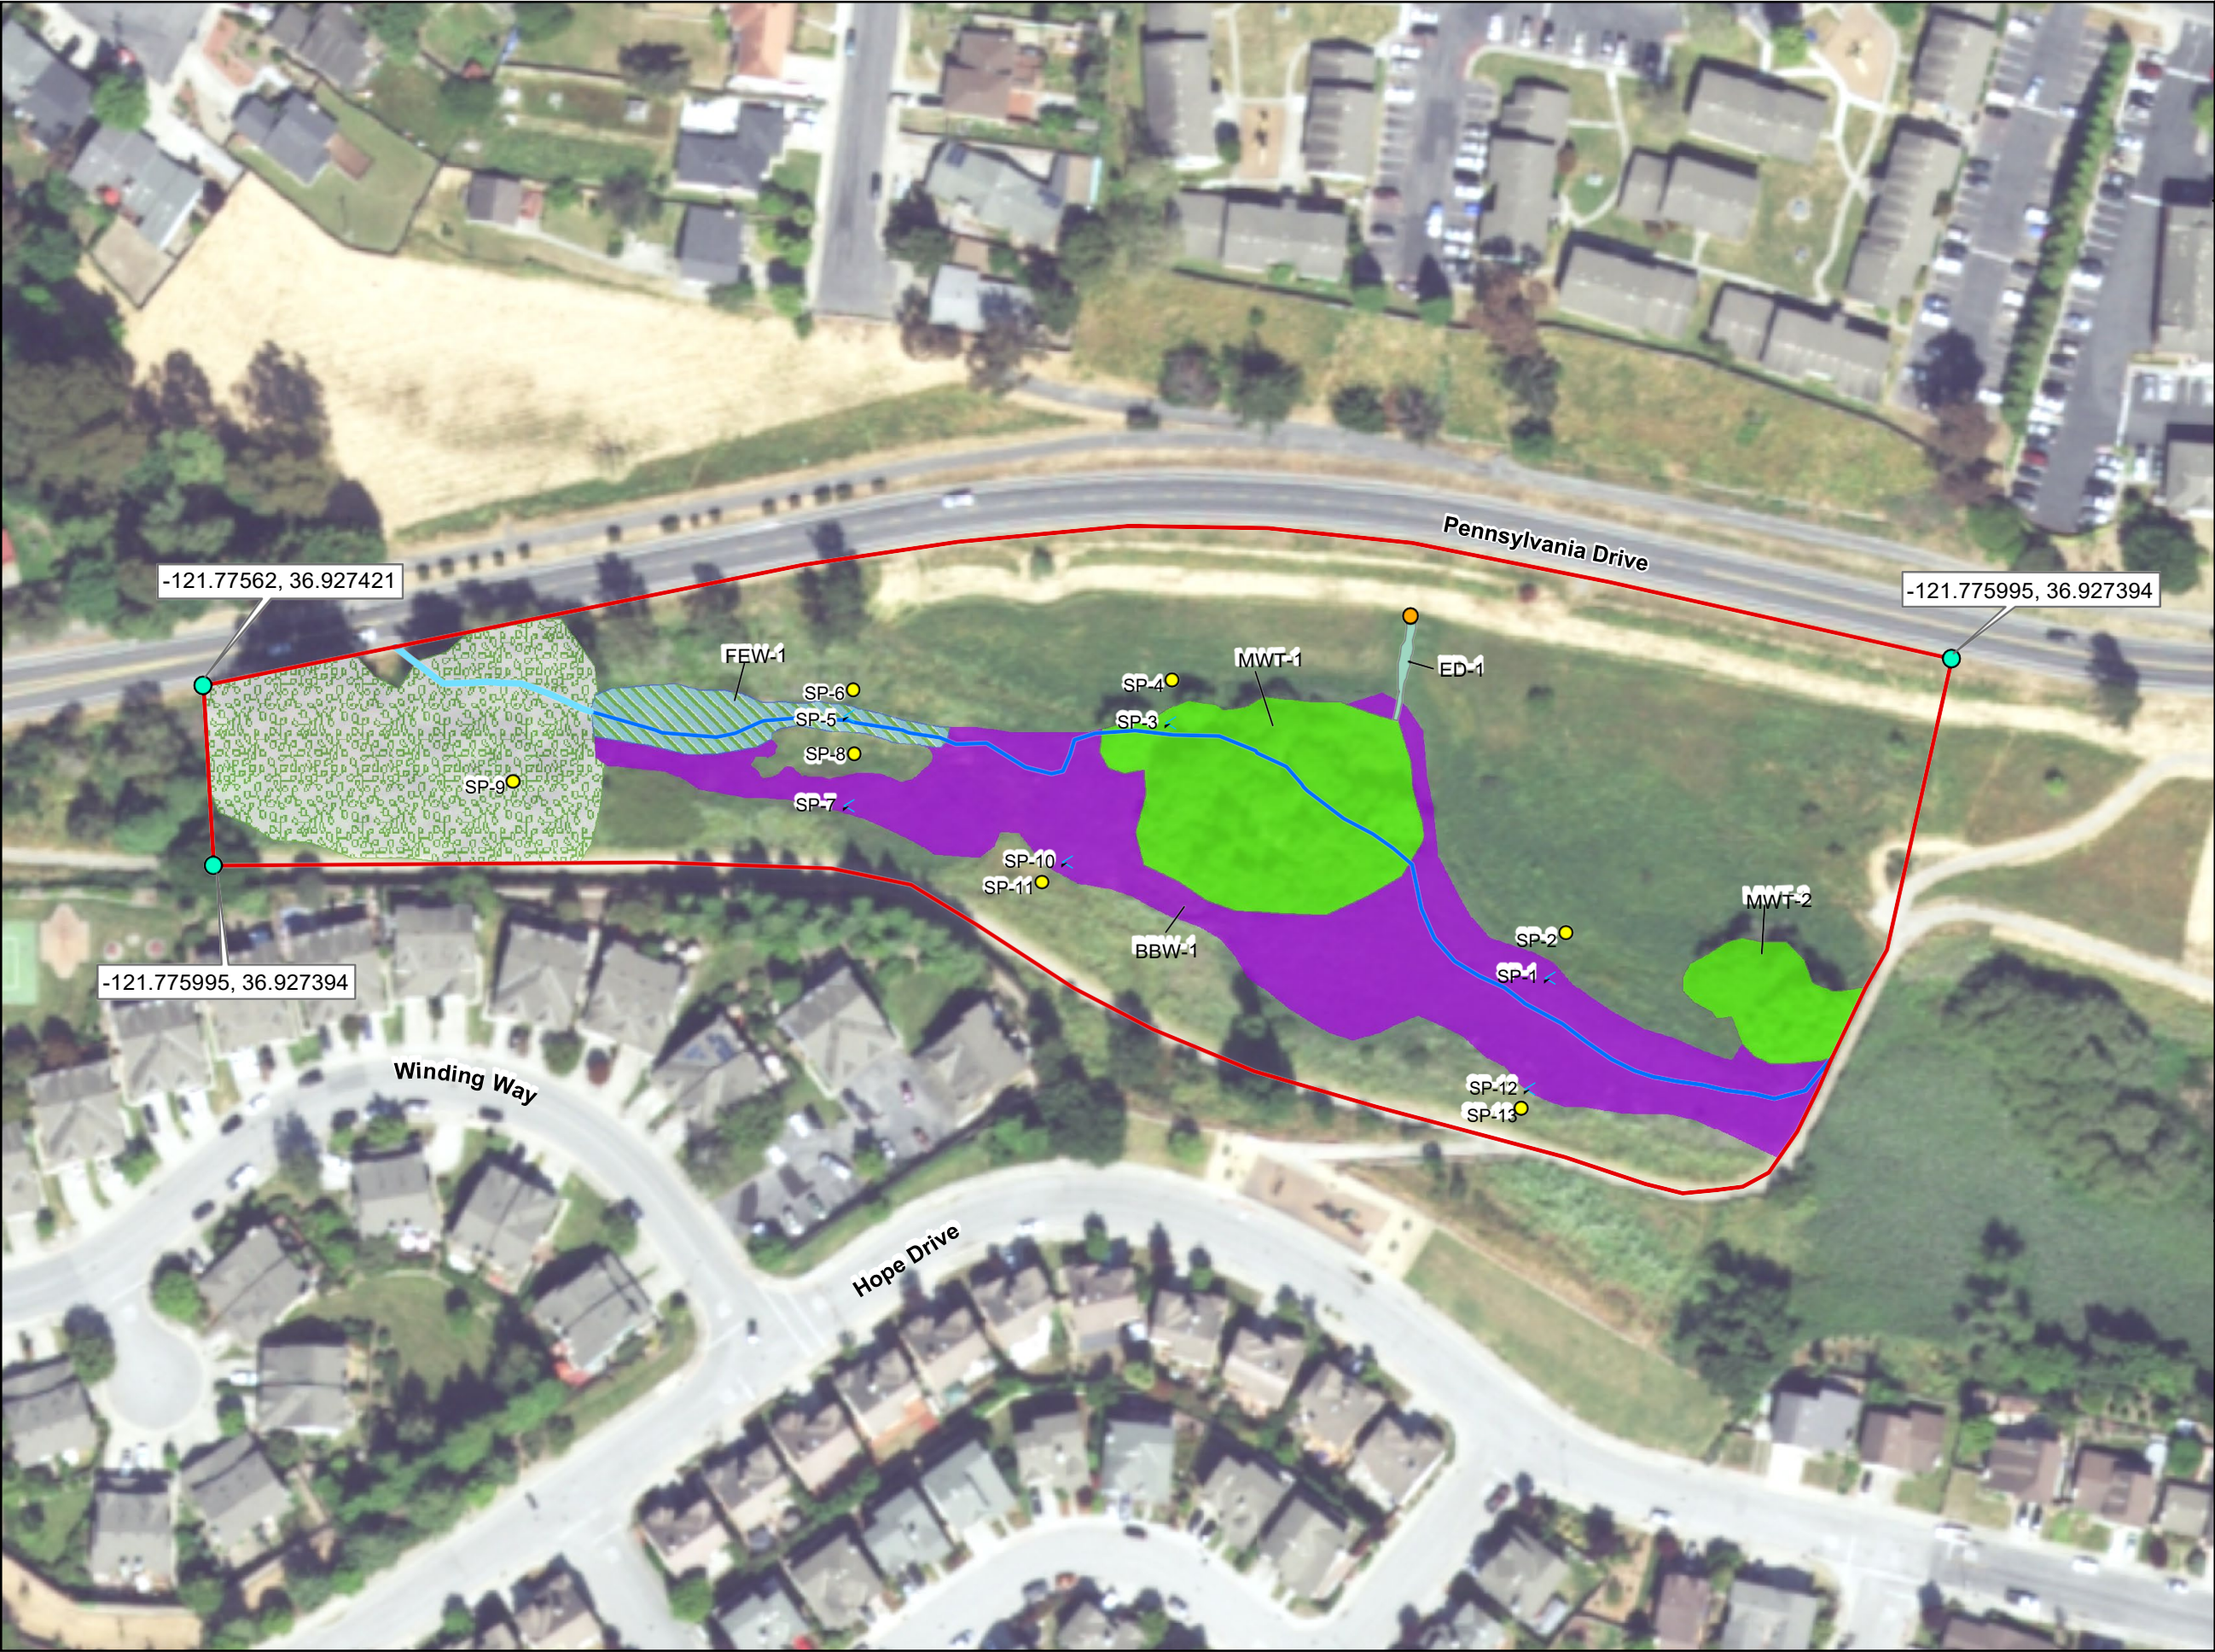
**Appendix A. Map of Potential Jurisdictional Wetlands and Waters of the U.S.  
for the Middle Struve Slough Wetland Enhancement Project Area**

Potential Jurisdictional Wetlands and Other Water of the U.S.

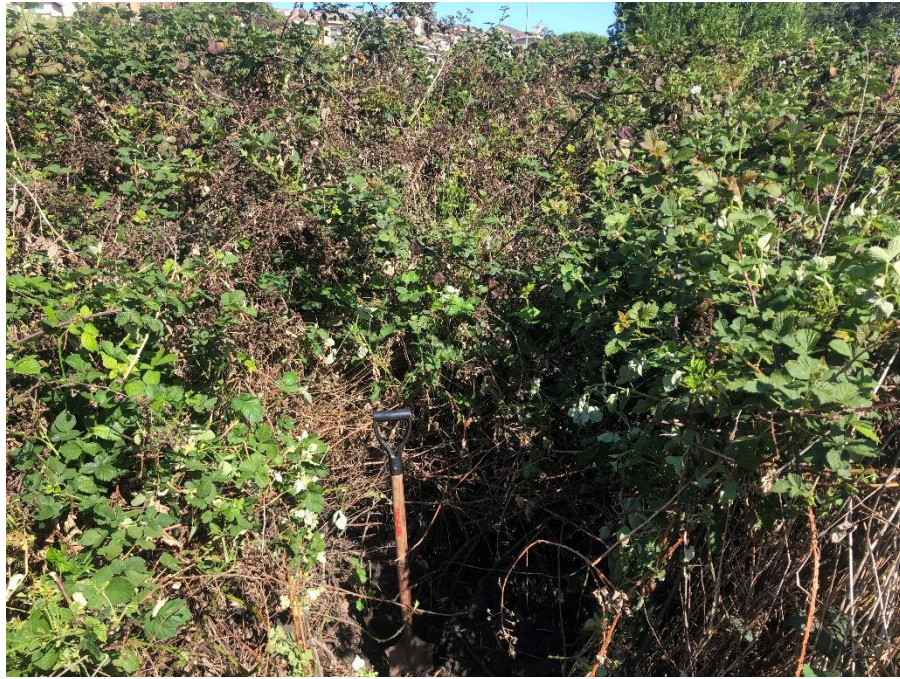
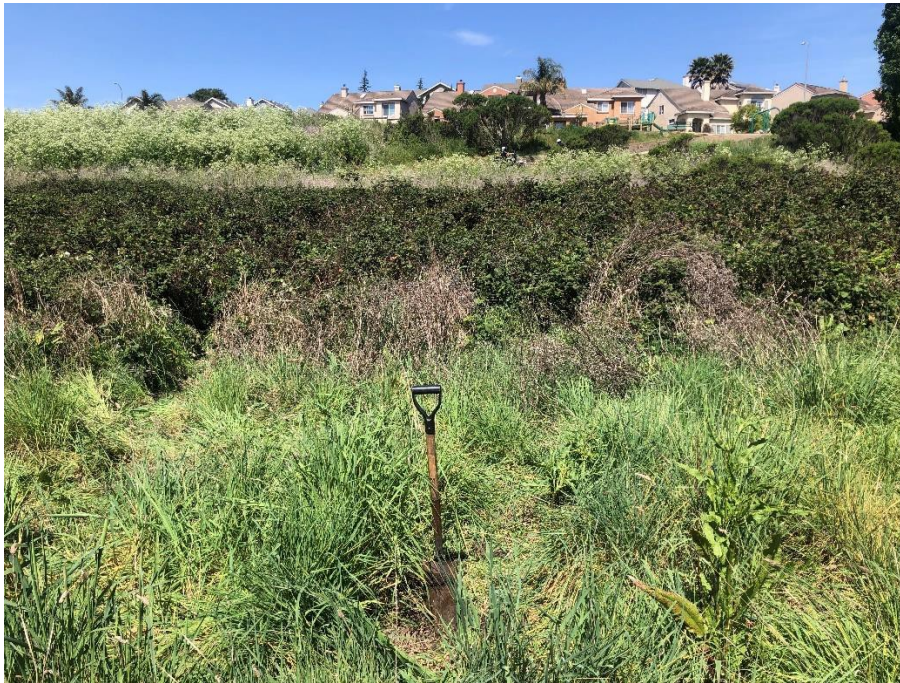
**Above.** Himalayan blackberry wetland sample point (SP-1) looking west (330°) in the southernmost portion of Middle Struve Slough.

**Below.** Paired upland sample point (SP-2)( 290°) immediately east of SP-1 dominated by Harding Grass and other weedy species.

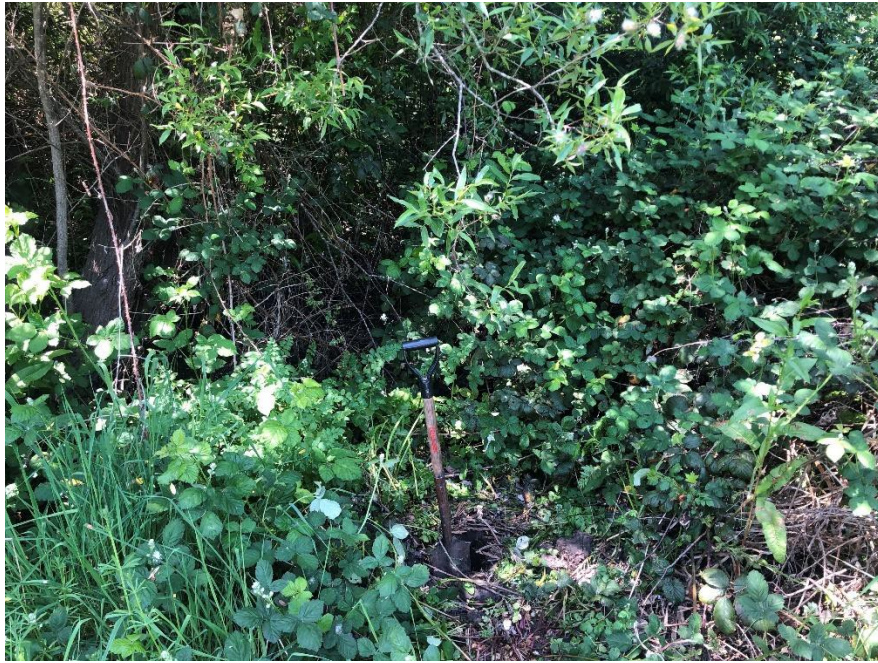
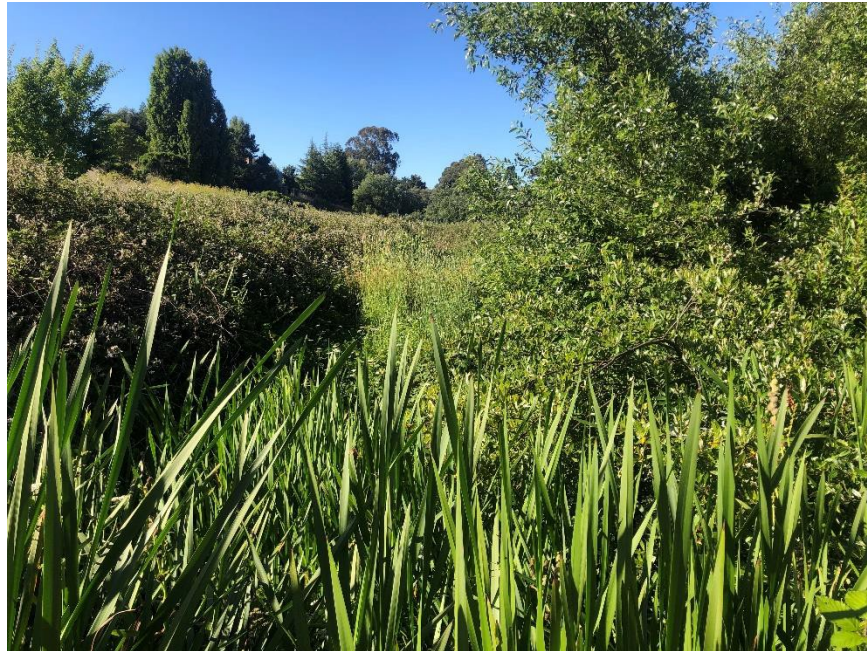
**Above.** Wetland sample point (SP-3)(245°) at edge of mixed willow thicket wetland adjacent to low-flow channel in central portion of the Project Area.

**Below.** Freshwater emergent wetland dominated by cattails along low flow channel immediately south of non-wetland riparian forest.

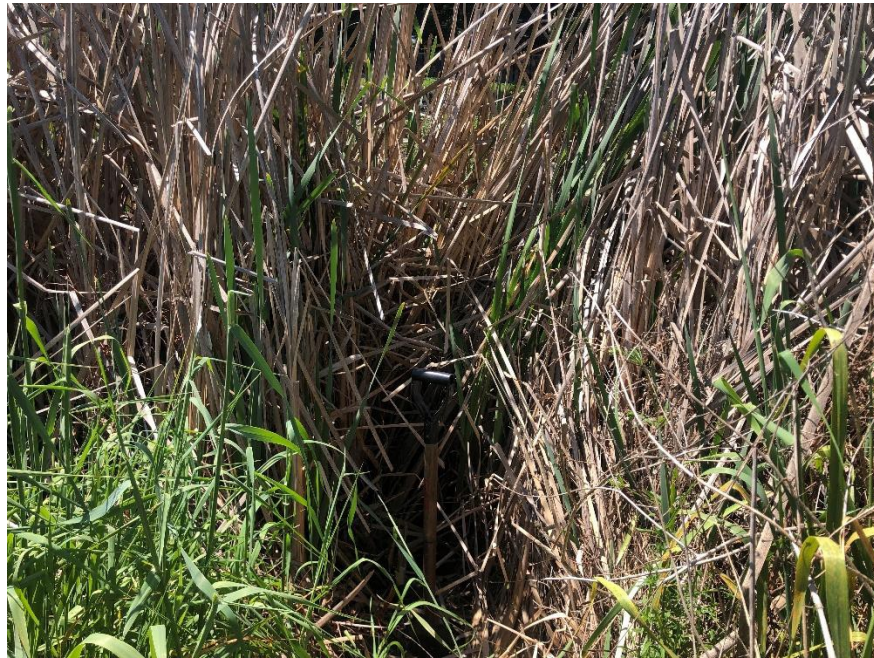
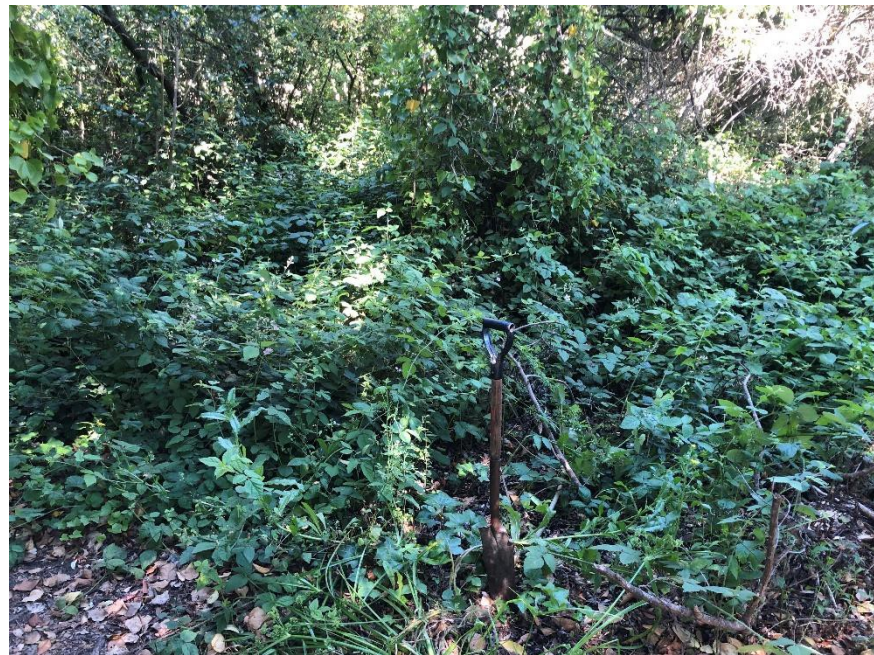
**Above.** Freshwater emergent marsh sample point (SP-5)(280°) along the east edge of cattails along low-flow channel.

**Below.** Non-wetland riparian sample point (SP-9) (90°) in Himalayan blackberry with willow and eucalyptus overstory in northernmost portion of the Project Area.
