Delineation of Potentially Jurisdictional Wetlands and Waters

5145 Calf Canyon Highway

Cannabis Cultivation Land Use Permit

Case No. DRC2018-00234

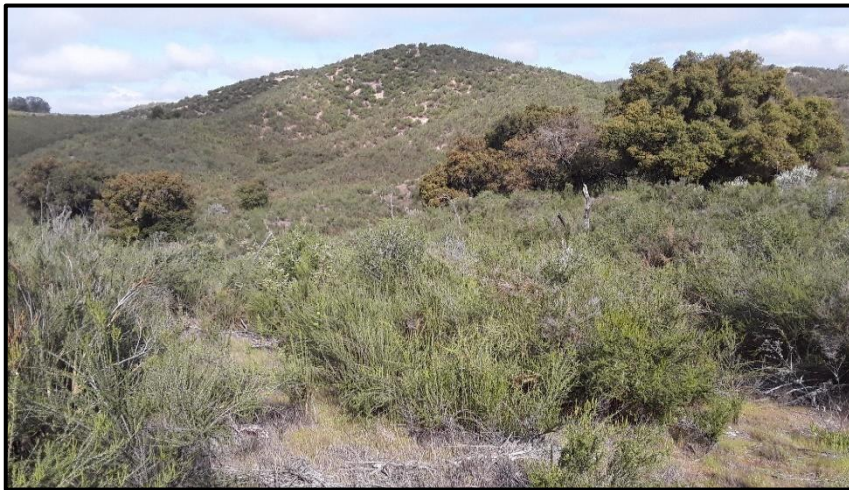
Photo 1. Chamise chaparral habitat typical of the area and dominant habitat in the Study Area, view west. April 17, 2020.

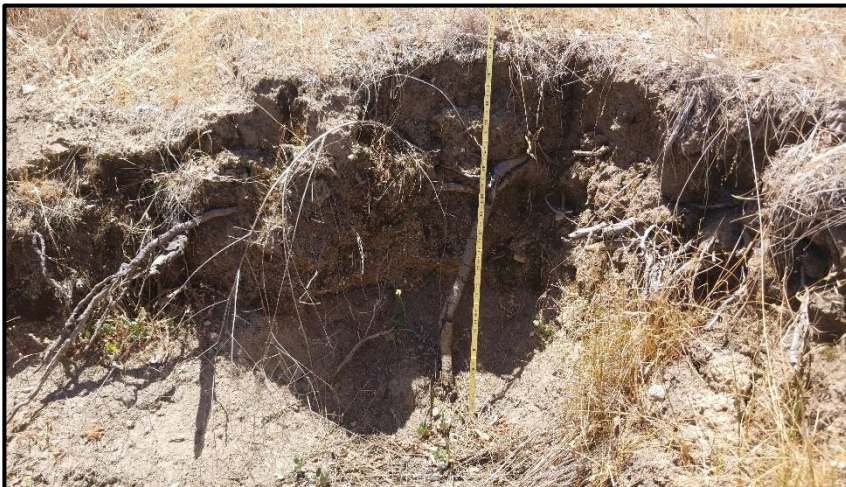
Photo 2. Bowl wetland feature (located upstream from Drainage A) during dry season in below-average average rain year. July 1, 2021.

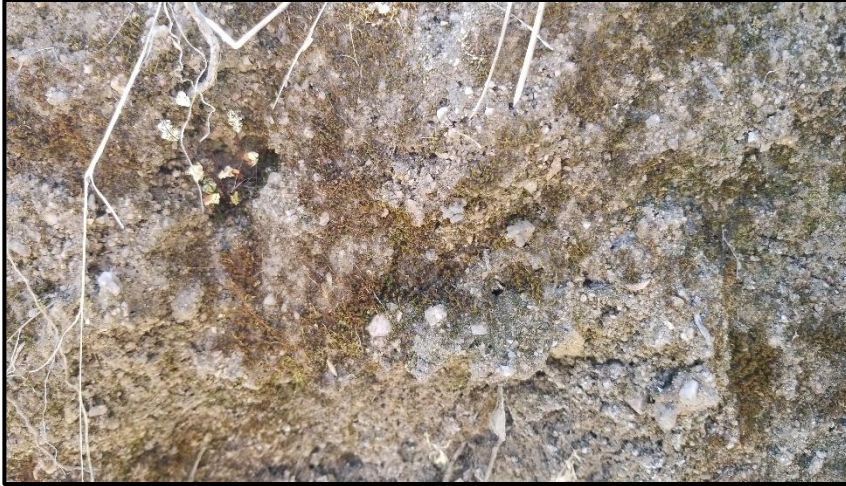
Photo 3. Vertical banks of bowl wetland with mosses. July 1, 2021.

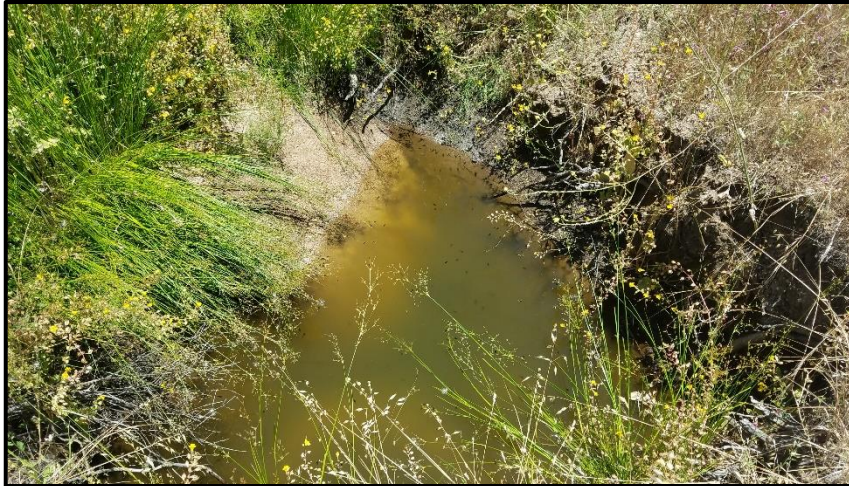
Vegetation passed the dominance test with 67 percent cover by wetland species. In addition to the Dominance Test, the Prevalence Index was calculated to be 2.08. Mariposa rush, a wetland facultative species, was dominant at approximately 25 percent cover. Facultative species common verbena was dominant at 15 percent cover, while obligate species seep monkey flower and wetland facultative species common toadrush were present at lower densities. Due to temporal inundation of the feature, percent bare ground was high in the herb stratum at approximately 50 percent. Moss was noted growing in high density on the steep banks of the feature, indicative of wetland function.

Photo 4. Wetland bowl feature with wetland facultative species, mariposa rush, and ponded water. June 17, 2019.

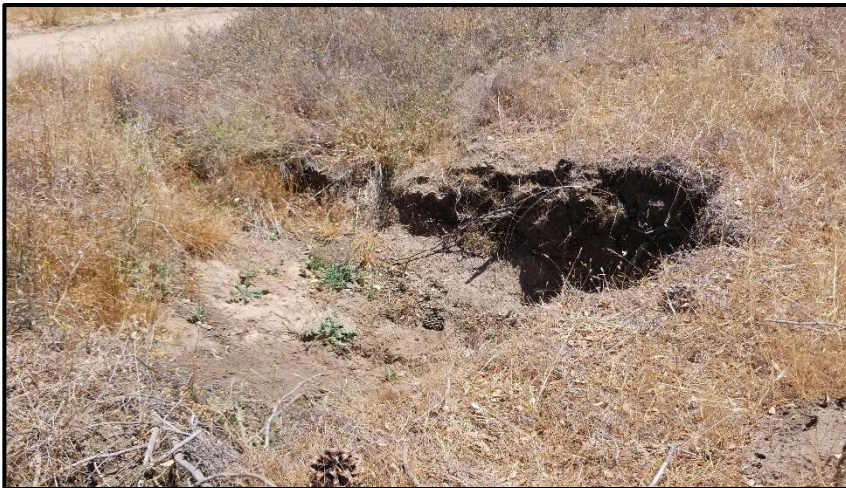
Photo 5. Wetland bowl feature during dry season in below-average average rain year. July 1, 2021.

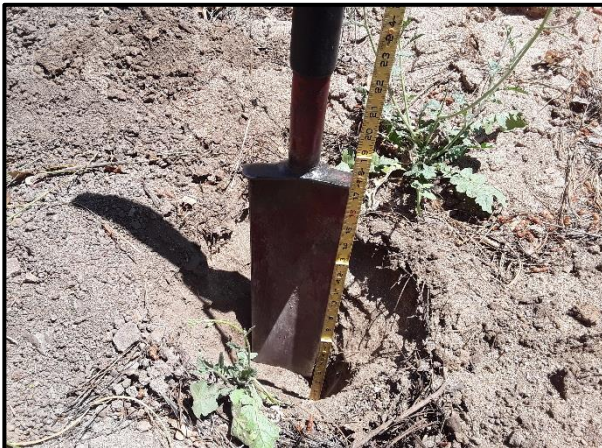
Wetland Pit 1 (WP1) was excavated at the northern end of the Study Area, upstream from Drainage A (Exhibit A). WP1 is a small, slumped feature with an area of approximately 19 square feet and a 4-foot depth. This bowl wetland has ponded water during the wet season (Photo 4) but was dry during the early July 2021 investigation (Photo 5). Soils are sandy in the 0–4-inch horizon, with sandy clay loam texture increasing with depth from 4 to 14 inches. A reduced matrix was observed throughout sampled soil peds, with redox features at 15 percent within the top 10 inches and increasing to 30 percent in the 10- to 14-inch depth horizon (Photo 6 and Photo 7).

Photo 6. Excavation of Wetland Pit 1, during dry season. July 1, 2021.

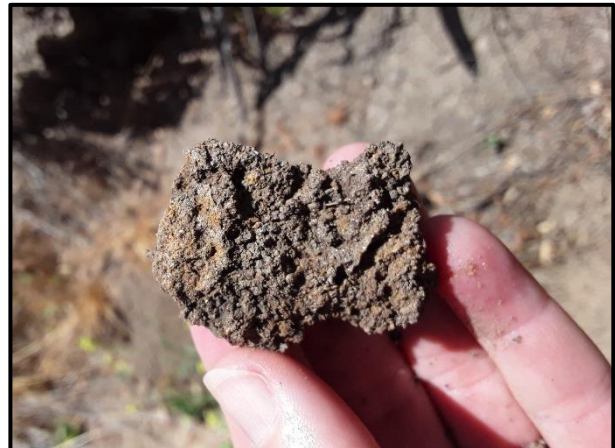
Photo 7. Soil ped with a reduced matrix taken from 10–14 inch depth at Wetland Pit 1. July 1, 2021.

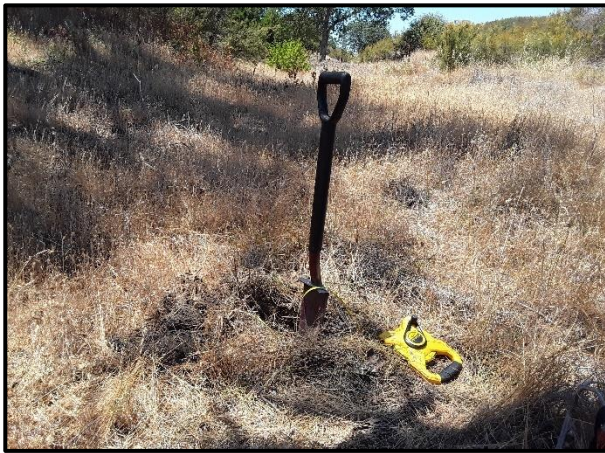
Wetland Pit 2 (WP2) was excavated adjacent to WP1 to determine the extent of the bowl wetland feature (Photo 8) (Exhibit A). Hydric soils were described as having 10 percent sandy redox with sandy clay loam texture (Photo 9). This portion of the Study Area has been defined by greener vegetation compared with surrounding upland habitat, suggesting potential wetland habitat (Photo X). Beardless wildrye (*Elymus triticoides*) is not listed in the National Wetland Plant List (USACE 2018) but occurs in wetlands and non-wetlands, therefore suggesting potential wetland habitat extending upstream from Drainage A. Wetland hydrology was not present; however, the absence of hydrologic factors could be a result of climatic conditions (refer to Section 1.3.4). This portion of the Study Area may have diminishing wetland habitat no longer defined by all three determining factors. Because this area has hydric soils and presence of potential hydrophytic vegetation, we can assume a minimum 2-parameter wetland extends west from Drainage A (Photo 10).

Photo 8. Excavation of Wetland Pit 2, upland from bowl wetland feature with dominant species beardless wild rye (*Elymus triticoides*). July 1, 2021.

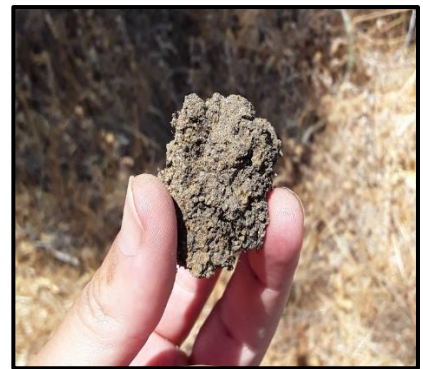
Photo 9. Soil ped with redoximorphic features from Wetland Pit 2, sample taken from 10-inch depth. July 1, 2021.

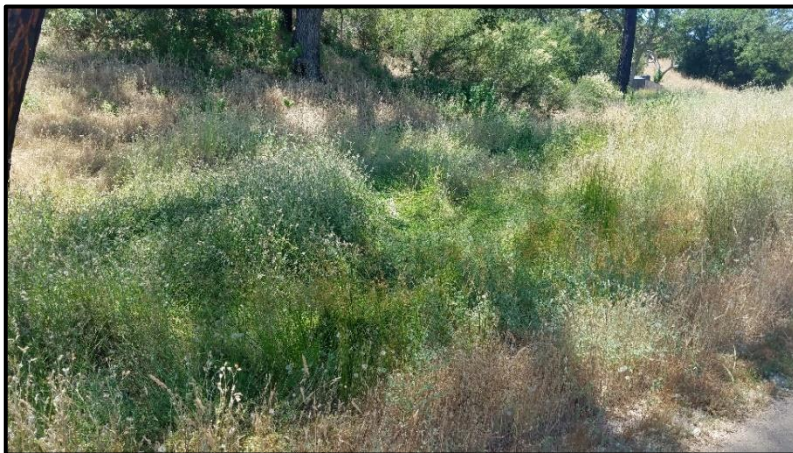
Photo 10. Two-parameter wetland habitat at WP2 extending west of WP1 and Drainage A. Feature is defined by green facultative vegetation, beardless wild rye, and hydric soils, view southwest. June 17, 2019.

Directly west of, and adjacent to, the bowl wetland is a depressional feature that may have once supported wetland habitat but no longer functions as a 3-parameter wetland. Hydric soils and non-listed facultative vegetation (beardless wild rye) suggest a 2-parameter wetland is present and that the absence of hydrologic indicators may be correlated with climatic drought conditions over the past decade. Two-parameter wetlands are no longer considered jurisdictional by the State and are not included in our calculations for wetland habitat.

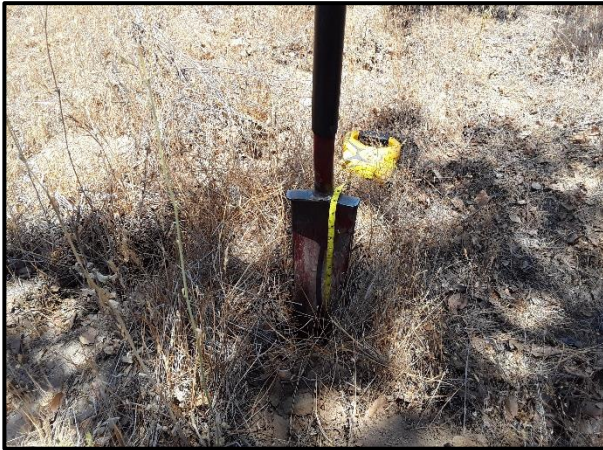
Wetland Pit 3 (WP3) was excavated east of WP1 within the thalweg of ephemeral Drainage A (Photo 11) (Exhibit A). WP3 consisted of sandy loam soils with a reduced matrix over four inches depth. Trace redox features were observed throughout, varying in percent concentrations within the matrix (Photo 12). Soils were dry with high infiltrative sand content in the upper horizon. Vegetation did not pass the dominance test, with only 17 percent facultative dominant species of common verberna. Drainage patterns of small, incisional rills were noted secondary hydrologic indicators. This portion of Drainage A is representative of the ephemeral channel and does not support wetland habitat.

Photo 11. Wetland Pit 3 excavated in Drainage A with no hydrophytic vegetation. July 1, 2021.

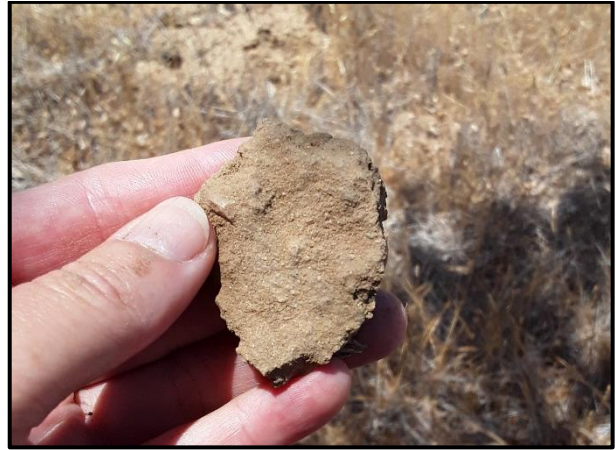
Photo 12. A subtly reduced matrix in soil ped from Wetland Pit 3, sample taken at 4-8 inches depth within Drainage A. July 1, 2021.

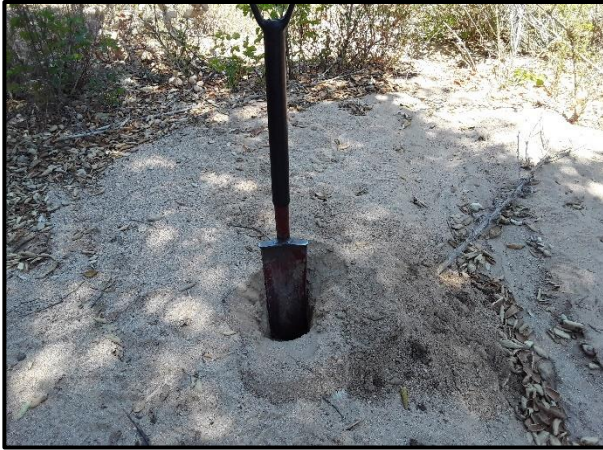
Wetland Pit 4 (WP4) was excavated from the thalweg of Drainage B (Photo 13) (Exhibit A). Dry sandy loam soil at WP4 has a naturally high chroma with depleted matrix in the top 12 inches of the soil profile (Photo 14). Drainage patterns were noted as secondary hydrologic indicators. Chamise (*Adenostoma fasciculatum*), poison oak (*Toxicodendron diversilobum*) and deerweed (*Acmispon glaber*) were dominant vegetation in the shrub and herbaceous strata, totaling 40 percent cover by upland species. Hydrophytic vegetation was not present at WP4.

Photo 13. Wetland Pit 4 in Drainage B with dry soils and sandy substrate of 50 percent bare ground. July 1, 2021.

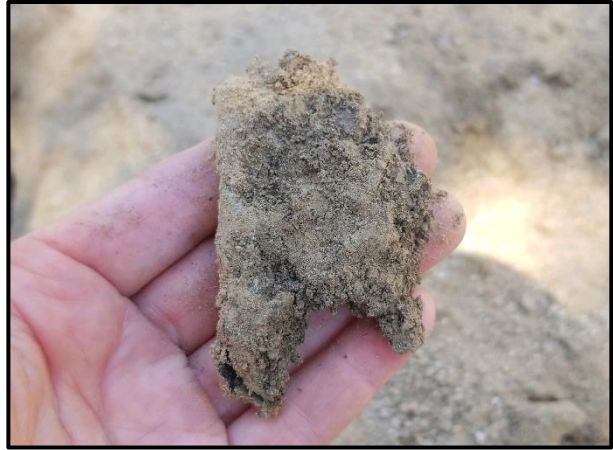
Photo 14. Depleted matrix in Wetland Pit 4, sample taken at 6-12 inches depth from Drainage B. July 1, 2021.

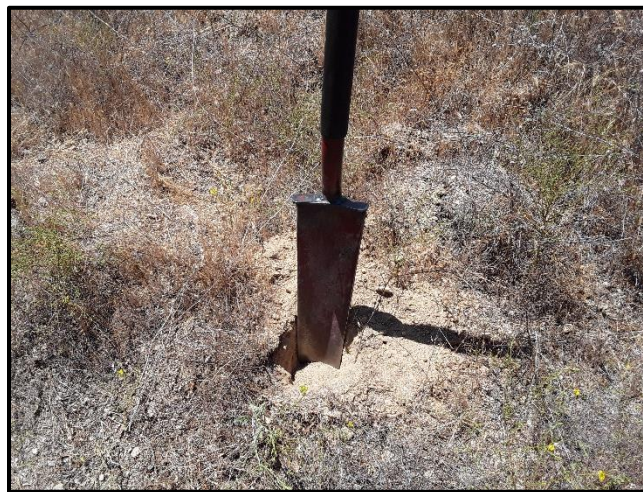
Upland Pit 5 (UP5) was sampled adjacent to WP2, just north of the 2-parameter wetland boundary (Photo 15) (Exhibit A). UP5 is a dry, sandy loam and decomposed granitic soil to 10 inches depth with no hydric soil indicators. Abundant fine roots are present in the top three inches. Upland plant species red brome (*Bromus rubens*) and clustered tarweed (*Deinandra fasciculata*) dominated the vegetation canopy at 40 percent cover. Hydrophytic vegetation was not present at UP5, and no wetland hydrology was observed.

Photo 15. Upland Pit 5 with no signs of hydric soils, wetland hydrology, or hydrophytic vegetation. July 1, 2021.

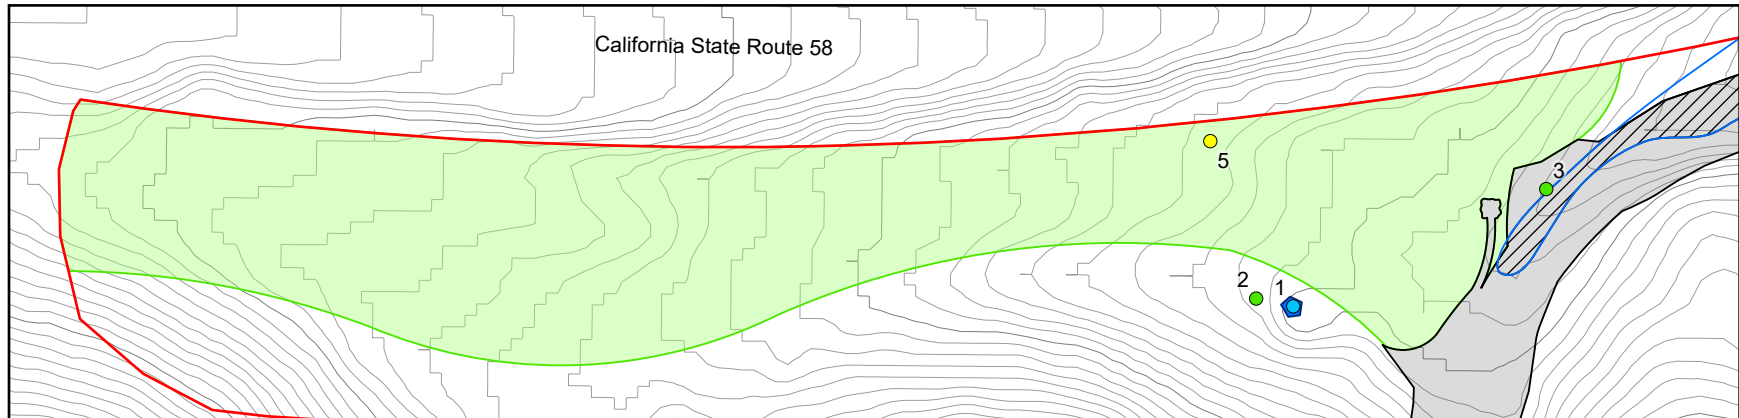
Exhibit B. Restoration Area and Impacts

Approximately 0.08 acre (or 3,485 square feet) of non-wetland Waters of the State would be impacted by the proposed Project (Exhibit B). To compensate for impacts to jurisdictional waters, we recommend implementation of a 3:1 mitigation for associated impacts through restoration. The existing access road entrance in the northeast portion of the Study Area will be abandoned as a result of the new driveway approach. The applicant proposes restoration of this approximate 0.40-acre area (Restoration Area) to offset impacts to ephemeral Drainage A, which would exceed the proposed 3:1 mitigation requirement by 0.1 acre (Exhibit B). The Restoration Area, adjacent to Drainage A and the Bowl Wetland feature, can act as suitable mitigation by stabilizing upland habitat through revegetation of the old access road, thereby reducing sedimentation input and protecting water quality. Restoration will consist of decompacting the existing access road and revegetating the 0.40-acre area. Revegetation will include a combination of seeding (hand-broadcasted and/or drill-seeded, where feasible) and planting of native species suited to the surrounding habitats. A Disturbed Area Stabilization Plan (DASP) will be prepared which will include a timeline for restoration, methods for implementation, an approved seed mix for revegetation, reporting requirements, and best management practices (BMPs) required to promote erosion control and bank stability. The DASP shall be submitted and approved by the Water Board prior to implementation.

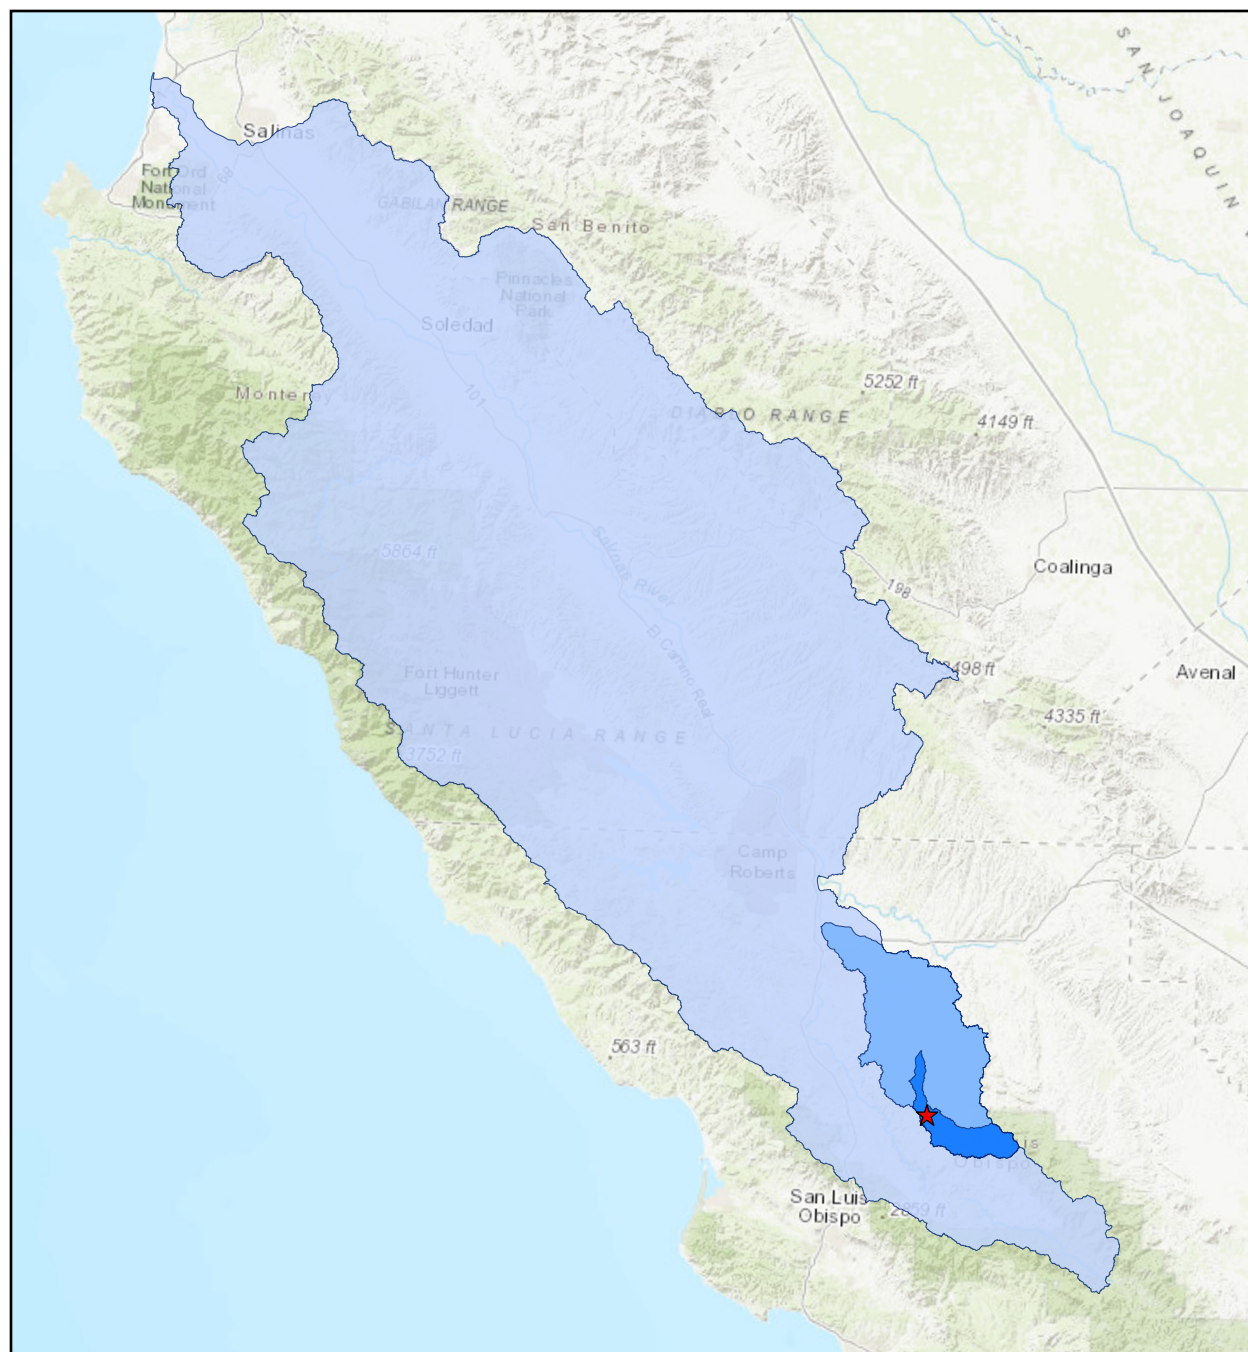
Figure 5. Hydrologic Unit Codes

- ★ Project Location
- 180600050302 (Middle Branch Huerhuero Creek)
- 1806000503 (Huerhuero Creek)
- 18060005 (Salinas)

The USGS and United States Department of Agriculture (USDA)-Natural Resource Conservation Service (NRCS) developed nationally consistent watershed boundaries, as shown in Figure 3, Figure 4, and Figure 5. The Study Area is in the Middle Branch Huerhuero Creek subwatershed 12-digit hydrologic unit, Hydrologic Unit Code (HUC) 180600050302, with a total area of 16,990 acres. This subwatershed is located in the southern portion of the Huerhuero Creek parent watershed, which is bound by the La Panza Range within the Los Padres National Forest land immediately to the south of the Property, with the Santa Lucia Range to the west, Coastal Range to the north, and Temblor Range to the southeast. Huerhuero Creek is an ephemeral underground stream which flows directly to the Salinas River, with headwaters in the Coast Ranges, south of Creston reaching elevations of approximately 3,312 feet.

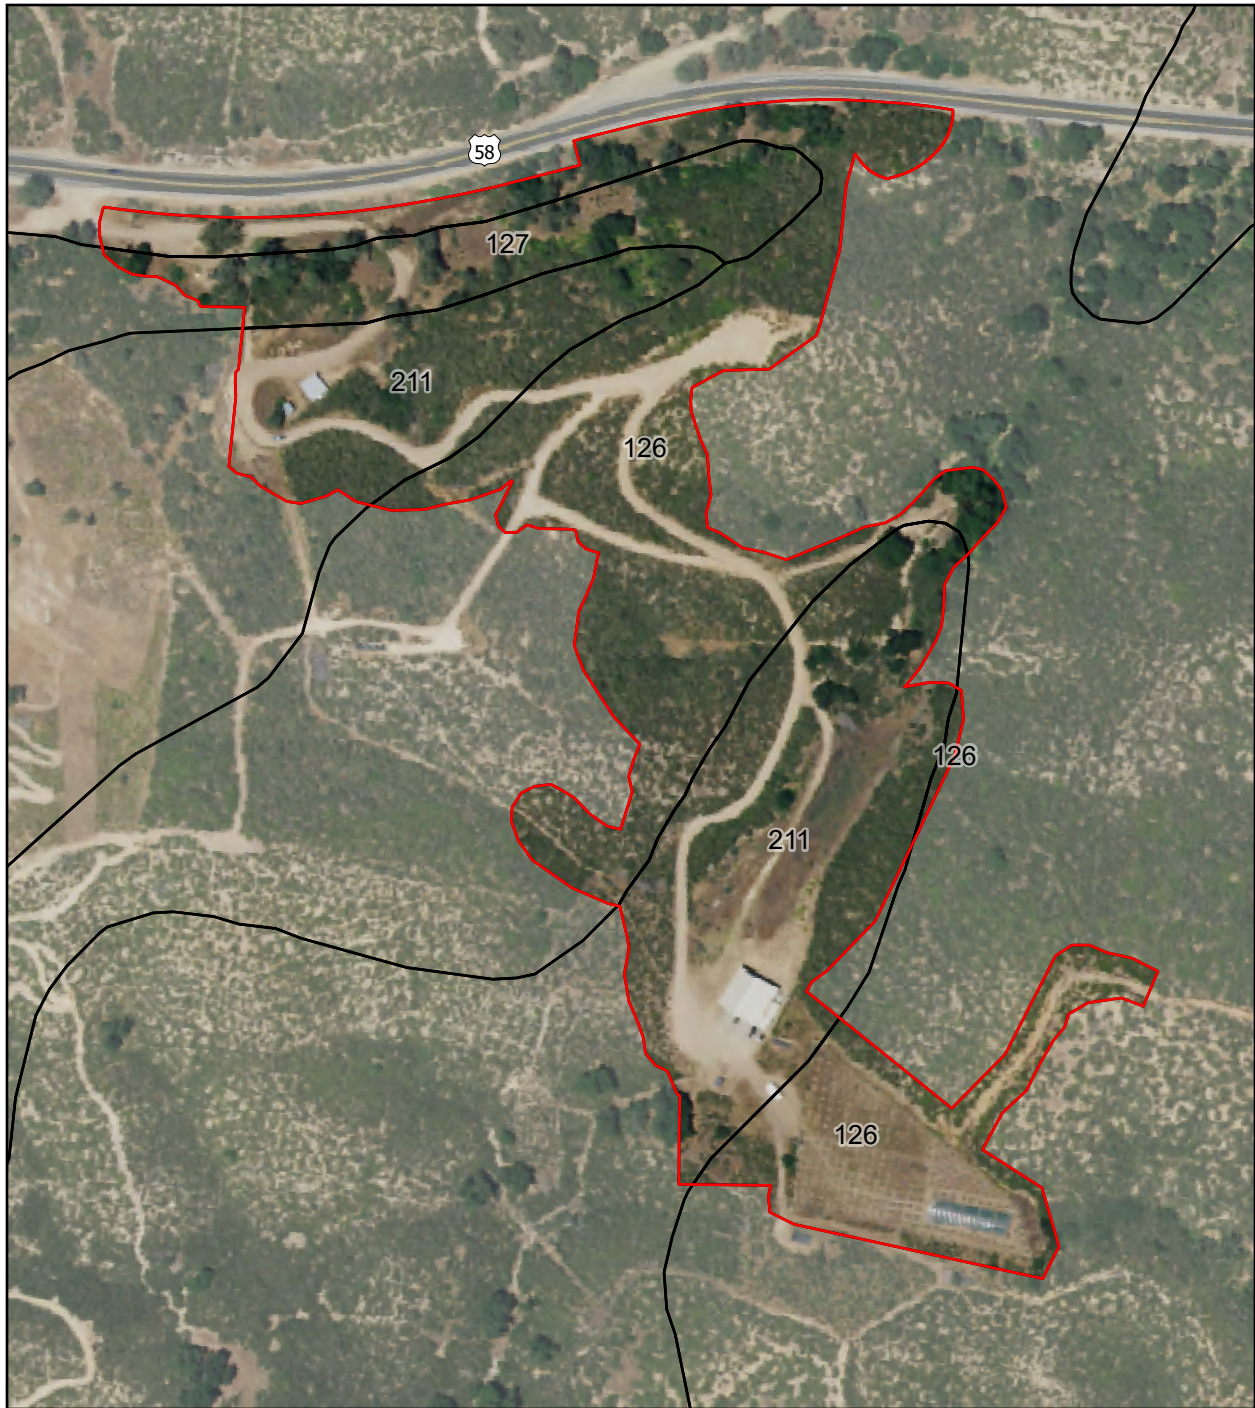
Figure 7. USDA Soil Survey

Soil Type	Study Area
126 - Cieneba coarse sandy loam, 30 to 75 percent slopes	49%
127 - Cieneba-Andregg complex, 30 to 75 percent slopes	11%
211 - Vista-Cieneba complex, 15 to 30 percent slopes	40%

Three soil map units are represented within the Study Area: Cieneba coarse sandy loam 30 to 75 percent slopes MLRA 15, Vista-Cieneba complex 15 to 30 percent slopes, and Cieneba-Andregg complex 30 to 75 percent slopes (USDA 2020a) (Figure 7).
