Aquatic Resources Delineation Report

Airport Road Distribution Center Project Redding, Shasta County, California

Prepared for:
42 Real Estate, LLC
November 2021
613-02

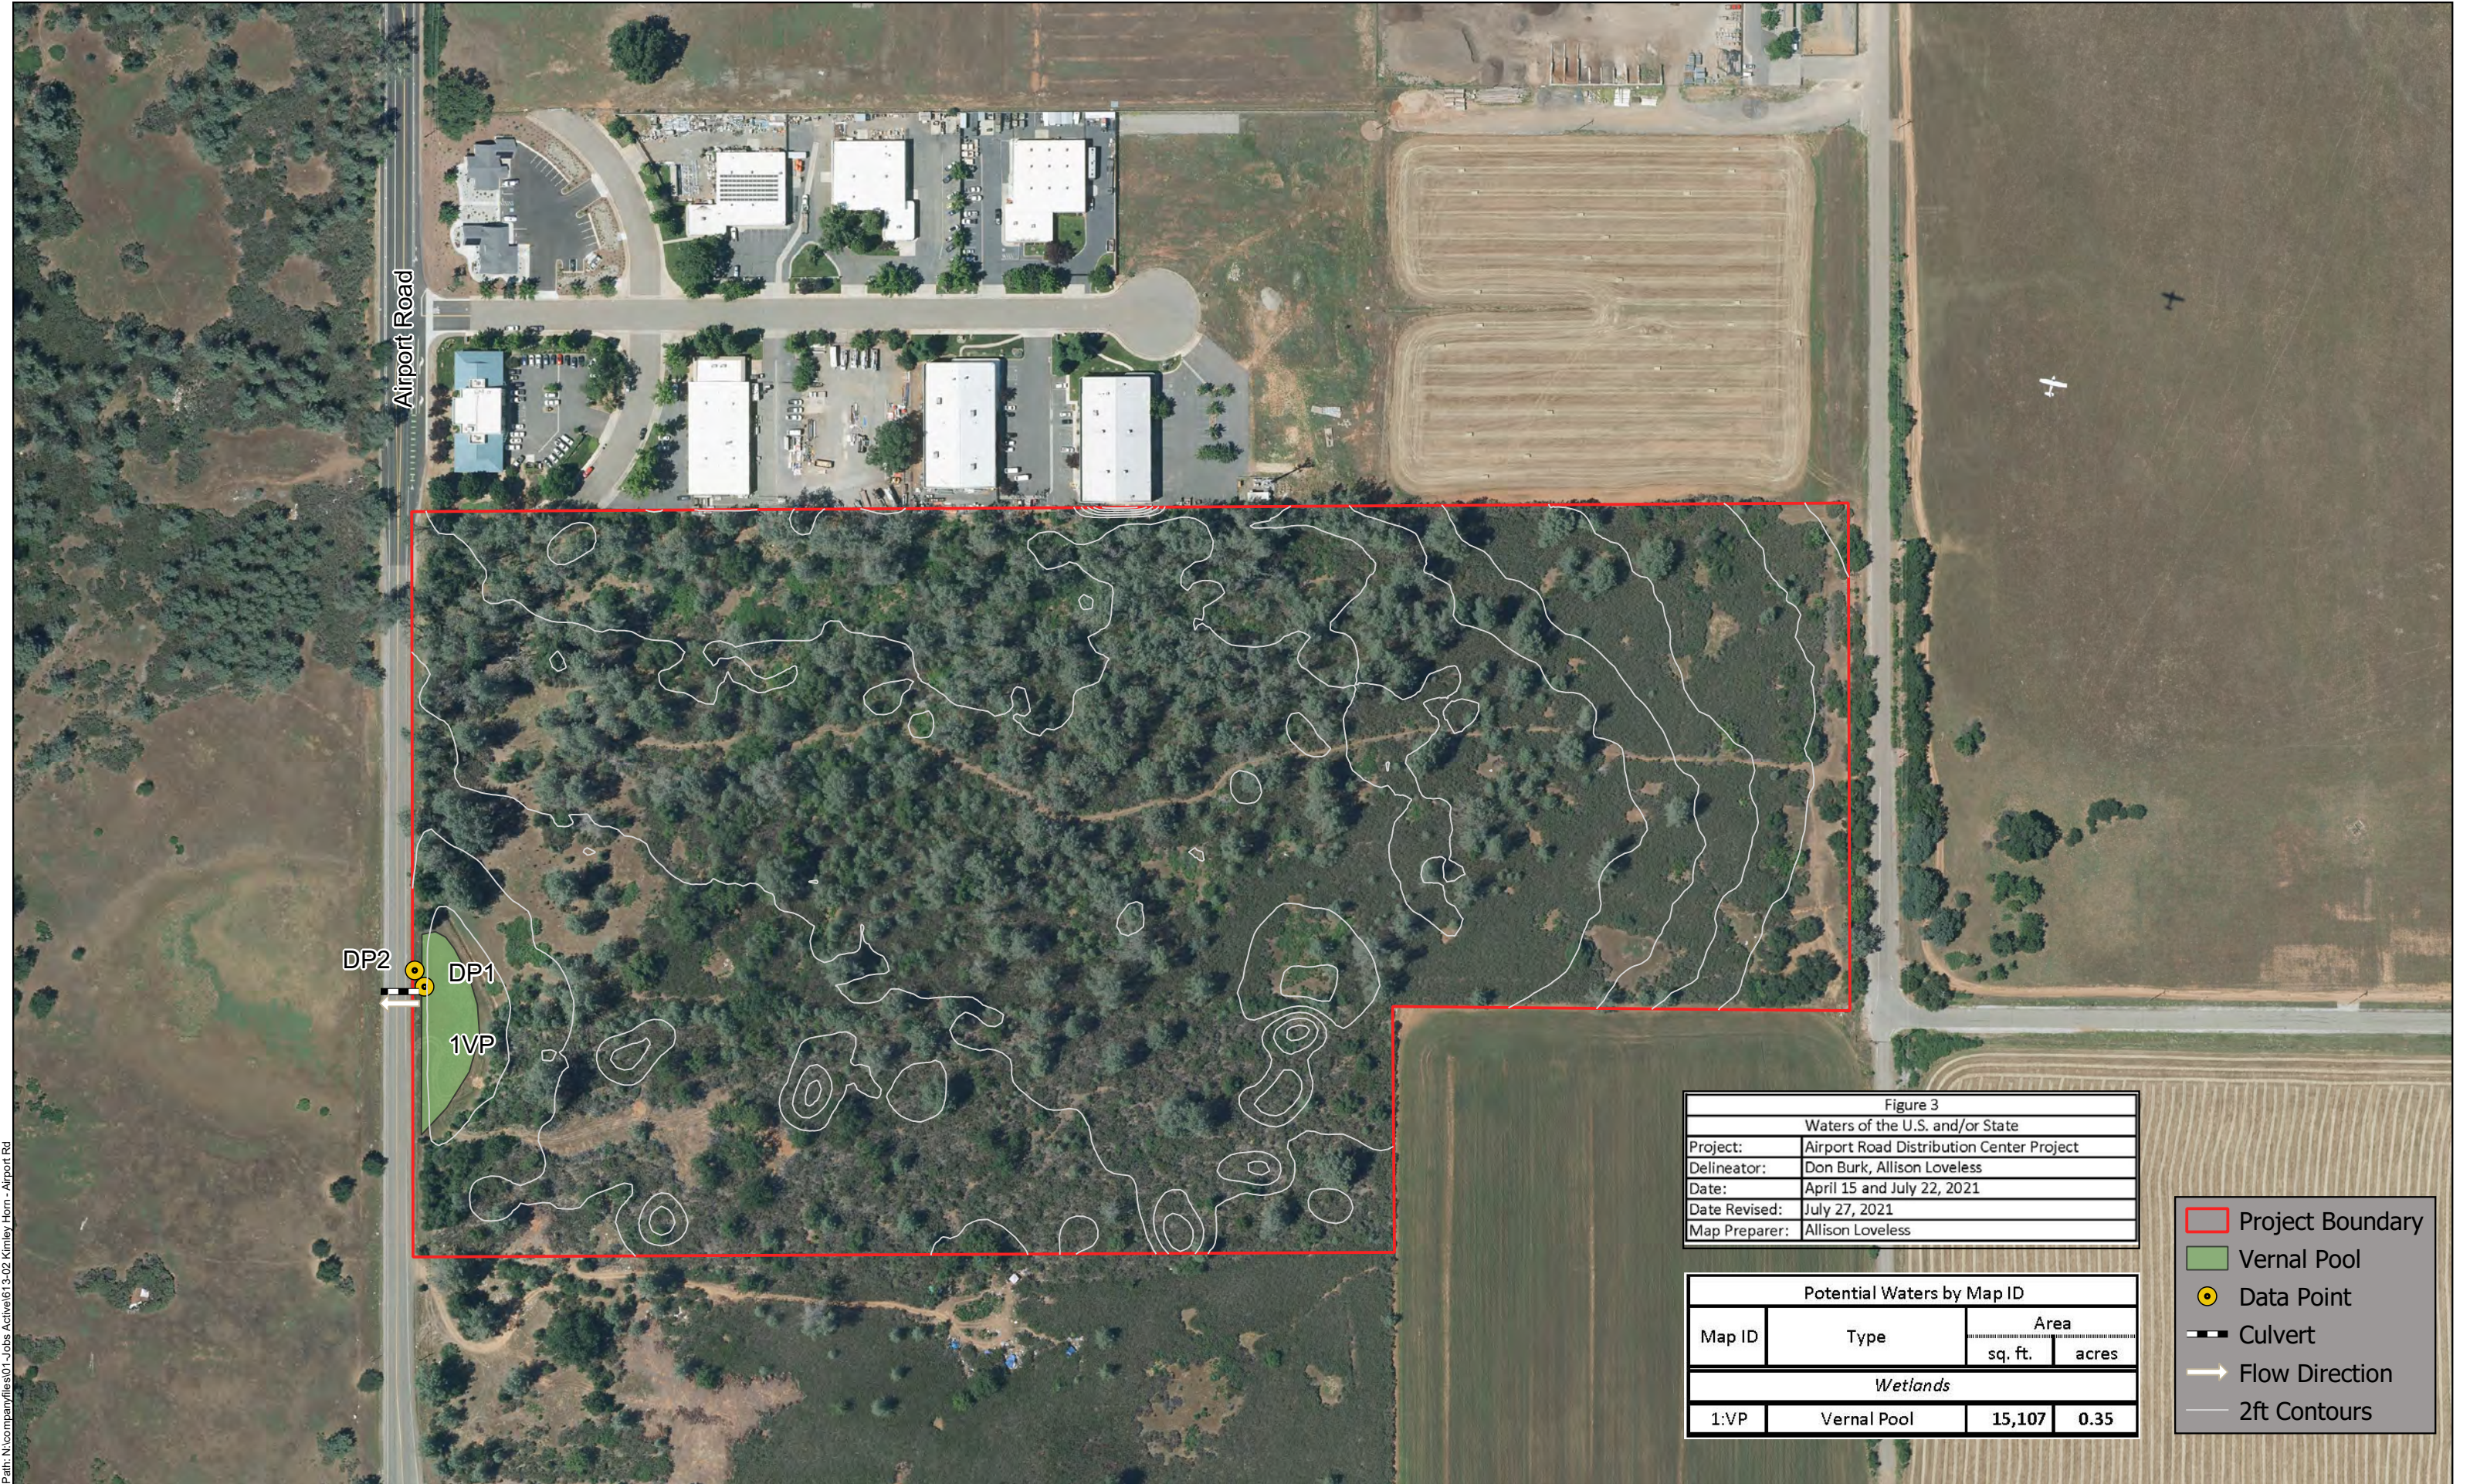
Figure 3
Aquatic Resources Delineation Results - Development Site

As a result of the field delineation effort, one feature potentially subject to state and/or federal jurisdiction was identified: a highly degraded remnant of a vernal pool (**Figures 3 and 4, Appendix A**). The feature was mapped as approximately 0.35 acres in size. The feature was delineated based on a combination of field indicators, as described in the previous section, and an evaluation of the 2004 study results.

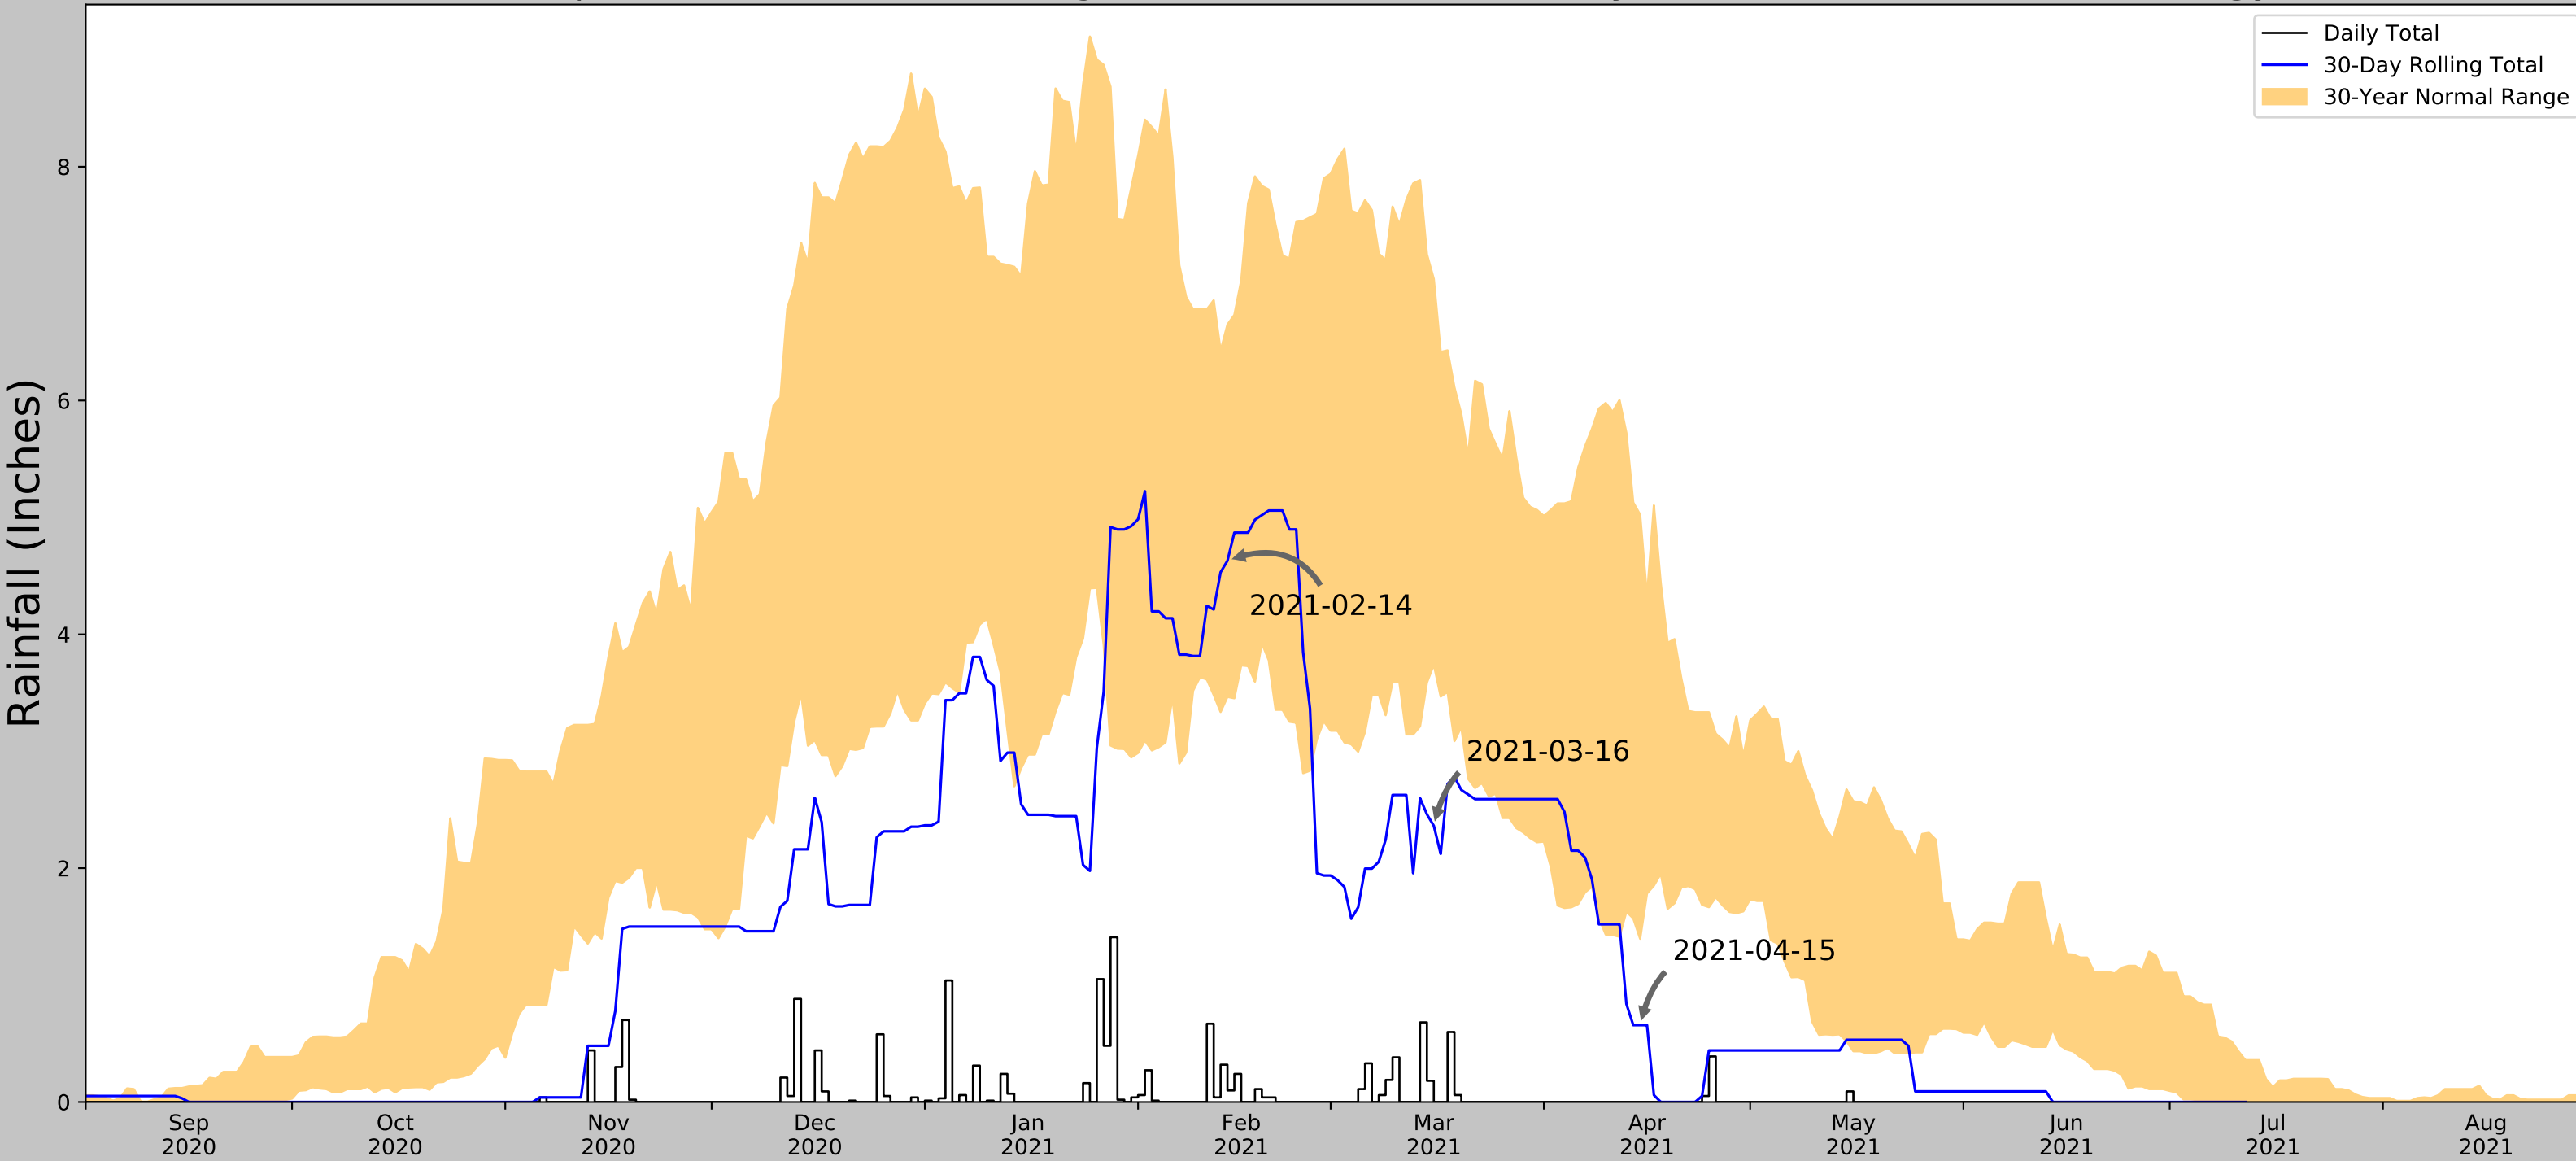
Antecedent Precipitation vs Normal Range based on NOAA's Daily Global Historical Climatology Network

Coordinates	40.5277203, -122.3014798
Observation Date	2021-04-15
Elevation (ft)	511.64
Drought Index (PDSI)	Extreme drought
WebWIMP H ₂ O Balance	Dry Season

30 Days Ending	30 th %ile (in)	70 th %ile (in)	Observed (in)	Wetness Condition	Condition Value	Month Weight	Product
2021-04-15	1.395669	5.023622	0.65748	Dry	1	3	3
2021-03-16	3.740945	7.039764	2.362205	Dry	1	2	2
2021-02-14	3.465354	6.649607	4.629921	Normal	2	1	2
Result							Drier than Normal - 7

The U.S. Army Corps of Engineers' Antecedent Precipitation Tool (APT) was used as an indicator of climatic circumstances at the time of the field delineation. Rainfall conditions for the three months prior to the field dates were calculated and compared to rainfall quantities during typical years. According to the APT, the present field delineation was conducted during dryer than normal conditions (Deters, 2020). Results produced by the APT are provided in **Appendix B**. Wetland determination forms were completed and are provided in **Appendix C**.

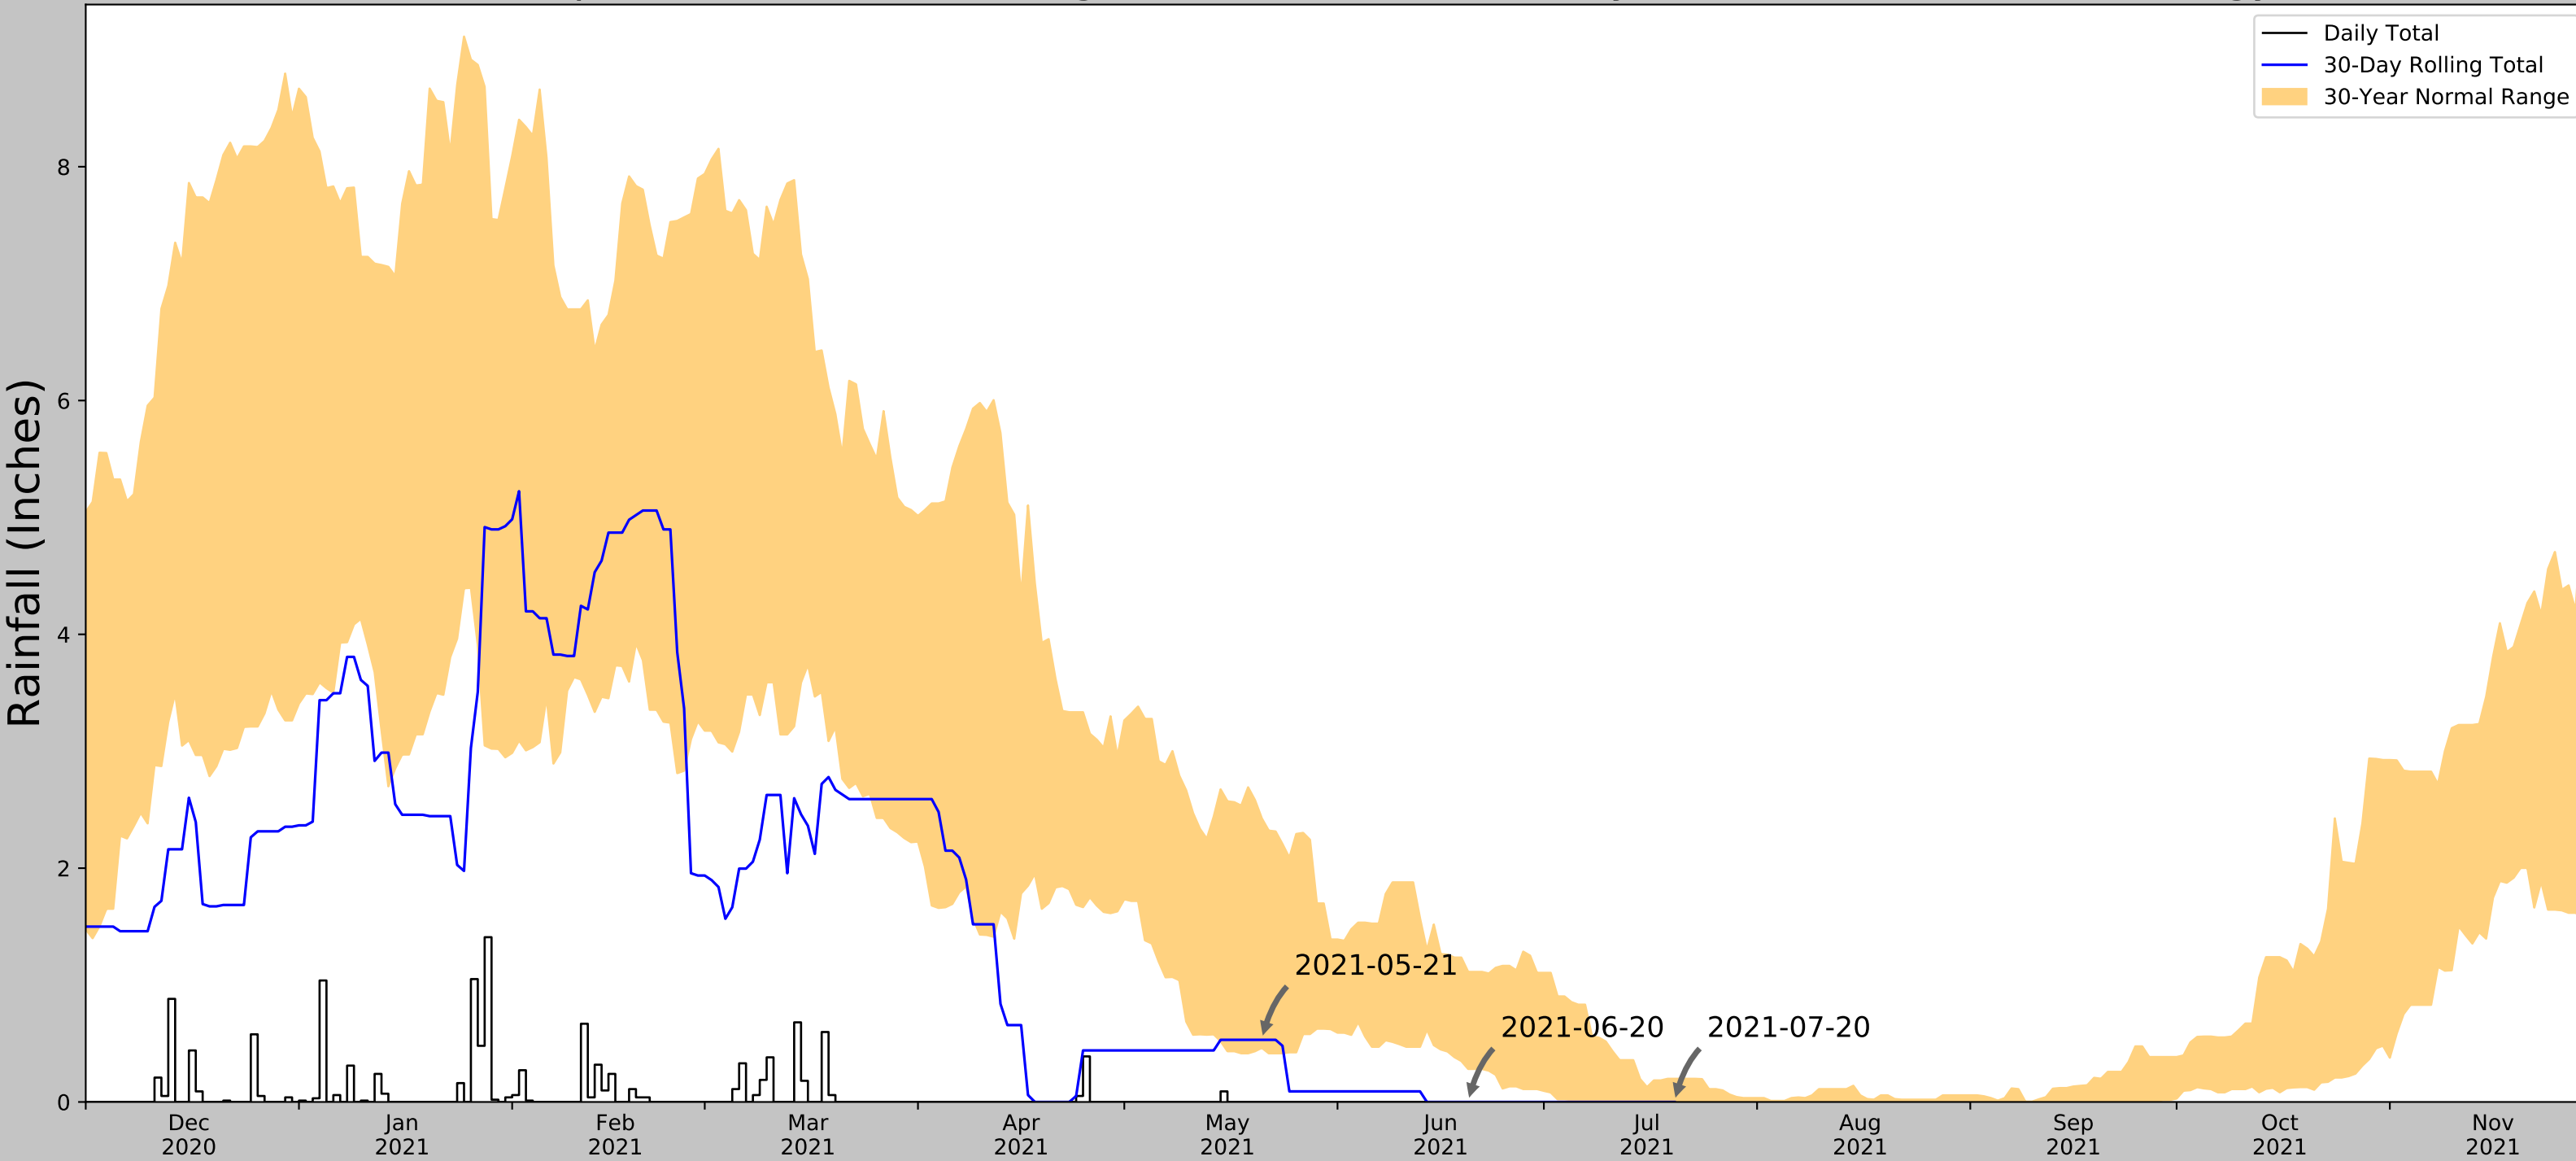
Antecedent Precipitation vs Normal Range based on NOAA's Daily Global Historical Climatology Network

Coordinates	40.5277203, -122.3014798
Observation Date	2021-07-20
Elevation (ft)	511.64
Drought Index (PDSI)	Extreme drought (2021-06)
WebWIMP H ₂ O Balance	Dry Season

30 Days Ending	30 th %ile (in)	70 th %ile (in)	Observed (in)	Wetness Condition	Condition Value	Month Weight	Product
2021-07-20	0.0	0.198425	0.0	Normal	2	3	6
2021-06-20	0.282283	1.112598	0.0	Dry	1	2	2
2021-05-21	0.462992	2.425197	0.531496	Normal	2	1	2
Result							Normal Conditions - 10

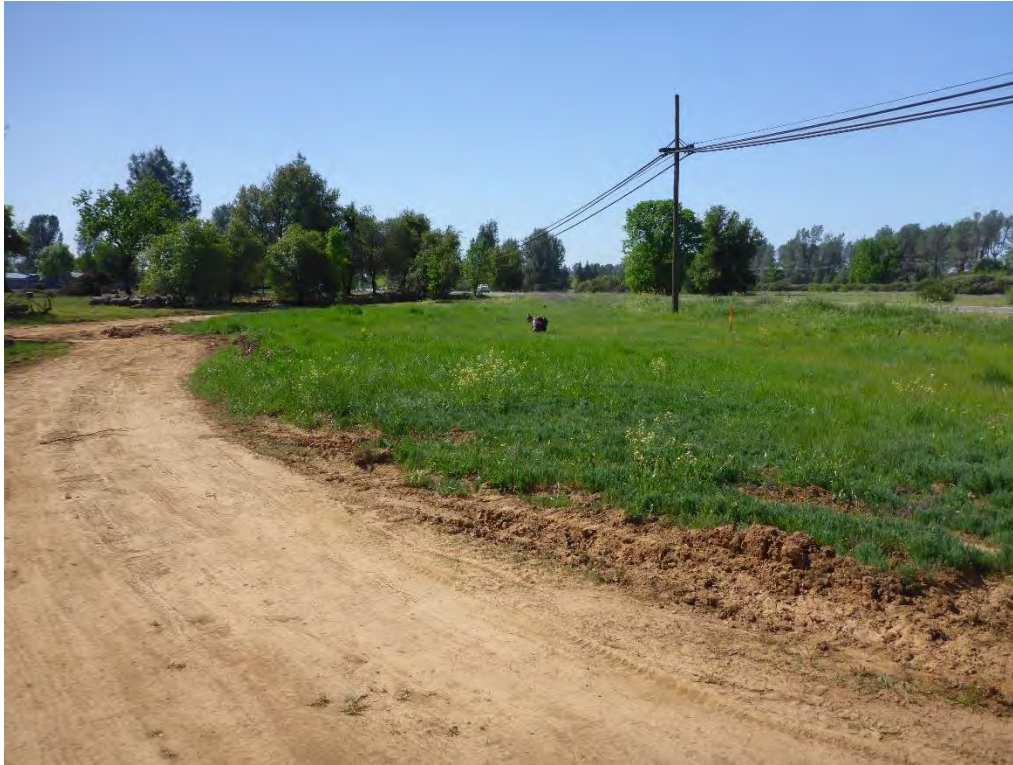
1VP: Vernal Pool. View to south, April 15, 2021

The present study documented the presence of hydric soils in the feature; neither hydrophytic vegetation nor indicators of wetland hydrology were present at the time of the field investigation. The absence of wetland hydrology indicators may be due in part to prolonged drought in the region. Additionally, the culvert under Airport Road is at least partially blocked, and roads and ditches have reduced the drainage area tributary to the feature. With respect to vegetation, the feature has been extensively disturbed by

pedestrian and vehicle traffic, which, combined with drought conditions, may have contributed to the introduction and spread of weedy species in the feature.

Although conditions at the site have significantly changed since the wetland was verified by the Corps in 2004, we anticipate that all three parameters would be met in a year with normal precipitation and absent the recent level of disturbance. The feature was therefore delineated and mapped as a wetland feature.

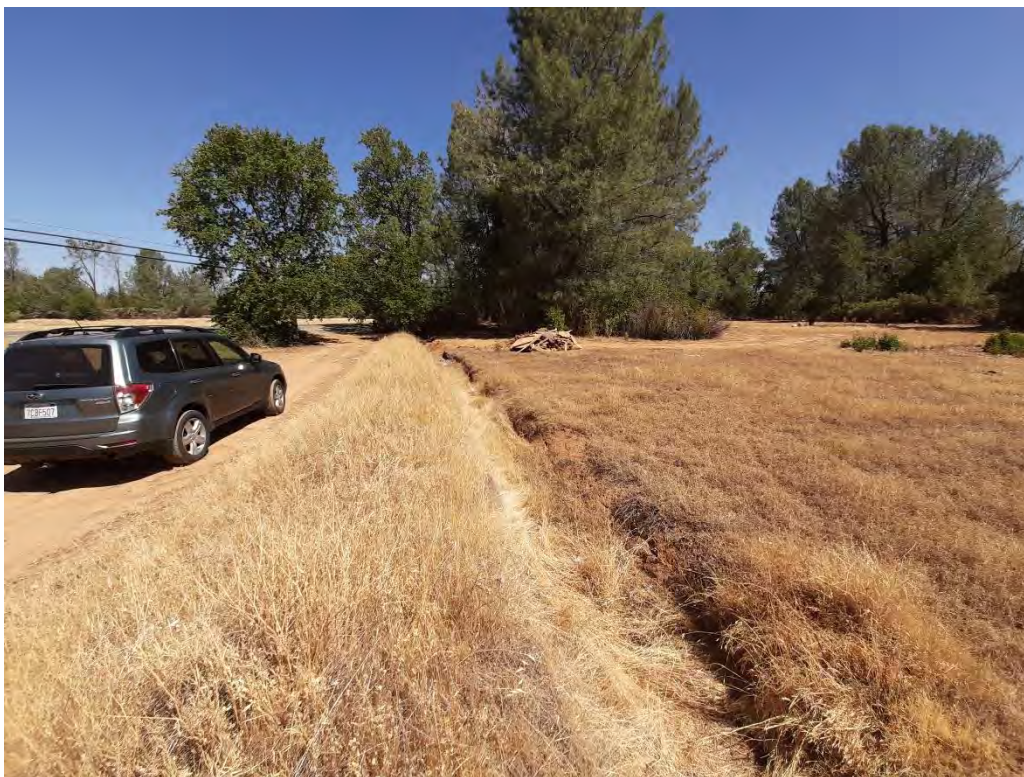
Upland trench located immediately east of 1VP, which blocks flow to the feature, July 21, 2021

Five man-made upland trenches were also observed in the study area, primarily along property boundaries. It appears that the trenches were created as barriers to prevent off-road vehicles from entering the site. The trenches were not identified as wetlands or other waters because they lack an ordinary high-water mark, wetland vegetation, do not show evidence of ponding, and are not connected to any surface water features.

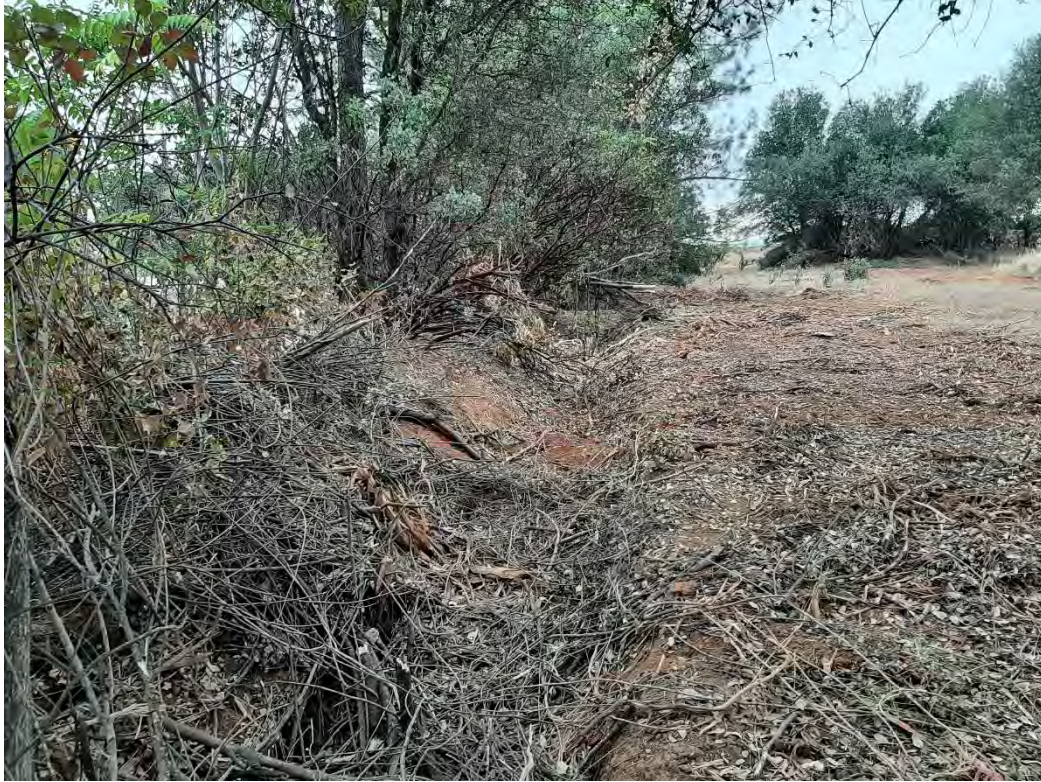
Upland trench located along the eastern edge of the project site, July 23, 2021

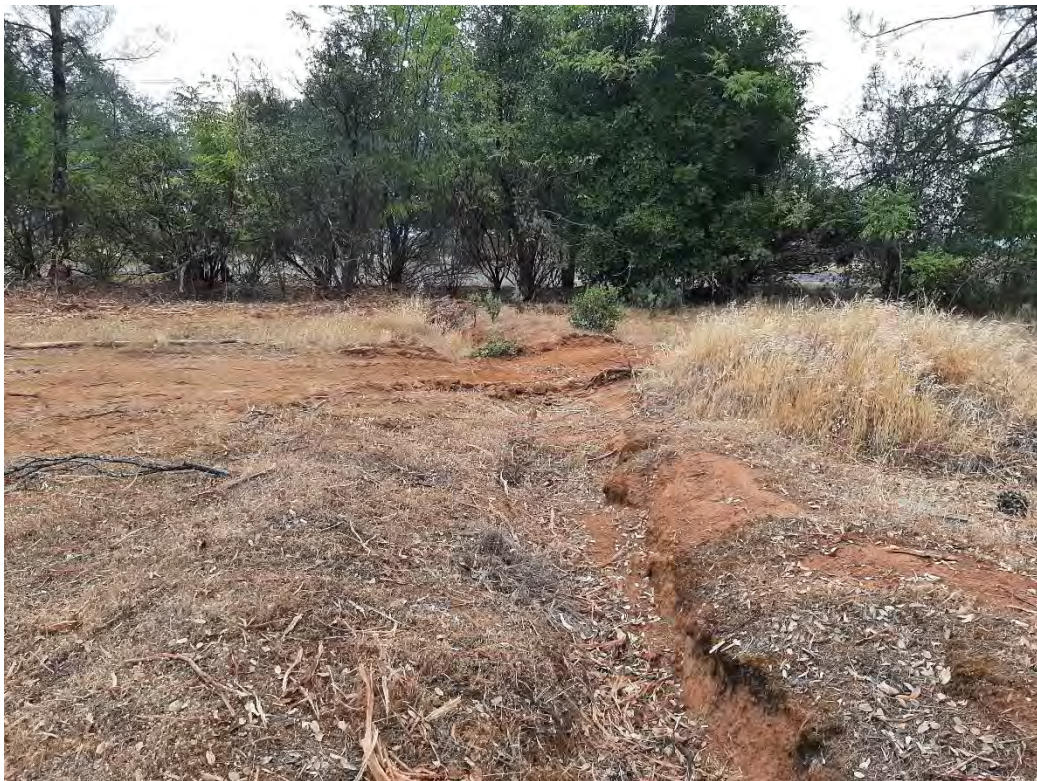
Upland trench located within the project site, July 23, 2021
