A HISTORIC RESOURCE EVALUATION OF THE PROPERTY AT 681 E. TRIMBLE ROAD, SAN JOSE, SANTA CLARA COUNTY, CALIFORNIA

Updated October 18, 2023

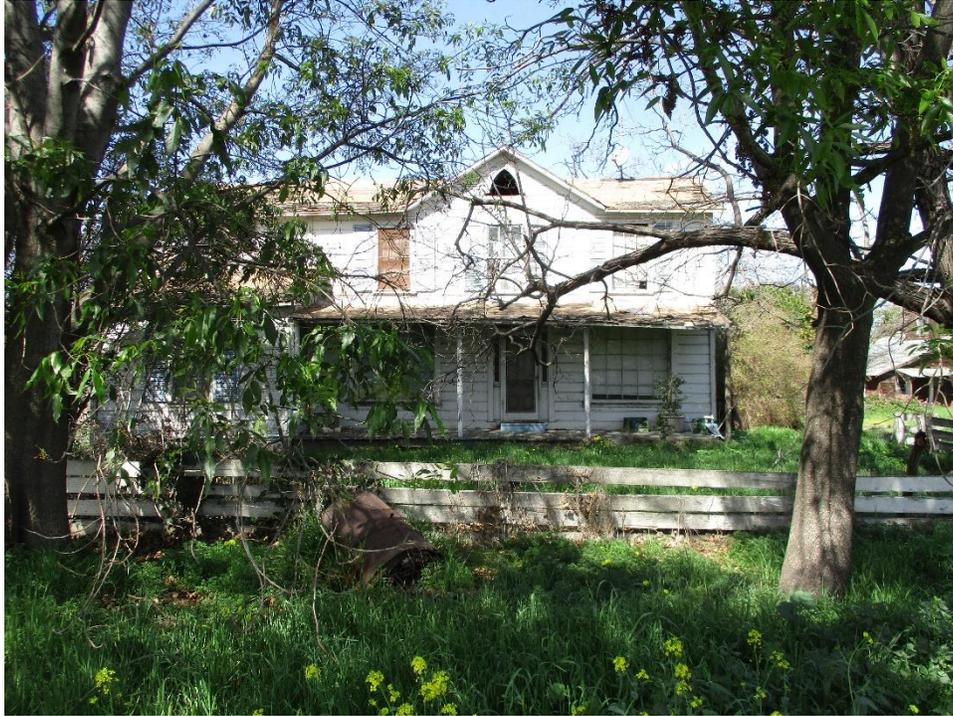
Figure 31. South elevation, facing north.

The **south elevation (primary façade)** consists of the original ca. 1880 portion of the side-gable form, the ca. 1900 two-story addition, and the ca. 1920s side gable addition (Figure 31). The two-story addition consists of a centered roof gable with a decorative Gothic-style window. There is no glass in the window, and the lower portion of the window casing is no longer present. The first floor consists of a shed porch that spans the length of the original section of the ca. 1880s house. The porch does not appear to be original to the house and may have replaced an original porch that was added in the ca. 1940s or 1950s (Figure 32). The porch consists of a shed roof supported by three square chamfered posts and one temporary wood post on the southeast corner. The porch floor is constructed of narrow wood boards and is not original to the house. The front door is situated within the porch and consists of two-side lights with decorative lower panels and a narrow transom light above the door. There is a wood-paneled door that appears to be original to the house. The ca. 1920s side gable addition consists of a two-story gable addition and a shed addition “bump-out” along the south elevation. The windows include two twenty-light, fixed, wood windows and two six-over-six, double-hung windows along the first floor; and three six-over-six, double-hung, wood windows, and one two-light, double-awning, wood window along the second floor. Several of the windows are flanked by decorative wood shutters.

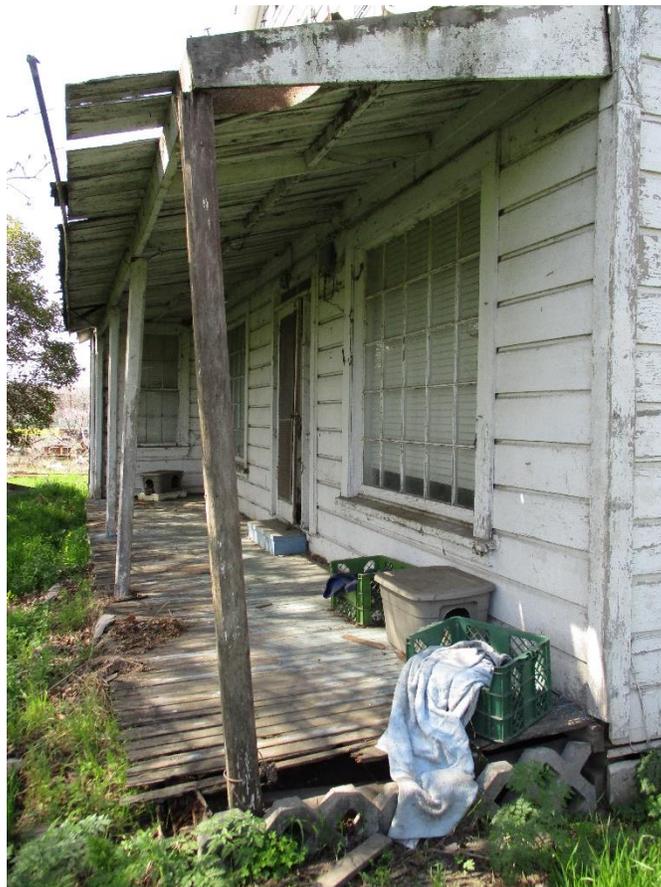
Figure 32. Photograph showing the primary façade front porch, facing west.

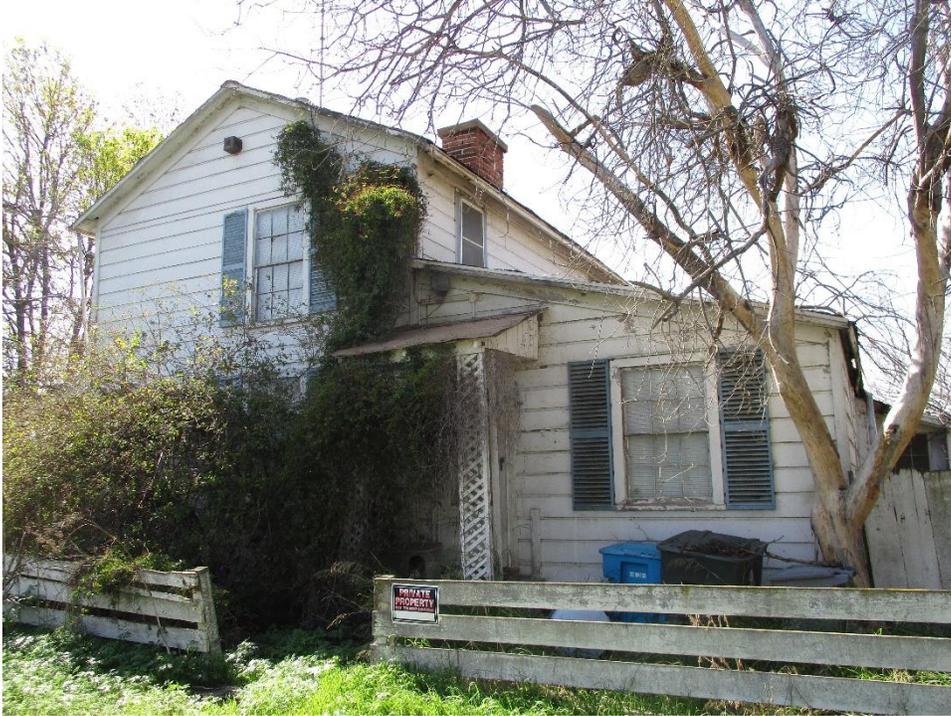
The **east elevation** consists of the ca. 1900 second-story addition and the ca. the 1920s shed addition north elevation (Figure 33). There is one six-over-six, double-hung, wood window on the second floor and two six-over-six, double-hung, wood windows on the first floor. The windows are flanked by decorative wood shutters. The east elevation also consists of a side entrance along the shed addition set under a shed porch roof. There are concrete stairs that lead to a rear door entrance, which are covered in overgrown vines.

Figure 33. Photograph showing the east elevation (left) and a portion of the north elevation (right), facing west.

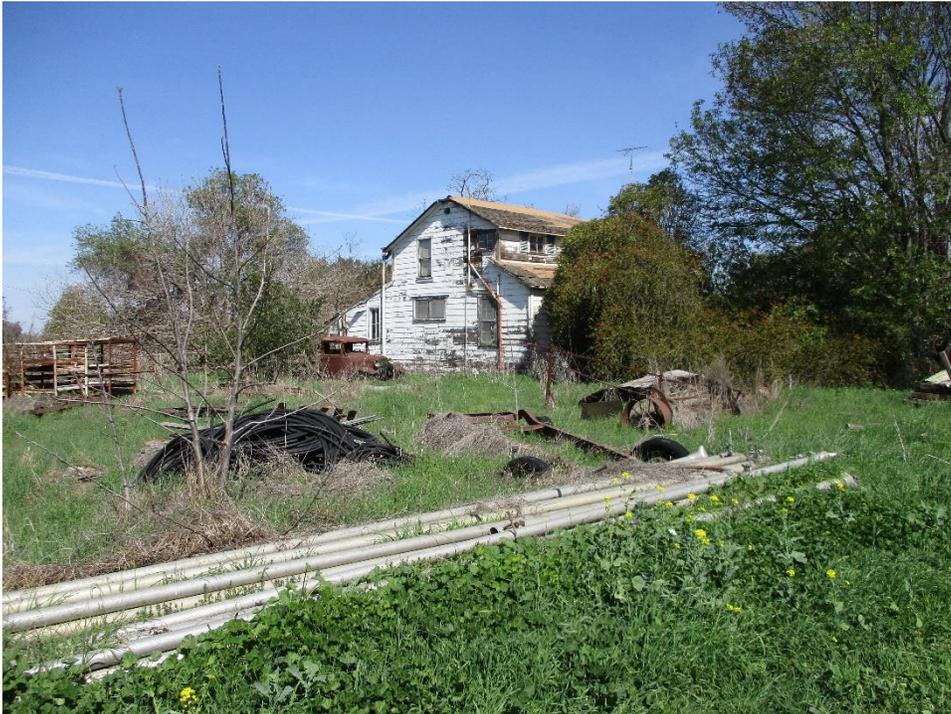
The **west elevation** consists of the ca. 1900 second-story addition, and the ca. 1920s shed addition. Along this façade, there are two six-over-six, double-hung, wood windows; one one-over-one, single-hung, wood window, two small wood windows, which appear to be awning windows, and two square-shaped, fixed, wood windows (Figure 34). There are several visible modifications along this elevation, including what seems to be the removal of a door along the first floor and a window along the second floor.

Figure 34. Photograph showing the west elevation, facing northeast.

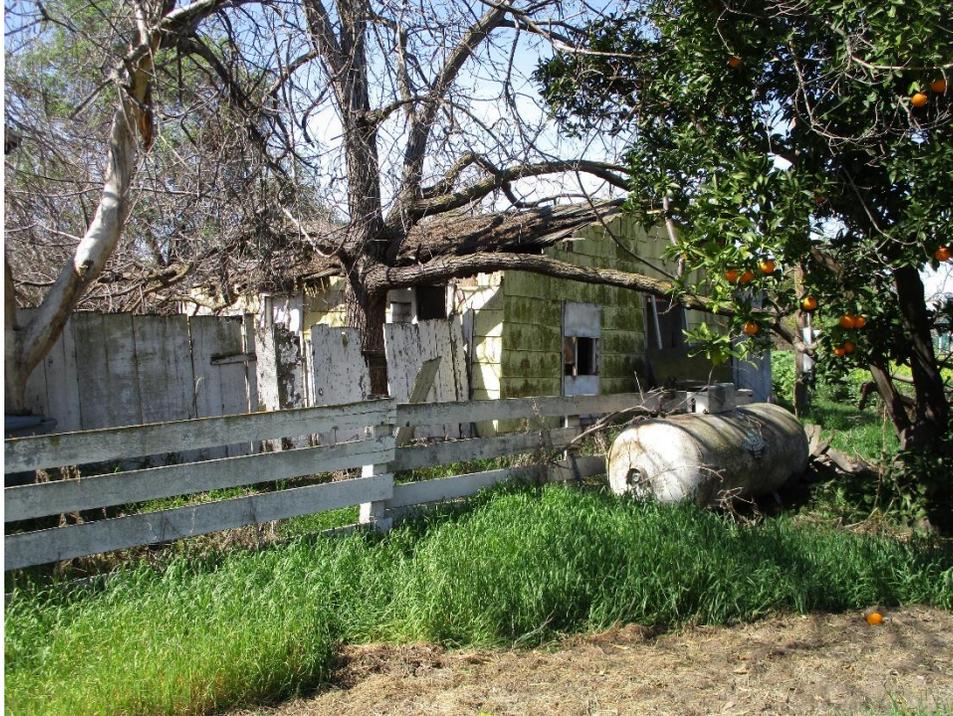
Figure 35. Photograph showing the south and east elevation of the ca. 1920 cottage, facing northwest.

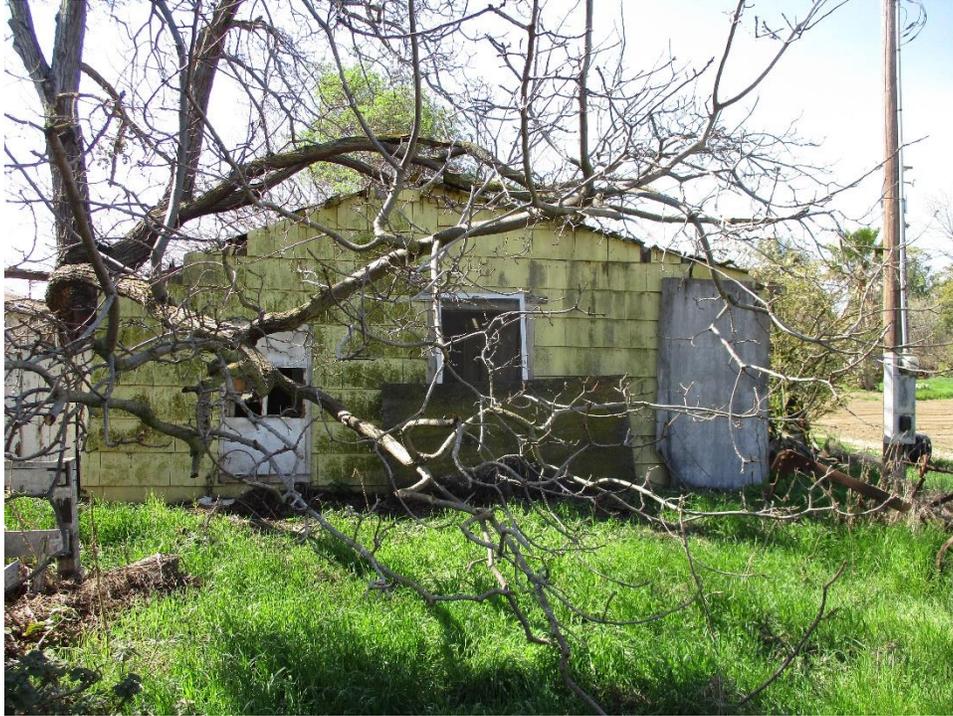
Figure 36. Photograph showing the east elevation of the ca. 1920 cottage, facing west.

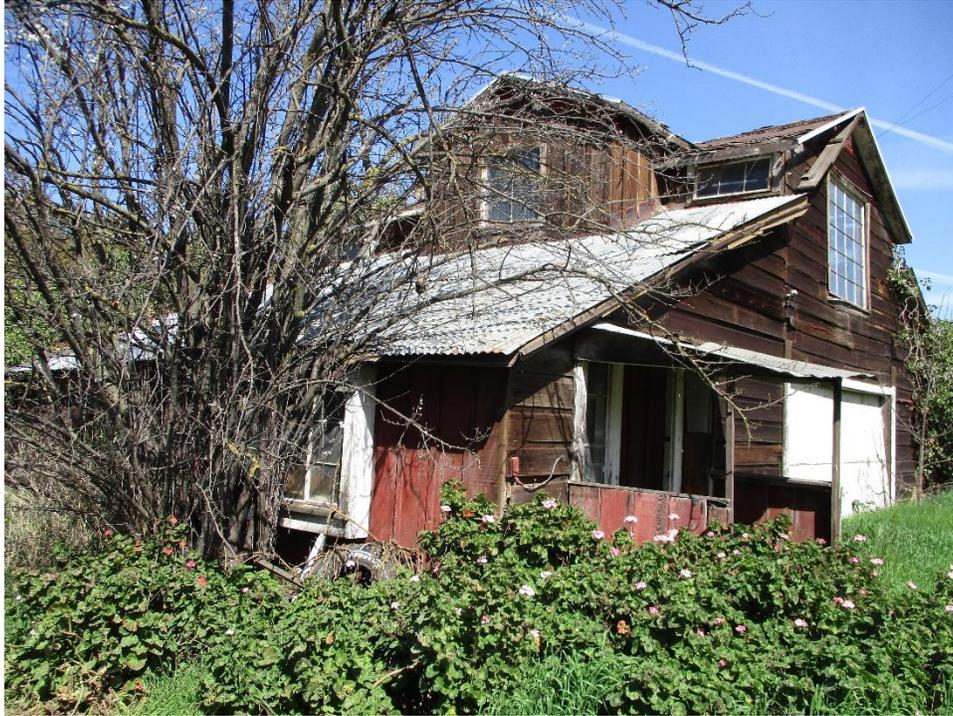
The ca. 1890 barn is a Vernacular form that has been significantly altered since its construction. The original ca. 1890 barn is a two-story, side-gable form with two shed “wing” additions that are visible along the south elevation; however, there have been alterations to the barn since its construction, including the enclosure of the shed addition along the west elevation (ca. 1930), gable dormer (ca. 1950), and changes that include the addition of multi-light wood windows, doors, and a garage door when the barn was converted for housing in the ca. 1930s (Figure 37). The original ca. 1890 form is wood-framed construction clad in wide wood boards with batten. The roof is a moderate pitch and is clad in wood, asphalt, and metal roofing material. The **south elevation** consists of a wooden hinged garage door that was likely added in the 1950s. There is a twenty-light, fixed, wood window along the second story and an entrance door set under the porch entry. The **east elevation**, though not entirely visible due to overgrown vegetation, consists of the original shed “wing” addition that was associated with the barn and is void of fenestrations along the wing addition. However, there are a series of multi-light hopper or fixed-light wood windows under the second-floor roof eaves that appear to have been added in ca. 1930. The **west elevation** consists of a second-story gable roof dormer and extended shed roof addition that has multi-light wood windows. The **north elevation**, although mostly covered with overgrown vegetation (Figure 38), consists of an exterior wood staircase that leads to a second-floor door and an exterior door along the first floor that appears to be original (Figure 39).

Figure 37. ca. 1890 barn showing west and south elevations, facing east.

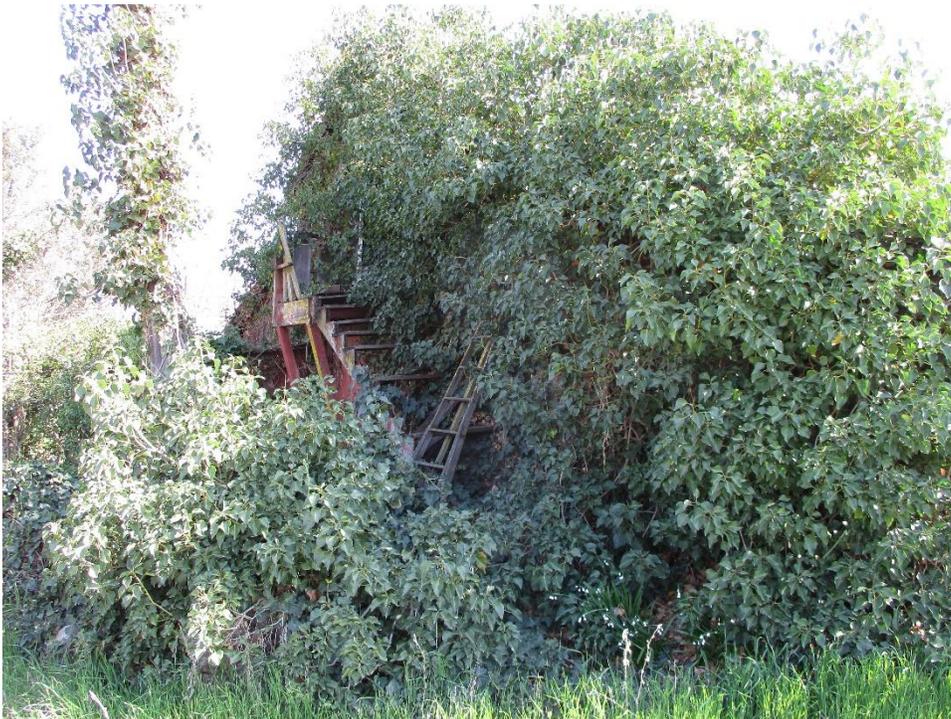
Figure 38. Photograph shows the overgrown vegetation along the west and north elevations of the ca. 1890 barn, facing east.

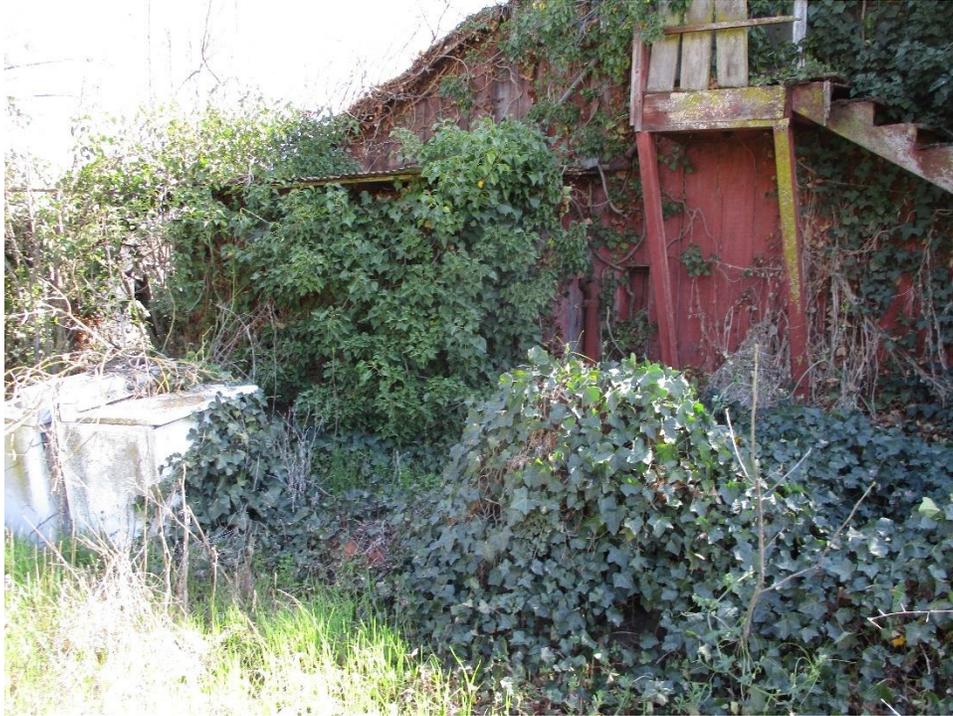
Figure 39. Photograph showing the north elevation, facing south.

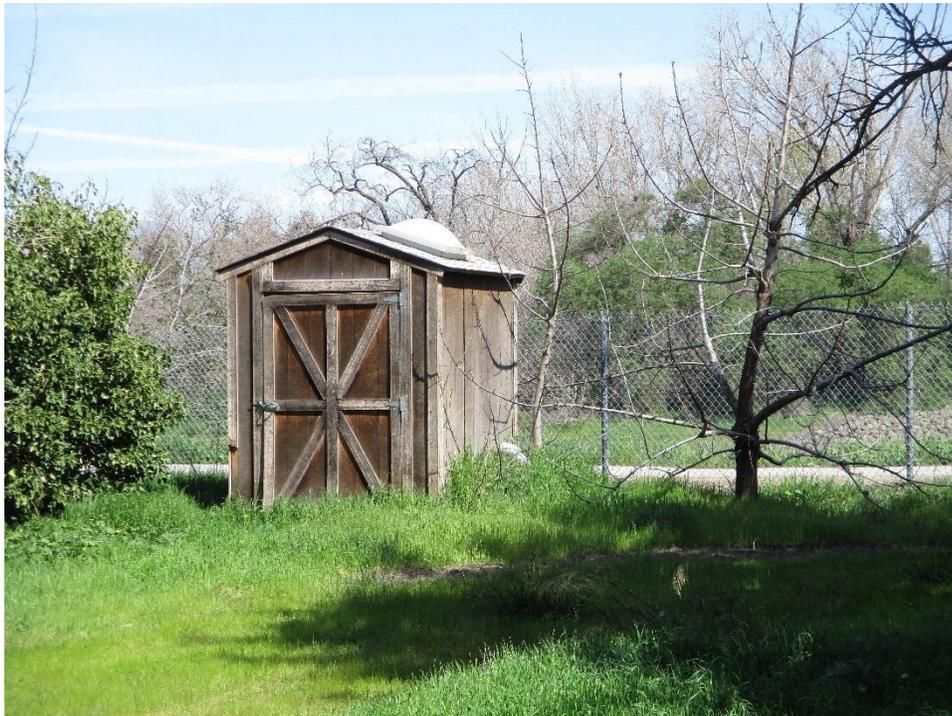
The ca. 1930 pump house is not associated with any architectural style. The building is a square form constructed of horizontal wood boards (Figure 40). The roof is clad in asphalt shingles, and there is a skylight that was installed in ca. 1980. There is a barn-style front entry door that has decorative wood trim.

Figure 40. West elevation, facing east.

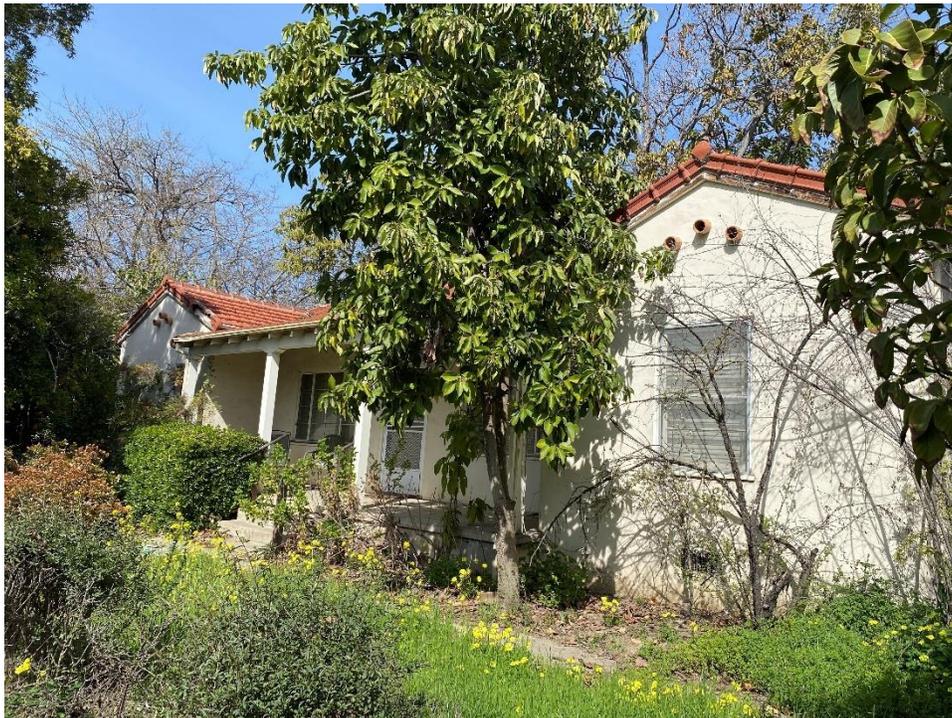
Figure 42. West elevation, facing northeast.

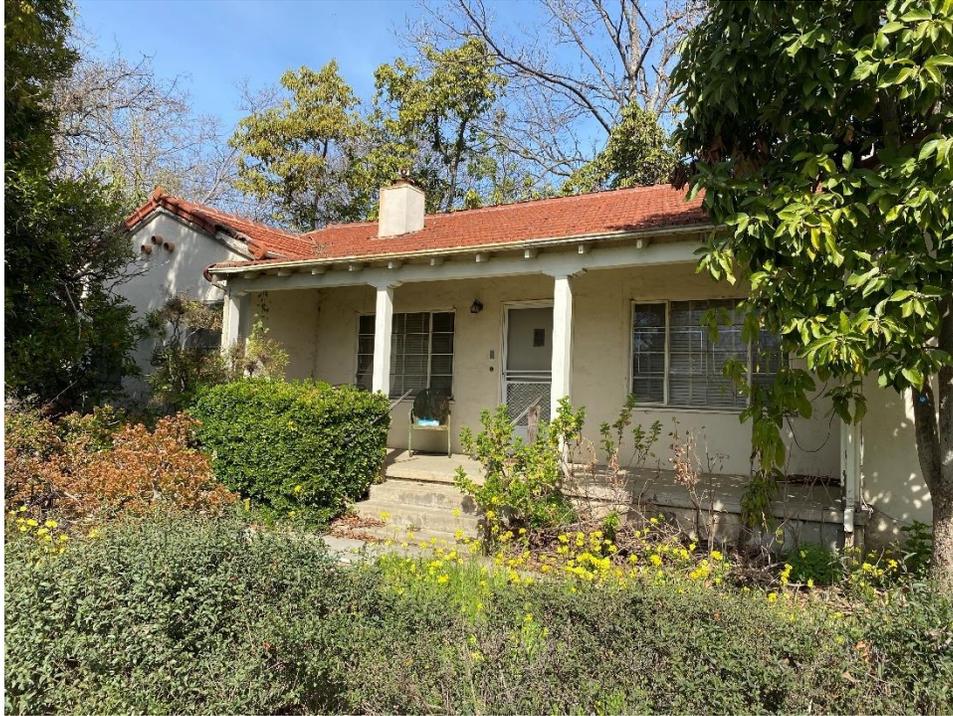
The **west elevation (Primary Façade)** consists of circular clay tile vents set below the eaves of the two gable wings (Figure 42). There are double-hung, wood windows with lugs along each gable wing. There is a central porch with a recessed and centered front entry that is accessed by concrete stairs (Figure 43). The shed porch roof consists of exposed rafter tails and is clad in Spanish red clay tiles. The porch is supported by square columns with decorative capital, and the porch is constructed with concrete. There are two multi-light casements and fixed windows that flank the front door. There is a wooden door with a small, centered, glazed “window” set within the door. The house is clad in stucco, and the roof is clad in Spanish red clay tile. The roof is low-pitched within decorative Spanish red clay tiles set along the edge of the shallow roof eaves.

Figure 43. West elevation, facing northeast.

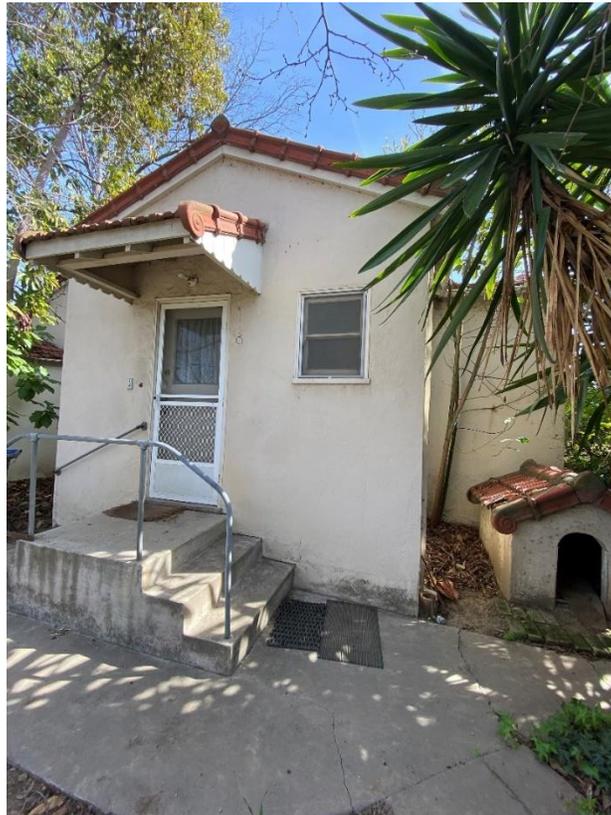
The **north elevation** consists of two projecting gables, one of which is the side entrance to the house (Figure 44), and the other provides access to the basement (Figure 45). Both projecting gable forms are set within the side-gable form of the house. All three gables are clad in stucco with roof eaves that are clad in Spanish red clay tile. The two projecting gable forms also have decorative Spanish clay tile scrollwork along the gable

Figure 44. North elevation, showing the side entrance to the house.

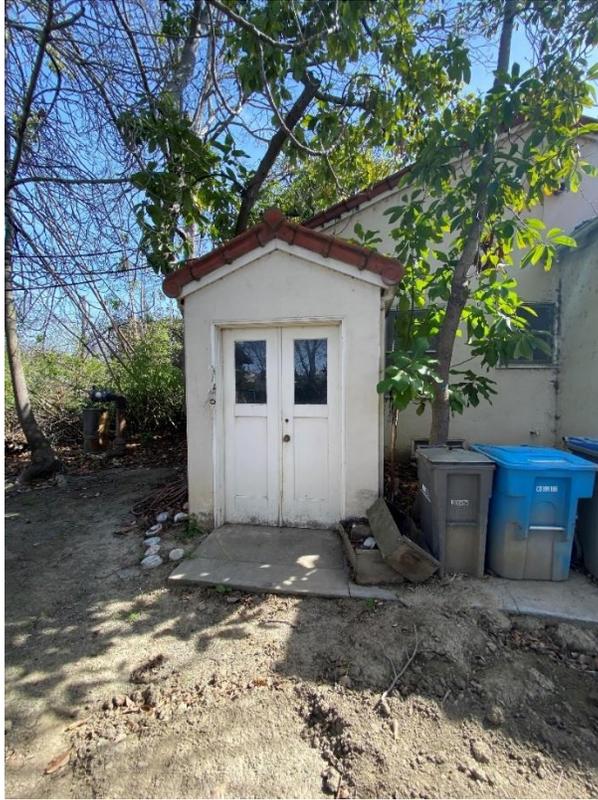
Figure 45. Photograph showing the projecting gable entry into the basement where the Sakauye family, as well as other Japanese Americans, stored their belongings during their internment from 1942 to 1945.

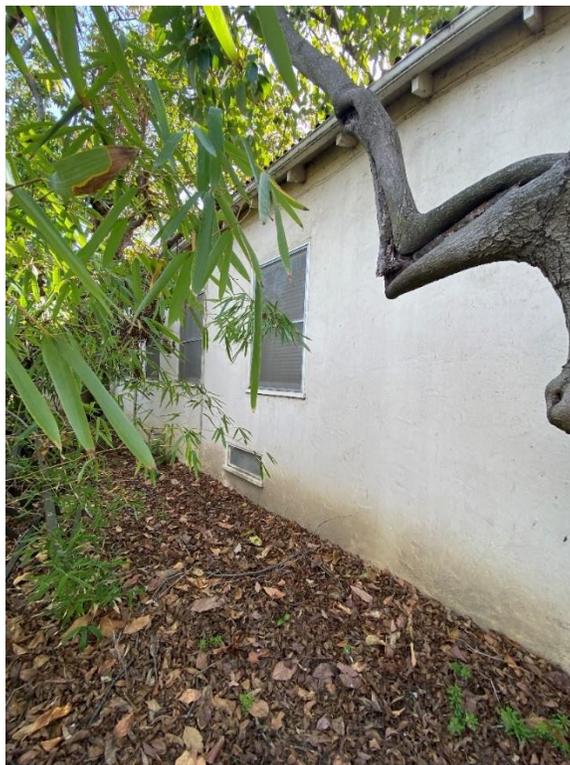
The **east elevation** consists of stucco exterior walls, and the roof has a slight eave overhang with exposed rafter tails (Figure 46). There are several metal basement vents along the lower portion of the exterior walls and four double-hung wood windows with lugs.

Figure 46. East elevation of the ca. 1920 house, facing south.

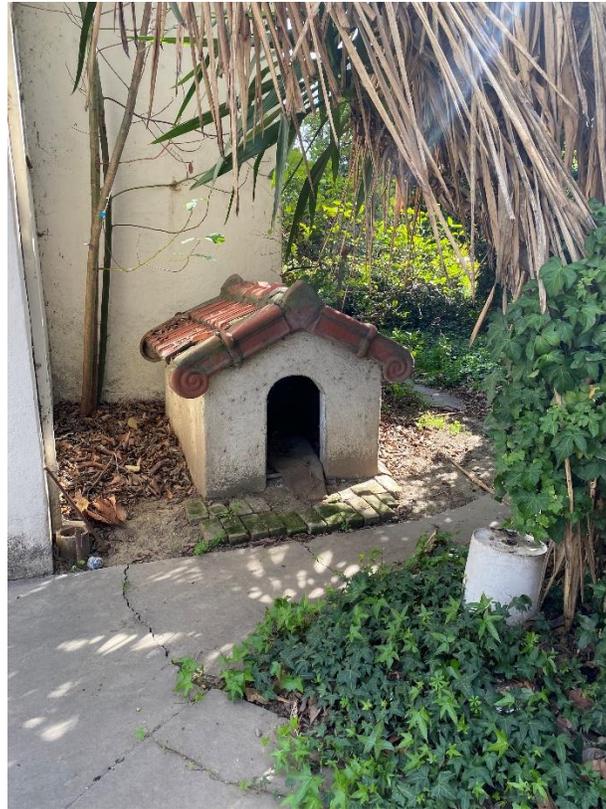
The ca. 1930 doghouse is “associated” with Spanish Colonial Revival architecture. It is a rectangular form constructed of concrete and clad in stucco. The roof is clad in Spanish clay tile with decorative scrollwork along the eave corners.

Figure 49. ca. 1930 doghouse designed to match the ca. 1920 “Sakauye house”.

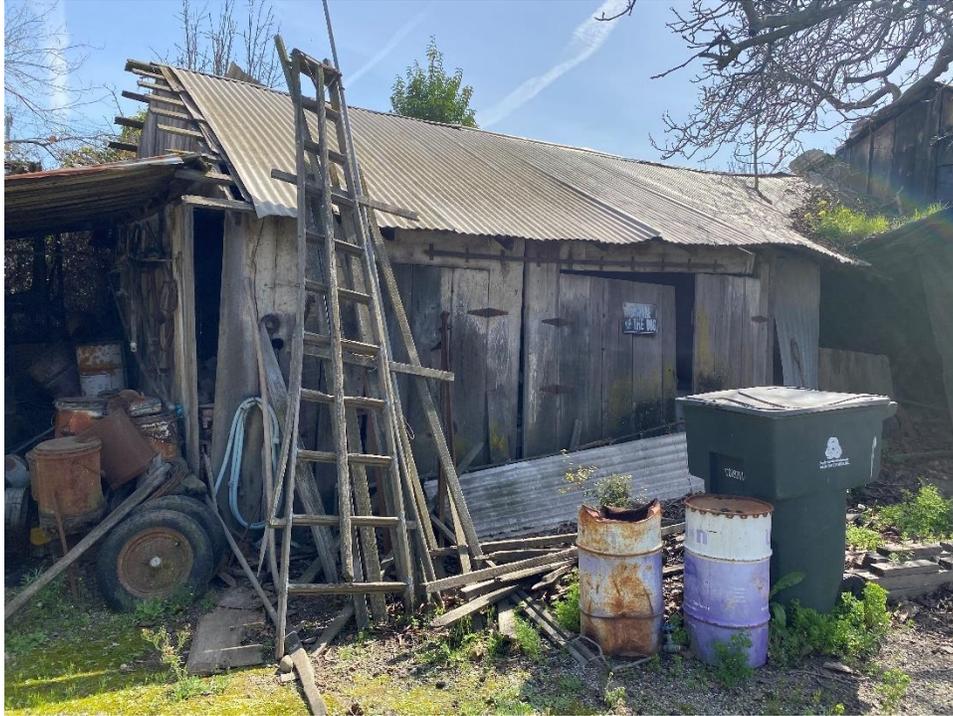
The ca. 1910 barn is associated with Vernacular architecture. The barn has been modified, though it appears the modifications all took place before ca. 1920. The barn is a wood-framed building with at least two additions, a gable addition and a shed addition, which make up the current L-shaped plan. The original barn appears to be the long linear form (southernmost section of the building, see previous Figure 30). This section is a wood-framed form clad in vertical wide wood boards. The roof is clad in corrugated metal sheets, and there is a shed roof along the east elevation that is utilized for storage. The northern elevation of this form consists of two hinged barn doors (Figure 50). Adjacent and north of the linear form are two gabled forms, one taller gable form and one lower gable form with a shed addition (Figure 51). These forms are constructed of wood boards, and the roofs are all clad in corrugated metal sheets. The lower gable and shed are open along the east elevation.

Figure 50. Photograph showing the north elevation of the linear form, facing south.

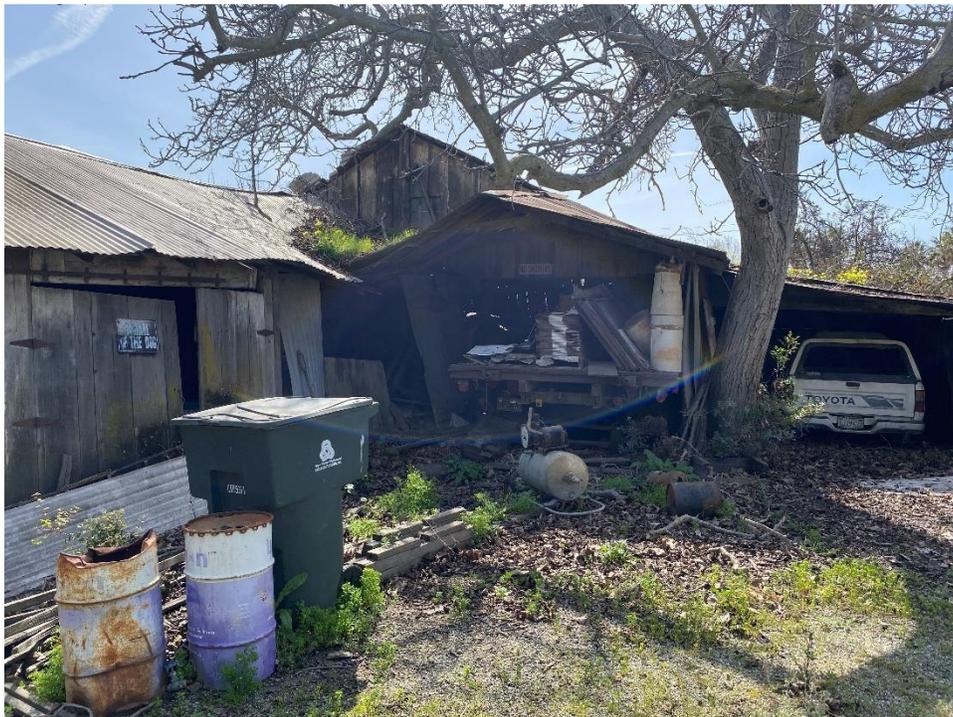
Figure 51. ca. 1910 barn, facing west.

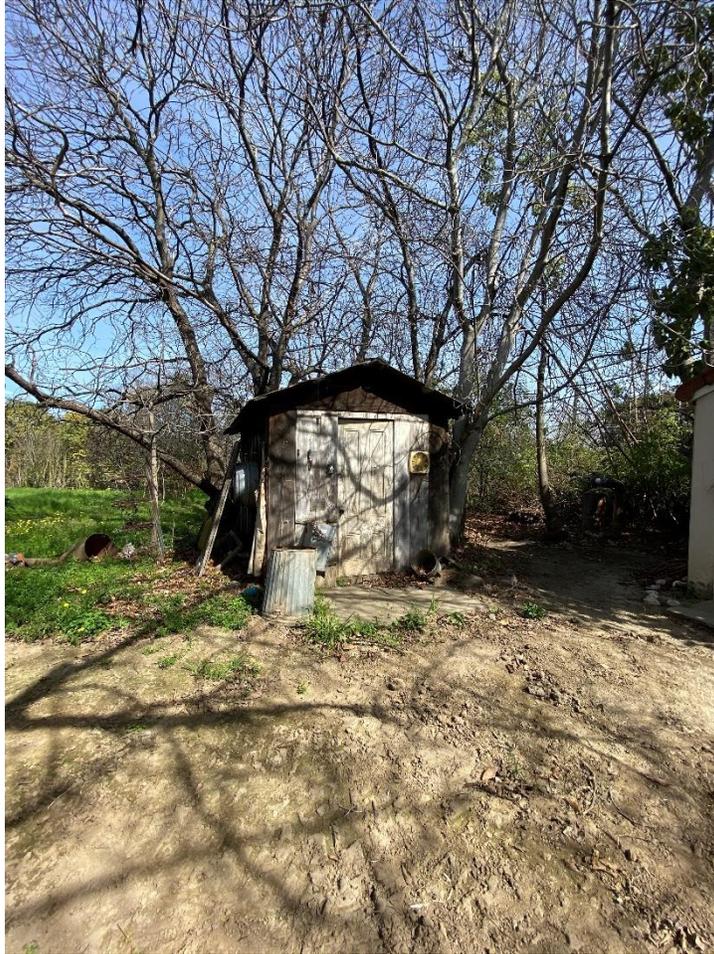
The ca. 1930 shed is not associated with any architectural style. The square-shaped building is constructed of vertical wood boards with a low-pitched roof clad in corrugated metal sheets. A door along the west elevation provides access to the shed. It is a four-panel wood door that appears to be older than the building and was likely reused from another building. The building appears to rest directly on the soil.

Figure 53. Photograph showing west elevation of the ca. 1930 shed.

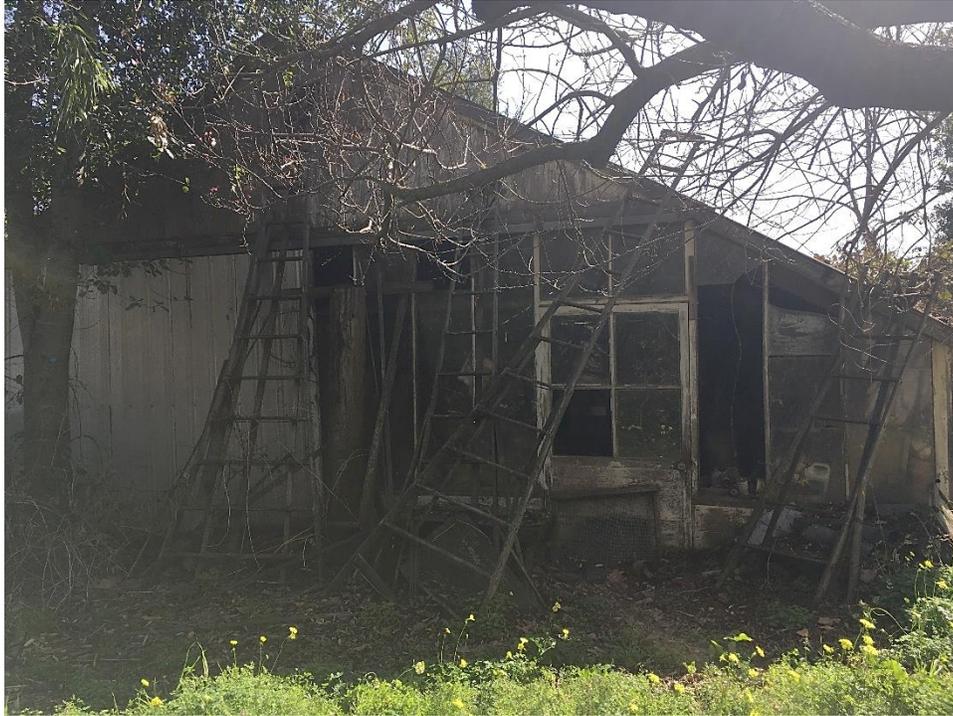
The ca. 1930 barn/wagon house is not associated with any architectural style. The building is a rectangular, front gable form with a moderate pitch roof. The building is clad in various materials, including corrugated sheet metal, wood boards, and plywood (Figure 55). The building also has several wood windows along a portion of the west elevation that provides light to the interior spaces. The windows appear to have been reused from another building. The roof is clad in corrugated metal sheets that appear modern and likely replaced the original metal roofing material. In a personal conversation with EDS Principal Archaeologist on March 5, 2021, Jim Kawaski, who lived within the Property for approximately 40 years, the barn was previously utilized to store wagons used for transporting produce.

Figure 55. Photograph showing west elevation of the ca. 1930 barn/wagon house.

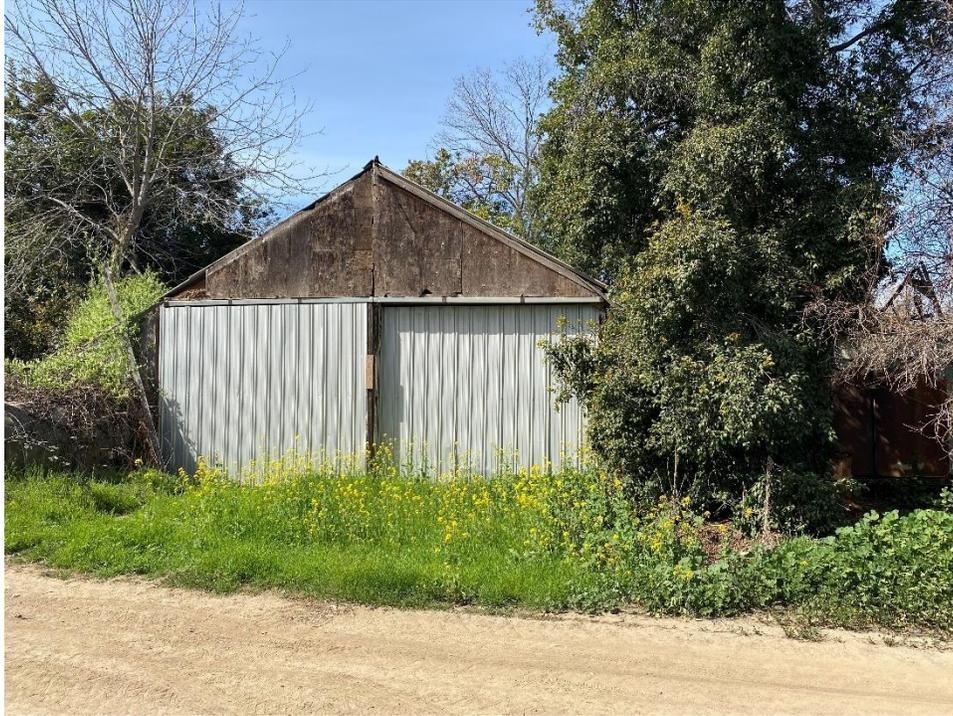
The ca. 1955 barn is not associated with any architectural style. The building is a rectangular, front gable form with a moderate pitch roof. The building is wood-framed and is clad in vertical wood boards (Figure 56). The roof is clad in corrugated metal sheets. The primary façade (south elevation) consists of two oversized corrugated metal “barn style” doors that are attached to a metal rail, which allows the doors to slide open. The building appears to rest on a concrete slab foundation.

Figure 56. Photograph showing the south elevation of the ca. 1955 barn, facing north.

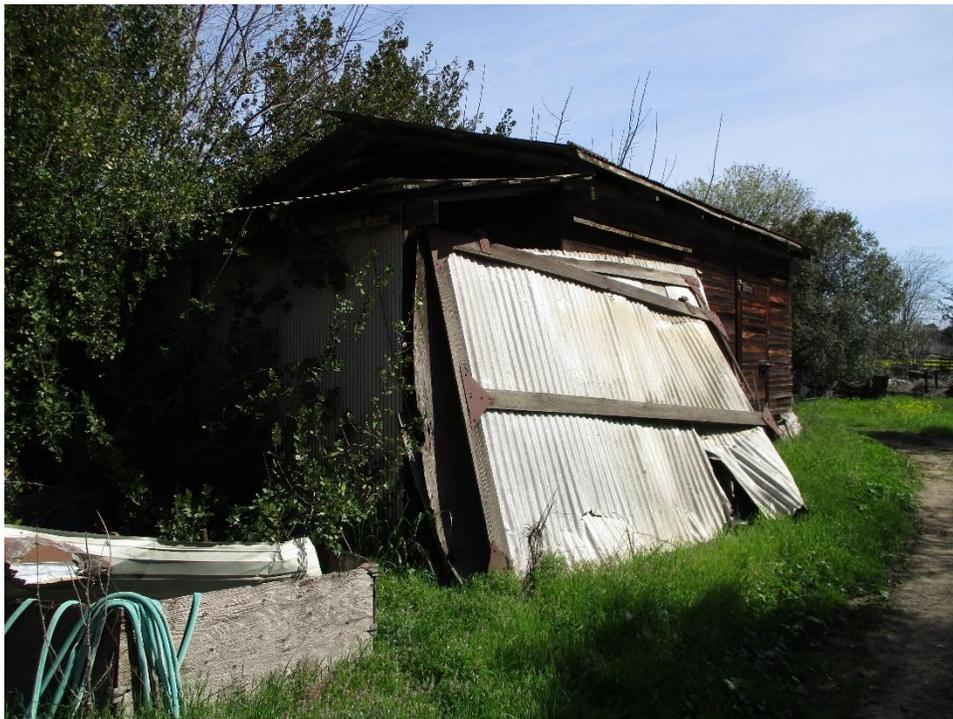
Although EDS-14 is not over 45 years of age, a photograph of the ca. 1985 cold storage shed (ice house) is included below (Figure 57).

Figure 57. Photograph showing the north and west elevations of ca. 1985 cold storage shed (ice house).

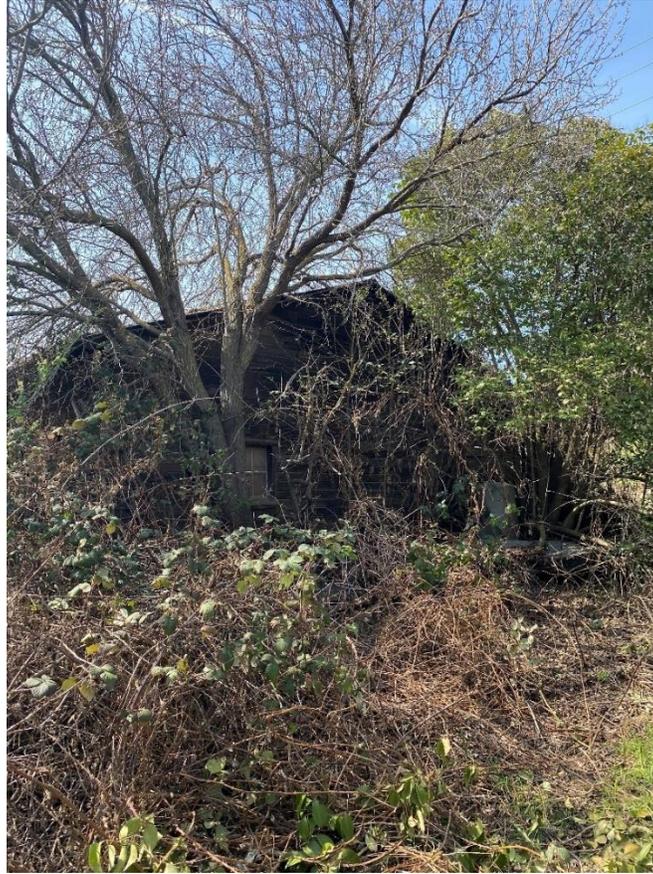
The ca. 1975 barn is not associated with any architectural style. The building is a rectangular, side-gable form with a moderate pitch roof. The building is wood-framed and is clad in narrow horizontal wood boards (Figure 59 and Figure 60). The roof is clad in corrugated metal sheets. The primary entrance to the building is along the west elevation, which consists of two oversized, barn-style entry doors attached to a metal rail. The building appears to rest on a concrete slab foundation.

Figure 59. Photograph showing the east elevation of the ca. 1975 barn, facing west.

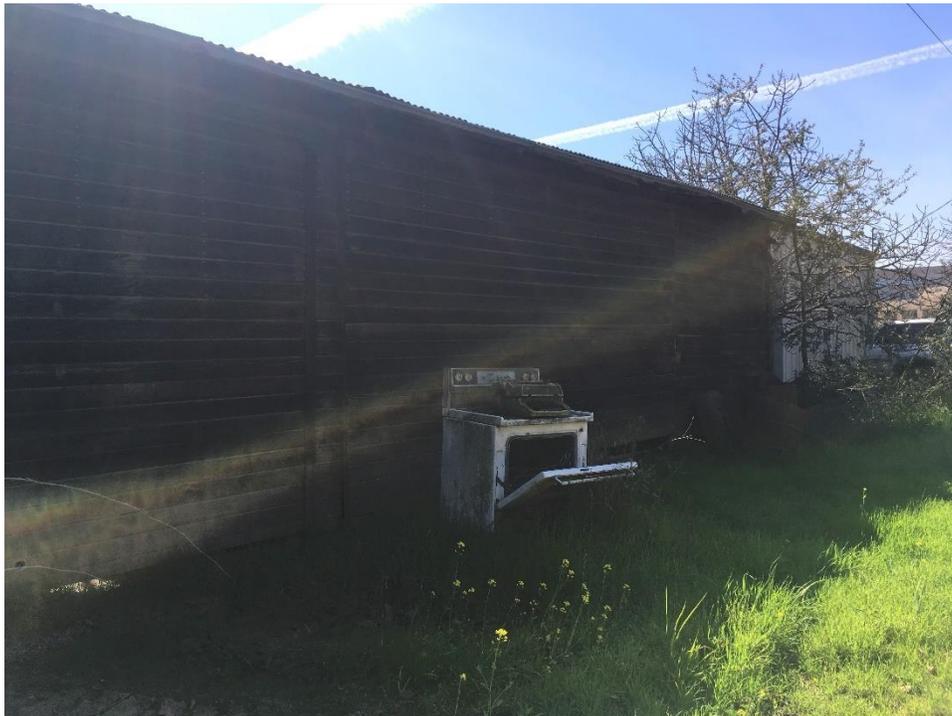
Figure 60. Photograph showing the north elevation of the ca. 1975 barn, facing west.

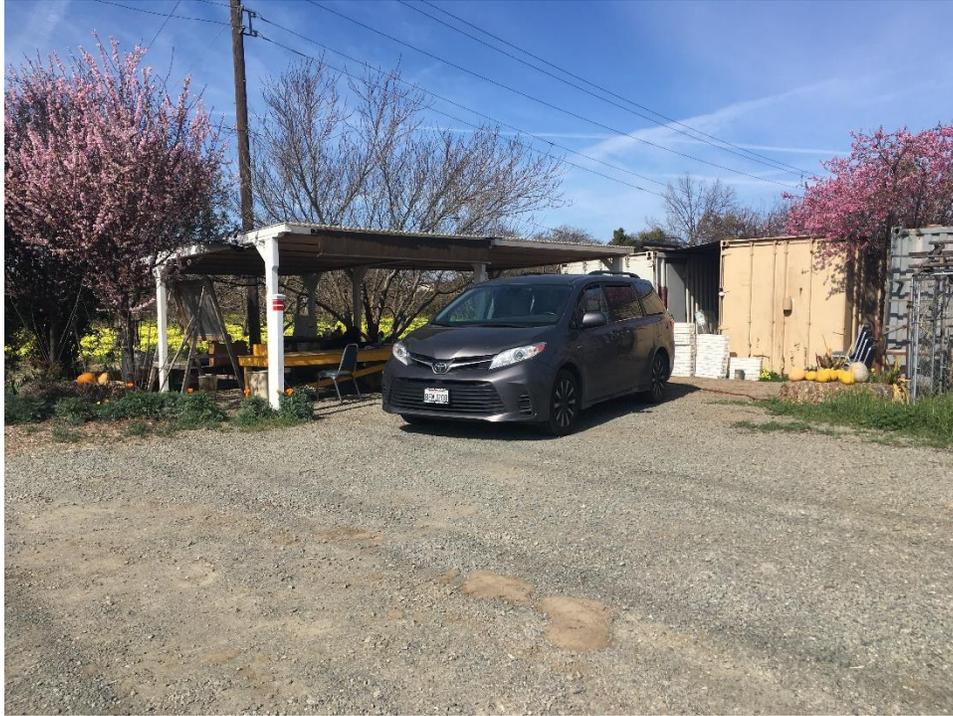
The ca. 1970 fruit stand is not associated with any architectural style. The fruit stand consists of three side-by-side metal shipping containers and an arbor (Figure 64). Adjacent and west of the containers is a patio/arbor constructed of four-square wood posts with brackets and a flat roof clad in corrugated sheet metal. The arbor structure appears to have been built in ca. 1970 when the containers were placed at this location; however, the metal roof appears to have been recently replaced.

Figure 64. Photograph showing the three shipping containers and the arbor facing northeast.

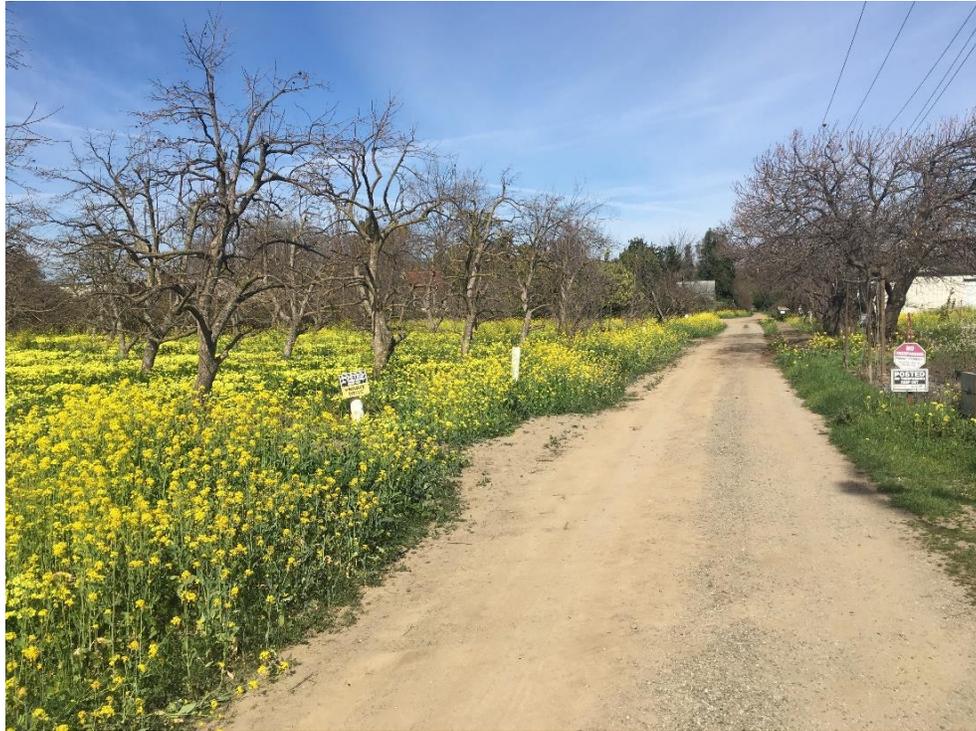
Figure 65. Photograph showing the dirt road accessed via Seely Avenue that extends to the easternmost boundary of the Property.

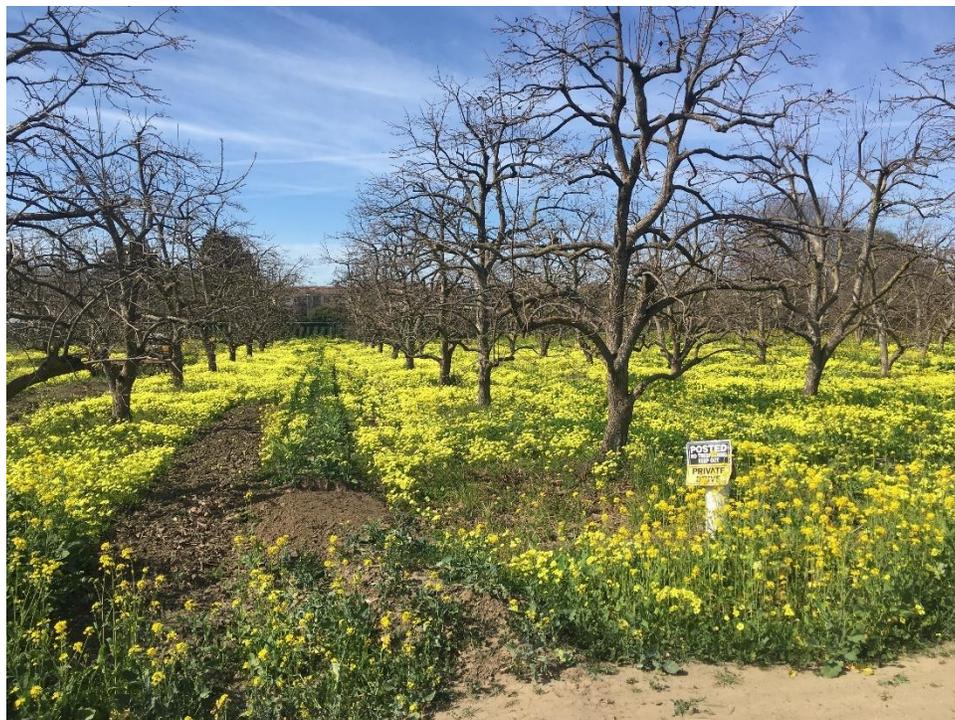
Figure 66. The photograph shows the orchard trees planted within the northwest portion of the Property.

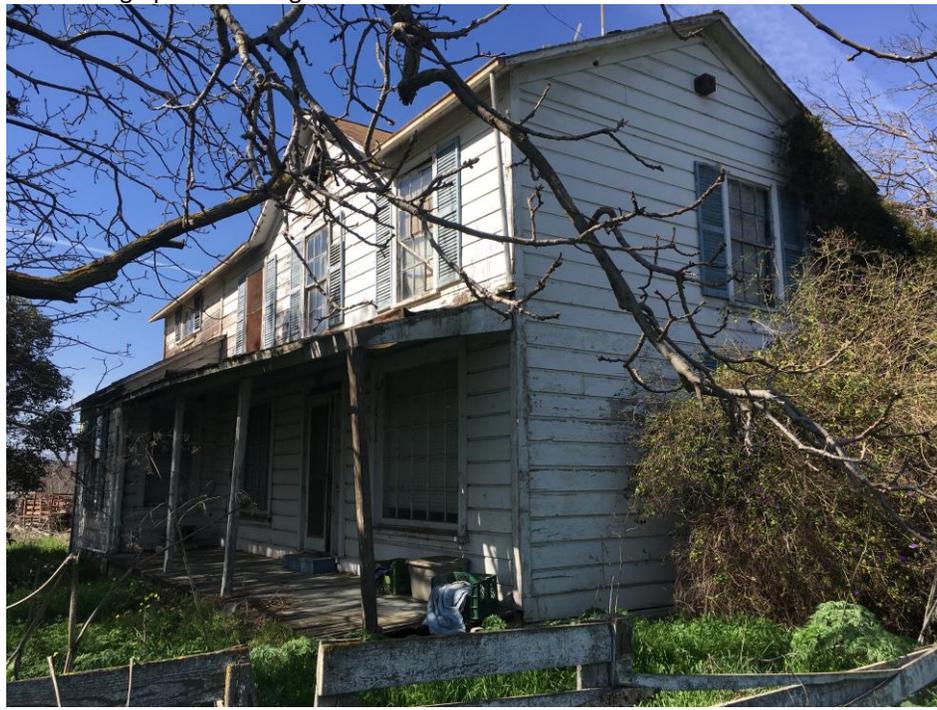
P5a. Photograph or Drawing

*P3a. Description: The resource is the ca. 1880 "Seely house" constructed within the Victorian Era with elements of Gothic Revival architecture. The ca. 1880 "Seely house" is a two-story, side-gable house was originally constructed as a small, one-story cottage. The house has several additions, including a second-story addition, which appears to have been added ca. 1900s, a ca. 1920s gable addition along the east elevation, and a ca. 1920s shed addition along the north elevation. The house is clad in wide channel shiplap wood siding. (Continued on Continuation Sheet 2)

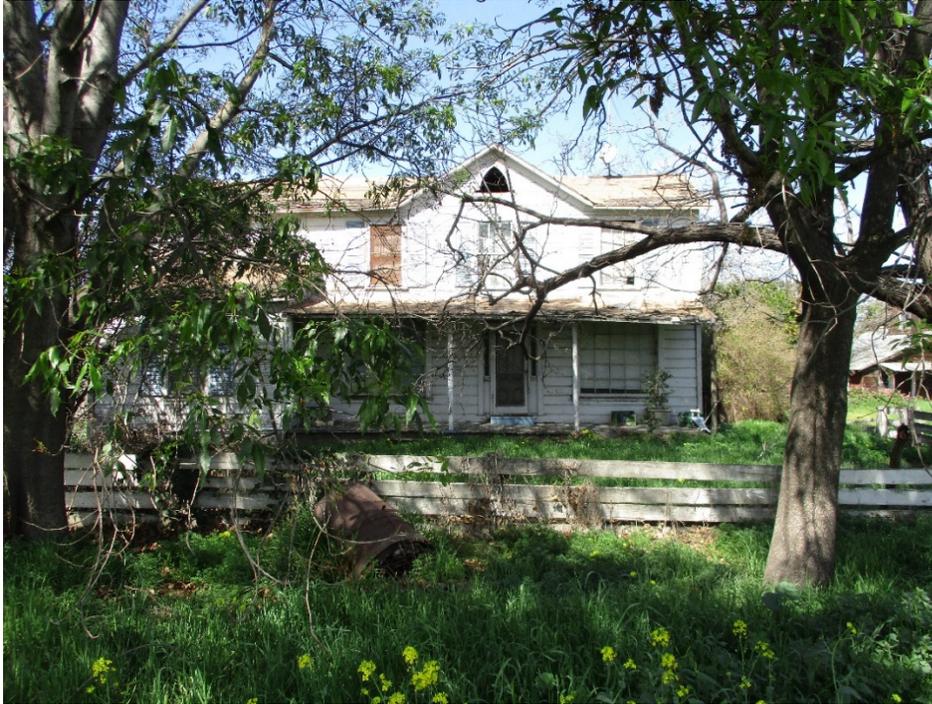
Figure 1. South elevation, facing north.

The **south elevation (primary façade)** consists of the original ca. 1880 portion of the side-gable form, the ca. 1900 two-story addition, and the ca. 1920s side gable addition (Figure 1). The two-story addition consists of a centered roof gable with a decorative Gothic-style window. There is no glass in the window, and the lower portion of the window casing is no longer present. The first floor consists of a shed porch that spans the original section of the ca. 1880s house. The porch does not appear to be original to the house and may have replaced an original porch added in the ca. the 1940s or 1950s (Figure 2). The porch consists of a shed roof supported by three square chamfered posts and one temporary wood post on the southeast corner. The porch floor is constructed of narrow wood boards and is not original to the house. The front door is situated within the porch and consists of two-side lights with decorative lower panels and a narrow transom light above the door. The is a wood-paneled door that appears to be original to the house. The ca. 1920s side gable addition consists of a two-story gable addition and a shed addition “bump-out” along the south elevation. The windows include two twenty-light, fixed, wood windows and two six-over-six, double-hung windows along the first floor; and three six-over-six, double-hung, wood windows, and one two-light, double-awning, wood window along the second floor. Decorative wood shutters flank several of the windows.
