A HISTORIC RESOURCE EVALUATION OF THE PROPERTY AT 681 E. TRIMBLE ROAD, SAN JOSE, SANTA CLARA COUNTY, CALIFORNIA

Updated October 18, 2023

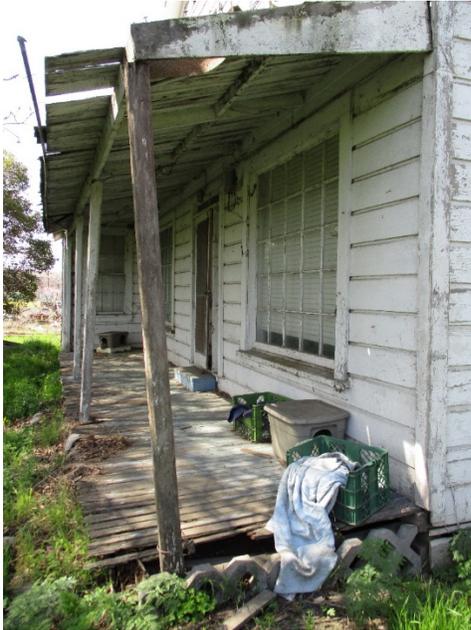
Figure 2. Photo showing the primary façade front porch, facing west.

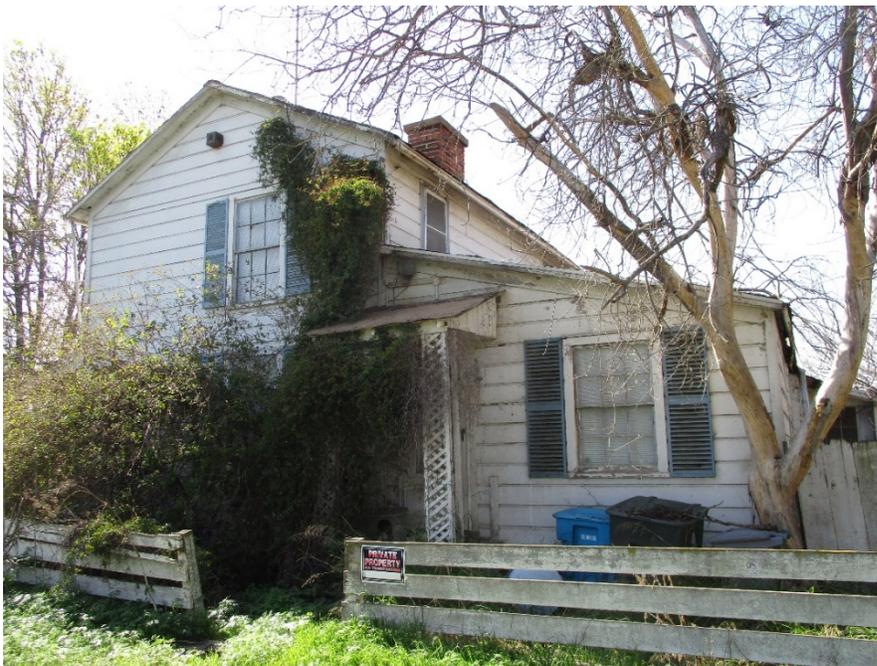
The **east elevation** consists of the ca. 1900 second-story addition and the ca. the 1920s shed addition north elevation (Figure 3). There is one six-over-six, double-hung, wood window on the second floor and two six-over-six, double-hung, wood windows on the first floor. Decorative wood shutters flank the windows. The east elevation also consists of a side entrance along the shed addition set under a shed porch roof. There are concrete stairs that lead to a rear door entrance, which are covered in overgrown vines.

Figure 3. Photo showing the east elevation (left) and a portion of the north elevation (right), facing west.

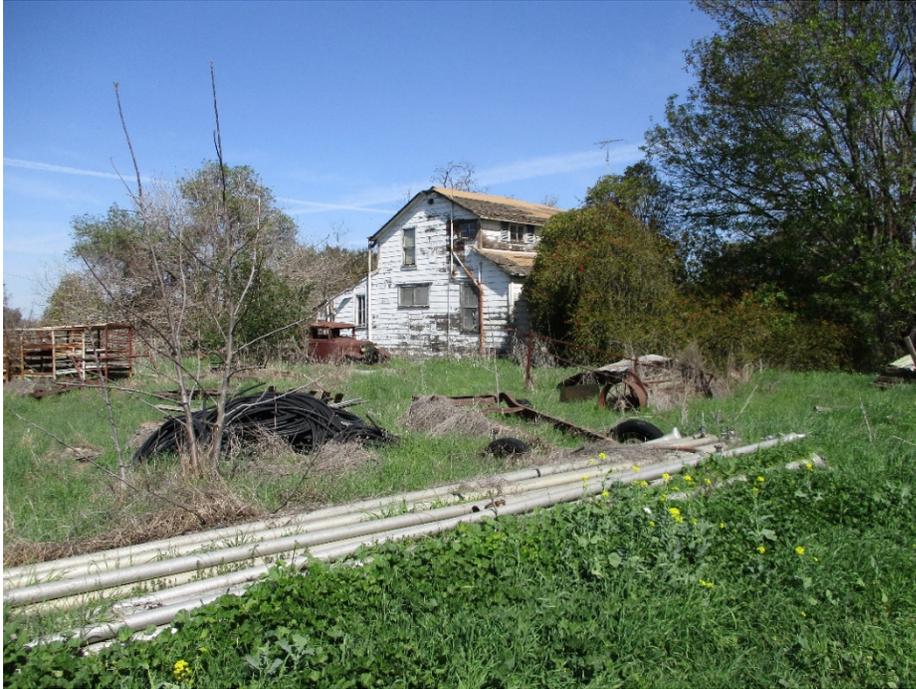
fixed, wood windows (Figure 4). There are several visible modifications along this elevation, including a section where a door was previously located at first floor, and a window also appears to have been removed and clad over in wood boards along the second floor.

Figure 4. Photo showing the west elevation, facing northeast.

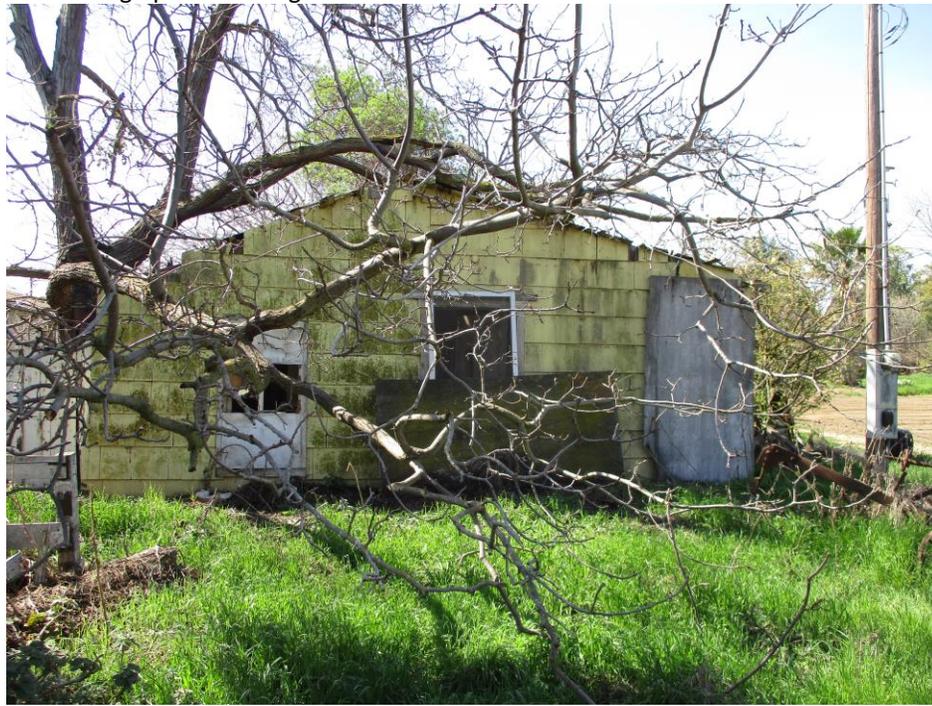
P5a. Photograph or Drawing

*P3a. Description: The resource is the ca. 1920 cottage, which is not associated with any architectural style. The side-gable portions of the building along the east and west elevations are clad in thin wood boards that were cut into "shingles", and the north and south elevations are clad in wide wood boards. There is a low-pitched roof with exposed rafter tails along the south and north elevations, and the roof is clad in wood boards and roofing membrane material. The building appears to have originally been constructed as a garage or accessory building that was converted into housing in the 1950s. The primary entrance to the building appears to be along the west elevation; however, the building also consists of a secondary primary entrance along the south elevation. The openings (unclear if they are windows or doors) along the east elevation of the building are partially covered with plywood) and a tree has fallen on the roof along the south elevation, and a portion of the roof that has collapsed.

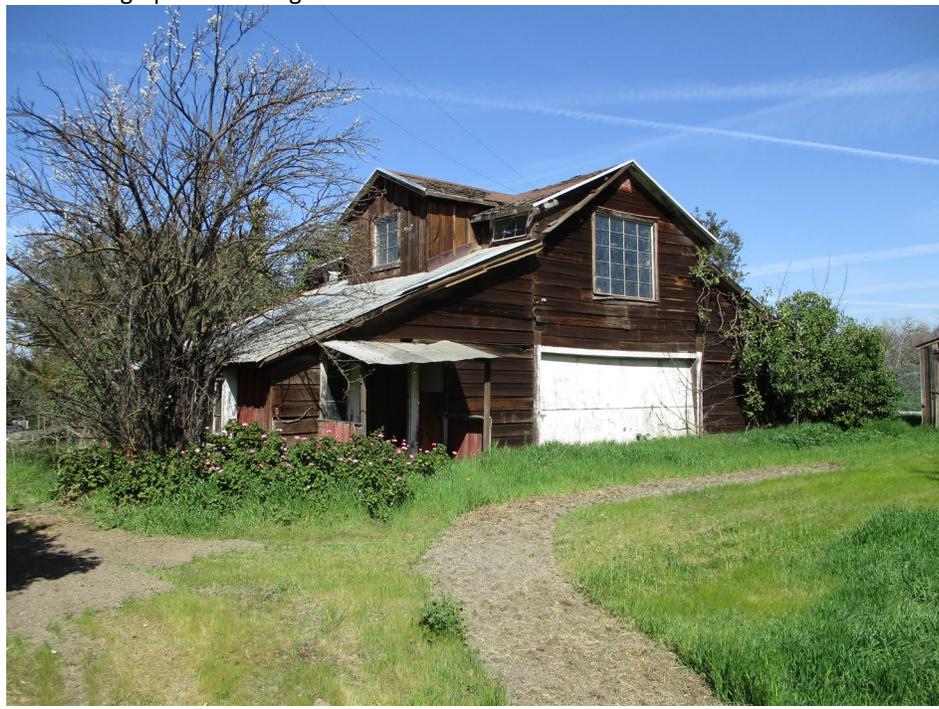
P5a. Photograph or Drawing

*P3a. Description: The resource consists of a ca. 1890 barn that is a Vernacular form that has been significantly altered since its construction. The original ca. 1890 barn is a two-story, side-gable form with two shed "wing" additions that are visible along the south elevation; however, there have been alterations to the barn since its construction, including the enclosure of the shed addition along the west elevation (ca. 1930), gable dormer (ca. 1950), and changes that include the addition of multi-light wood windows, doors, and a garage door when the barn was converted for housing in the ca. 1930s. (Continued on Continuation Sheet 2)

P5b. Description of Photo: ca. 1890 barn, facing north.

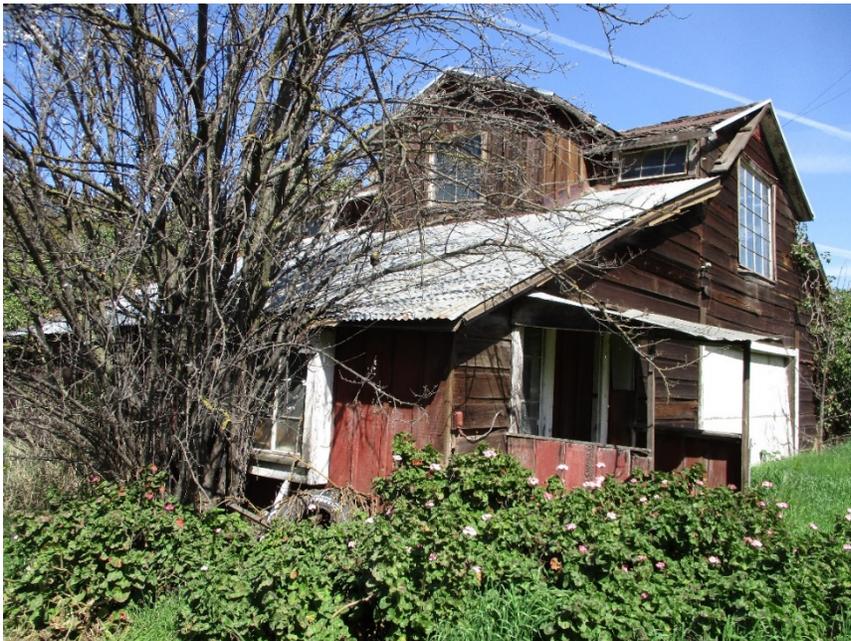
The original ca. 1890 form is wood-framed construction clad in wide wood boards with batten (Figure 1). The roof is a moderate pitch and is clad in wood, asphalt, and metal roofing material. The south elevation consists of a wooden hinged garage door that was likely added in the 1950s. There is a twenty-light, fixed, wood window along the second story and an entrance door set under the porch entry. The east elevation, though not entirely visible due to overgrown vegetation, consists of the original shed “wing” addition that was associated with the barn and is void of fenestrations along the wing addition. However, there are a series of multi-light hopper or fixed-light wood windows under the second-floor roof eaves that appear to have been added in ca. 1930. The west elevation consists of a second-story gable roof dormer and extended shed roof addition that has multi-light wood windows. The north elevation, although mostly covered with overgrown vegetation (Figure 2), consists of an exterior wood staircase that leads to a second-floor door and an exterior door along the first floor that appears to be original (Figure 3).

Figure 1. ca. 1890 barn showing west and south elevations, facing east.

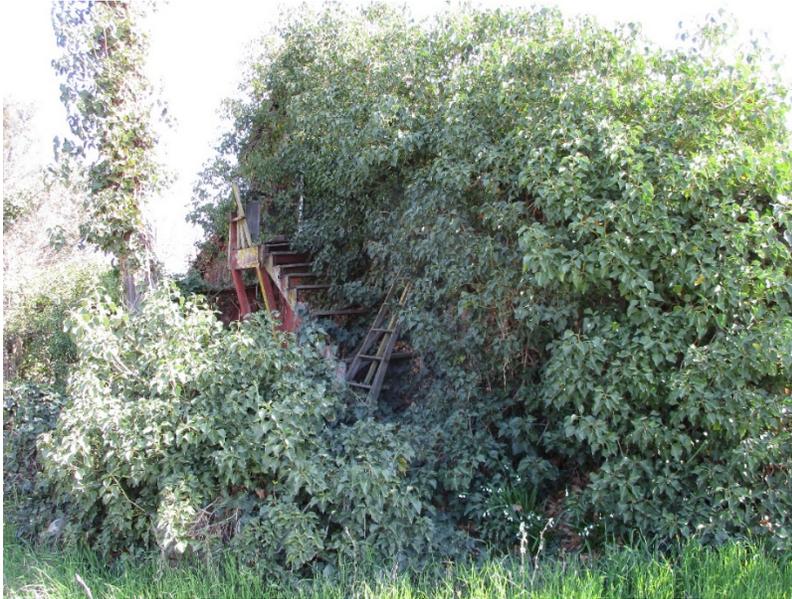
Figure 2. Photograph showing the overgrown vegetation along the west and north elevations of the ca. 1890 barn, facing east.

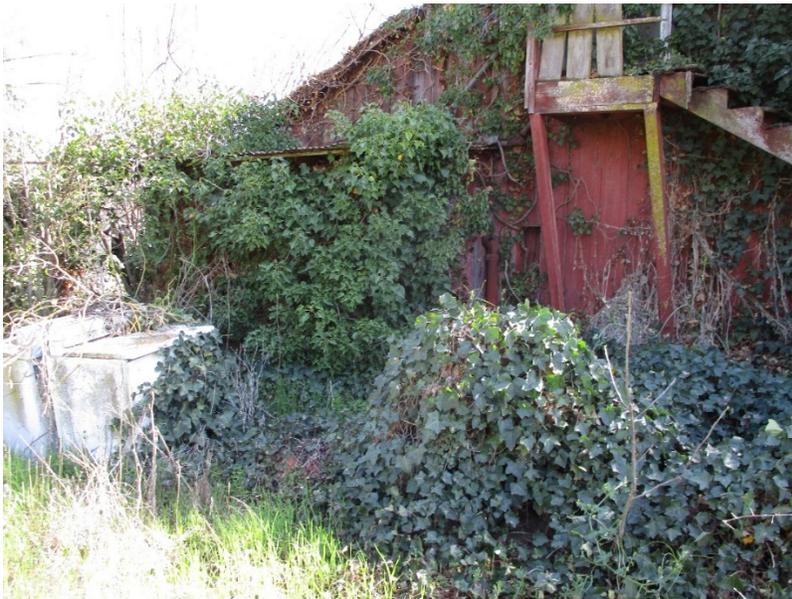
Figure 3. Photograph showing the north elevation, facing south.

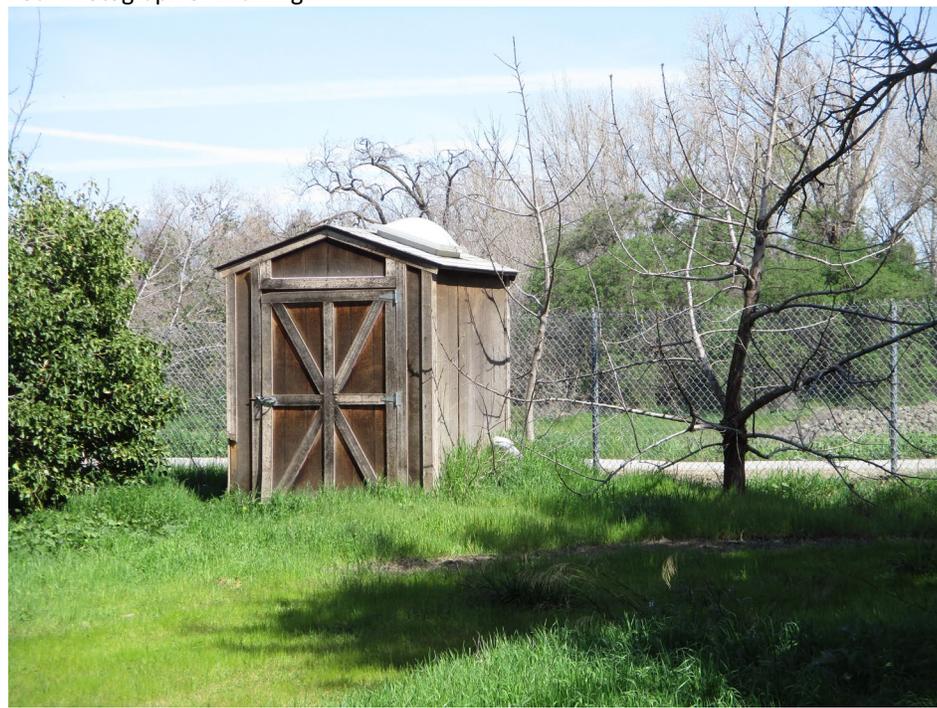
P5a. Photograph or Drawing

P5b. Description of Photo: ca. 1930 pump house, facing northeast.

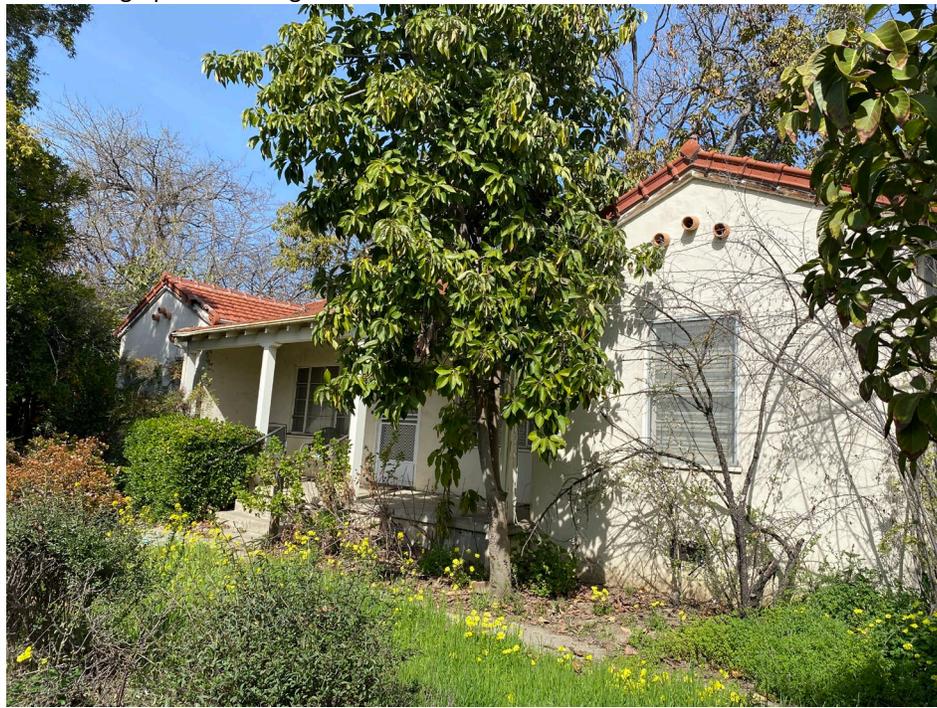
*P3a. Description: The resource is the ca. 1920 "Sakauye house" designed in the Spanish Colonial Revival architectural style. The house is a rectangular plan building that is flanked by two projecting front gable wings. The house is clad in stucco, and the roof is clad in Spanish red clay tile. The roof is low-pitched within decorative Spanish red clay tiles set along the edge of the shallow roof eaves. The house appears to rest on a perimeter foundation. (Continued on Continuation Sheet 2)

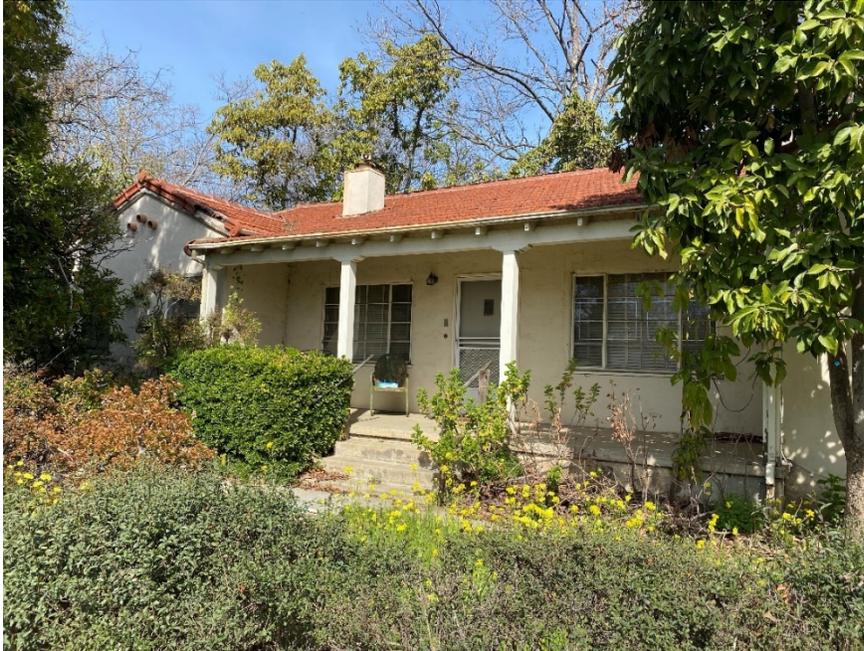
Figure 1. West elevation, facing northeast.

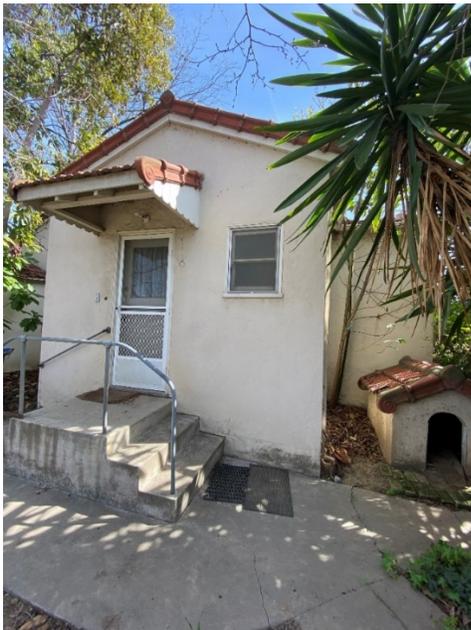
The **north elevation** consists of two projecting gables, one of which is the side entrance to the house (Figure 2), and the other provides access to the basement (Figure 3). Both projecting gable forms are set within the side-gable form of the house. All three gables are clad in stucco with roof eaves that are clad in Spanish red clay tile. The two projecting gable forms also have decorative Spanish clay tile scrollwork along the gable peak and the corners of the eaves. The side entrance gable consists of a scalloped, shed-style porch roof that is clad Spanish red clay tile with decorative scroll work along the eave corners. The side entrance is accessed via a set of concrete stairs with a metal handrail that appears to have been added in the 1970s. The side entrance door is wood and glazed and appears to be from the ca. 1950s, and there is double-hung, wood widow with lugs within the projecting gable. The projecting gable with the basement access consists of double wood and glazed doors that are original to the house. There are also two double-hung, wood widows with lugs along the house gable.

Figure 2. North elevation, showing the side entrance to the house.

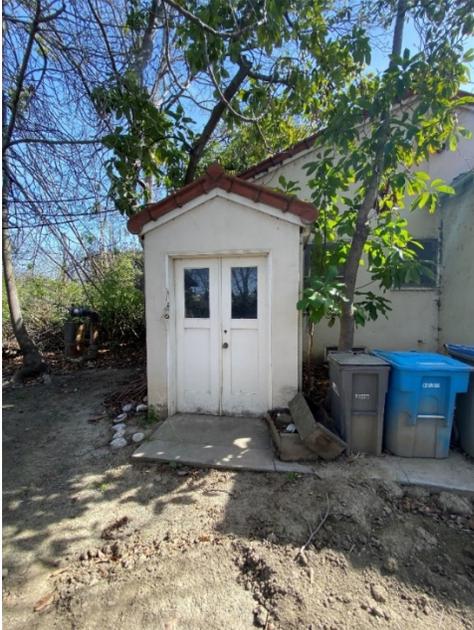
Figure 3. Photograph showing the projecting gable entry into the basement where the Sakauye family, as well as other Japanese Americans, stored their belongings during their internment from 1942 to 1945.

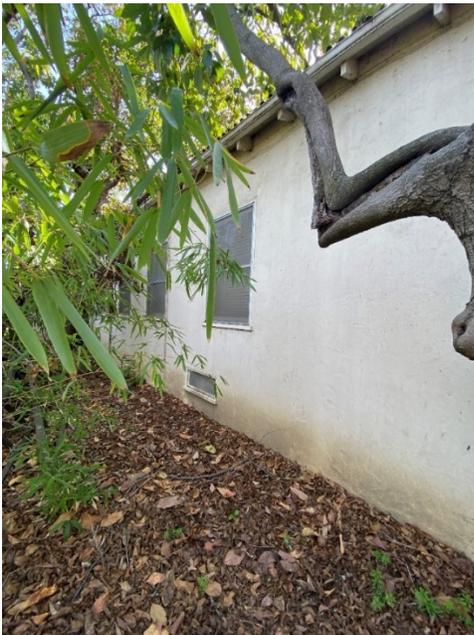
The **east elevation** consists of stucco exterior walls and the roof has a slight eave overhang with exposed rafter tails (Figure 4). There are several metal vents along the lower portion of the exterior walls and four double-hung wood windows with lugs.

Figure 4. East elevation of the ca. 1920 house, facing south.

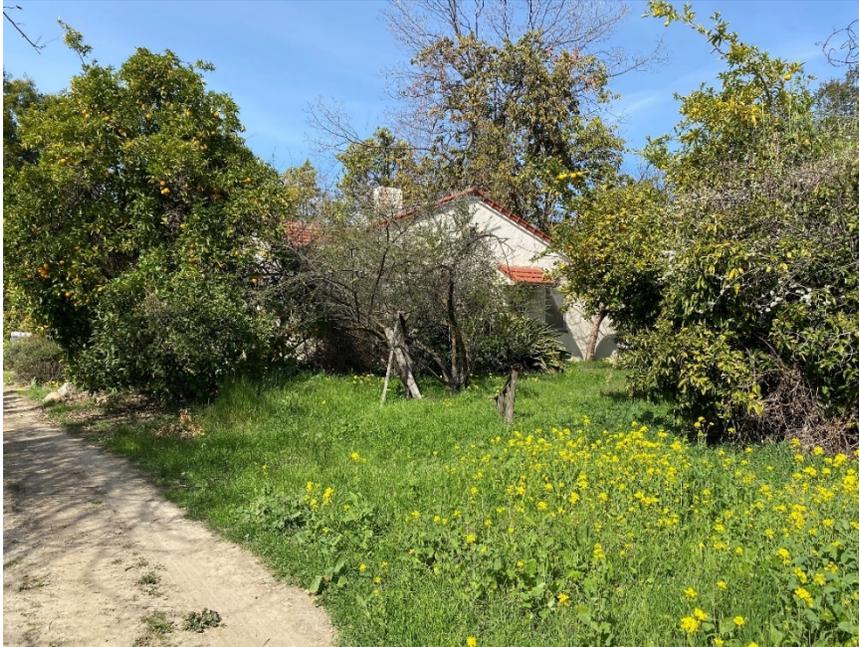
The **south elevation** consists of stucco walls with roof eaves that are clad in Spanish red clay tile and three circular clay tile vents along the top of the gable (Figure 5). There is a side entrance to the house along the south elevation that consists of a scalloped shed-style porch roof constructed of wood with exposed rafter tails (Figure 6). The porch roof is clad Spanish red clay tile with decorative scroll work along the eave corners. The side entrance is accessed via a set of concrete stairs. The side entrance door was partially covered by overgrown vegetation but appears to be the original wood door. There are four double-hung, wood widows with lugs and several basement vents along this elevation.

Figure 5. South elevation, facing north.

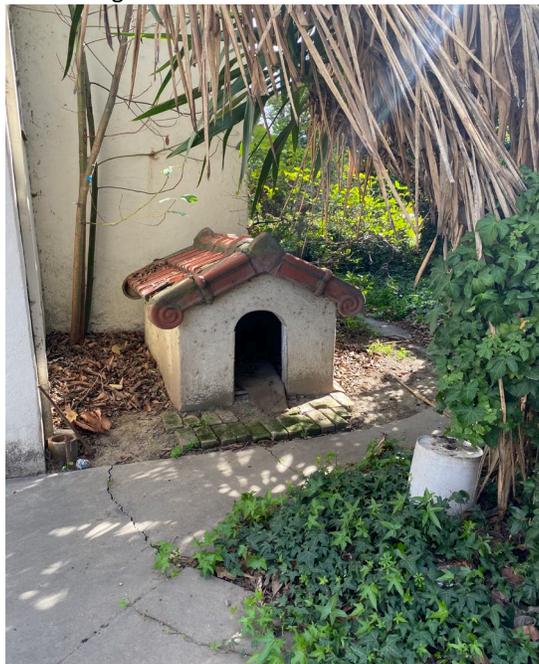
P5a. Photograph or Drawing

*P3a. Description: The resource consists of a ca. 1930 doghouse that is associated with Spanish Colonial Revival architecture. It is a rectangular form constructed of concrete and clad in stucco. The roof is clad in Spanish clay tile with decorative scrollwork along the eave corners.

P5b. Description of Photo: ca. 1930 doghouse, facing south

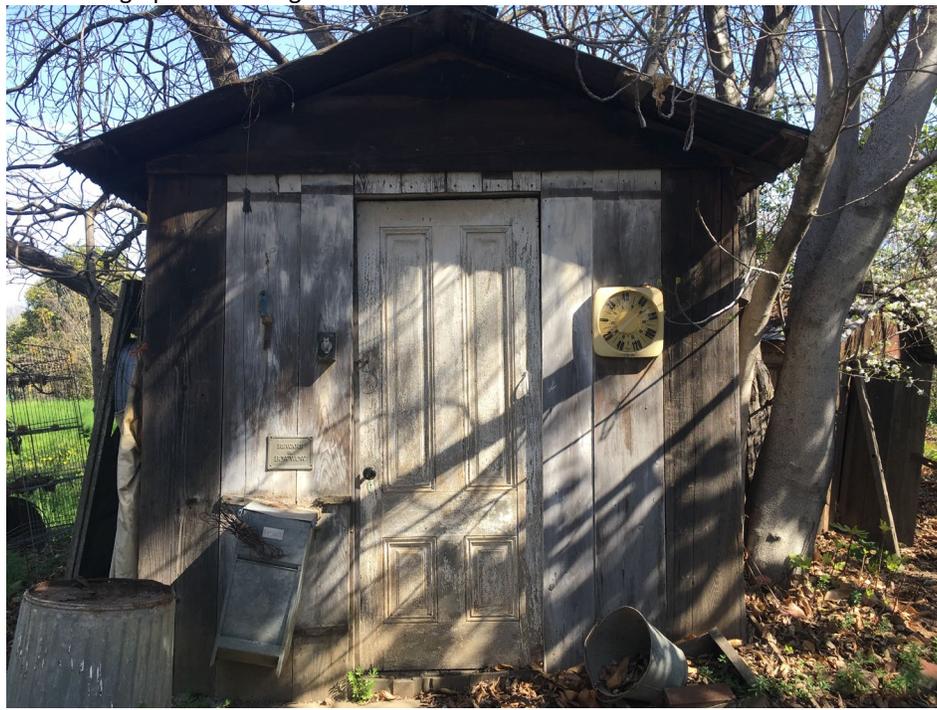
P5a. Photograph or Drawing

*P3a. Description: The resource is a ca. 1930 shed. The ca. 1930 shed is not associated with any architectural style. The square-shaped building is constructed of vertical wood boards with a low-pitched roof clad in corrugated metal sheets. There is a door along the west elevation that provides access to the shed. The door is a four-panel wood door and appears to be older than the building, and as such was likely reused from another building. The building appears to rest directly on the soil.

P5b. Description of Photo: ca. 1930 shed; facing east

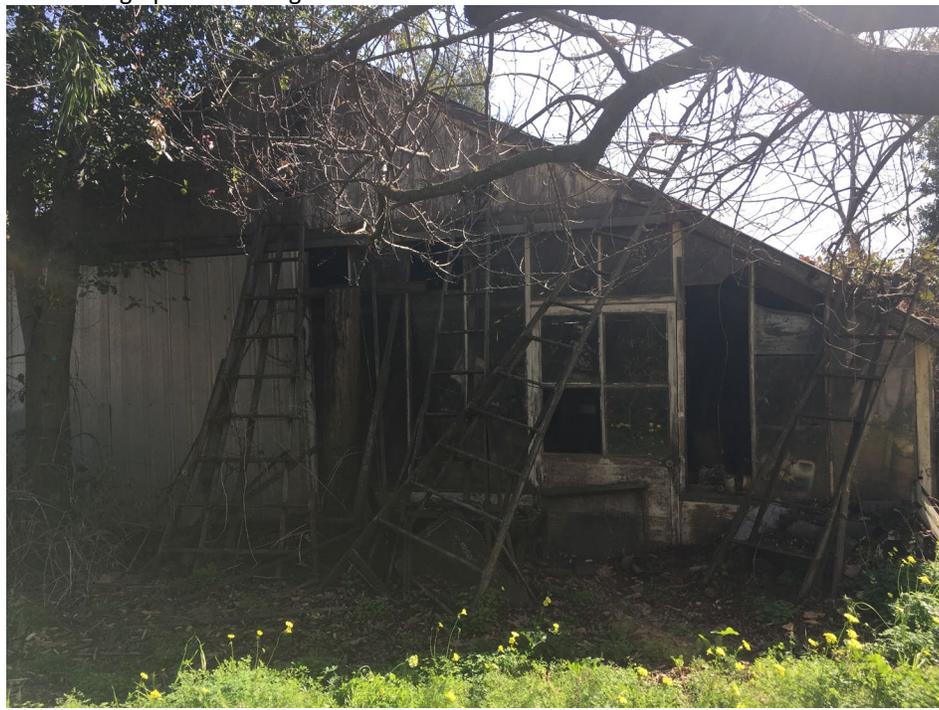
*P3a. Description: The resource is the ca. 1930 barn/wagon house, which is not associated with any architectural style. The building is a rectangular, front gable form with a moderate pitch roof. The building is clad in various materials including corrugated sheet metal, wood boards, and plywood. The building also has several wood windows along a portion of the west elevation that provide light to the interior spaces. The windows appear to have been reused from another building. The roof is clad in corrugated metal sheets that appear to be modern and likely replaced the original metal roofing material.

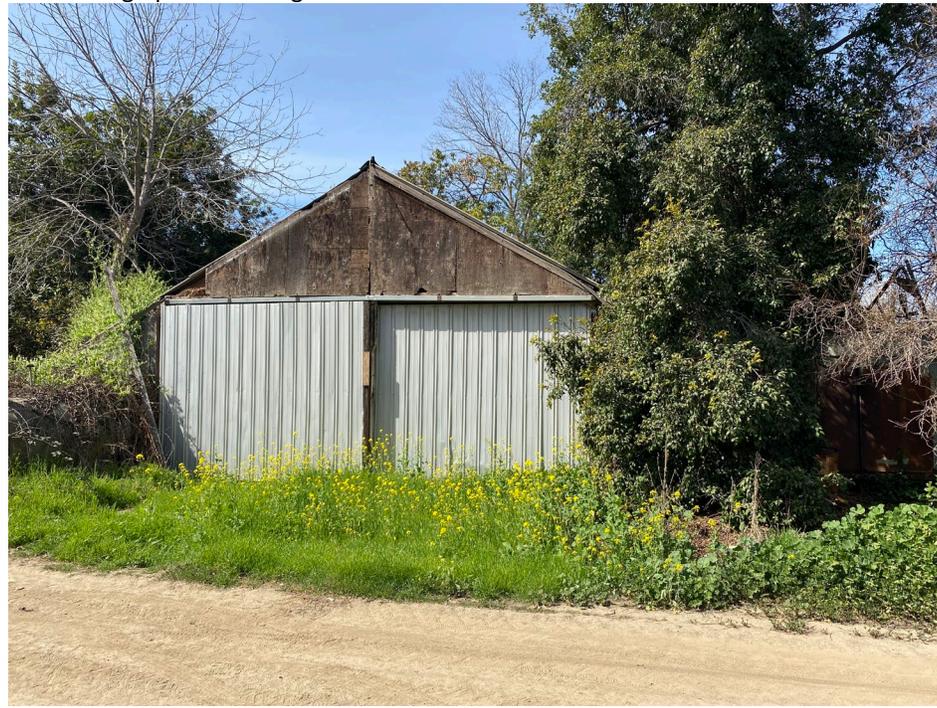
*P3a. Description: The resource is the ca. 1955 barn, which is not associated with any architectural style. The building is a rectangular, front gable form with a moderate pitch roof. The building is wood-framed and is clad in vertical wood boards. The roof is clad in corrugated metal sheets. The primary façade (south elevation) consists of two oversized corrugated metal "barn style" doors that are attached to a metal rail, which allow the doors to slide open. The building appears to rest on a concrete slab foundation.

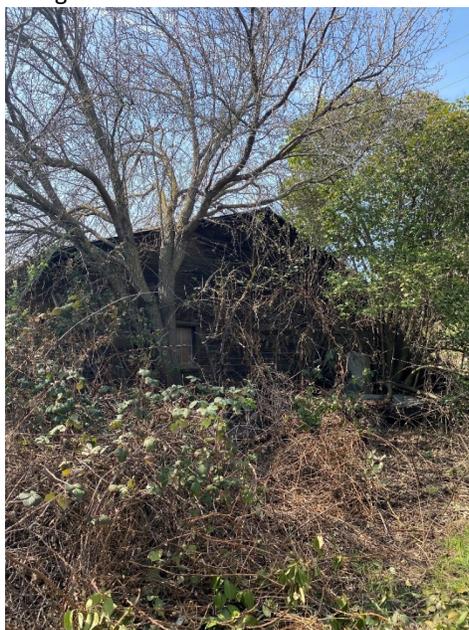
*P3a. Description: The resource is the ca. 1975 barn, which is not associated with any architectural style. The building is a rectangular, side-gable form with a moderate pitch roof. The building is wood-framed and is clad in narrow horizontal wood boards. The roof is clad in corrugated metal sheets. The primary entrance to the building is along the west elevation, which consists of two oversized, barn-style, entry doors attached to a metal rail. The building appears to rest on a concrete slab foundation.

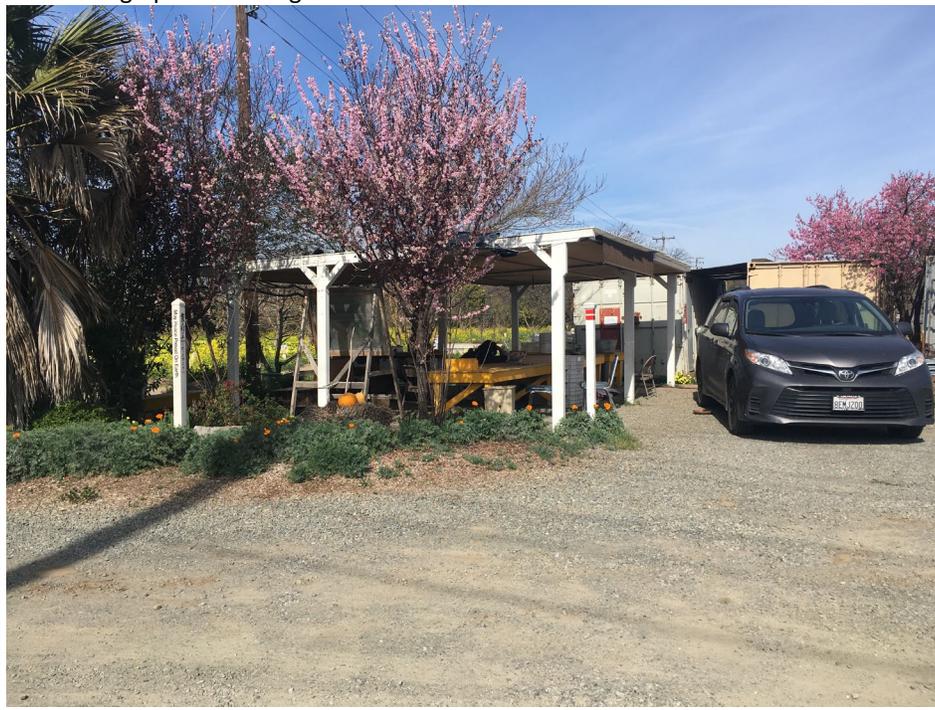
*P3a. Description: The resource is the ca. 1970 fruit stand, which is not associated with any architectural style. The fruit stand consists of three side-by-side, metal shipping containers and an arbor. Adjacent and west of the containers is a patio/arbor constructed of four-square wood posts with brackets and a flat roof clad in corrugated sheet metal. The arbor structure appears to have been built in ca. 1970 when the containers were placed at this location; however, the metal roof appears to have been recently replaced.

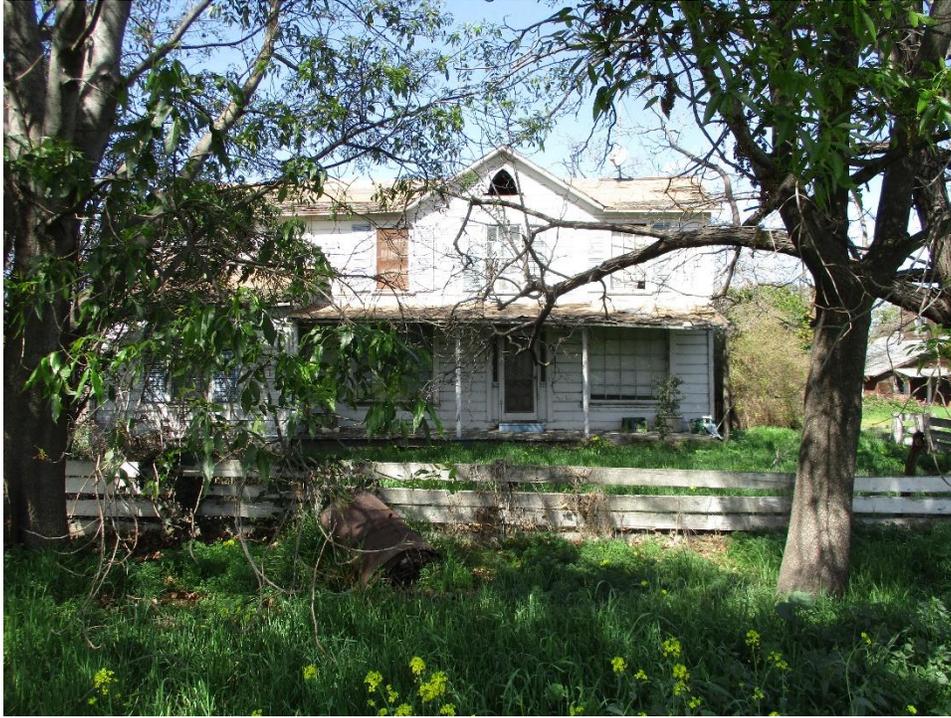
The ca. 1880 Seely House does not embody elements of any architectural or engineering design, detail, materials, or craftsmanship representing any unique or significant architectural innovation. The house has also undergone significant alterations, and only the primary façade demonstrates any elements of Gothic Revival design – such as the centered roof gable with a decorative Gothic-style window. As such, the ca. 1880 Seely House is not recommended as eligible for designation as a city landmark under this criterion.

Figure 1. ca. 1880 Seely House.⁶

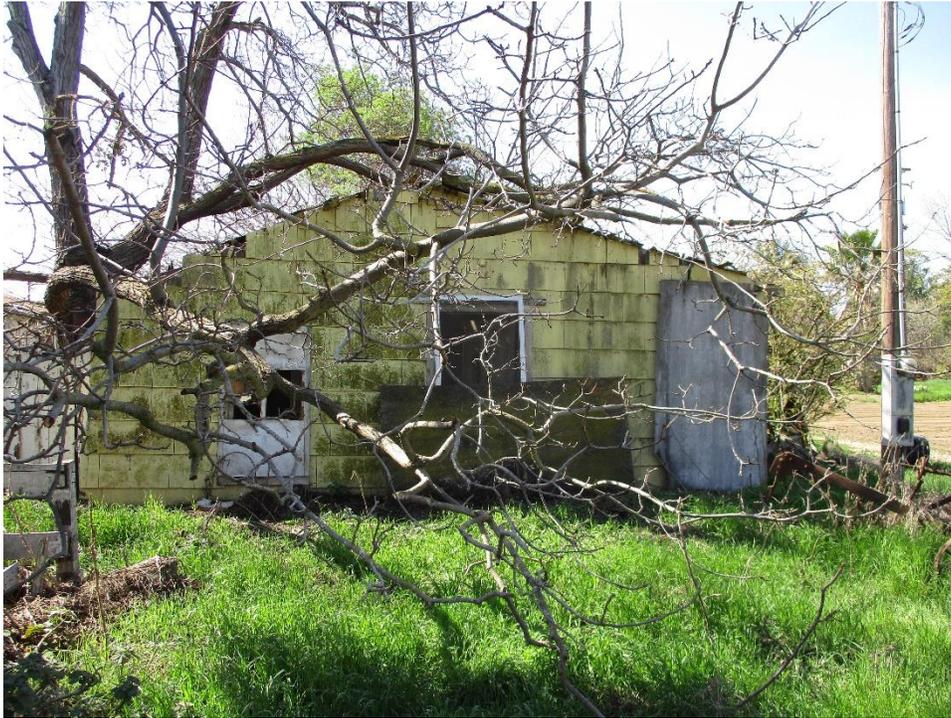
The ca. 1920 cottage does not embody elements of any architectural or engineering design, detail, materials, or craftsmanship that represents any unique or significant architectural innovation. The ca. 1920 cottage has also undergone significant alterations since its construction date. As such, the ca. 1920 cottage is not recommended as eligible for designation as a city landmark under this criterion.

Figure 1. ca. 1920 cottage.⁵

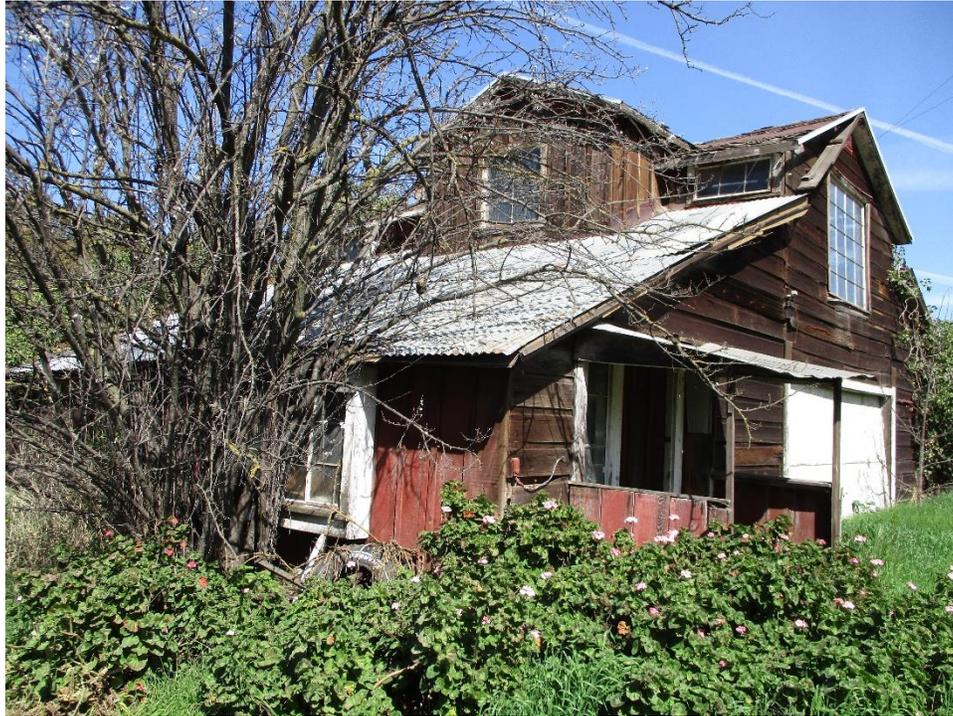
The ca. 1890 barn does not embody elements of any architectural or engineering design, detail, materials, or craftsmanship representing any unique or significant architectural innovation. Also, the barn has undergone significant alterations, which has affected the original design. As such, the ca. 1890 barn is not recommended as eligible for designation as a city landmark under this criterion.

Figure 1. ca. 1890 Barn.⁴

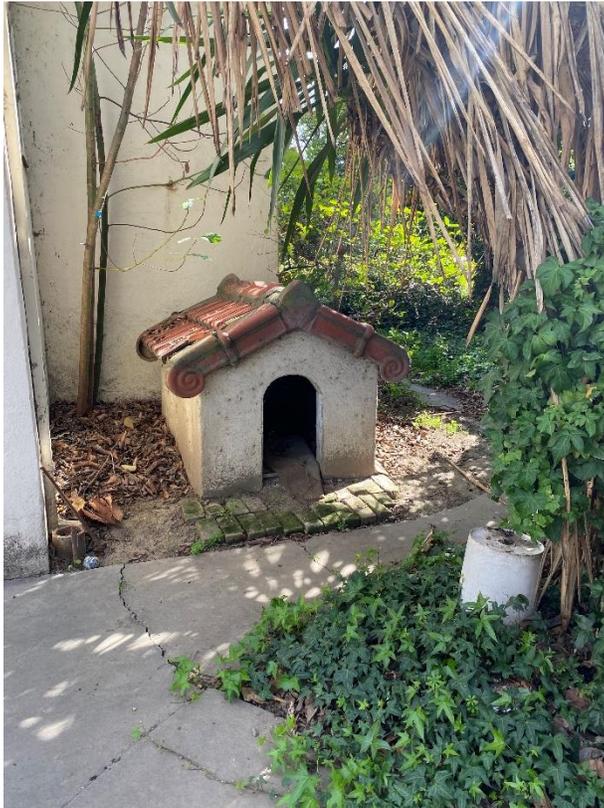
Although the ca. 1930 doghouse demonstrates elements of the Spanish Colonial Revival architectural style, it does not embody elements of any architectural or engineering design, detail, materials, or craftsmanship that represents any unique or significant architectural innovation. As such, the ca. 1930 doghouse is not recommended as eligible for designation as a city landmark under this criterion.

Figure 1. ca. 1930 doghouse.²

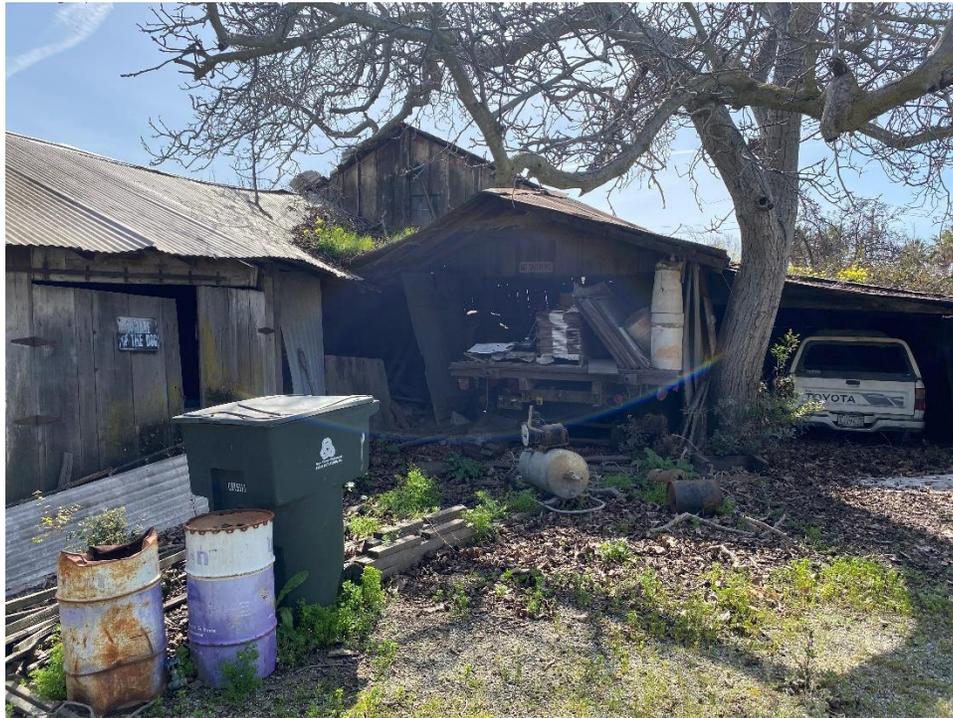
The ca. 1910 barn was built in a Vernacular style – typical of barns during the early 20th century. However, the original long, linear, front-facing gable form was altered to include a gable and shed additions. Although the barn is associated with orchard farming and farming in San Jose during the early 20th century,¹ it does not consist of the character necessary to convey this interest or value for designation as an individual city landmark. As such, the ca. 1910 barn is not recommended as eligible for designation as a city landmark under this criterion.

The ca. 1910 barn does not embody elements of any architectural or engineering design, detail, materials, or craftsmanship representing any unique or significant architectural innovation. As such, the ca. 1910 barn is not recommended as eligible for designation as a city landmark under this criterion.

Figure 1. ca. 1910 barn.²

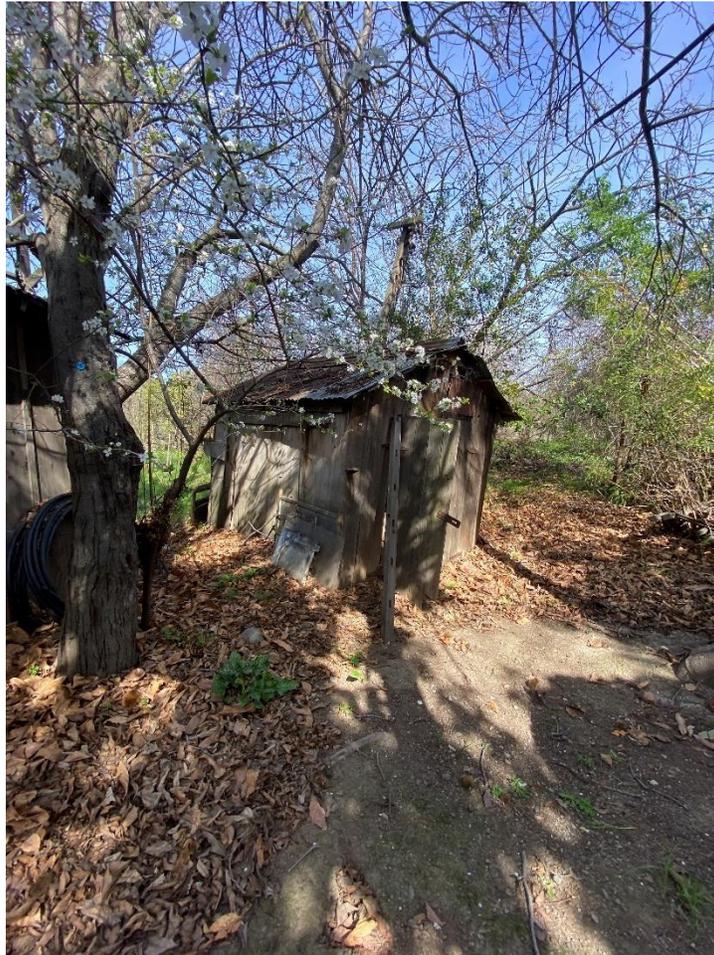
The ca. 1930 pump house was not built in a particular style. It has a front-facing gable form with a moderate-pitched roof and does not demonstrate any character, interest, or value as part of the local, regional, state, or national history, heritage, or culture. As such, the ca. 1930 pump house is not recommended as eligible for designation as a city landmark under this criterion.

The ca. 1930 pump house does not embody elements of any architectural or engineering design, detail, materials, or craftsmanship that represents any unique or significant architectural innovation. As such, the ca. 1930 pump house is not recommended as eligible for designation as a city landmark under this criterion.

Figure 1. ca. 1930 pump house.²

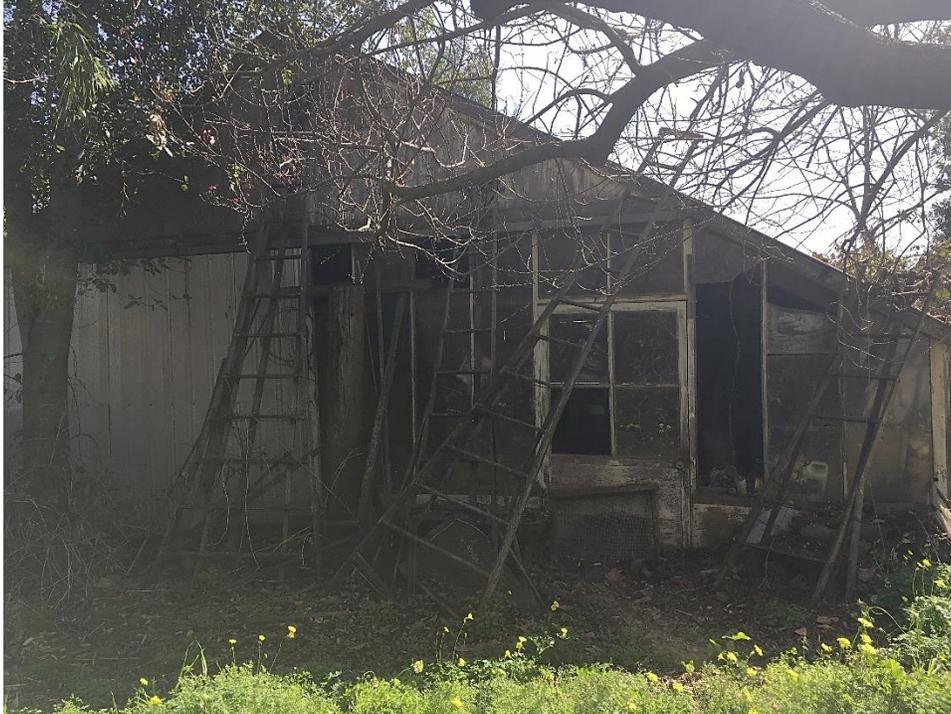
such, the ca. 1930 barn/wagon house is not recommended as eligible for designation as a city landmark under this criterion.

Figure 1. ca. 1930 barn/wagon house.²

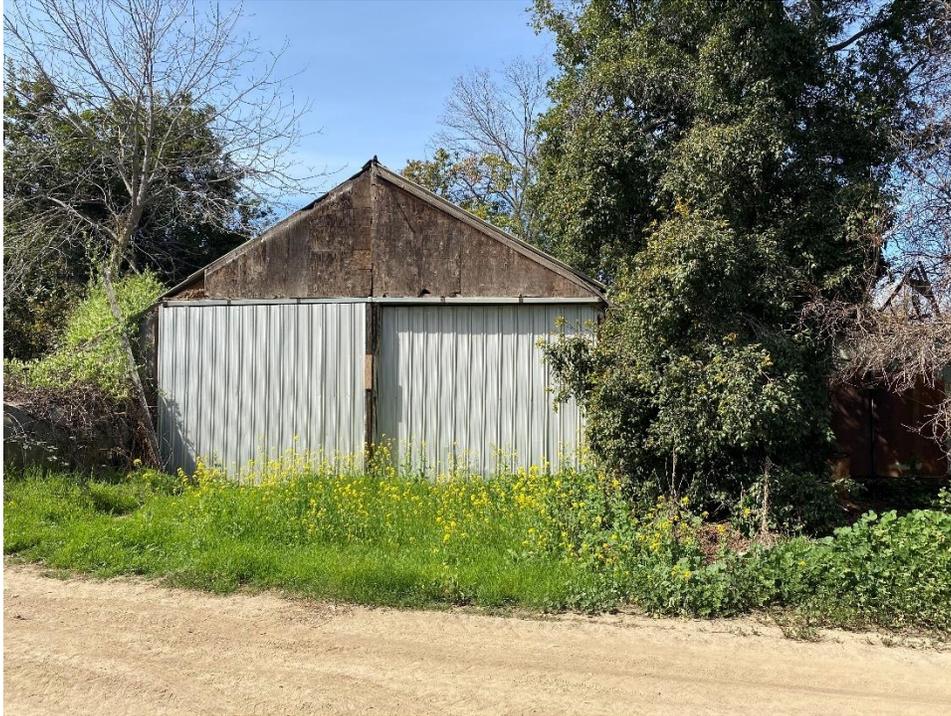
The ca. 1955 barn does not embody elements of any architectural or engineering design, detail, materials, or craftsmanship that represents any unique or significant architectural innovation. As such, the ca. 1955 barn is not recommended as eligible for designation as a city landmark under this criterion.

Figure 1. ca. 1955 barn.²

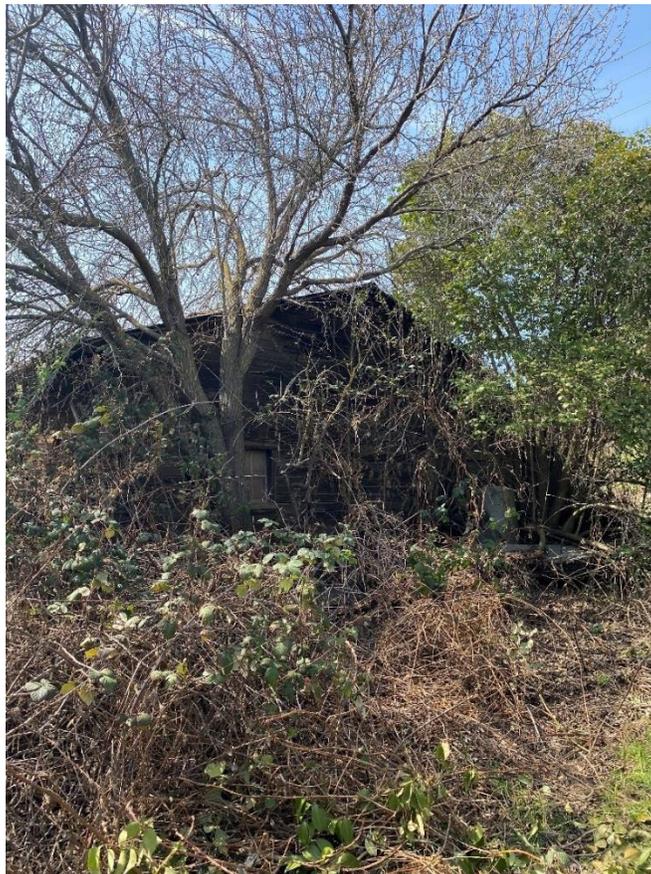
The ca. 1975 barn does not embody elements of any architectural or engineering design, detail, materials or craftsmanship that represents any unique or significant architectural innovation. As such, the ca. 1975 barn is not recommended as eligible for designation as a city landmark under this criterion.

Figure 1. ca. 1975 barn.³

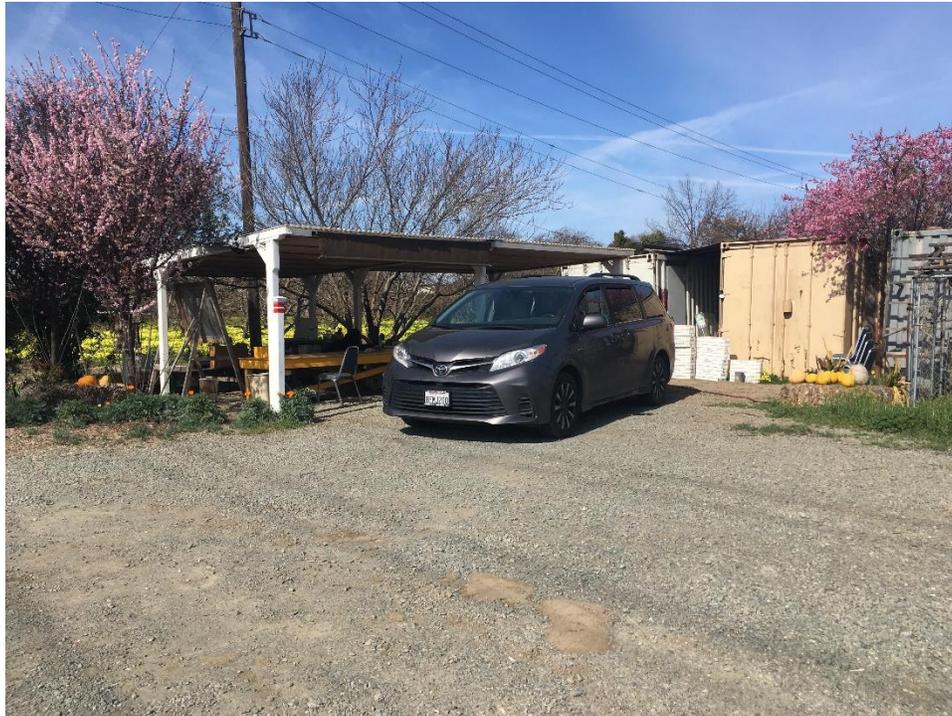
The ca. 1970 fruit stand does not embody elements of any architectural or engineering design, detail, materials, or craftsmanship that represents any unique or significant architectural innovation. As such, the ca. 1970 fruit stand is not recommended as eligible for designation as a city landmark under this criterion.

Figure 1. ca. 1970 fruit stand.³
