A HISTORIC RESOURCE EVALUATION OF THE PROPERTY AT 681 E. TRIMBLE ROAD, SAN JOSE, SANTA CLARA COUNTY, CALIFORNIA

Updated October 18, 2023

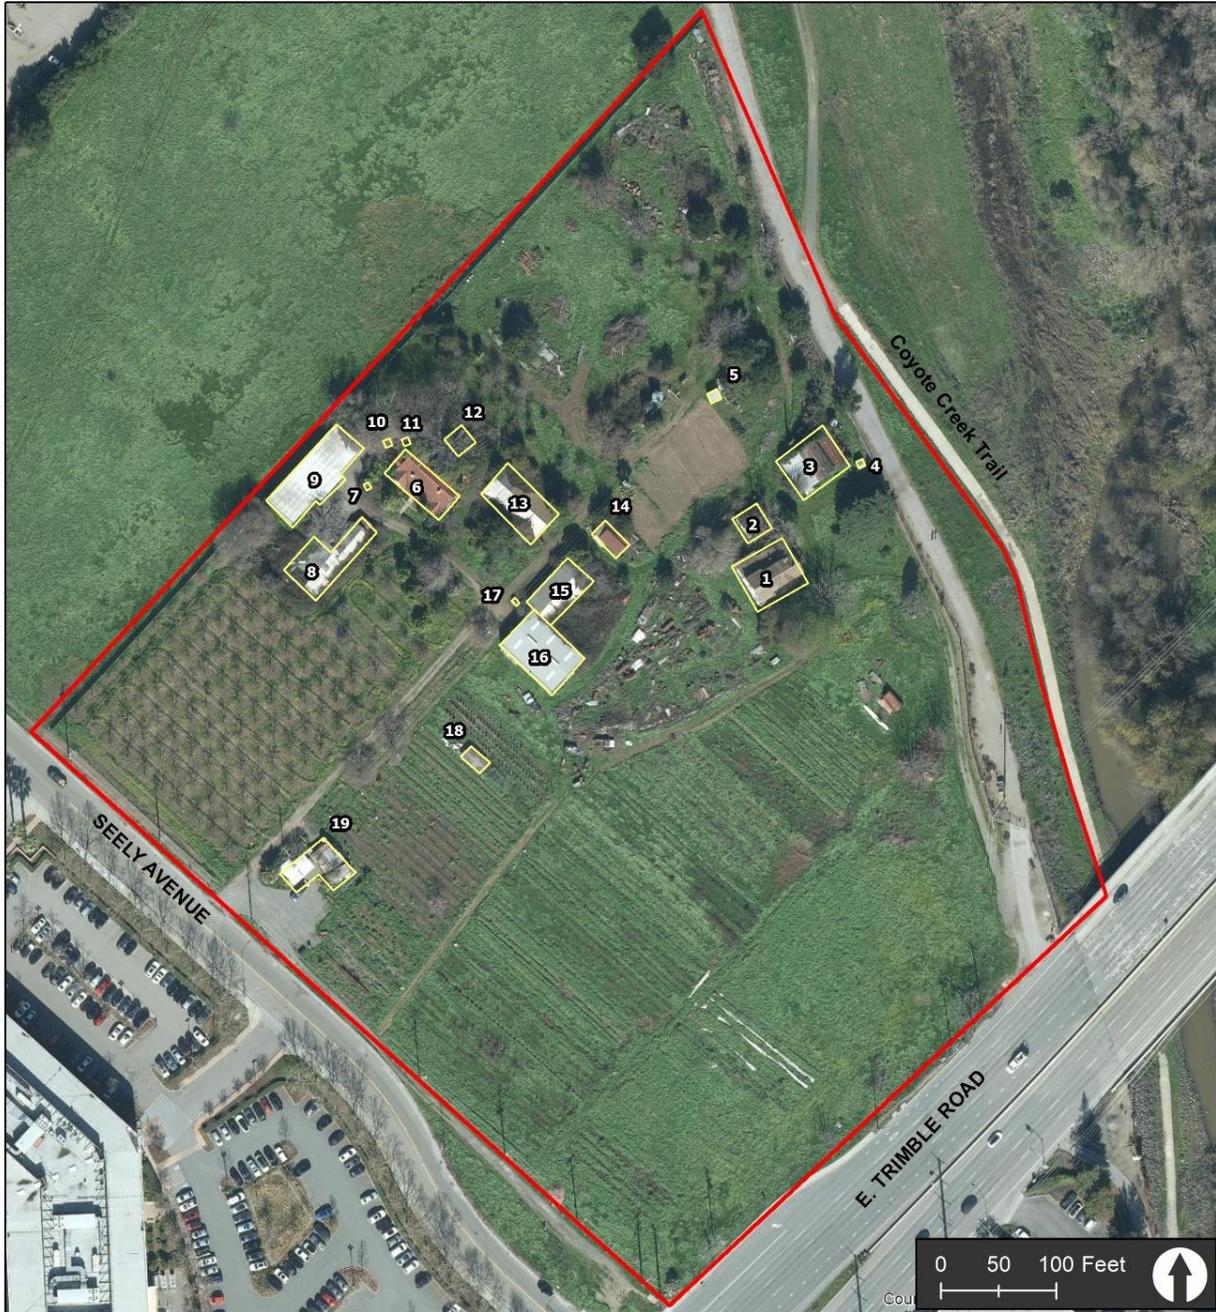
Resource Sketch Map

Eiichii Sakauye Farm
 681 E. Trimble Road, San Jose
 Santa Clara County, California
 (APN 097-15-033)
