LIMITED SUBSURFACE INVESTIGATION REPORT

AUTO REPAIR CENTER 1011 GRAND AVENUE SAN DIEGO, CALIFORNIA

DMG Project No. PISDOmt

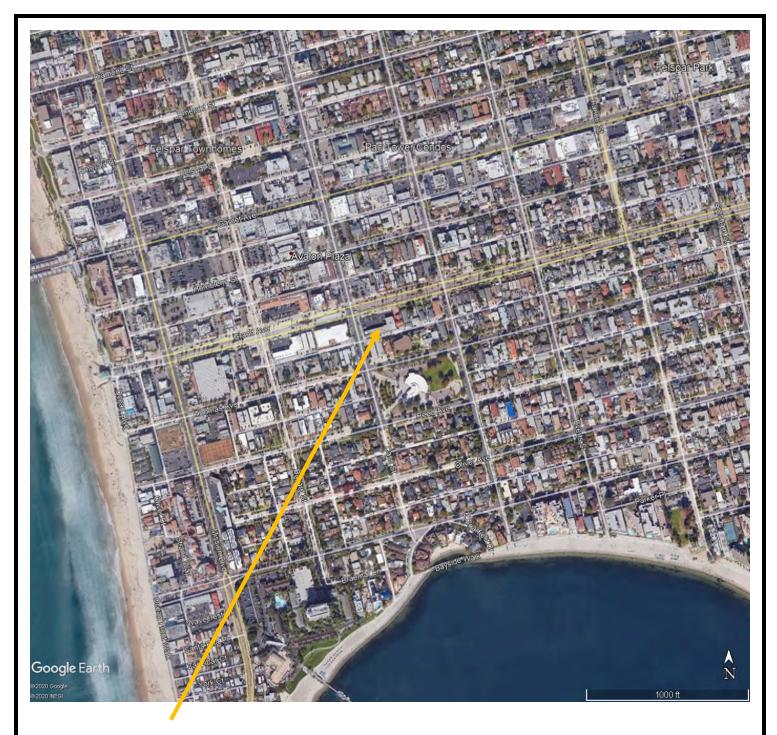
FIGURE 1

SITE VICINITY MAP AUTO REPAIR CENTER 1011 Grand Avenue San Diego, CA

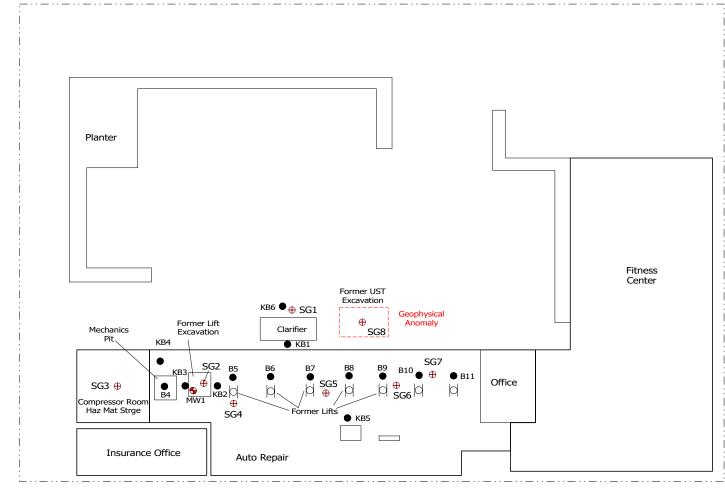
FIGURE 2 GENERAL SITE PLAN AUTO REPAIR CENTER 1011 Grand Avenue San Diego, California

- Soil Borings (Kleinfelder 2001-2002)
- Groundwater Well (Kleinfelder 2002)
- ⊕ Soil Gas Probes (DMG 2020)

On September 30, 2020, DMG installed 8 temporary soil gas sampling probes (SG1-SG8) in targeted locations at the site including near the clarifier, former hydraulic lifts and near former boring KB3. The probes were installed to total depths ranging from 4-8 feet below grade using hand auger tools. During drilling, a California Professional Geologist described the soil using the Unified Soil Classification System The probe locations are shown on **Figure 2**.
