## MEMORANDUM

**Subject:** Western Riverside County Multiple Species Habitat Conservation Plan (MSHCP)  
Sections 6.1.2 and 6.3.2 Determination of Biologically Equivalent or Superior  
Preservation (DBESP) for the Menifee Valley Project

***DRAFT MENIFEE VALLEY PROJECT – FOCUSED  
BURROWING OWL SURVEY REPORT, PREPARED BY RBC  
AND DATED JULY 29, 2022, REVISED NOVEMBER 23, 2022***

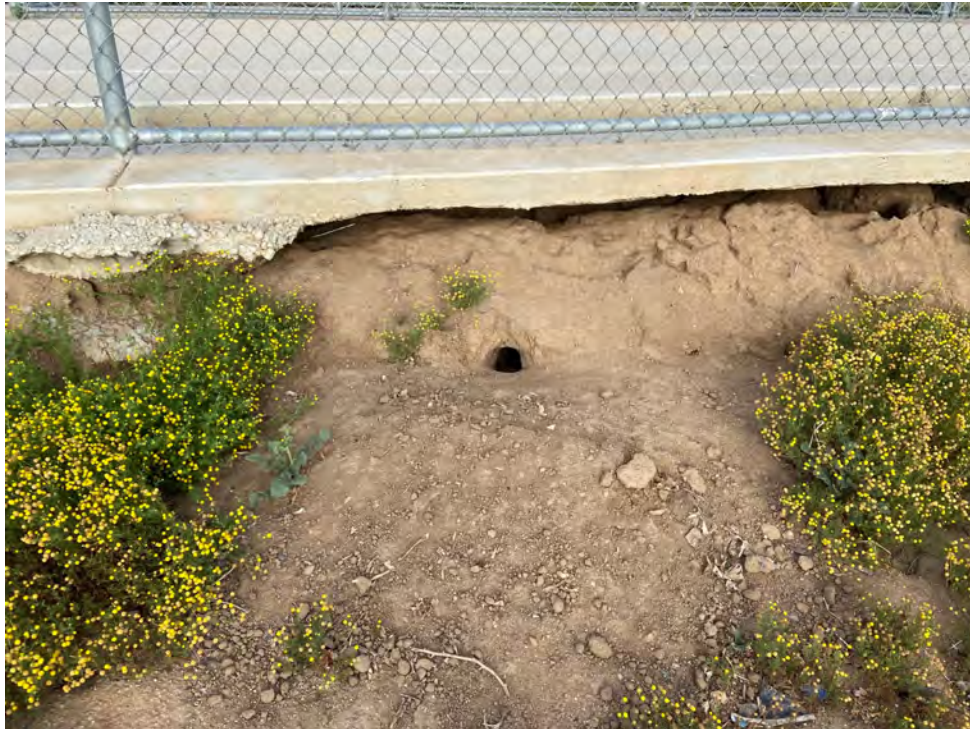
Photo 5. Representative photo from April 29, 2022, of a California ground squirrel (*Otospermophilus beecheyi*) burrow that is suitable but unoccupied by burrowing owl on the eastern boundary of the project site.

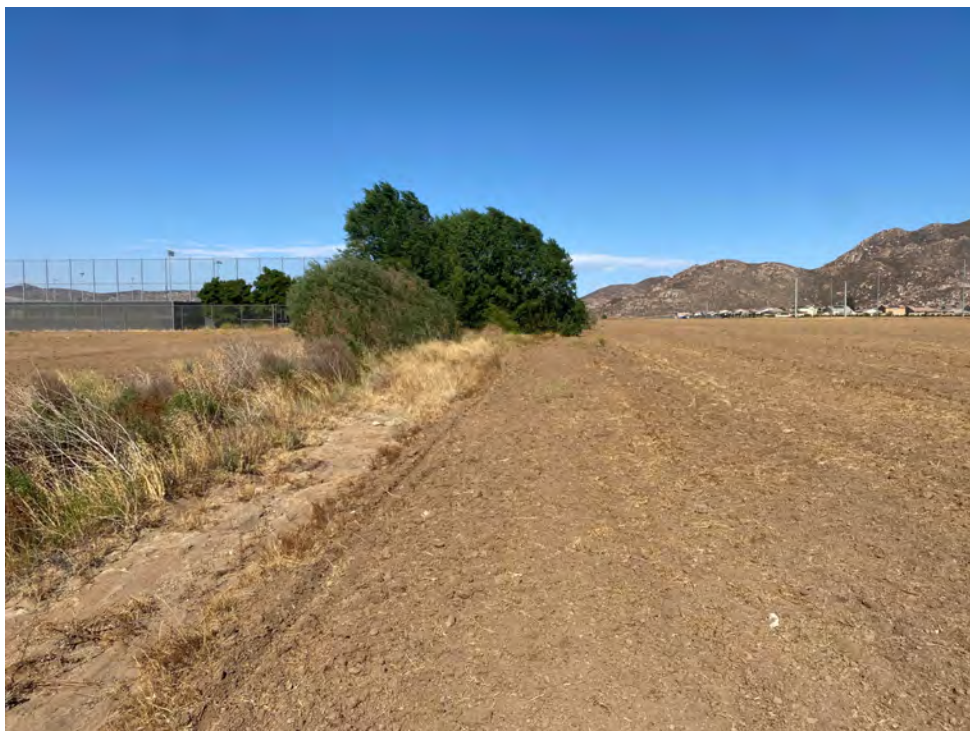
Photo 6. East-facing view of disturbed habitat - ephemeral streambed and recent disturbance within the eastern portion of the site, facing east on June 30, 2022.

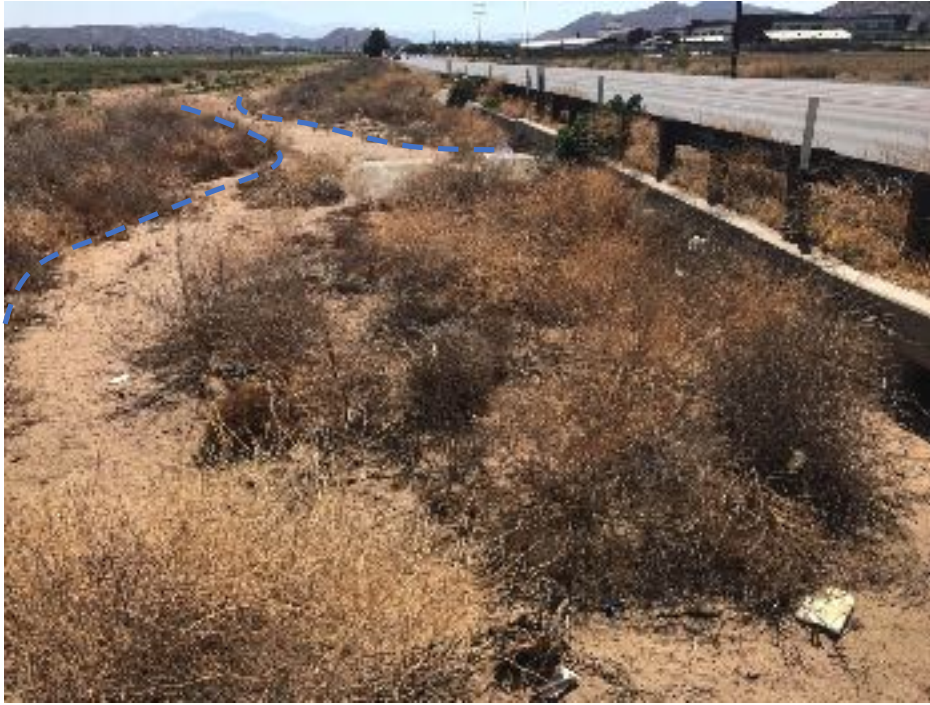
Photo 1. Upstream view of off-site flows feeding two culverts on the northside of CA-74, that drain on-site to create Feature 1. Photo taken facing southeast.

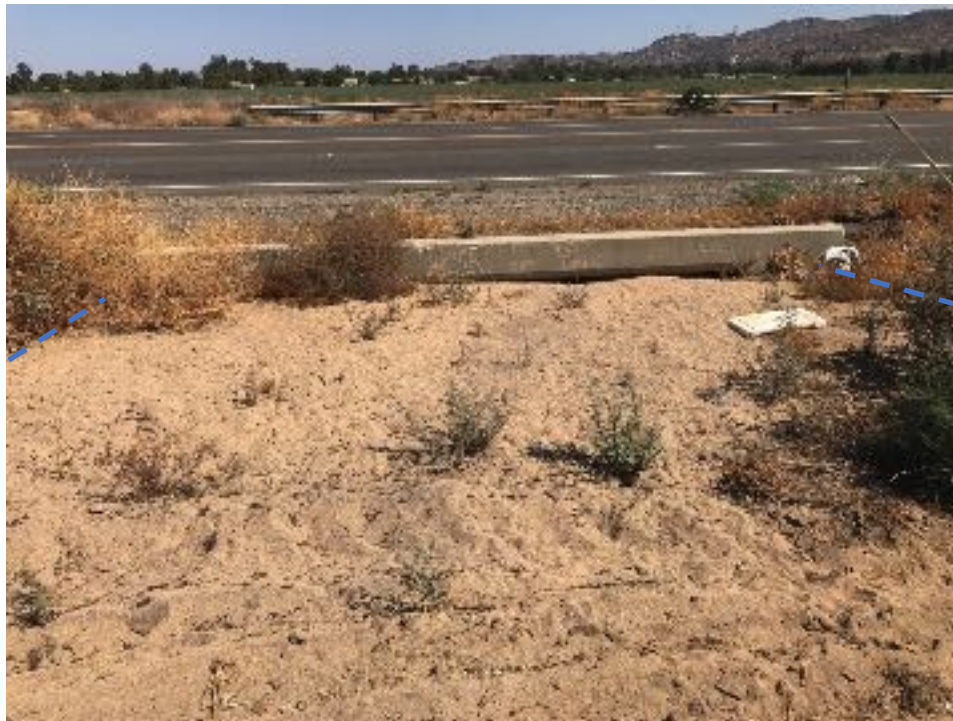
Photo 2. Upstream view of Feature 1 at its northern on-site entry point along CA-74.  
Photo taken facing north.

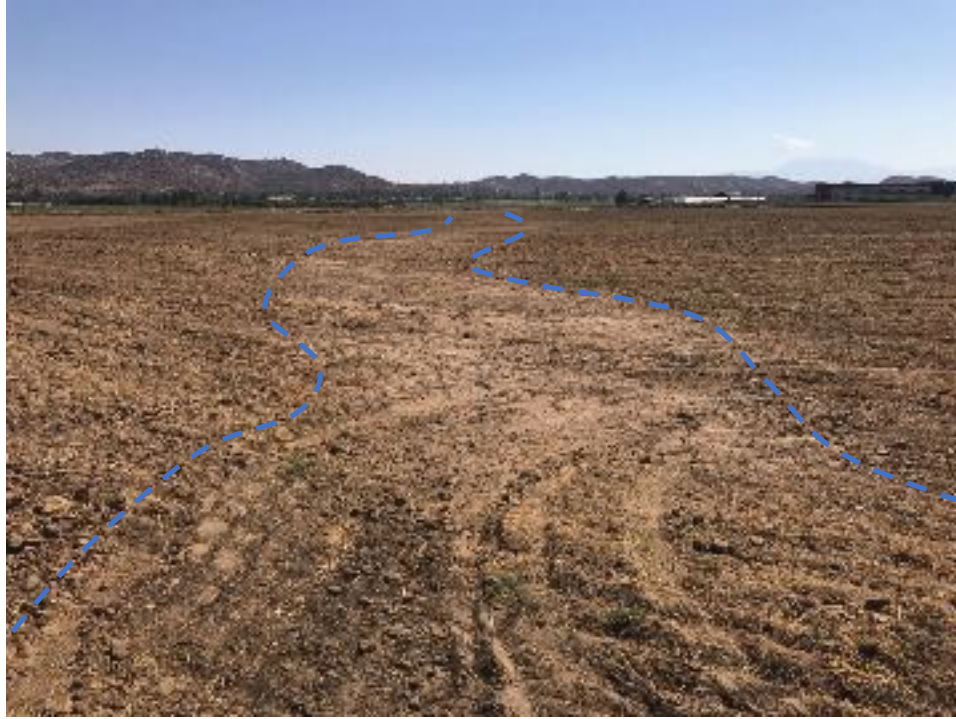
Photo 3. Upstream view of the northeast portion of Feature 1, at Ordinary High Water Mark Data Point 3 (OHWM 3). Photo taken facing northeast towards its on-site entry point along CA-74.

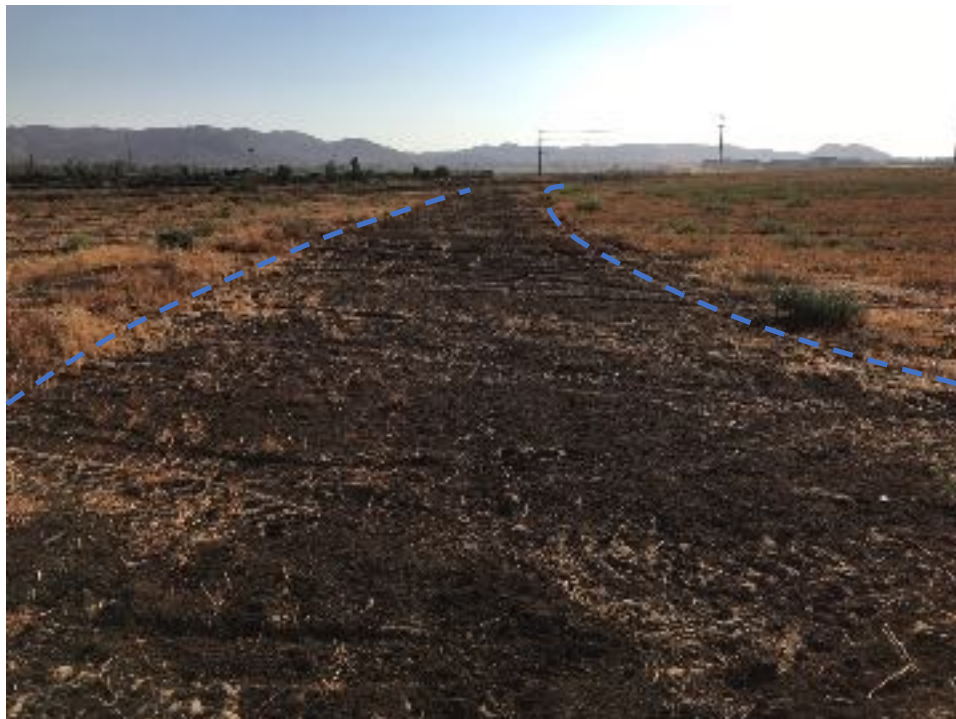
Photo 4. Upstream view of Feature 1. Photo taken within the western portion of the feature, facing east.

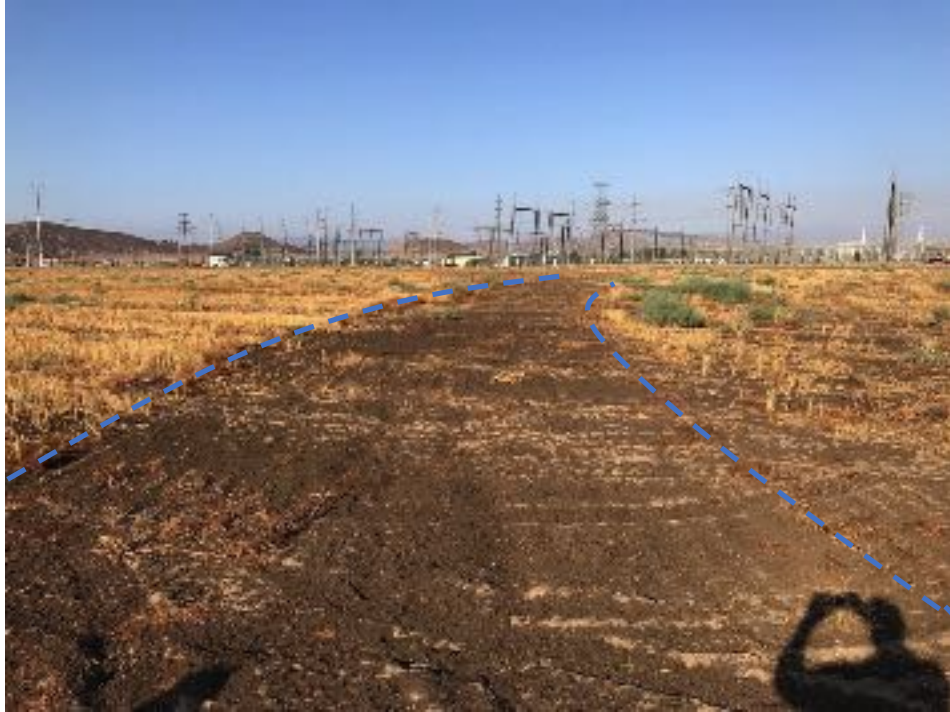
Photo 5. Downstream view of the western portion of Feature 1, at OHWM 4 and Wetland Sample Point (WSP) 4. Photo taken facing west.

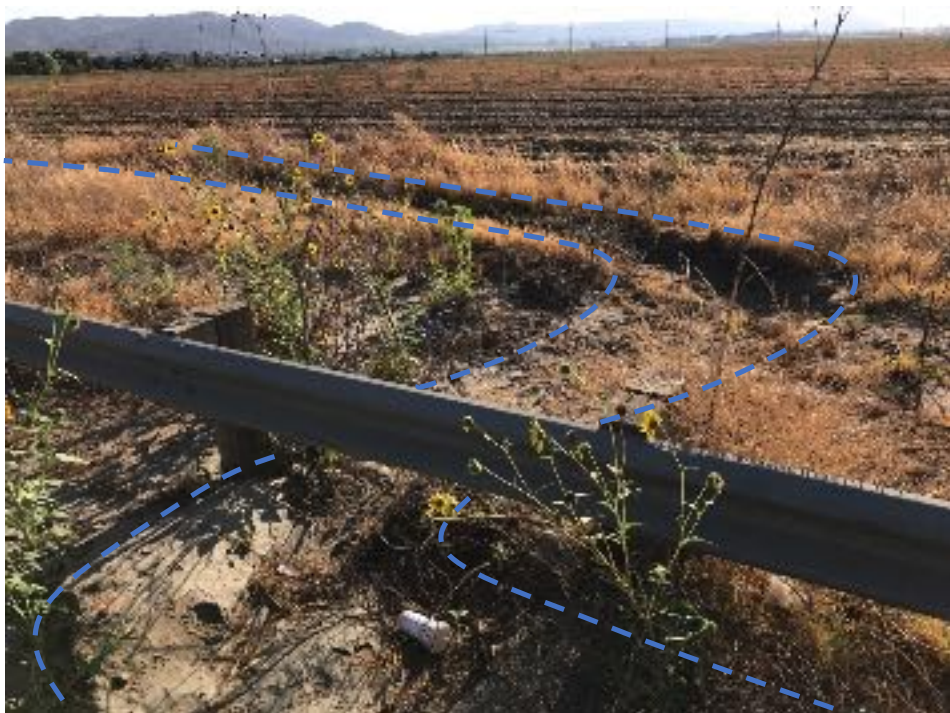
Photo 6. Upstream view of Feature 1, near the western project boundary. The feature continues south along Meniffee Road and flows into a set of on-site storm drains. Photo taken facing northeast.

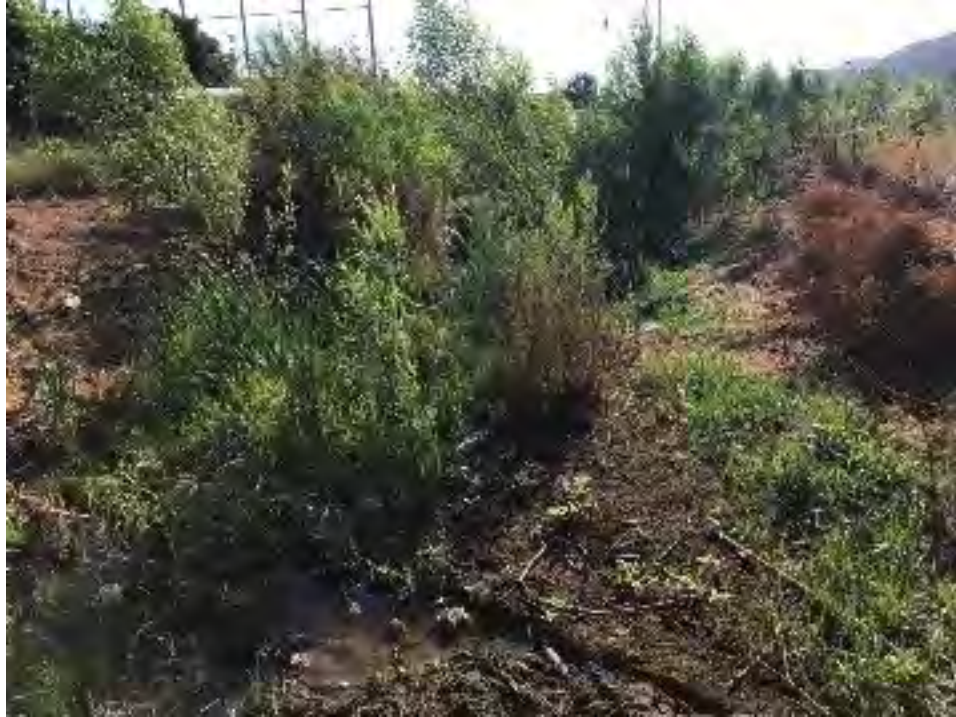
Photo 7. Upstream view of Feature 2, at the locations of WSP 1 and WSP 2. The feature drains on-site from a culvert along Briggs Road and a culvert near the southwest corner of Heritage High School.

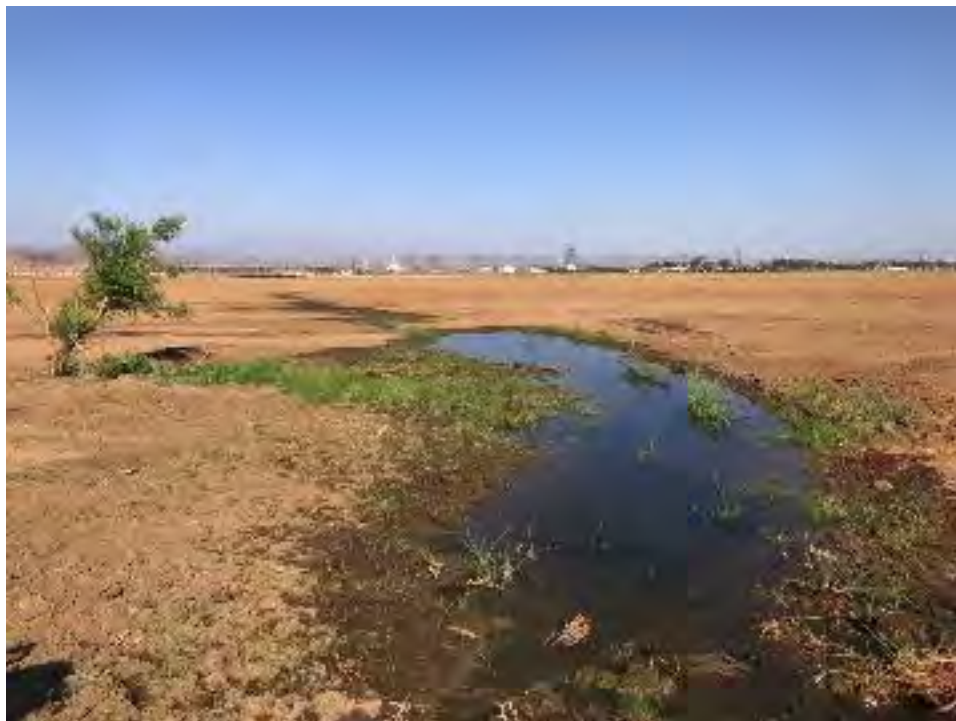
Photo 8. Downstream view of Feature 2 at WSP 1 and WSP 2 at the approximate location of OHWM 1. Photo taken facing northwest.

Photo 8. Downstream view of Feature 2 at WSP 1 and WSP 2 at the approximate location of OHWM 1. Photo taken facing northwest.

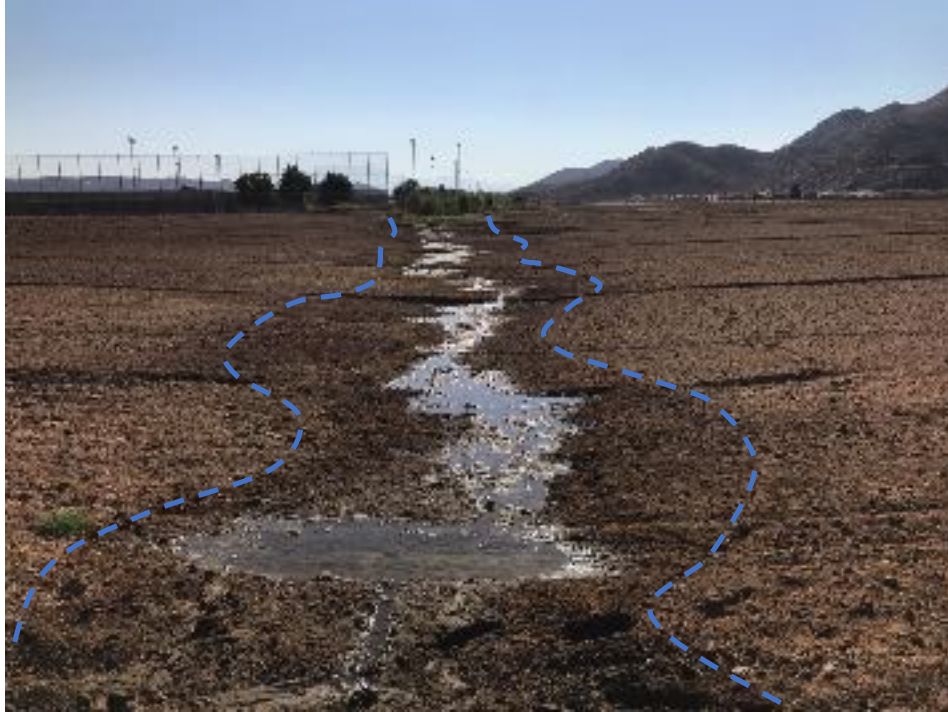
Photo 9. Upstream view of Feature 2, at OHWM 1.  
Photo taken facing east toward the wetland area.

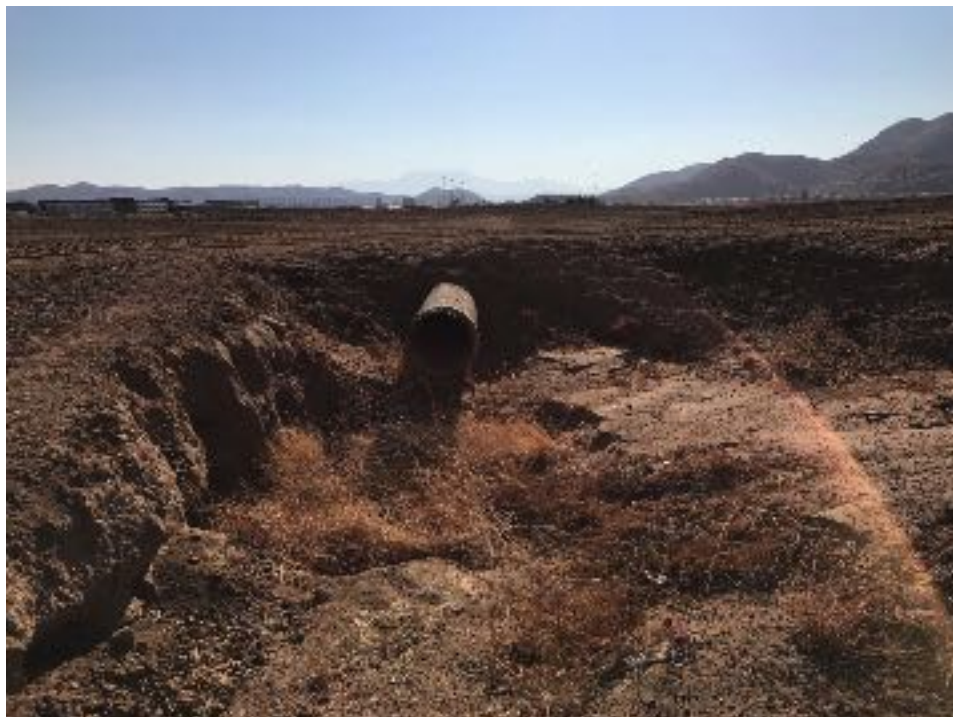
Photo 10. Upstream view of culvert within the center portion of Feature 2. The feature expands to 20 feet wide here. Photo taken facing northeast.

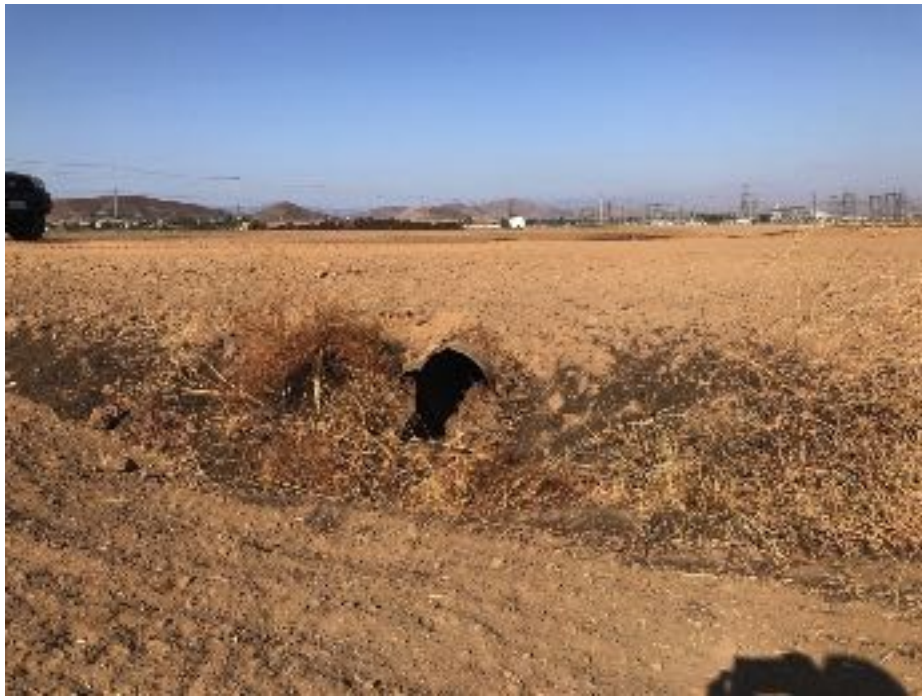
Photo 11. Downstream view of culvert within the center portion of Feature 2.  
Photo taken facing west.

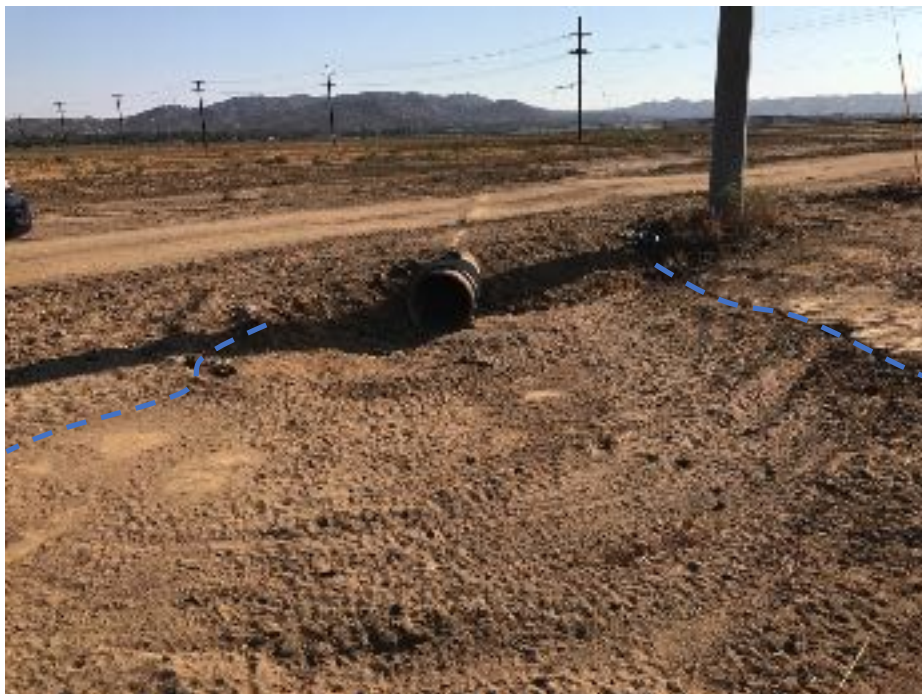
Photo 12. Upstream view of a culvert road crossing within Feature 2. The project site contains two centrally located parallel roads that run from the western to eastern project boundary. Feature 2 drains from this culvert outlet onto the southernmost road and continues west along the road into a set of storm drains on the western project boundary. Photo taken facing northeast.

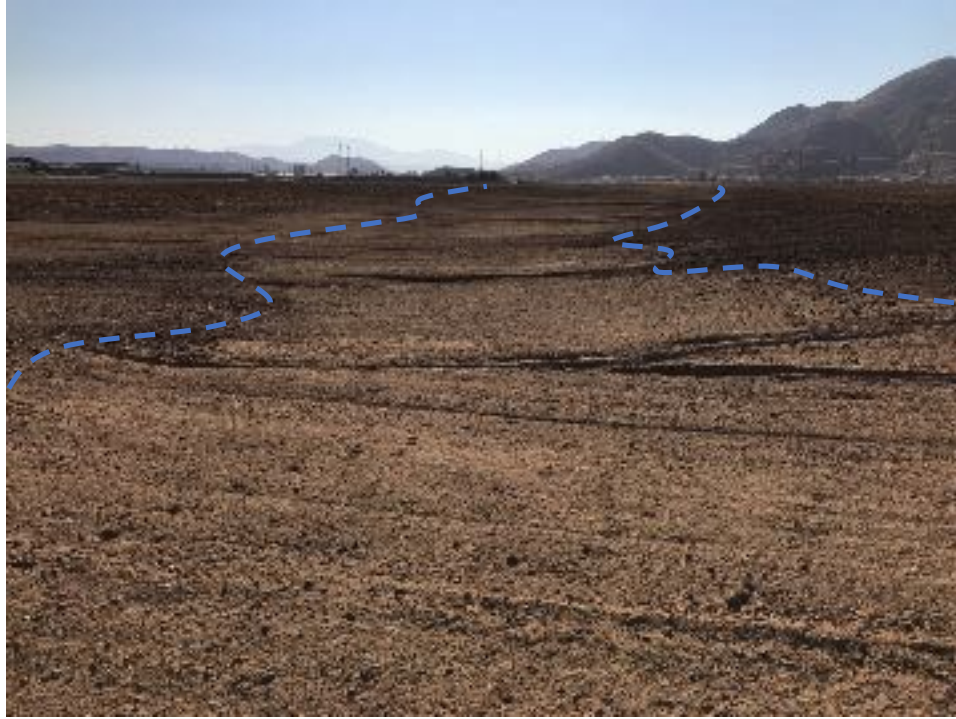
Photo 13. Feature 2 facing upstream, where OHWM 2 was taken within the recently disced area.

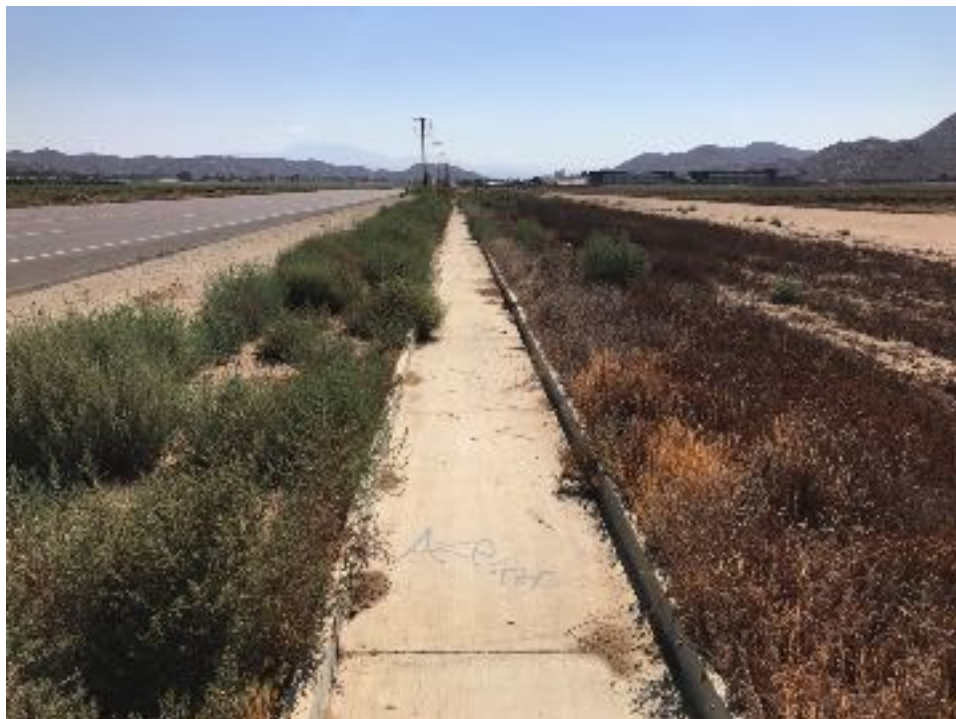
Photo 14. Upstream view of Ditch 1, along CA-74. The feature is concrete-lined for approximately 1,263 linear feet. Photo taken facing east.

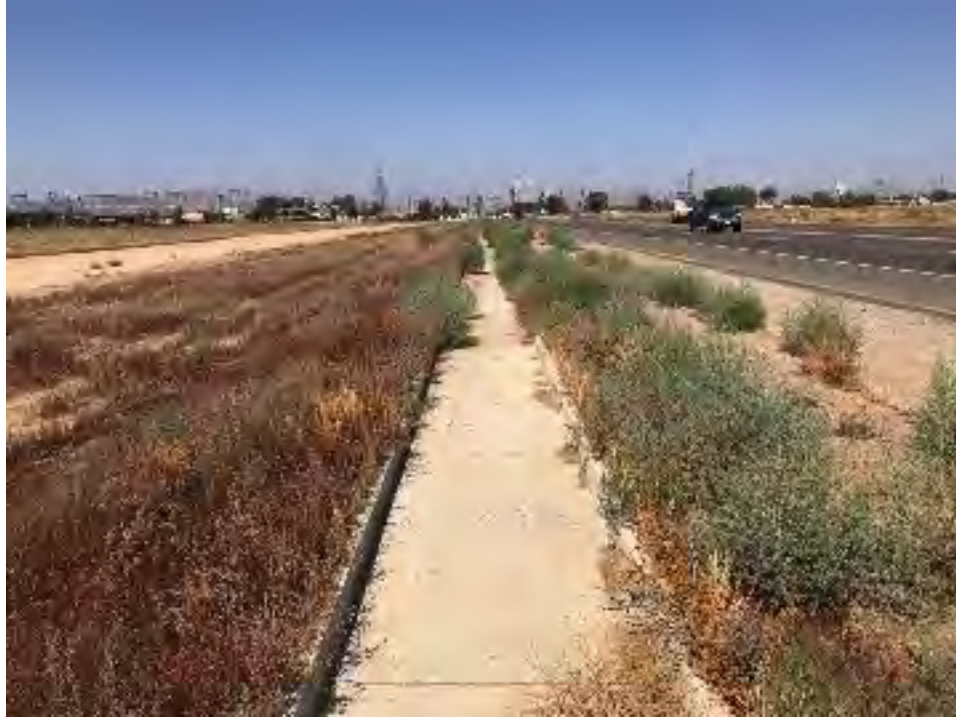
Photo 15. Downstream view of Ditch 1, along CA-74. Photo taken facing west.

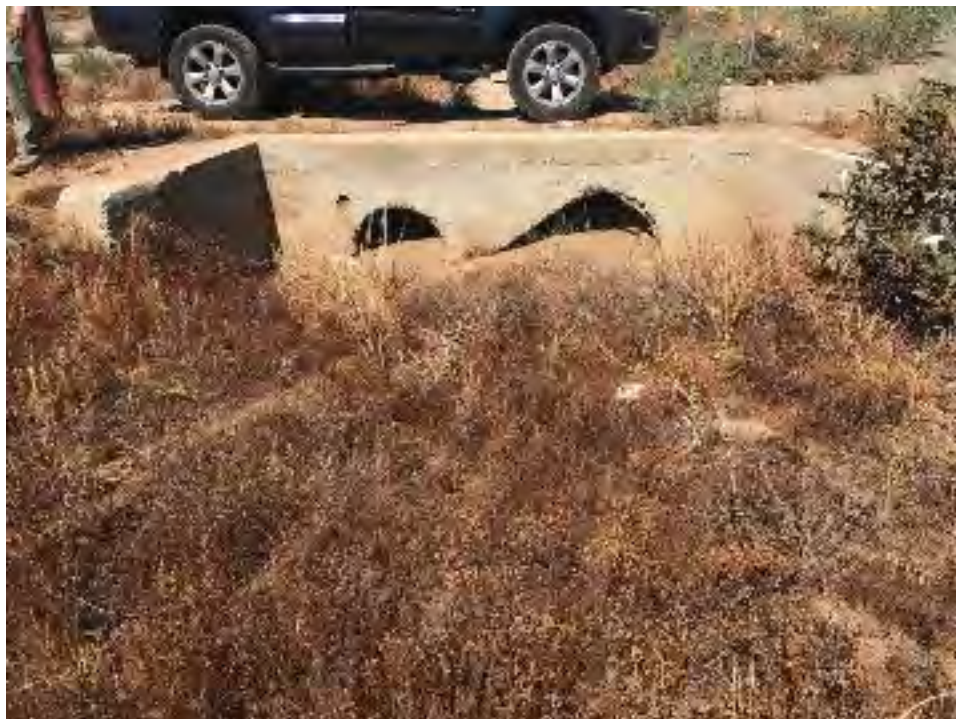
Photo 16. Downstream view of Ditch 1, along CA-74. The feature flows to this culvert for approximately 509 feet and is concrete-lined on the other side. Photo taken facing west.

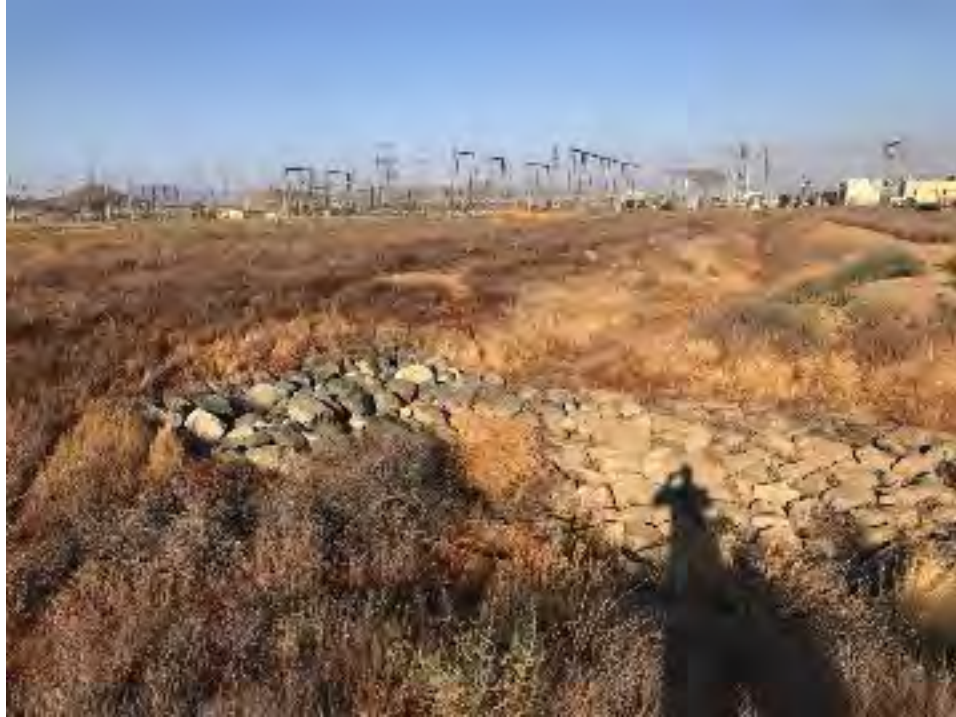
Photo 17. Downstream view of Ditch 2. Photo taken facing west.

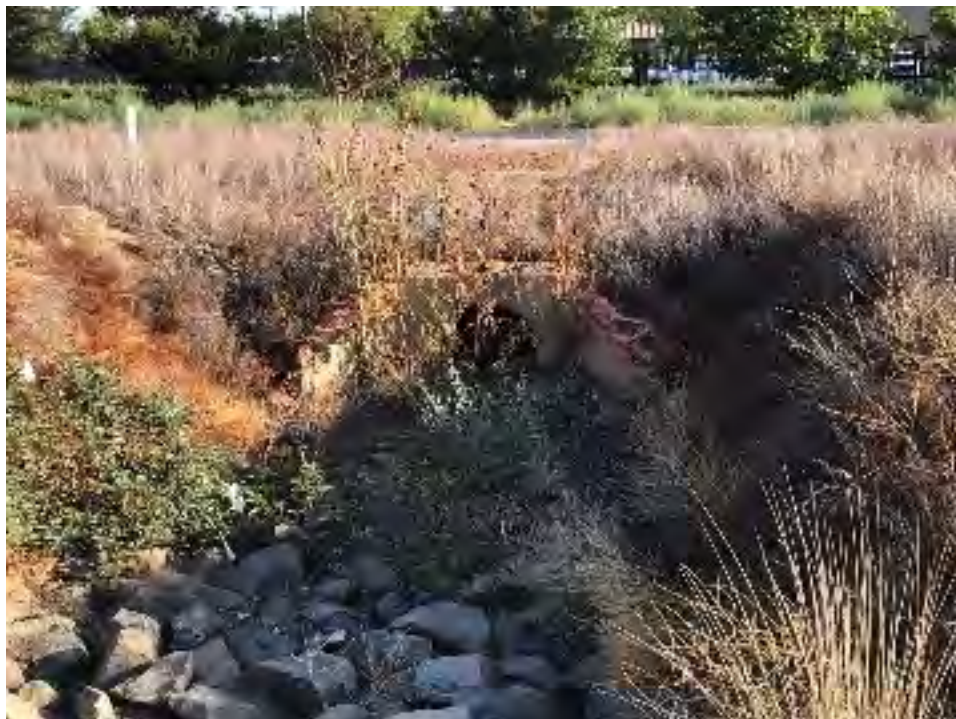
Photo 18. View of a culvert along Ditch 2, under Biscayne Street. Photo taken facing north.

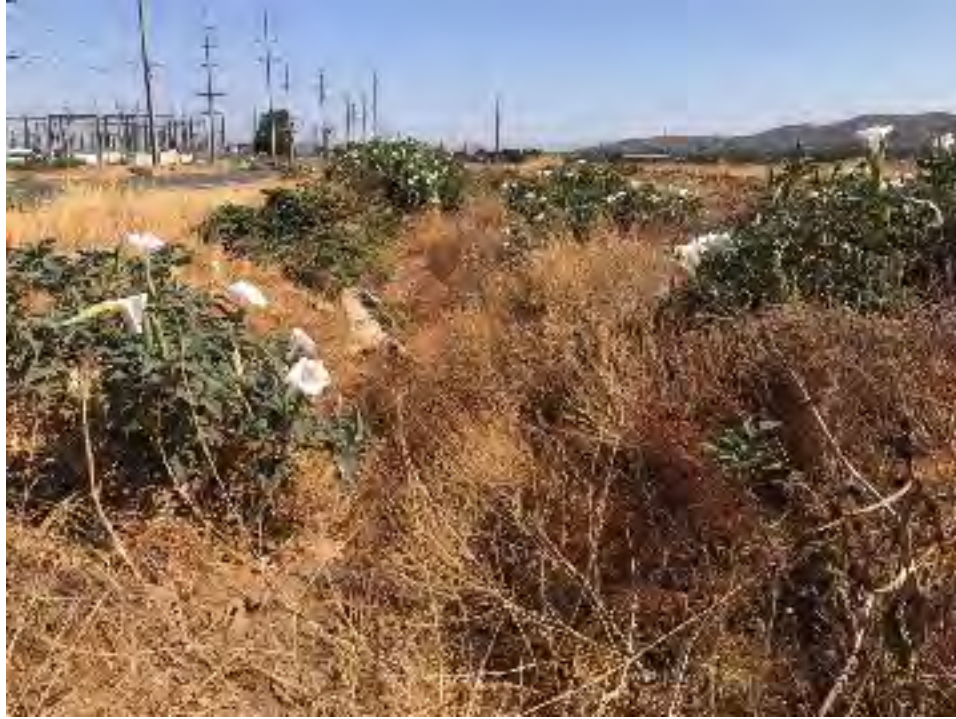
Photo 19. Upstream view of roadside Ditch 3, which runs along Meniffee Road on the western project boundary. Photo taken facing north.

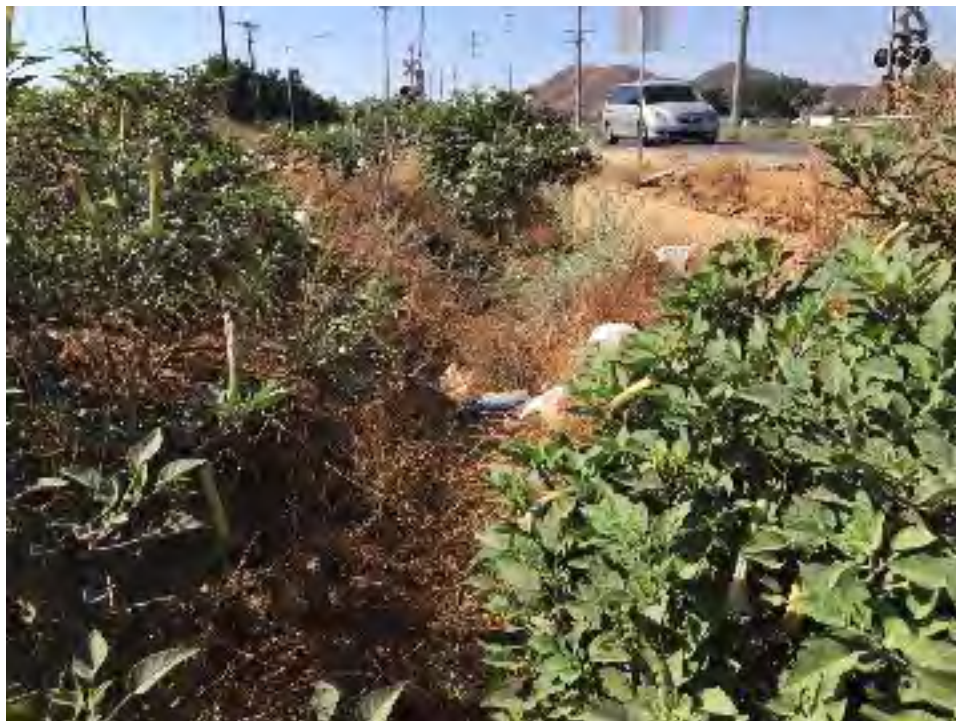
Photo 20. Downstream view of roadside Ditch 3, which runs along Meniffee Road.

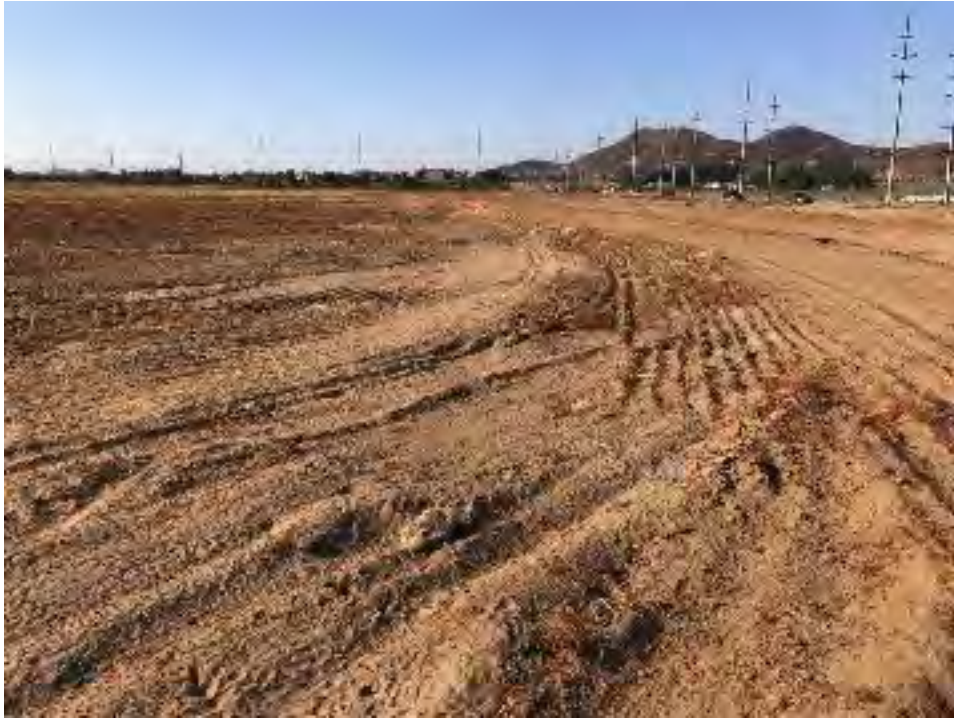
Photo 21. General view of project site from the corner of the southwest quadrant facing south along Menifee Road. No drainage patterns or potential ponding areas observed.

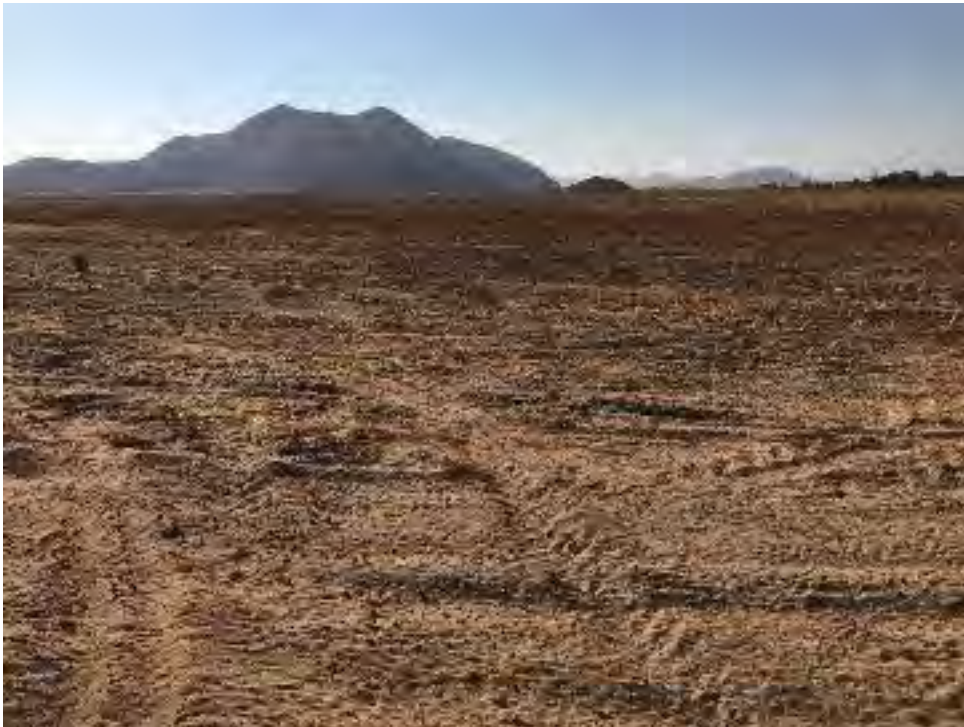
Photo 22. General view of the project site from the corner of the southwest quadrant facing southeast. No drainage patterns or potential ponding areas observed.

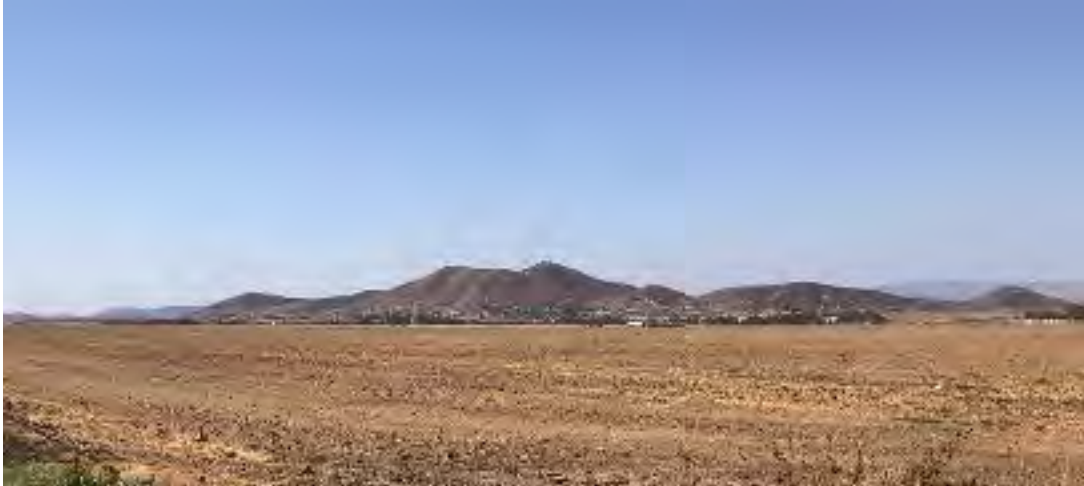
Photo 23. General view of the project site from the northeastern corner, along CA-74 and adjacent to Heritage High School, facing southwest.  
No drainage patterns or potential ponding areas observed.

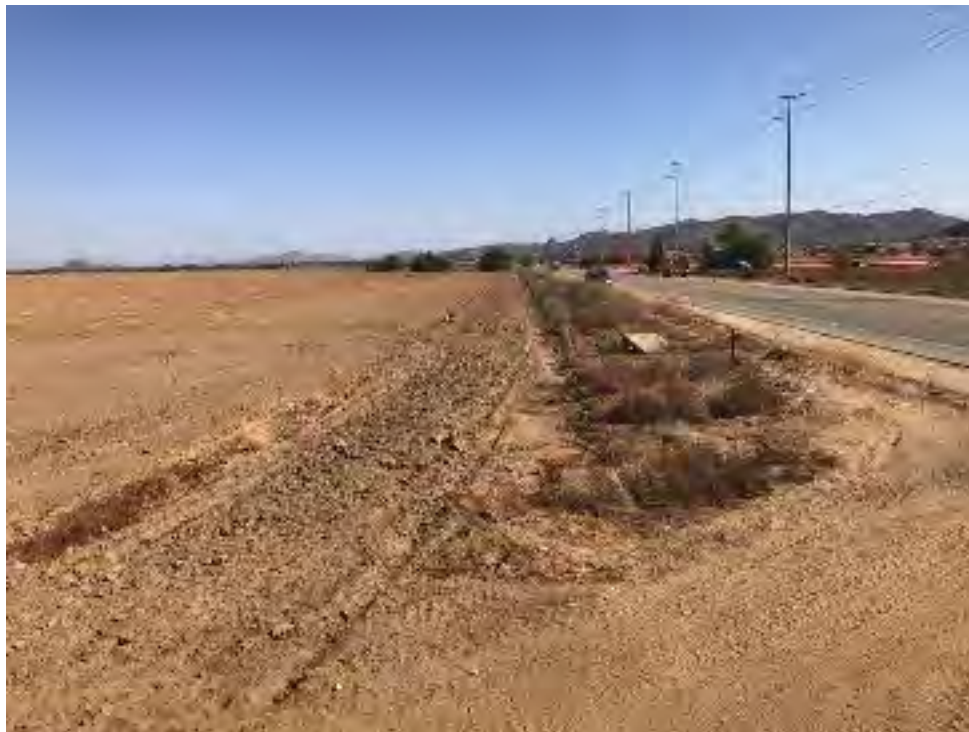
Photo 24. General view of the project site from the southeastern corner, along Briggs Road, facing north. No drainage patterns or potential ponding areas observed.

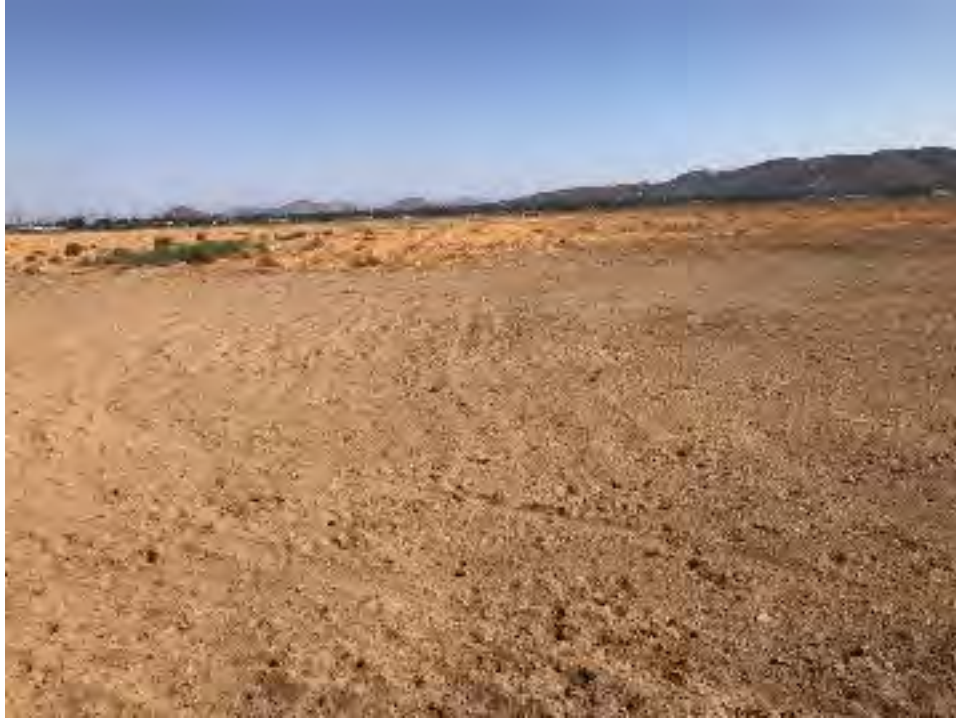
Photo 25. General view of the project site from the southern project boundary.  
Photo taken along Case Road facing northwest.

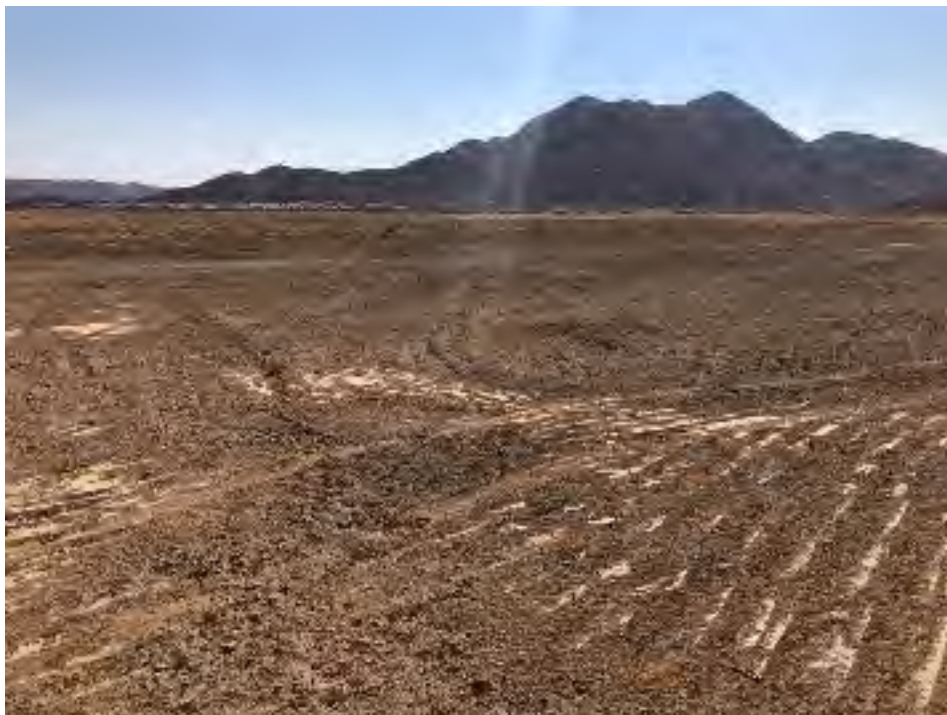
Photo 26. General view of the project site from the southern project boundary.  
Photo taken along Case Road facing southeast.

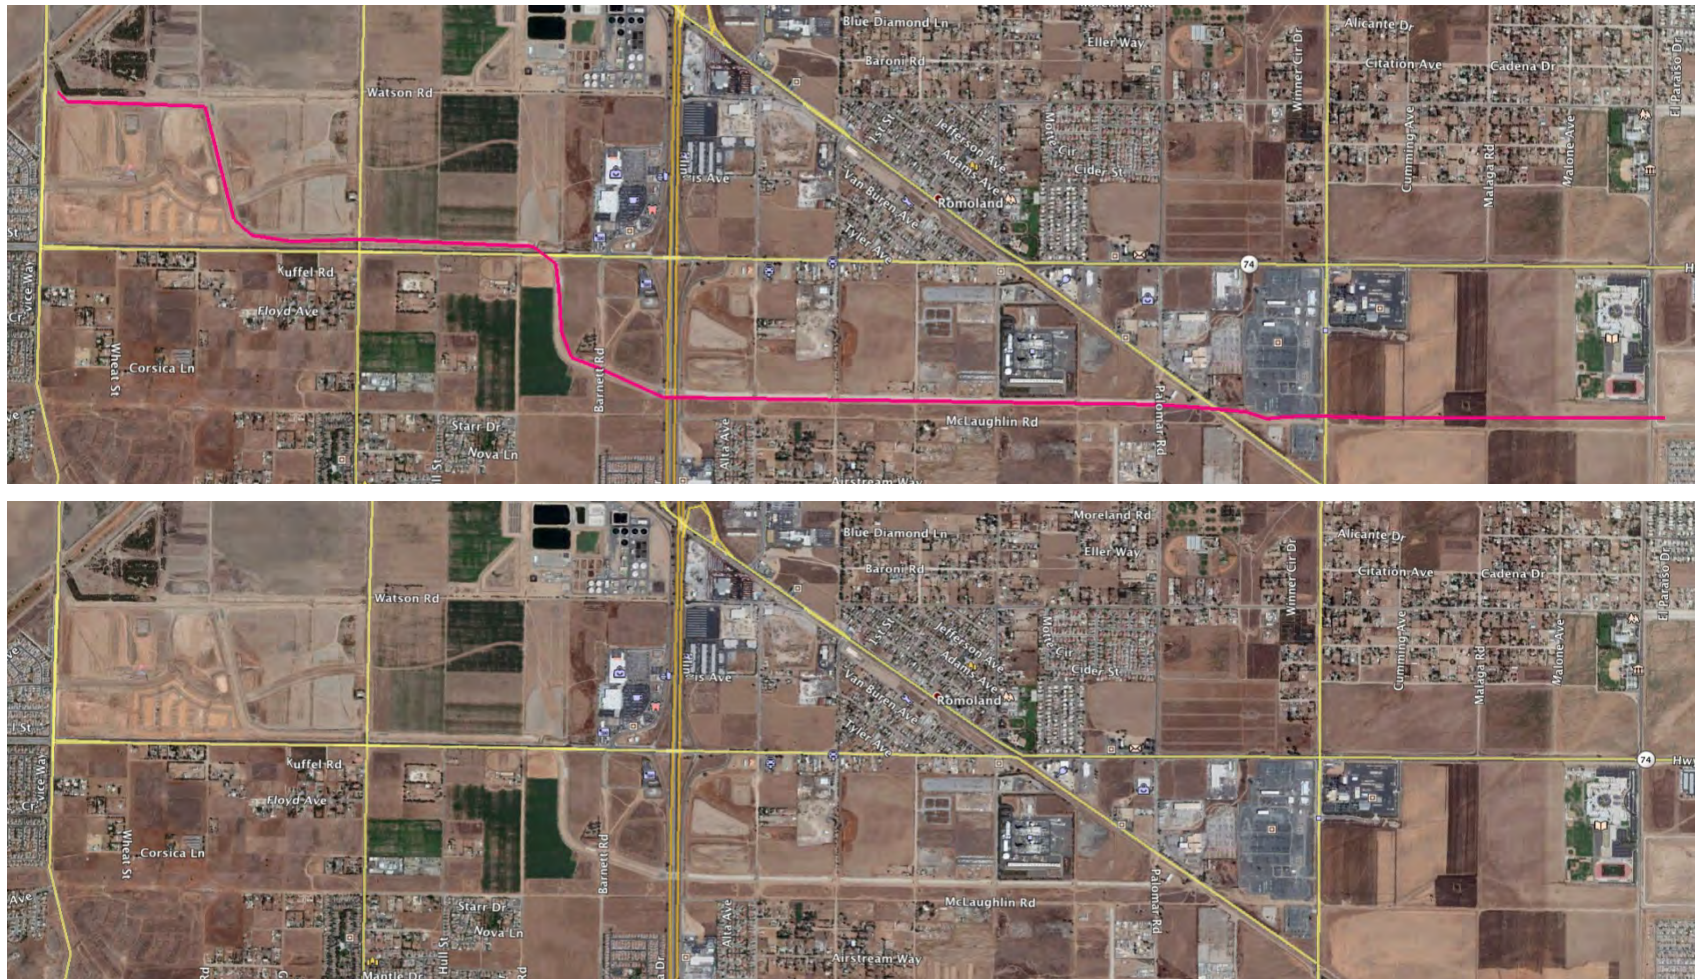
August 2018 (after construction of Line A). Pink line denotes existing alignment of Line A. Note Briggs Detention Basin is fully constructed just east of the project site where Line A originates as an underground storm drain through the project site, removing upstream hydrology onto the project site (i.e., into Feature 2).

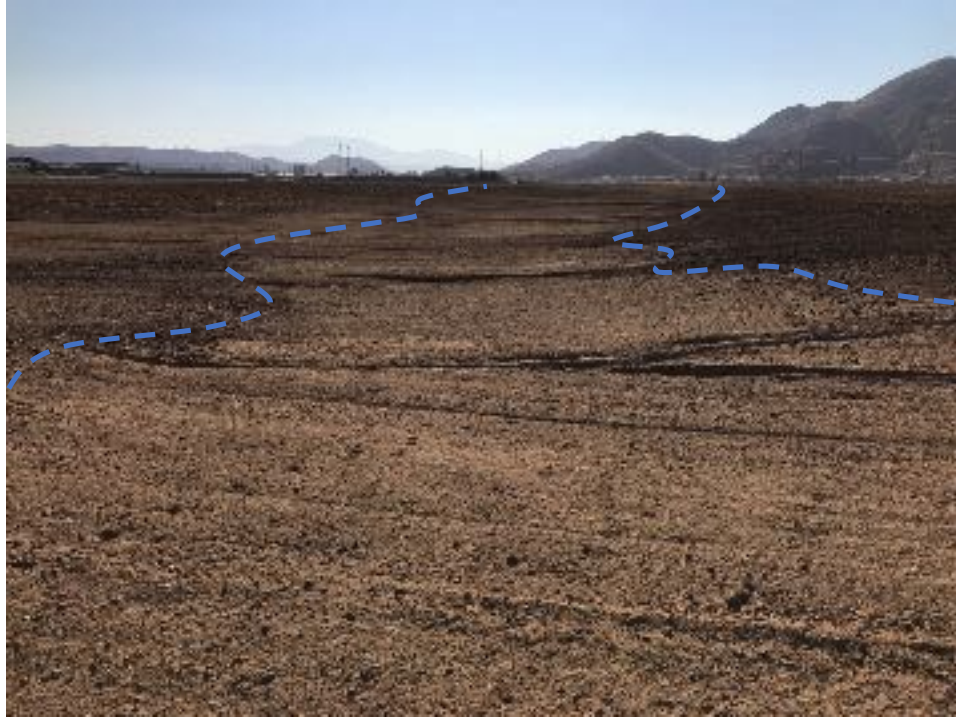
Photo 13. Feature 2 facing upstream, where OHWM 2 was taken within the recently disced area.
