## MEMORANDUM

**Subject:** Western Riverside County Multiple Species Habitat Conservation Plan (MSHCP)  
Sections 6.1.2 and 6.3.2 Determination of Biologically Equivalent or Superior  
Preservation (DBESP) for the Menifee Valley Project

***DRAFT MENIFEE VALLEY PROJECT – FOCUSED  
BURROWING OWL SURVEY REPORT, PREPARED BY RBC  
AND DATED JULY 29, 2022, REVISED NOVEMBER 23, 2022***

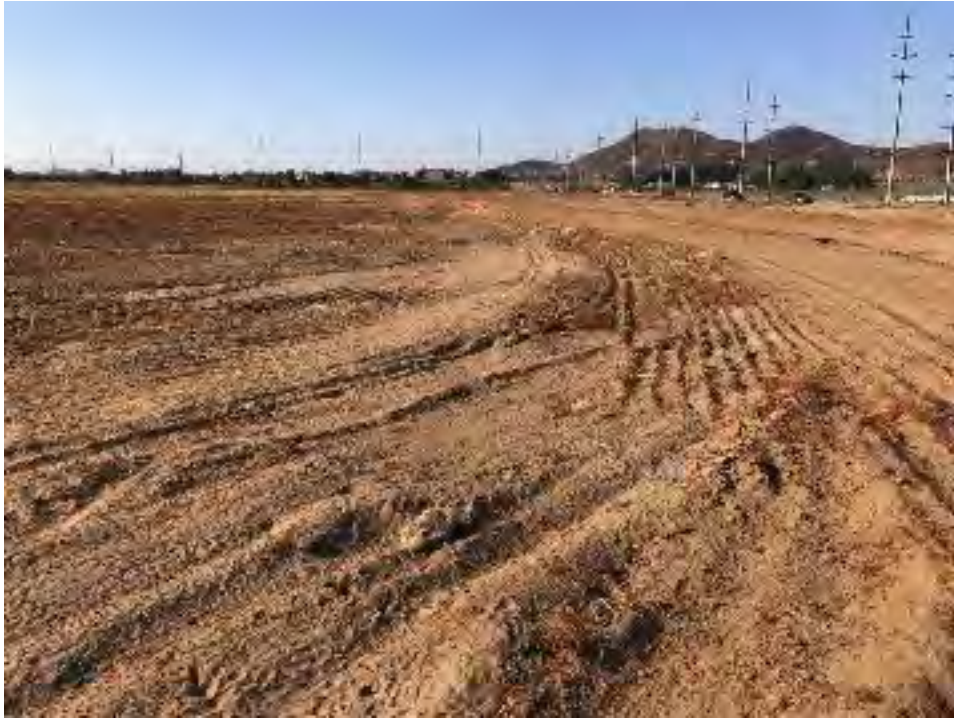
Photo 21. General view of project site from the corner of the southwest quadrant facing south along Menifee Road. No drainage patterns or potential ponding areas observed.

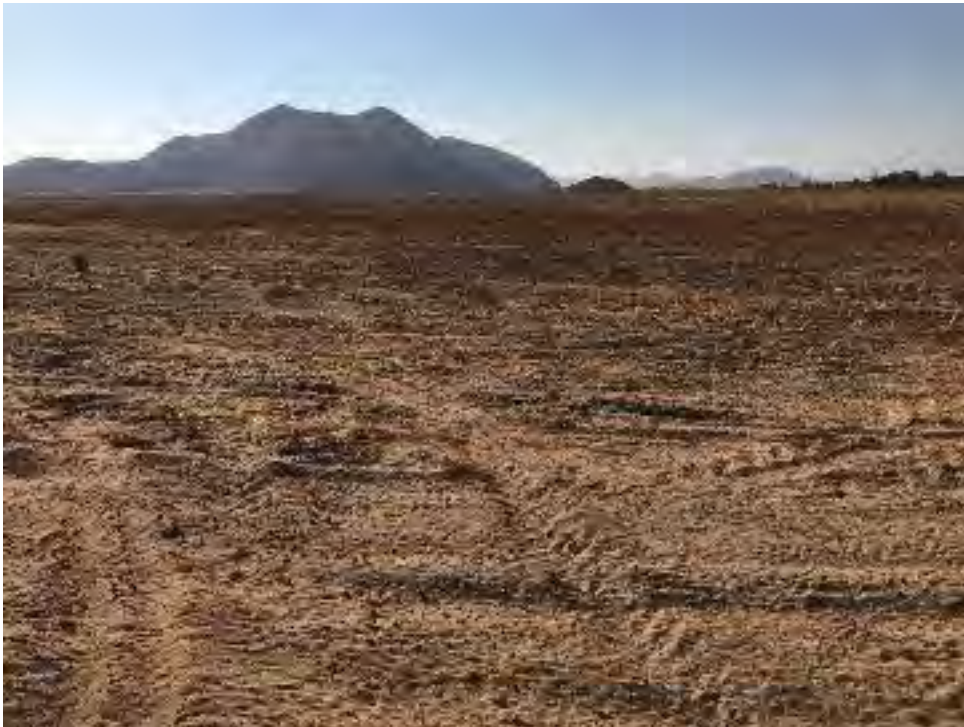
Photo 22. General view of the project site from the corner of the southwest quadrant facing southeast. No drainage patterns or potential ponding areas observed.

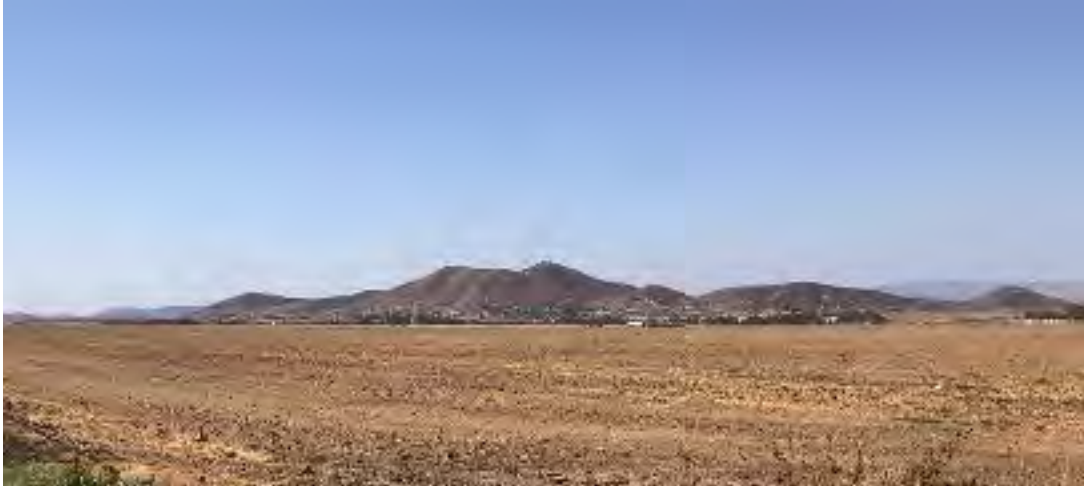
Photo 23. General view of the project site from the northeastern corner, along CA-74 and adjacent to Heritage High School, facing southwest.  
No drainage patterns or potential ponding areas observed.

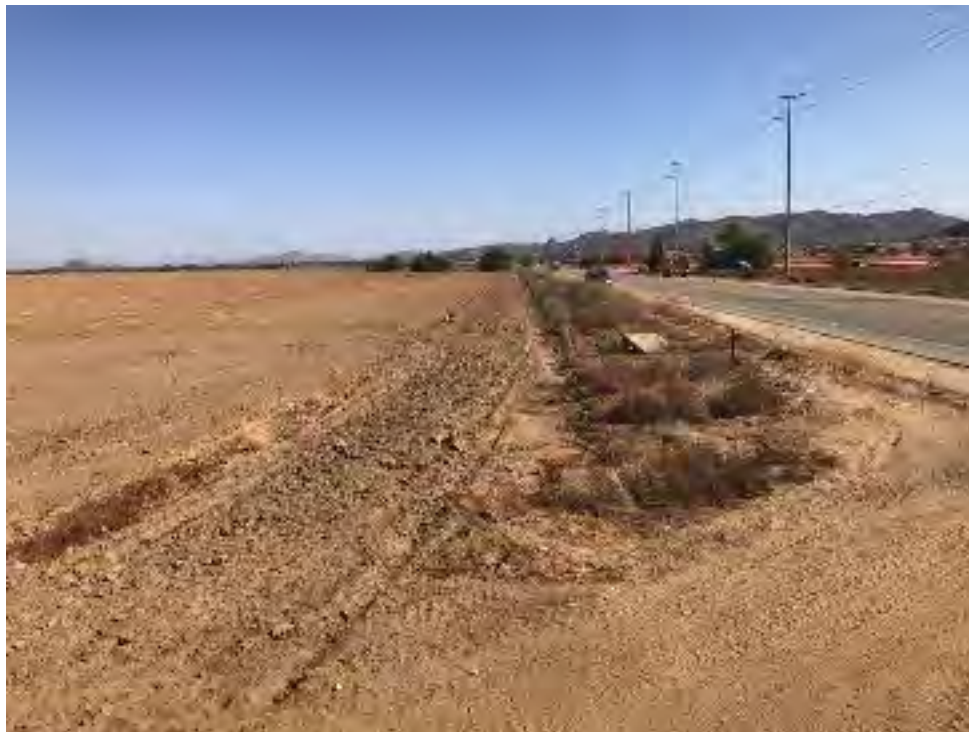
Photo 24. General view of the project site from the southeastern corner, along Briggs Road, facing north. No drainage patterns or potential ponding areas observed.

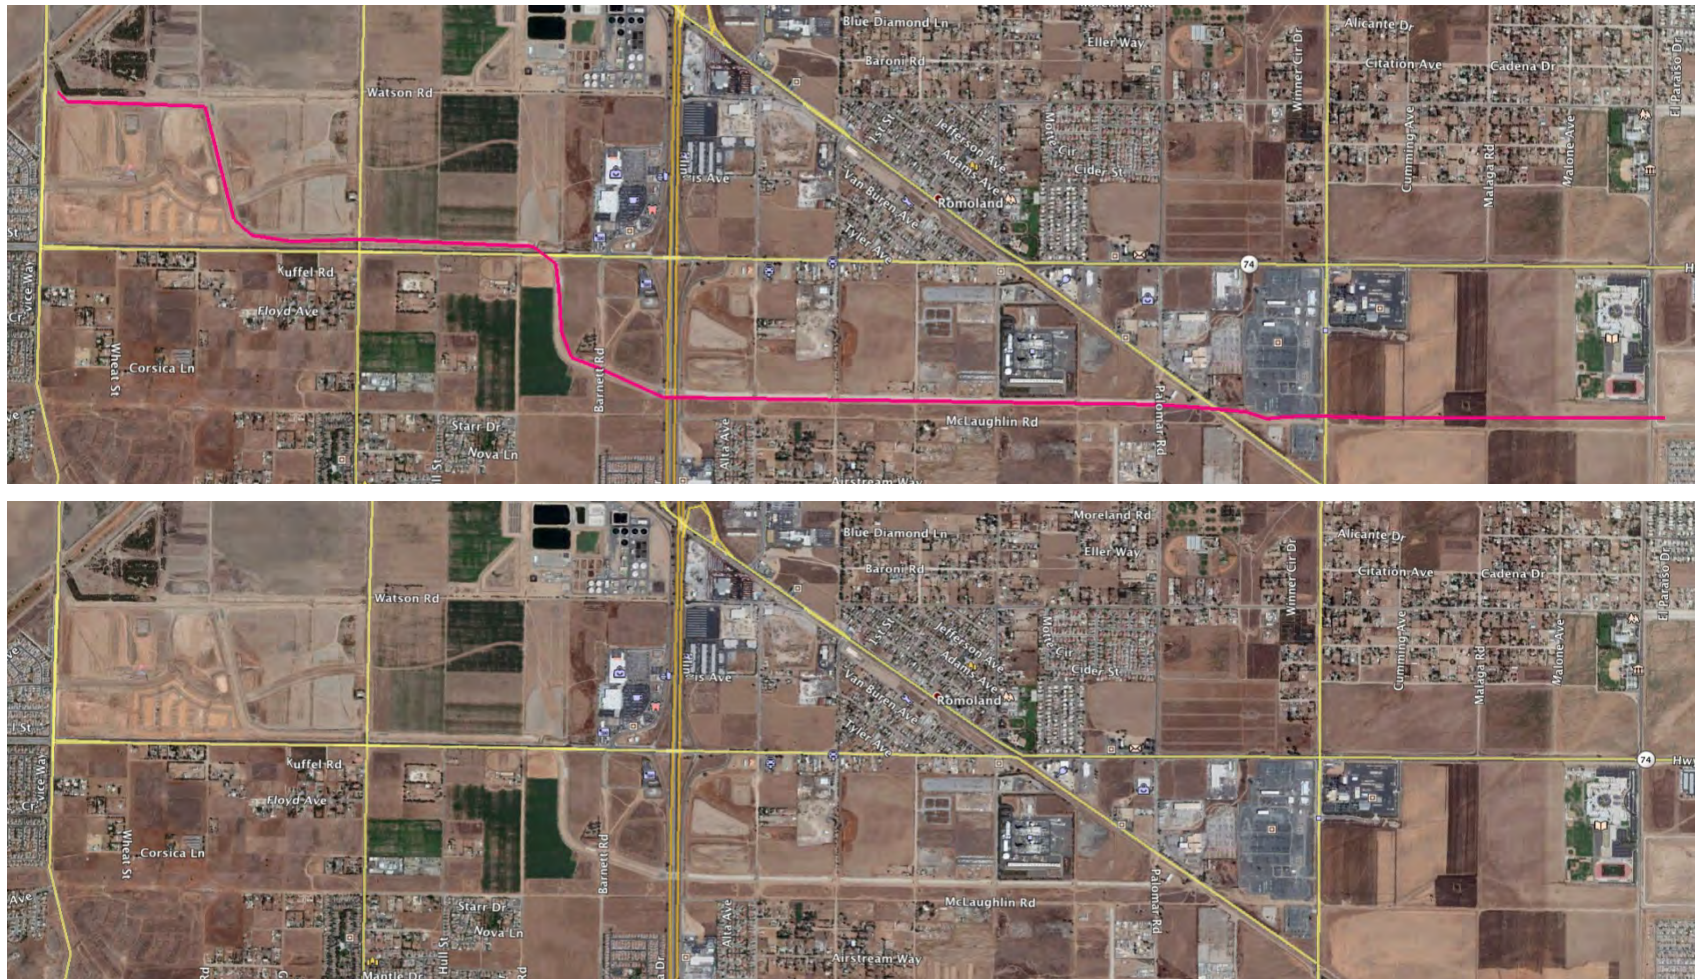
August 2018 (after construction of Line A). Pink line denotes existing alignment of Line A. Note Briggs Detention Basin is fully constructed just east of the project site where Line A originates as an underground storm drain through the project site, removing upstream hydrology onto the project site (i.e., into Feature 2).

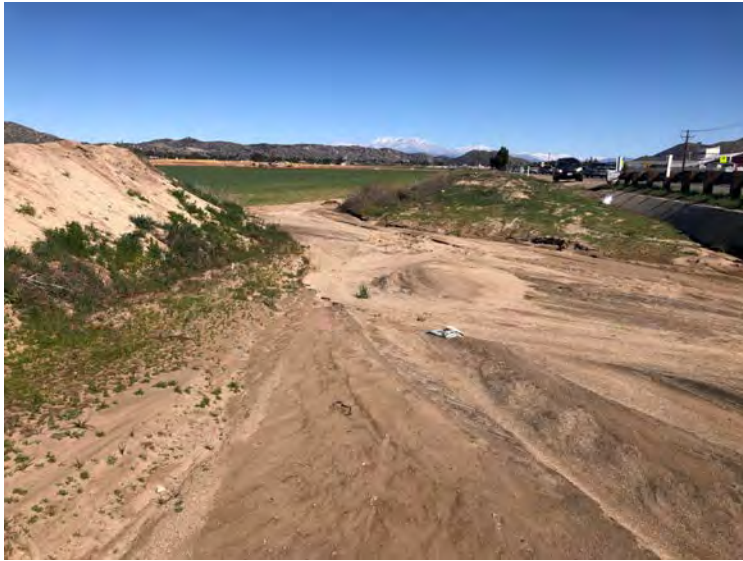
Photo 1. Upstream view of Feature 1, facing east, within disturbed habitat (33.743165, -117.142734). February 24, 2022.

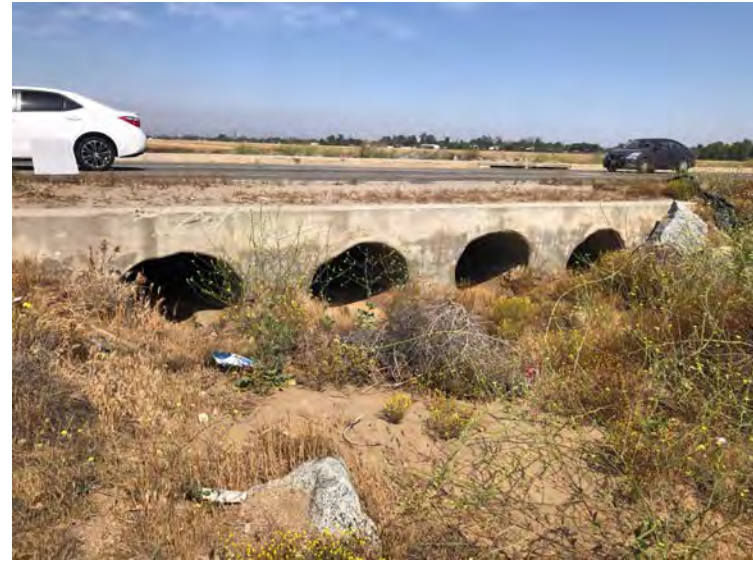
Photo 2. Downstream view of Feature 3, facing west towards Briggs Road, within disturbed habitat (33.743353, -117.136317). May 26, 2022.

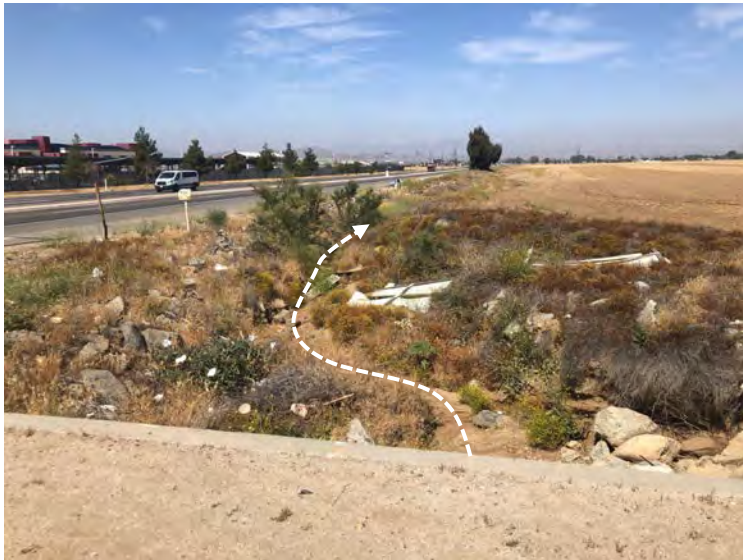
Photo 3. Downstream view of Feature 3 (white dashed line), facing west, after it travels through culverts under Briggs Road (33.743400, -117.136608). May 26, 2022.

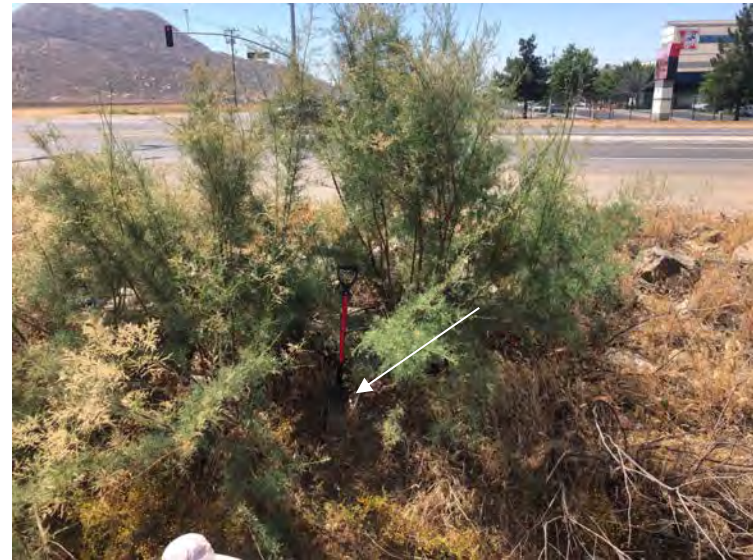
Photo 4. View of Wetland Data Form Point (WDP) 6 (white arrow) within disturbed habitat, facing south, adjacent to/within Feature 3. WDP 6 did not meet any of the three wetland parameters (33.743352, -117.136840). May 26, 2022.

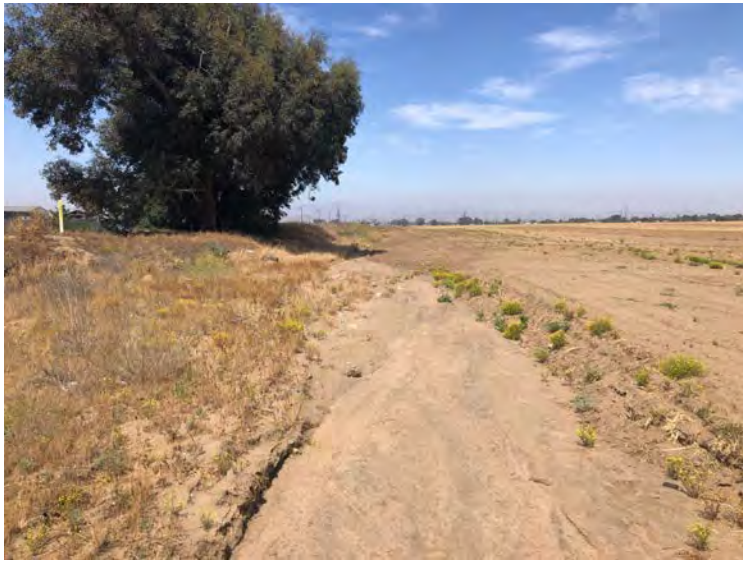
Photo 5. View of Feature 3, facing west, within disturbed habitat as the feature dissipates into the agricultural field (33.743414, -117.138496). May 26, 2022.

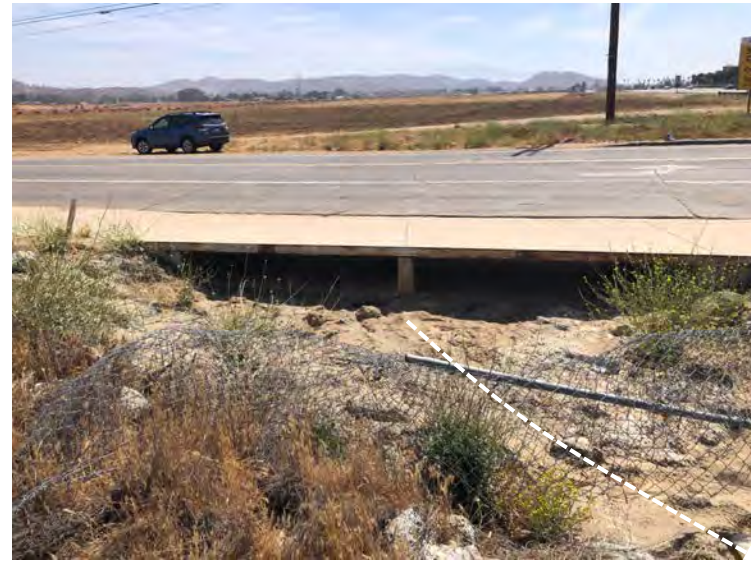
Photo 6. View of commencement of Feature 3A (white dashed line), facing east, as runoff from Briggs Road (33.743546, -117.136688). May 26, 2022.

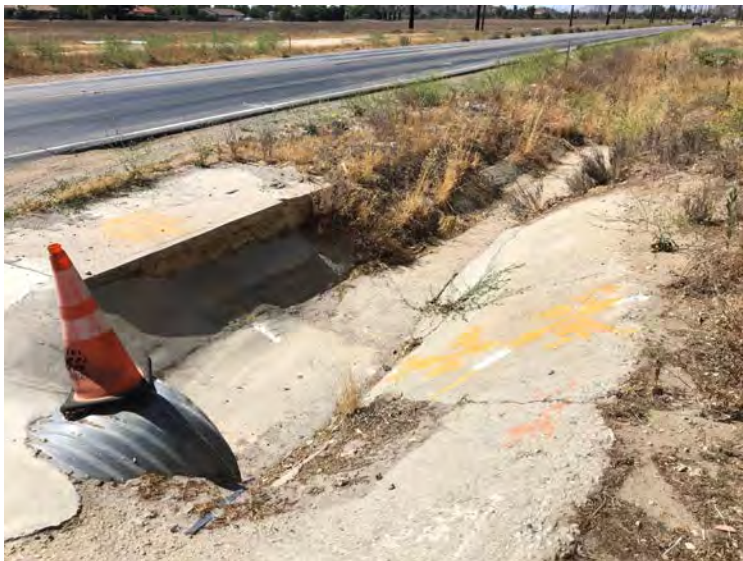
Photo 7. View of concrete portion of Ditch 4, facing northwest, within disturbed habitat north of Watson Road (33.750578, -117.153972). May 26, 2022.

created in uplands to convey runoff away from the surrounding developed areas. Ditch 4 displayed an inconsistent break in bank slope and a slight change in vegetation cover due to being artificially excavated but did not exhibit a distinctive change in average sediment texture, change in vegetation species, or any other OHWM indicators. Vegetation within the southern extent of Ditch 4 was well established and the feature quickly dissipated indicating that this ditch receives flows infrequently and does not convey flows downstream via observed flow patterns, culverts, or other flow paths and thus does not provide/has no impact on downstream beneficial uses and/or aquatic resource functions.

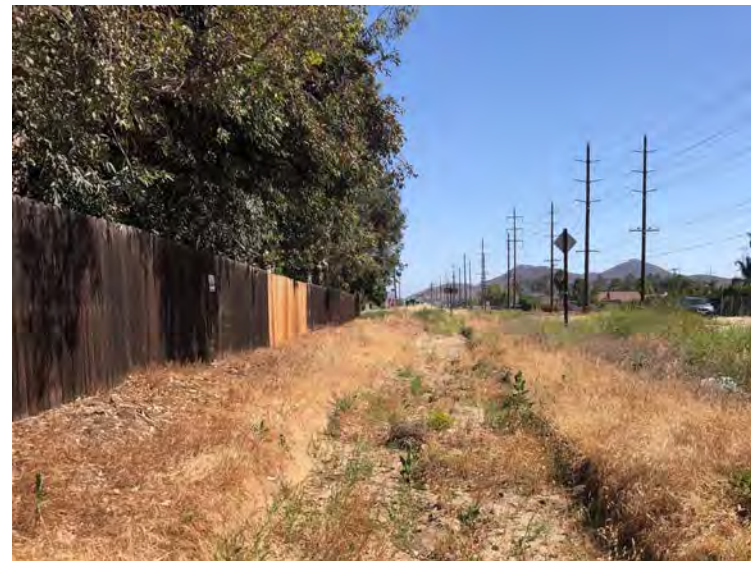
Photo 8. View of Ditch 4, facing south, within disturbed habitat south of Watson Road (33.750072, -117.153961). May 26, 2022.

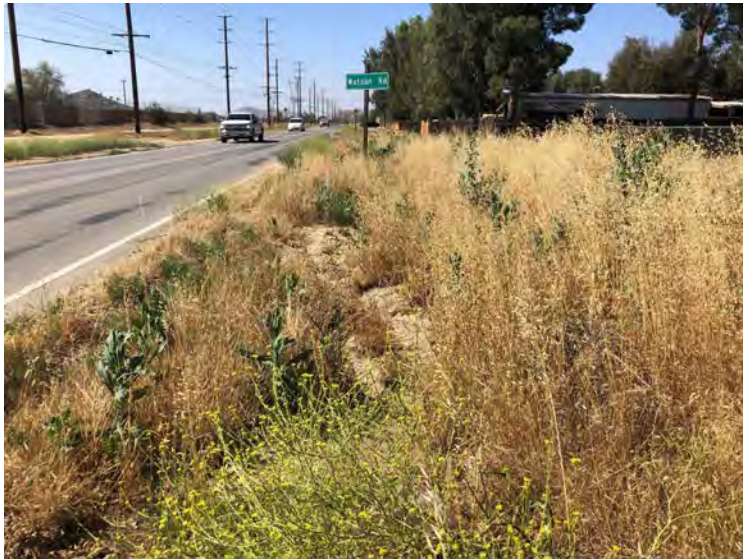
Photo 9. View of southern extent of Ditch 4, facing north, within disturbed habitat as Ditch 4 becomes more swale-like before dissipating (33.749217, -117.154034). May 26, 2022.

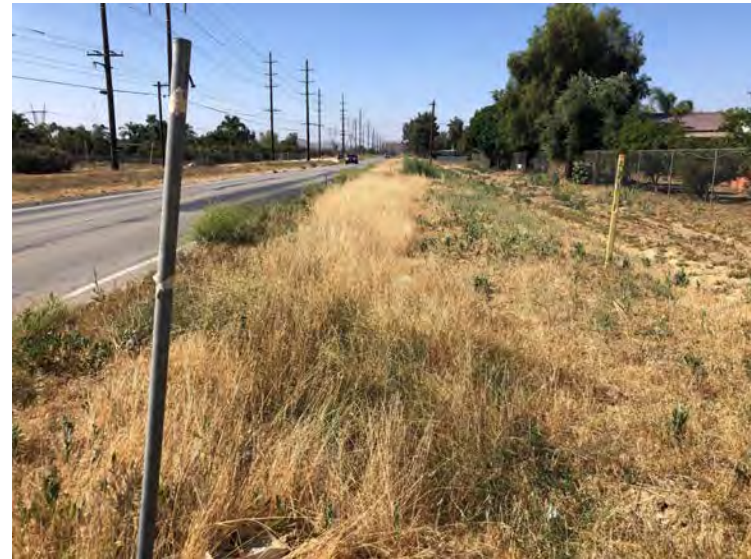
Photo 10. View of southern extent of Swale 1, facing north, within disturbed habitat (33.747830, -117.153961). May 26, 2022.

Swale 1, Swale 2, and Swale 3 are slightly concave drainage areas located in the northwestern portion of the review area, east of Menifee Road and south of Calle de Caballos (Figures 5A to 5C; Attachment C, Photos 10 to 13). Swale 1, Swale 2, and Swale 3 did not display an observable OHWM or bed and bank and instead appeared to convey surface flows as runoff from the neighboring developed areas, including Menifee Road. Swale 1, Swale 2, and Swale 3 also did not appear to convey flows to downstream aquatic resources via observed flow patterns, culverts, or other flow paths and thus do not provide/have no impact on downstream beneficial uses and/or aquatic resource functions.

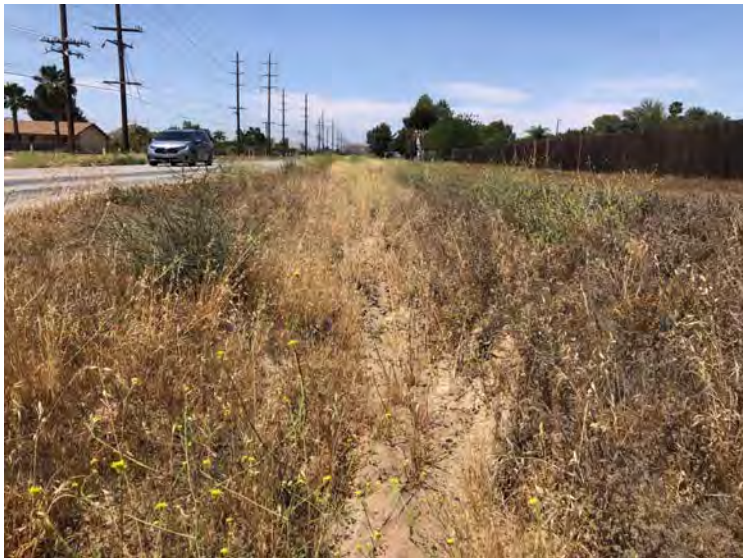
Photo 11. View of Swale 2, facing north, within disturbed habitat just north of Varela Lane (33.747100, -117.154006). May 26, 2022.

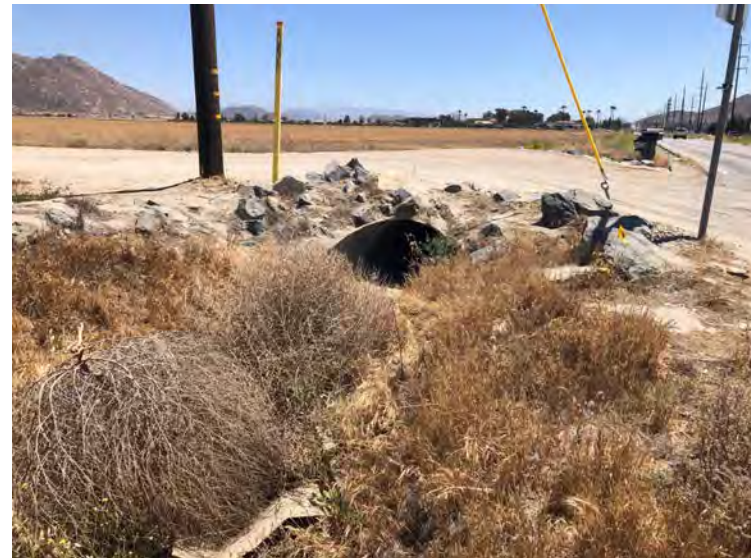
Photo 12. View of Swale 2, facing south, within disturbed habitat just north of Varela Lane (33.747155, -117.153998). May 26, 2022.

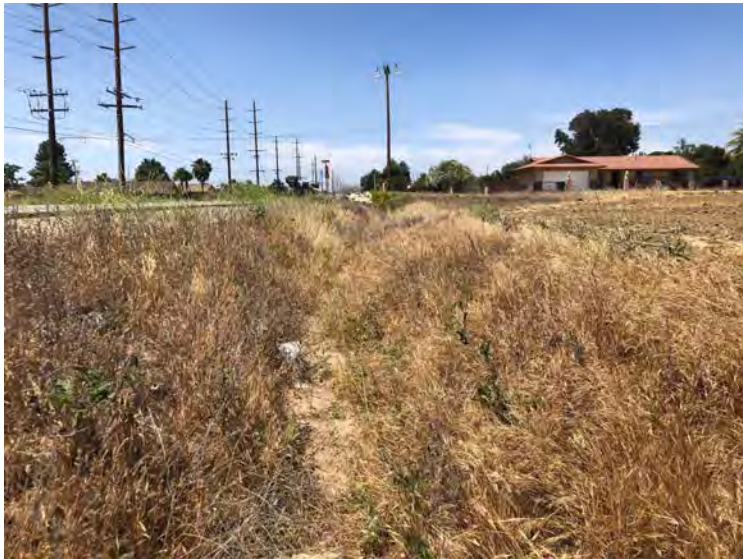
Photo 13. View of Swale 3, facing north, within disturbed habitat (33.746335, -117.153972). May 26, 2022.

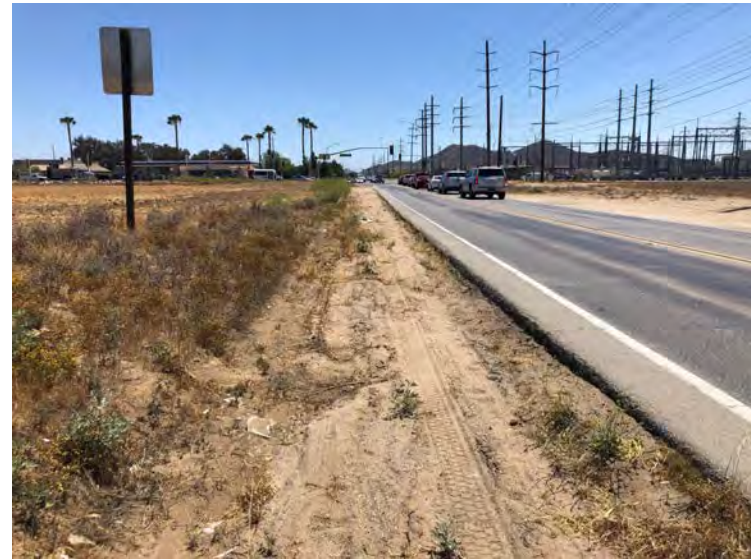
Photo 14. View, facing south, from southernmost point of Swale 3, within disturbed habitat (33.744359, -117.154030). May 26, 2022.

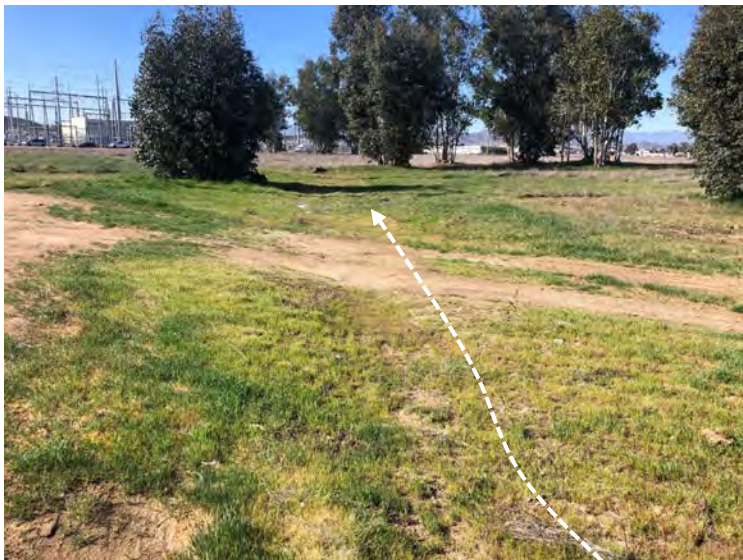
Photo 15. View of Swale 4 (white dashed line), facing southwest, as it continues off site (33.744372, -117.154150). February 24, 2022.

Swale 4 is a slightly concave drainage area located in the northwestern portion of the review area, west of Menifee Road and north of CA-74 (Figures 5A to 5C; Attachment C, Photo 15). Swale 4 resulted from runoff from Menifee Road based on field observations and a review of historic aerials (Google Earth Pro 2022). Swale 4 did not display an observable OHWM or bed and bank and did not appear to convey flows to downstream aquatic resources via

observed flow patterns, culverts, or other flow paths and thus does not provide/has no impact on downstream beneficial uses and/or aquatic resource functions.

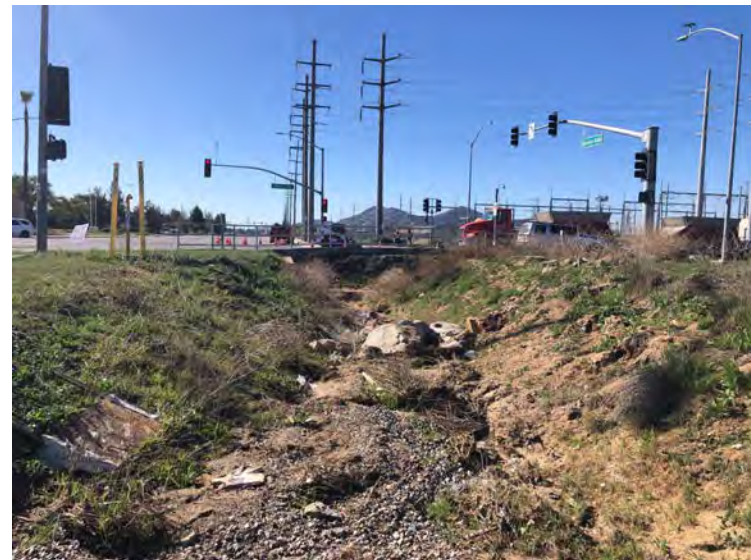
Photo 16. Downstream view of Feature 4A, facing southeast, within disturbed habitat (33.743434, -117.154201). February 24, 2022.

Feature 4A is a sparsely vegetated drainage composed of disturbed habitat (Figures 5A and 5B; Tables 5 and 6; Attachment C, Photo 16). Feature 4A originates as road runoff north of CA-74 and west of Menifee Road, as shown on Figures 5A and 5B, then generally flows southwest before converging with Feature 4. Feature 4A did not meet all three federal/State wetland parameters. See Tables 5 and 6 for the estimated OHWM and representative OHWM and wetland delineation data for this feature.

Feature 4A is a sparsely vegetated streambed composed of disturbed habitat (Figure 5C; Table 7; Attachment C, Photo 16). Feature 4A originates as road runoff north of CA-74 and west of Menifee Road, as shown on Figure 5C, then generally flows southwest before converging with Feature 4. See Table 7 for the estimated extent of CDFW jurisdiction for this feature.

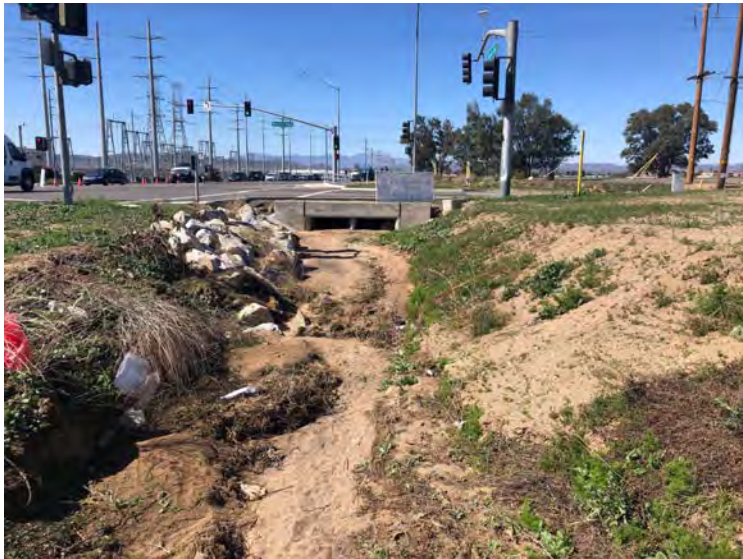
Photo 17. Downstream view of Feature 4, facing west, east of Meniffee Road within disturbed habitat (33.743321, -117.153764). February 24, 2022.

Feature 4 is a sparsely vegetated drainage generally composed of disturbed habitat (Figures 5A and 5B; Tables 5 and 6; Attachment C, Photos 17 to 20). Feature 4 occurs north of CA-74 and east and west of Menifee Road, as shown on Figures 5A and 5B. Feature 4 generally flows west before entering a culvert, traveling under Menifee Road, then daylighting and continuing west, before eventually continuing off site. Feature 4 did not meet all three

Feature 4 is a streambed composed of disturbed habitat (Figure 5C; Table 7; Attachment C, Photos 17 to 20). Feature 4 occurs north of CA-74 and east and west of Menifee Road, as shown on Figure 5C. Feature 4 enters the review area as a sparsely vegetated streambed, before transitioning to an unvegetated/concrete-lined streambed and traveling through a culvert under Menifee Road. After daylighting west of Menifee Road as a vegetated streambed, Feature 4 continues west, before eventually transitioning to an unvegetated streambed and continuing off site. See Table 7 for the estimated extent of CDFW jurisdiction for this feature.

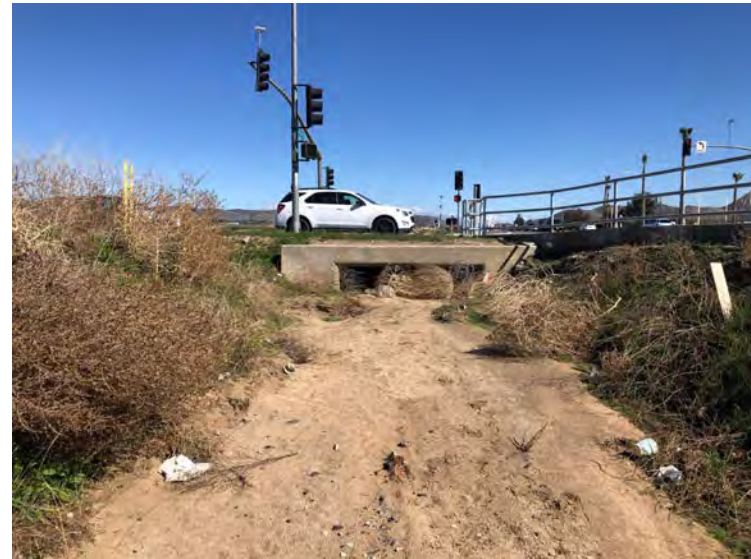
Photo 18. Upstream view of Ordinary High Water Mark (OHWM) Data Point (ODP) 7, facing east, within Feature 4 west of Meniffee Road. ODP 7 exhibited a break in bank slope, change in average sediment texture, and change in vegetation cover (33.743275, -117.154294). February 24, 2022.

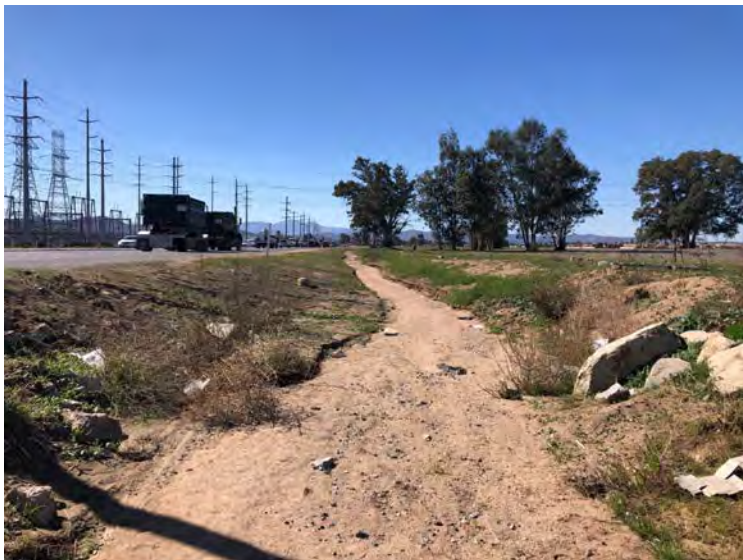
Photo 19. Downstream view of ODP 7, facing west, in disturbed habitat within Feature 4 (33.743269, -117.154322). February 24, 2022.

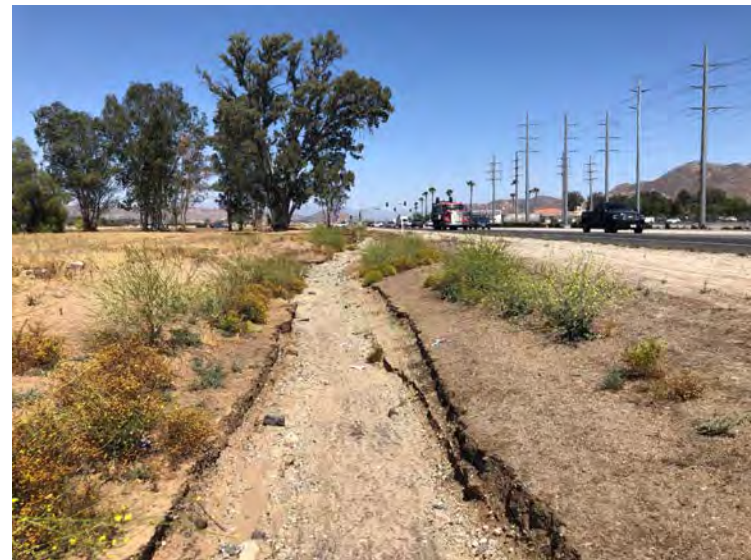
Photo 20. Upstream view of Feature 4, facing east, within disturbed habitat (33.743240, -117.156411). May 26, 2022.

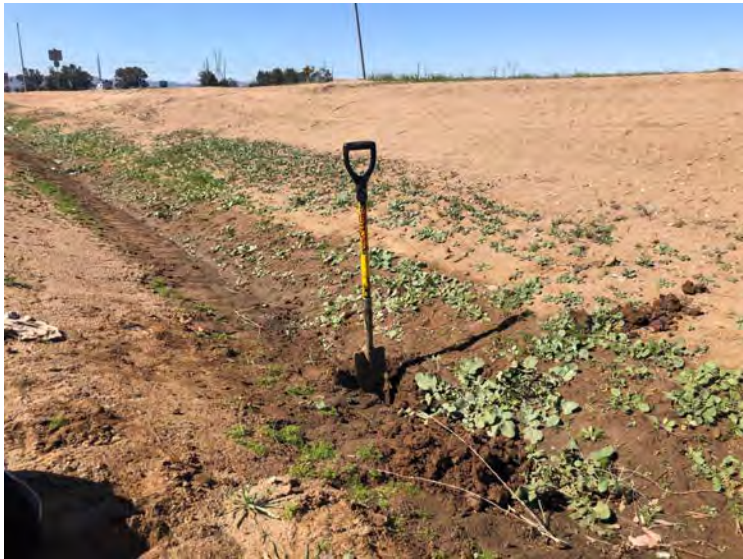
Photo 21. View of WDP 5, facing west, within Swale 5. WDP 5 did not meet any of the three wetland parameters (33.742914, -117.150244). February 24, 2022.

Swale 5 is a slightly concave drainage area located in the northern portion of the review area, south of CA-74 and west of McKinley Road (Figures 5A to 5C; Attachment C, Photos 21 to 23). Swale 5 did not display an observable OHWM or bed and bank and instead appeared to convey surface flows as runoff from the neighboring developed areas, including CA-74. WDP 5, taken in an area of disturbed habitat, did not meet any of the three federal wetland parameters (Attachment B, WDP 5). ODP 5, also taken in an area of disturbed habitat, contained a slight change in upland vegetation species between the swale and the adjacent upland area; however, ODP 5 did not show evidence of a break in slope or a defined bed and bank between the swale and adjacent uplands. Additionally, ODP 5 did not contain a change in sediment texture, change in vegetation cover, or any additional OHWM indicators between the swale and the adjacent upland area (Figures 5A to 5C; Attachment B, ODP 5). Thus, this swale was determined to not have an OHWM or defined bed and bank and did not appear to convey flows to downstream aquatic resources via observed flow patterns, culverts, or other flow paths and thus does not provide/has no impact on downstream beneficial uses and/or aquatic resource functions.

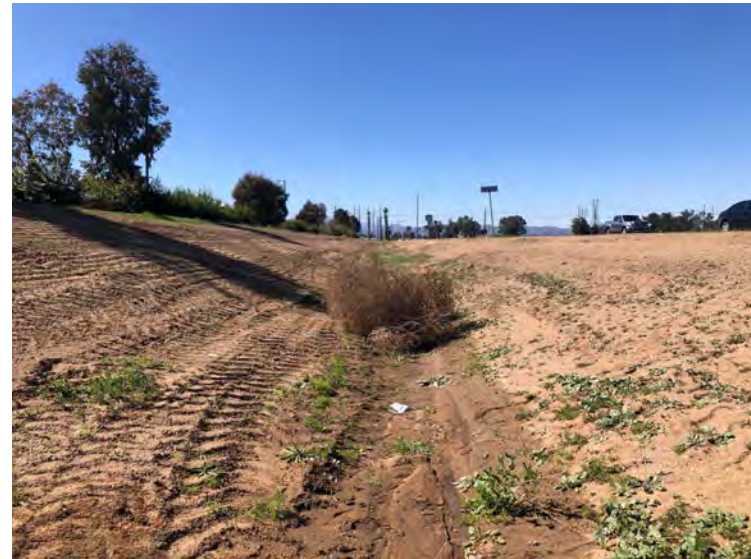
Photo 22. View of ODP 5, facing west, within disturbed habitat in Swale 5 (33.742903, -117.150003). February 24, 2022.

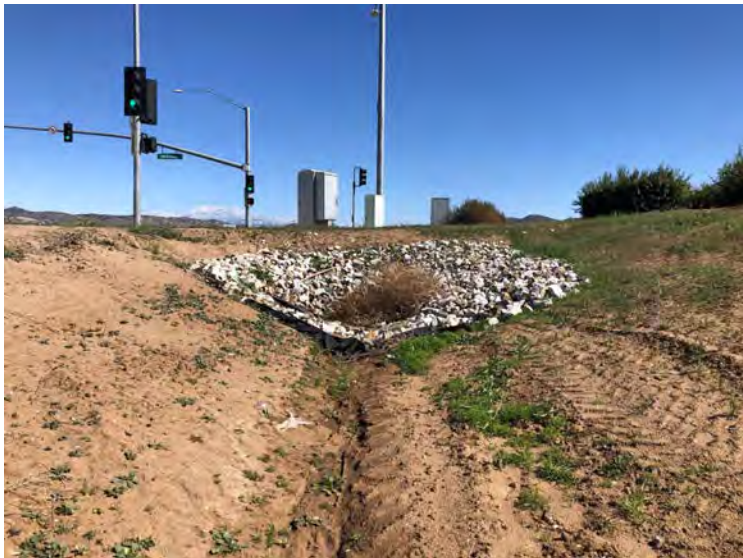
Photo 23. View of ODP 5, facing east, within disturbed habitat in Swale 5 (33.742920, -117.150024). February 24, 2022.

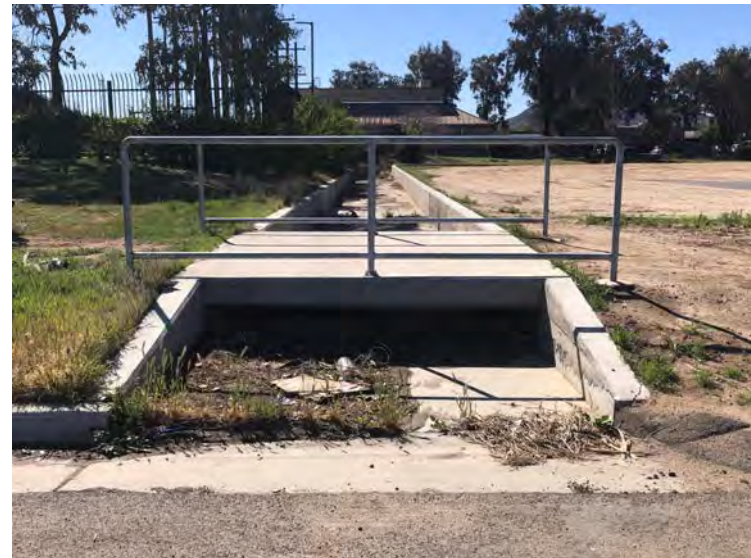
Photo 24. View of Ditch 5, facing south, from California State Route 74 (CA-74) (33.742986, -117.152703). February 24, 2022.

Ditch 5 is a concrete-lined ditch/stormwater conveyance feature located southeast of the intersection of Menifee Road and CA-74 (Figures 5A to 5C; Attachment C, Photos 24 to 26). Based on a review of historic aerials and field observations, Ditch 5 was constructed in uplands between January 2007 and May 2009 (Google Earth Pro 2022) and appears to direct runoff from CA-74 and Menifee Road. Specifically, road runoff from CA-74 travels south and road runoff from Menifee Road travels east to an off-site confluence in the center of Ditch 5 where flows remain and do not continue downstream (i.e., no culverts or storm drains were observed throughout the extent of Ditch 5). Ditch 5 was extended slightly north to connect to CA-74 between April 2014 and February 2016 (Google Earth Pro 2022). Ditch 5 contained debris present as dead plant material and sediment one day after a rain event (Attachment B, ODP 6); however, Ditch 5 did not display an observable bed and bank, lacked association with a natural feature/streambed, and did not support wildlife habitat. Ditch 5 appeared to be a maintained artificial structure that does not convey flows downstream via observed flow patterns, culverts, or other flow paths. As such, Ditch 5 functions as localized stormwater runoff conveyance with no downstream connectivity and thus does not provide/has no impact on downstream beneficial uses and/or aquatic resource functions.

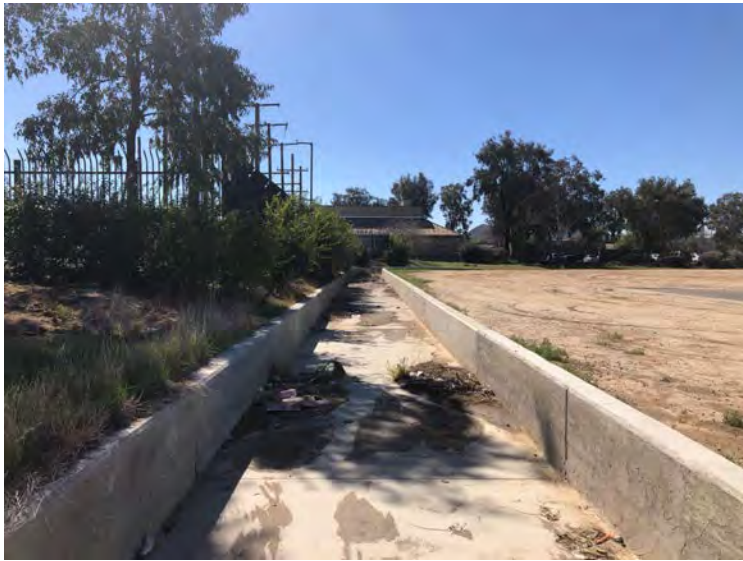
Photo 25. View of ODP 6, facing south, within Ditch 5. ODP 6 contained debris present as sediment and dead plant material one day after a rain event; however, Ditch 5 did not exhibit any other OHWM indicators (33.742870, -117.152704). February 24, 2022.

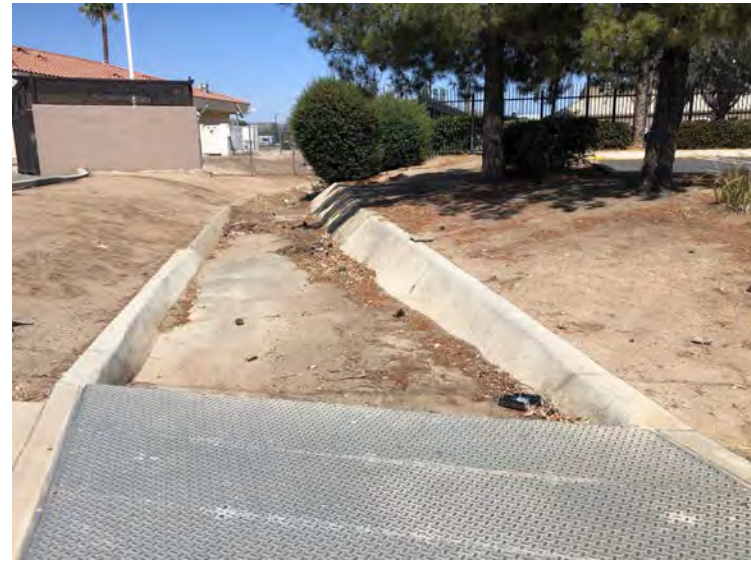
Photo 26. View of Ditch 5, facing east, from Meniffee Road (33.742183, -117.153917). May 26, 2022.
