PROPERTY MANAGEMENT PLAN
EMERALD MOUNTAIN FARMS, INC.

**1850 Ogulin Canyon Road
Clearlake, CA 95422**

PROJECT DESCRIPTION

PROPOSED CONDITIONS SITE PLAN
EMERALD MOUNTAIN FARMS, INC.
APN: 010-053-03
1650 OGU LIN CANYON RD.
CLEAR LAKE, CA 94722
LAKE COUNTY

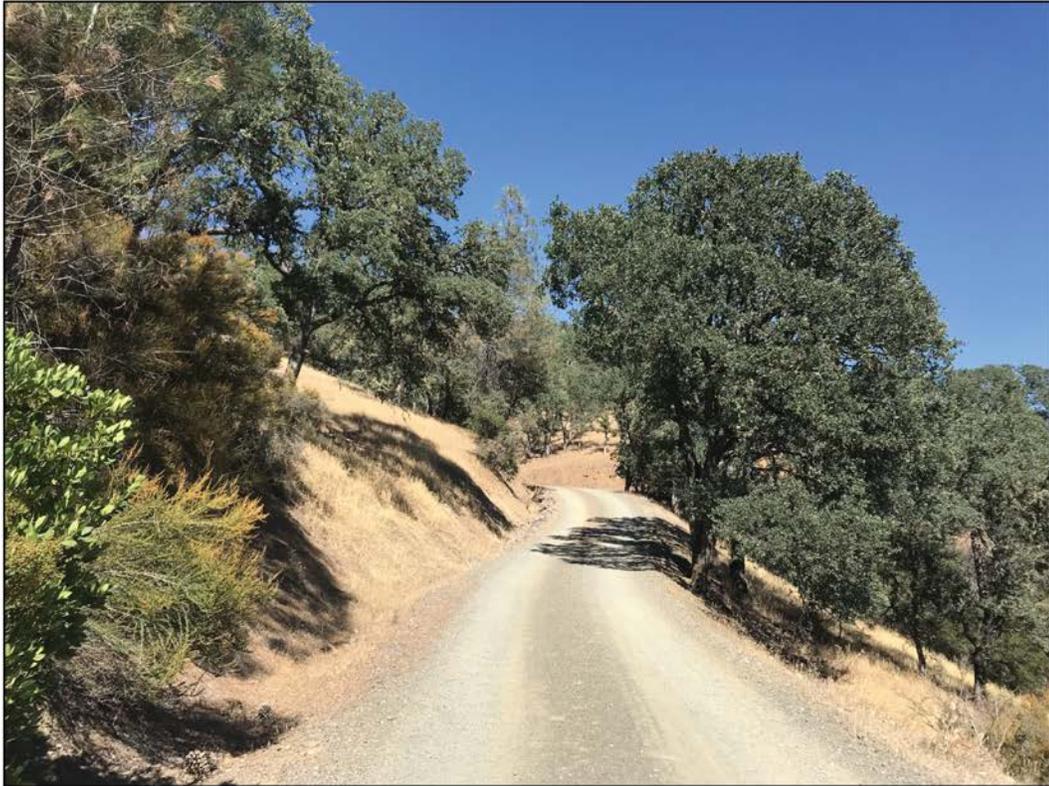
FIGURE 6: PHOTOGRAPH OF ACCESS ROAD

The driveway that passes through Blackeye Canyon is known as Ogulin Canyon Road and is in good condition, packed dirt and gravel (Figure 6). Access is controlled by a locking metal automatic entry gate equipped with emergency lock access box. The road is in good condition and exhibits rock protection in numerous locations. Culverts are well built and maintained free of debris and appear to be adequately sized. There is one occupied single family residence onsite that is located approximately 0.3 miles past the entrance to the parcel. An existing 1,500 gallon septic system exits downhill from the main residence to the southeast. The proposed cultivation areas are located approximately 0.15 miles further to the east on the top of the main ridge (Figure 9) in an area of annual grassland and blue oak trees. There is a solar powered well located near the residence and water is pumped into a series of HDPE water storage tanks located at the top of the ridge near the proposed cultivation areas. The cultivation areas are surrounded by chain link fencing with visibility screening. There is a vehicle garage and outbuilding onsite but no other permanent structures.
