**SOIL MANAGEMENT PLAN  
AND RESPONSE TO RIVERSIDE COUNTY  
DEPARTMENT OF ENVIRONMENTAL HEALTH COMMENTS  
LOT 39 OF TRACT 7240, ±10.01-ACRE SITE  
APN 290-190-083, PROPOSED GLEN IVY SENIOR COMMUNITY  
AND RETAIL/COMMERCIAL PROJECT, TEMESCAL VALLEY AREA  
RIVERSIDE COUNTY, CALIFORNIA 92883  
CUP200011: PHASE I REVIEW**

**W.O. E7731-SC**

**SEPTEMBER 8, 2021**

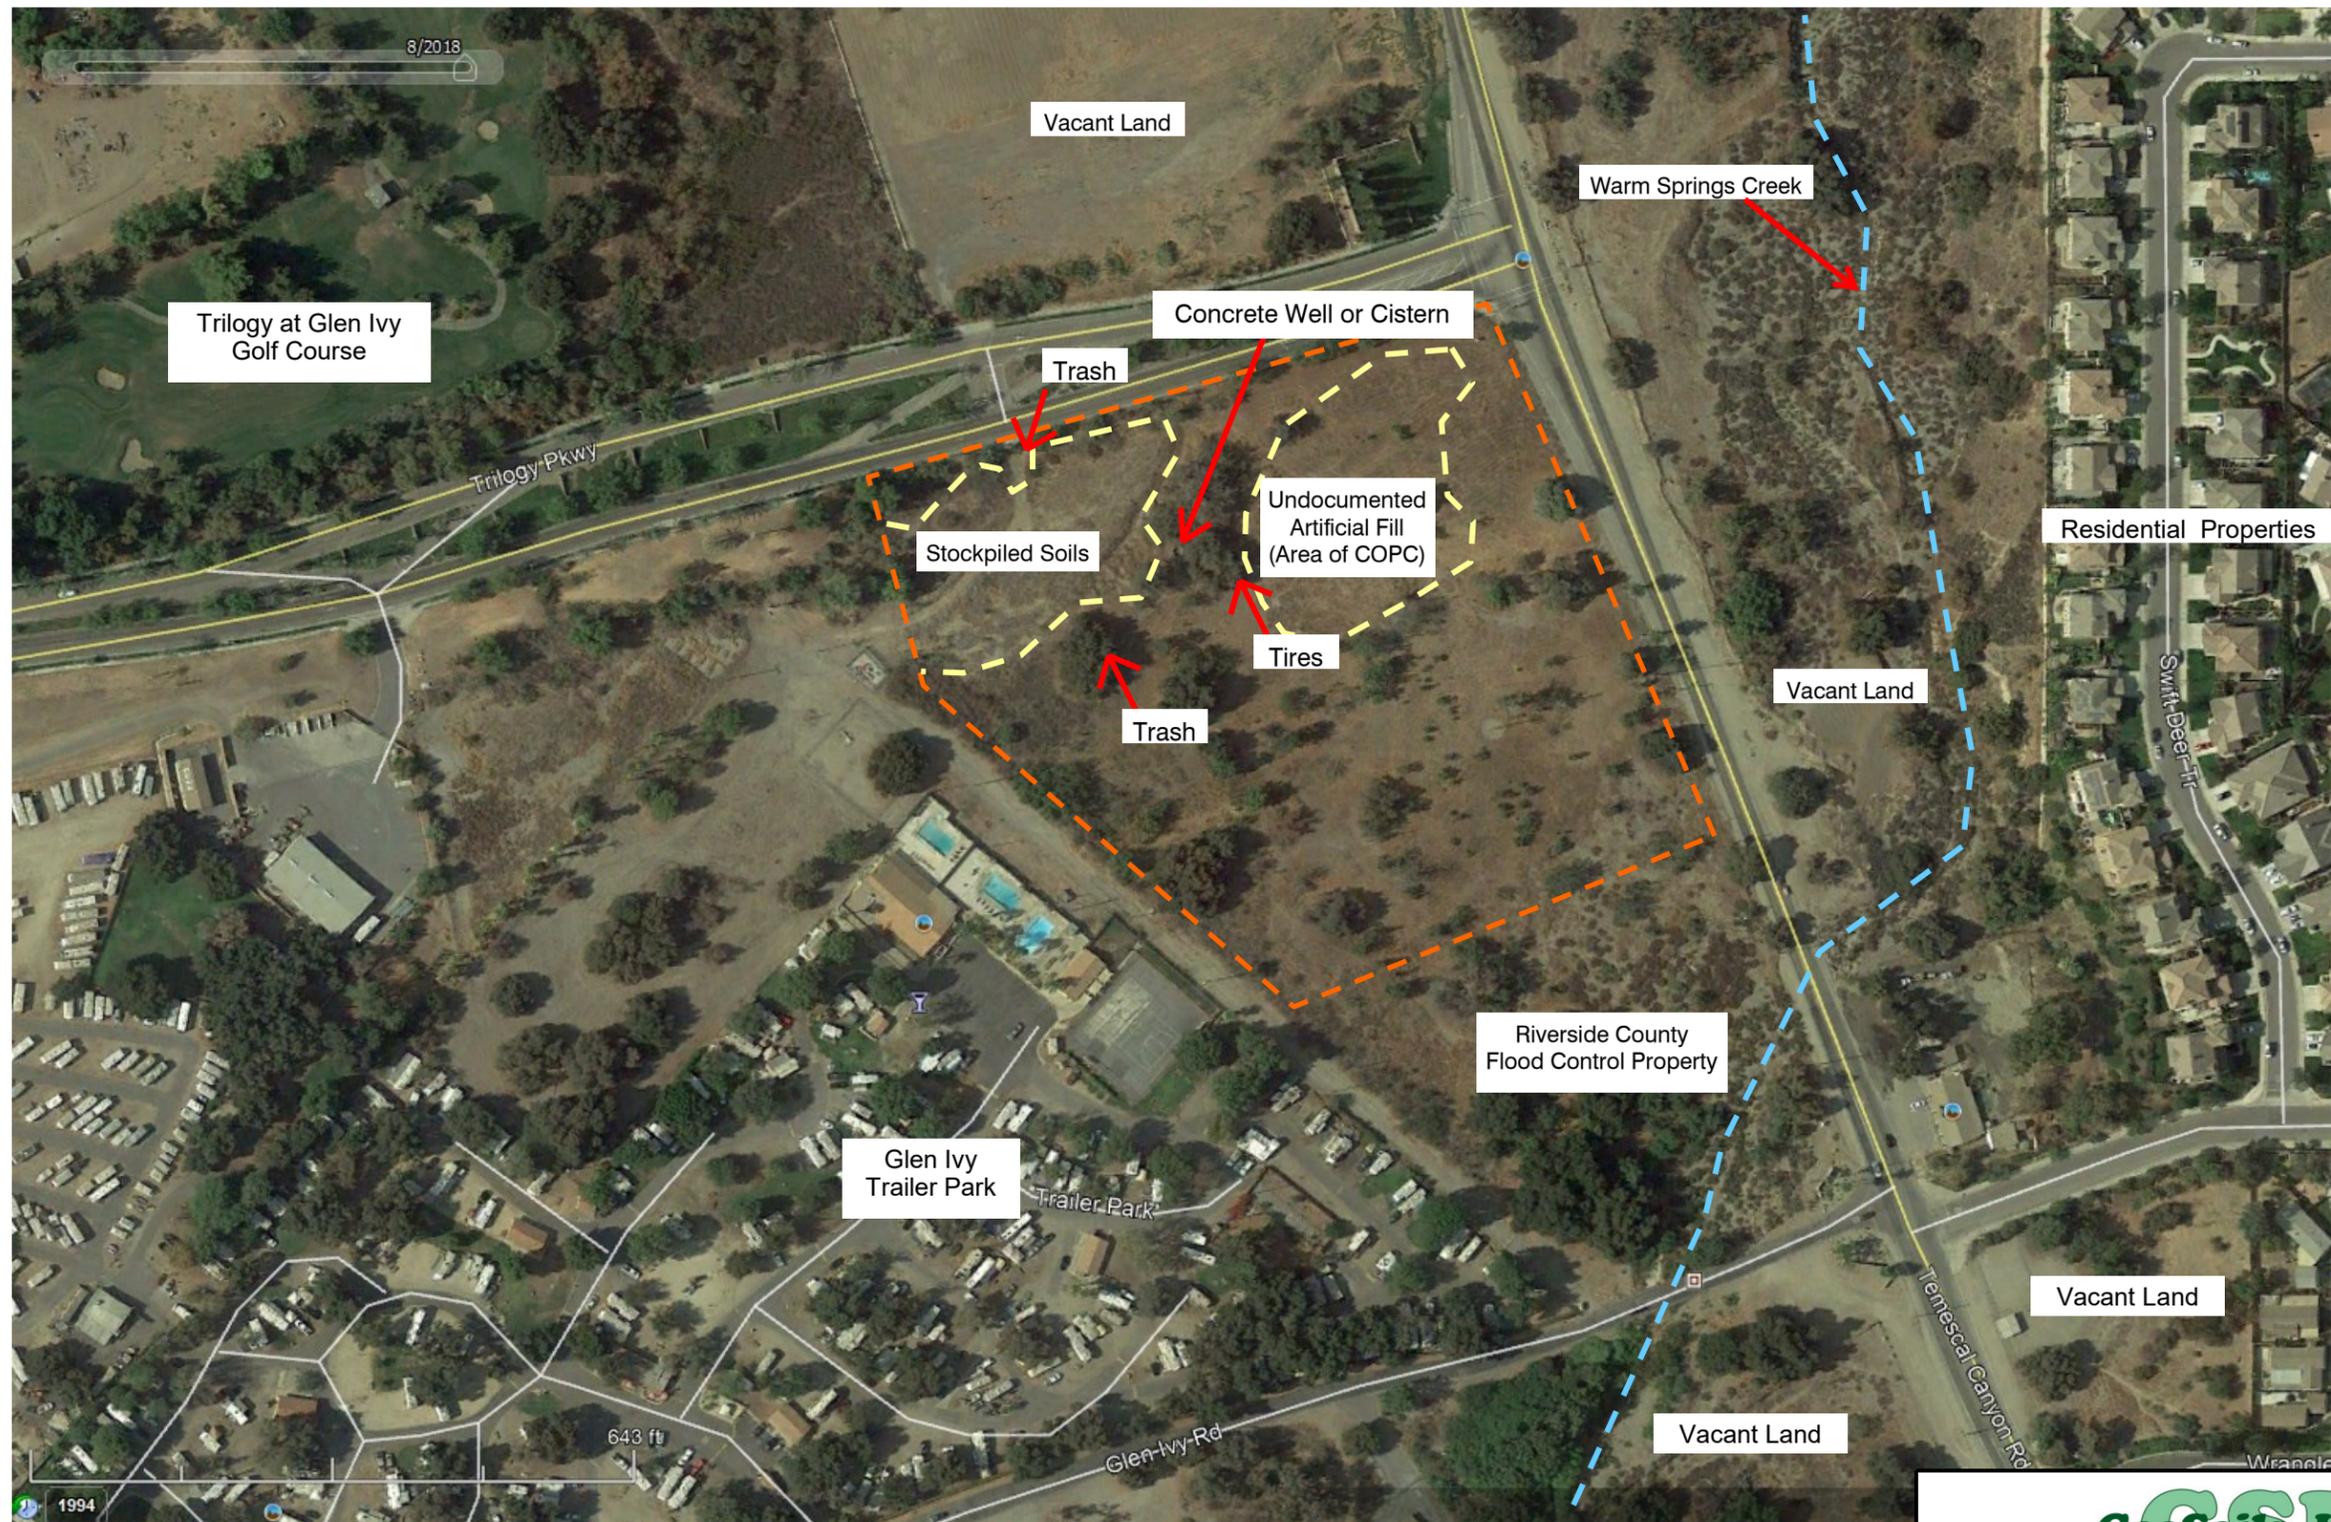
Plate 1

Undocumented artificial fill was observed in localized areas generally associated with previous stockpiling, backfill of previous fault finding exploratory trenches, and dumped fills from previous land use (see Plate 1). As indicated in our Phase I ESA (GSI, 2020c), a fairly large area of “undocumented artificial fill” is located in the northern-central portion of the site, from an unknown source (area of question). The large soil stockpile in the northwestern portion of the site was previously imported under permit from the adjoining Tract 29307 (Canyon Oaks project) as excess spoils. During our previous onsite fault finding investigation (GSI, 1999a), which excavated through the “undocumented artificial fill” in the northern central portion of the site, locally abundant trash and debris (e.g., asphalt spoils, organic debris, and a car body) were encountered within our excavation (trench T-301, GSI 1999a). Based on our observations and previous onsite excavations the “undocumented artificial fill” in the northern central portion of the site ranges in depth from approximately  $\pm 1$  to as much as  $\pm 20$  feet (within previous fault trenches). All undocumented fill and stockpiled soil materials are potentially compressible in their existing state and may settle appreciably under additional fill or foundation and improvement loadings, and therefore, should be removed and recompacted. The “undocumented artificial fill” located in the northern-central portion of the site, from an unknown source (area of question) should be removed, environmentally evaluated, and recompacted, as appropriate, under the protocols established herein, and as approved by CRDEH.

Older alluvial fan deposits underlie the eastern portions of the site (see Plate 1). The alluvial fan deposits are generally silty to gravelly sands, to sands with pebbles, gravels, cobbles, and minor boulders. They are generally pale brown to reddish yellow, dry to damp, and medium dense to dense. Additionally, they are thinly to medium bedded, and locally form grossly fining upward sequences. They are generally flat lying to gently inclined to the northeast. These sediments may reach several tens of feet in thickness. The older alluvial fan deposits are estimated to be latest Pleistocene-age (GSI; 2007a, 2007b, 1999a, and 1999c). The near surface older alluvial fan deposits are weathered.

**SITE MAP**

As indicated in GSI (2020c), an old concrete water well or cistern is present in the northwest portion of the site. As requested by the CRDEH (2021), the approximate location of the old concrete water well or cistern that is present in the northwest portion of the site is presented on Plate 1. Removal of the structure will be conducted under the guidance of GSI. Although not anticipated, if any other structures such as vaults, hoists, sumps, clarifiers, etc. are encountered during earthwork construction, the structure should be evaluated by GSI to determine whether residual chemicals are present based on visual/olfactory observation, or measurements taken with a hand-held PID. If field observations and/or PID readings indicate that chemicals are or may have been present within the structure, the contents should be sampled and the structure inspected for cracks/holes. If there is evidence of a release of the structure's contents to surrounding soils, additional environmental assessment may be necessary.
