# Glen Ivy Senior Community

## Determination of Biologically Equivalent or Superior Preservation Report

February 18, 2022 | 00821.00016.001

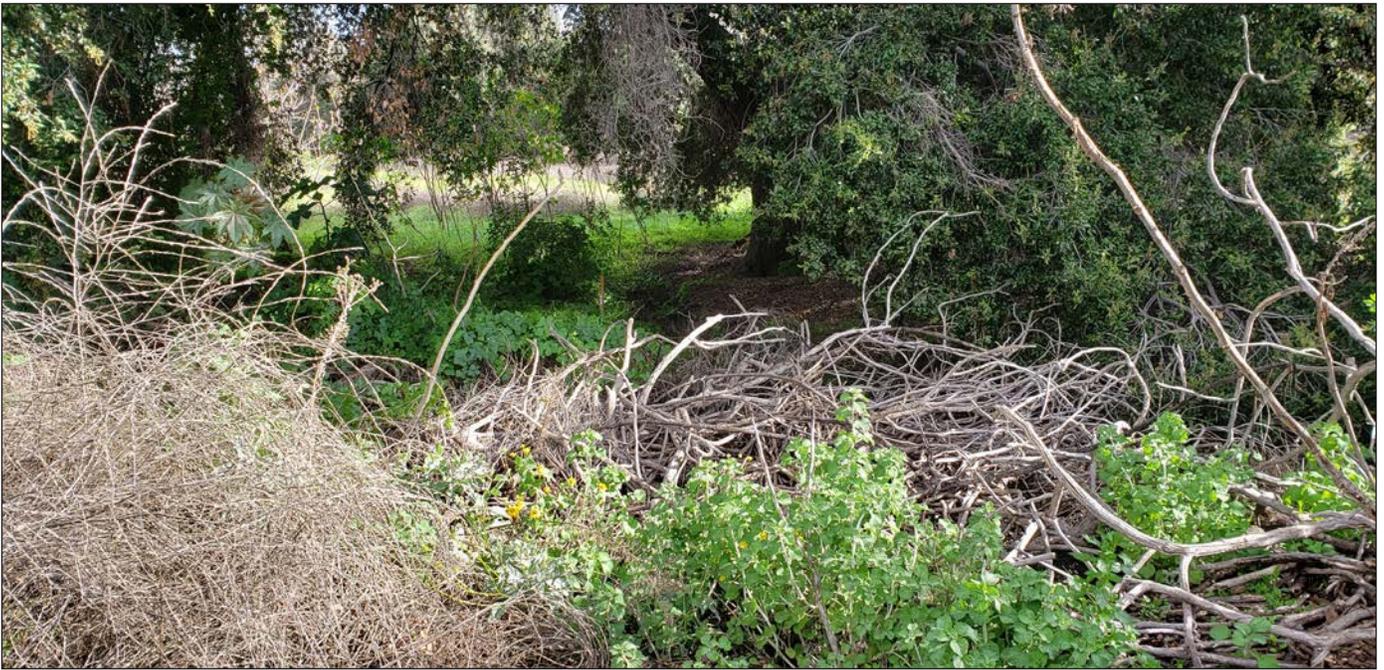
View of Drainage 1 looking east from western edge of project showing path of drainage under canopy of an oak with annual vegetation. Photo taken March 24, 2020.

Drainage 1 is 0.02 acre and 172 linear feet long and dissipates on-site. The erosional feature originates from road runoff, totals less than 0.01 acre, and dissipates on-site after 49 feet. Drainage 1 and the erosional feature have no connection to downstream resources or upstream resources. The nearest downstream Riparian/Riverine resource is Coldwater Creek, which is more than 500 feet from point of dissipation of Drainage 1 and slightly farther from the erosional feature. Structures associated with the adjacent RV park were constructed between 1967 and 1980 according to historic aerials (NETRonline 2021). The historic aerial review indicates that the stream is not naturally occurring and not the redirection or modification of a naturally occurring stream.

Drainage 1 occurs primarily under the canopy of one of the many coast live oak trees that occur in the study area. The erosional feature occurs within non-native woodland habitat. As Drainage 1 and the erosional feature are not of natural origin and do not have a connection to downstream resources, they have been determined by HELIX to not be classified as a Riverine under the MSHCP.

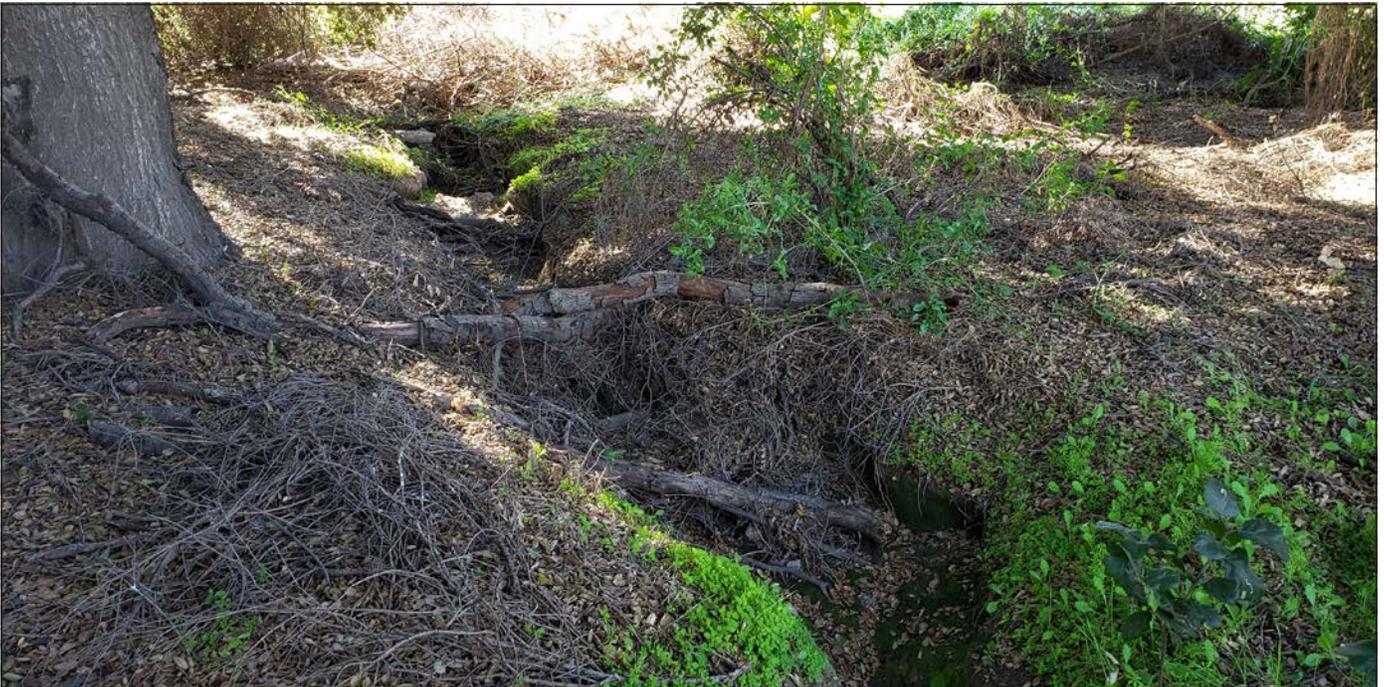
Closeup view of Drainage 1 showing lack of riparian vegetation. Photo taken January 28, 2020.

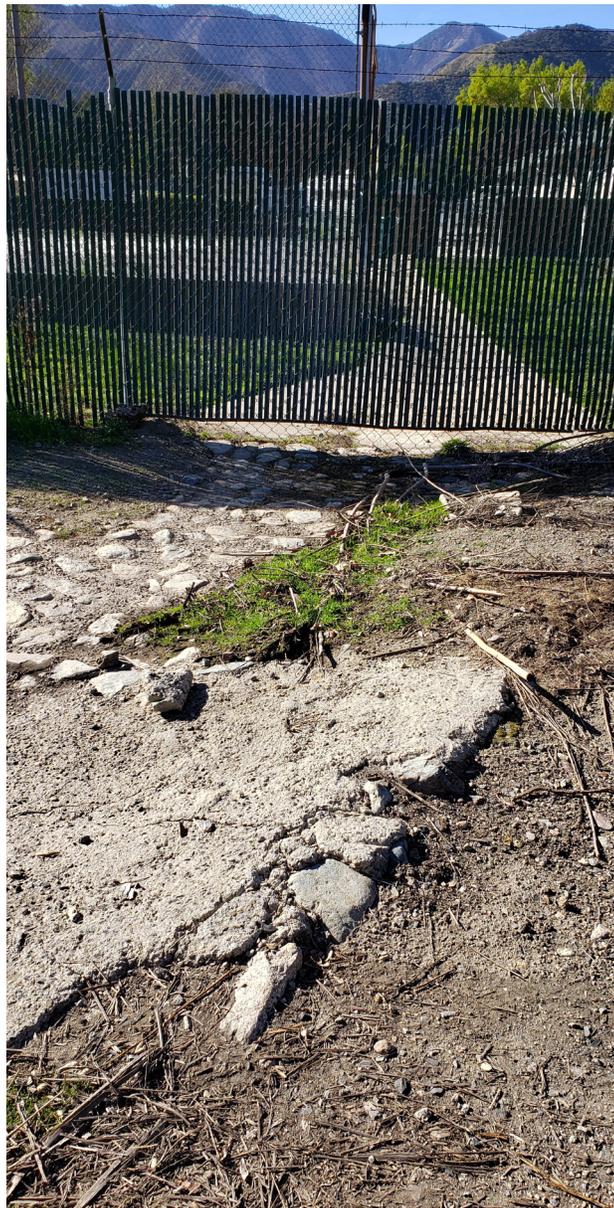
View to west showing concrete lined development runoff that is source for Drainage 1. Photo taken January 28, 2020.

Potential Riverine habitat in the on-site portion (west of Temescal Canyon Road) of the study area consists of a small drainage (Drainage 1) and an erosional feature in the southwest portion of the study area. These two features, which resemble ephemeral streams (Drainage 1 and an erosional feature), originate as runoff from the parking lot and road from the adjacent development (RV park) to the west. Both Drainage 1 and the erosional feature more closely resemble erosional features than natural streams. Although both of these features occur under a canopy of vegetation, there is no vegetation within the banks of the features other than a few sparse annuals (Appendix A, *Representative Site Photos*). A review of historical aerial photographs shows the streams did not exist prior to the creation

of the impermeable surfaces created by the adjacent development to the west (NETRonline 2021). The features are not the result of a redirection of a previous existing natural stream.

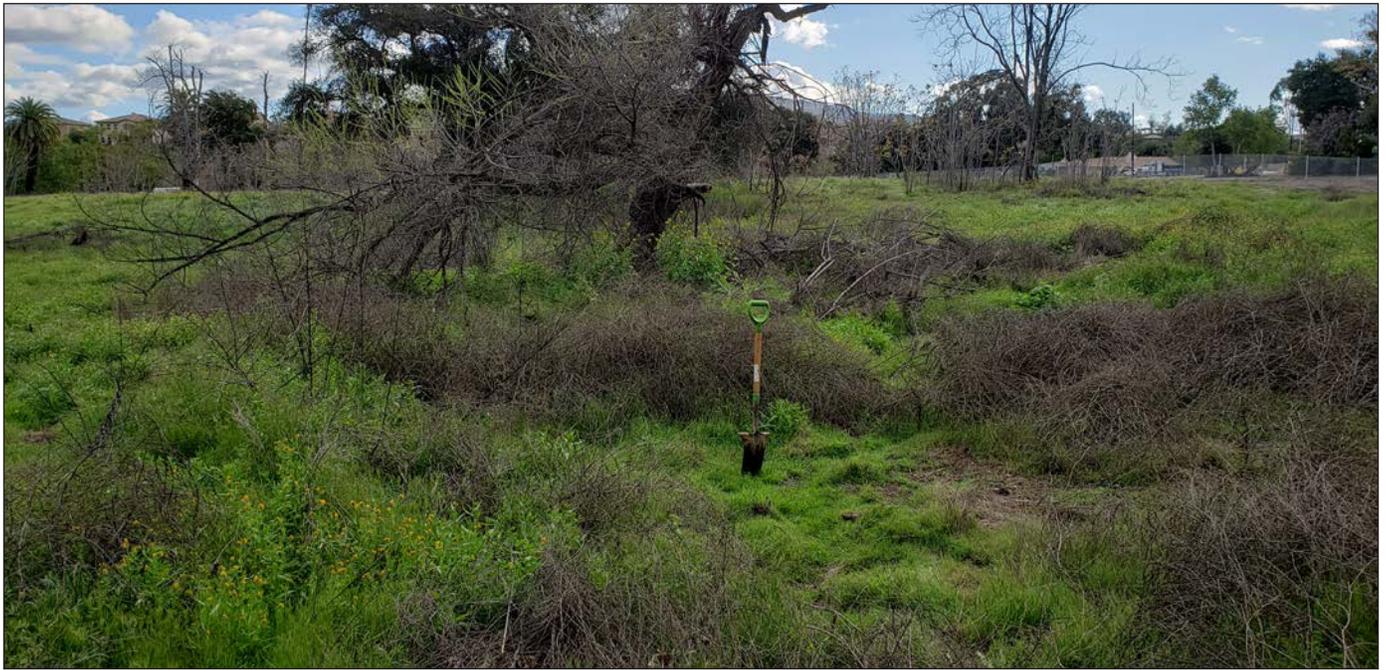
View looking south of Lone Willow that occurs on the property showing surrounding upland annual vegetation and low health of the willow. Photo taken March 24, 2020.

Potential riparian habitat on-site within the study area is comprised of a single Goodding's black willow (*Salix gooddingii*). The single willow is in poor health, as evident by multiple broken branches and a split trunk with a limited number of live branches producing leaves. This single willow occurs near but is not connected to the east end of the Drainage 1. This single willow does not have potential to support animals associated with the MSHCP Riparian/Riverine habitat. The willow comprises 0.02 acre of southern willow scrub habitat that is an MSHCP Riparian resource.

The study area does not include habitat with potential to support MSHCP riparian birds, given the mapped southern willow scrub consists of a single willow in poor health. No impacts are proposed to occur to riparian bird habitat therefore no surveys or mitigation is required.

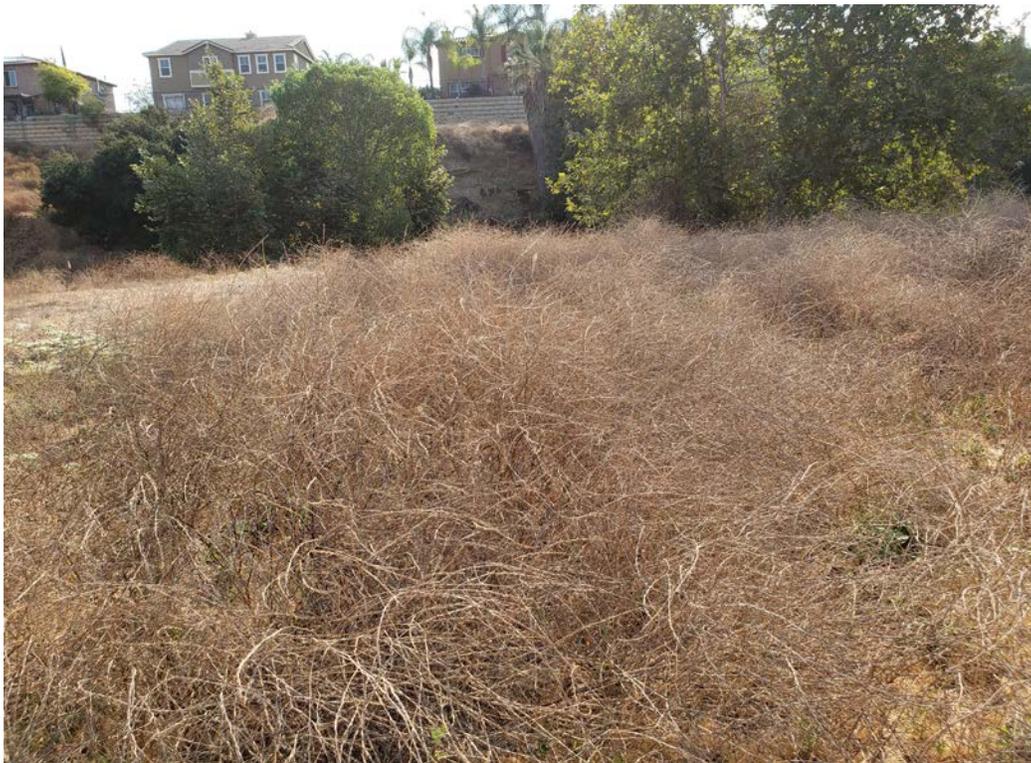
View looking east at disturbed habitat along outfall pipe install location. Pipe will follow along left edge of photo. Photo taken August 20, 2020.

The majority of the 0.40 acre area proposed for temporary disturbance from the installation of the underground pipeline is comprised of disturbed habitat that is dominated by the invasive non-native species short-podded mustard (*Hirschfeldia incana*) or has minimal vegetation cover. The 0.40 acre area to be seeded is estimated to currently have a native cover of less than 20 percent with a non-native cover of over 50 percent. Seeding this temporarily disturbed area with a native seed mix will ultimately improve the native species cover of the area. Monitoring and reporting of the seeded temporary impact area is not proposed as this area is primarily comprised of disturbed upland habitat that is mitigated via the payment of the MSHCP local development mitigation fee, and the temporary impacts to 0.074 acre Riparian/Riverine habitat are being mitigated via purchase of 0.10 acre mitigation credits. The seeding will act as erosion control and hopefully be a positive improvement from the existing disturbed habitat.

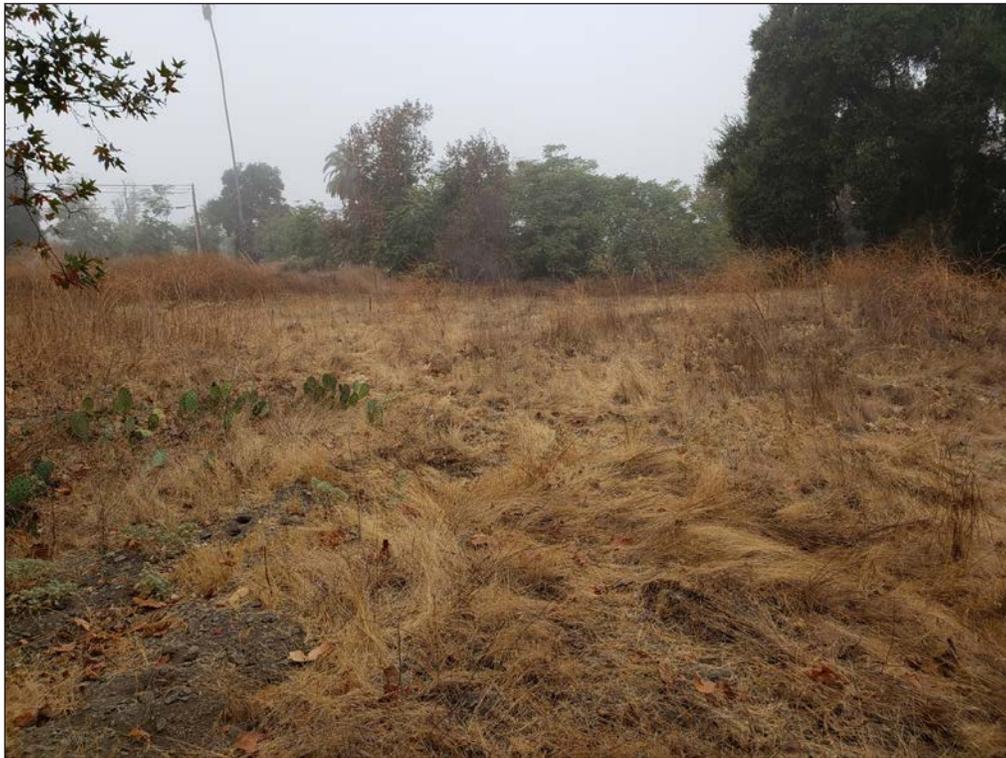
View looking north across the offsite pipe path showing mostly non-native vegetation along pipe path with the oak tree visible to the right. Photo taken October 21, 2020.

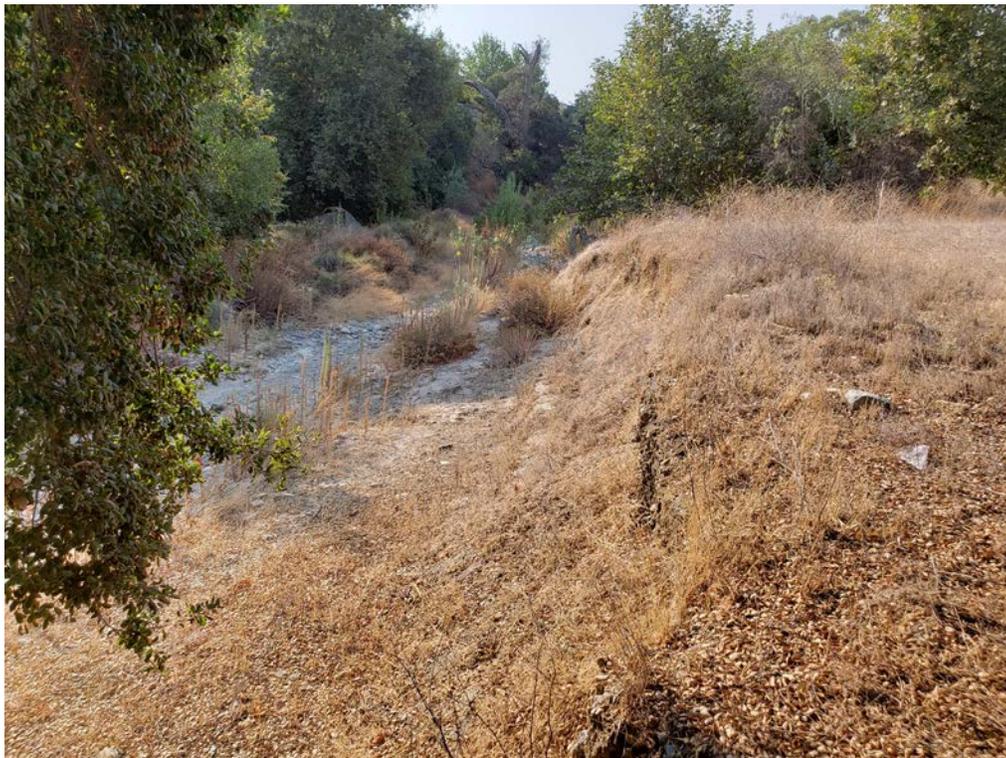
View looking south at outfall location along edge of Cold Water Creek showing mostly non-native annuals in impact area. Photo taken August 20, 2020.

The project proposed to install an outfall structure at the western bank of Coldwater Creek that would result in a mix of temporary and permanent impacts to the Riparian/Riverine habitat. The impacts include work within a drip line of one coast live oak tree and the possible trimming of branches to complete the work. The proposed impacts to the oak are included in the riparian habitat mitigation proposed below, and the coast live oak tree impact will be mitigated by replacing the oak as discussed in the oak tree mitigation plan under separate documentation.

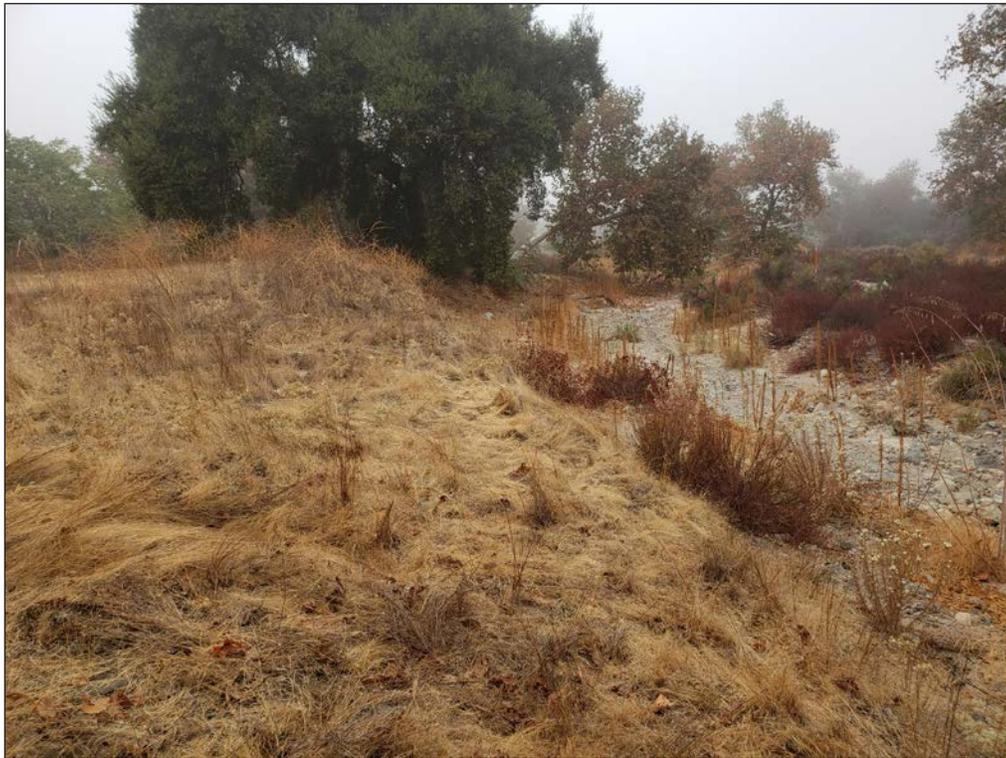
View looking north at outfall location showing an oak tree that is immediately adjacent to outfall location, and that the location is dominated by non-native annuals. Photo taken October 21, 2020.
