# Aquatic Resources Delineation Report

## USMCA Mitigation of Contaminated Transboundary Flows Project

31 May 2022  
Final Report

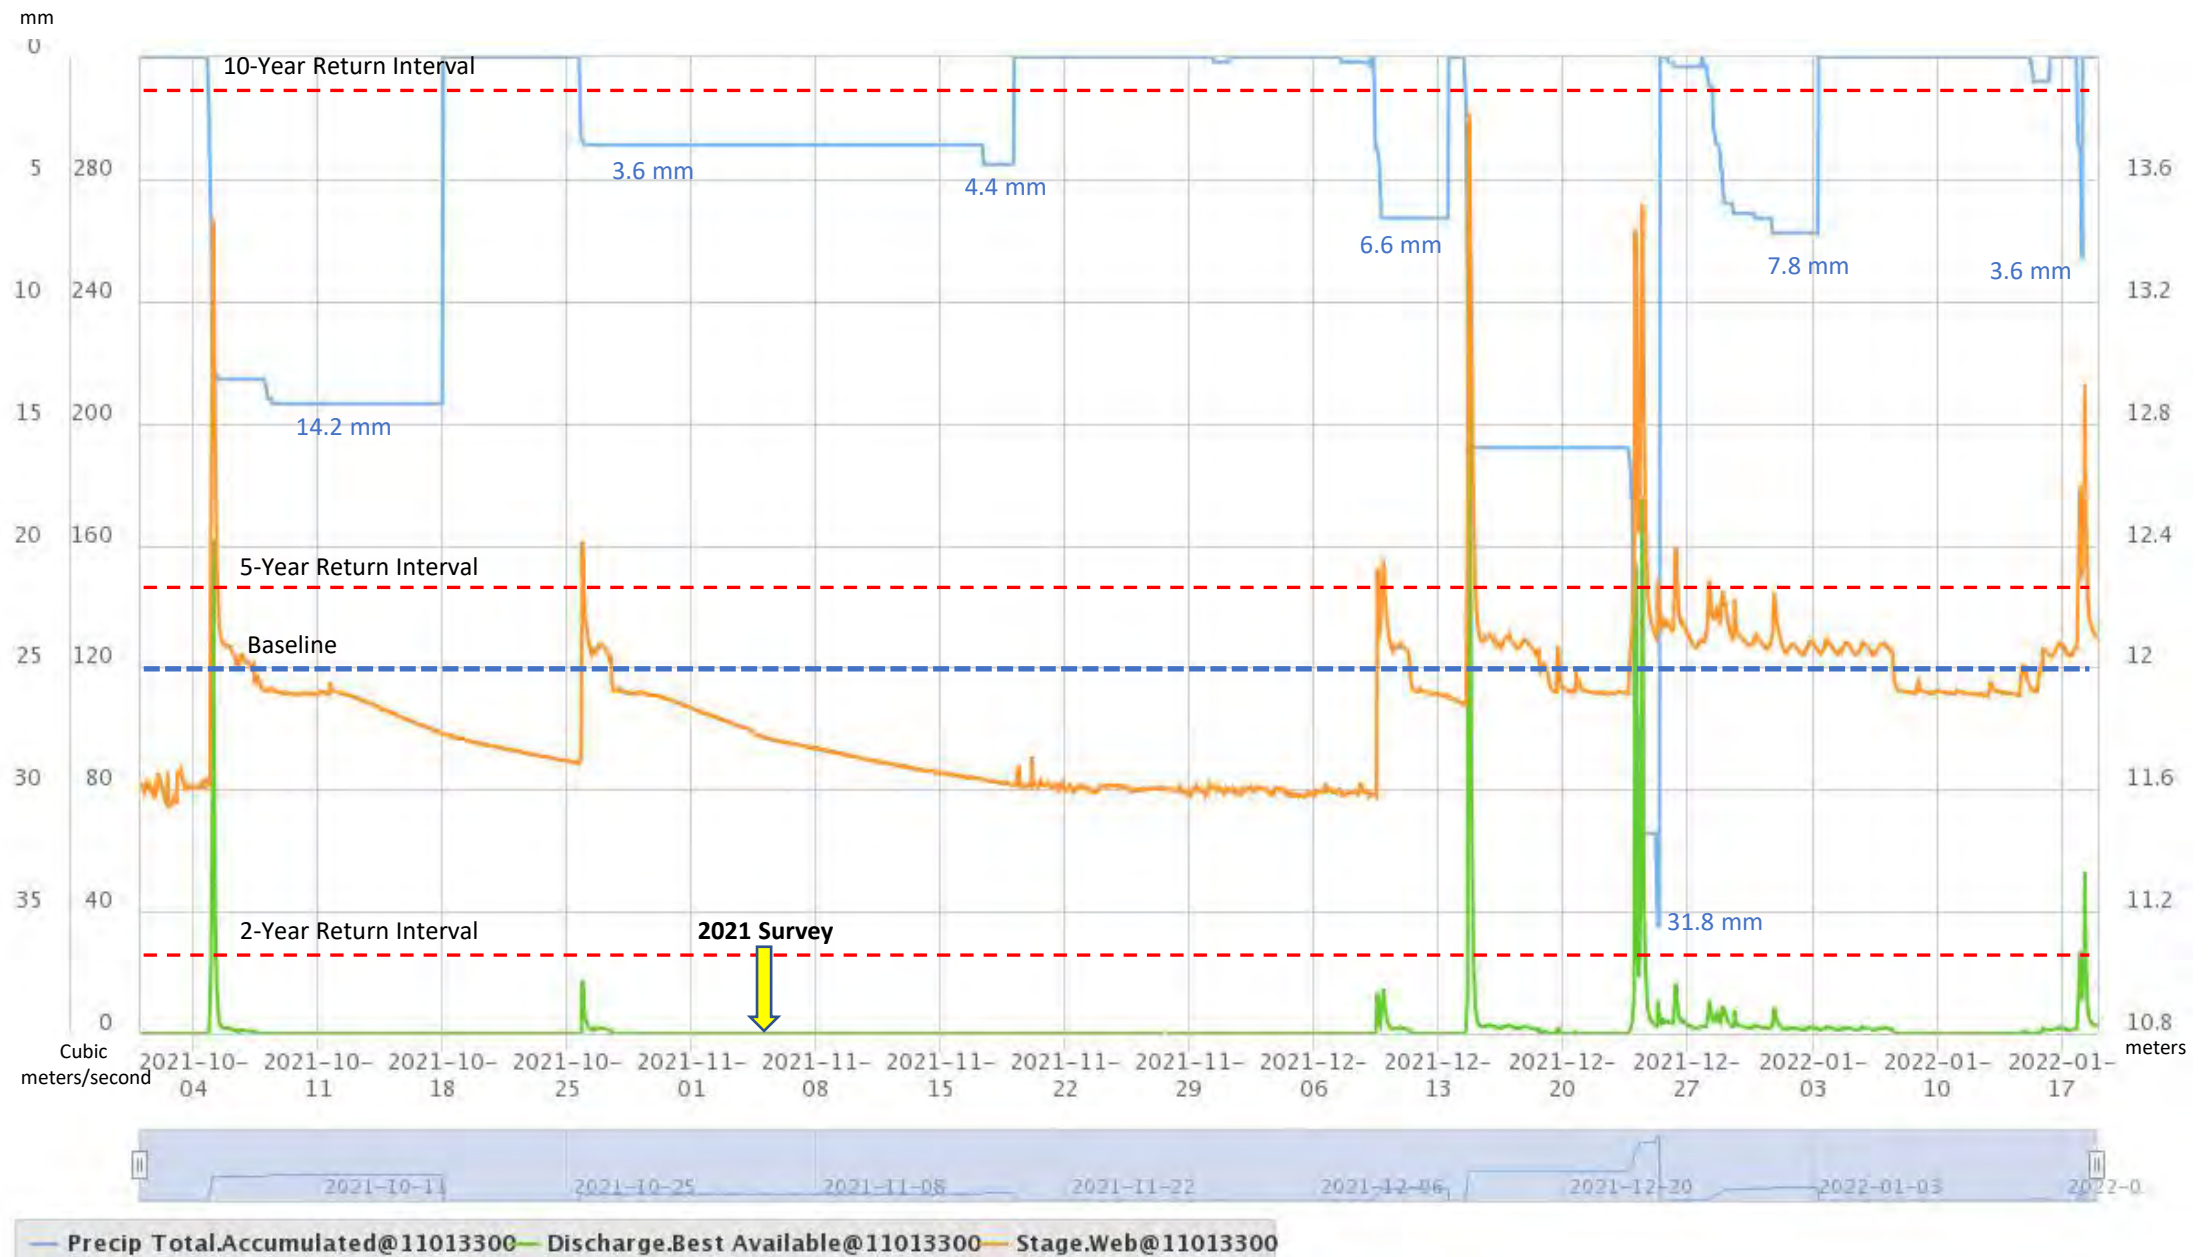
USIBWC gage reported flow discharge, stage height, and accumulated precipitation from October 2021 through January 18, 2022. Prior to the 2021 survey, a less than 2-year discharge event was reported one-week prior, which resulted in overbank flows. Additionally, a 5-year event was reported approximately 1-month prior. Horizontal Lines indicate flood intervals; baseline refers to stage height at approximate floodplain elevation.

PG's 2021 field investigations were conducted roughly one week following a rain event that resulted in 0.16 inches (4 mm) of rainfall (reported at San Ysidro) within a 24-hour period and corresponded with an USIBWC gage reported discharge of 580 cubic feet per second (cfs) which PG classified as a small (less than two-year) event. A larger rain event on October 4, 2021, resulted in a 5,721 cfs discharge, classified as a moderate (five-year) event. During the 2021 site visit, PG staff observed sporadic hydrologic indicators in the floodplain in addition to an incised and well-defined low-flow channel and a series of high-flow channels, which were generally indicative of a floodplain condition without a recent effective (floodplain defining) discharge (Lichvar and McColley 2008) (see Appendix B). Generally, the distribution of OHWM indicators did not entirely align with the 2018 USACE five-year inundation model. PG attributed this to several factors: the low magnitude of the recent discharge event resulted in development of primarily low-flow channel indicators and few floodplain indicators; rapid revegetation of the floodplain by weedy species which masked indicators from the most recent five-year event; and a trend of aggrading conditions from sediment deposits throughout the TRF (see Appendix B).

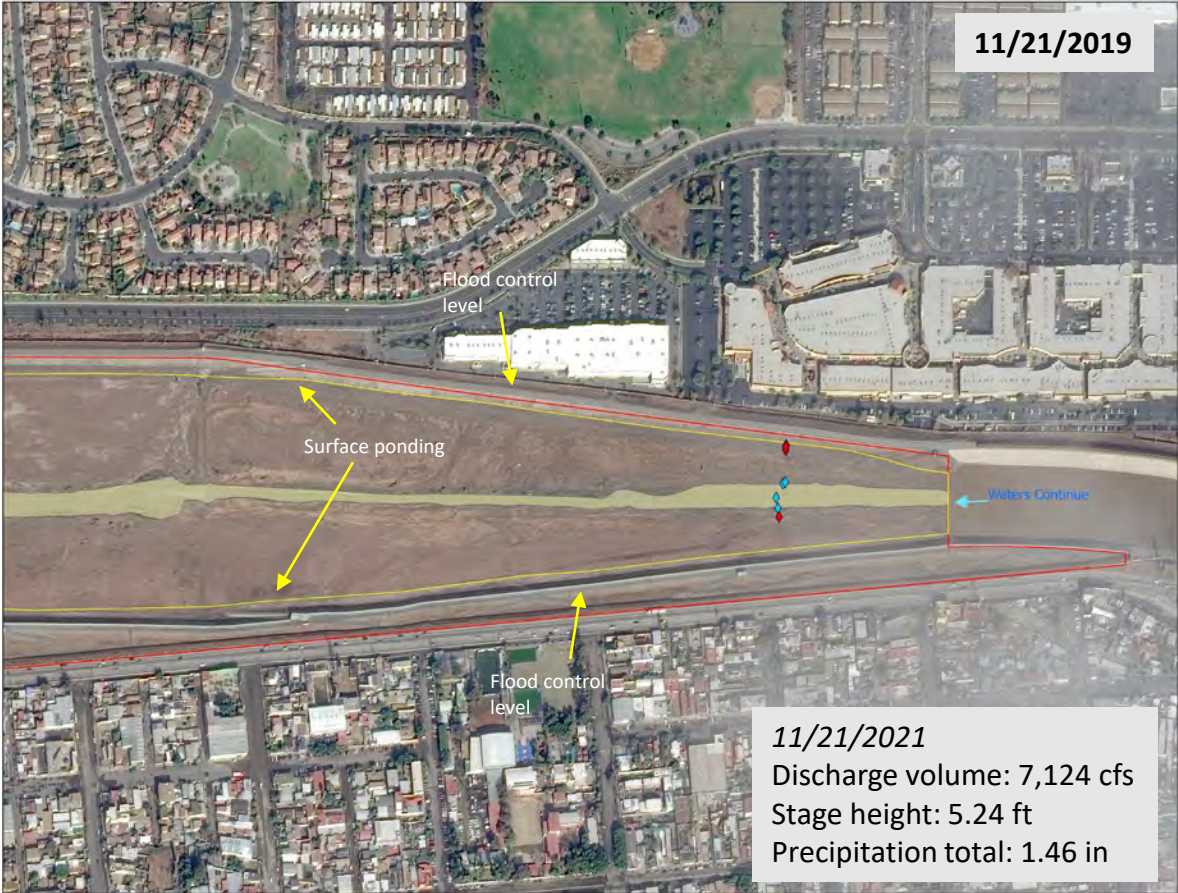
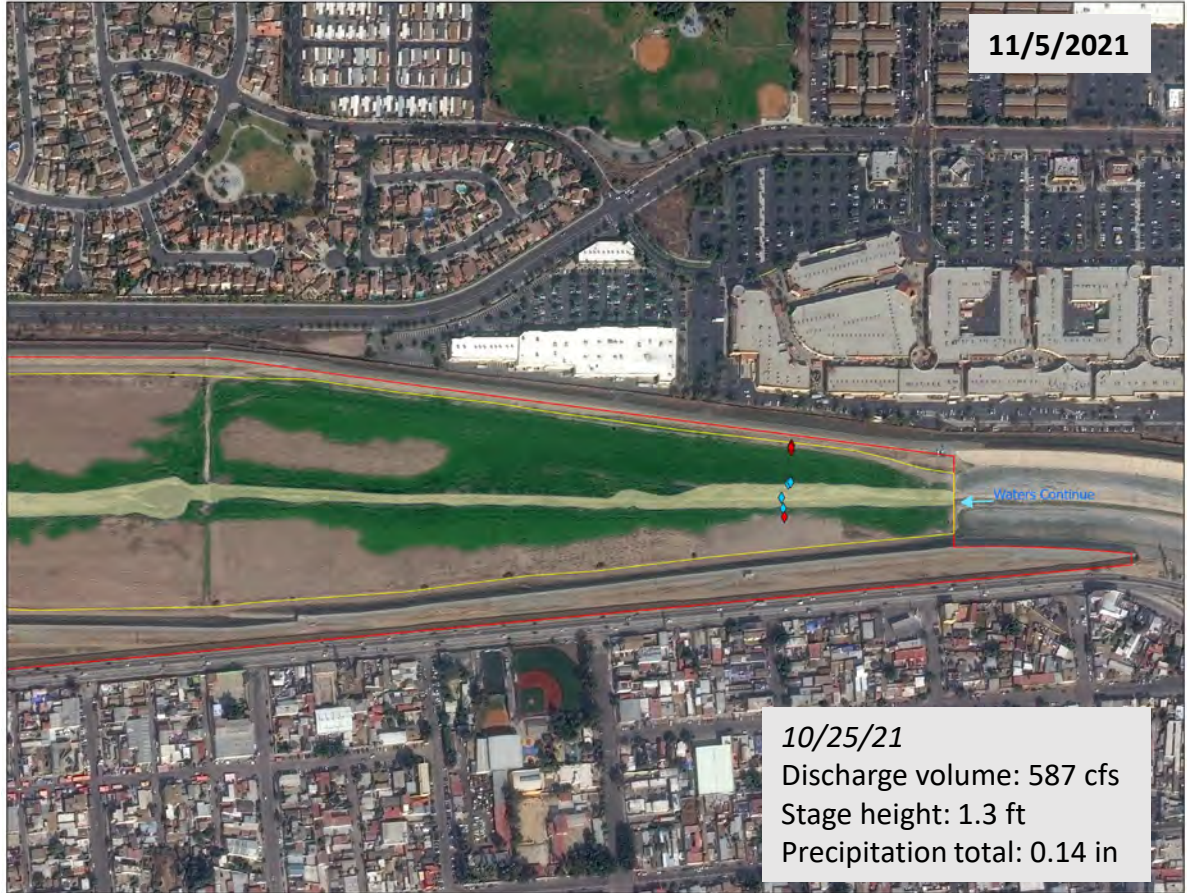
Correlation of floodplain inundation and discharge volume was completed through review of high-resolution Digital Globe imagery from 2018 through 2021. Aerial imagery was captured on 11/21/2021 following a 5- to 10-year flood event (7,124 cfs reported discharge by the USIBWC gage), as shown on the left. The image on the right was captured two days after the 2021 field survey and 10 days after a storm event that resulted in a reported discharge volume of 587 cfs.

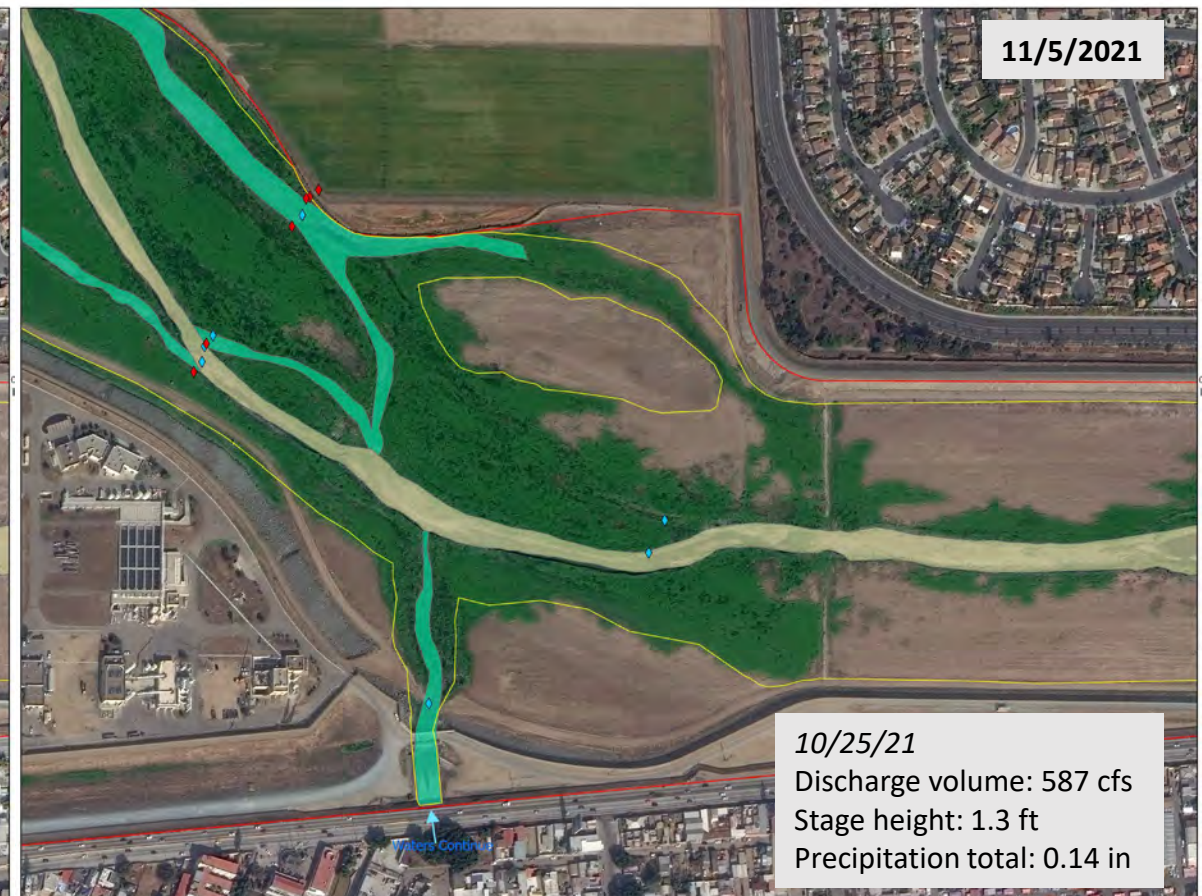
Correlation of floodplain inundation and discharge volume was completed through review of high-resolution Digital Globe imagery from 2018 through 2021. Aerial imagery was captured on 11/21/2021 following a 5- to 10-year flood event (7,124 cfs reported discharge by the USBWC gage), as shown on the left. The image on the right was captured two days after the 2021 field survey and 10 days after a storm event that resulted in a reported discharge volume of 587 cfs.
