# PHASE I ENVIRONMENTAL SITE ASSESSMENT

## **143.41 ACRE TRACT (UNDEVELOPED)**

STODDARD WELLS ROAD  
APPLE VALLEY, SAN BERNADINO COUNTY, CALIFORNIA 92307  
CCG PROJECT #: CCG-5024

ISSUE DATE: NOVEMBER 12, 2021

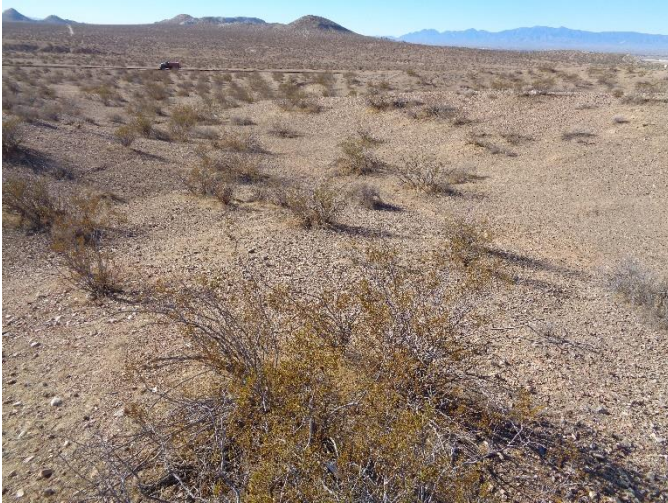
Representative view of subject property  
(undeveloped land)

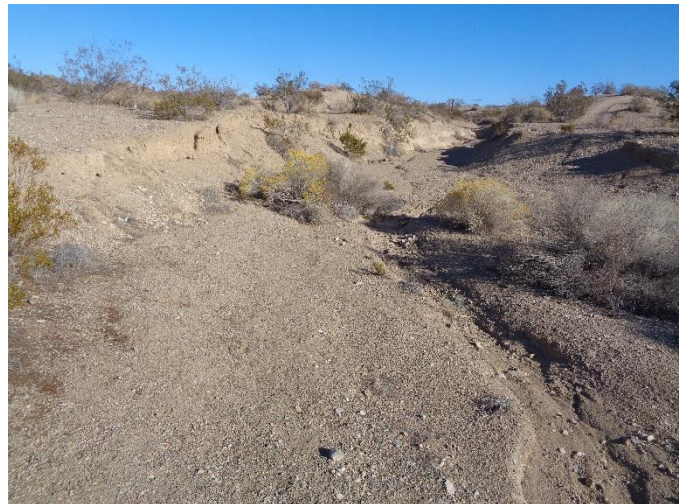
On-site Suspect Wetlands or Jurisdictional Waters Observed:	Yes – Several unnamed washes / drainage features run north to south through the central portion of the subject property. While they were dry at the time of CCG’s site inspection, these surface water features exhibit potential wetland hydrology indicators such as drainage patterns and drift deposits.
Adjacent Suspect Wetlands or Jurisdictional Waters Observed:	Yes – The above-mentioned washes / drainage features extend onto the adjoining properties.
Documented Wetlands Identified:	Yes – The above-mentioned washes / drainage features are identified as an R4SBJ (Riverine, Intermittent, Streambed, Intermittently Flooded) wetland areas.
Source:	Victorville, CA / Apple Valley North, CA Topographic Map, dated 1957, 1958, 1960, 1964, 1968, 1969, 1974, 1980, 1982, 1985, 1987, 1993, 2012, 2015 & 2018; U.S. Fish & Wildlife Service, Geospatial Wetlands Digital Data website

View of representative unnamed wash / drainage feature

***Recommendation:*** Considering the indications of wetland features and/or jurisdictional waters described above, CCG recommends that prior to initiating activities which may impact the potential wetland areas/jurisdictional waters identified on the subject property, that an evaluation of these areas and any subsequent associated regulatory requirements be conducted.

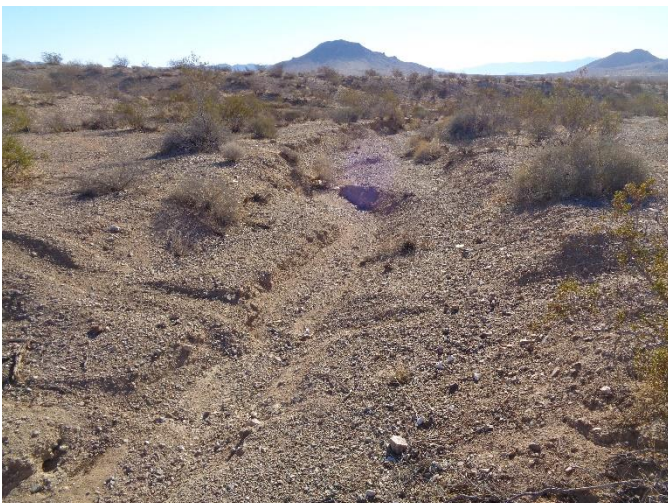
View of representative unnamed wash / drainage feature

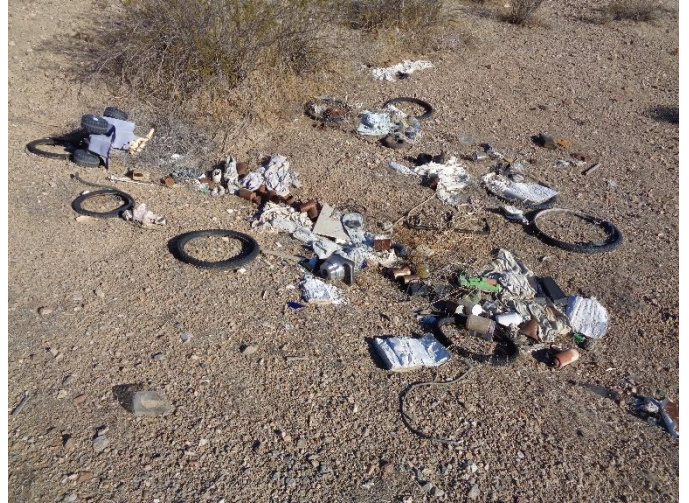
- CCG did not observe any evidence of current or historic landfills on the subject property. However, several debris piles / dump sites and scattered windblown debris were observed throughout the subject property, with the most concentrated area of debris / waste being observed on the southern and western portions of the subject property, proximate to Stoddard Wells Road and Interstate Highway 15 respectively. Observed debris generally consisted of municipal waste (paper, plastic, etc.) and construction debris (lumber, concrete, asphalt / gravel, etc.); however, multiple scrap tires were also observed. No staining or other obvious evidence of petroleum product / hazardous substance releases was observed in or around the debris. CCG considers the observed debris (including scrap tires) to represent a de minimis condition in connection with the subject property.

View of representative dumping / debris

**Recommendation:** CCG recommends that the observed debris / wastes be removed from the subject property, and properly disposed of in accordance with all applicable local, state and federal guidelines. If during future development activities visually impacted soils are identified, impacted soils should be

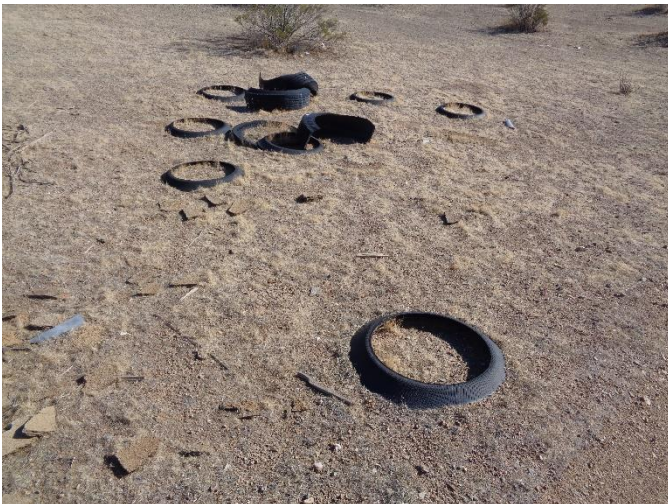
View of representative dumping / debris

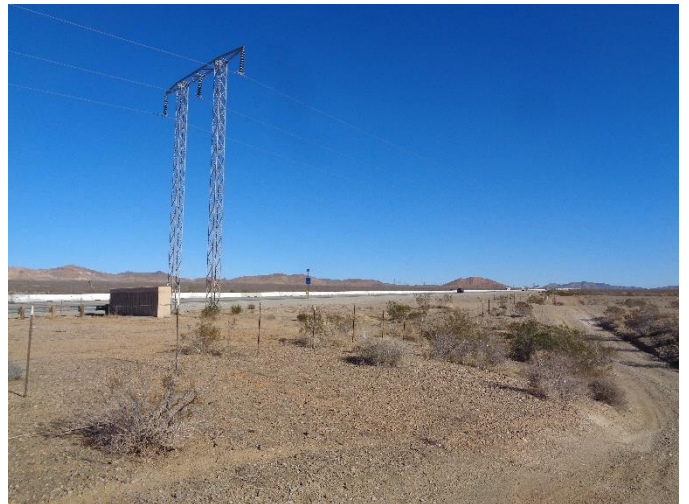
View of high tension power lines crossing the northwest corner of the subject property
