Appendix B: Biological Resources Supporting Information

BIOLOGICAL RESOURCES ANALYSIS REPORT
FOR THE
SKELLY PROPERTY
CITY OF HERCULES, CONTRA COSTA COUNTY, CALIFORNIA

ARBORIST REPORT

215 Skelly - Hercules CA

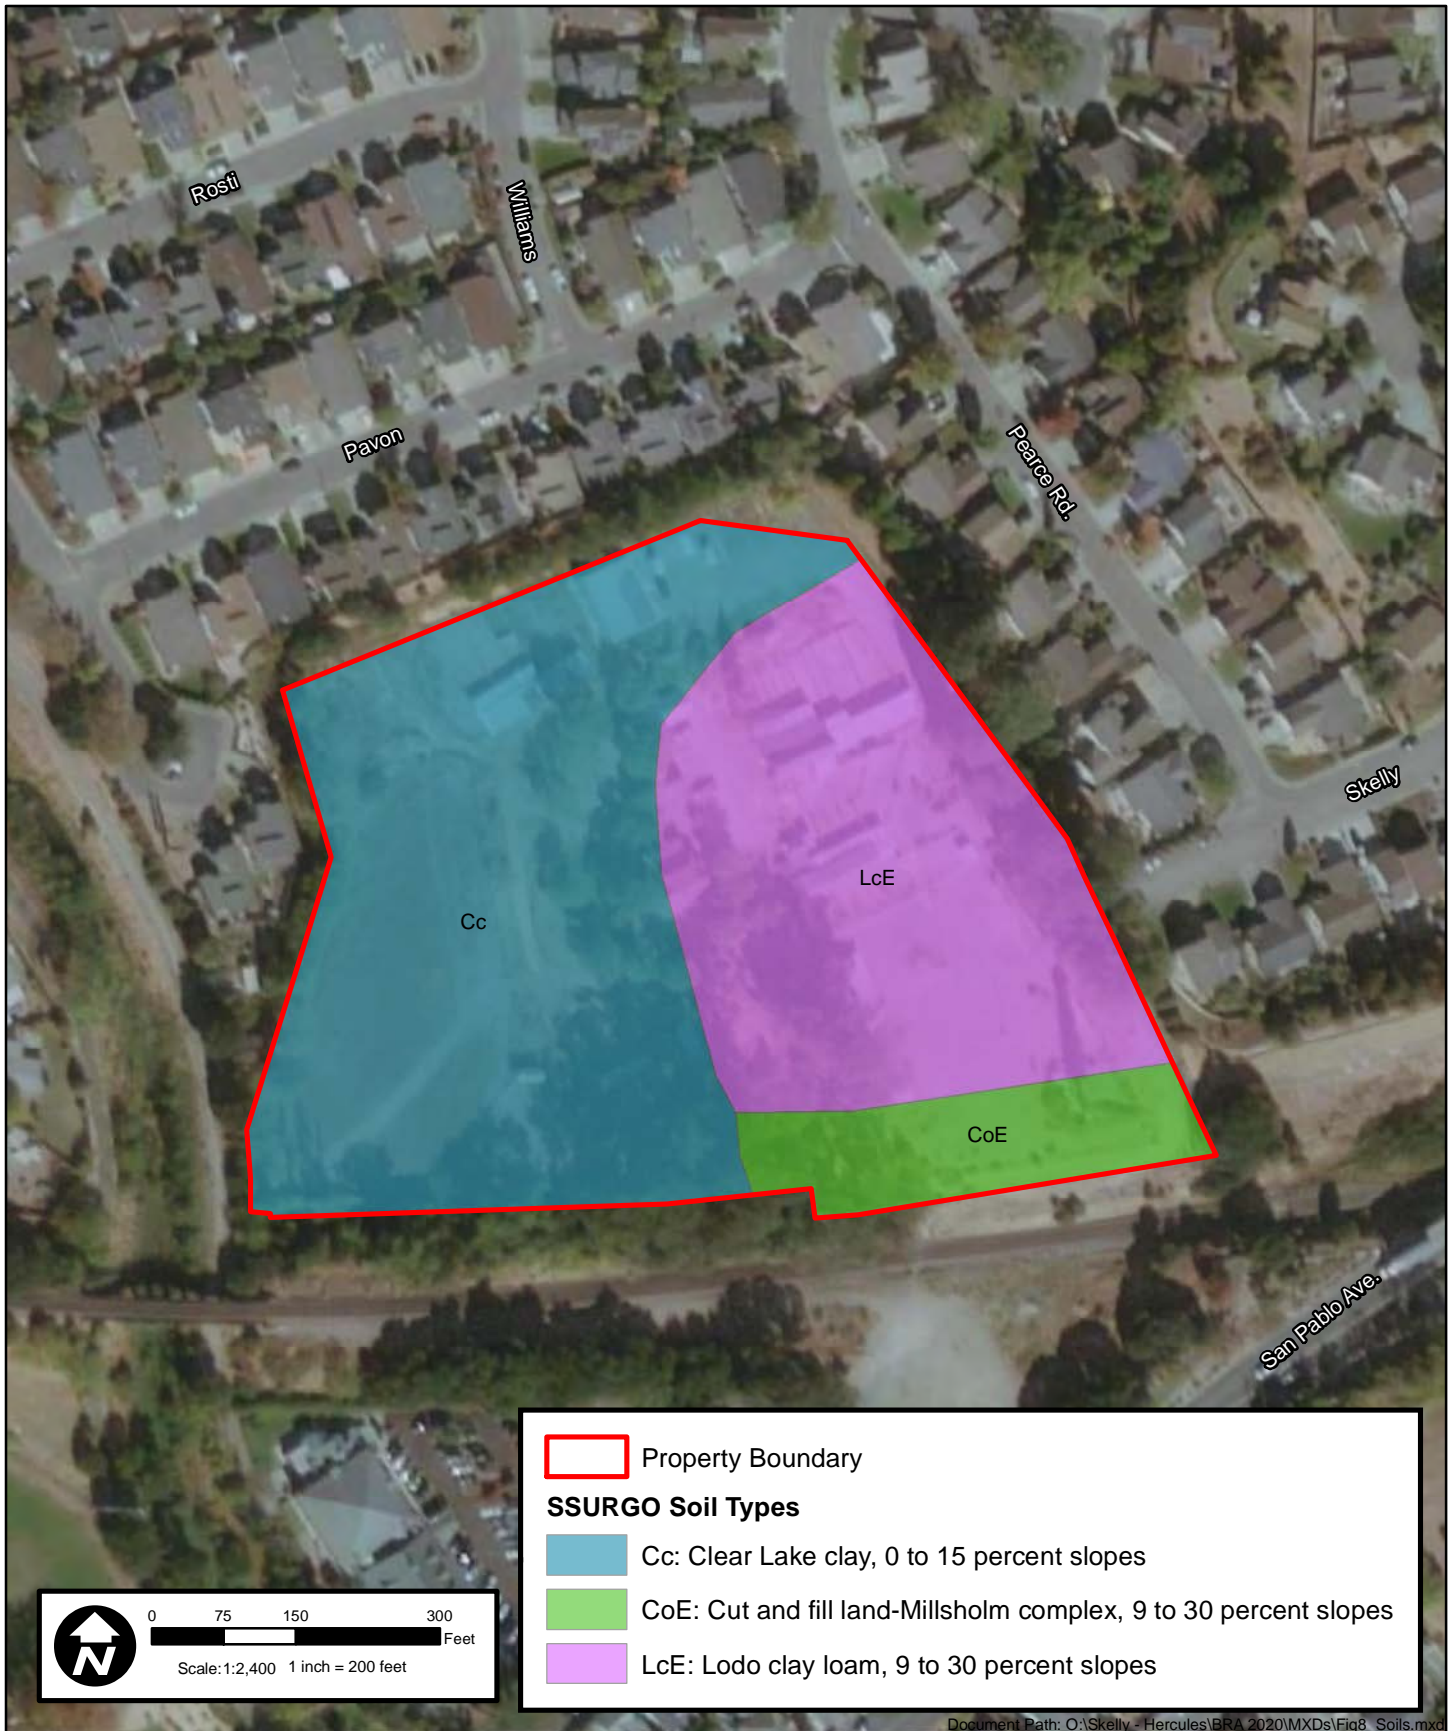
Figure 8
Soils Map

The NRCS (2020) reports three soil types within the Property. A map of the soil types can be found in Attachment 1, Figure 8. The soil type mapped included the following:

Figure 8: Soils Map
Skelly Property
City of Hercules, Contra Costa County, California

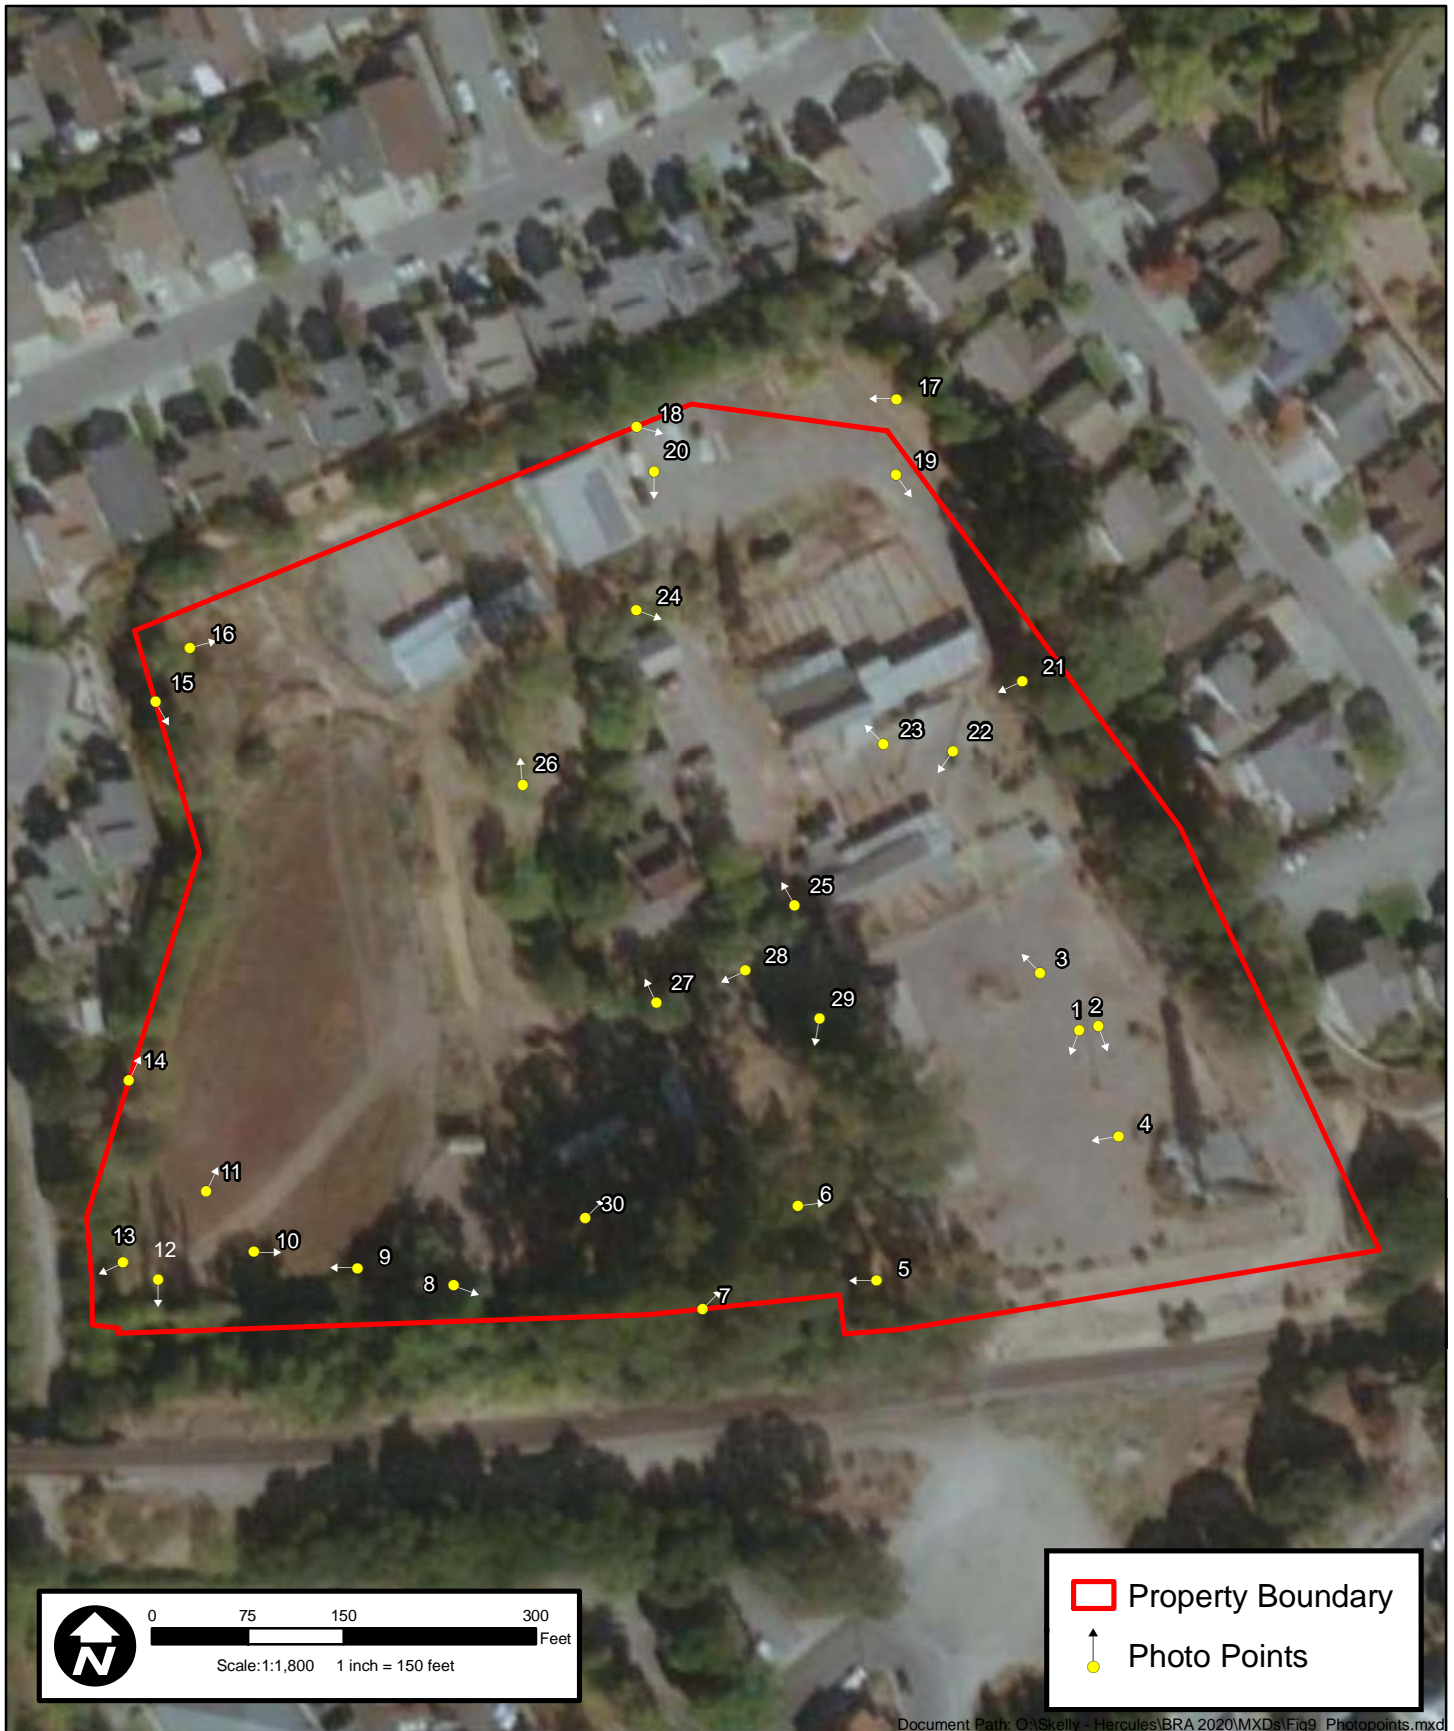
Figure 9
Photo Location Map

Figure 9: Photo Points Map
Skelly Property
City of Hercules, Contra Costa County, California

Olberding Environmental biologists conducted a reconnaissance-level survey of the Property on November 11, 2020. The survey consisted of walking throughout the Property and evaluating the site and adjacent lands for potential biological resources. Existing conditions observed plants and wildlife, adjacent land use, soils and potential biological resource constraints were recorded during the visit. Plant and wildlife species observed within and adjacent to the Property during the reconnaissance survey are listed in Attachment 2, Table 1. Site photographs are provided in Attachment 3 of this document. Attachment 1, Figure 9 shows where each site photo was taken.

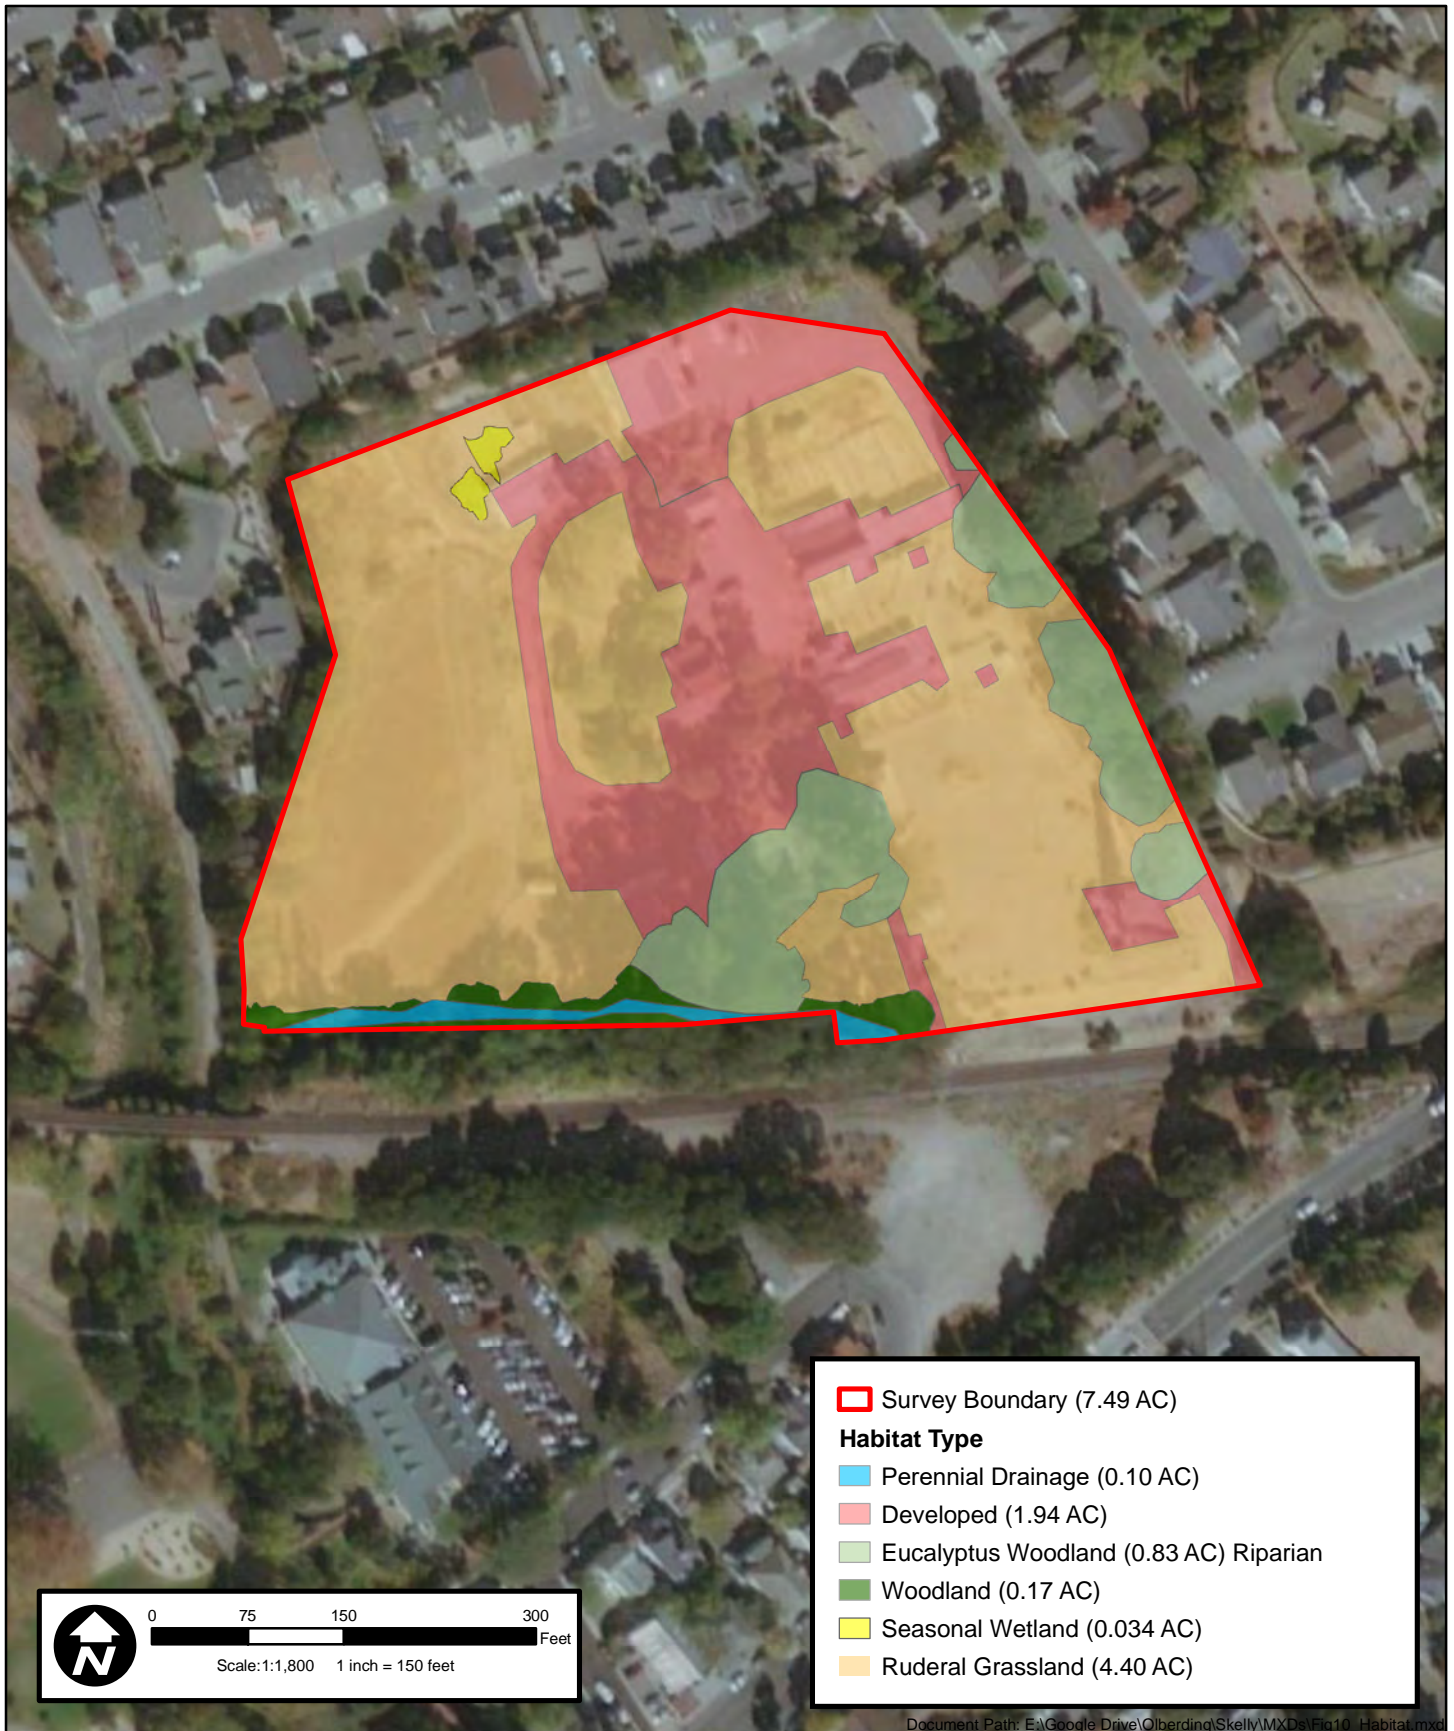
Figure 10
Habitat Map

Figure 10: Habitat Map
Skelly Property
City of Hercules, Contra Costa County, California

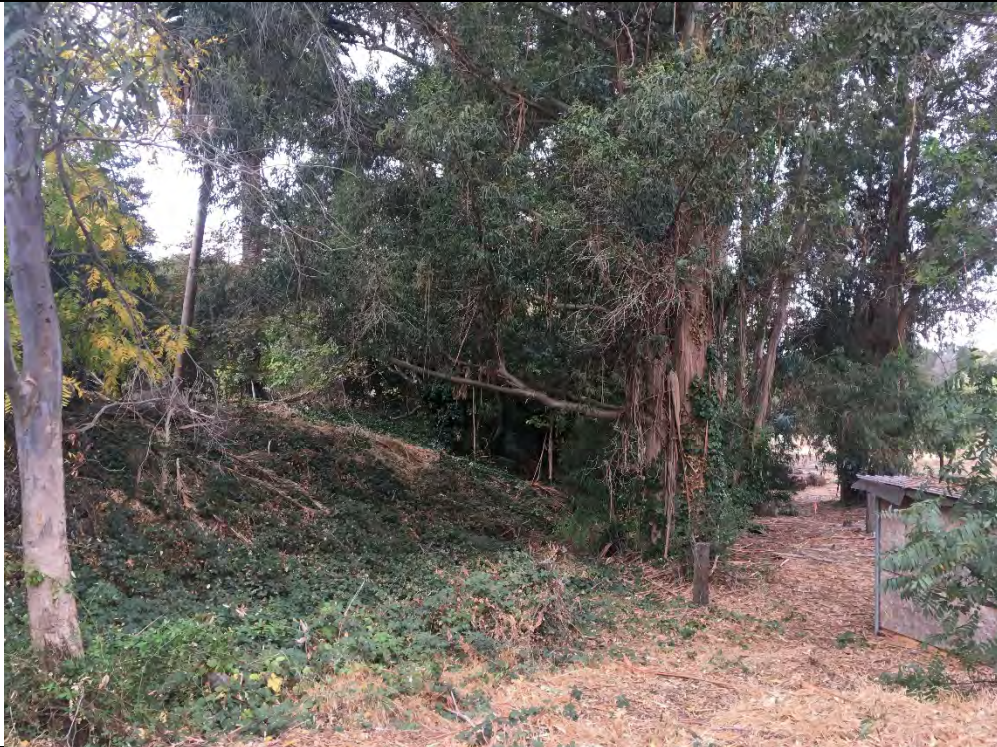
5. Facing west, the photo shows the eastern portion of the perennial drainage feature. Several large blue gum eucalyptus trees form a lush canopy along the southern section of the Property with an understory of dense Himalayan blackberry.

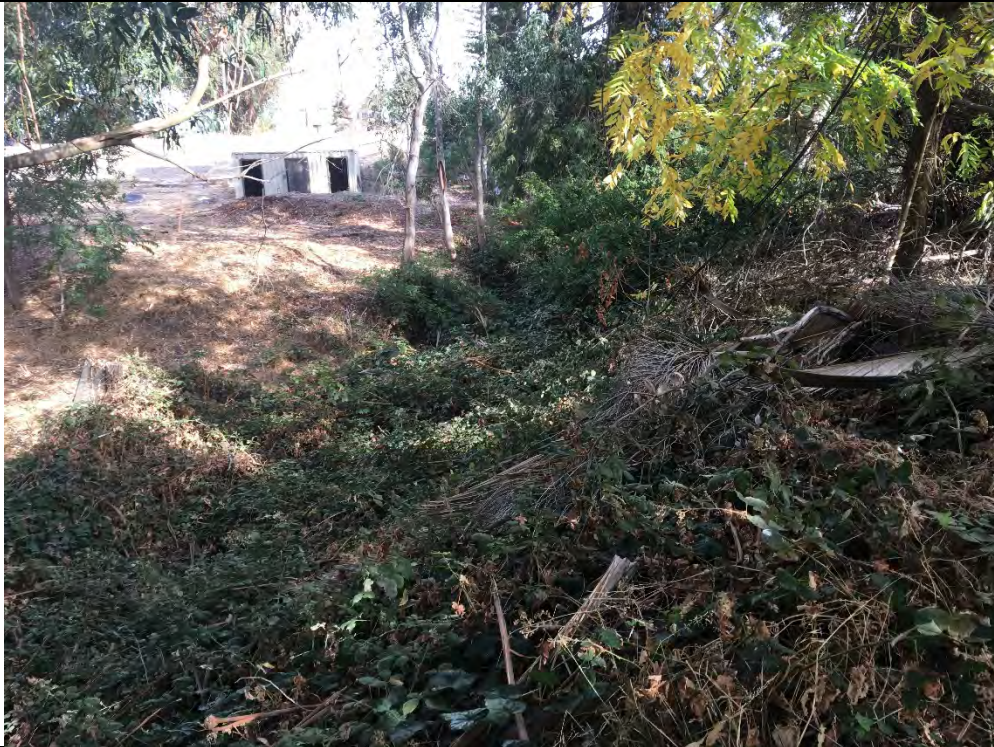
7. The perennial drainage flows along the southern boundary of the Property, and is surrounded by a dense cover of Himalayan blackberry. Photo facing northeast.

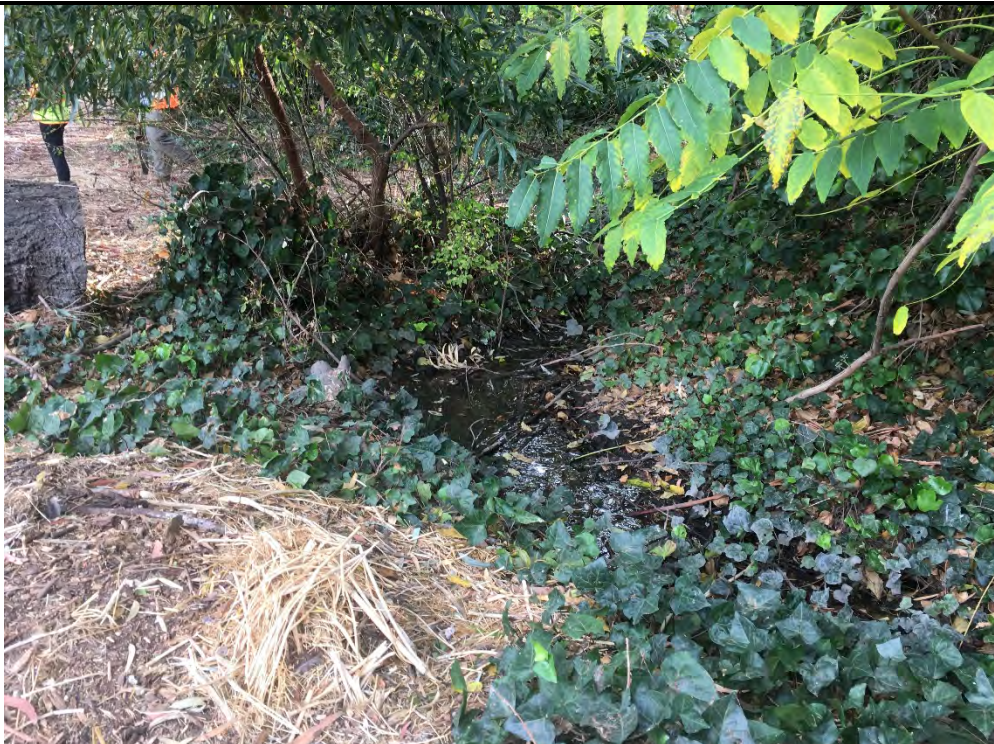
8. Facing southeast, the photo shows the perennial drainage on the Property, surrounded by an understory of English ivy. Water was present in this feature during the time of the survey.

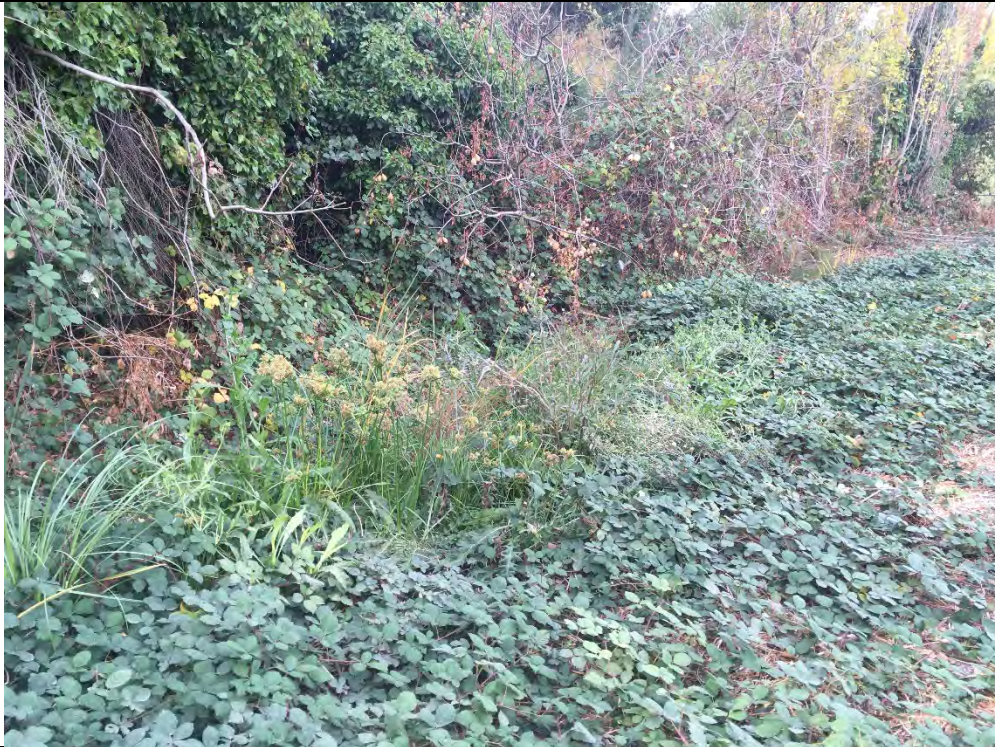
9. Facing west, the photo shows the western portion of the perennial drainage. Vegetation such as narrow-leaved cattail, and umbrella sedge can be seen growing within the drainage.

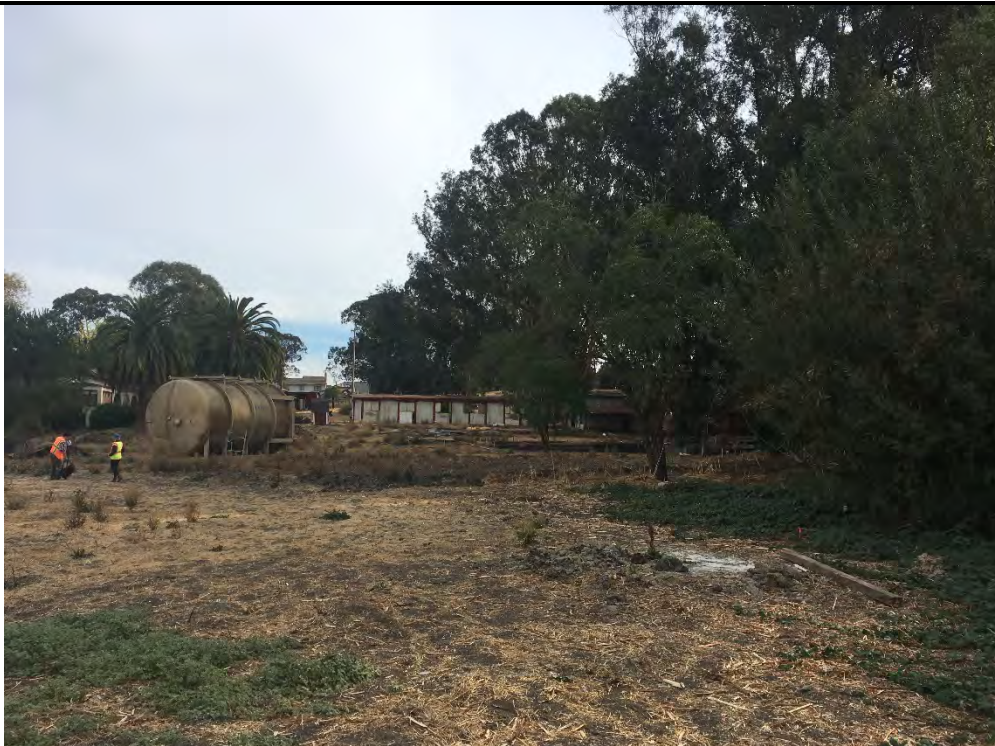
10. Facing east, the photo depicts part of the ruderal grassland habitat, and the water storage tank present on the Property. The large trees present within the riparian woodland habitat on the right-hand side of the photo are ideal for nesting birds and raptors.

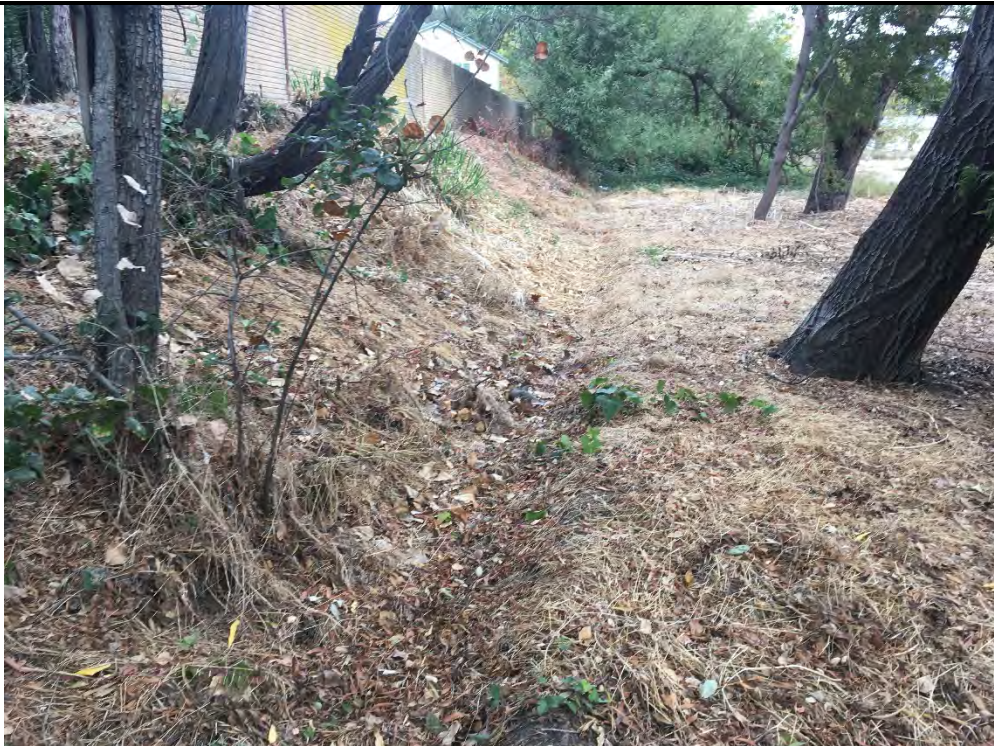
14. Facing northeast, the photo shows a portion of the concrete v-ditch located just outside the western boundary of the Property. This feature did not contain water during the time of the survey, and was just outside the Property boundary.

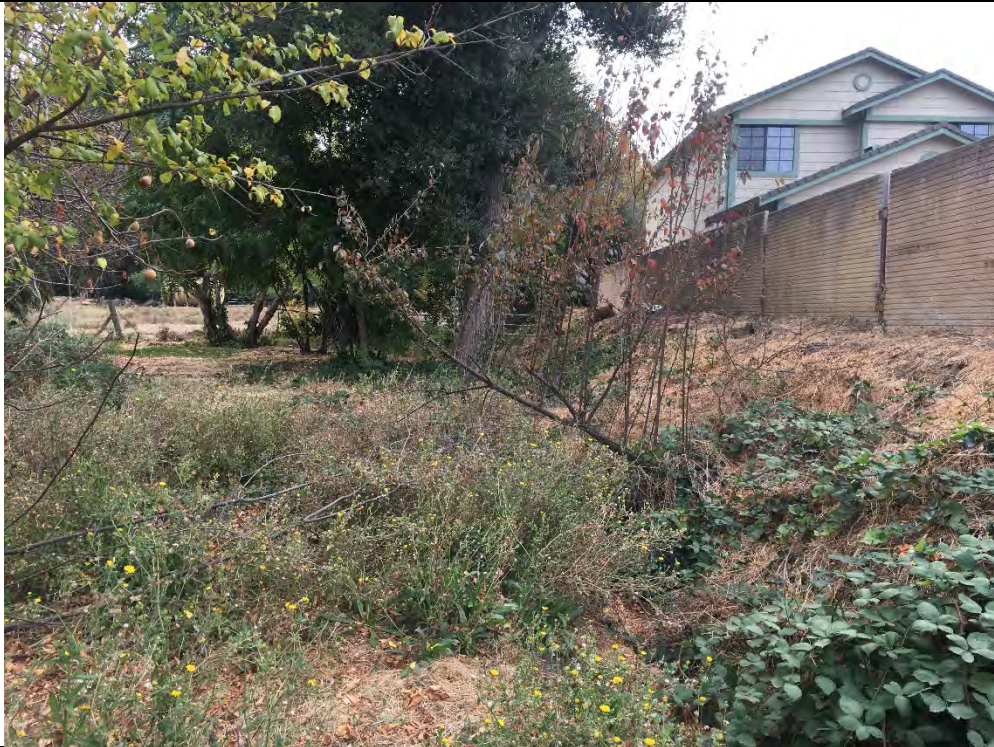
15. Facing southeast, the photo shows a portion of the western boundary of the Property. The concrete v-ditch lies just outside of the Property boundary and is pictured here covered in ruderal vegetation and Himalayan blackberry.

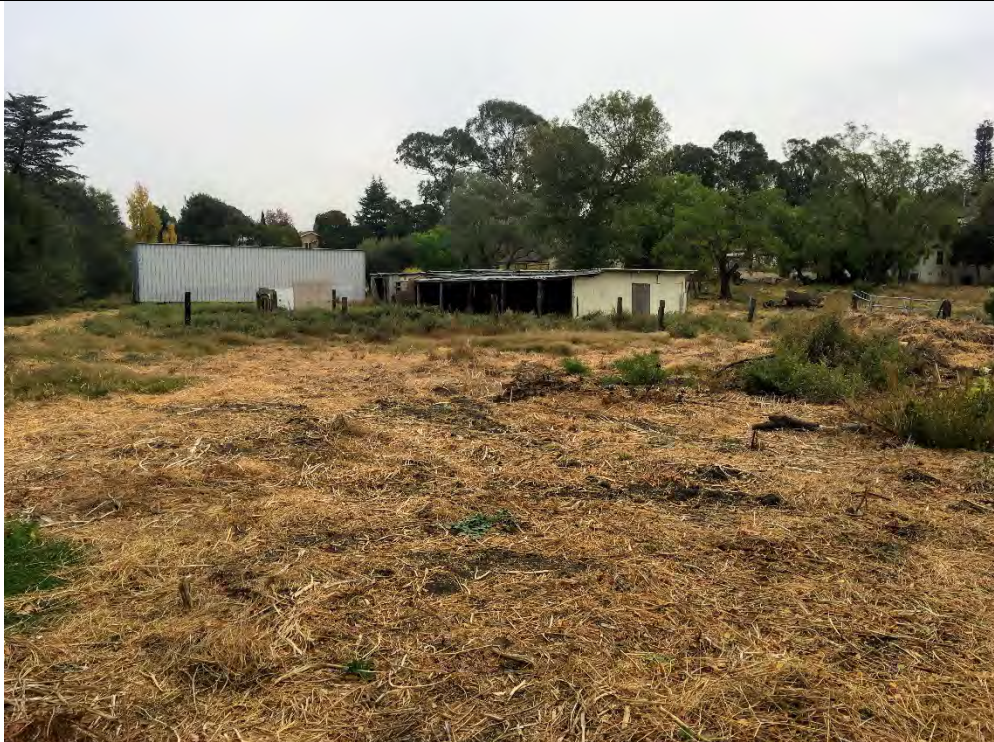
16. Facing east, the photo shows an overview of the potential seasonal wetland habitat adjacent to the vacant horse stall and paddock.
