TECHNICAL MEMORANDUM

Subject: Updated Main Ditch Water Loss Analysis with 2020 Data

The purpose of this memorandum is to provide the results of an analysis performed by Tully & Young to understand and quantify the water losses associated with water conveyance in the El Dorado Irrigation District's (EID) Upper Main Ditch (Main Ditch). The document refines the analysis from a prior memorandum used to support EID's CEQA document that assessed potential environmental impacts of the proposed project to pipe the water supply that is currently conveyed through the Main Ditch (hereafter the "Project"). Additionally, the document is intended to support EID's efforts to market for transfer the water that would be conserved through implementation of the Project until it is needed to support future growth within EID's service area. This memorandum incorporates the most recent operational data from 2020.

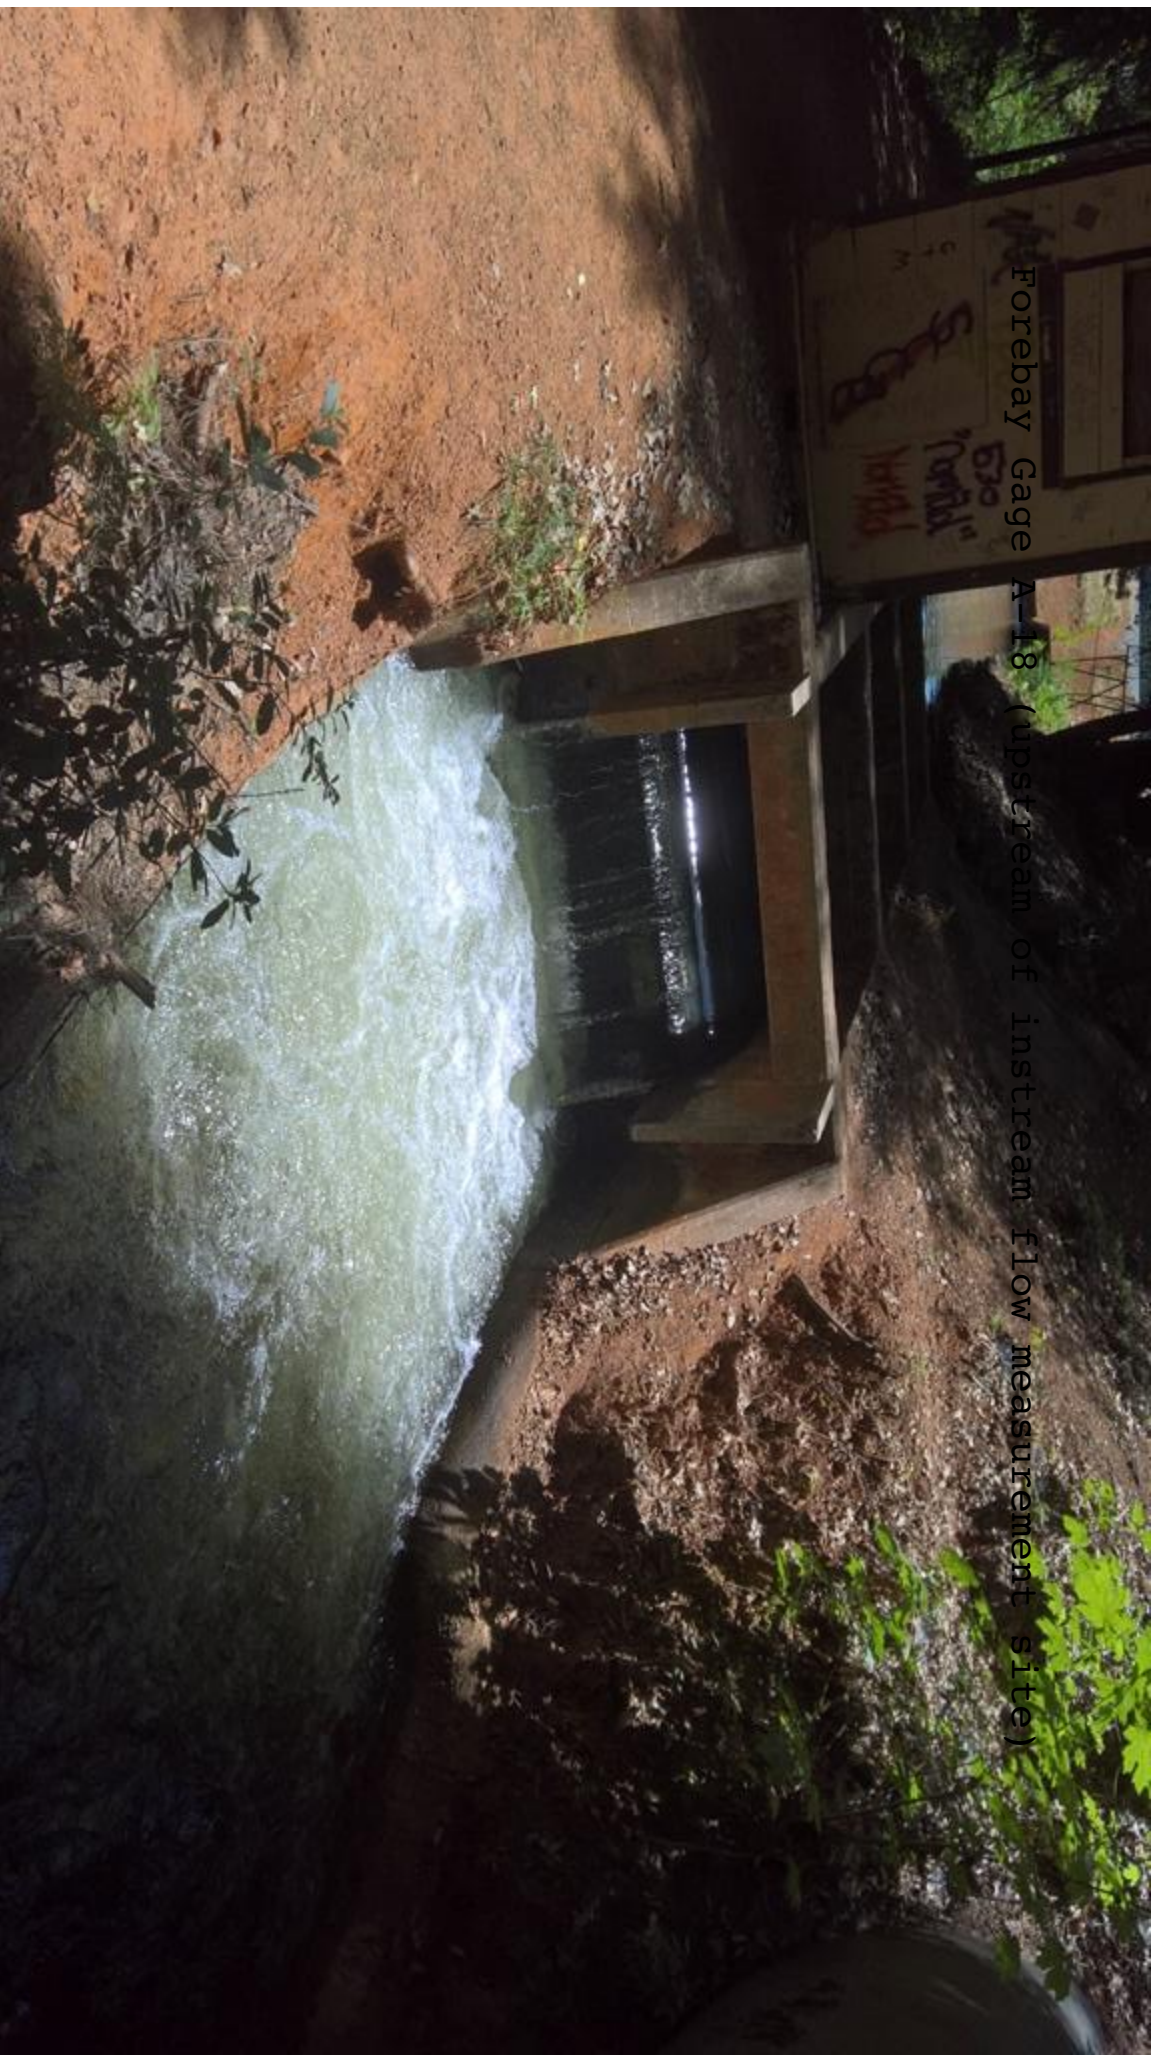
Forebay Gage A-18 (upstream of instream flow measurement site)

Gene Gutenberger was requested by Reservoir 1 Plant personnel to perform flow monitoring along the Main Ditch because of the low flow reaching the plant compared to releases from Forebay. The flow monitoring was completed on January 27, 2012. The flow rate just downstream of Gage A18 was 8.51 cfs and matched the A18 flow meter. The flow rate at Patrick Land downstream of Grizzly was 6.04 cfs, indicating a 29% loss. Gene indicated that he observed multiple crawdad burrows. Later a crew found larger holes that were repaired by filling them with bentonite.
