# **BIOLOGICAL ASSESSMENT**

**23180 SHADY GROVE ROAD [APN 014-006-16]  
LAKE COUNTY, CALIFORNIA**

PROJECT № LAK008

FEBRUARY 3, 2020

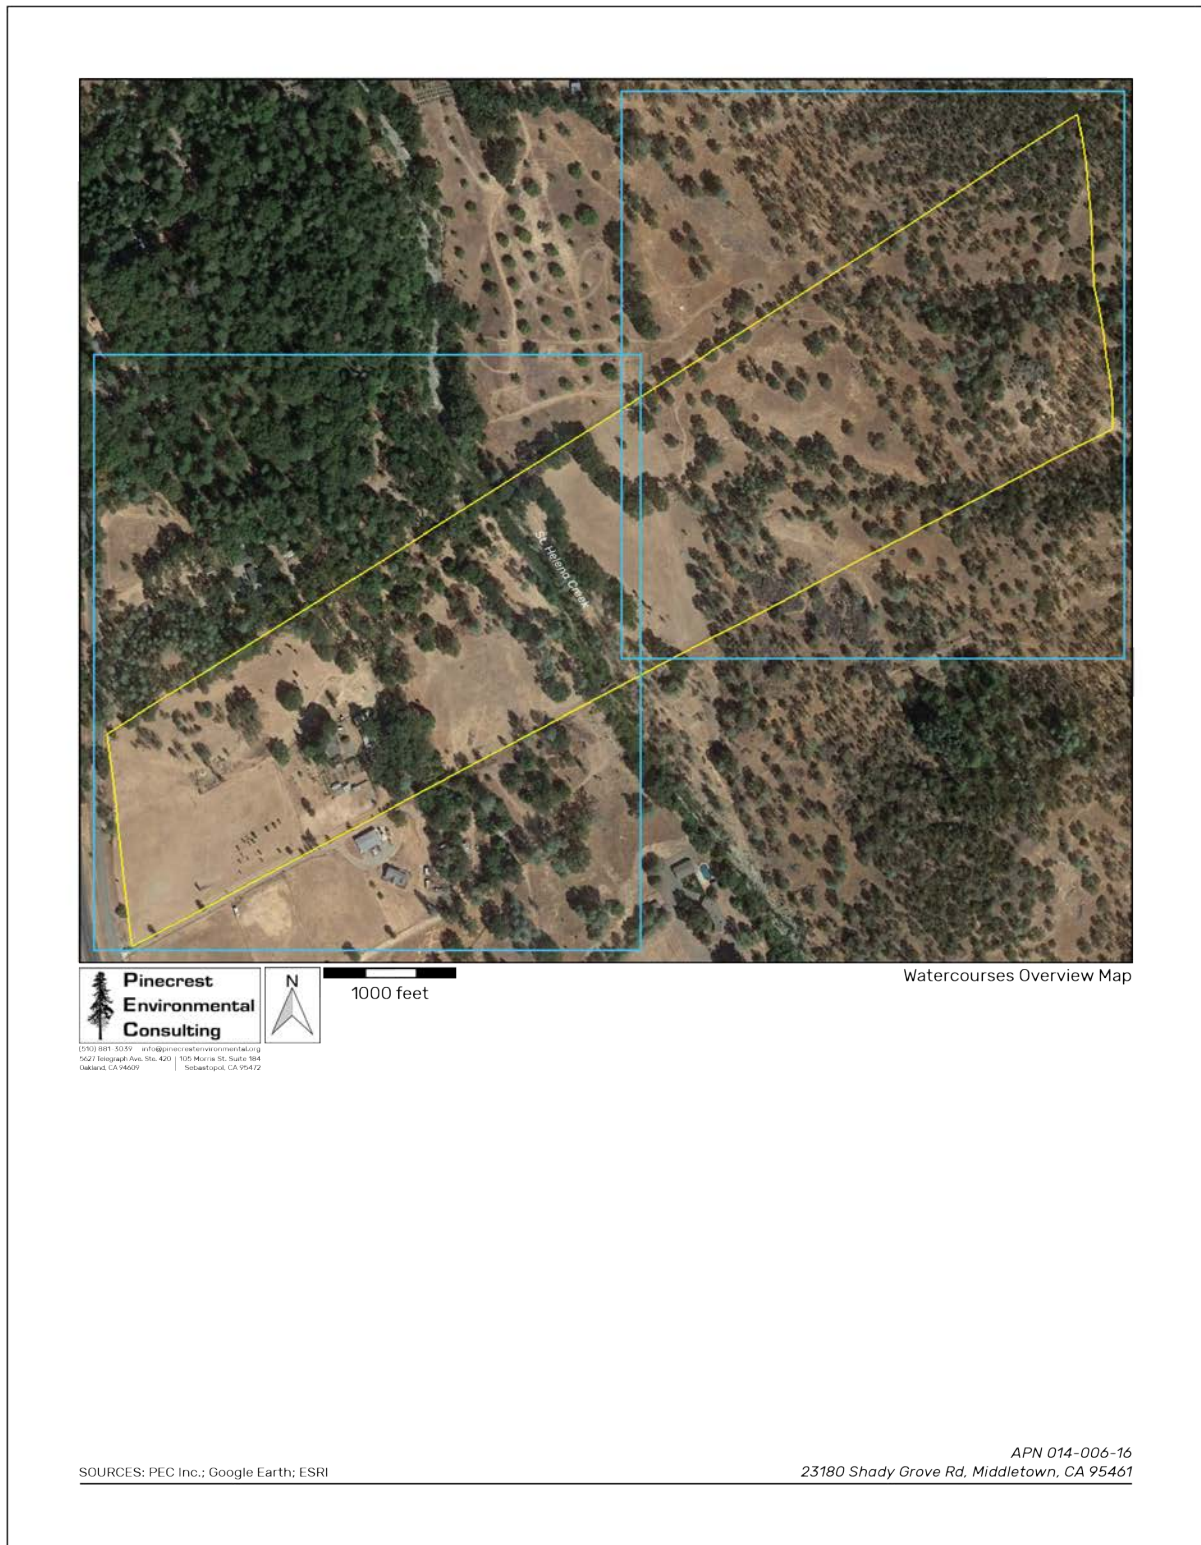
**FIGURE 3: WATER FEATURES OVERVIEW**

There are several unnamed and one named watercourse on site, as well as several potential wetlands (Figures 3-5). A Class I perennial reach of St. Helena Creek divides the parcel in two, flowing north through the middle of the property (Figure 12). St. Helena Creek is crossed by a metal span bridge (Figure 11) that appears to be stable and with footings that are not obviously eroding. The riparian corridor surrounding St. Helena Creek is well developed and stable. There is also an unnamed seasonal Class II watercourse flowing north through the western portion of the parcel (Figure 13) that is crossed via triple-barrel corrugated metal culvert crossing (Figure 10) that is not obviously in danger of failing but likely does not meet current design specifications for withstanding 100-year floods. This Class II watercourse exits the parcel to the north and joins with St. Helena Creek after flowing offsite for approximately 500 feet. There are also several Class III watercourses onsite. In the western portion of the site, two small stock ponds (Figures 15 & 17) are connected with a vegetated swale (Figure 16) that eventually empty into an unnamed ephemeral Class III watercourse (Figure 14) that flows east for approximately 150 feet before the confluence with the aforementioned unnamed Class II watercourse. There is some wetland vegetation surrounding the ponds and swale but not around the Class III watercourse.

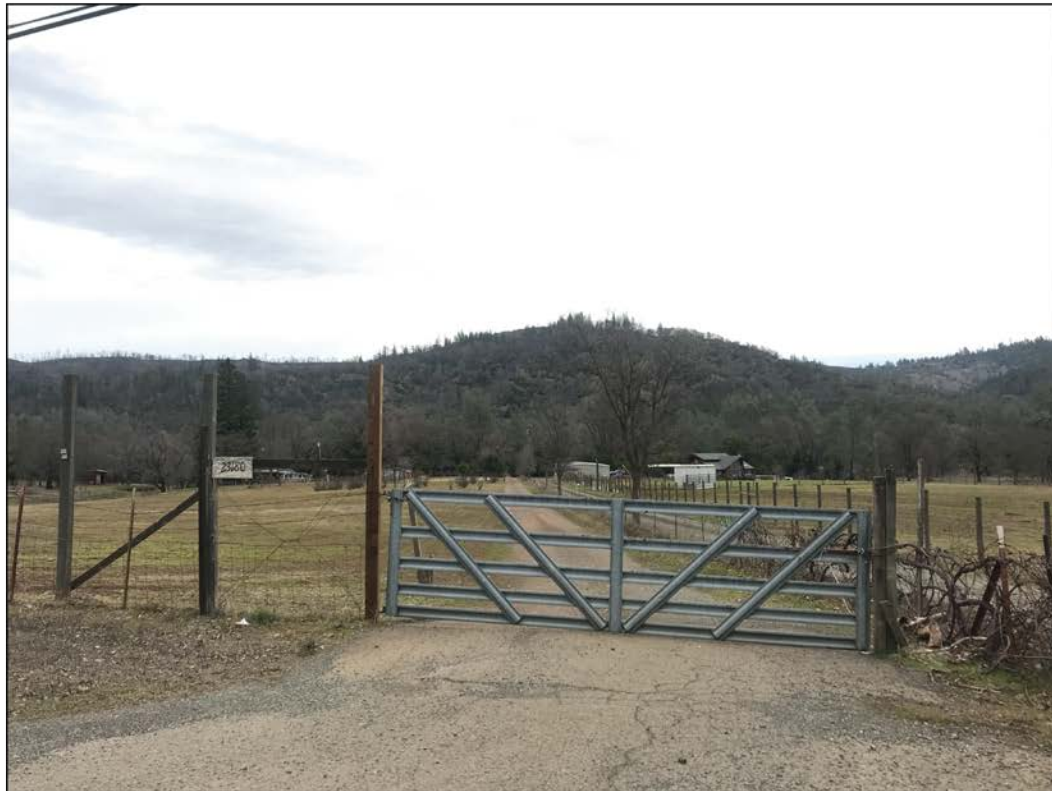
**FIGURE 6: PHOTOGRAPH OF ACCESS GATE**

Access to the parcel is provided off of Shady Grove Road to the south and is controlled via locking manual entry metal gate (Figure 6). The activity area is located at the end of a graded and graveled unpaved driveway (Figure 7) that is in good condition that travels east from the main gate. This driveway also continues past the main residence and follows the southern property line providing access to the remainder of the parcel (Figures 3-5). There are several existing structures onsite associated with the residence and rural agricultural and animal husbandry activities. There is one residence with garage and multiple outbuildings for chickens, tractors, and other farm related activities (Figure 8). After crossing the triple culvert (Figure 10) you reach a groundwater well and several HDPE water storage tanks (Figure 9) adjacent to a large grassland area that would be suitable for cultivation (Figure 18). Further along the road is a metal span bridge (Figure 11) and another potential cultivation area (Figure 19). Most of the parcel is surrounded by barbed wire fence, and there is a utility pole that transmits electricity via aerial lines off of Shady Grove Road. Other than that there are no other built structures onsite.

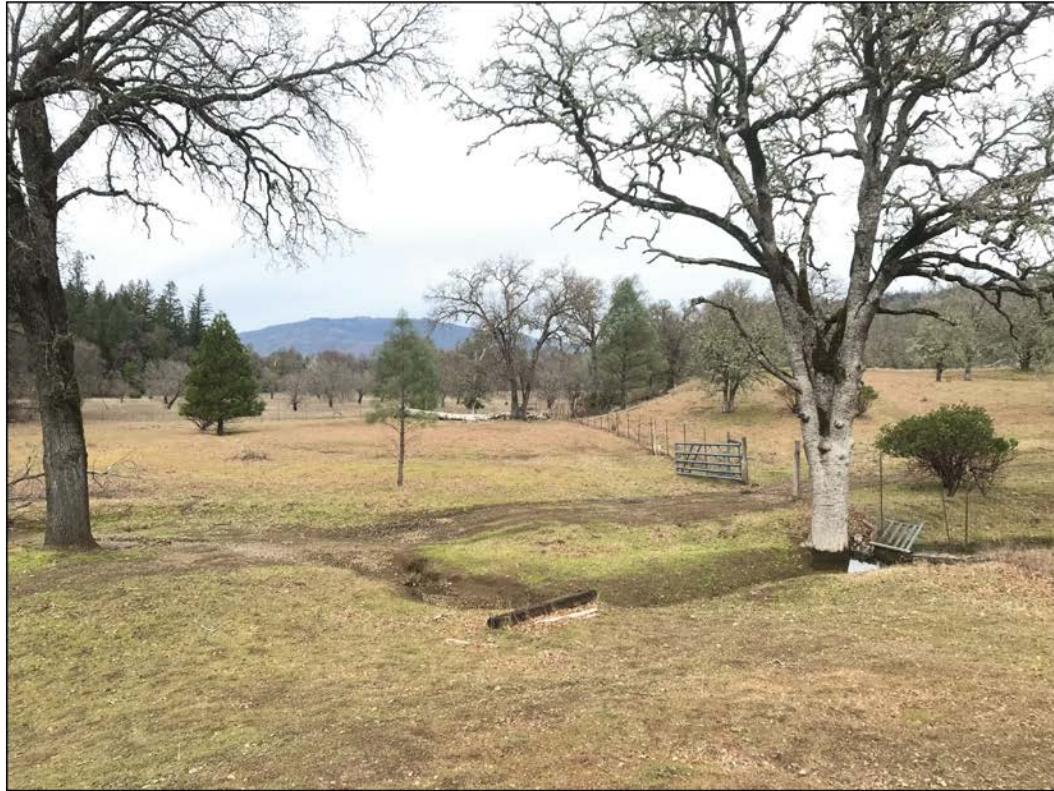
**FIGURE 14: PHOTOGRAPH OF CLASS III WATERCOURSE**

There is also a series of unnamed ephemeral Class III watercourses in the eastern portion of the site that drain the oak and chaparral hillslopes. These are conveyed over the roadway via gravel ford or rolling dip, located just before a locking metal gate (Figure 3). This Class III watercourse meets up with another Class III watercourse and then flows along the northern property line for approximately 300 feet before the confluence with St. Helena Creek. From the confluence, St. Helena Creek flows north for 3.3 miles before the confluence with Putah Creek, which flows southeast for 24.5 miles before entering Lake Berryessa. From the outlet of Lake Berryessa at Monticello Dam, Putah Creek continues east for 27 miles flowing into the Central Valley and past the City of Davis before emptying into a series of low-lying basins known as the Putah Creek Sinks. From there water flows into the Yolo Bypass and south into the Sacramento River which flows south for approximately 40 miles before emptying into Suisun Bay and the Pacific Ocean.
