River Memo

To: Ben Besley – Midwood Investment & Development
From: Jennifer Johnson, Senior Biologist
Date: April 1, 2021
Subject: Sportsmen’s Lodge Mixed-Use Project Los Angeles River Impact Analysis
Memorandum

Tree Report and Addendum

**Protected Tree Report
for
Sportsmen's Lodge Events Center
12825 Ventura Blvd
Los Angeles, CA 91604**

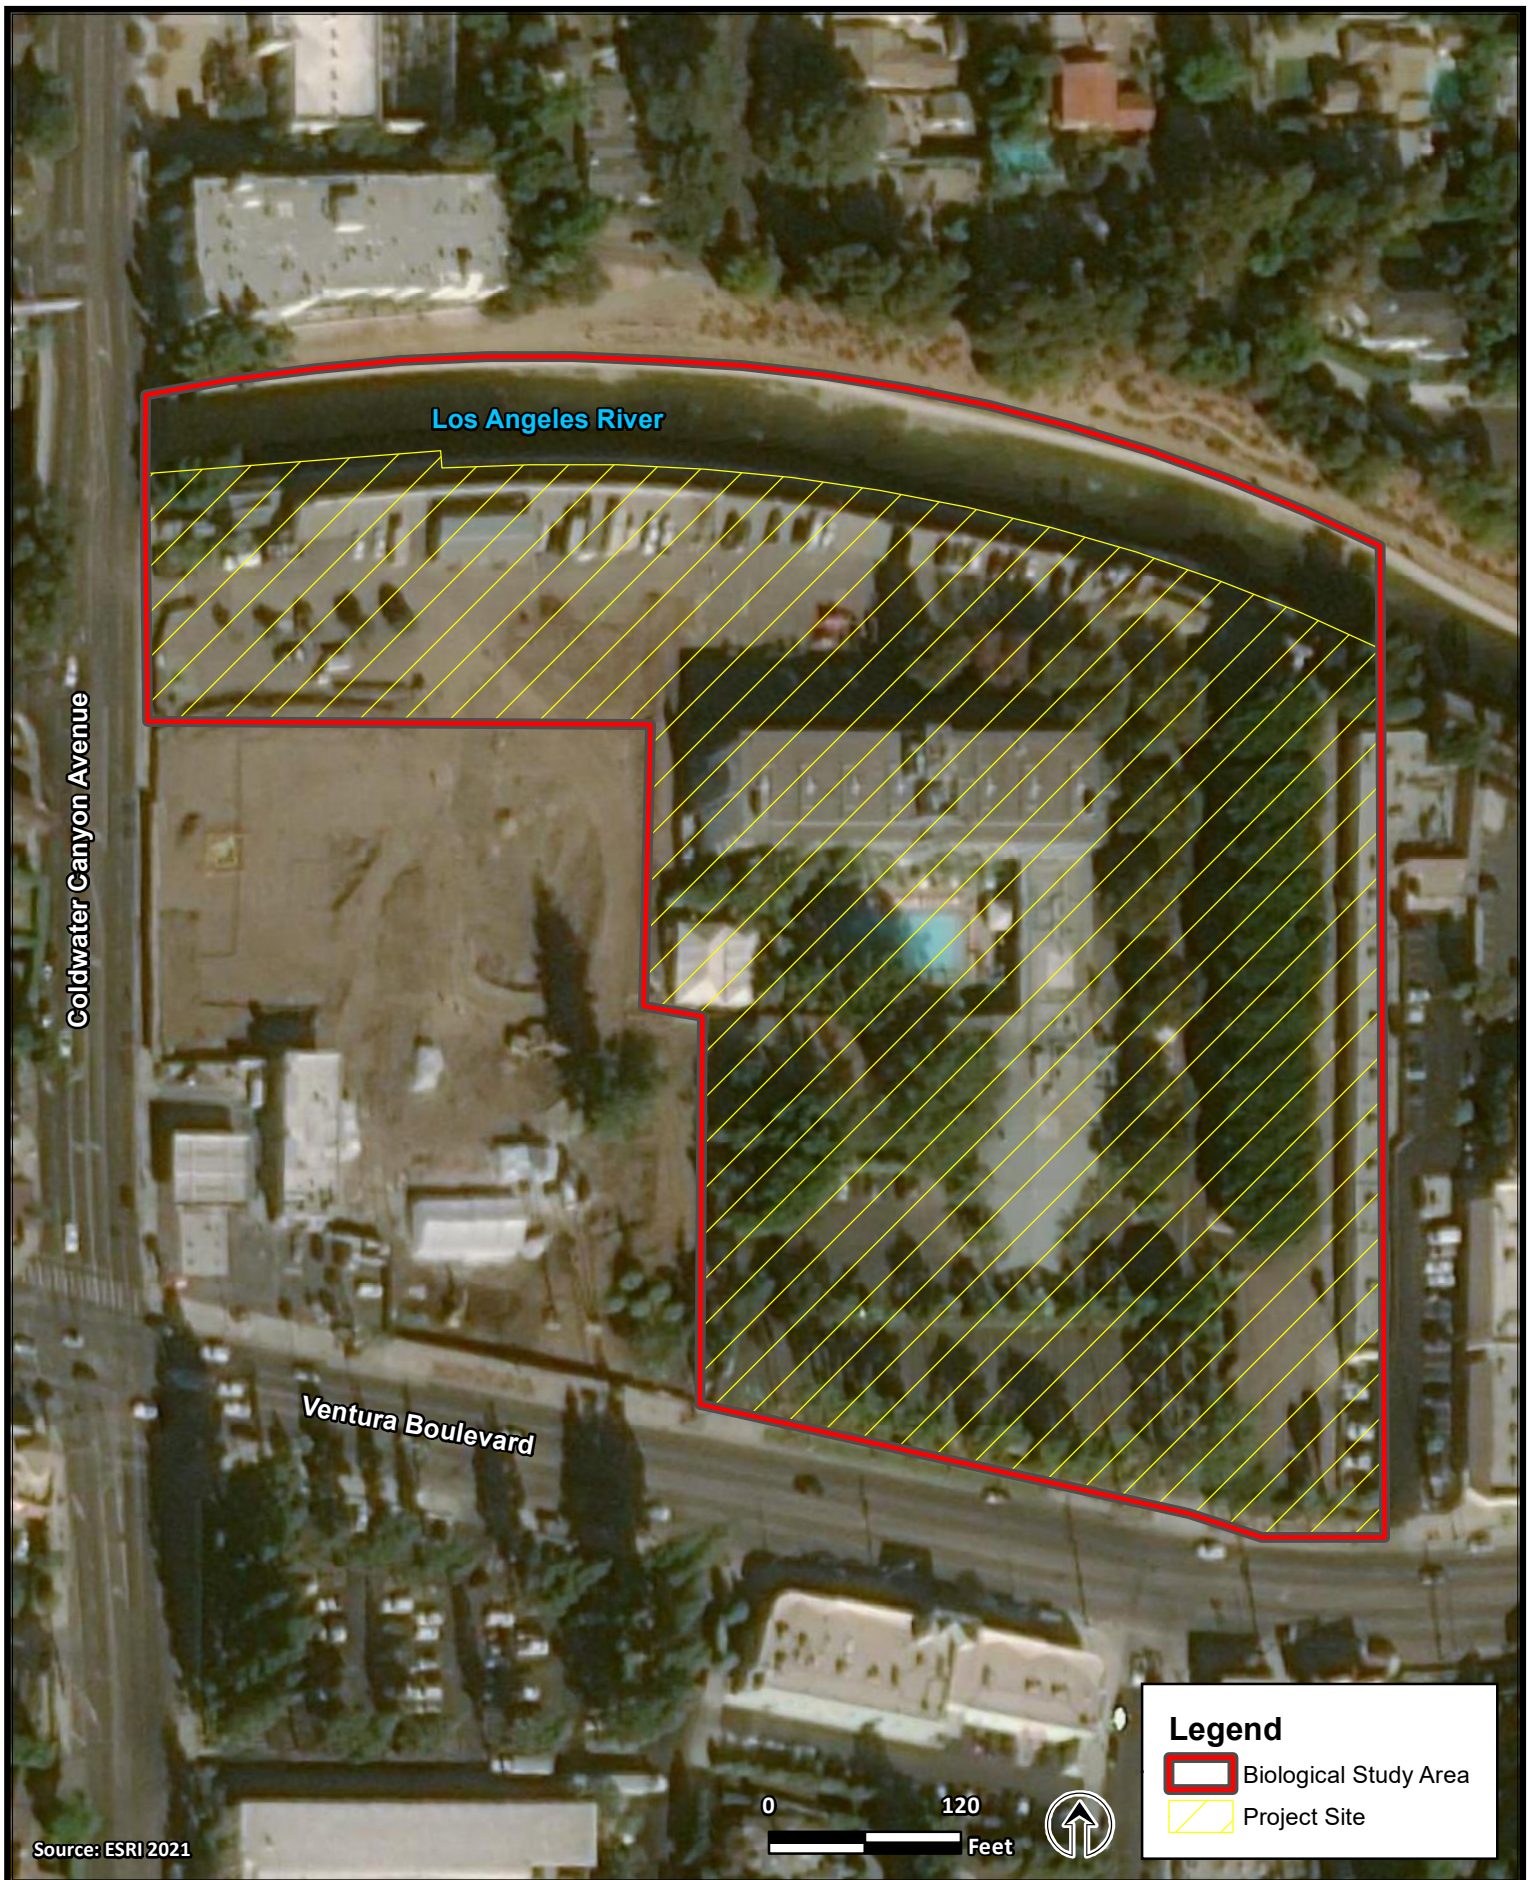
FIGURE 3. BIOLOGICAL STUDY AREA
Sportsmen's Lodge Mixed-Use Project

The BSA is located at the northeast corner of Ventura Boulevard and Coldwater Canyon Avenue and encompasses approximately eight acres, including the existing Sportsmen's Lodge Hotel, large parking areas, and the Los Angeles River (see **Appendix A - Figure 3**). The Los Angeles River is within the BSA and is directly adjacent to the project site. Land uses within the BSA include commercial and open space. Land uses adjacent to the BSA consist of residential and commercial development, recreational bike paths, and the Zev Yaroslavsky LA River Greenway Trail. The limits of the BSA were determined by reviewing project plans and aerial imagery. The BSA includes areas that could be directly and indirectly impacted by the project, either temporarily or permanently.

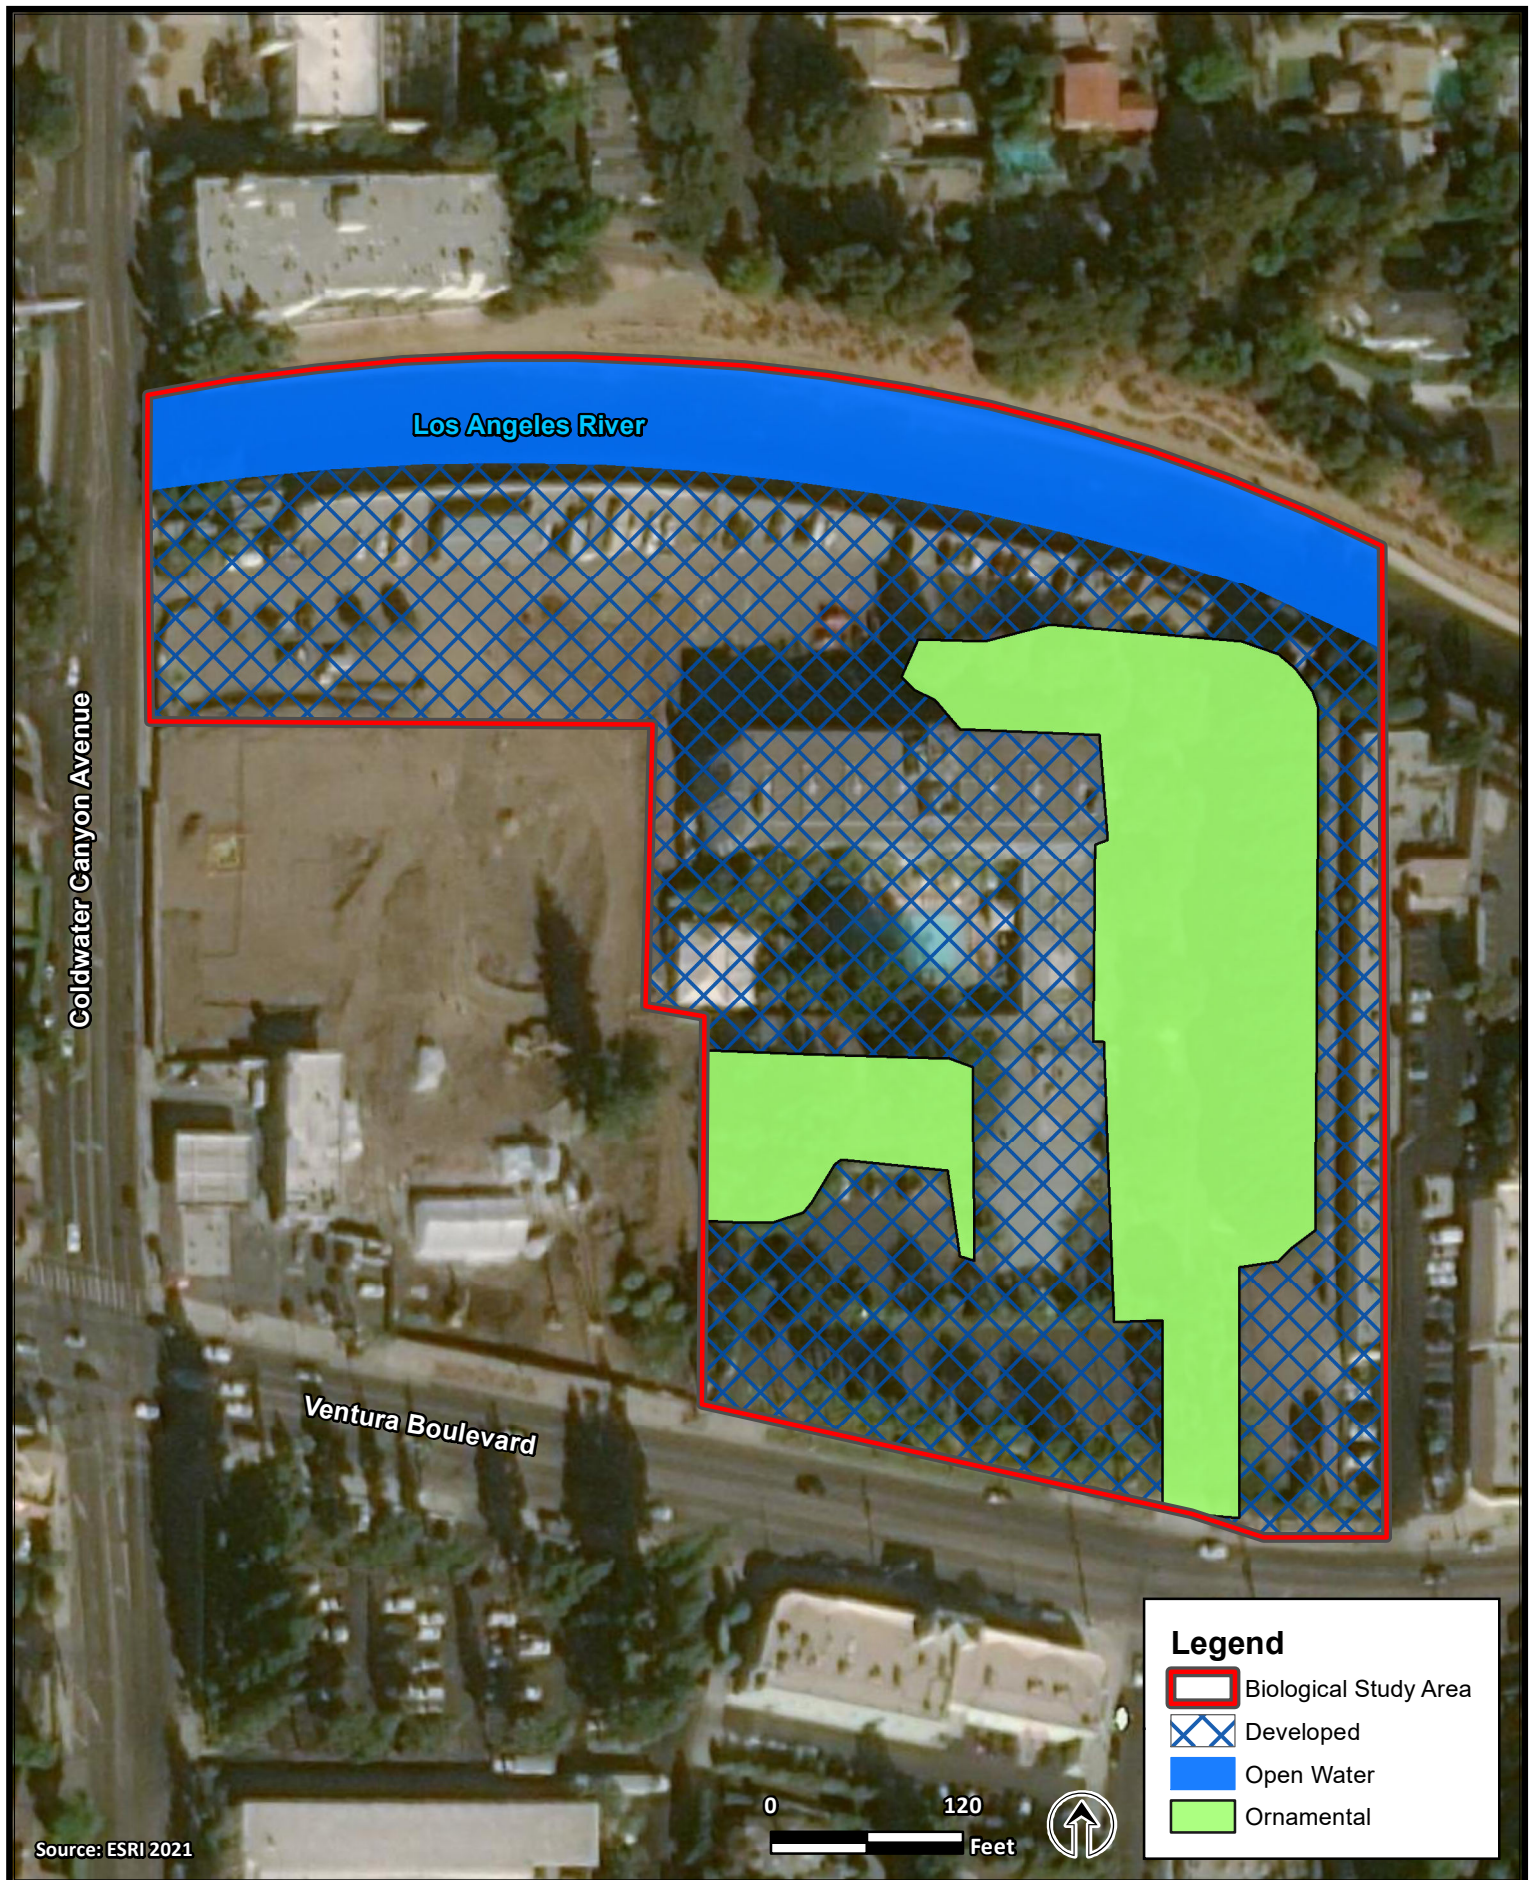
FIGURE 4. COVER CLASSES
Sportsmen's Lodge Mixed-Use Project

Cover classes observed in the BSA include Ornamental, Developed, and Open Water (see **Appendix A - Figure 4**). Each of these are described below.

Developed areas are where human disturbance has resulted in permanent impacts on natural communities. These include paved areas, buildings, bridges, and other structures. Within the BSA, the developed area includes the existing Sportsmen's Lodge Hotel and surrounding parking lots.

Open Water areas are permanently flooded waterways or other water features that may support sparse emergent or submerged vegetation or may be unvegetated. Within the BSA, Open Water areas are in the Los Angeles River.

Ornamental communities predominantly consist of non-native horticultural plants, including introduced trees, shrubs, flowers, and turf grass. Within the BSA, species in the Ornamental community include eucalyptus (*Eucalyptus* sp.), Mexican fan palm (*Washingtonia robusta*), and Chinese elm (*Ulmus parvifolia*). Within the BSA, Ornamental communities are found within the existing Sportsmen's Lodge Hotel and surrounding parking lots.

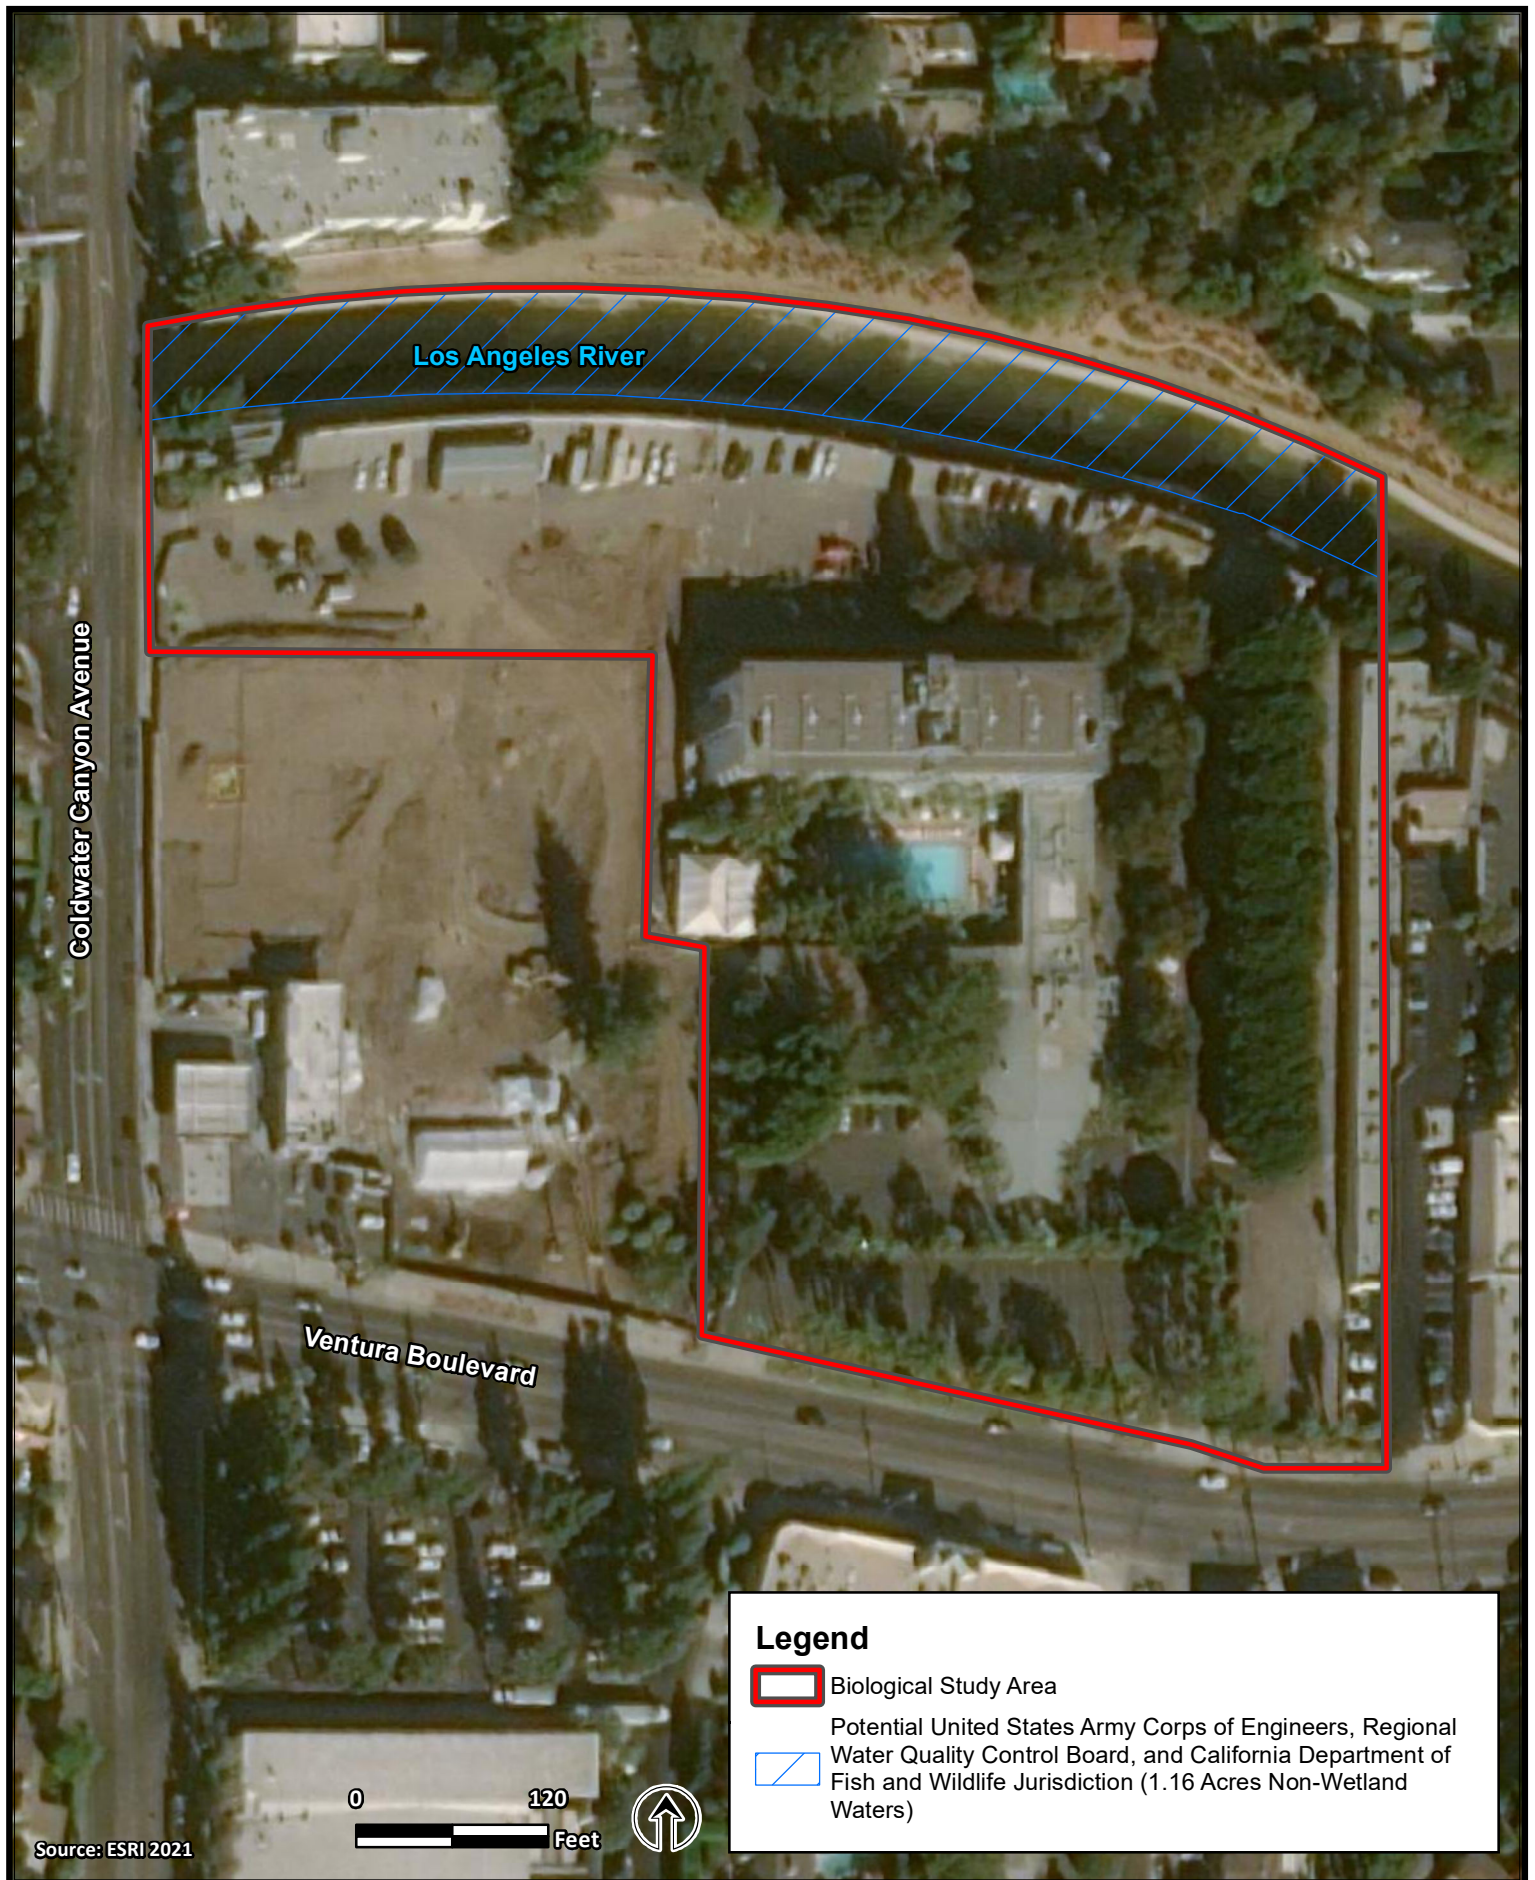
FIGURE 5. JURISDICTIONAL FEATURES
Sportsmen's Lodge Mixed-Use Project

The Los Angeles River has perennial surface flow, is a traditionally navigable waterway, and flows directly to the Pacific Ocean. The river is considered non-wetland waters under jurisdiction of the USACE, RWQCB, and CDFW (see **Appendix A - Figure 5**). No wetland or riparian habitat was observed along the river's

banks within the BSA.

All construction activities would be outside of the Los Angeles River; therefore, the project would have no direct impacts on wetlands or waters under the USACE, RWQCB, or CDFW jurisdiction. Therefore, no regulatory permits would be required. However, during grading and construction of the project there is potential for construction dust, debris and materials to enter into the river, resulting in water quality impacts. However, the project would be conducted in compliance with the applicable water quality regulations. With implementation of the proposed avoidance and minimization measures listed below, direct and indirect impacts on jurisdictional features would be avoided, and adverse impacts are not anticipated.

To avoid and/or minimize impacts on jurisdictional waters within the Los Angeles River, the following avoidance and minimization measures would be implemented:

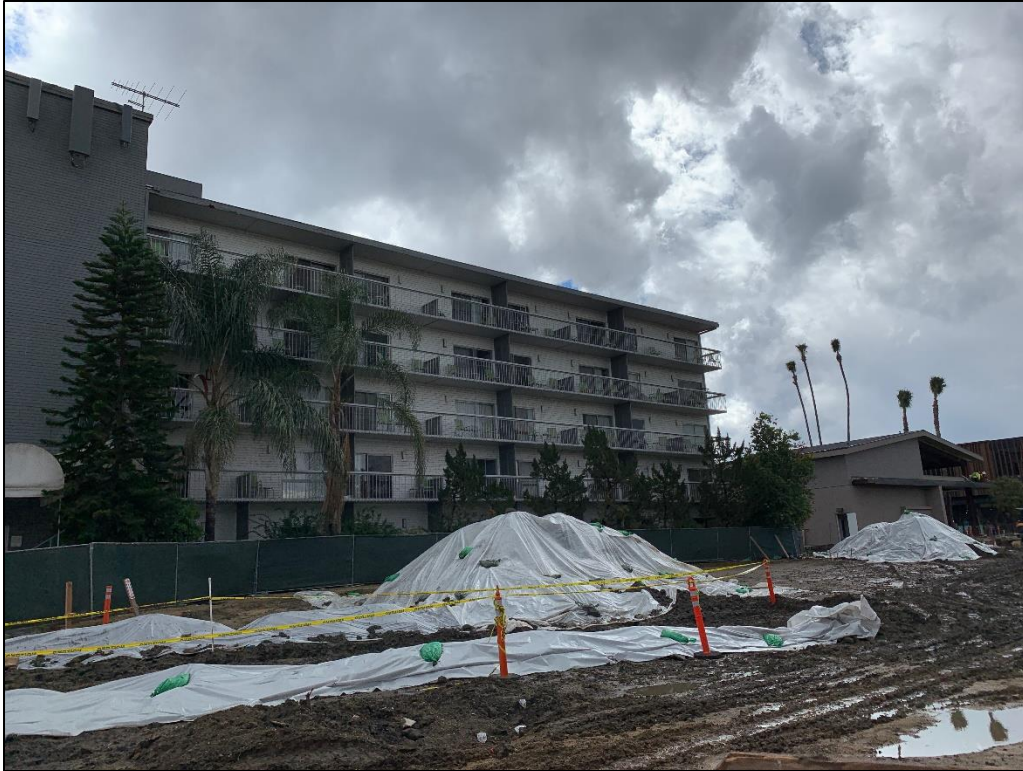
Photo 1. Construction work area in the existing parking lot, view facing southwest

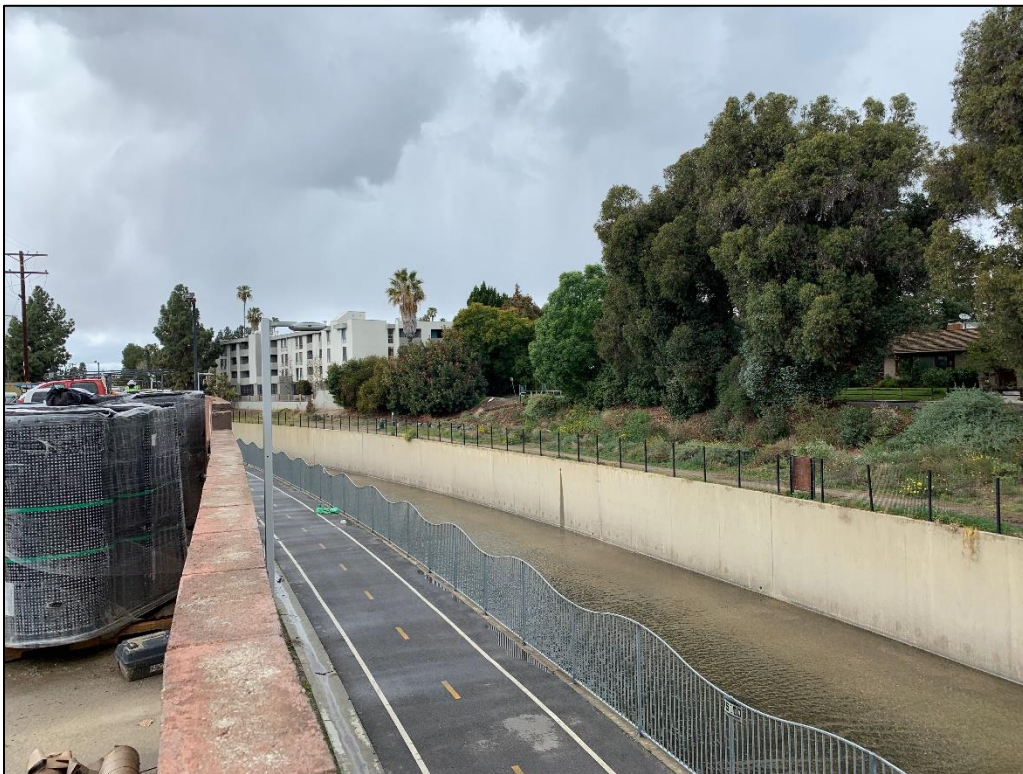
Photo 2. Los Angeles River and bike path north and adjacent to the project site, view facing northwest

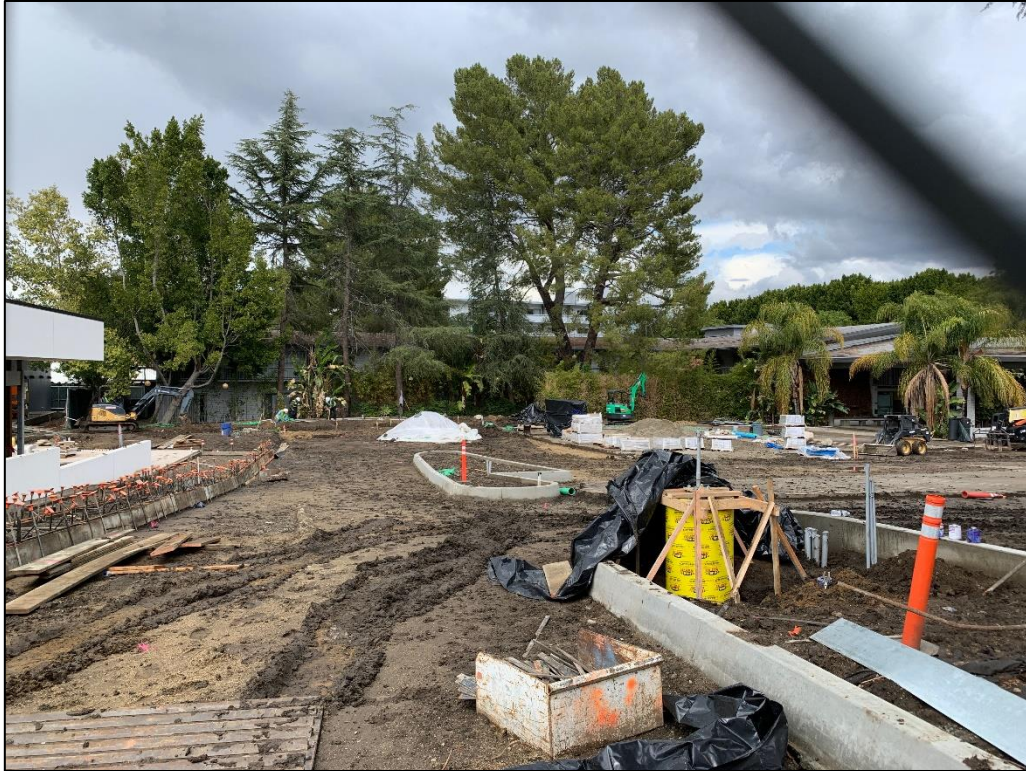
Photo 3. Construction work area adjacent to the hotel, view facing northeast

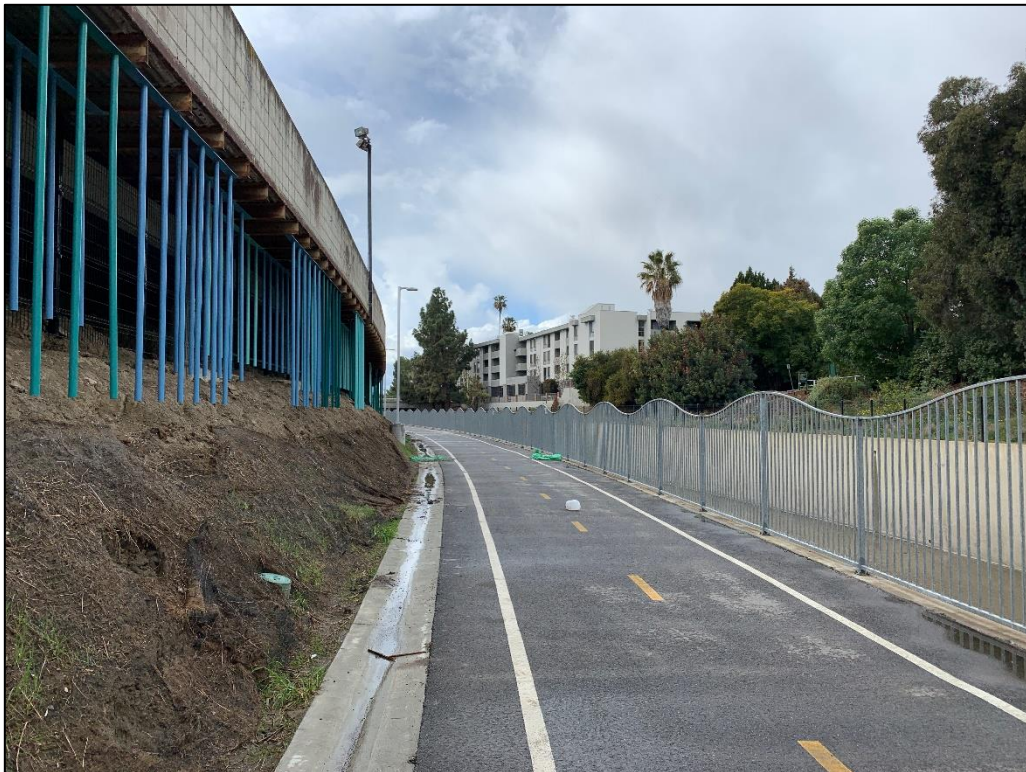
Photo 4. Bike path separating the extent of project site (left and above) and the Los Angeles River (right beyond fence), view facing northeast

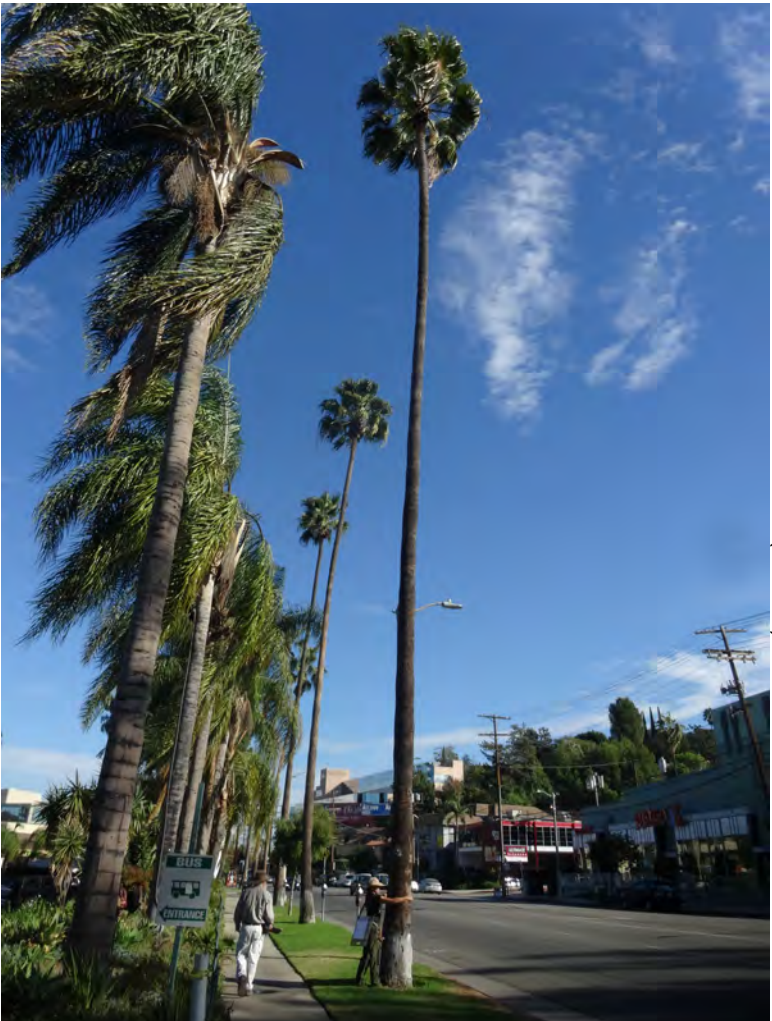
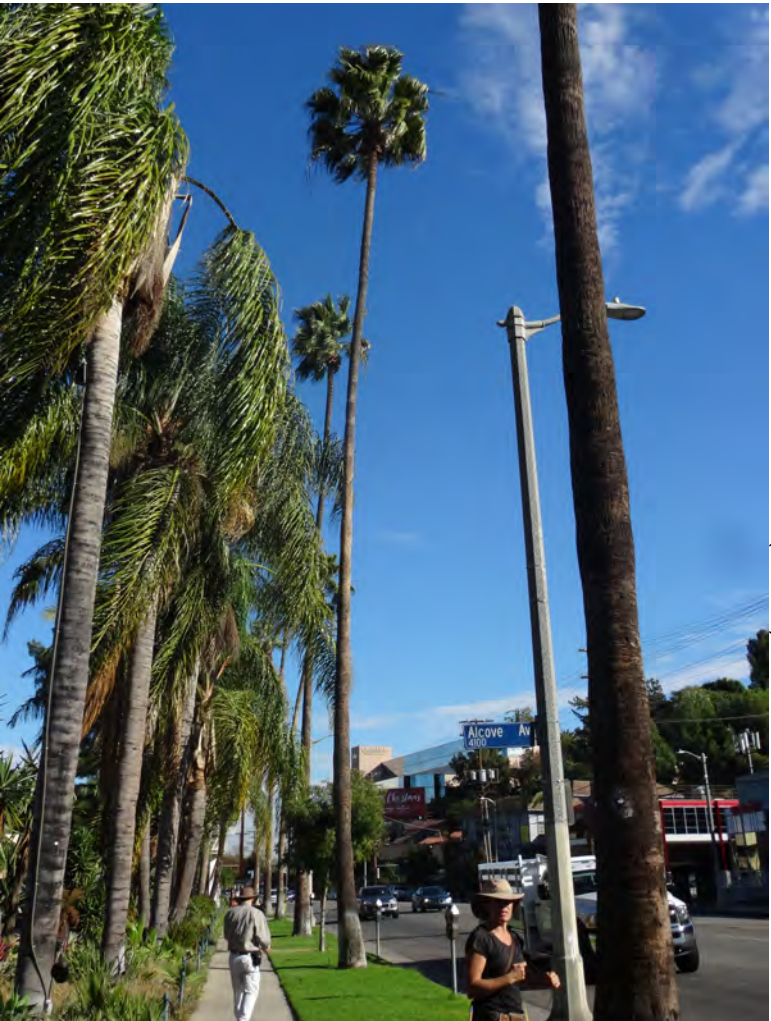
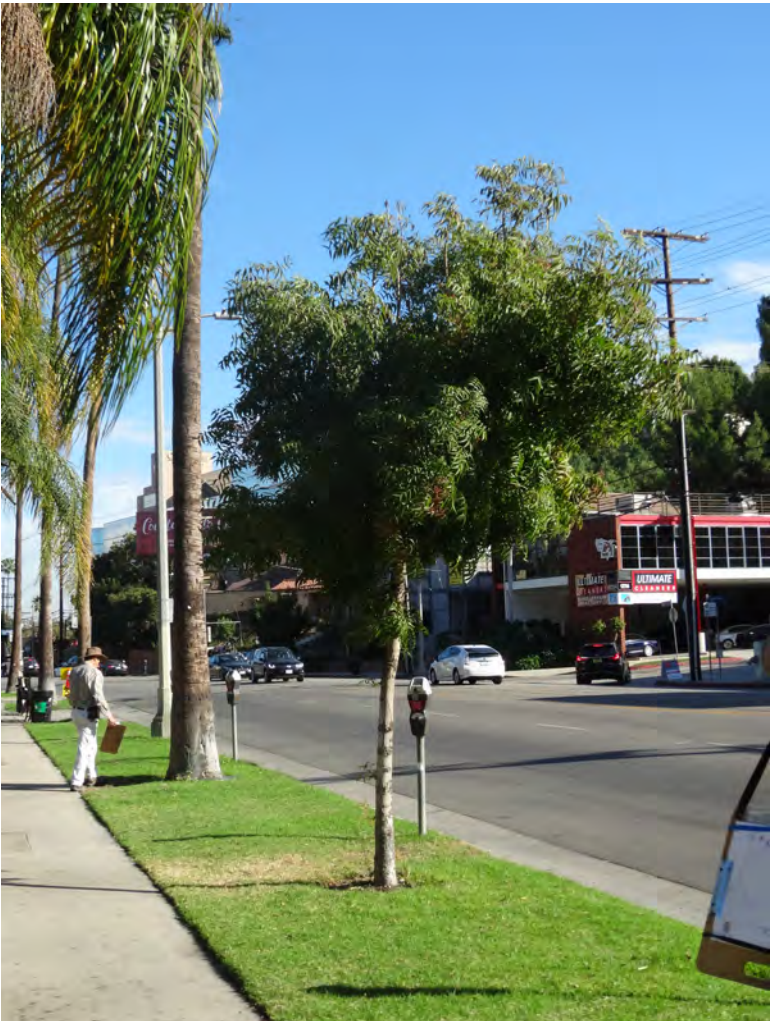
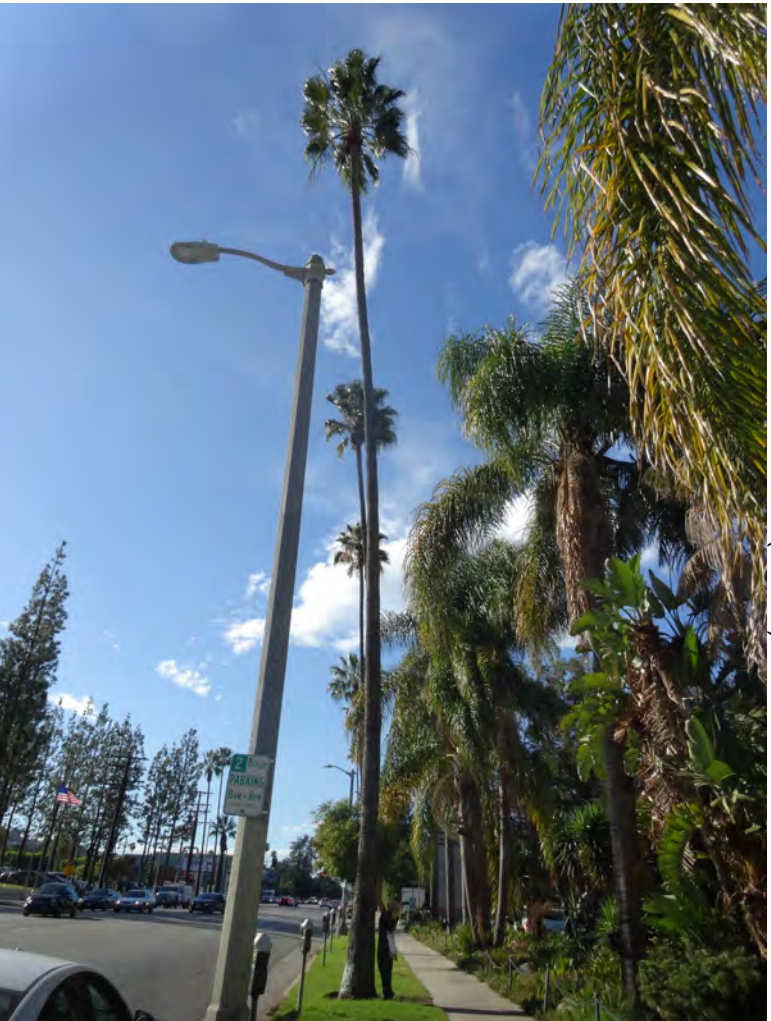
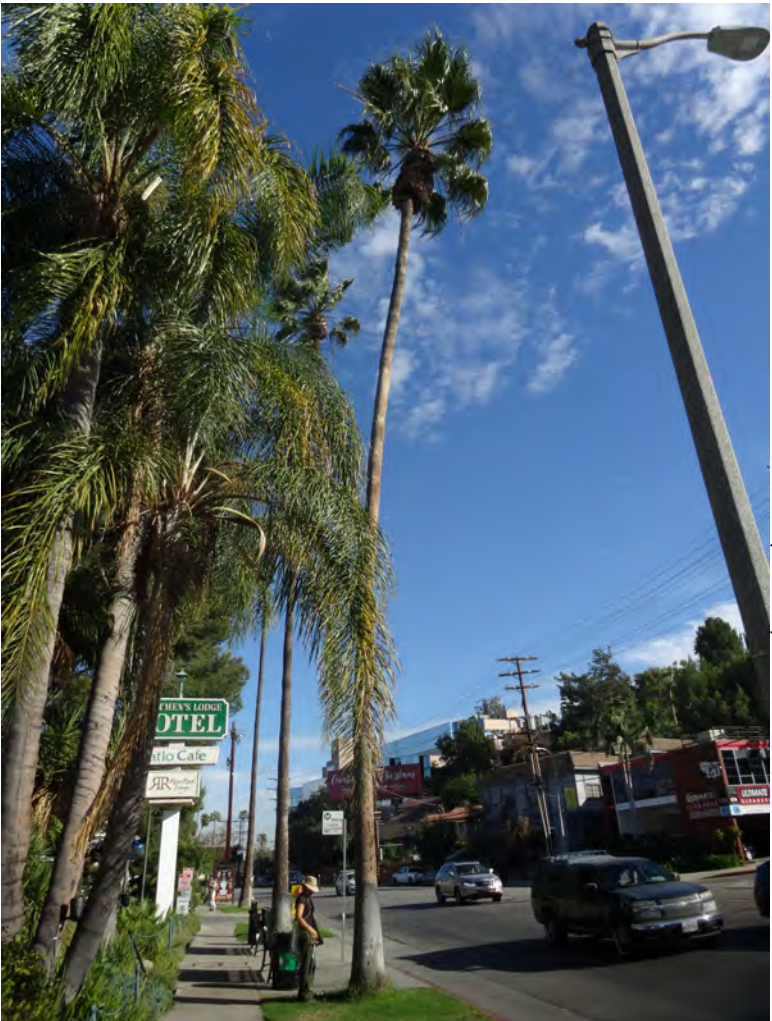
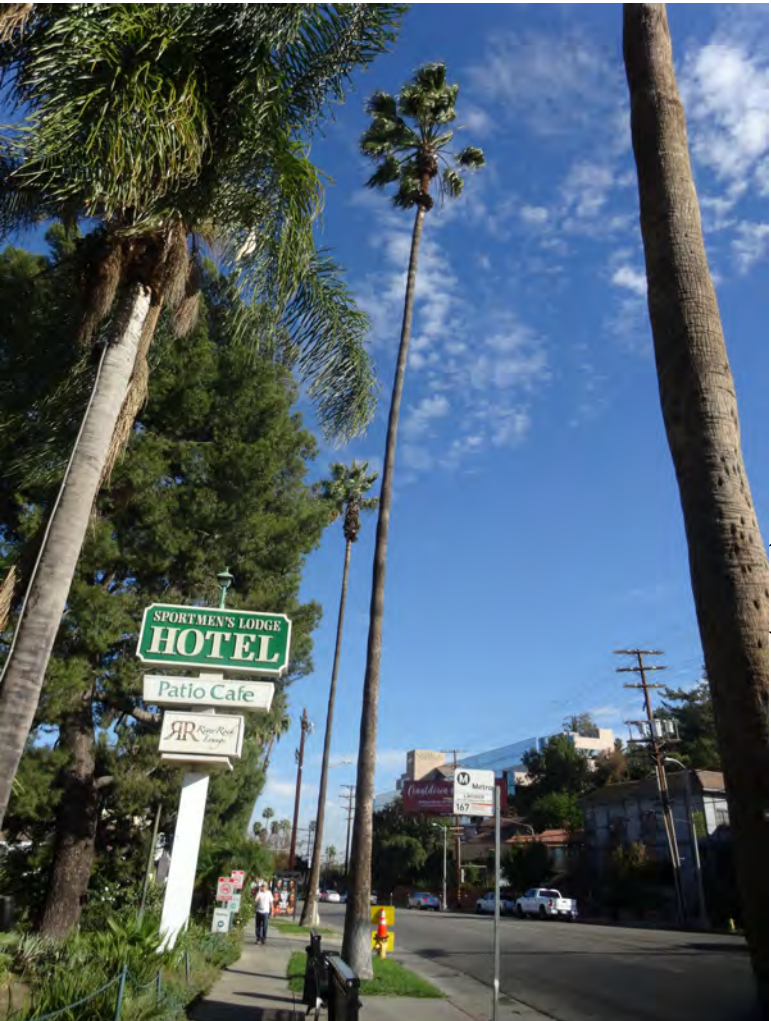
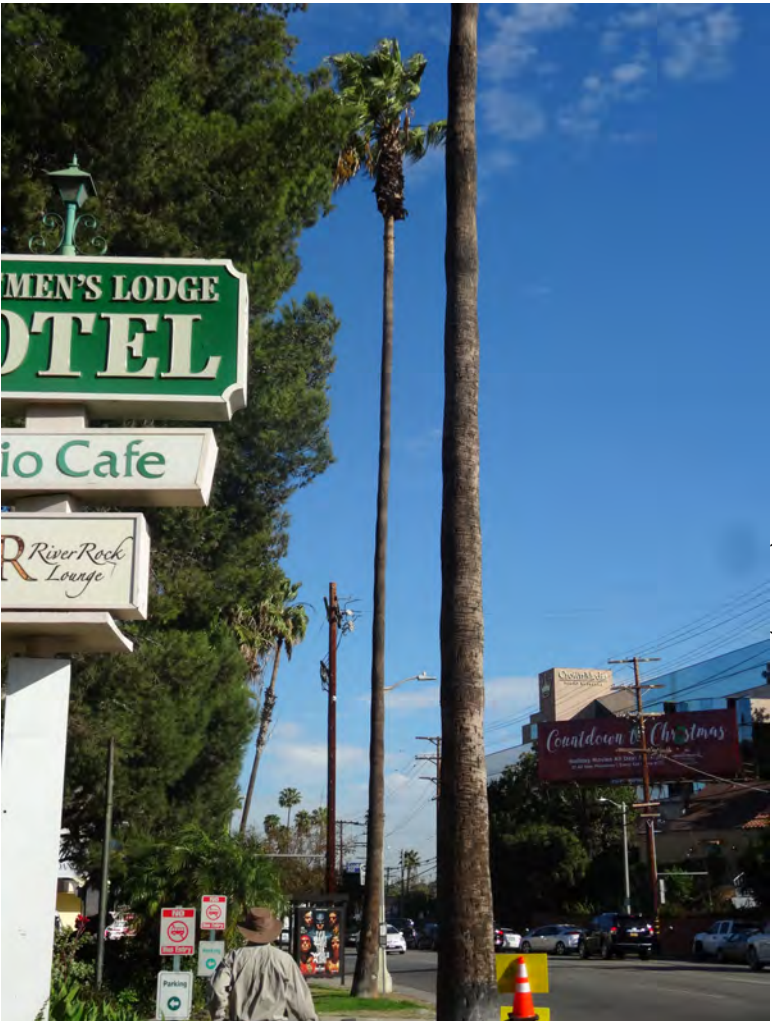
The proposed project does not cause the removal of any protected native trees. There are four street trees that will be removed by the proposed project; these are addressed under "Tree removals" below.

The proposed project causes the removal of four street trees. Street tree removals shall be mitigated at a ratio of 1:1, meaning four new street trees will need to be planted. Replacement tree species, size, and location should be determined in coordination with the Los Angeles Bureau of Street Services Urban Forestry Division.

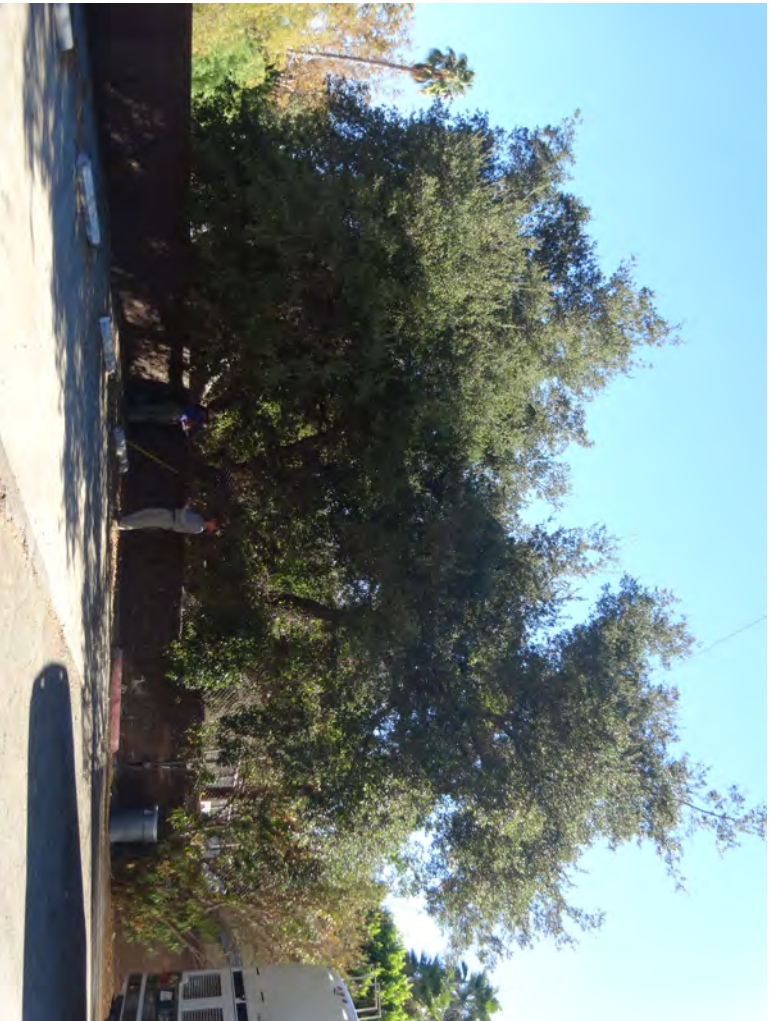
Tree OP130

Demolition- The existing parking area along the River (at the rear of the site) is a cantilevered structure, including at the northeast corner of the site near Tree OP130. This parking area will be demolished as part of the proposed project. If the demolition contractor is not careful, demolition equipment and/or debris could mechanically damage the canopy, trunk, or roots of Tree OP130.

Excavation- Excavation for a shoring wall is proposed within 30 inches of Tree OP130¹. Excavation at such a close distance to the tree would most likely result in its removal. To avoid removal of, and significant harm to, Tree OP130, we have recommended a project design change that will move the excavation an acceptable distance away from the tree and reduce impacts to moderate or less.

Design Change- In order to reduce impacts to Tree OP130, we recommend altering the proposed project design such that there will be no excavation of any kind (over-excavation, shoring, footings, etc.) within 15 feet of the trunk of that tree. This may mean adjusting the proposed building footprint near this tree, changes to the grading plan, alterations to the proposed landscape and hardscape design, etc. ***The Project Arborist should review the revised project design once complete.***

excavation within 15 feet of the trunk of Tree OP130. The trench shall be as deep as the required excavation, and as wide as necessary (away from the tree) to accommodate digging. **The exploratory trench shall be dug using hand tools or an AirSpade only**, and any roots less than two inches in diameter shall be cut cleanly using a sharp saw or pruning tool. No roots two inches or larger in diameter shall be cut during digging. The **Project Arborist** shall inspect the exploratory trench and the exposed roots that are two inches or larger in diameter and provide mitigation recommendations accordingly.

Excavation- If roots two inches or greater in diameter are encountered during excavation near Tree OP130, cuts should be made cleanly with a sharp saw or pruning tool, far enough behind any damage that all split and cracked root portions are removed. The cut should be made at right angles to the root so that the wound is no larger than necessary. When practical, cut roots back to a branching lateral root. Do not apply any pruning wound treatment to cuts.
