Appendix C

Biological Resources

River Memo

To: Ben Besley – Midwood Investment & Development
From: Jennifer Johnson, Senior Biologist
Date: April 1, 2021
Subject: Sportsmen’s Lodge Mixed-Use Project Los Angeles River Impact Analysis
Memorandum

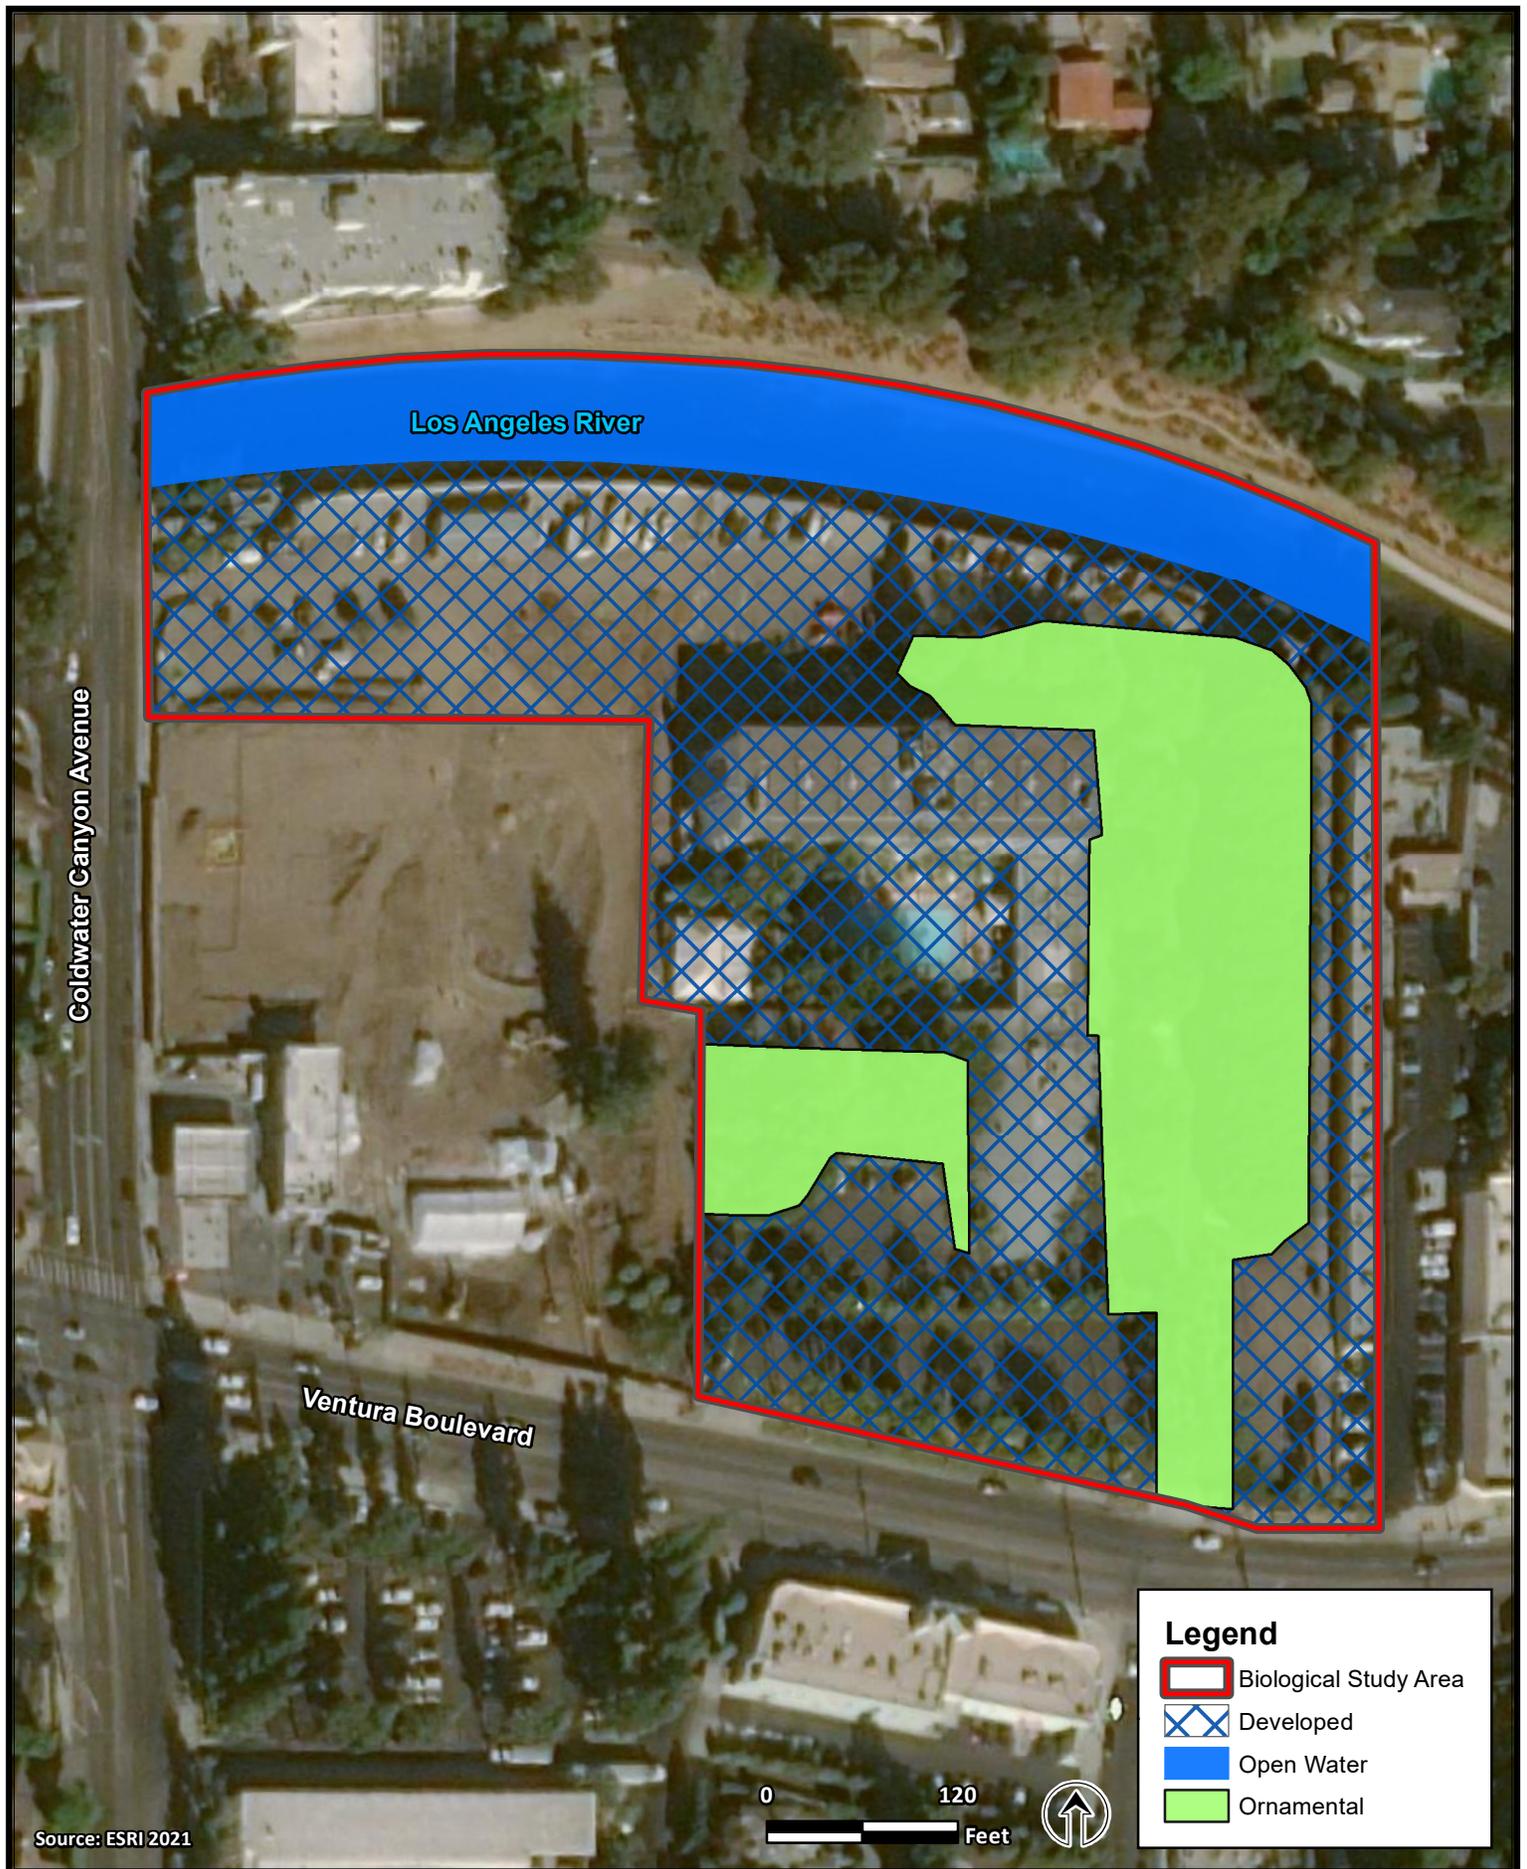
FIGURE 4. COVER CLASSES
Sportsmen's Lodge Mixed-Use Project

Cover classes observed in the BSA include Ornamental, Developed, and Open Water (see **Appendix A - Figure 4**). Each of these are described below.

Developed areas are where human disturbance has resulted in permanent impacts on natural communities. These include paved areas, buildings, bridges, and other structures. Within the BSA, the developed area includes the existing Sportsmen's Lodge Hotel and surrounding parking lots.

Open Water areas are permanently flooded waterways or other water features that may support sparse emergent or submerged vegetation or may be unvegetated. Within the BSA, Open Water areas are in the Los Angeles River.

Ornamental communities predominantly consist of non-native horticultural plants, including introduced trees, shrubs, flowers, and turf grass. Within the BSA, species in the Ornamental community include eucalyptus (*Eucalyptus* sp.), Mexican fan palm (*Washingtonia robusta*), and Chinese elm (*Ulmus parvifolia*). Within the BSA, Ornamental communities are found within the existing Sportsmen's Lodge Hotel and surrounding parking lots.

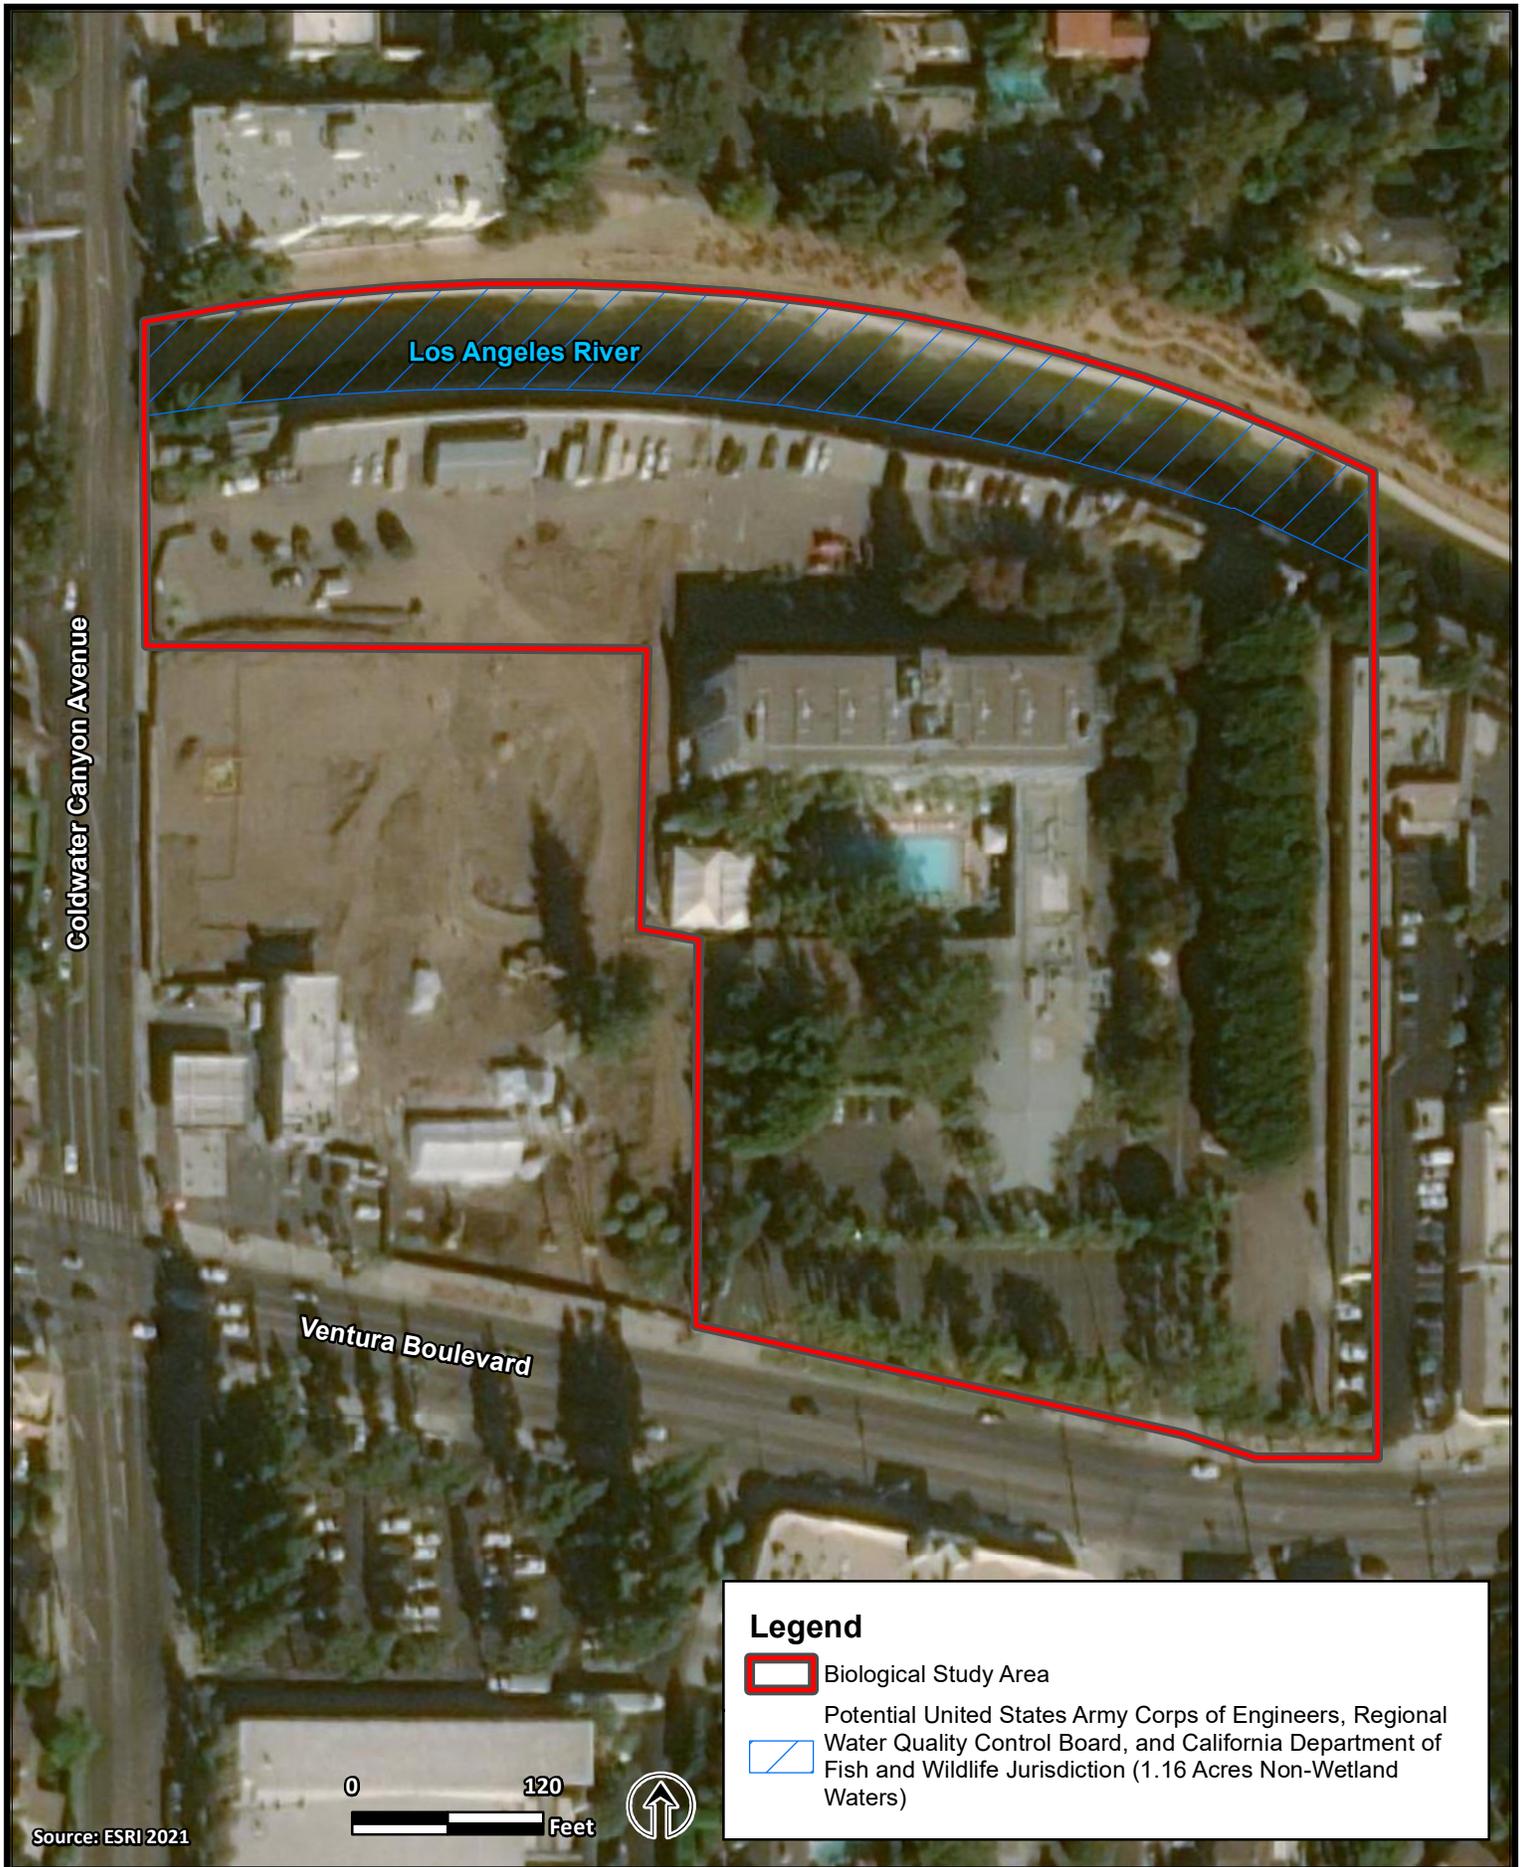
The Los Angeles River has perennial surface flow, is a traditionally navigable waterway, and flows directly to the Pacific Ocean. The river is considered non-wetland waters under jurisdiction of the USACE, RWQCB, and CDFW (see **Appendix A - Figure 5**). No wetland or riparian habitat was observed along the river's

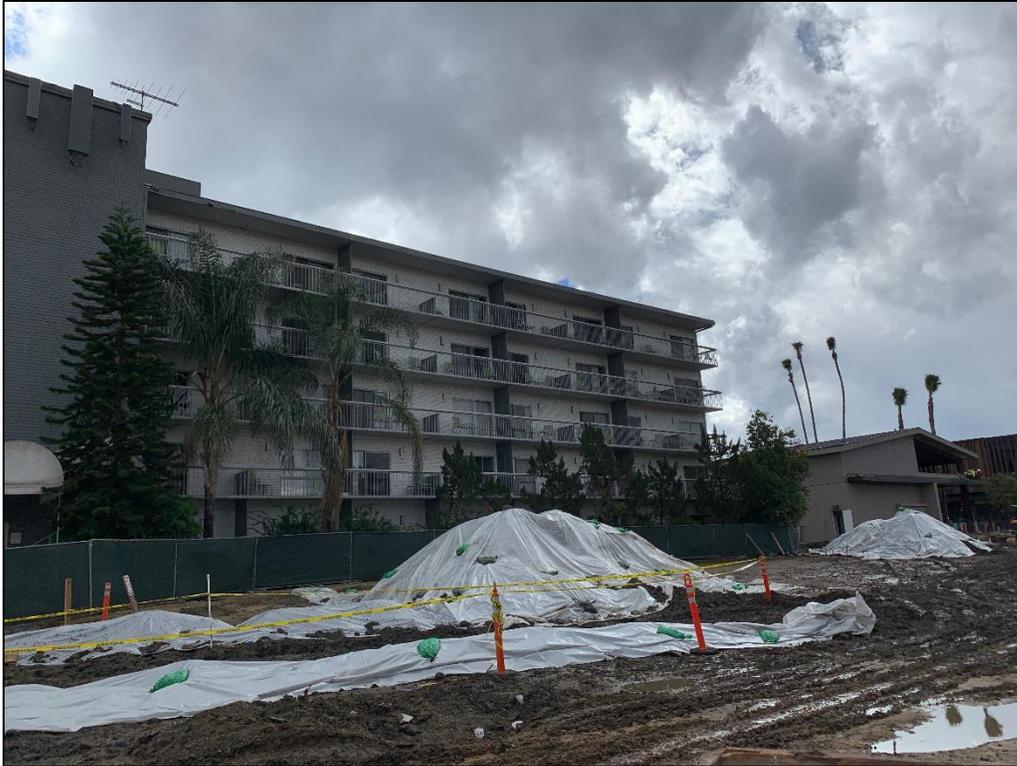
Photo 1. Construction work area in the existing parking lot, view facing southwest

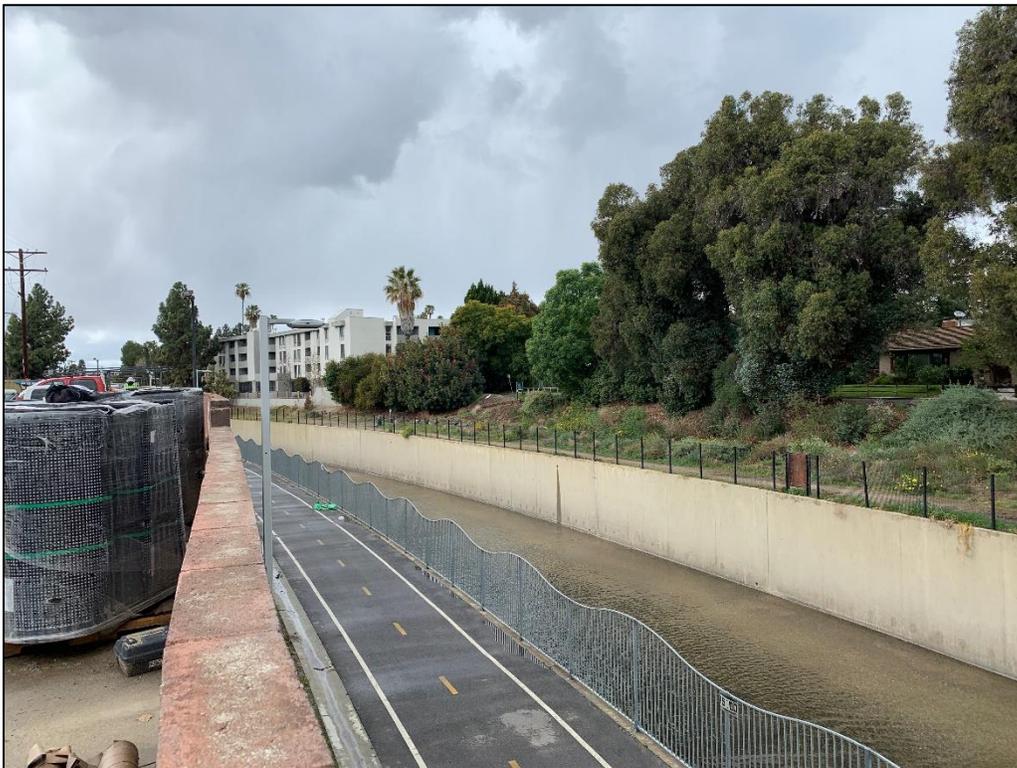
Photo 2. Los Angeles River and bike path north and adjacent to the project site, view facing northwest

- Work areas would be reduced to the maximum extent feasible, and staging areas for equipment refueling and maintenance would be located 50 feet from jurisdictional features.

- Best management practices (BMP), such as silt fencing, fiber rolls, straw bales, or other measures would be implemented during construction to minimize dust, dirt, and construction debris from entering the river and/or leaving the construction area.

- Appropriate hazardous material BMPs would be implemented during construction to reduce the potential for chemical spills or contaminant releases into the river, including any non-stormwater discharge.

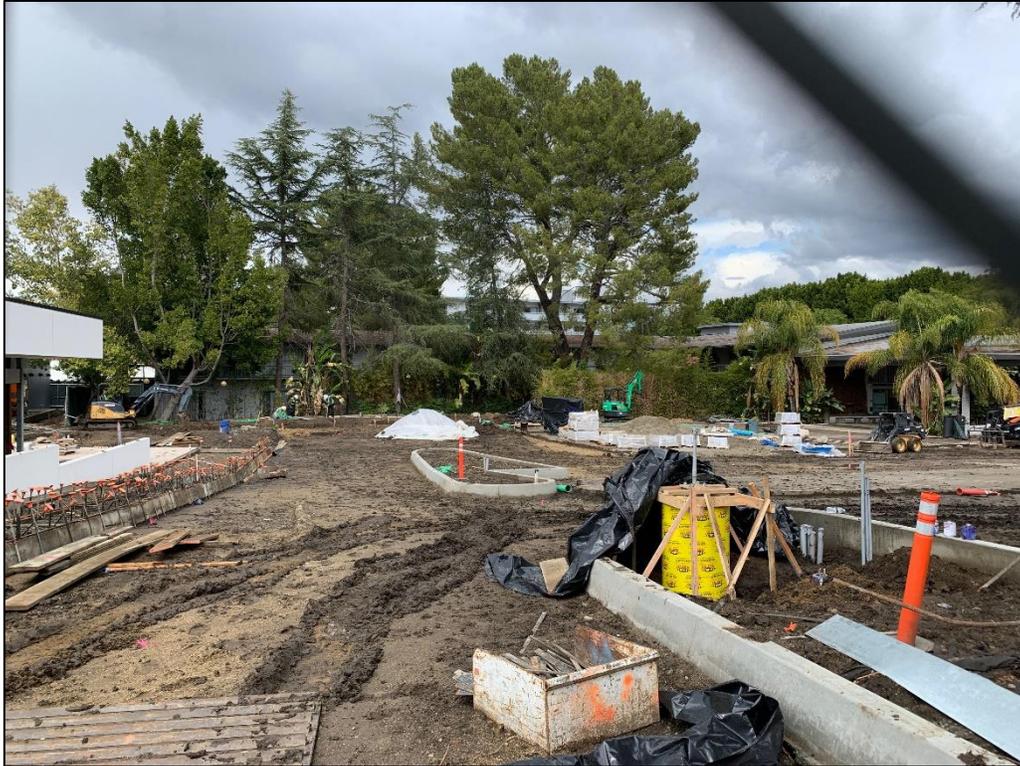
Photo 3. Construction work area adjacent to the hotel, view facing northeast

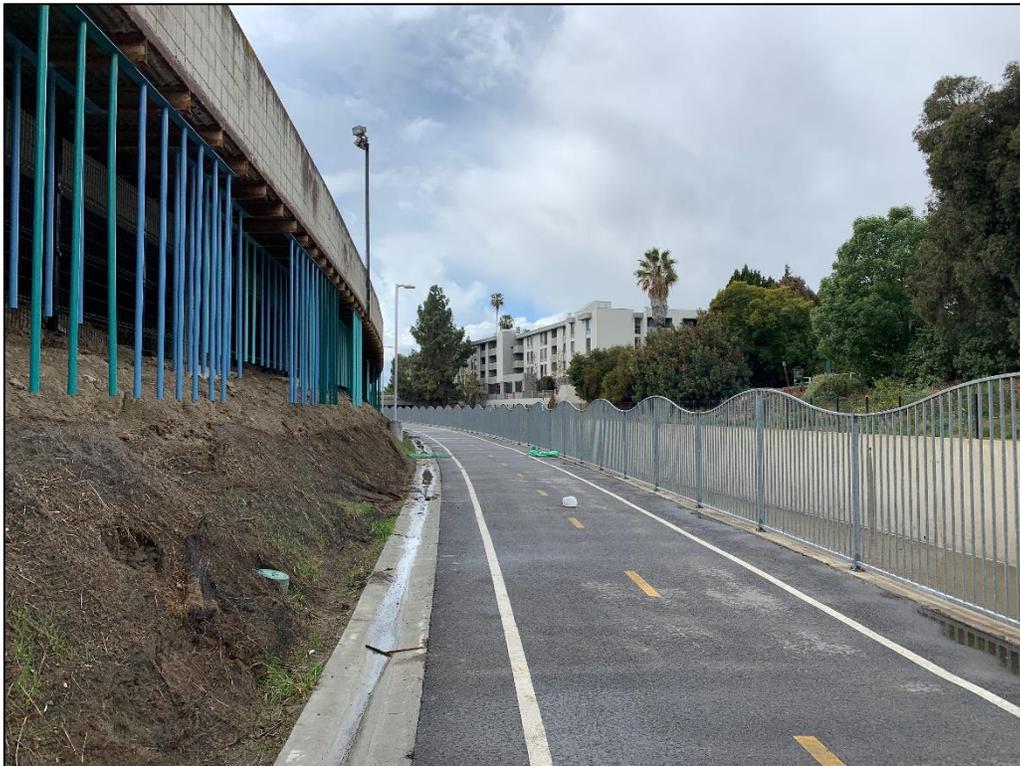
Photo 4. Bike path separating the extent of project site (left and above) and the Los Angeles River (right beyond fence), view facing northeast

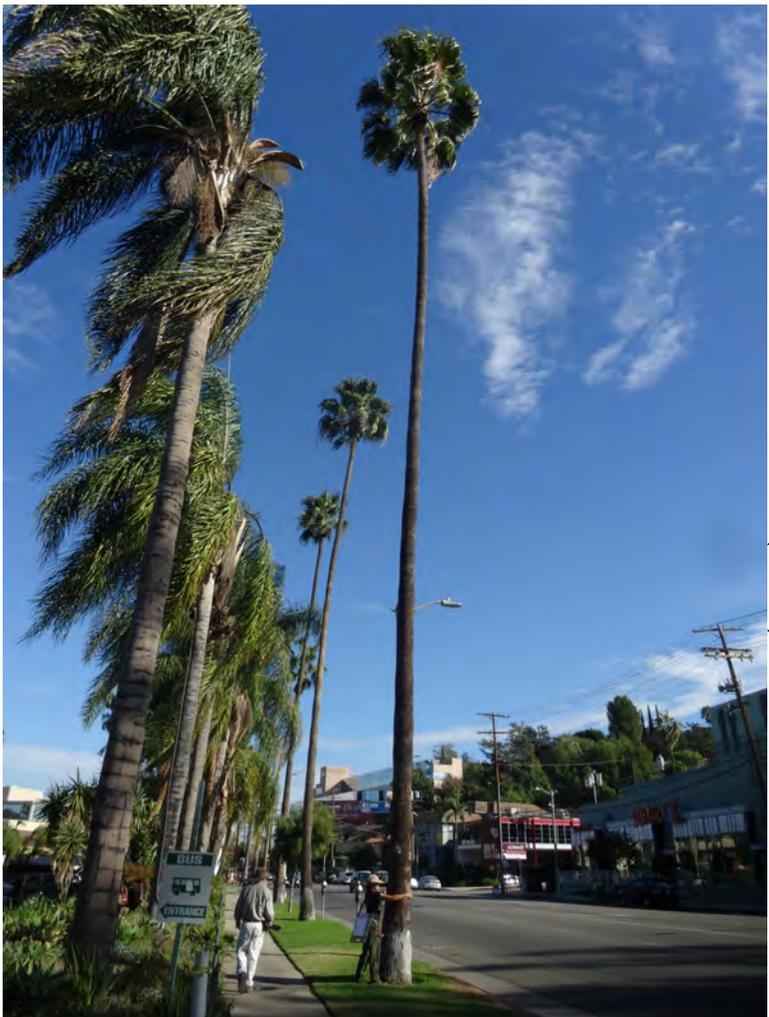
Tree ST69 (center)

The proposed project does not cause the removal of any protected native trees. There are four street trees that will be removed by the proposed project; these are addressed under "Tree removals" below.

The proposed project causes the removal of four street trees. Street tree removals shall be mitigated at a ratio of 1:1, meaning four new street trees will need to be planted. Replacement tree species, size, and location should be determined in coordination with the Los Angeles Bureau of Street Services Urban Forestry Division.

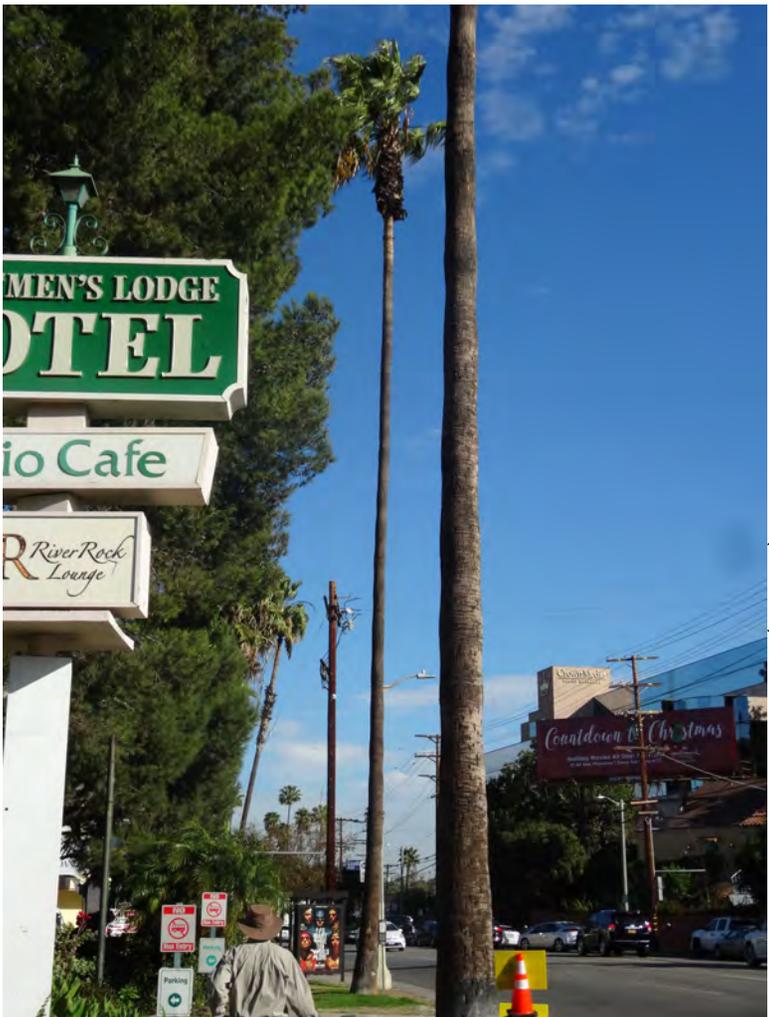
Tree OP130

Demolition- The existing parking area along the River (at the rear of the site) is a cantilevered structure, including at the northeast corner of the site near Tree OP130. This parking area will be demolished as part of the proposed project. If the demolition contractor is not careful, demolition equipment and/or debris could mechanically damage the canopy, trunk, or roots of Tree OP130.

Excavation- Excavation for a shoring wall is proposed within 30 inches of Tree OP130¹. Excavation at such a close distance to the tree would most likely result in its removal. To avoid removal of, and significant harm to, Tree OP130, we have recommended a project design change that will move the excavation an acceptable distance away from the tree and reduce impacts to moderate or less.

Design Change- In order to reduce impacts to Tree OP130, we recommend altering the proposed project design such that there will be no excavation of any kind (over-excavation, shoring, footings, etc.) within 15 feet of the trunk of that tree. This may mean adjusting the proposed building footprint near this tree, changes to the grading plan, alterations to the proposed landscape and hardscape design, etc. ***The Project Arborist should review the revised project design once complete.***

excavation within 15 feet of the trunk of Tree OP130. The trench shall be as deep as the required excavation, and as wide as necessary (away from the tree) to accommodate digging. **The exploratory trench shall be dug using hand tools or an AirSpade only**, and any roots less than two inches in diameter shall be cut cleanly using a sharp saw or pruning tool. No roots two inches or larger in diameter shall be cut during digging. The **Project Arborist** shall inspect the exploratory trench and the exposed roots that are two inches or larger in diameter and provide mitigation recommendations accordingly.

Excavation- If roots two inches or greater in diameter are encountered during excavation near Tree OP130, cuts should be made cleanly with a sharp saw or pruning tool, far enough behind any damage that all split and cracked root portions are removed. The cut should be made at right angles to the root so that the wound is no larger than necessary. When practical, cut roots back to a branching lateral root. Do not apply any pruning wound treatment to cuts.
