January 28, 2022

RE: *Supplemental Cultural Resources Inventory and Evaluation for the Arrive Fairfield Project in the City of Fairfield, Solano County, California*

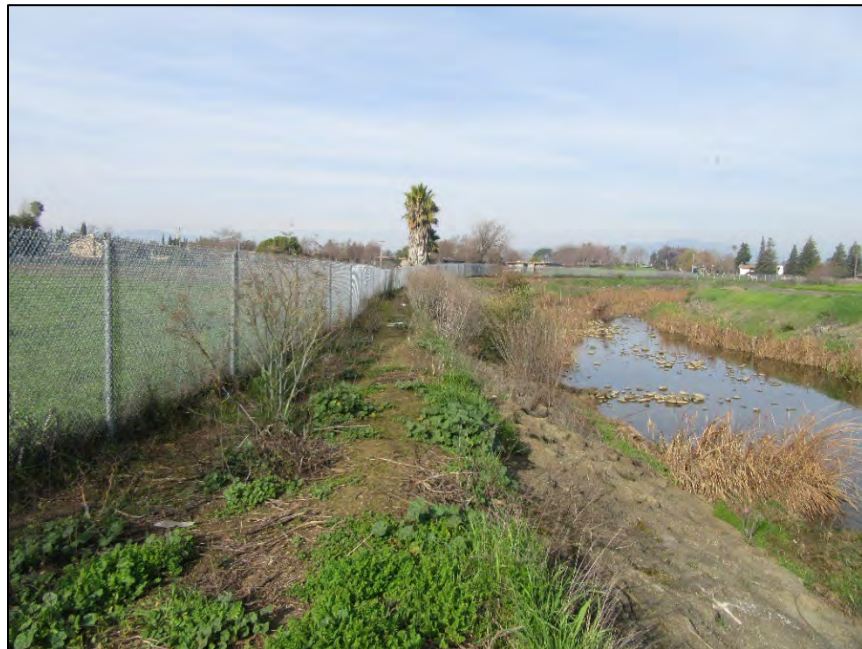
Figure 3. Outfall area overview (view north; January 13, 2021).

ECORP surveyed the outfall area for cultural resources on January 13, 2022. The pedestrian survey revealed that the land within the outfall fall area had been heavily modified throughout the years. The outfall area is located on the western bank of the channelized portion of Laurel Creek (Figure 3). Aerial photographs reveal that Laurel Creek was realigned east of its original route and channelized along the eastern edge of Project Area between 1982 and 1993. The outfall area contained sparse vegetation that resulted in good ground visibility. Sections of the channel bank contained riprap or had been sprayed with a concrete lining. No cultural resources were observed within the outfall area.

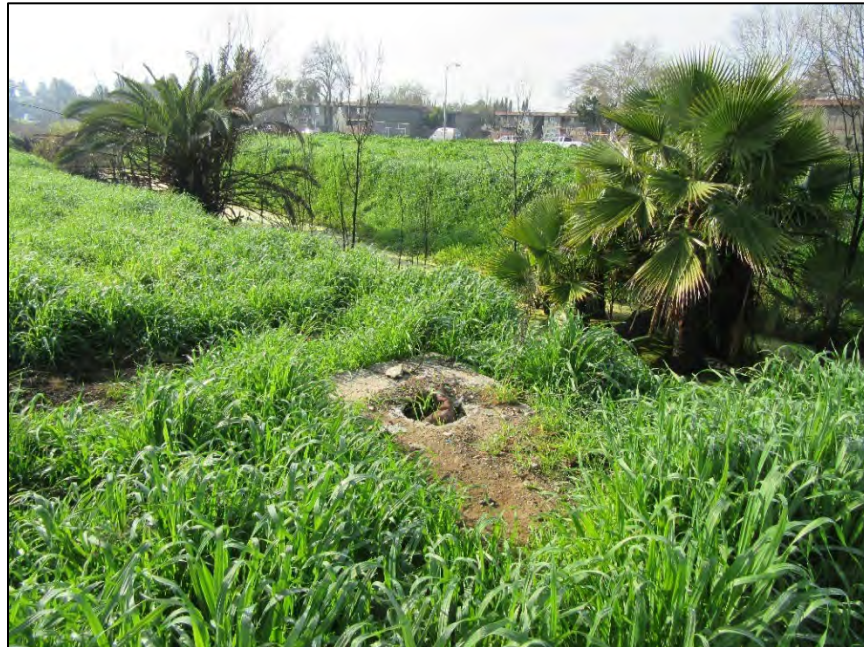
Figure 4. P-48-2002 well overview (view southwest; January 13, 2021).

P-48-2002 is a historic-period well located on the eastern side of the natural channel of Laurel Creek. The well is located within the northern portion of the Project Area and approximately 100 feet south of East Tabor Avenue. The well contains a 2-foot-square and a 6-inch-thick rough aggregate concrete pad with an 8-inch-diameter crushed metal pipe (Figures 4 and 5). The exact date of construction is unknown, but the historic aerial photographs taken in 1957 and 1965 faintly reveal the indication of the well pad or possible pump at this location. Undiagnostic hardware/anchors are present on the exterior edge pad. These metal pieces may have secured a pump, or some other type of machinery associated with the well. No other associated features were present at this site. The well appears to no longer be in use. Research conducted at the Solano County Assessor/Recorder's office did not reveal information on the well.

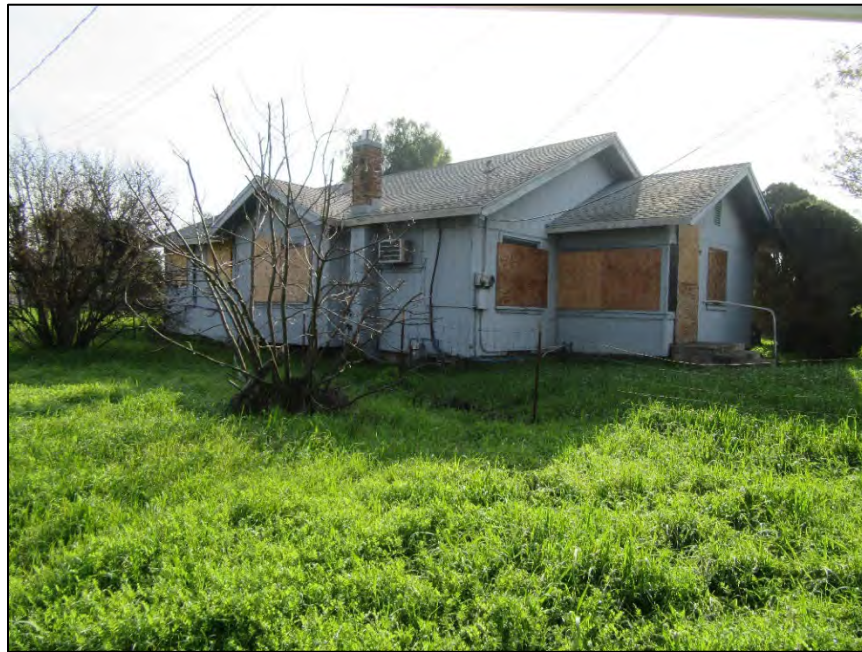
The residence is a typical small house containing some architectural elements of the Minimal architectural style but does not strongly represent the style. The roof is a moderately pitch, front gabled with modern composite shingles (Figures 6 and 7). The house has wide overhang eaves with exposed rafters. The

foundation is raised and concrete, and the house has a brick chimney on the exterior of northern facing façade. A modern composite vertical siding covers the exterior of the building. The house is minimal in size with no ornamentation, simple form and footprint, and contains no unique design or materials.

Figure 6. P-48-2003 residence overview (view southeast; January 13, 2021).

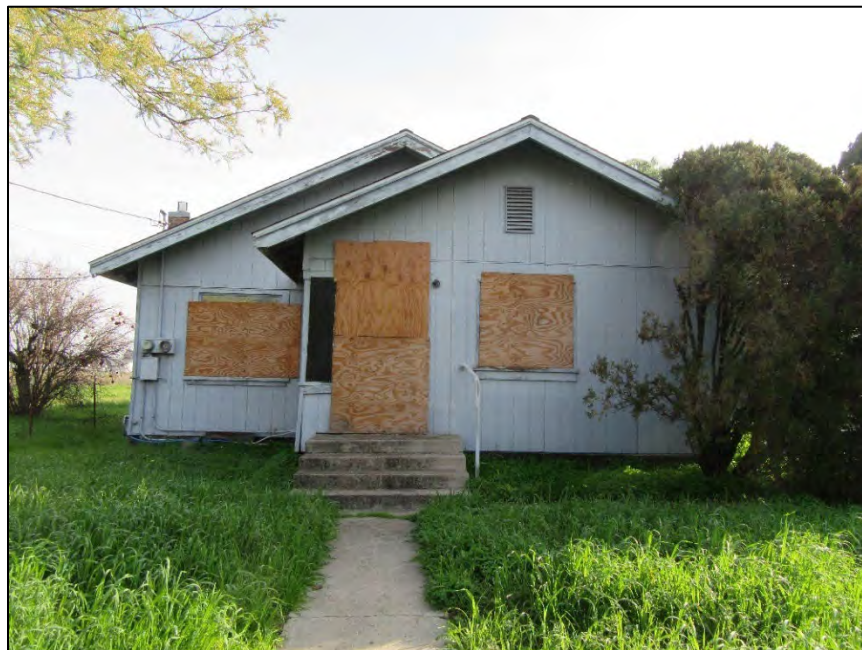
Figure 7. P-48-2003 residence; western facing façade (view east; January 13, 2021).

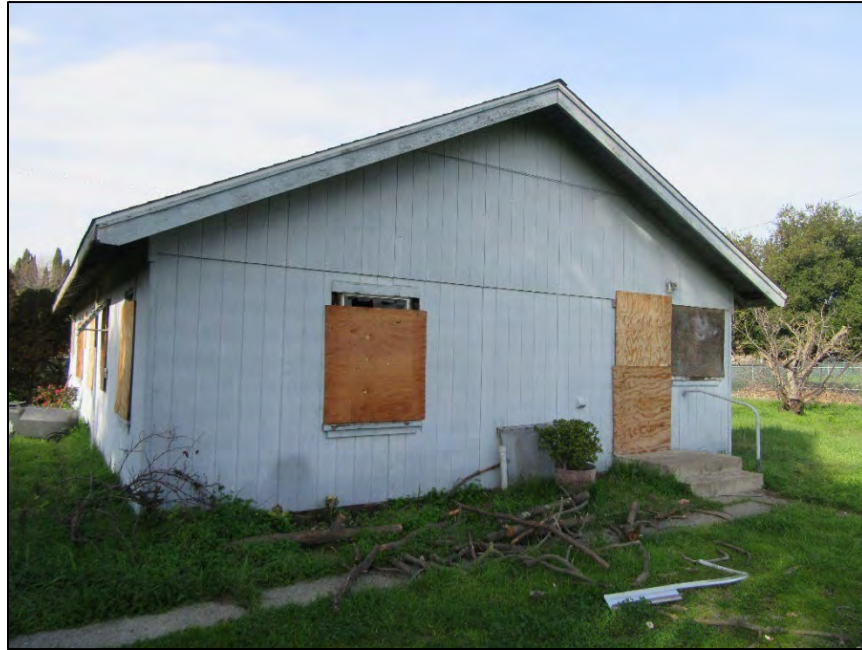
Figure 8. P-48-2003 residence overview (view west; January 13, 2021).

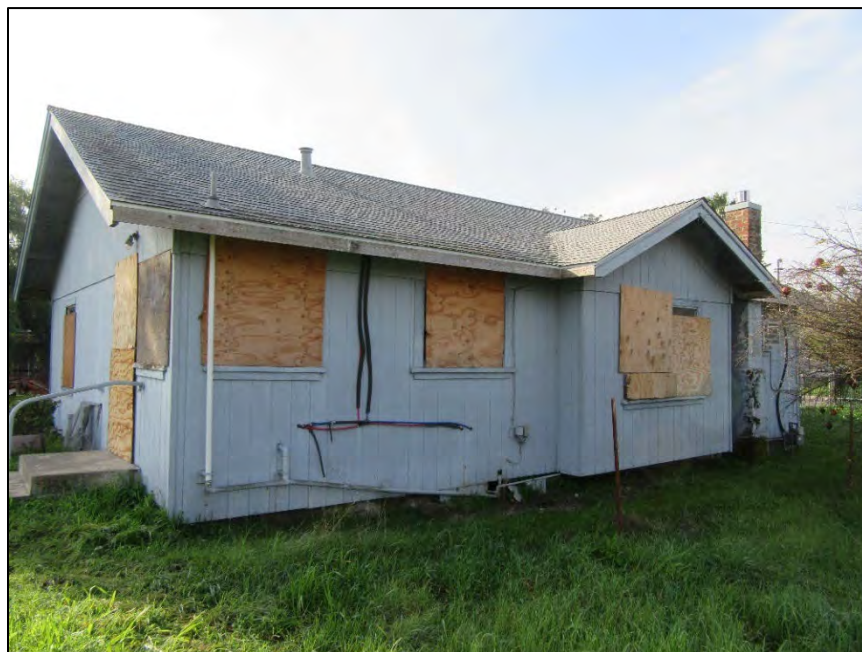
Figure 9. P-48-2003 residence; northern facing façade (view southwest; January 13, 2021).

During the property visit, it was observed that the fenestration on the exterior of the building consists of the original wood frame windows that have been boarded with plywood (Figure 8). Access to the house is provided by two single-entry doors that are located on the western and eastern facing façades. Each entrance has concrete stairs and a simple metal railing to access the building. The main entry is on the western facing façade and contains two front-facing gable roof lines. The northern facing façade also contains a boxed extension of the interior living space (Figures 9 and 10).

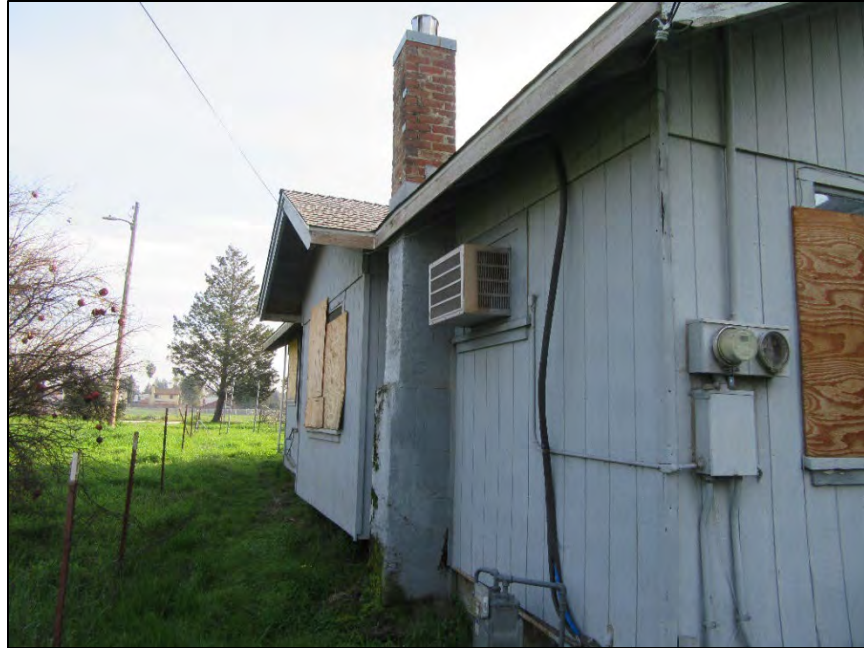
Figure 10. P-48-2003 residence; northern facing façade (view southeast; January 13, 2021).

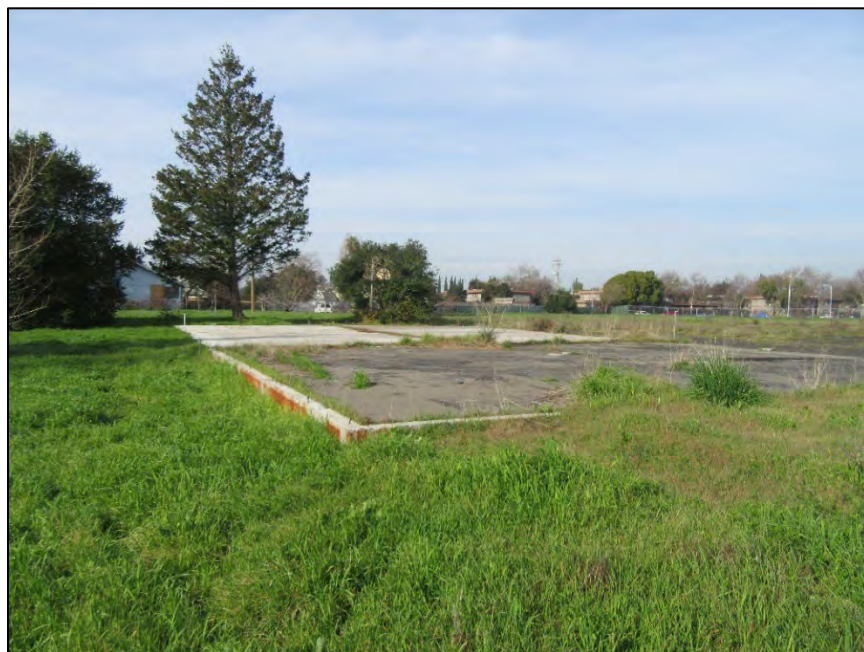
A concrete slab was observed 115 feet east of the house that has intact bolt and structure footings (Figure 11). It appears to have been a structure/warehouse in 1965 and was removed in early 2020 according to aerial photographs. A water tank is situated 40 feet south of the concrete pad and has an associated powered pump, presumably a well. Additional photographs of the residence are provided as Attachment B.

Figure 11. P-48-2003 residence; concrete pad to east (view west; January 13, 2021).
